Report on an Archaeological Watching Brief at the Church of St.Helen, Trowell, Nottinghamshire.

Church of St. Helen, Trowell, Nottinghamshire

Report Number: 153/2016

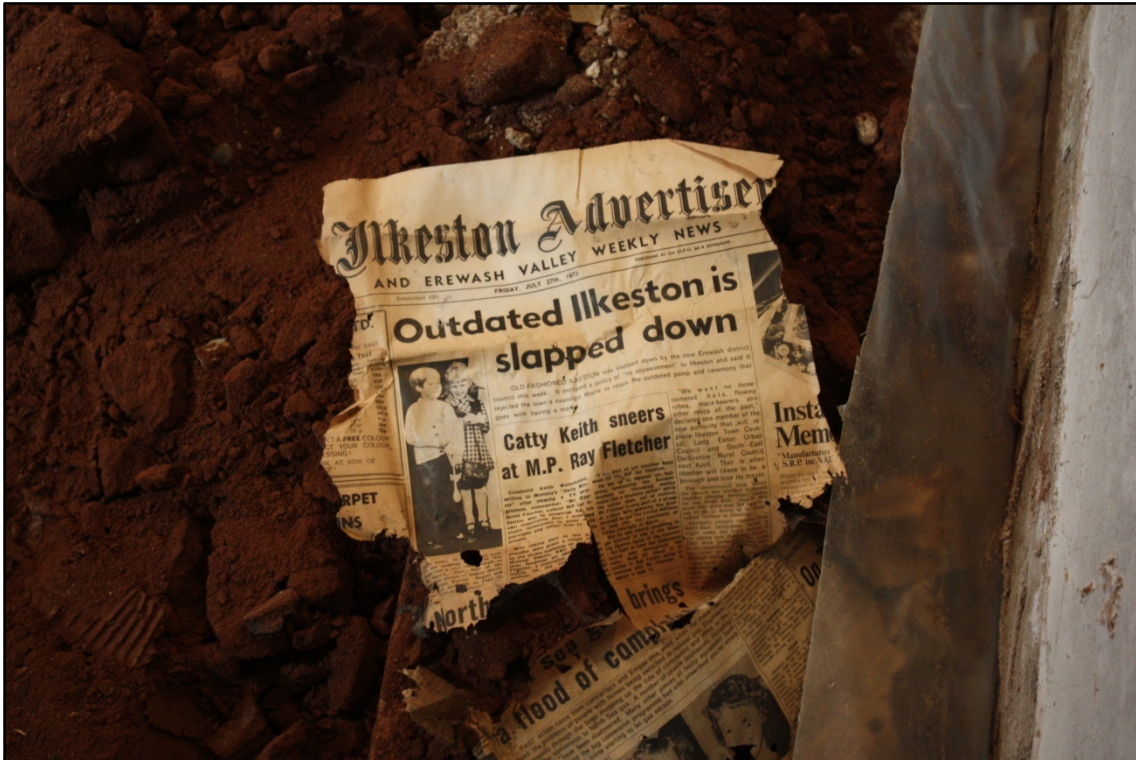
Plate 10: Fragment of c.1973 newspaper discovered beneath (0001).

- 6.2 (0001) comprised a layer of red sand present only at the East end of the chancel. A segment of a newspaper dated c.1973 (*plate 2*) was located at the base of this layer, and represents a separated depositional event, likely relating to the building of the new chapel porch to the East. This was seen as distinct from the late c.19th rising of the floor level in the chancel.

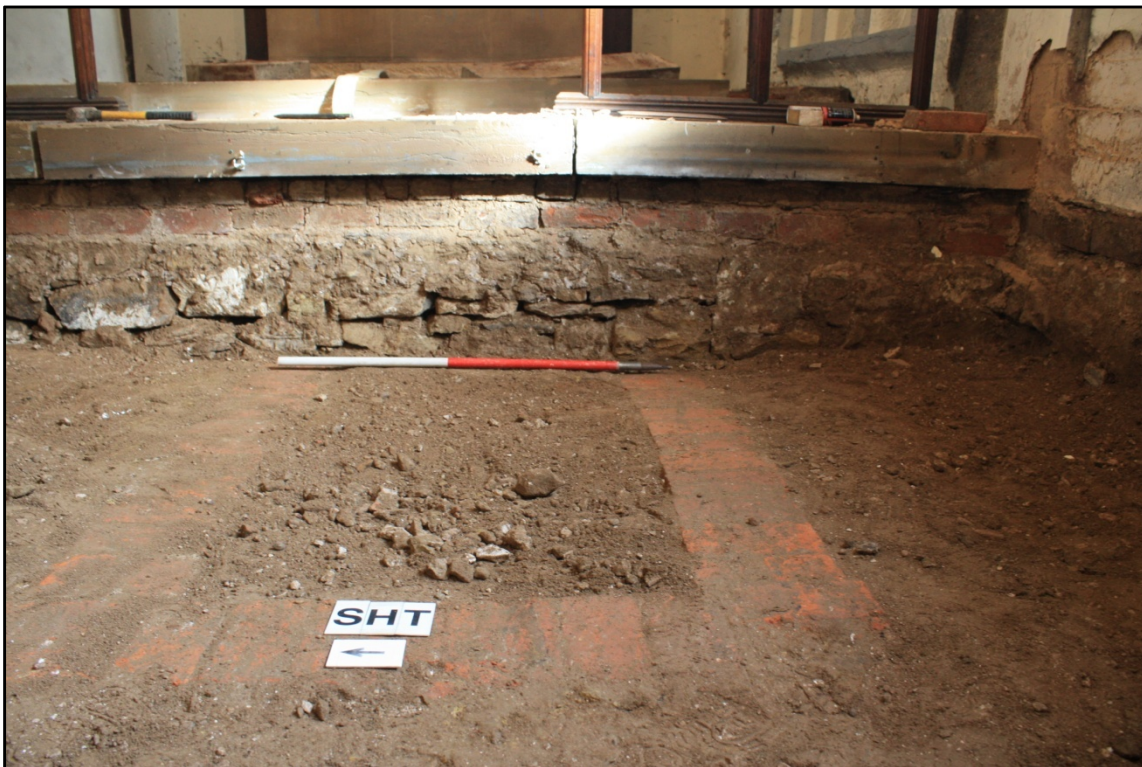
Plate 11: Brick grave vault [0007], partially uncovered with low stone and brick wall [0009] laid overtop. Looking East; Scale = 1m.

- 6.9 With the rubble layer, (0003), removed a rectangular brick burial vault, [0007], was observed. Only the existing top course of [0007] was revealed, no further excavation was required.

- 6.13 Two low brick and stone walls, [0009], and [0010], had been constructed across the chancel from the South wall to the North wall. [0009] ran across the upper course of brickwork of the grave vault [0007], and [0010] crossed above the possible foundation of [0011].

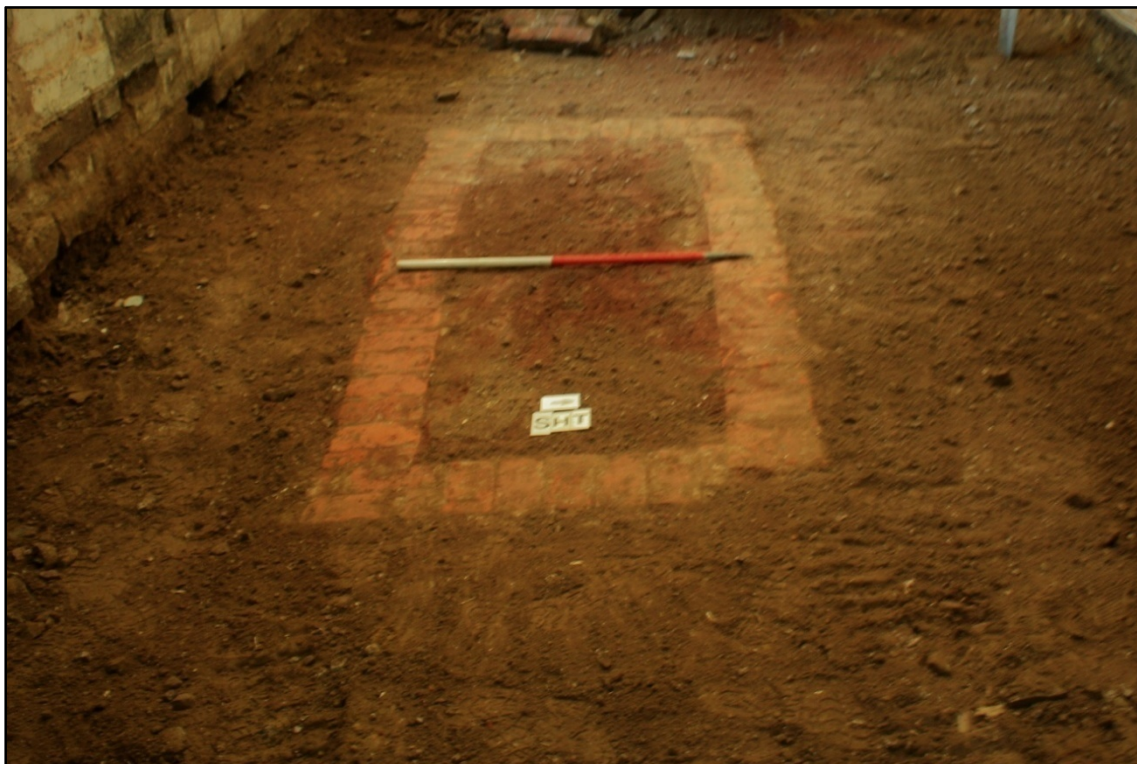
Plate 12: Brick grave vault [0007] completely exposed. Looking West; Scale = 1m.

- 6.10 A burial vault inside the church and indeed inside the chancel suggests that it belonged to a locally important family. There was, however, no plaque or slab present that identified who the vault belonged to. However, the window in the South wall above the vault depicts four brass plaques recording the deaths of the Evans family, (*Plate 5 and Appendix 2*), and it is possible that they are the occupants of the vault. The plaques date the internments to the late c.18th.

- 7.3 The brick grave vault, [0007], can tentatively be dated to the latter half of the 18th century. There was no dating evidence directly associated with the vault, and it may be that any slab covering it was removed during the work to raise the floor in the late 19th century. However, in the window recess above the vault on the South wall, there are four brass plaques that record the deaths and burials of the Evans family; the father, mother and two sons who died in childhood (see *Appendix 2*). The first of the children to die, Robert has the name Hacker inserted between his given name and surname. The Hackers were an important County family in Nottinghamshire in the 17th-18th centuries, and one of the immediate members of the family is commemorated with a memorial in the church. The memorial, now situated in the nave, is thought to have been moved at some point so that the actual site of the Hacker grave is lost. One member of the Hacker family in the 17th century had been a colonel in the New Model and had signed to death warrant of Charles Stewart in c.1649. Other members of the Hacker family had fought on the Royalist side in the Civil War. The insertion on the Hacker name in the brass plaque recording the death of Robert Evans suggests that this may have been his mother's maiden name and therefore links the probable occupants of the vault with this important family, which in turn explains the prominent location of the vault in the chancel floor, which had historically been reserved for wealthy patrons and benefactors.

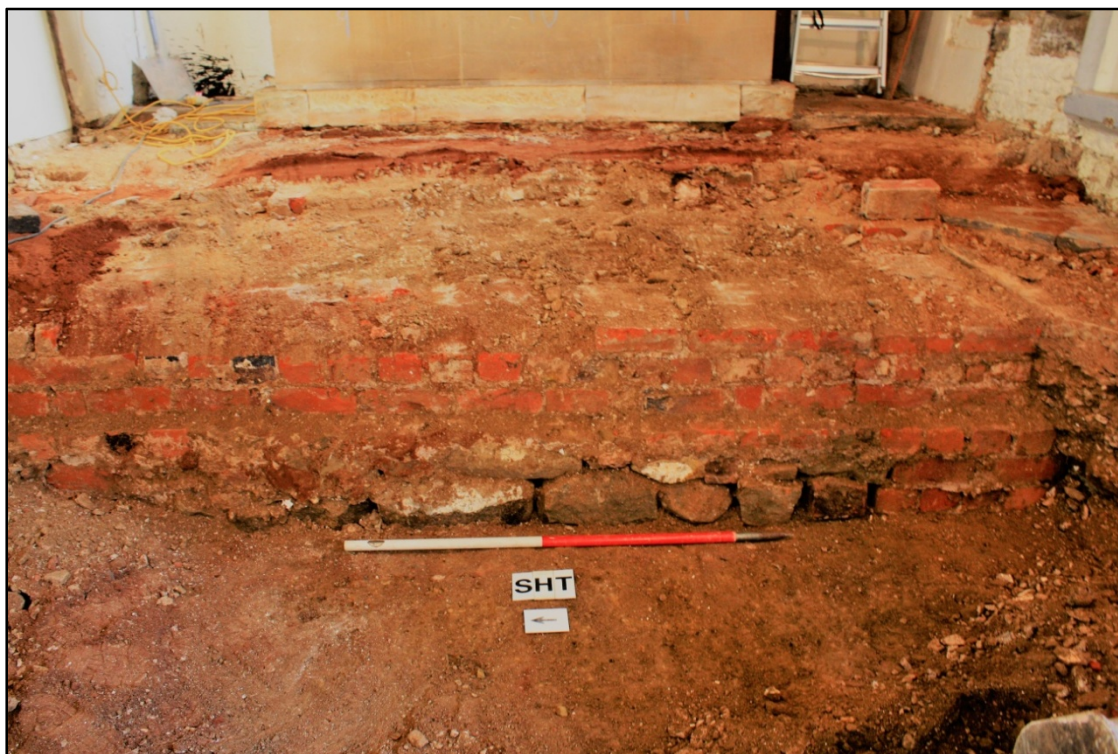
Plate 13: Stone and brick wall [0010] support for the raised chancel floor. Looking East; Scale = 1m.

- 6.14 The construction of [0009] and [0010] were the same, three courses of roughly worked sandstone, which was then topped by two or three brick courses. There is a possibility that the stone used in these walls, [0009], and [0010], were reused parts of the existing church fabric, but there is no indication of where in the church they may have come from. Their function, as part of the late c.19th restoration, would have been to support the newly raised floor.

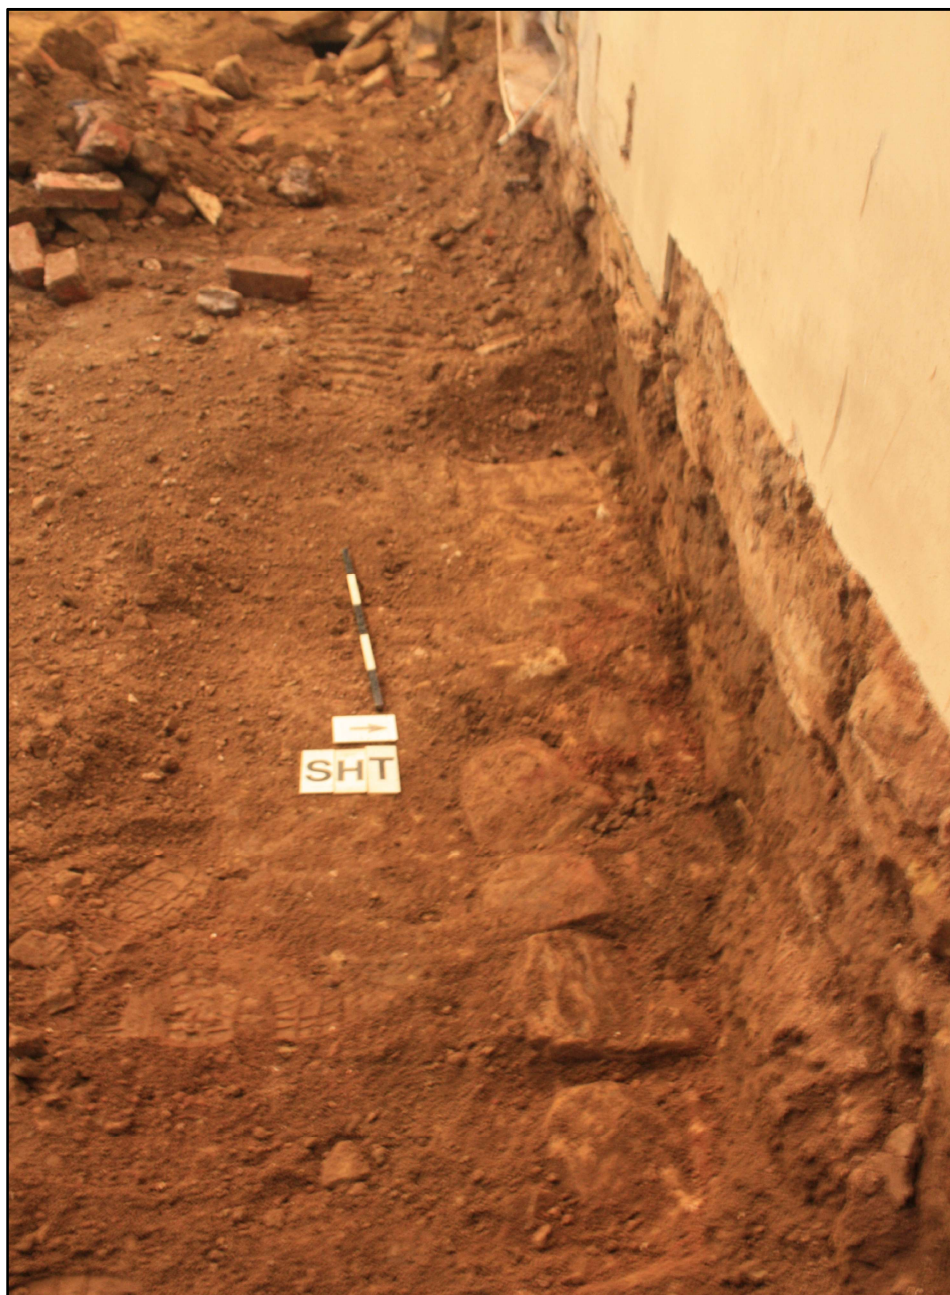
Plate 15: Possible remains of an early stone wall foundation [0011] running along the inside of the North wall of the chancel.
Looking West; Scale = 0.5m.

- 6.7 A line of roughly dressed stones, labelled [0011], was observed set into (0008) towards the North wall. The joints between the stones were packed with smaller pieces of stone rubble. The interpretation of [0011] cannot be stated with any certainty but their position may indicate a roughly organised foundation of an earlier structure on the site of the current chancel.
- 6.8 There were no finds associated with [0011] which would assist in establishing a date for the feature.

- 7.2 There are anecdotal records for the remains of the foundations of an earlier chancel which pre-dates the present c.1180 build. It is a possibility that [0011], the layer of stones along part of the North wall, are a part of these, though it is unlikely that they represent an *in-situ* structure. Such an interpretation can only be tentative since there was no dating evidence associated with [0011] and it did not extend the whole length of the North wall. There were no similar features observed along the South or East walls of the chancel.

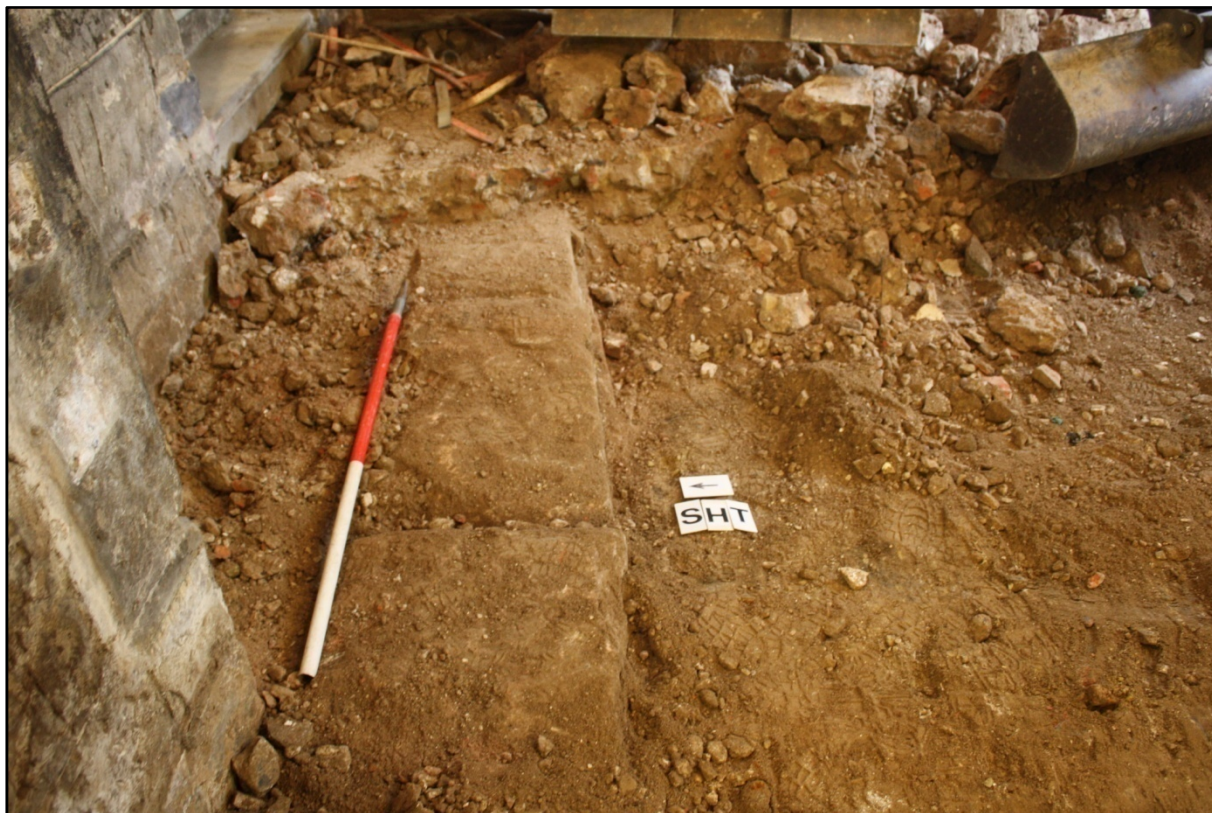
Plate 16: Stone capping [0005] of heating duct [0004], along the North wall of the chancel. Looking East; Scale = 1m.

- 6.12 Along both the North and South interior walls of the chancel, heating ducts had been installed [0004], [0006] during the raising of the floor in the late c.19th, over a period of restoration works. These comprised a small brick culvert into which the heating pipe was laid, which were topped off with sandstone slabs [0005], [0011]. The slabs on the north side of the chancel, [0005], were roughly worked and may have been robbed from earlier fabric in the chancel. Those on the south side, [0011], were much more regular in appearance and could conceivably have been brought in during the c.19th restorations.
