Anglian Water 10447508

Tattershall Lakes, Sleaford Road:

Report on Archaeological Monitoring

TPA Report Code: 036/2018

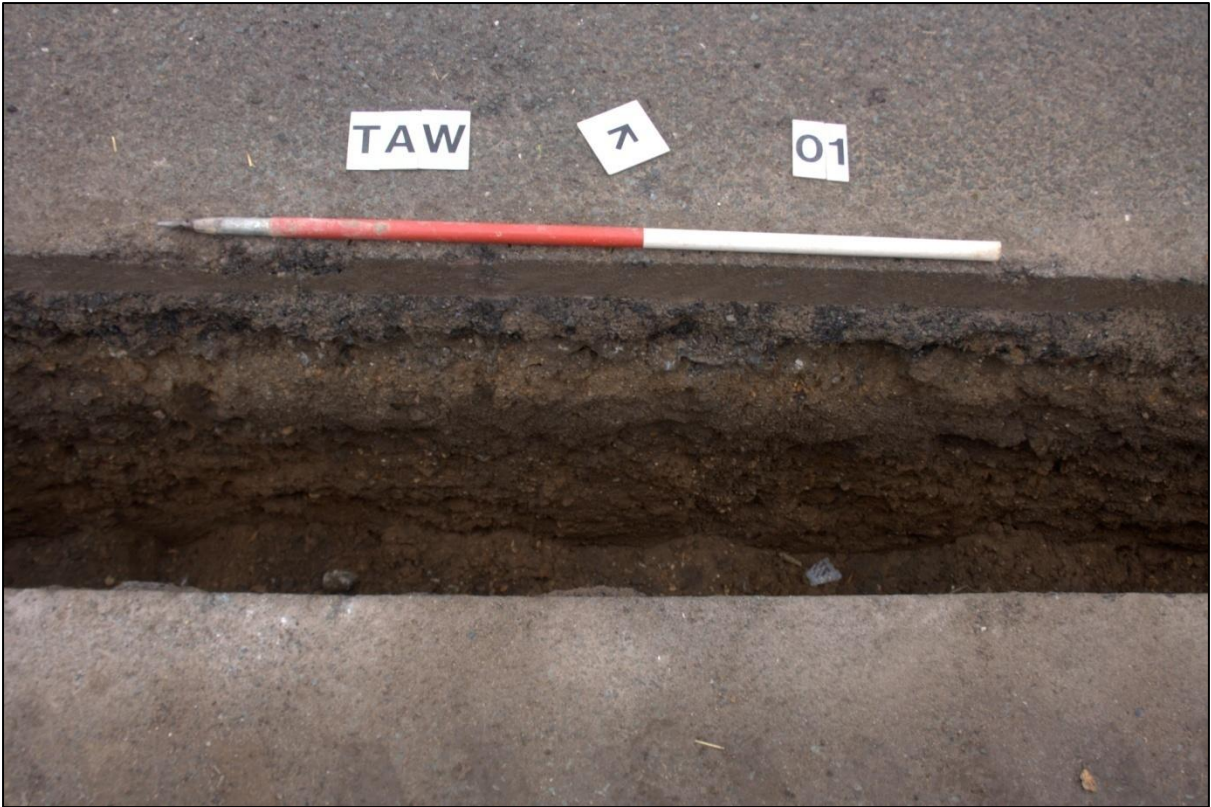
Plate 3: Stratigraphy within TR01, looking north. Scale 1m.

- 6.1.2 Trench 01 was machine excavated on an east-west alignment following a 300m stretch of Sleaford Road (Fig 2, Fig 3 Dr#1, Plates 3-5), measuring approximately 0.5m in width, which was excavated to a depth of 1.15m.

- 6.1.3 The basal layers within the observable limit of excavation constituted varying deposits of made ground (01003) and (01004), comprised of dark greyish brown and black silty sand, which was sealed by (01007), (01008) and (01009), and (01002) sporadically across the extent of the trench, formed of relatively sterile clayey sandy silty made ground deposits of varying thickness. These represent general dumping/ backfilling events preceding road creation, and subsequent service maintenance. All made ground deposits within trench 01 were sealed by hardcore (01001) to a depth of 0.28m, and finally by tarmac, which constituted the current road surface, at a depth of 0.1m across the site.

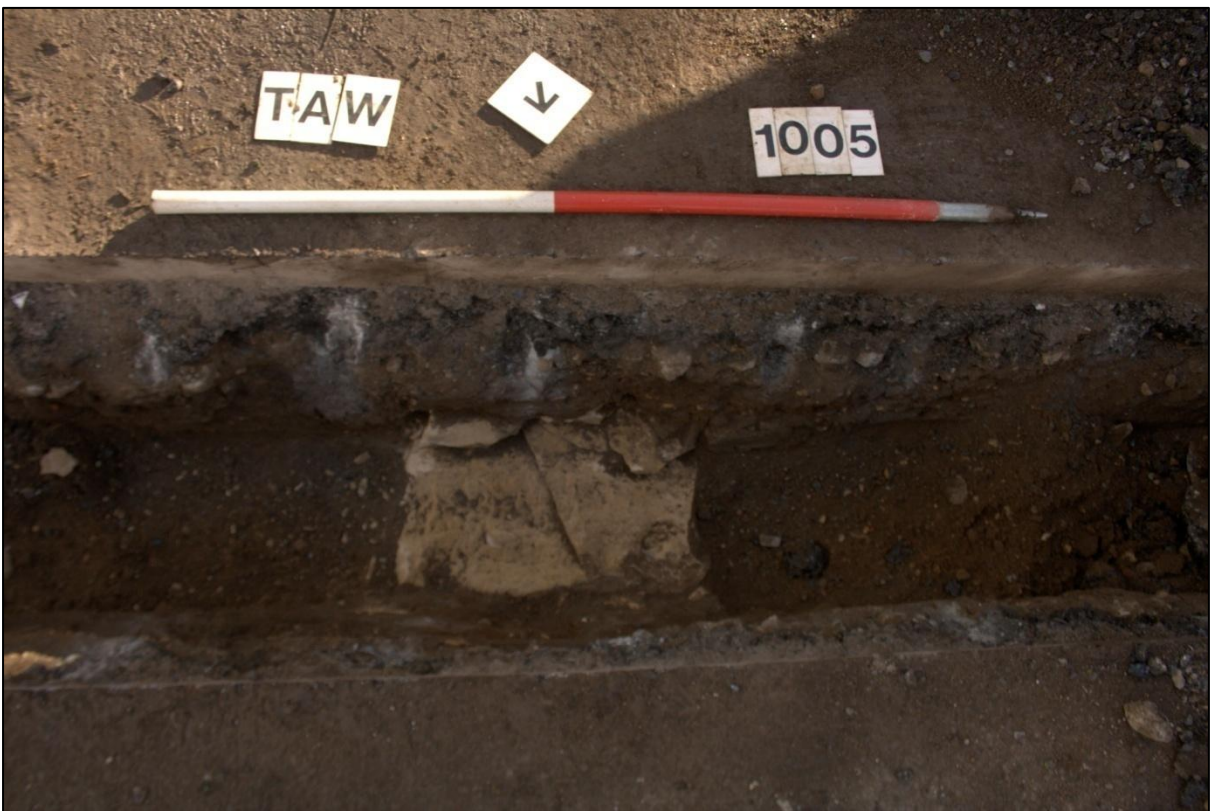
Plate 4: Sandstone block (01005) within TR01, looking south. Scale 1m.

- 6.1.4 Within trench 01, two separate sandstone blocks (01005) and (01006) were observed within modern made ground layers, approximately 0.50m below current ground level (Plates 4 and 5). These had to be removed by machine excavation and were found to overly further made ground deposits. The stone fragmented during removal and was not retained. Neither block showed evidence of working.

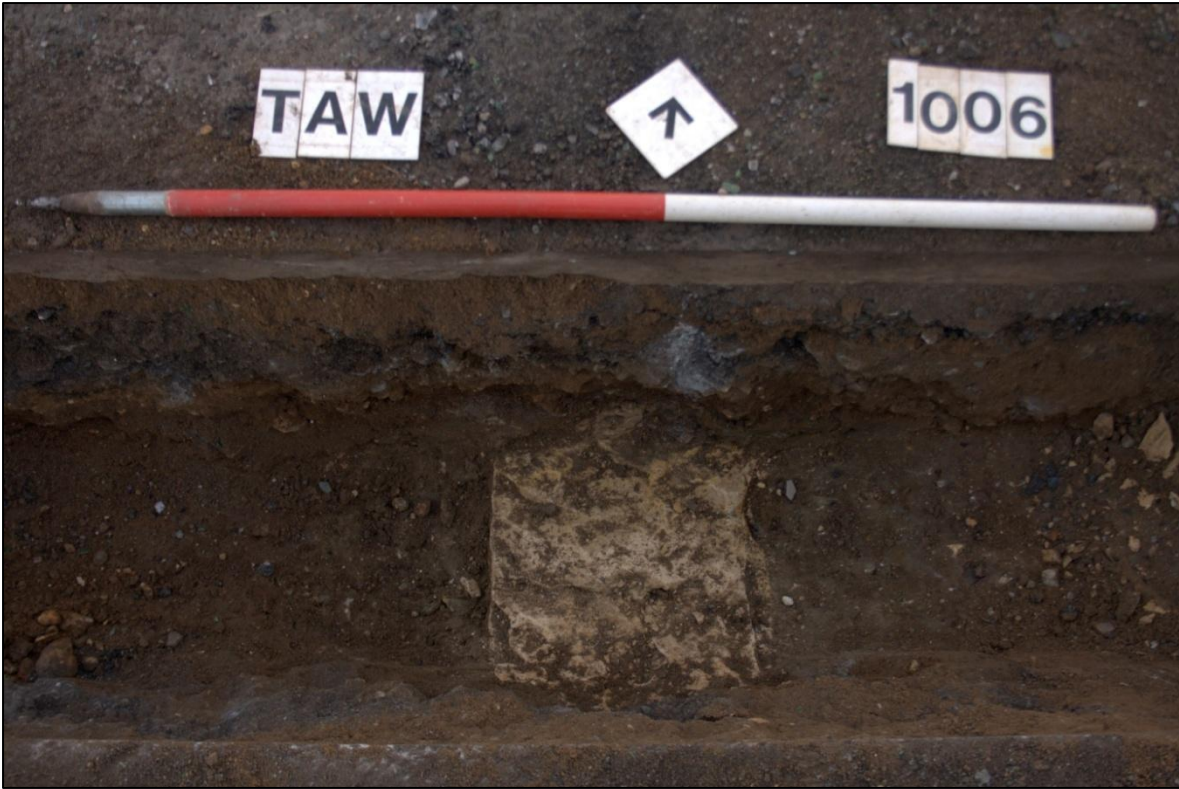
Plate 5: Sandstone block (01006) within TR01, looking north. Scale 1m.

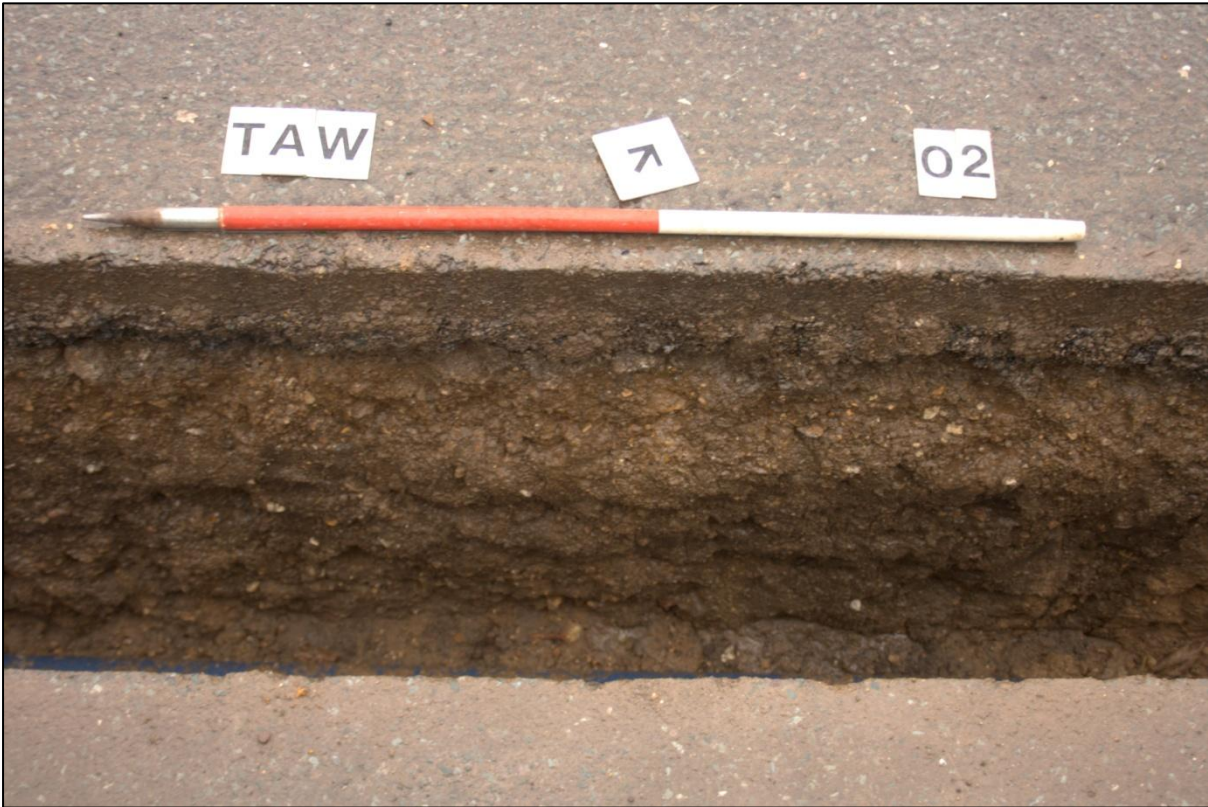
Plate 6: Stratigraphy within TR02, looking north-north-east. Scale 1m.

- 6.1.5 Trench 02 abuted the southeastern end of trench 01, which cut through a pedestrian walkway (Fig 2, Fig 3 Dr#2, Plates 6 and 7). This extension to trench 01 measured approximately 16m in length, 0.75m in width and was machine excavated to a maximum depth of 1.1m.
- 6.1.6 The basal layer within trench 02 comprised of dark greyish black sandy silt, (02005). The full depth of this deposit was not observed, but was machine excavated to a depth of 0.6m. This was sealed by (02004), and (02002) to a depth of 0.6m, comprised of varying deposits of sandy clay made ground, and (02003), forming a thin 0.02m band of tar. This was overlain by a layer of packed demolition rubble with a depth of 0.3m, and tarmac (02000), constituting the current road surface and walkway.

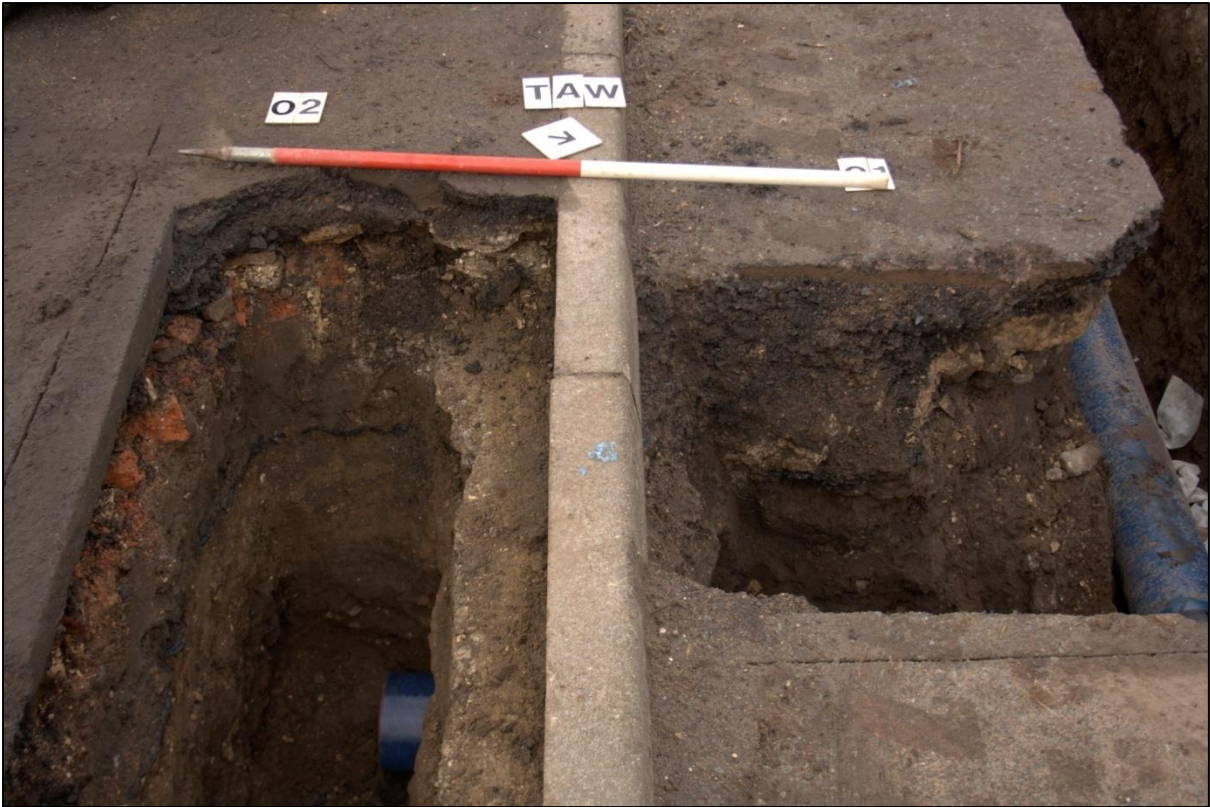
Plate 7: Stratigraphy within TR02 against the pedestrian walkway, looking west. Scale 1m

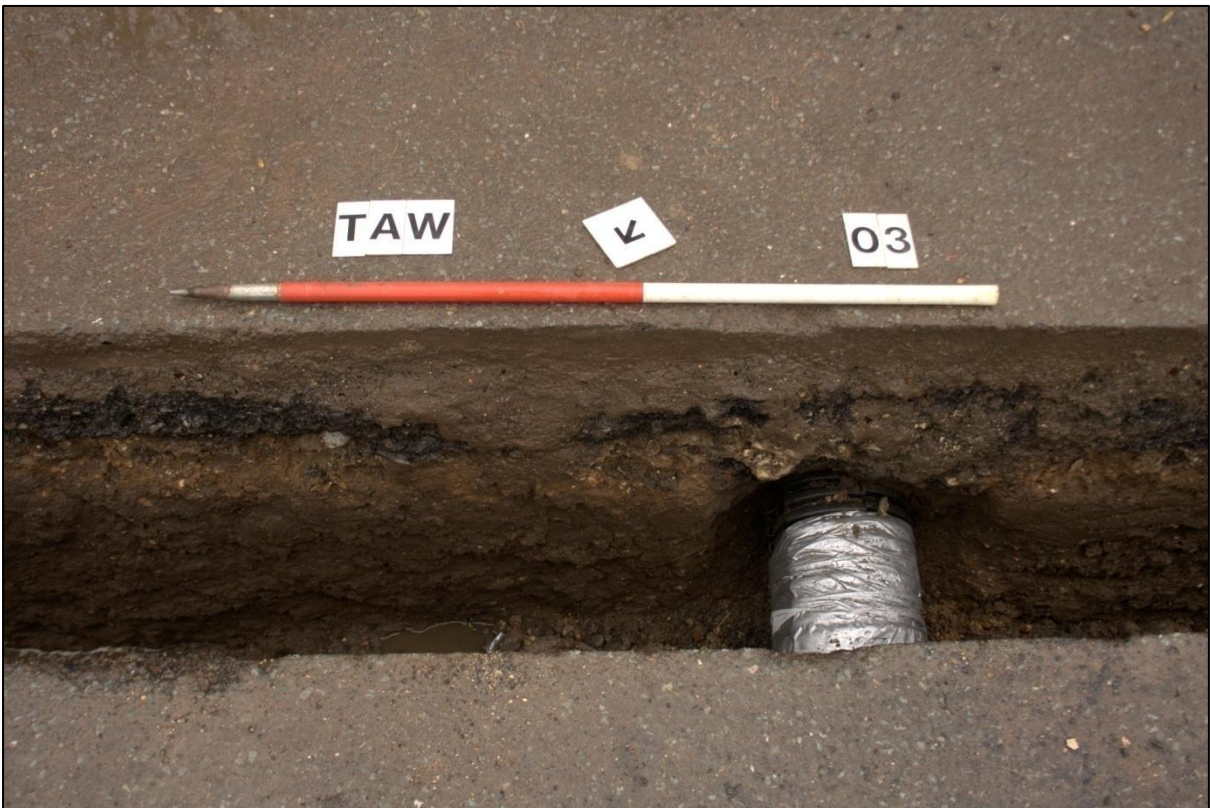
Plate 8: Stratigraphy within TR03, looking south. Scale 1m.

- 6.1.7 A small ancillary box trench was cut approximately 30m east of trench 02, measuring 2m x 1.6m x 1.03m, to facilitate water mains connections to exiting pipelines. The trench was backfilled immediately upon recording.
- 6.1.8 The basal fill recorded within trench 03 was (03004), which constitutes the same fill observed in (02005) and (01004). (03004) was sealed by (03003) and (03002), comprised of silty sandy made ground deposits with varied depth. These were sealed by demolition dump/ hardcore (03001) to a depth of 0.3m, and tarmac (03000) constituting the current road surface. A single cut for a north-south aligned known services trench was observed as [03005], which constitutes the extant water mains pipeline.

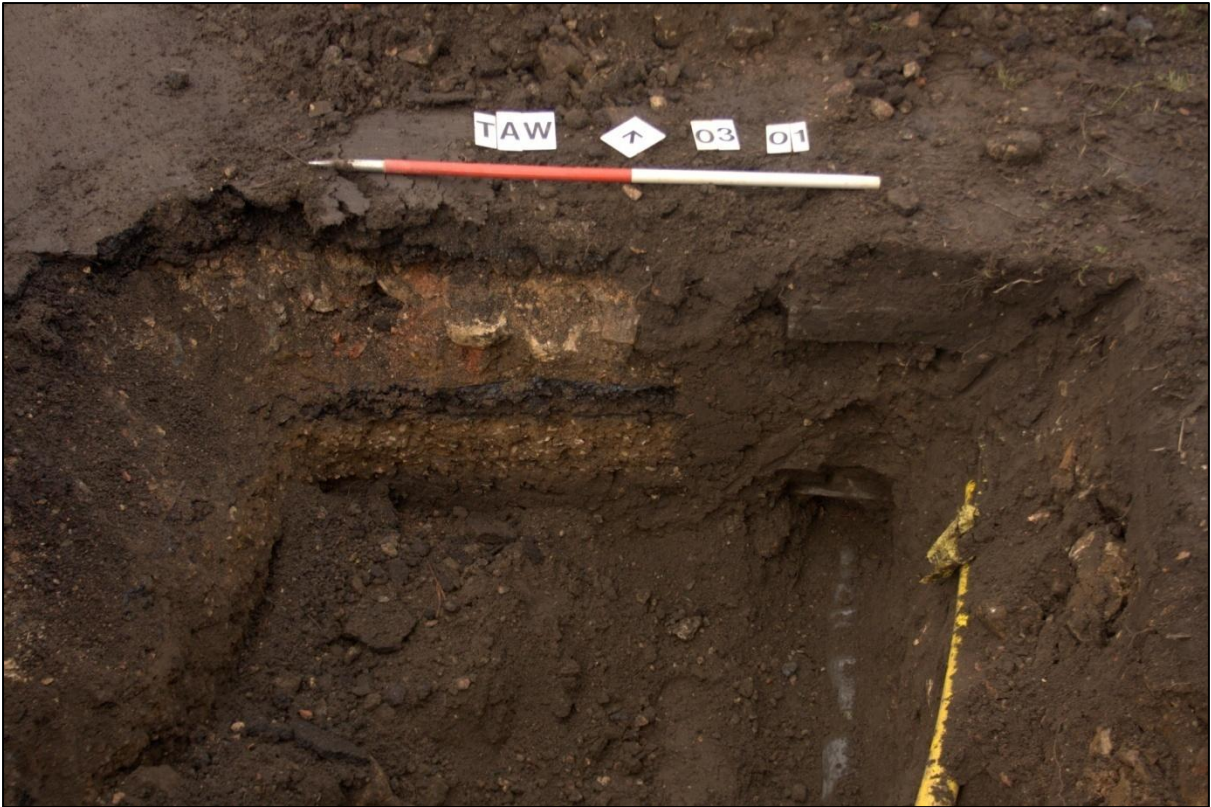
Plate 9: Deposits within TR03, looking north. Scale 1m.
