**100-104 Derby Road, Nottingham.
Archaeological Monitoring of Boreholes and Watching Brief
During Groundworks.**

TPA Report No: 094/2019

Document Title: 100-104 Derby Road, Nottingham. Archaeological Monitoring of Boreholes and Watching Brief.

Document Type: Draft Report

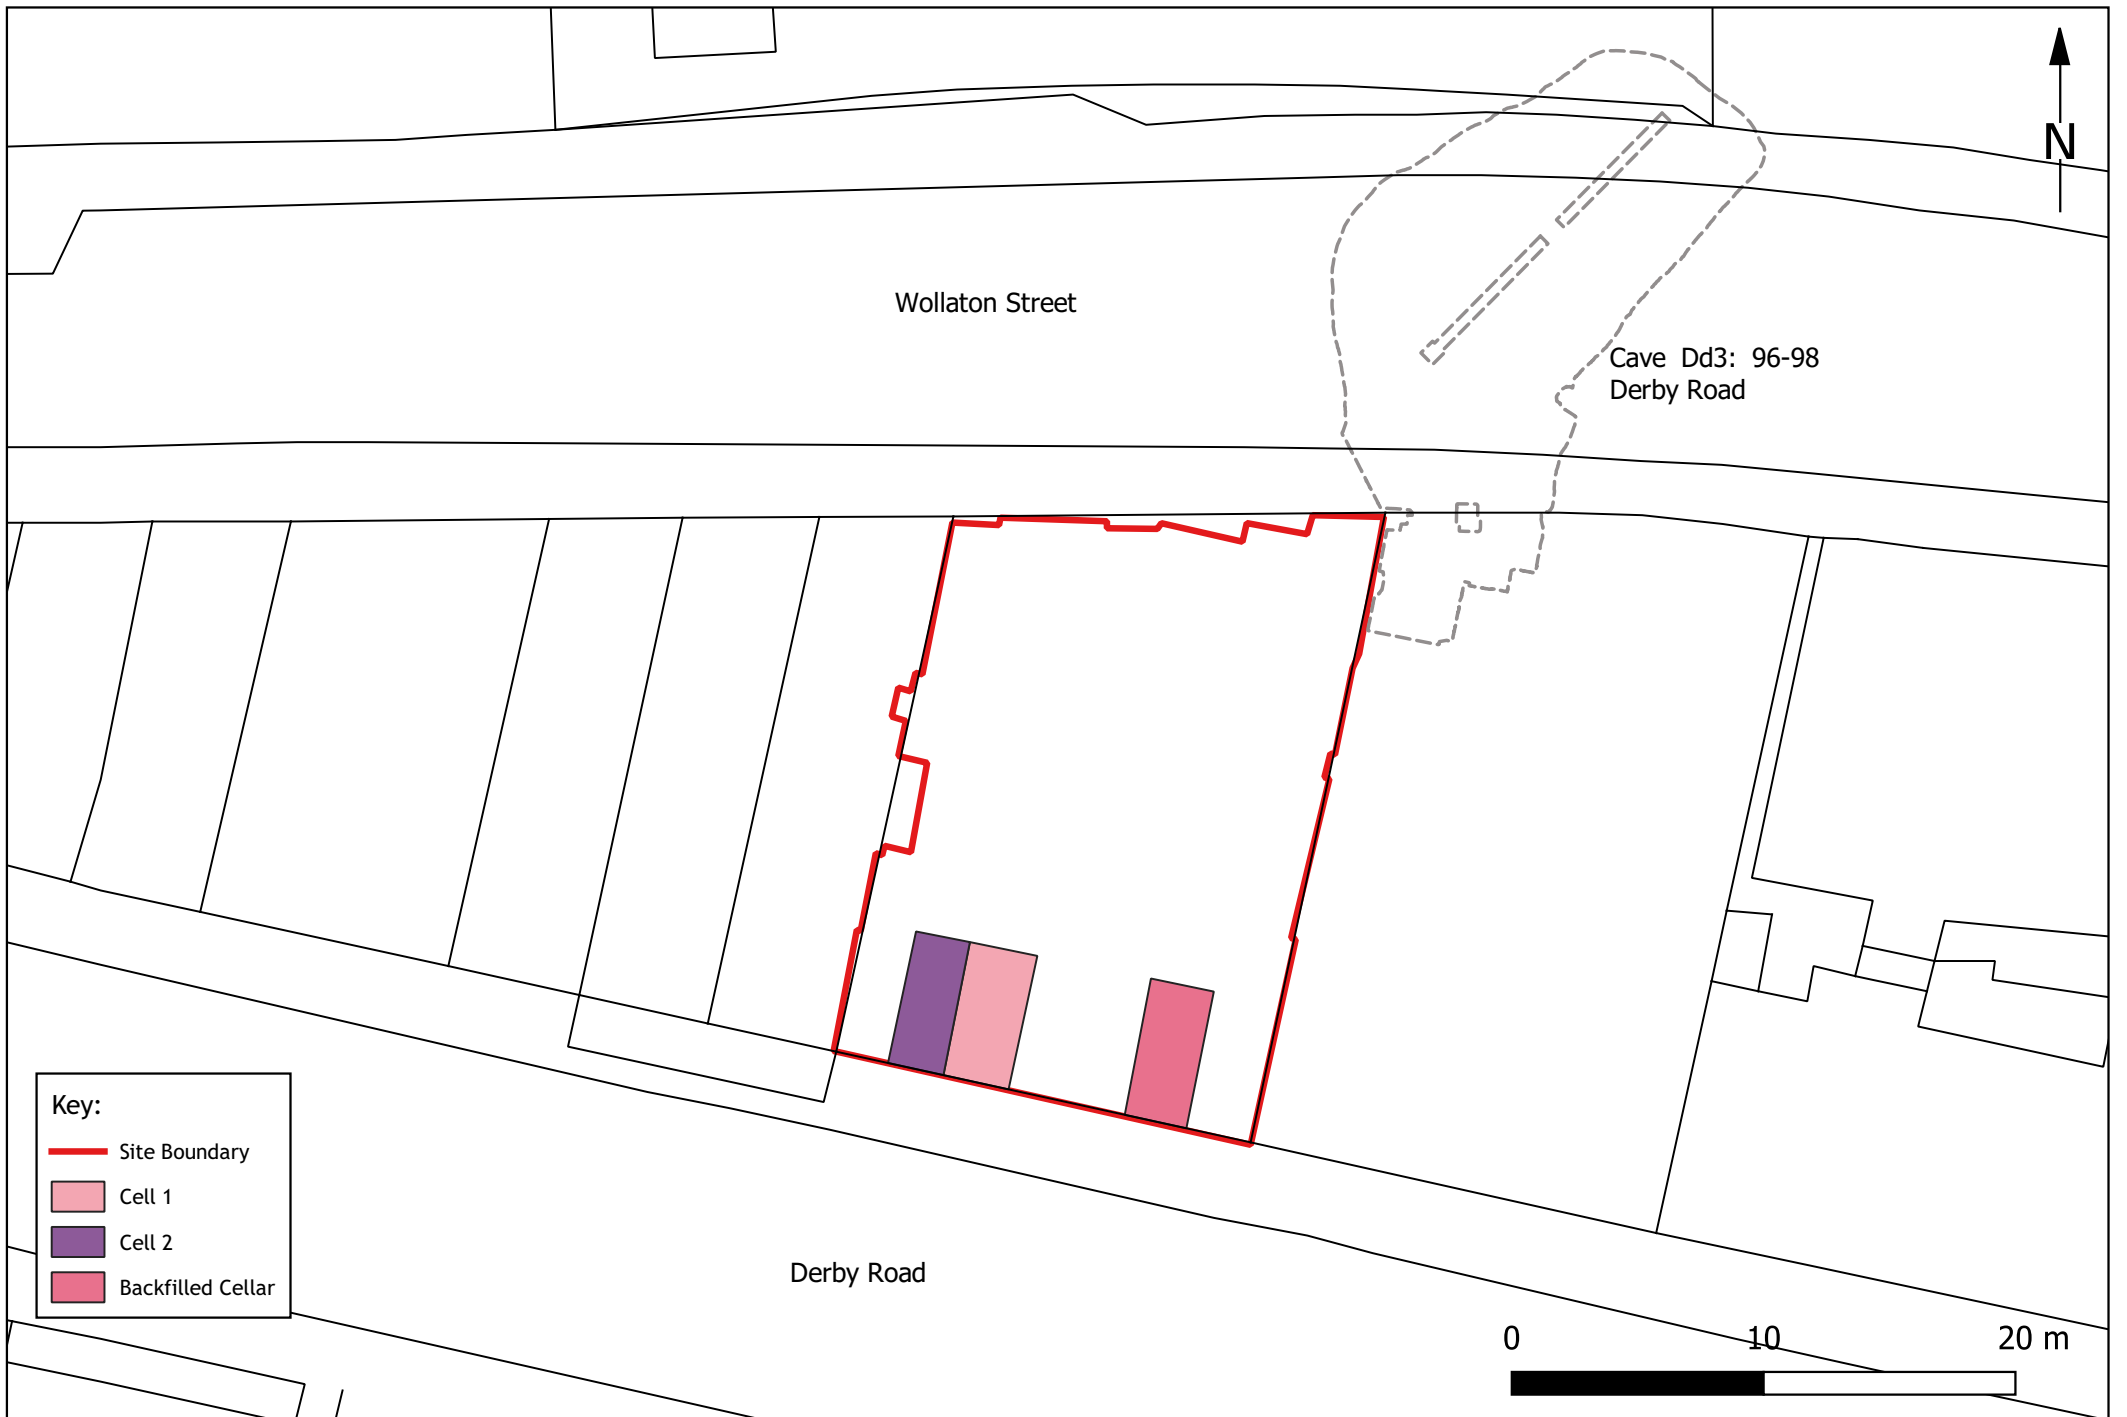
Figure 3: Location of built features exposed during ground reduction works
 Site Code: DBY

Key:

- Site Boundary
- Partially Exposed Wall
- Cellar Vault Remains
- Cellar Vault Arch
- Pile Locations

- 4.3.3. A follow up visit was made when this southern area of the site was due to be reduced. The cellar to the south-eastern corner of the site (Figure 3: Backfilled cellar, Plate 17), observed during the initial visit, was found to be backfilled with demolition material, with little of the overall structure surviving (Plate 18).

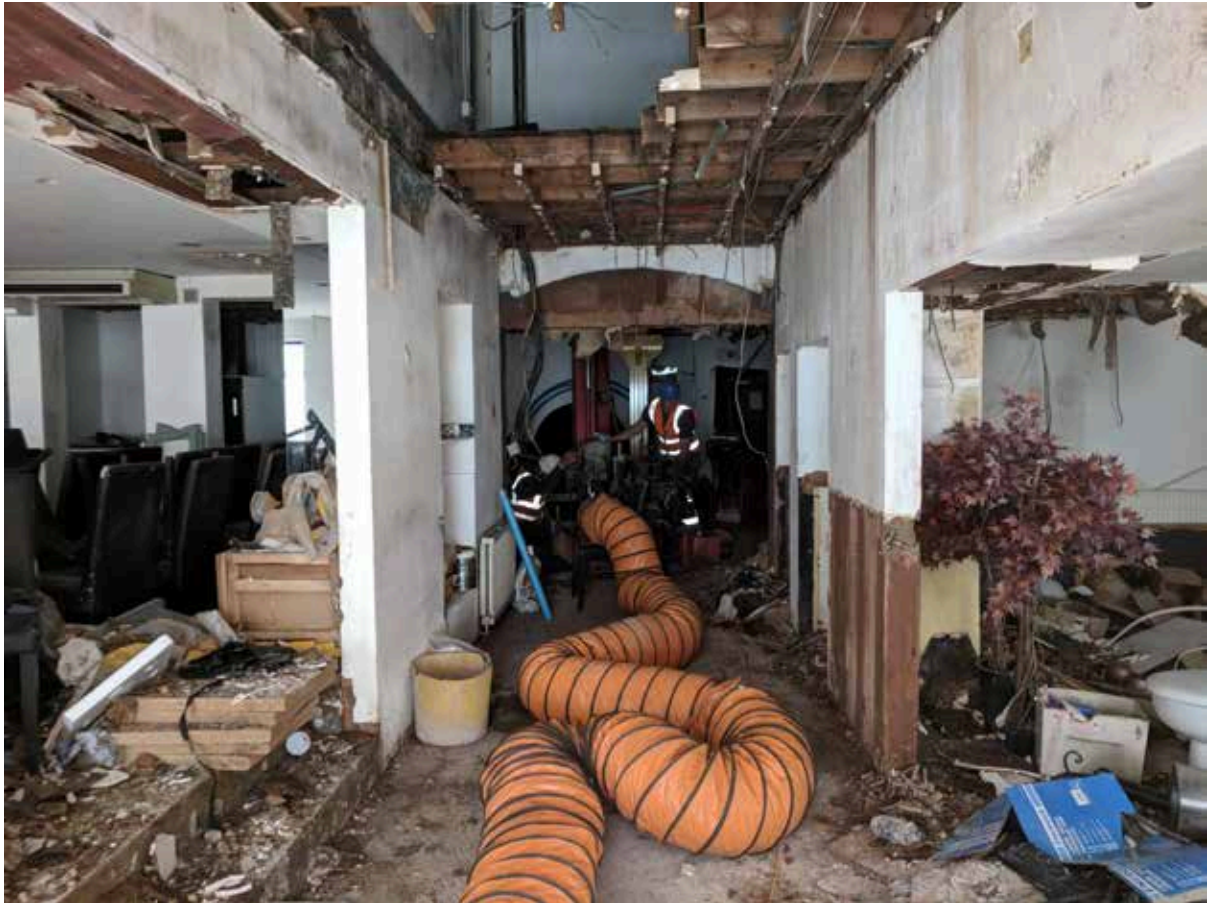
Plate 1: General shot of the drilling of WS04.

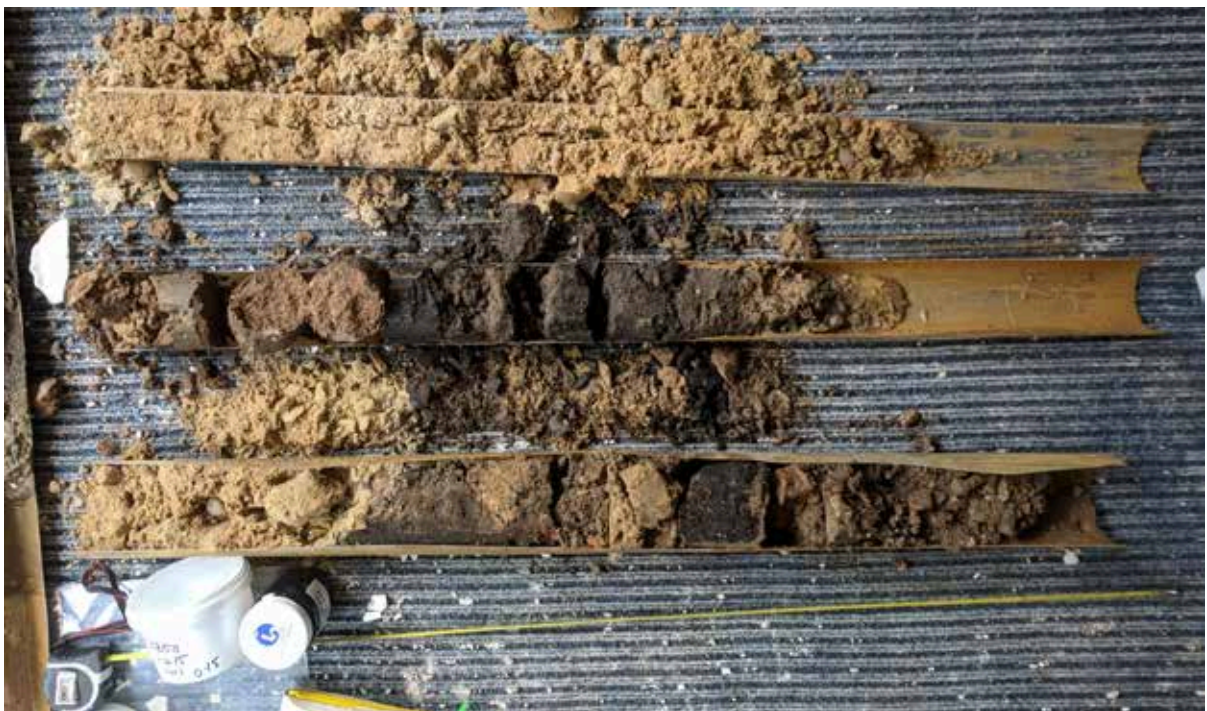
Plate 2: Complete cores from WS01. 0.00m is at the bottom right, on the lowest core. The cores can be read right to left, from bottom to top.

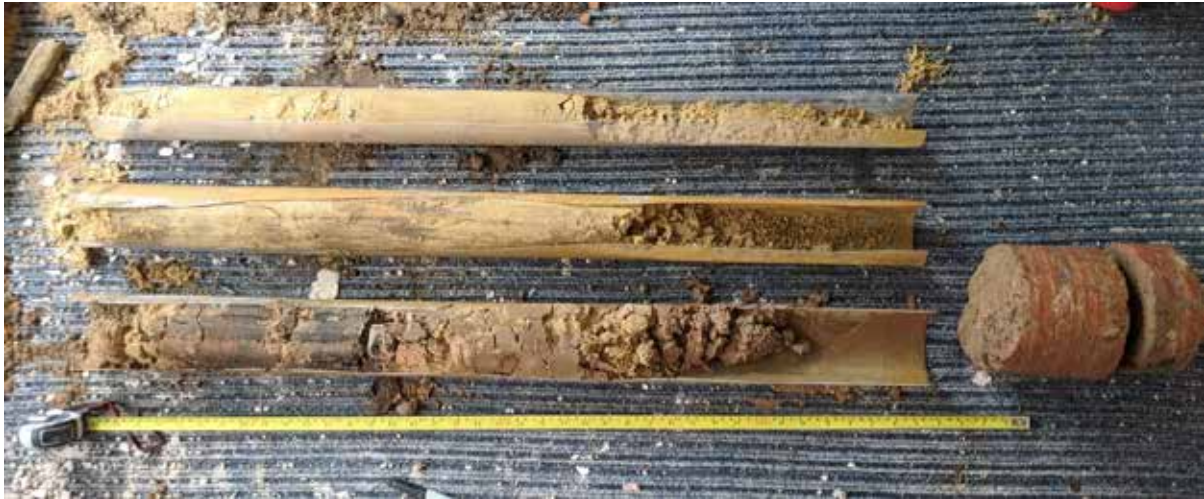
Plate 3: Complete cores from WS02.

4.1.3. WS02 was located at the back of the building and encountered the underlying bedrock geology of sandstone at 3.95m BGL (Figure 2, Plate 3). Overlying this was made ground material comprising mixed sands, containing degraded sandstone and modern CBM fragments between 3.95-0.35m BGL (Table 2). This was overlain by artificial levelling sand and gravel between 0.35-0.20m BGL, sealed by concrete between 0.20-0.00m BGL.

WS	Height (m AOD)	Top (mBGL)	Base (mBGL)	Description	Interpretation
02	69.00	0.20	0.35	Artificial levelling sand and gravels	Made Ground
02	69.00	0.35	0.70	Redeposited sand with frequent quartzite pebble inclusions and modern CBM fragments	Made Ground
02	69.00	0.70	0.90	Mixed dark mid brown silt sand with charcoal, modern CBM fragments.	Made Ground
02	69.00	0.90	2.00	Mixed redeposited yellow brown/grey sand with silt.	Made Ground
02	69.00	2.00	3.80	Loose degraded/weathered sandstone fragments and sand	Made Ground
02	69.00	3.80	3.85	Loose yellow brown/grey sand with charcoal fragments	Made Ground
02	69.00	3.85	3.95	Mid orange brown sand	Made Ground
02	69.00	3.95	4.00	Laminated yellow grey/brown weathered sandstone. Refusal.	Chester Formation

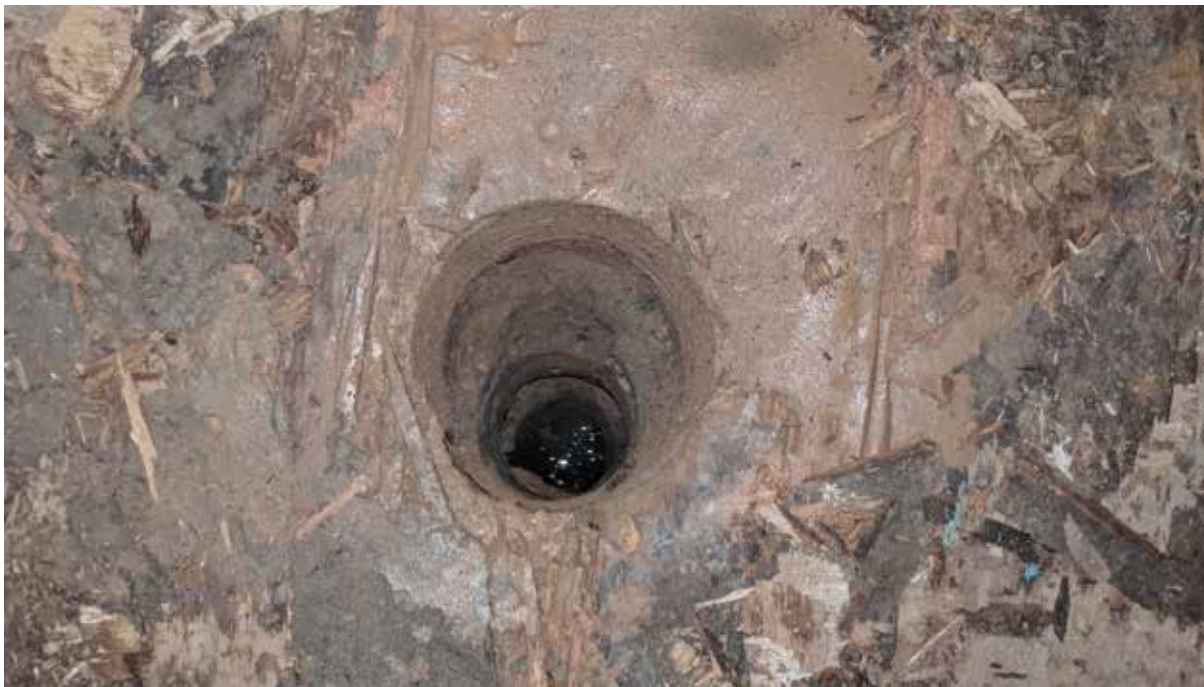
Plate 4: WS03 void. The borehole showing the void and water at approximately 1.10m BGL. There was no recordable recovery of the material in the first 1.30m from the ground surface due to it being very loosely compacted.

4.1.4. WS03 encountered was located at the back of the building on the western side and encountered a void at 2.70-1.30m BGL with refusal at 2.70m BGL (Figure 2, Plate 4). Overlying this void was a brick layer between 0.90-0.75m BGL, which in turn was overlain by mixed made ground material between 0.75-0.20m BGL (Table 3). This was sealed by the concrete floor of the building between 0.20-0.00m BGL. Ground water was observed at 1.40m BGL.

- 5.3.5. The sources of the voids and brick obstructions recorded in the initial window sample survey were ultimately not observed directly during the watching brief. It is possible that the brick obstruction in WS106 and the void in WS03 related to the brick wall and barrel-vaulted cellar which were partially recorded on the western side of the site (Figure 4). The source of the obstruction in WS103 is unknown but may also relate to the same cellar noted above. The same could be stated for the void in WS101 and WS105 which also encountered a brick obstruction. These may relate to the southern complex of cellars but this is uncertain.

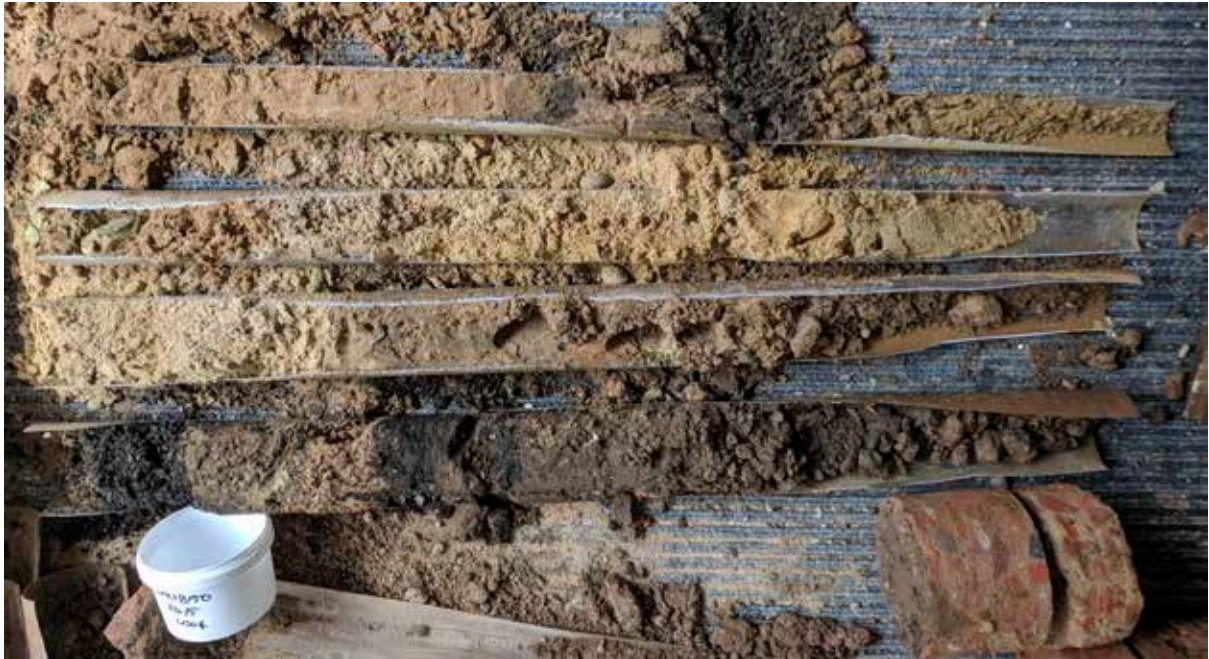
Plate 5: Complete cores from WS04.

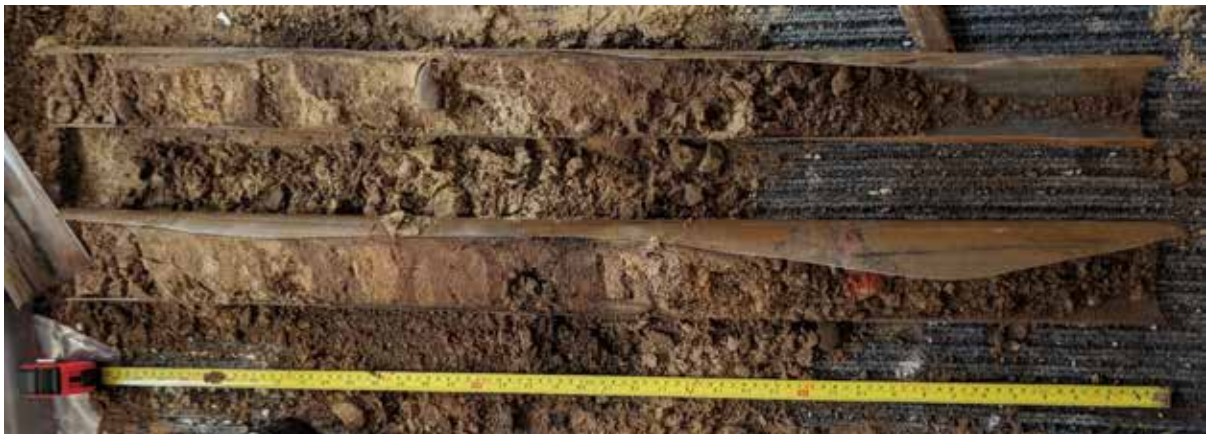
Plate 6: Complete cores from WS05.

WS	Height (m AOD)	Top (mBGL)	Base (mBGL)	Description	Interpretation
05	69.00	2.10	2.70	Degraded weathered sandstone with quartzite pebbles. Refusal at 2.70	Chester Formation

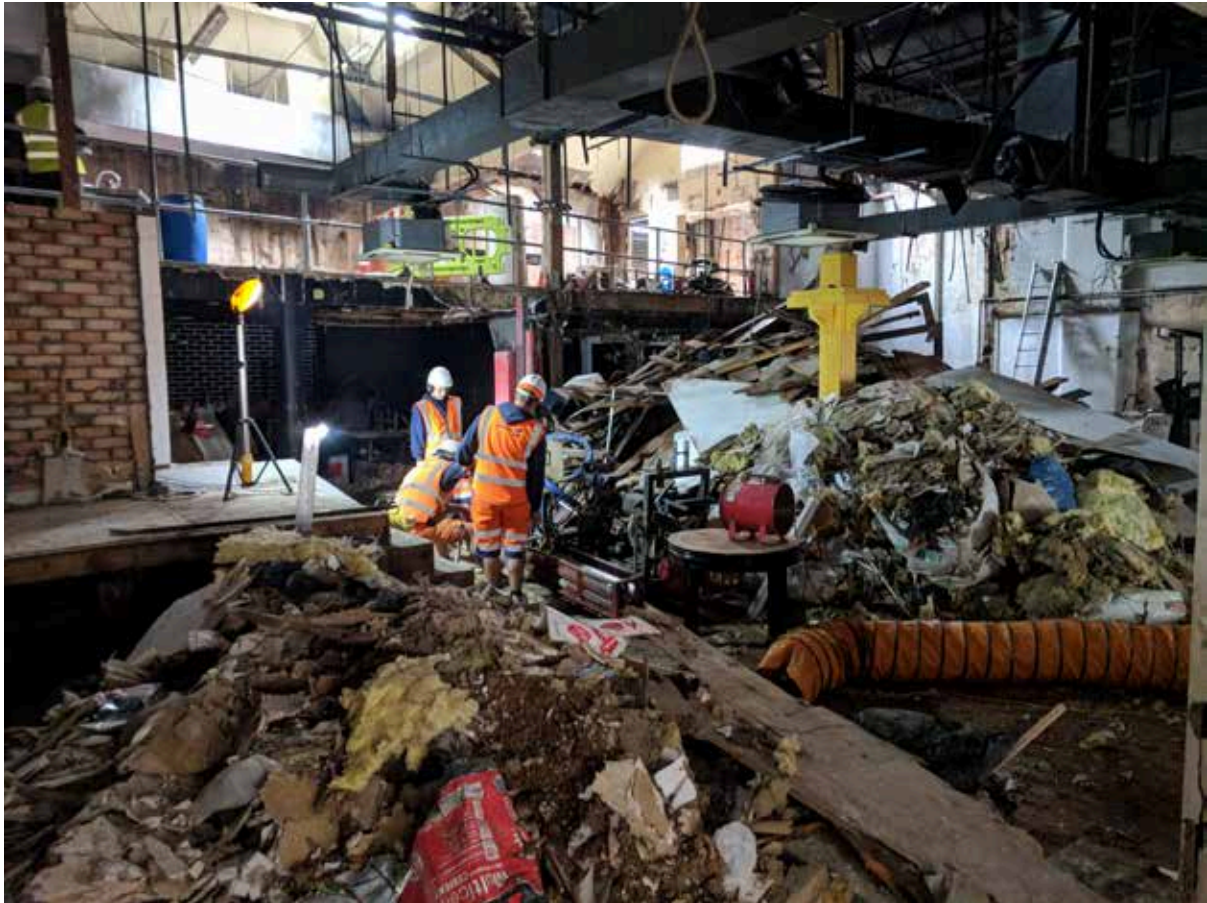
Plate 7: General shot of the drilling of WS106

4.2.1. A total of seven additional window sample boreholes were monitored (Figure 2, Plate 7, WS101-107). The borehole descriptions are outlined in the tables below, in addition to interpretations. Locations are approximate, based on the geotechnical contractor reporting. The heights (m AOD) are based on client provided elevations.

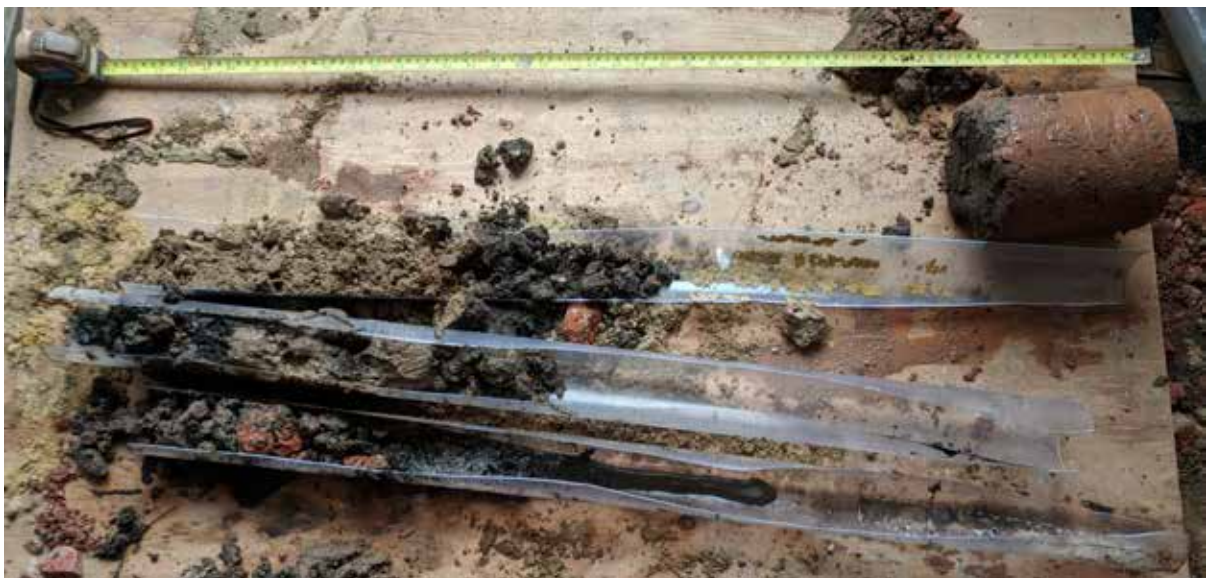
Plate 8: Complete cores from WS101

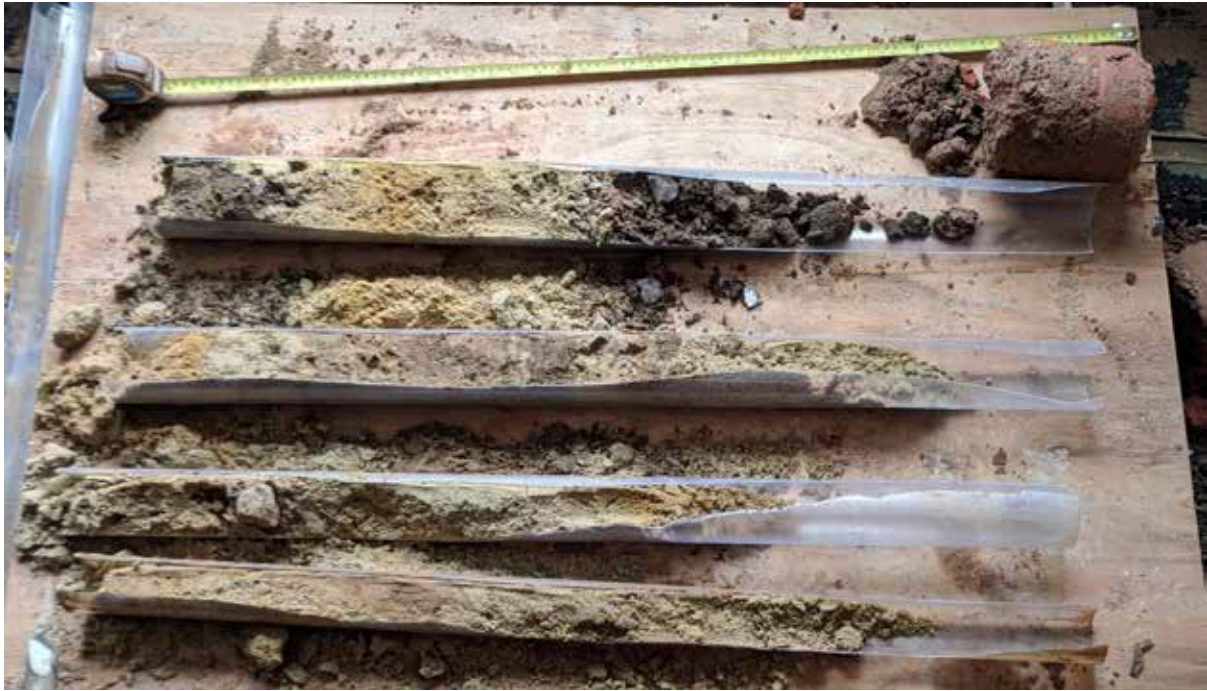
Plate 9: Complete cores from WS102. Top to bottom, right to left.

WS	Height (m AOD)	Top (mBGL)	Base (mBGL)	Description	Interpretation
102	69.00	1.80	4.00	Top of degraded sandstone. Refusal at 4.00m	Chester Formation

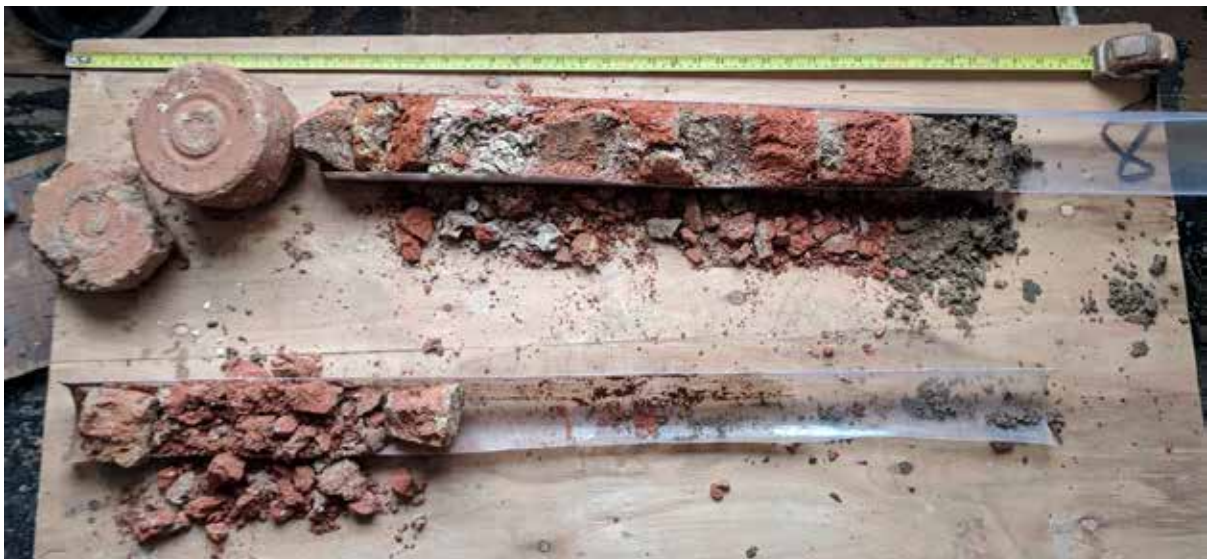
Plate 10: Complete cores from WS103. 0.00-1.00m top to bottom, left to right.

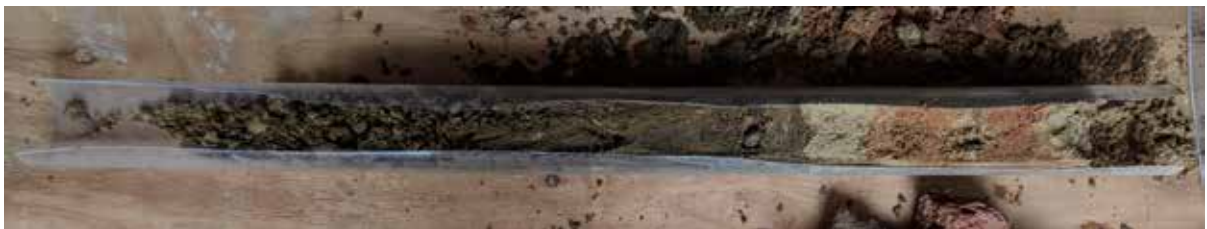
Plate 11: The core from 1.00-2.00m BGL (left to right) from WS104. 0.00-1.00m was concrete and brick which was cored and was unphotographable.

WS	Height (m AOD)	Top (mBGL)	Base (mBGL)	Description	Interpretation
104	69.00	0.00	0.25	Concrete	Made Ground
104	69.00	0.25	0.90	Modern bricks with mortar	Made Ground
104	69.00	0.90	1.00	Mixed sand, CBM fragments	Made Ground
104	69.00	1.00	1.50	Laminated weathered sand	Made Ground
104	69.00	1.50	2.00	Degraded sandstone. Refusal.	Chester Formation

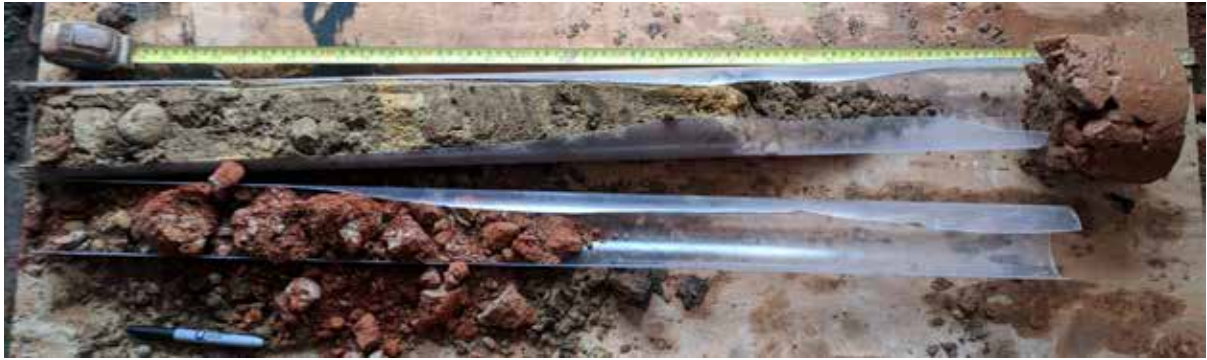
Plate 12: Complete cores from WS105 showing brick obstruction. Top to bottom, right to left.

4.2.6. WS105 was located between WS02 and WS03 and encountered a brick obstruction at 1.00m BGL, with refusal at 1.70m permitting no further progress (Figure 2, Plate 12). Overlying this from 1.00-0.15m was made ground comprising mixed sand, modern CBM fragments, and fragments of degraded sandstone, sealed by concrete between 0.15-0.00m BGL (Table 10).

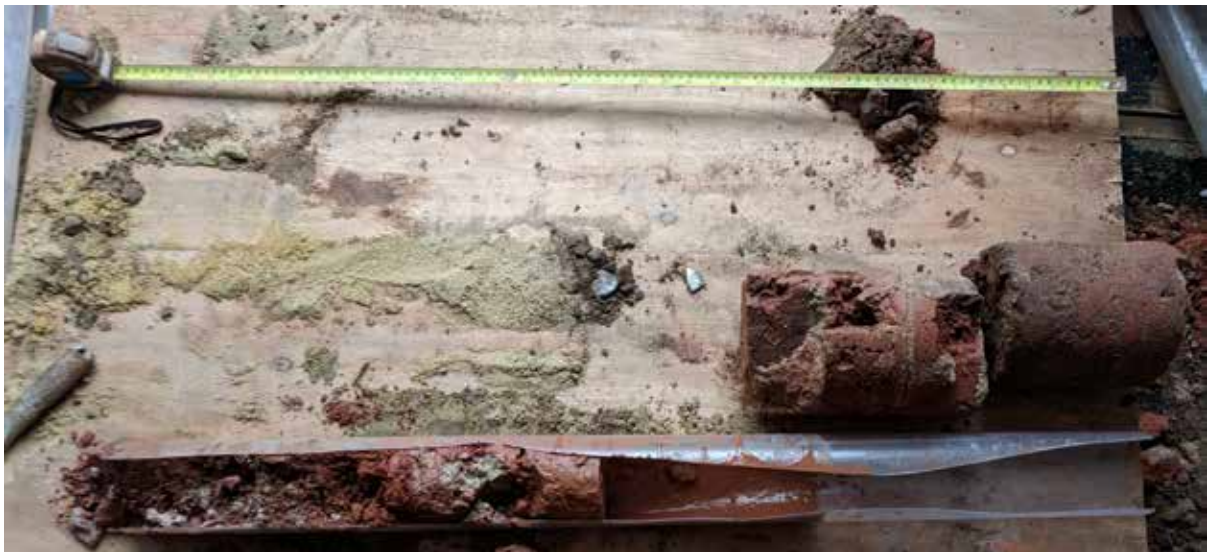
Plate 13: Complete core from WS106 showing brick obstruction. Right to left.

4.2.7. WS106 was located between WS03 and WS05 and encountered a brick obstruction at 0.40m BGL, with refusal at 1.00m inhibiting further progress (Figure 2, Plate 13). The same brick material was observed between 0.40-0.15m BGL, which was sealed by concrete between 0.15-0.00m BGL.

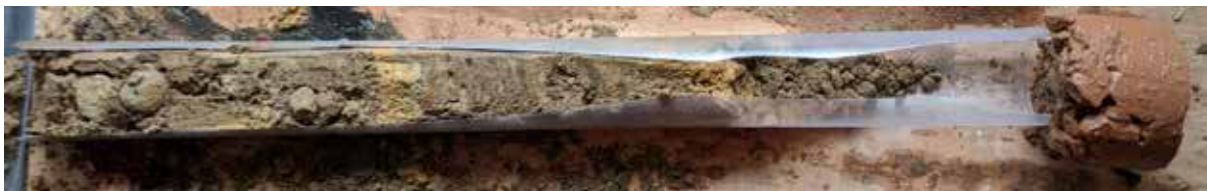
Plate 14: Partially complete core (0.00-1.00m, right to left) from WS107. 1.00-1.60m was unrecoverable.

WS	Height (m AOD)	Top (mBGL)	Base (mBGL)	Description	Interpretation
107	69.00	0.00	0.15	Concrete	Made Ground
107	69.00	0.15	0.80	Mixed sand with charcoal flecks/smears, modern CBM fragments	Made Ground
107	69.00	0.80	1.00	Mixed sand with sandstone fragments, modern CBM	Made Ground
107	69.00	1.00	1.40	Darker mixed sand with sandstone fragments and rubble.	Made Ground
107	69.00	1.40	1.60	Yellow brown degraded sandstone	Chester Formation

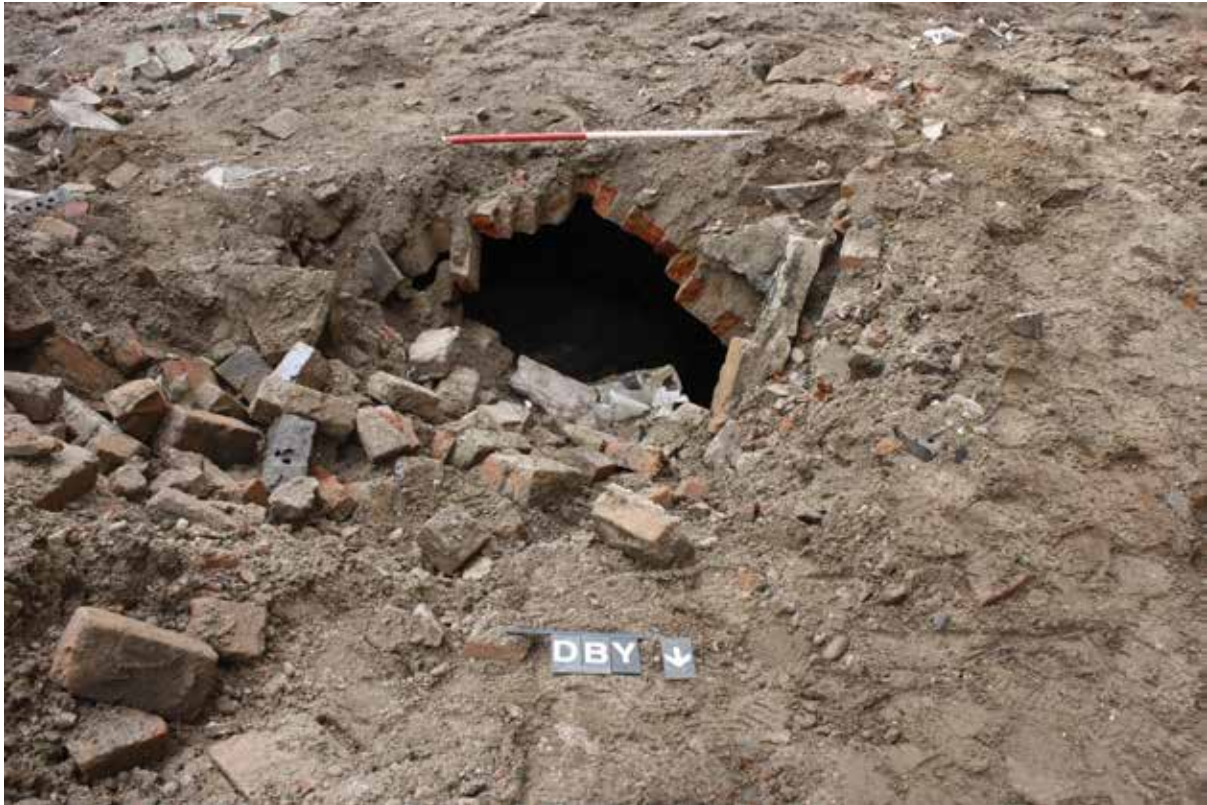
Plate 15: Cell 1 entrance, looking south, prior to ground reduction, post-structural demolition.

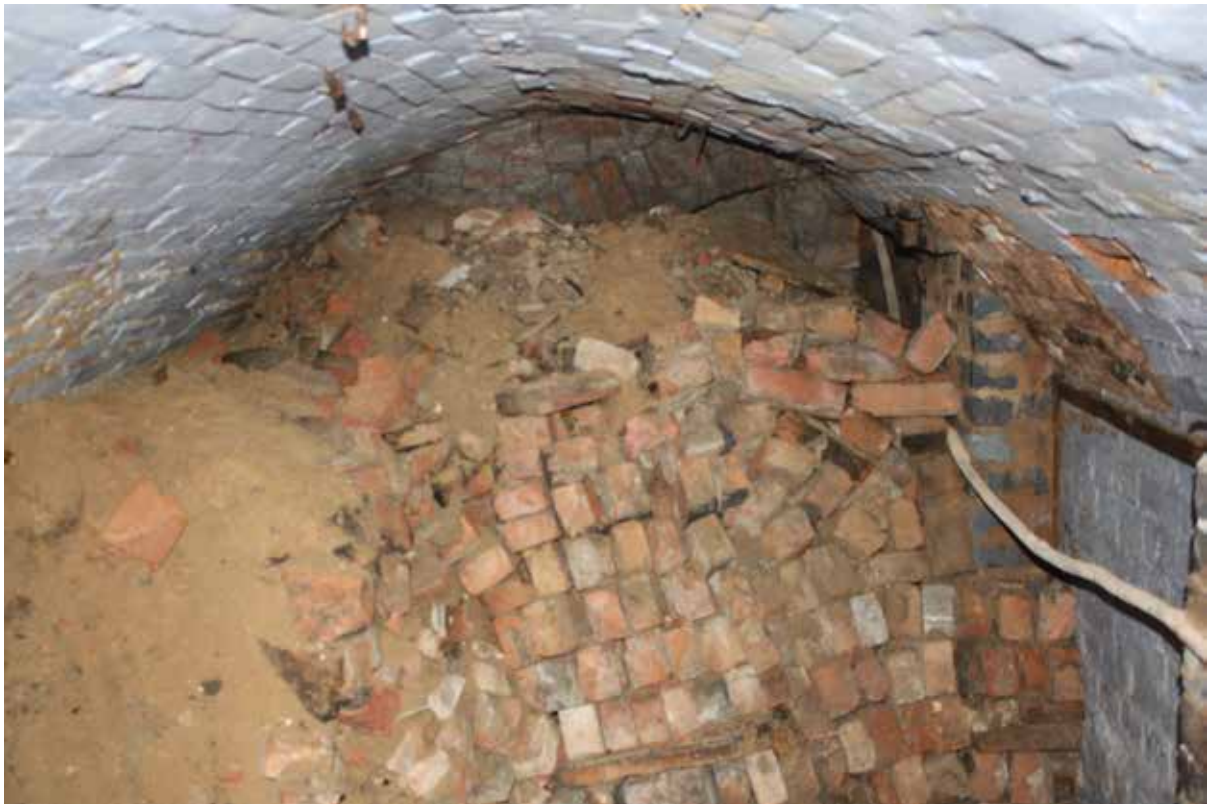
Plate 16: Cell 1, looking south, prior to exposure during ground reduction. Note the infilled material from a partial collapse as well as the arches in the background from earlier phases of construction. The bricks were loosely stacked as if being stored.

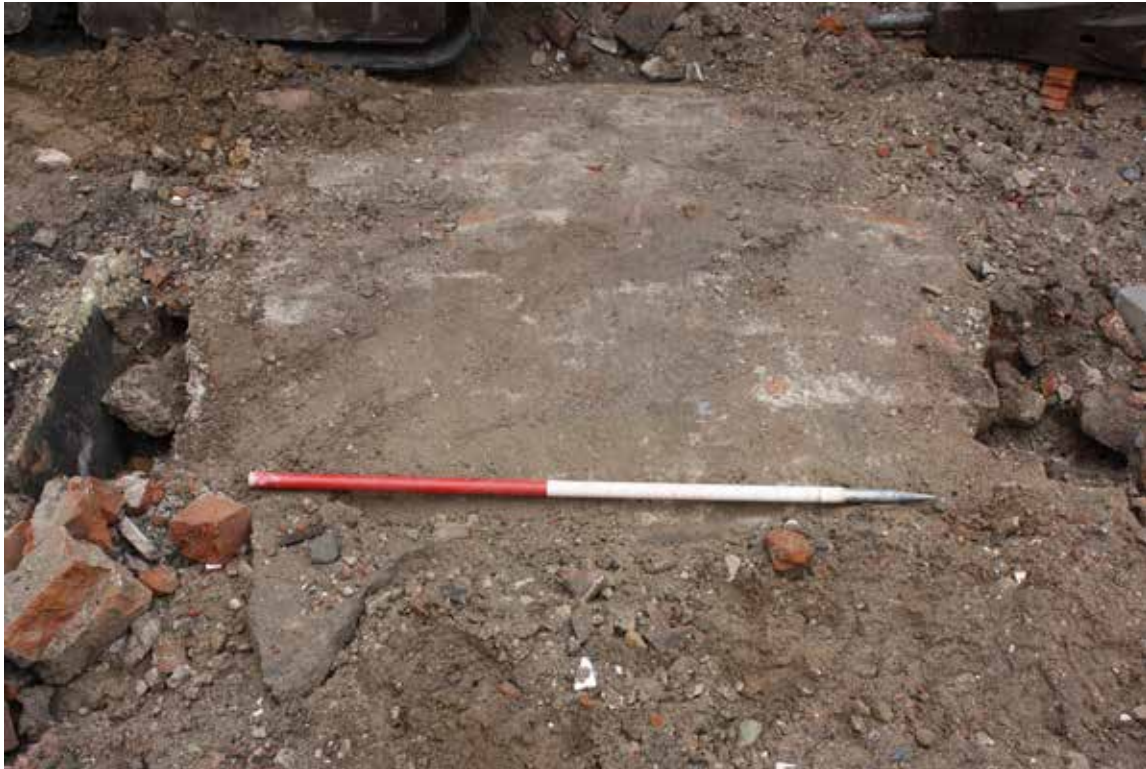
Plate 17: Partially surviving vault of the truncated / backfilled cellar to the south-east corner of the site.

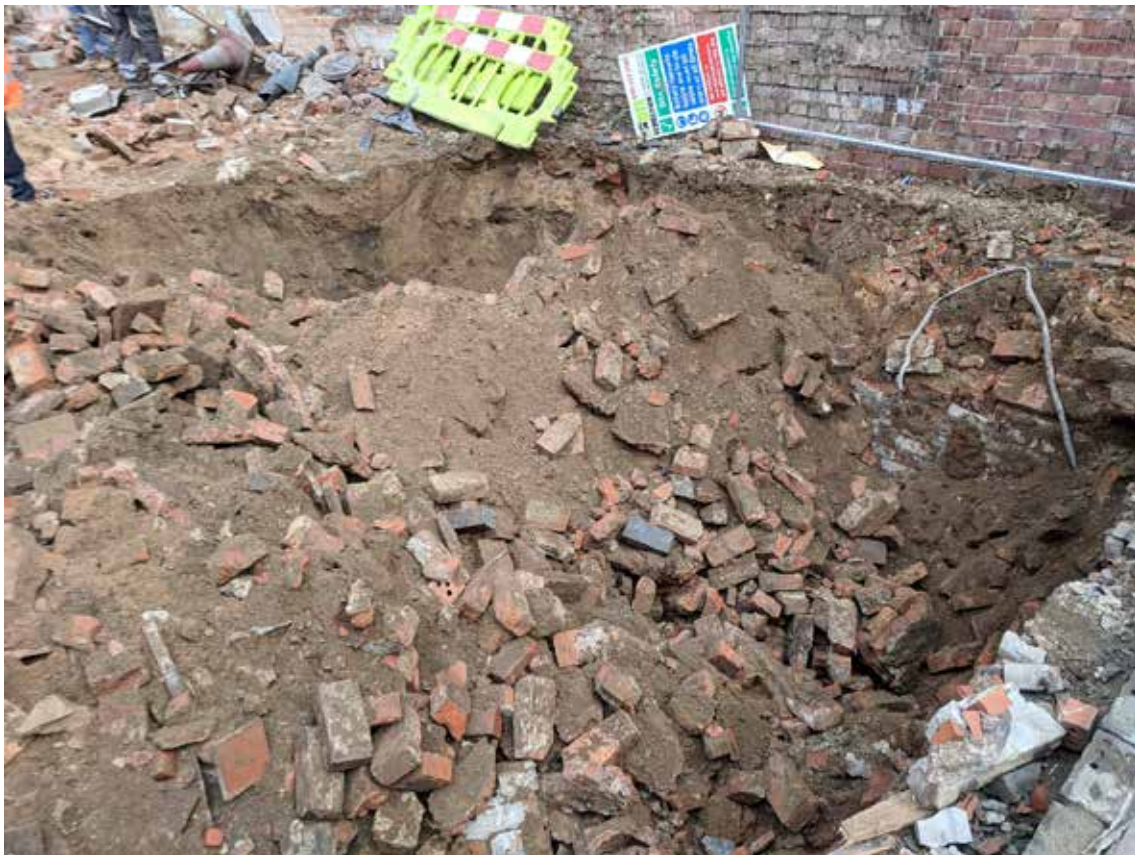
Plate 18: Partially backfilled and demolished cellars in the south-eastern corner of the site, facing north-east. It appears that the cellars were backfilled prior to demolition works on the site as well as being partially collapsed.

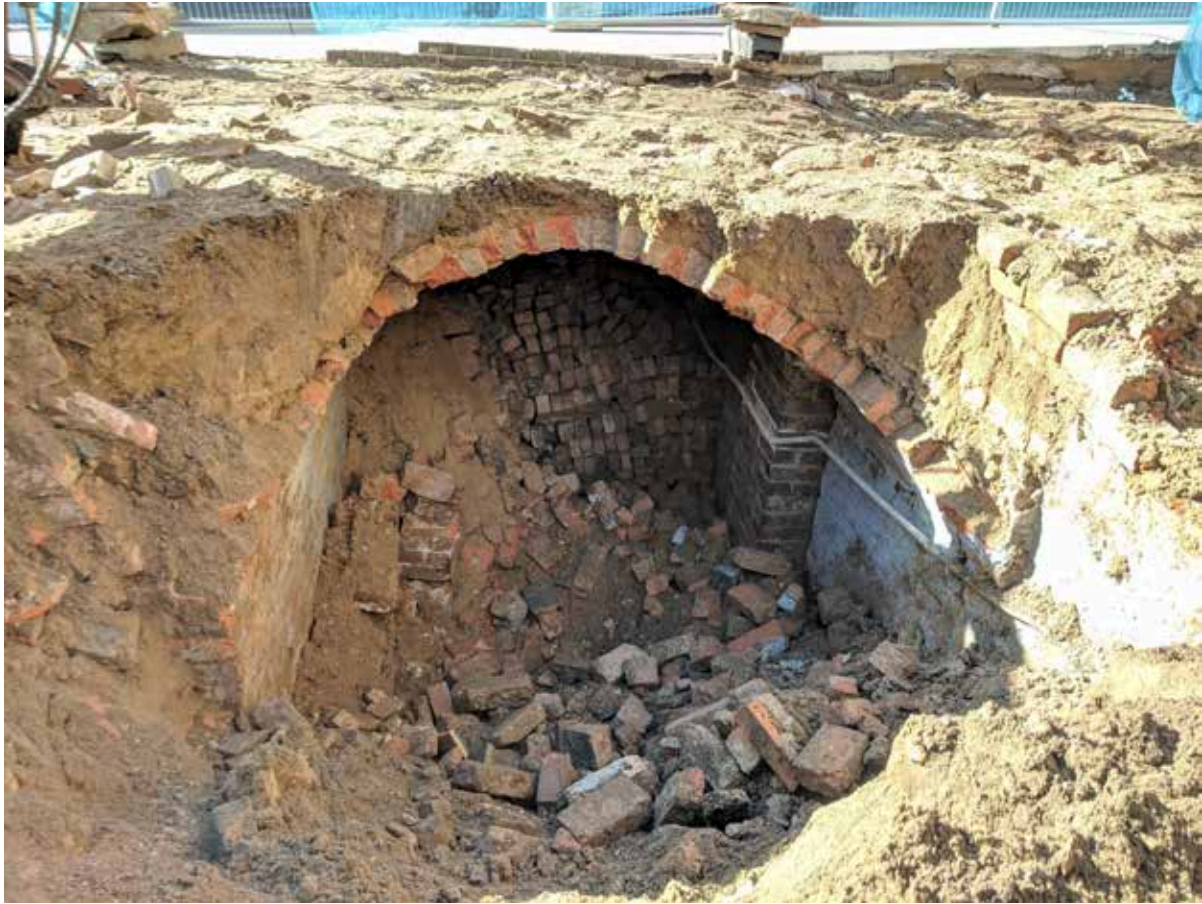
Plate 19: Cell 1 during ground reduction works / demolition, looking south.

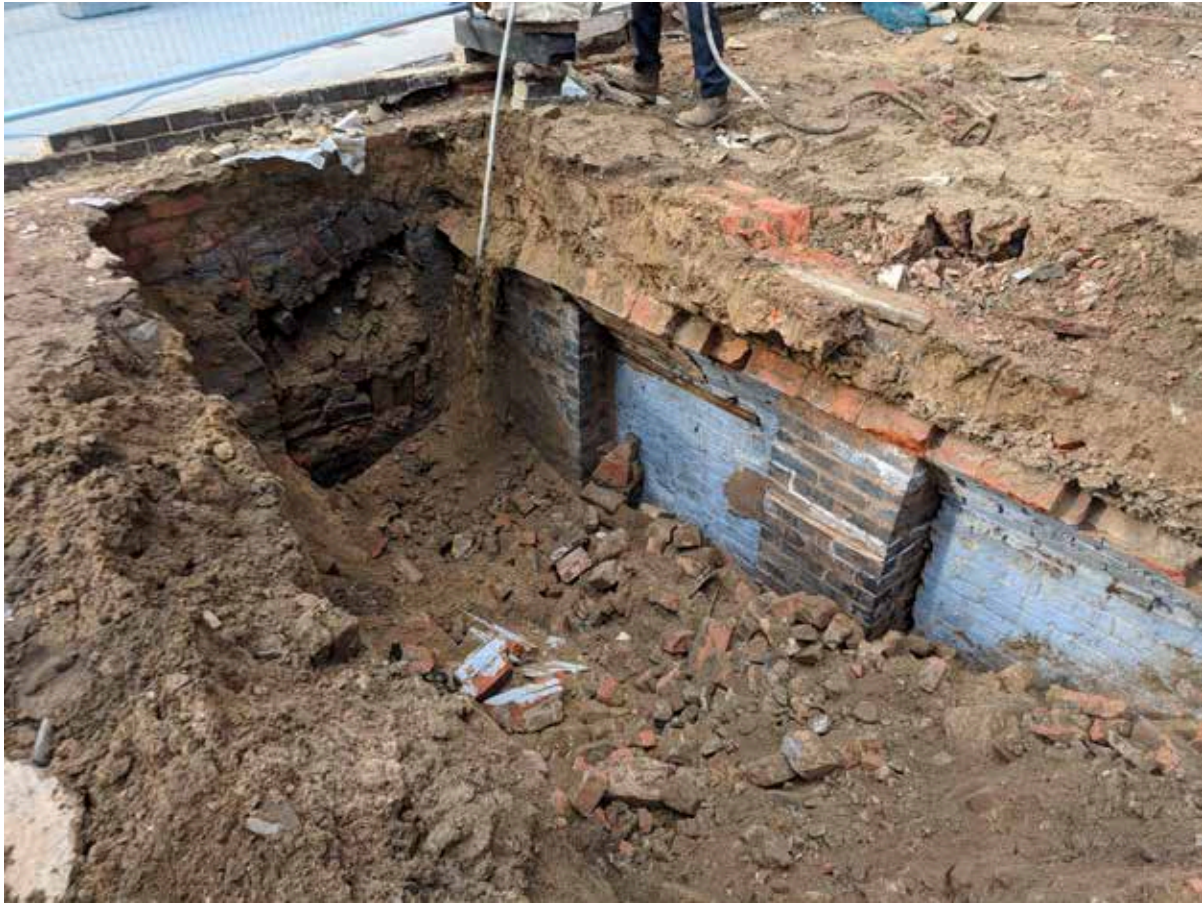
Plate 20: Cell 1 following further ground reduction works / demolition, looking south-west. The graffiti can be seen to the left hand side of the later brick piers.

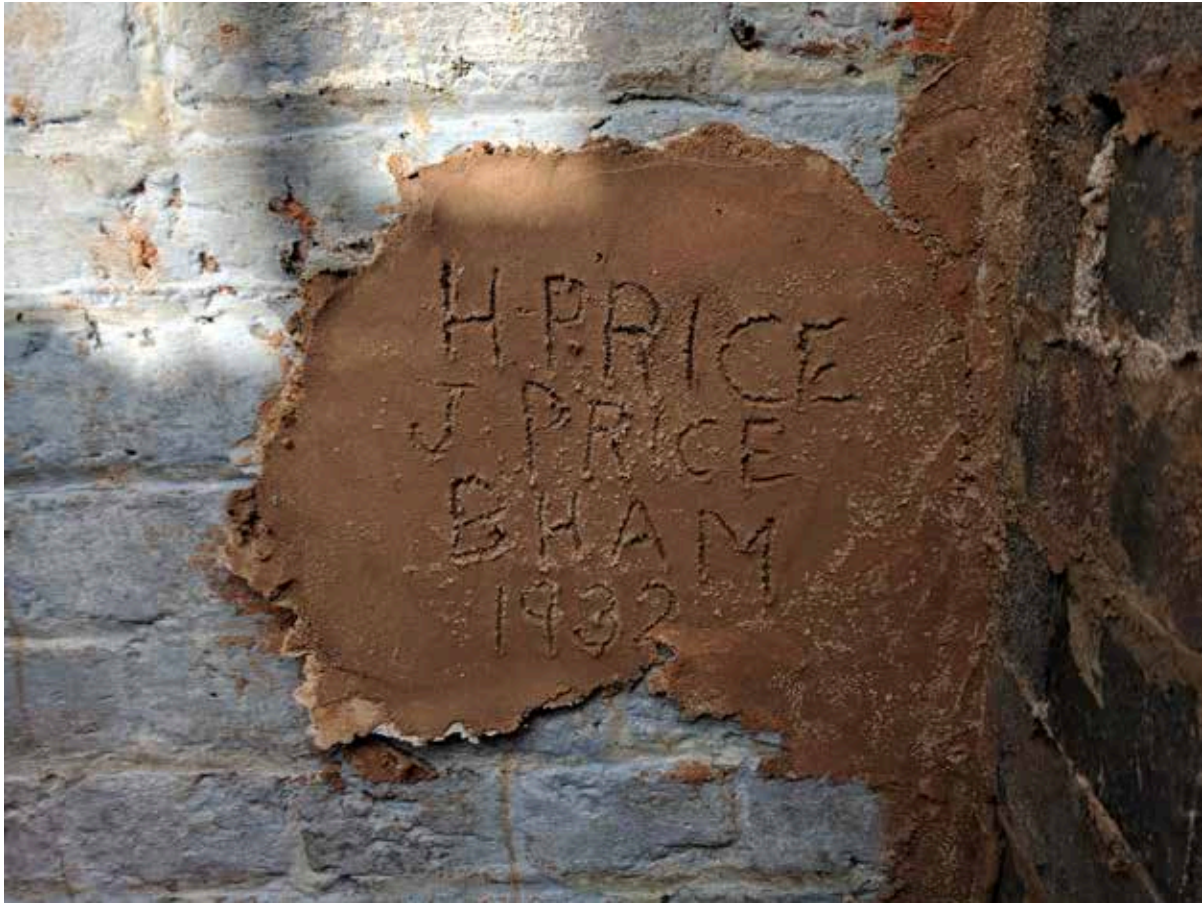
Plate 21: Detail of the graffiti in Cell 1, likely to be dating the construction of the later brick piers, facing west.

- 4.3.5. The brickwork and construction of the cellars was modern (early 20th century). The internal walls of the cellar were constructed from mass-produced bricks, in English garden bond, heavily whitewashed. Abutting the internal walls were later brick piers, constructed with Staffordshire blue mass-produced bricks, laid in Flemish bond, likely to have formed an earlier phase of construction (Plate 20). Subsequently, graffiti 'H. PRICE, J. PRICE, B HAM, 1932' was found on the plaster lining of the cellar, confirming the early 20th century construction date (Plate 21):

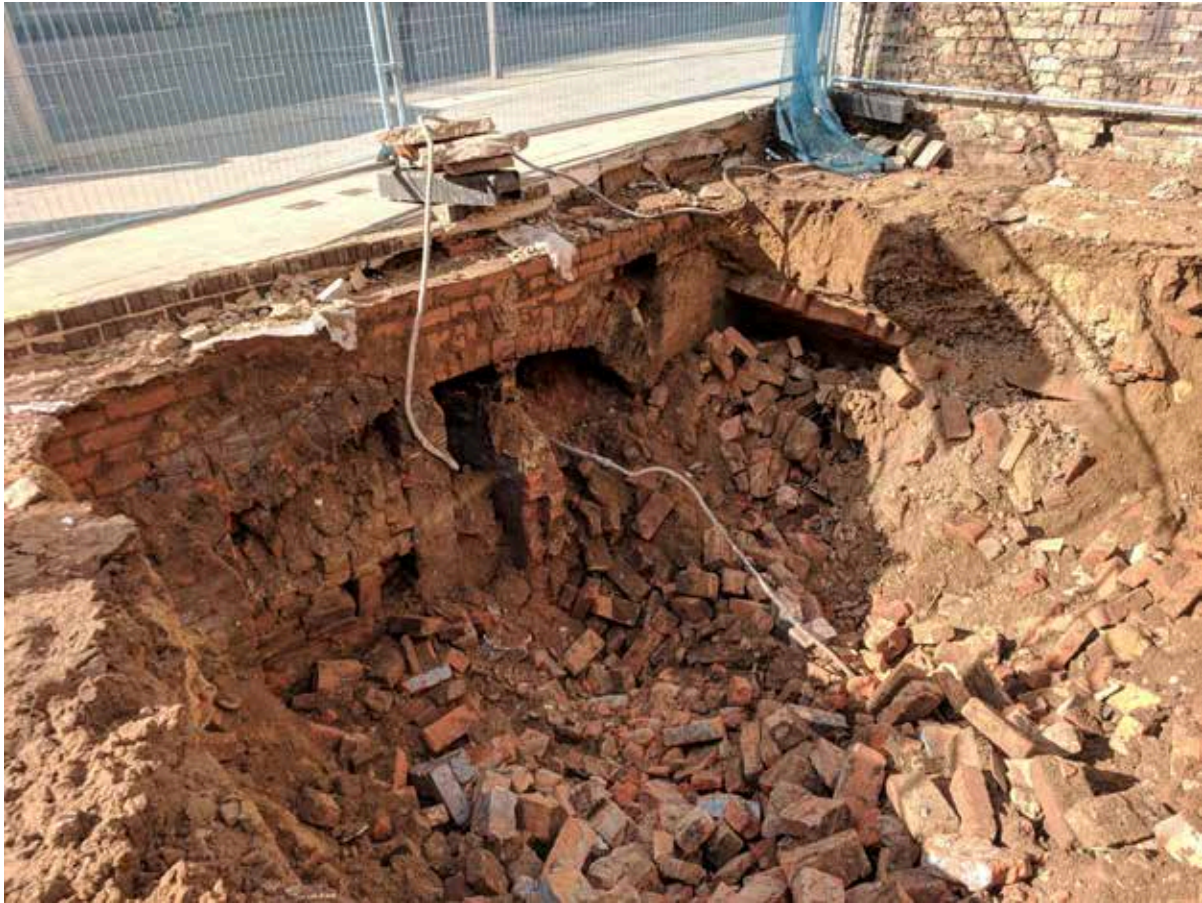
Plate 22: Cell 1 following the breach of the dividing wall into Cell 2, revealing an earlier brick arch, facing south-west. Derby Road is in the background.
