**100-104 Derby Road, Nottingham.
Archaeological Monitoring of Boreholes and Watching Brief
During Groundworks.**

TPA Report No: 094/2019

Document Title: 100-104 Derby Road, Nottingham. Archaeological Monitoring of Boreholes and Watching Brief.

Document Type: Draft Report

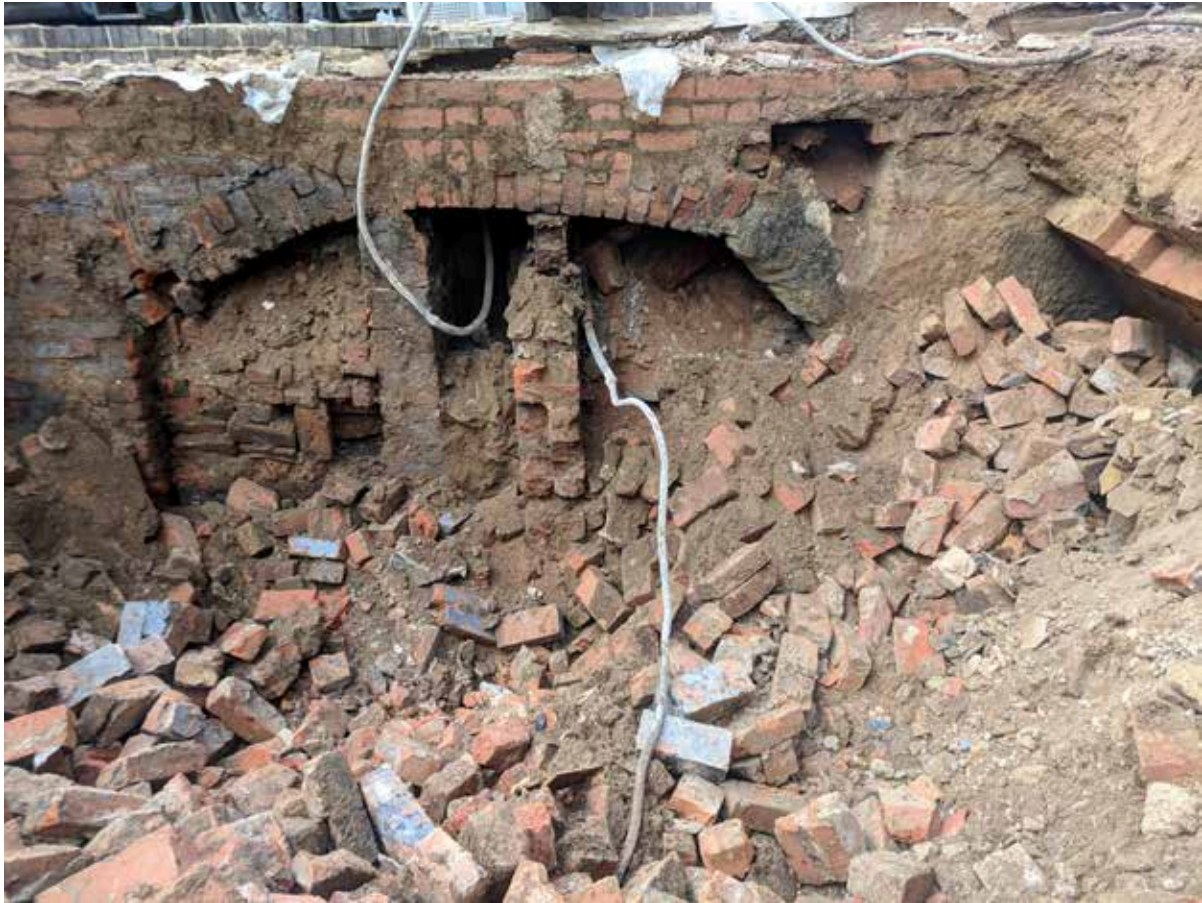
Plate 23: Cell 2, showing the remains of Cell 1 to the left, facing south. The partially exposed sandstone to the right, showing the brick arch springing from the sandstone skewback. The recess continued south, under the pavement, the extent of which is unknown.

5.3.4. The observed cellars, specifically Cell 2, demonstrated a possible pre-brick phase of rock-cut construction. The lateral extent of this structure could not be established due to ground conditions on site as well as the extensive truncation caused by later cellarage. It is likely that if the site was previously occupied by rock-cut cellars then these were largely destroyed by later, specifically post-1892. The desk-based assessment did not record any documentary or cartographic evidence for the presence of rock-cut structures. However, a passage relating to the area provides some relevant context:

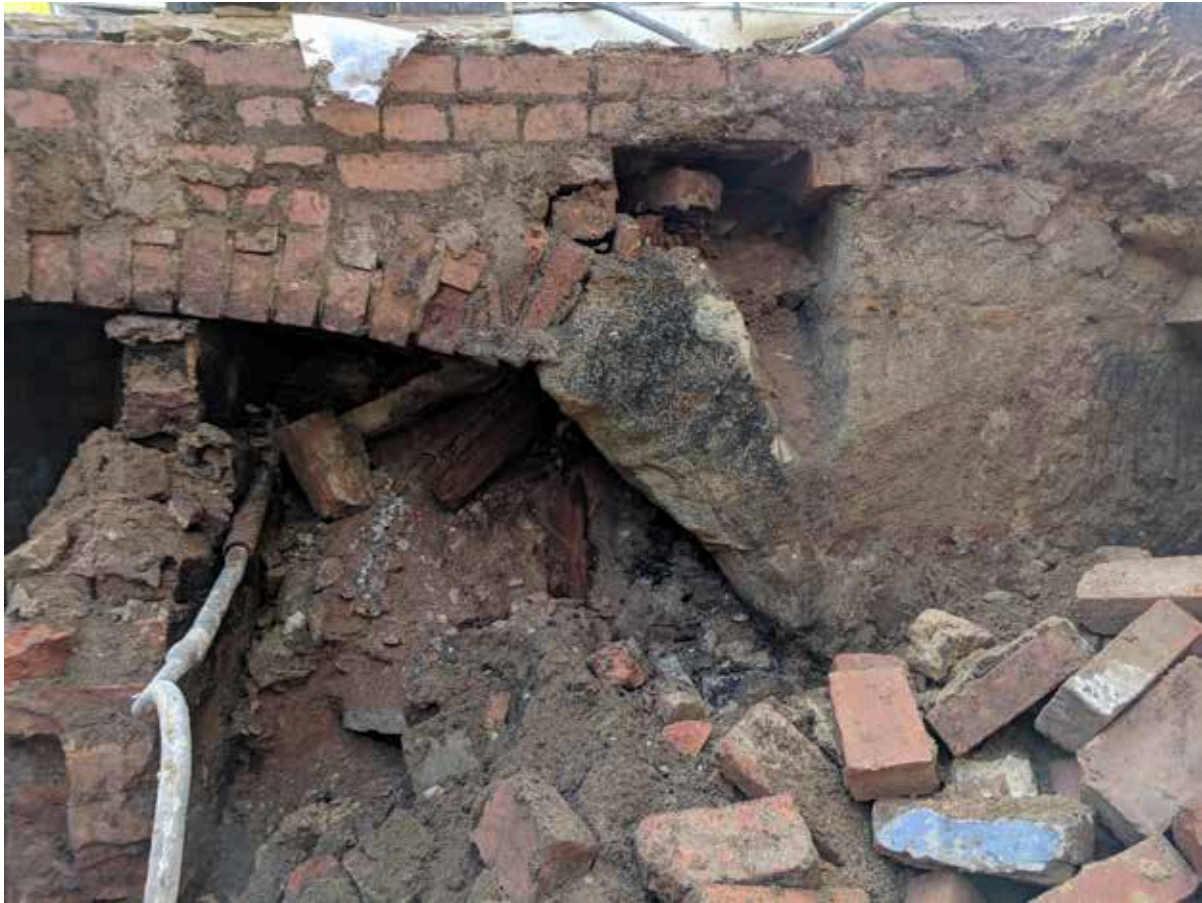
Plate 24: Detail of the sandstone skewback and brick arch in Cell 2, facing south.

- 4.3.7. The western skewback in Cell 2, on which the segmental brick arch rests, was carved sandstone bedrock (Plate 24). The projecting form and angle of the sandstone skewback suggests that an original rock-cut three-hinged arch may have been present before being replaced by the later segmental brick arch. It is possible that the walls supporting the later arch may have formed part of a recess, extending to the south.

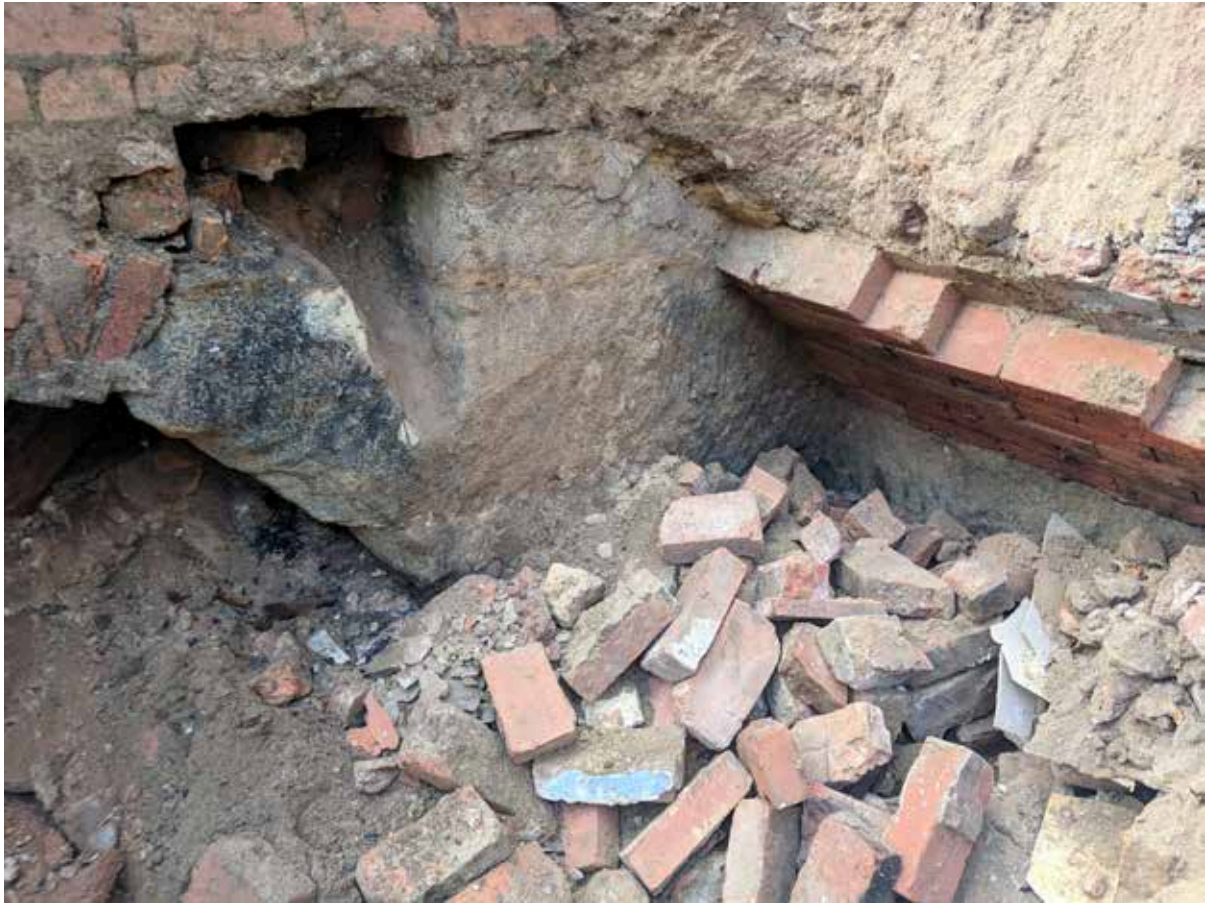
Plate 25: Detail of the sandstone skewback and brick arch in Cell 2, as well as the partially exposed rock cut wall with another barrel arch springing from it, facing south-west.

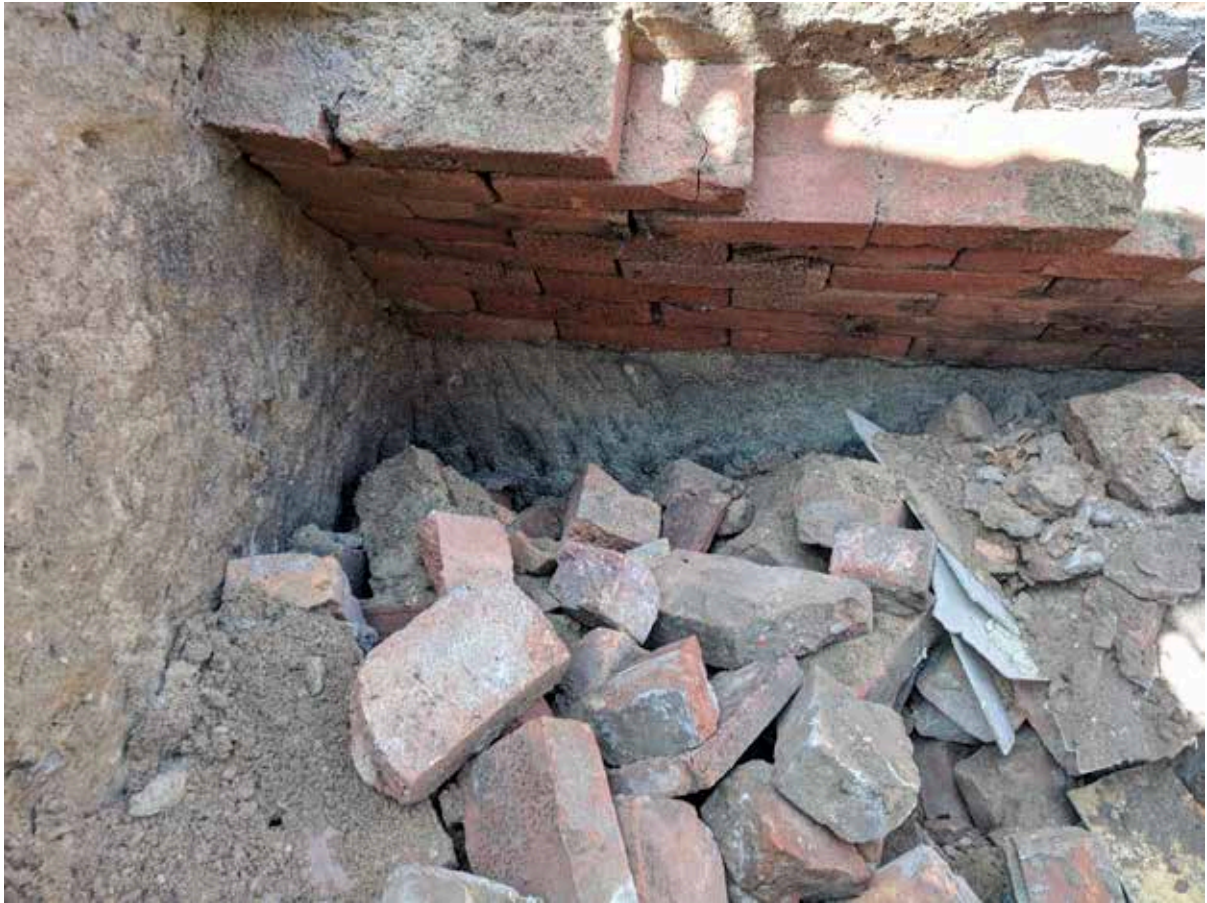
Plate 26: Detail of the rock cut wall and barrel vault bricks springing from the sandstone wall, facing west.

- 5.4.3. The partially exposed rock-cut elements relating to the southern cellar (Cell 2) were the earliest observed feature on the site, however this had been truncated / modified by later developments and the extent and nature of the earlier feature could not be easily established. It was also not possible to determine an age for this rock-cut element, although it is likely to be post-medieval in date

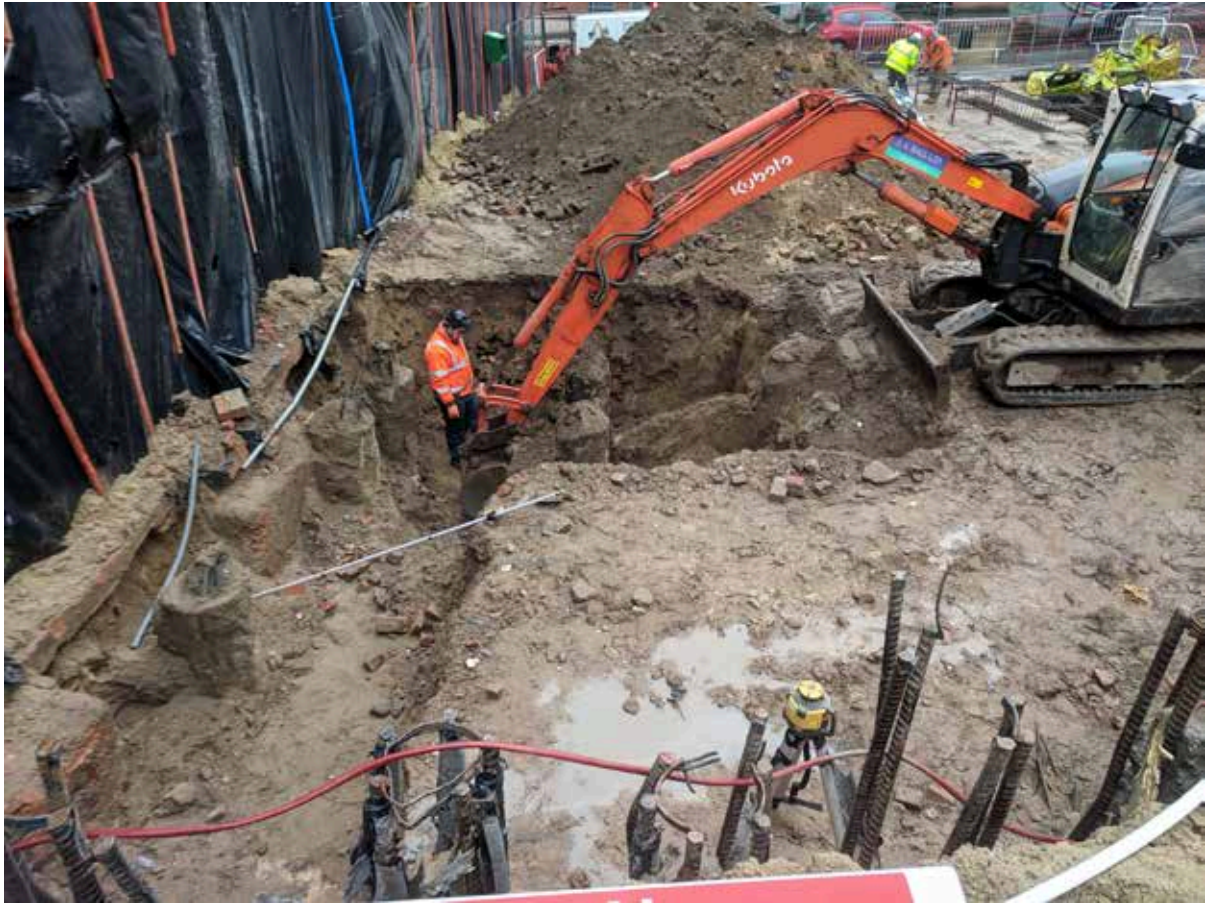
Plate 27: Site visit post-piling, facing south towards Derby Road, from Wollaton Street. The partially exposed brick arch can be seen to the west, behind the machine banksman.

4.4.2. A visit was made during the excavation and clearing of the north-eastern corner of the site (Plate 27). The material observed comprised made ground material similar to that observed during the monitoring of the boreholes. No archaeological features were recorded in this area.

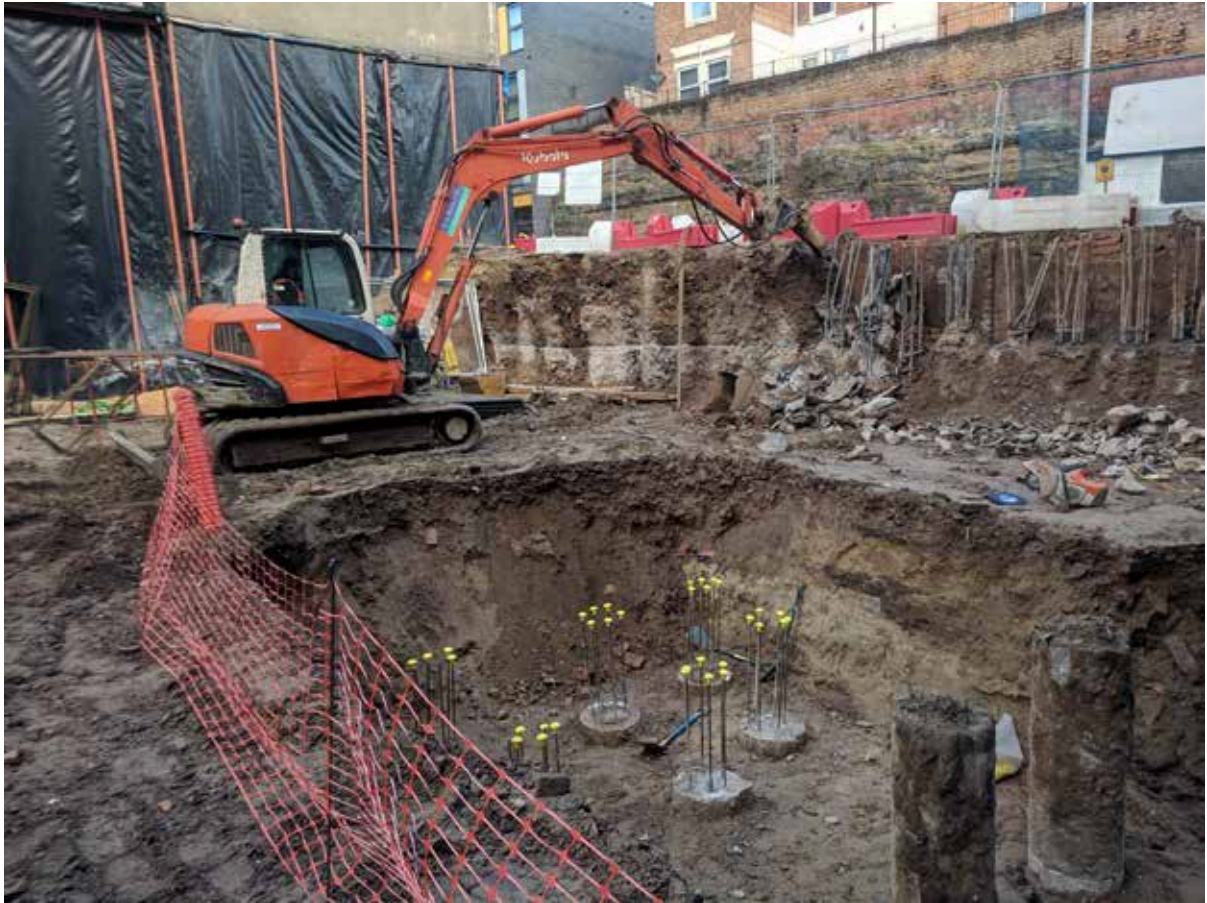
Plate 28: Site visit, facing north-west towards Wollaton Street. The sandstone bedrock (Chester Formation) can be seen in the foreground, behind the unreduced piles. The machine is exposing historical piling, which provided support for the retaining wall for Wollaton Street. Exposed sandstone bedrock can also be seen in the background of the image, on the northern side of Wollaton Street.

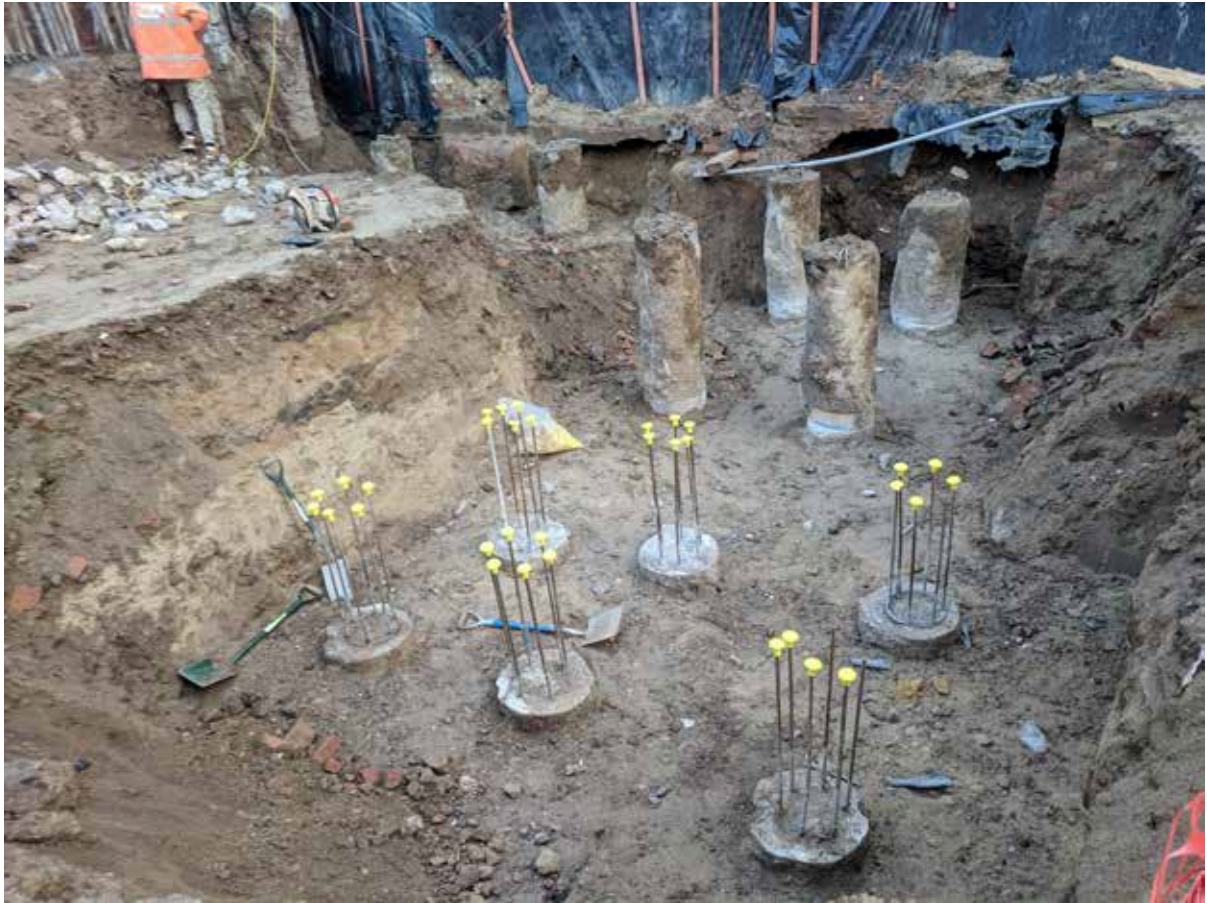
Plate 29: Site visit, facing north-east. The sandstone can be seen in the foreground. In the background, behind the unreduced piles, the partially exposed remains of a brick arch can be seen.

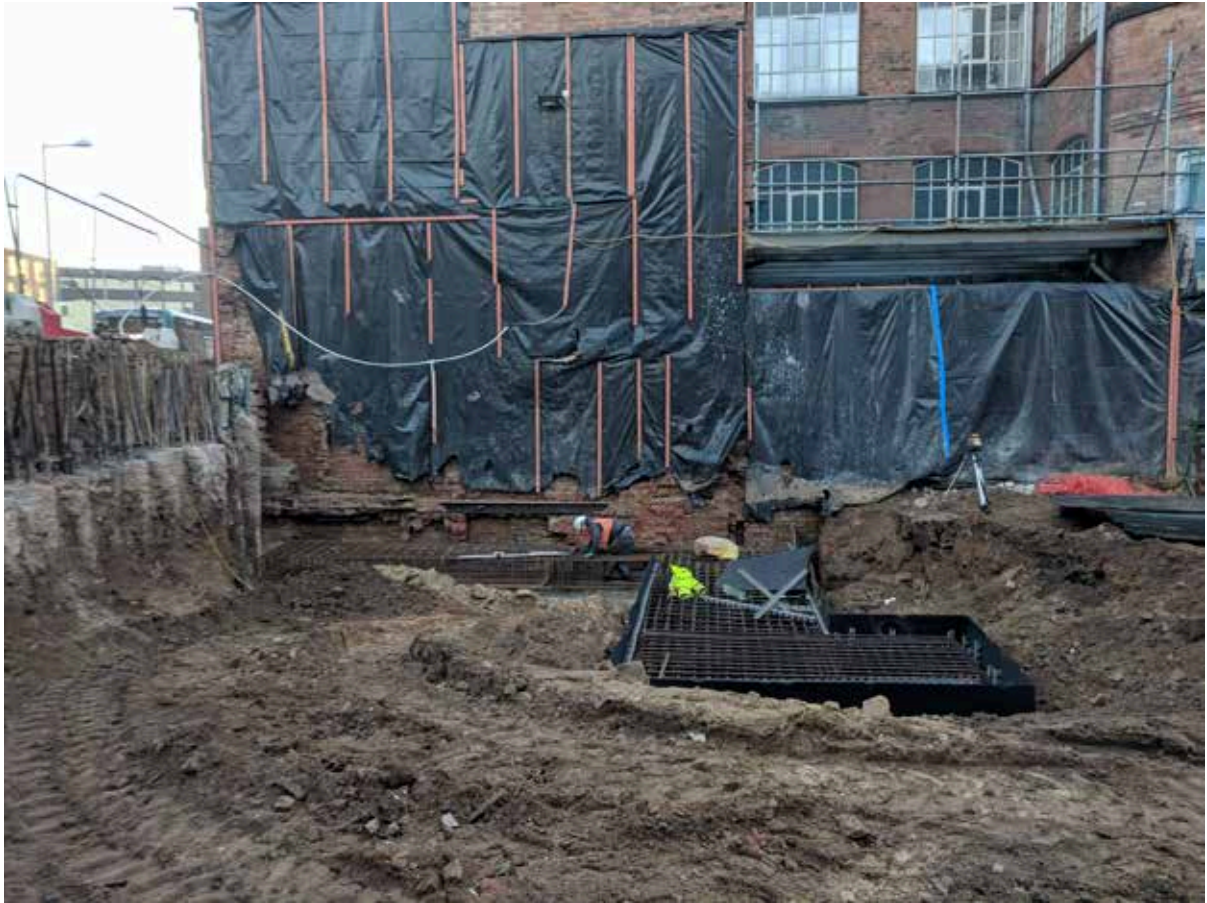
Plate 30: Site visit, facing east. Area of piling following capping.

4.4.4. The site was visited again whilst reinforced concrete rafting structures were being assembled (Plate 30). No excavation works were ongoing during this time and consequently there were no additional archaeological observations.

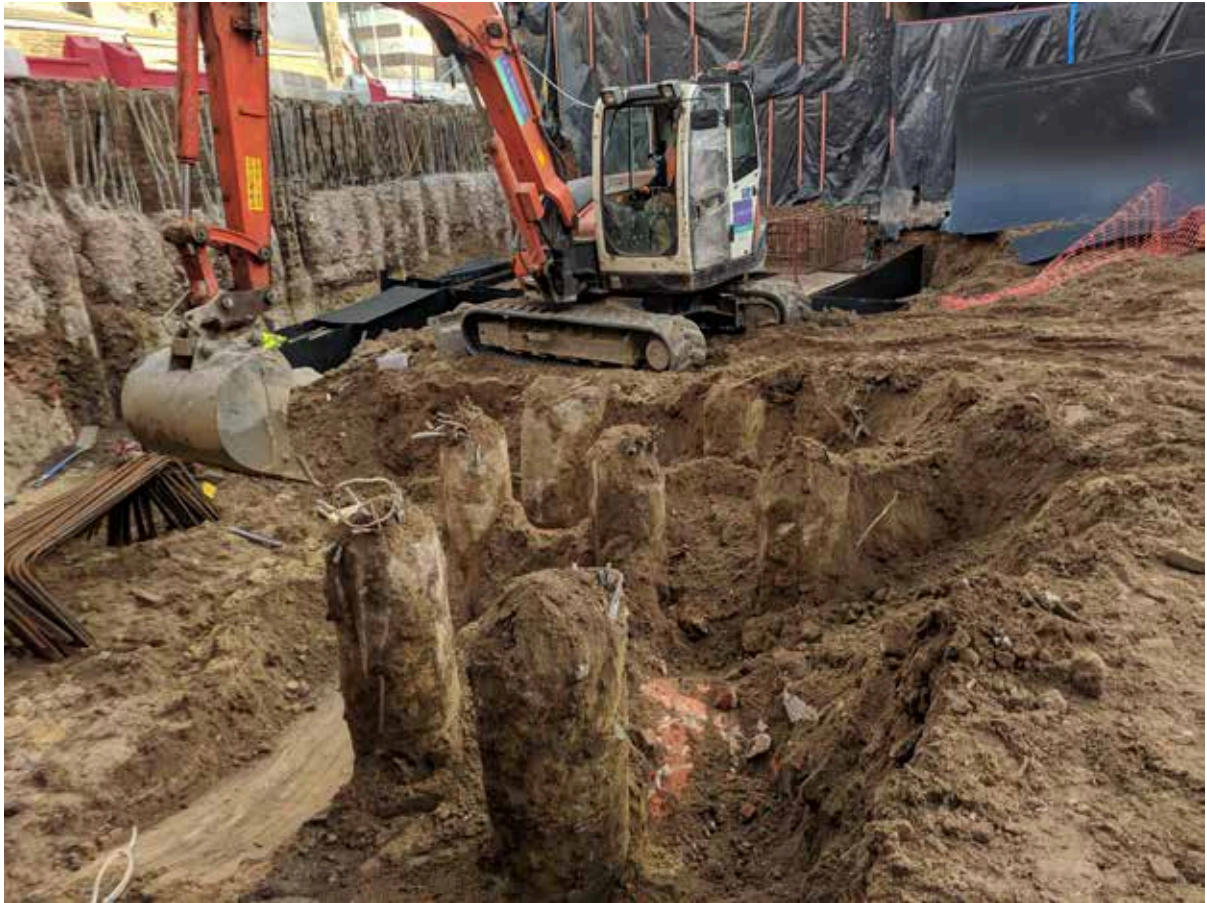
Plate 31: Site visit, facing north-east. In the foreground an area of piling can be seen, having truncated and largely destroyed a likely cellar structure.

4.4.5. In addition, the north-western portion of the site was inspected in the vicinity of piles P60 and P61. A further barrel-vaulted brick cellar was recorded but was largely obscured by the piles (Plate 31). A brick wall, a likely cause of the brick obstruction in WS106, was partially revealed to the south of P59, P60, and P61 (Plate 32). The southern boundary of the site was also found to have previous piles which were supporting a retaining wall to the south of Wollaton Street (Plate 33).

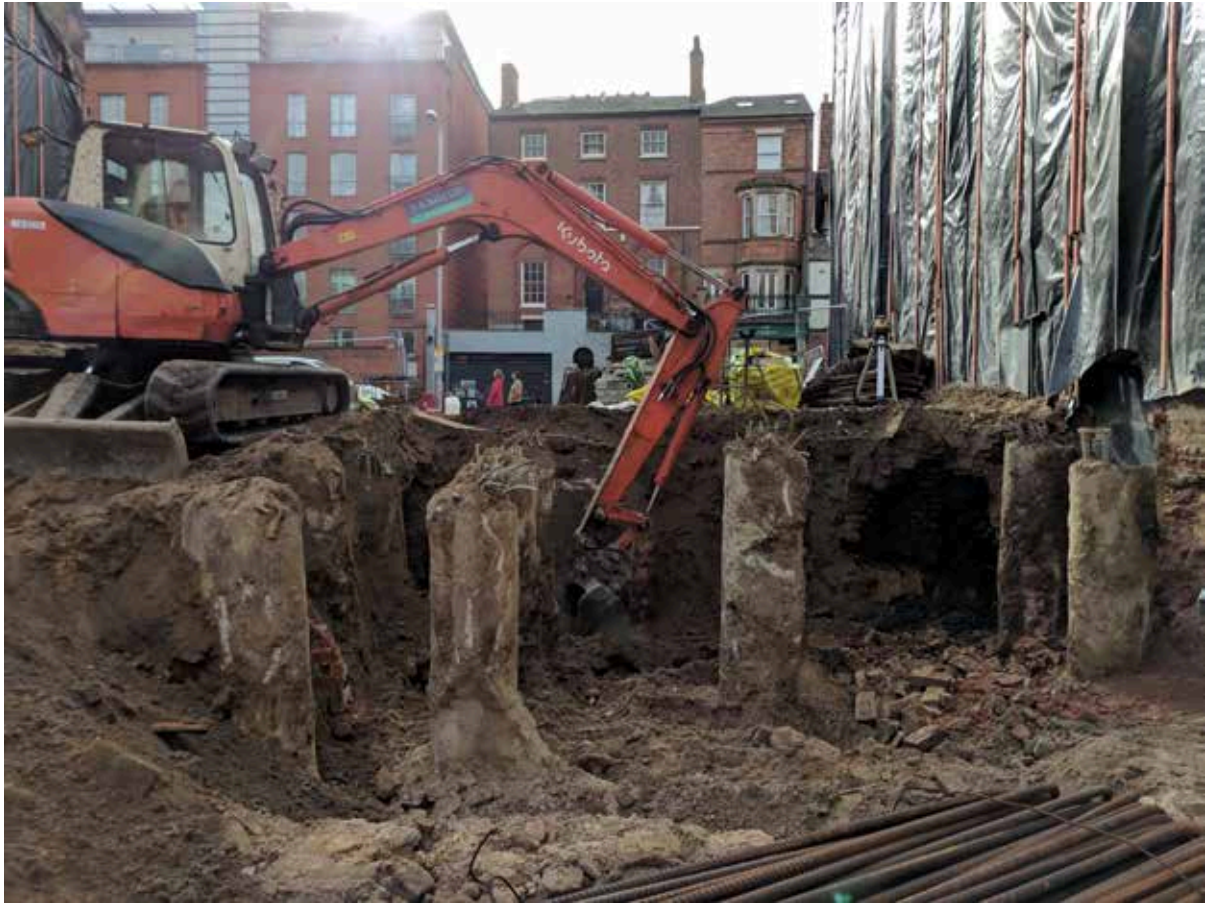
Plate 32: Site visit, facing north towards Derby Road. A partially exposed brick wall can be seen to the west (right) of the machine.

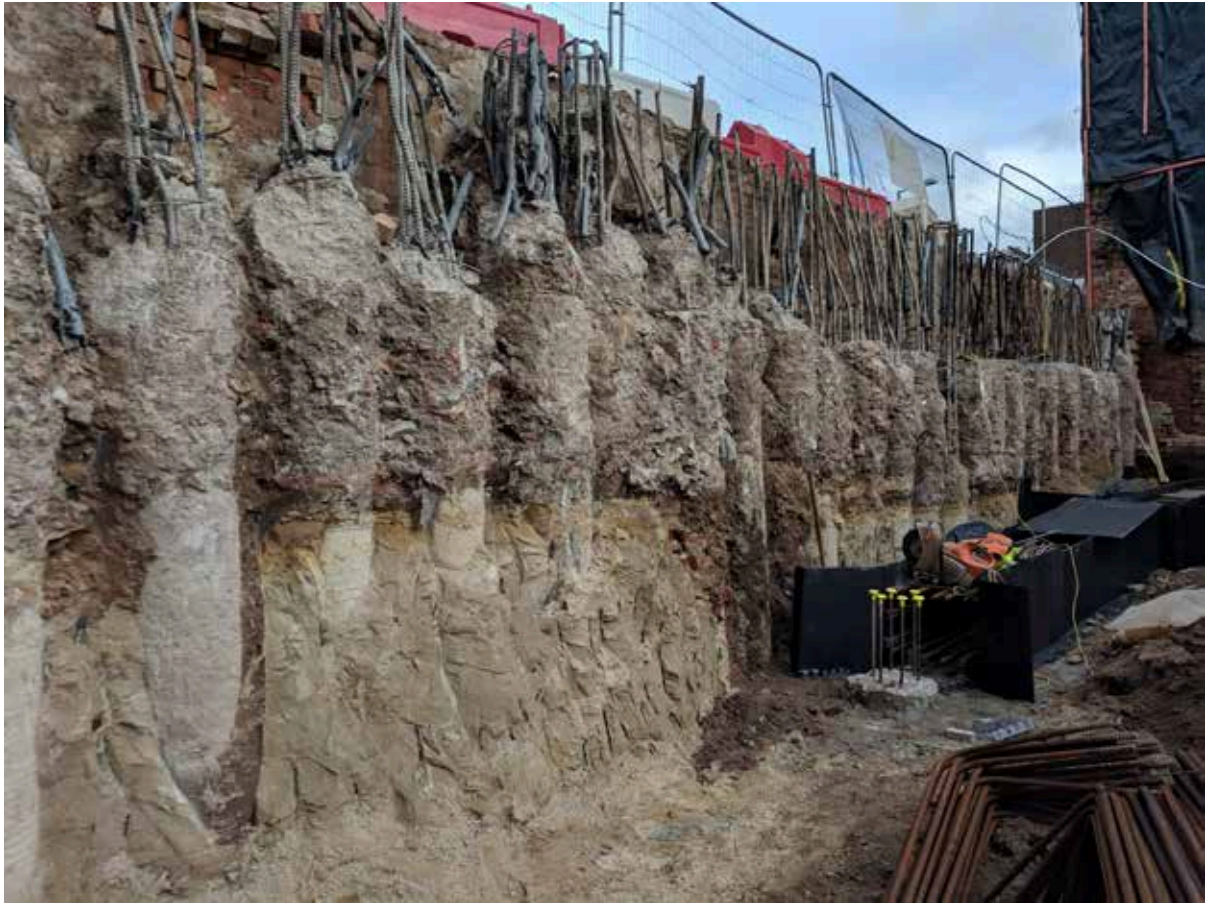
Plate 33: Site visit, facing north-east. Historical piling can be seen supporting a retaining wall to the south of Wollaton Street. In the foreground, remnants of the sandstone bedrock are visible.

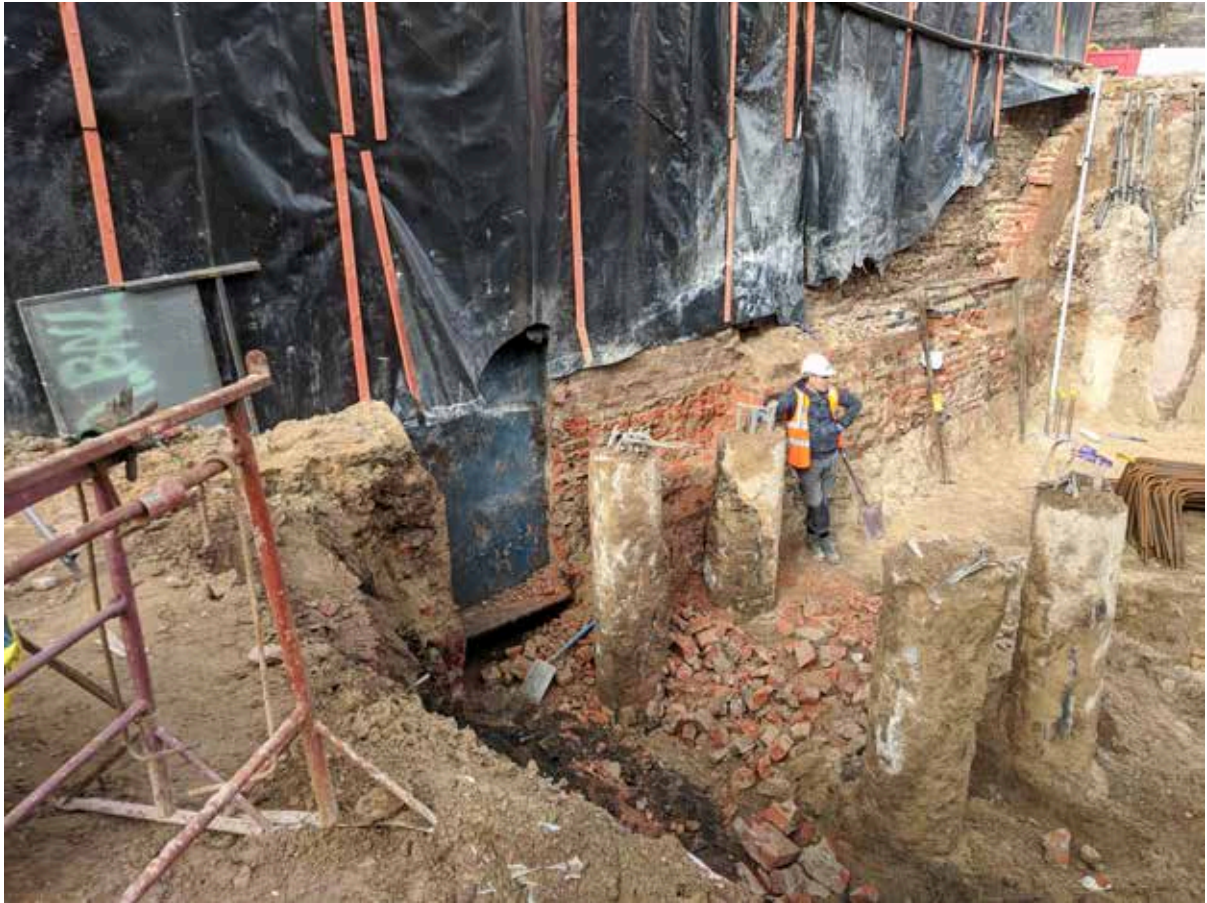
Plate 34: Site visit, facing north-west. A blocked entrance to the cellar on the site was revealed, with access from 106 Derby Road.

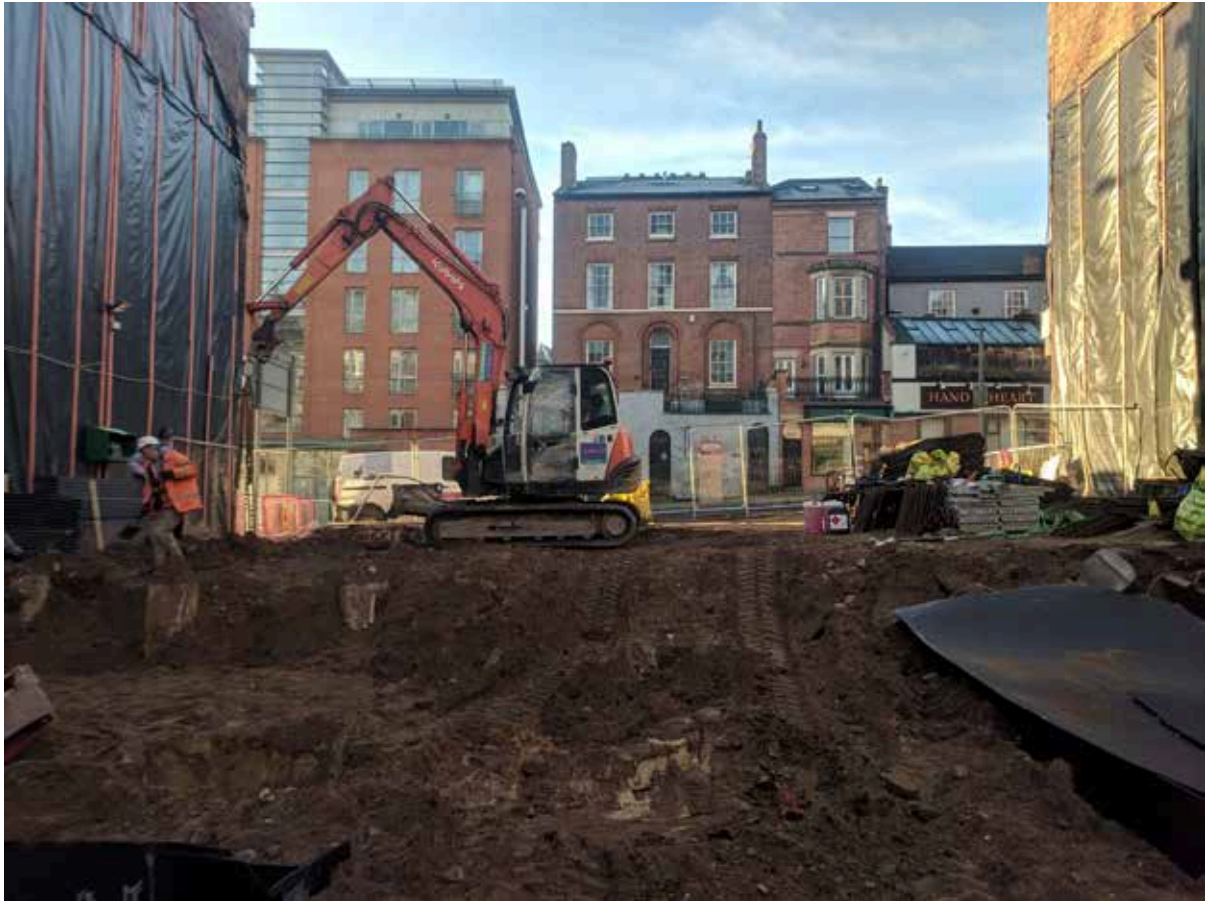
4.4.7. An additional visit was made during the beginning of excavations of the piles in the central, eastern half of the site P47, P48, etc. No excavations works were ongoing at this time and the majority of the northern half of the site had concrete setting (Plate 35).

Plate 35: Site visit, looking south towards Derby Road. The southern half of the site had been previously monitored during the ground reduction stages.

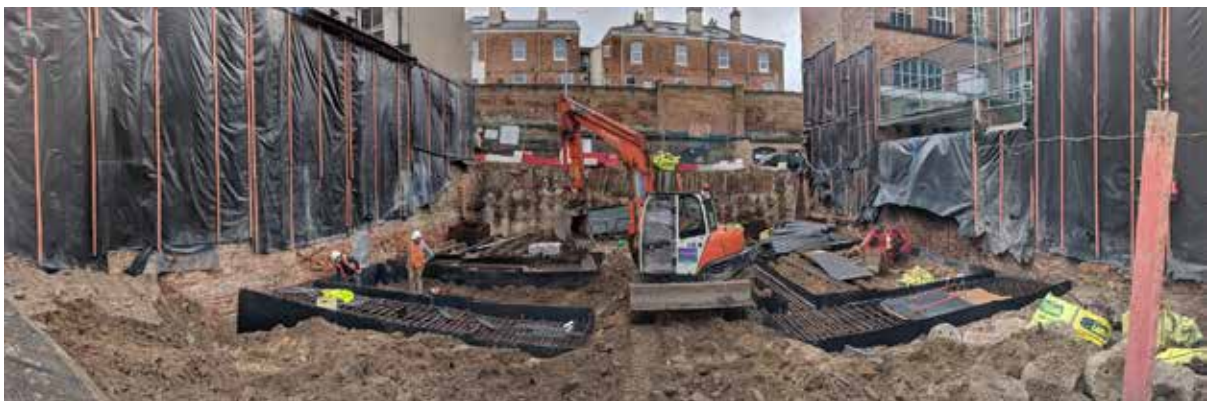
Plate 36: Final site visit, panoramic shot, looking north towards Wollaton Street.

4.4.8. A final site visit was made, when the works had been completed (Plate 36).
