# Sawcliffe Medieval Village and Moated Site: Archaeological Monitoring and Recording

**TPA Report Code:** 187/2018

**Document Type:** Final Report

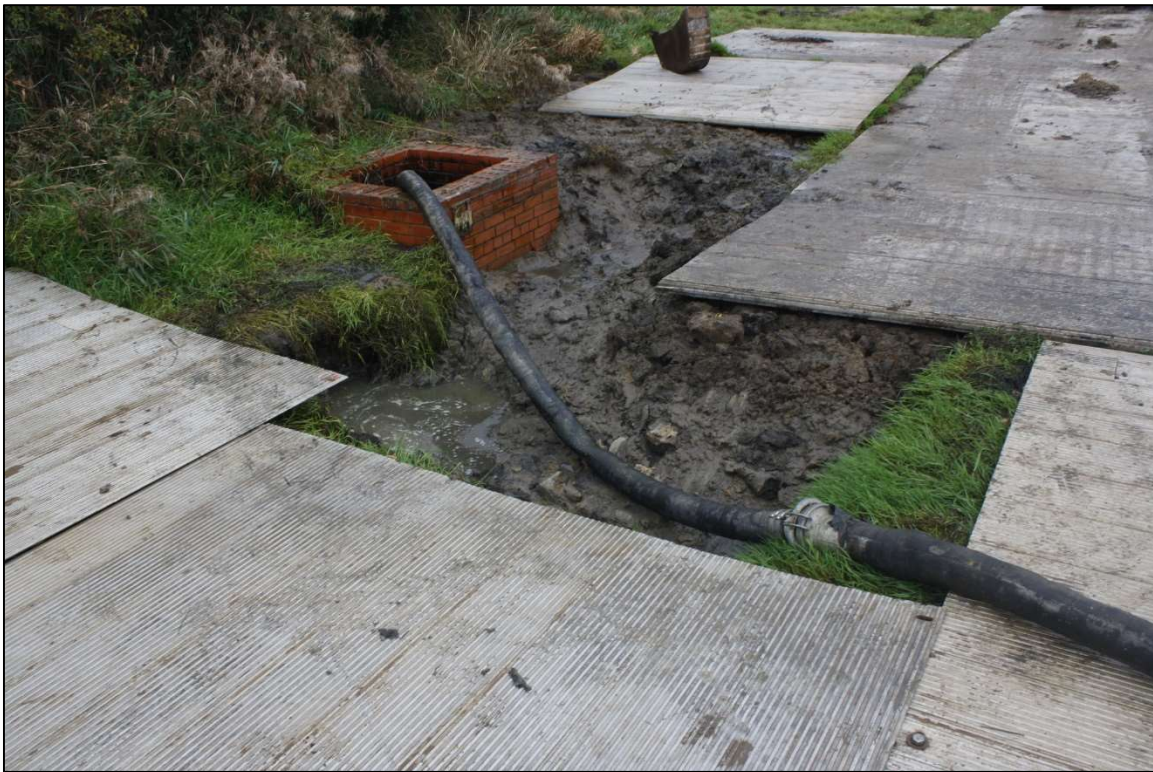
Plate 2: Initial trench excavation of the repair trench, using a trash pump. No scale.

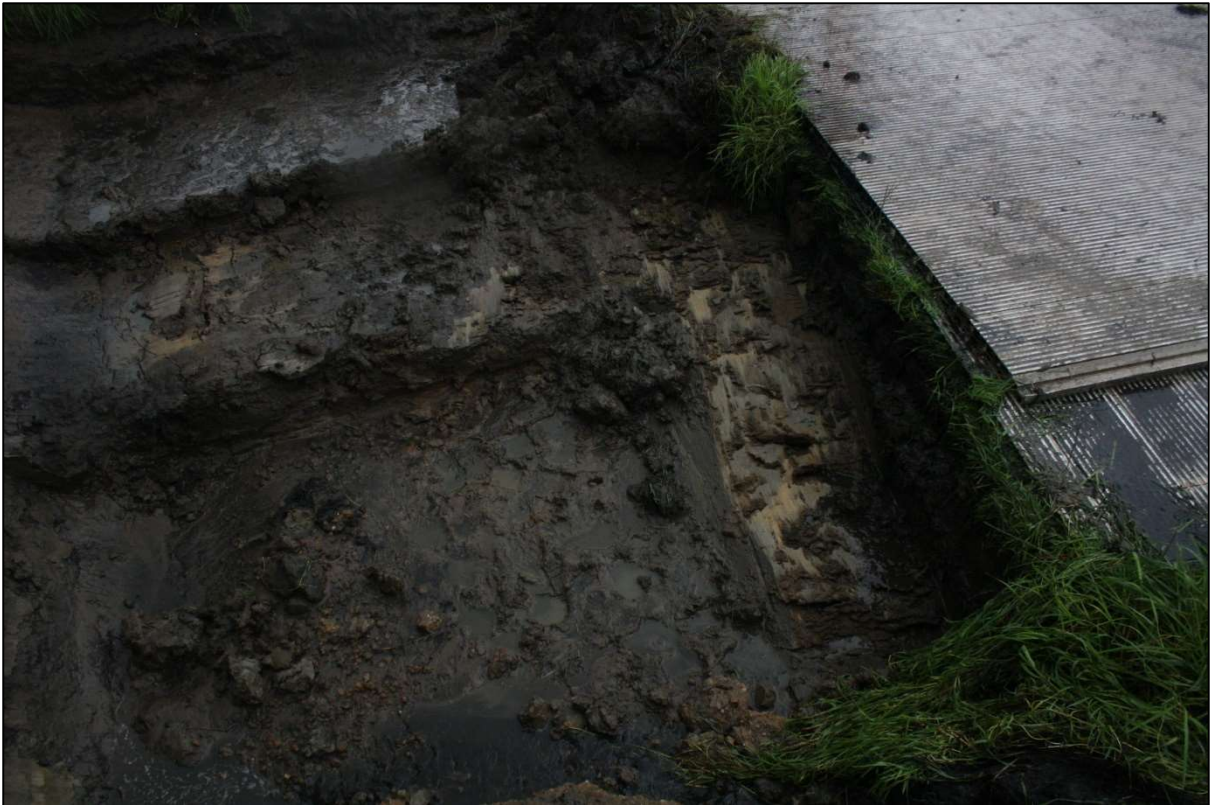
Plate 3: Final excavation of the steeped repair trench, showing natural (1003). No scale.

- 6.2 Geological substratum, formed of light orange grey sand and clay was identified at a depth of c.0.75m b.g.l. This was sealed by a c.0.14m thick deposit of loose very dark grey/brown buried topsoil which produced a single body sherd of medieval green glazed pottery. This deposit was overlain by a mid-orange grey sandy silt subsoil c.0.14m thick, into which the cut for the 1994 water pipeline was identified ([1005]) (Figure 2; Dr#01). This was finally sealed by a dark grey brown sandy silty clay topsoil c.0.29m thick.

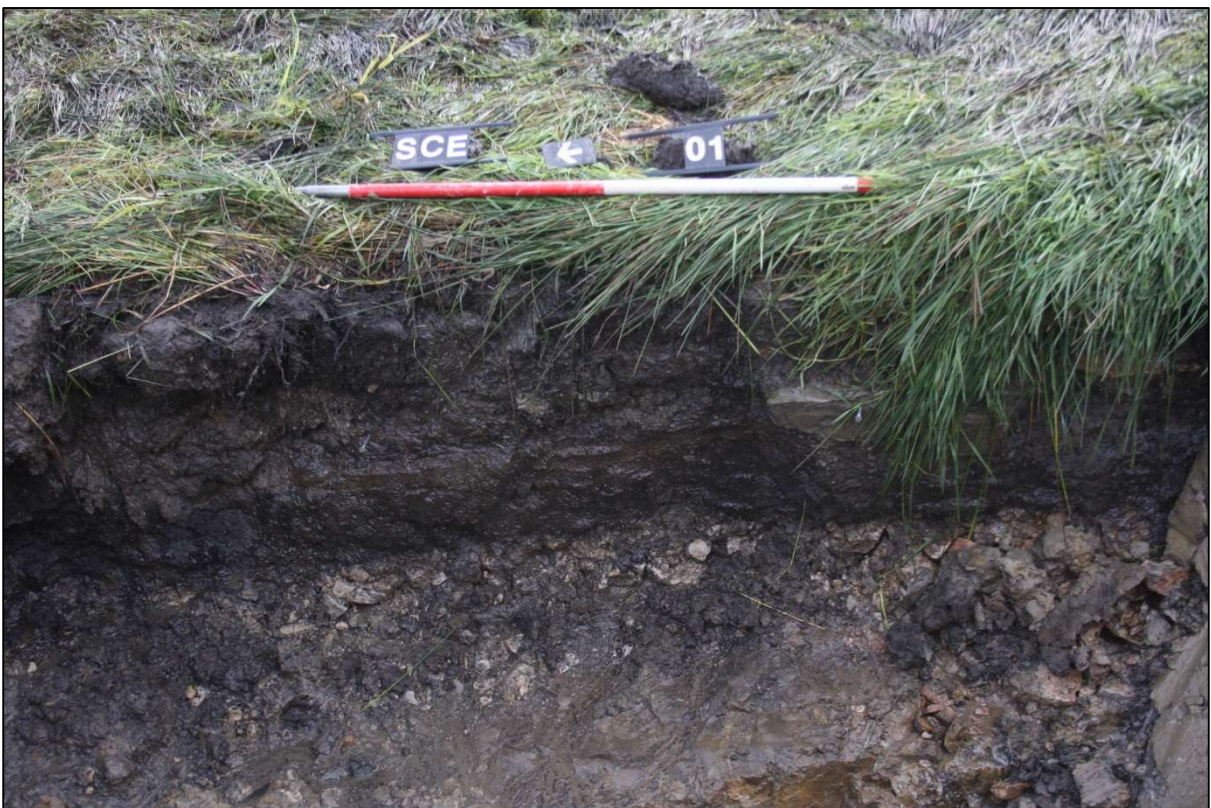
Plate 4: Representative section of repair trench, showing topsoil (1000), subsoil (1001) and possible med layer (1002). Scale 1m. Looking west.
