# 123 Huntingdon Street, Nottingham: Results of an Archaeological Watching Brief

Prepared for: Lanpro  
Prepared by: Victoria Owen  
TPA Project Code: HSN  
TPA Report Code: 142/2019

Client Name: Lanpro  
 Document Title: 123 Huntingdon Street Nottingham. Results of an Archaeological Watching Brief  
 Document Type: Client Report  
 Issue/Version N<sup>o</sup>: 1  
 Grid Reference: SK 5745 4056  
 Report Number: 142/2019  
 Trent & Peak Site Code: HSN  
 Planning Application: 18/506258/FULL

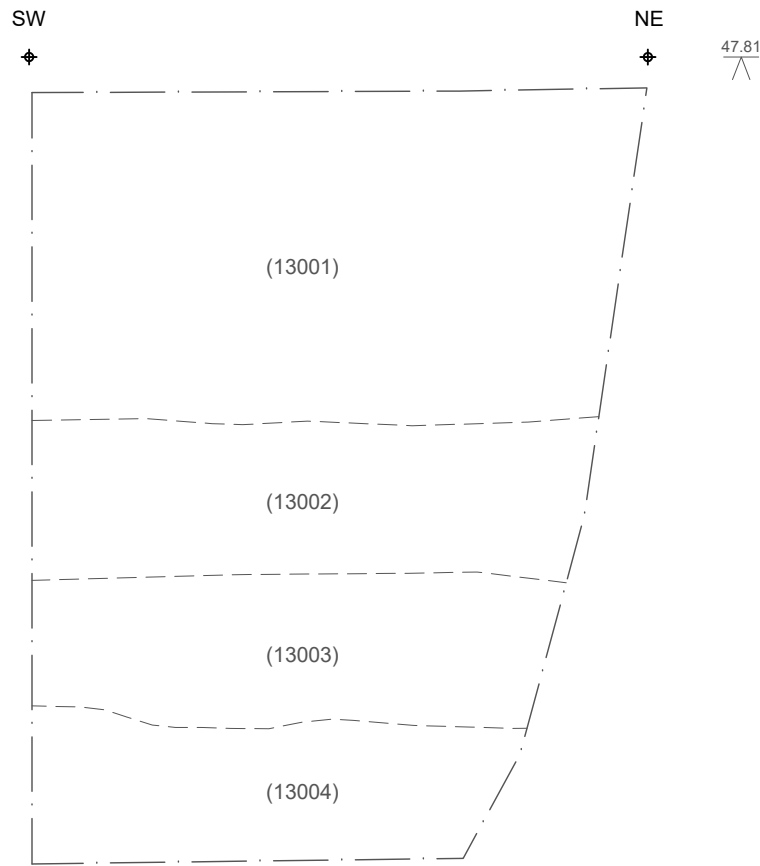
DR.01  
South East Facing Representative Section, Test Pit 13

*Buried Subsoil Horizon (3002), (8003), (11004), (13003), (14003), (15003), (16003), (18002), (24002), (30004) (Plates 4-5, 16-17; Figure 4, Drs# 01, 02, 03 & 04)*

- 8.4 A deposit of dark yellowish brown sandy silt was identified sporadically across the northern third of the site, which increased in thickness from 0.24m to approximately 0.7m from east to west. Where this deposit was identified, it generally contained frequent charcoal flecks, fragments of ceramic building material (CBM), and sub-rounded pebbles. The deposit may relate to the former workhouse garden, visible in historic mapping from 1851 (Jackson's Map of Nottingham, Plate 16), which appears to have been separated into allotment plots.

*Buried Topsoil Horizon (1002), (13002), (14002), (15002) (Plates 2, 4, 16-17, Figure 4, Drs# 01, 06)*

- 8.5 A c 0.08m – 0.1m thick deposit of buried topsoil, comprised of dark brownish black silty sand, was identified sporadically across the northern third of the site. These broadly corresponded to areas with preserved subsoil, though the topsoil appears to have been removed across much of the site to make way for later c 19th century housing. In addition to the identified deposits of subsoil, the topsoil may relate to the former workhouse garden visible on historic mapping (Plate 16).

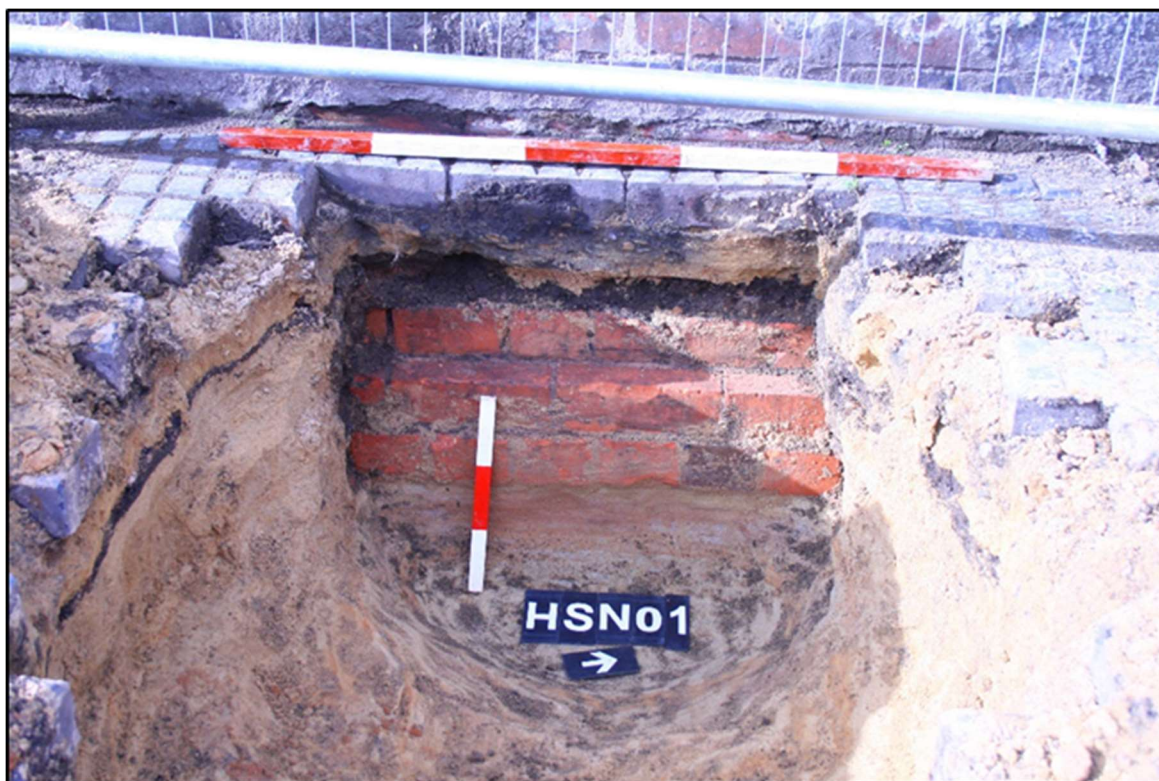
- 8.6 On average, all structural remains (including coal chutes, painted cellar or chimney stack walls, and external walls) identified across the site corresponded to former c 19th century housing, and broadly comprised either single or double lined courses of frogged brick (measuring the standard size of c 215mm x 1.2mm x 65mm) constructed in English Cross Bond. All structures were bonded with the same very light pinkish white mortar. Occasionally, where modern perforated engineering bricks were also identified, these were primarily to the south-west of the site.

Plate 1: Block A: Example of below ground stratigraphy to the north-west of the site within TP01. Showing brick foundations identified across the site. Looking west, scale 1m x 0.3m.

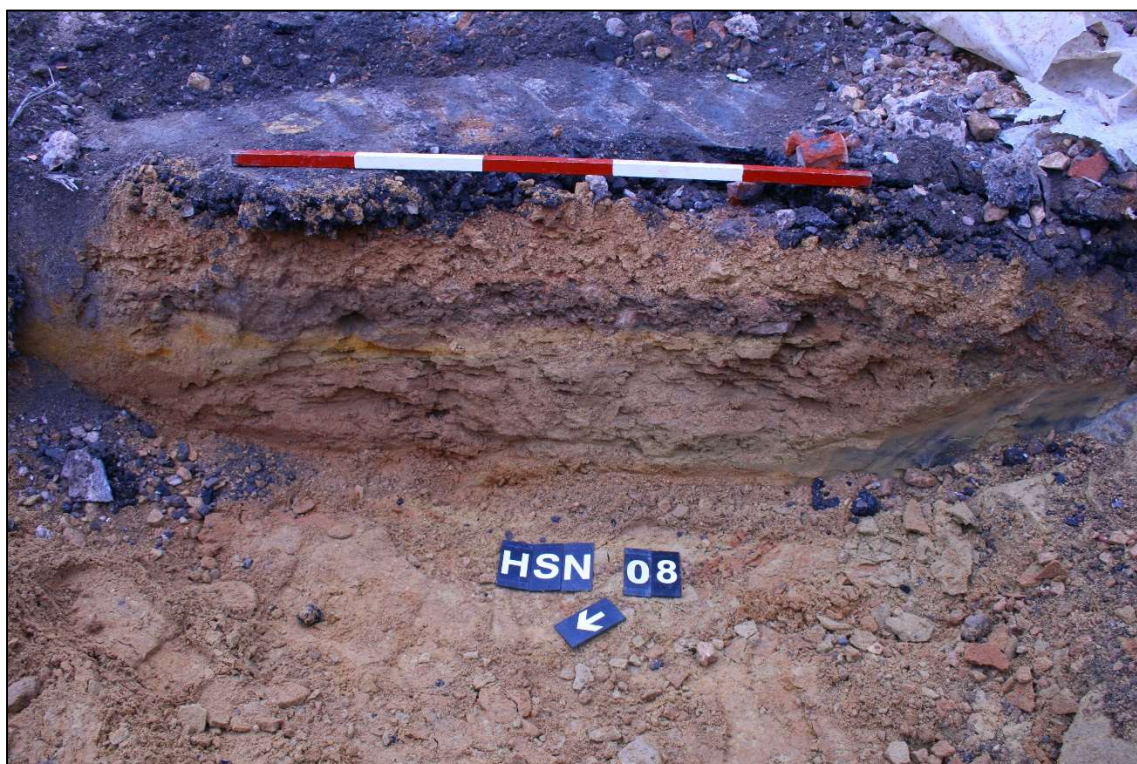
Plate 2: Block A: Example of below ground stratigraphy within the north-west portion of the site, showing a possible buried subsoil horizon. Looking south-east, scale 1m.

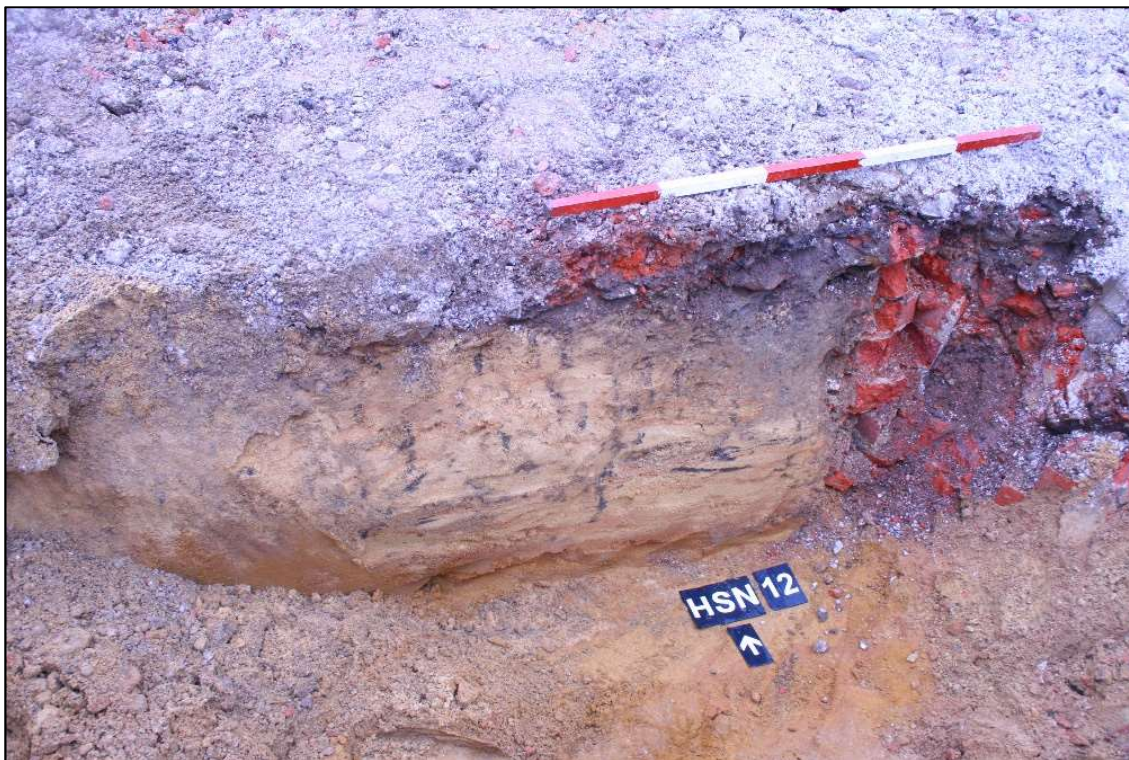
Plate 3: Block E: Example of below ground stratigraphy within the central portion of the site, encountering brick foundations.

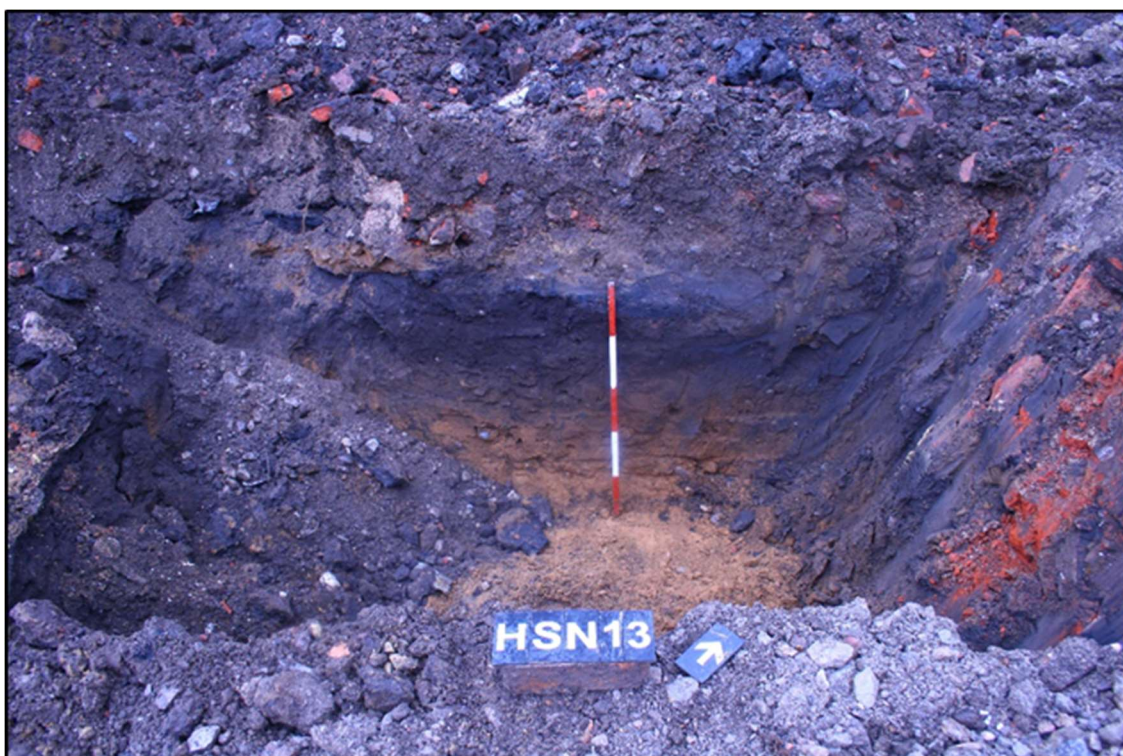
Plate 4: Block D: Example of below ground stratigraphy noted to the north east of the site, showing possible buried subsoil and topsoil horizon. Looking north-east, scale 1m.

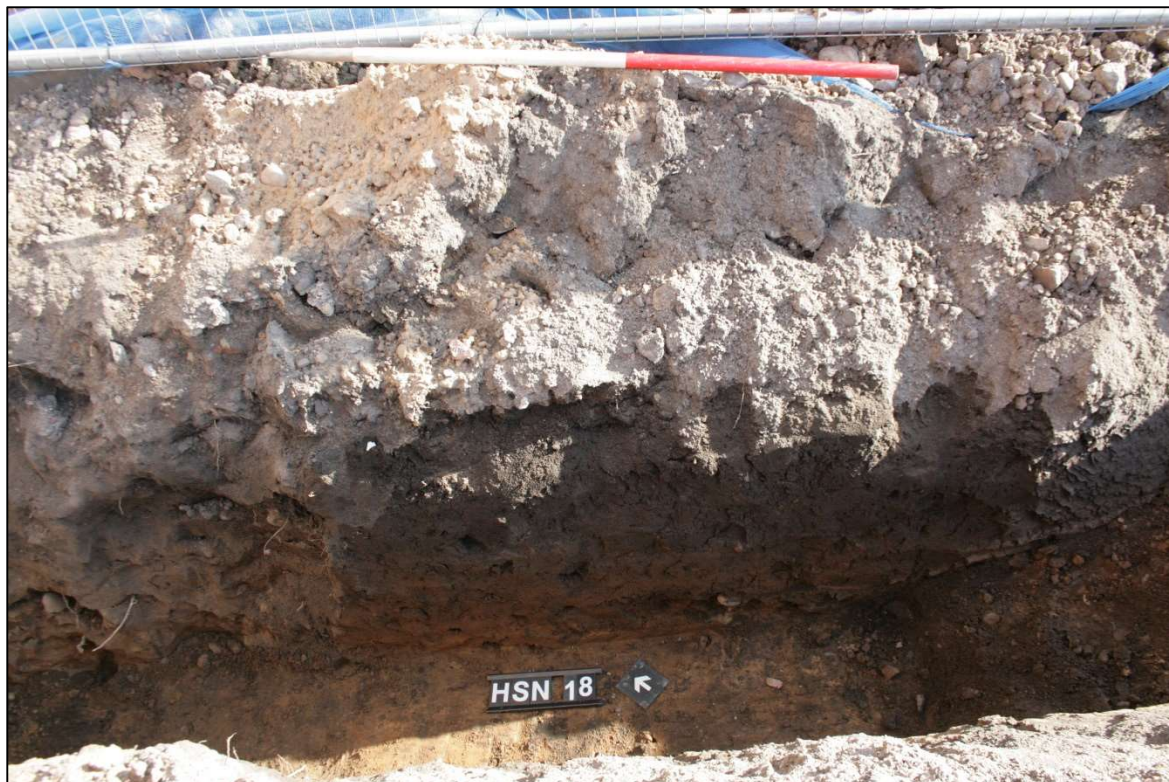
Plate 5: Block D: Example of below ground stratigraphy to the north-east of the site, showing probable buried subsoil deposits and ground levelling material. Looking north-west, scale 1m.

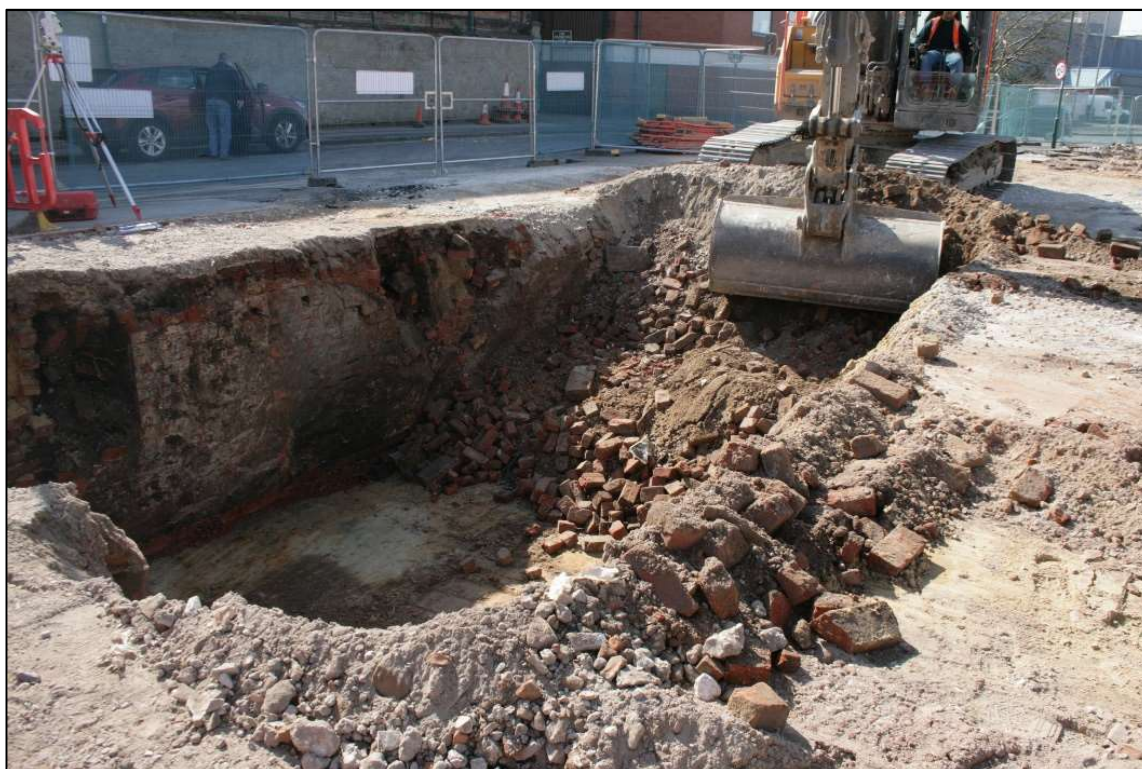
Plate 6: Block B showing wall structures associated with former terraced housing which fronted Great Freeman Street. No scale.

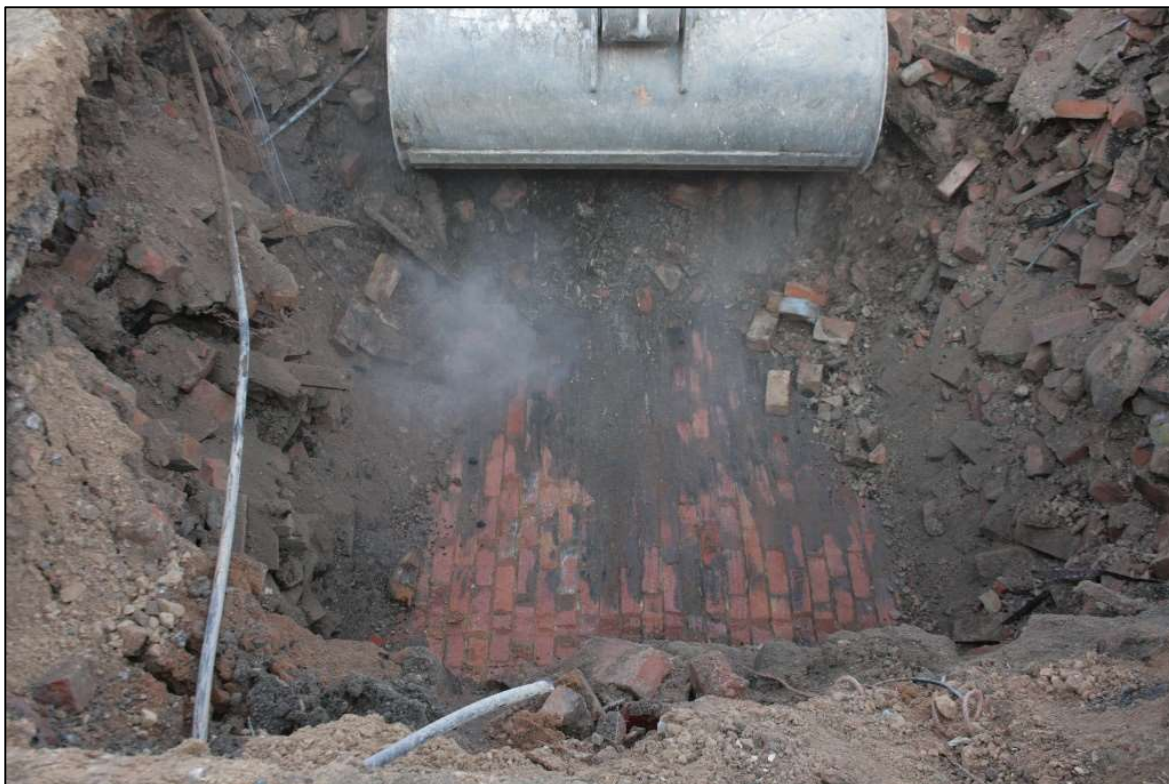
Plate 7: Block A: Floor surface of the former lace factory identified at c 2.7m b.g.l

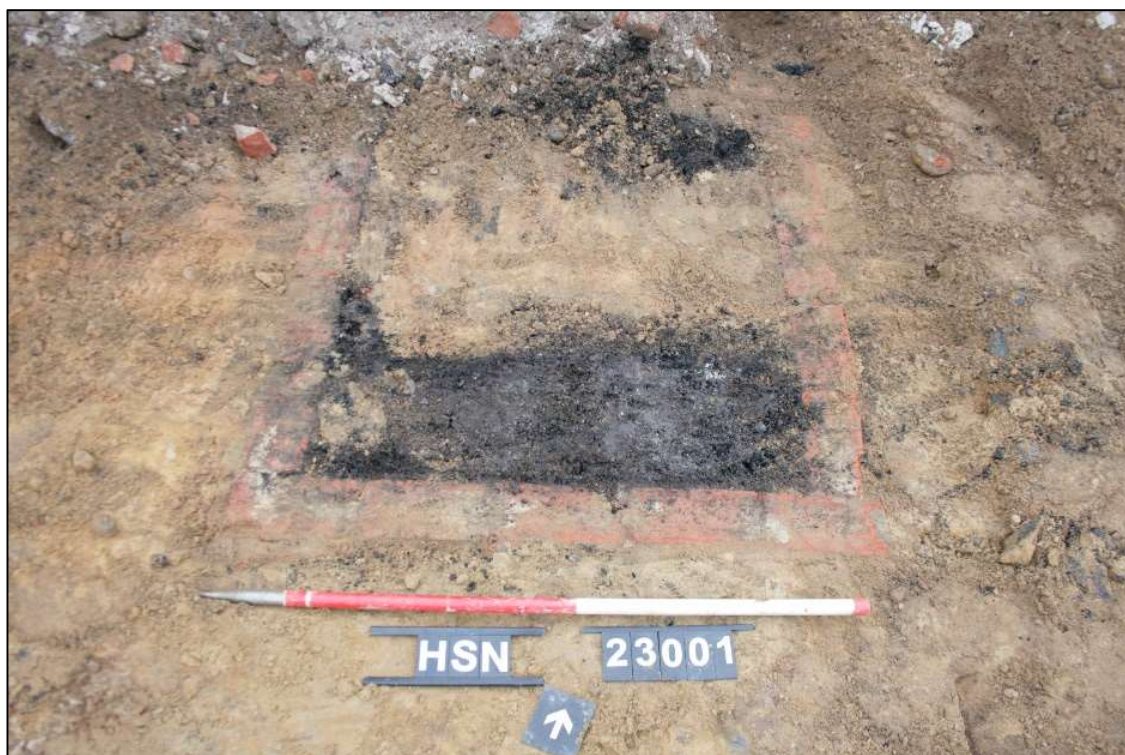
Plate 8: Block B: Partially demolished manhole, backfilled by dark silty sand and clinker debris.

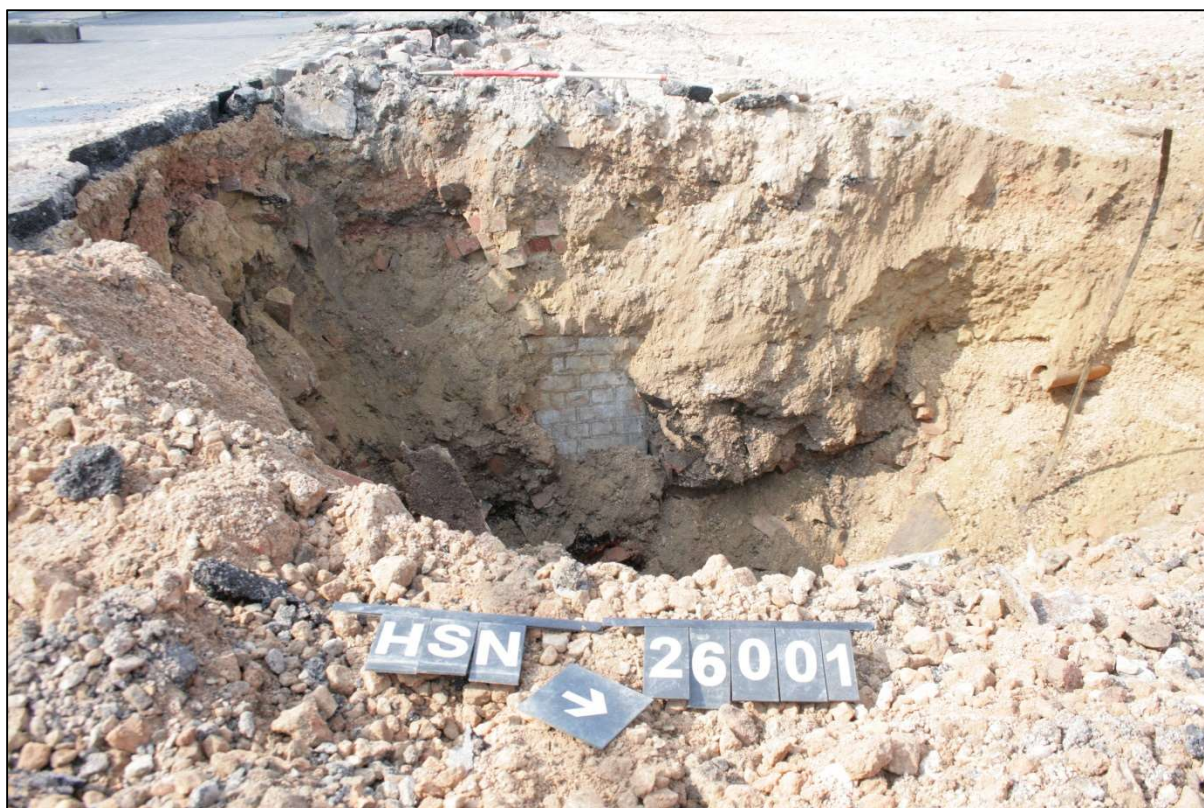
Plate 9: Block A: Painted wall foundations identified within the southern portion of the site. Looking south-west, no scale.

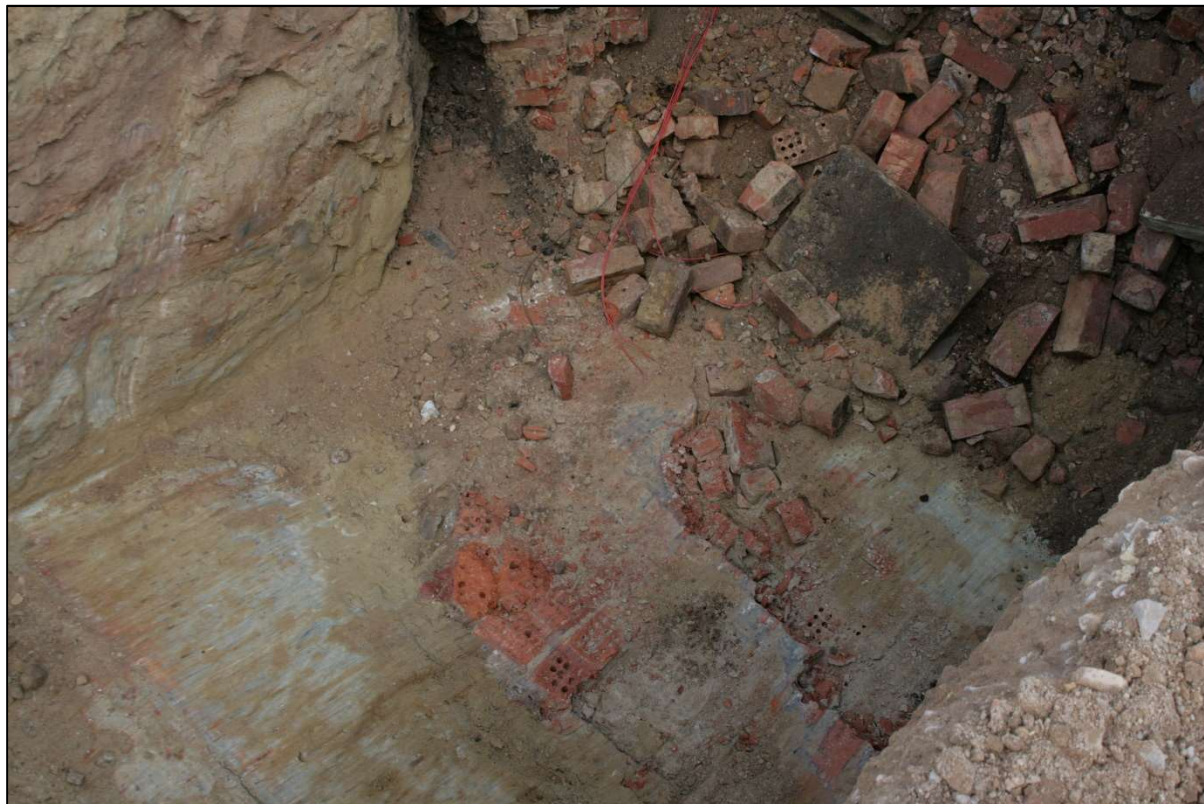
Plate 10: Blocks A&B: Modern engineering bricks identified at 2.7m below ground level. No scale.

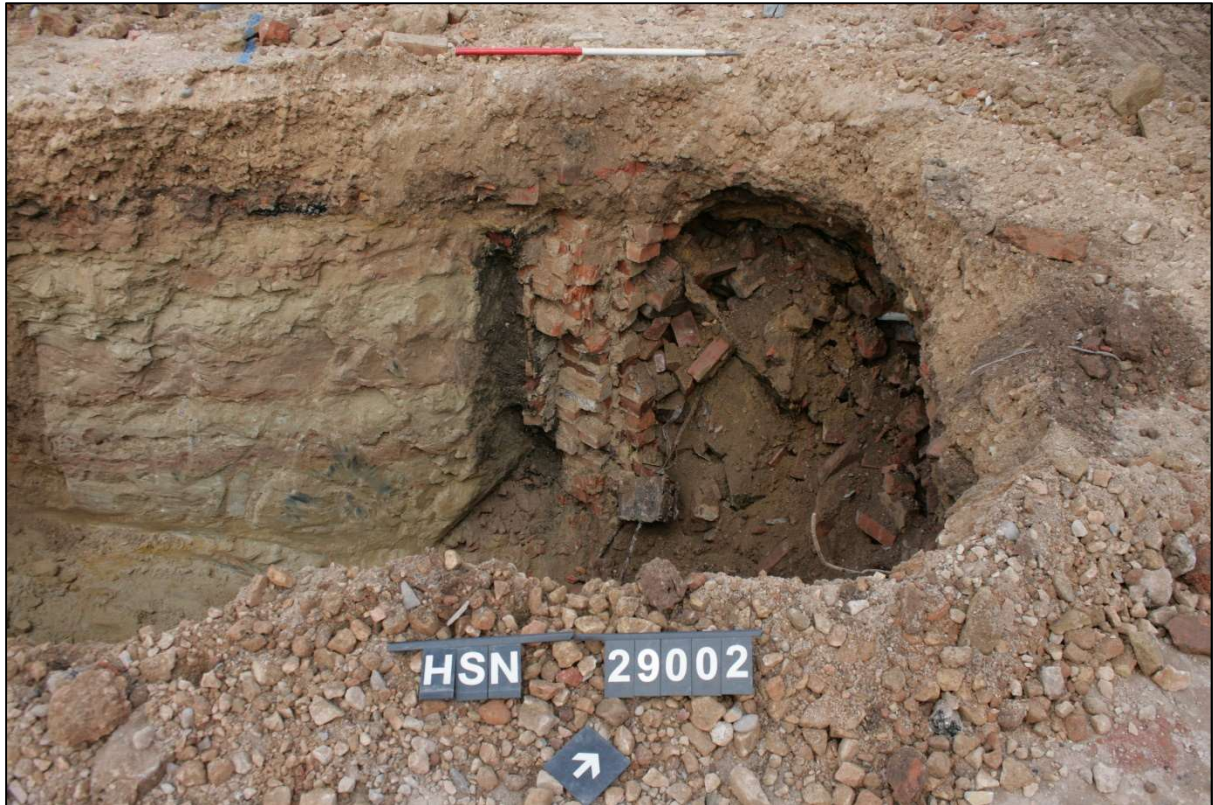
Plate 11: Brick rubble demolition within Block A, showing impact depth. Looking north-east, scale 1m.

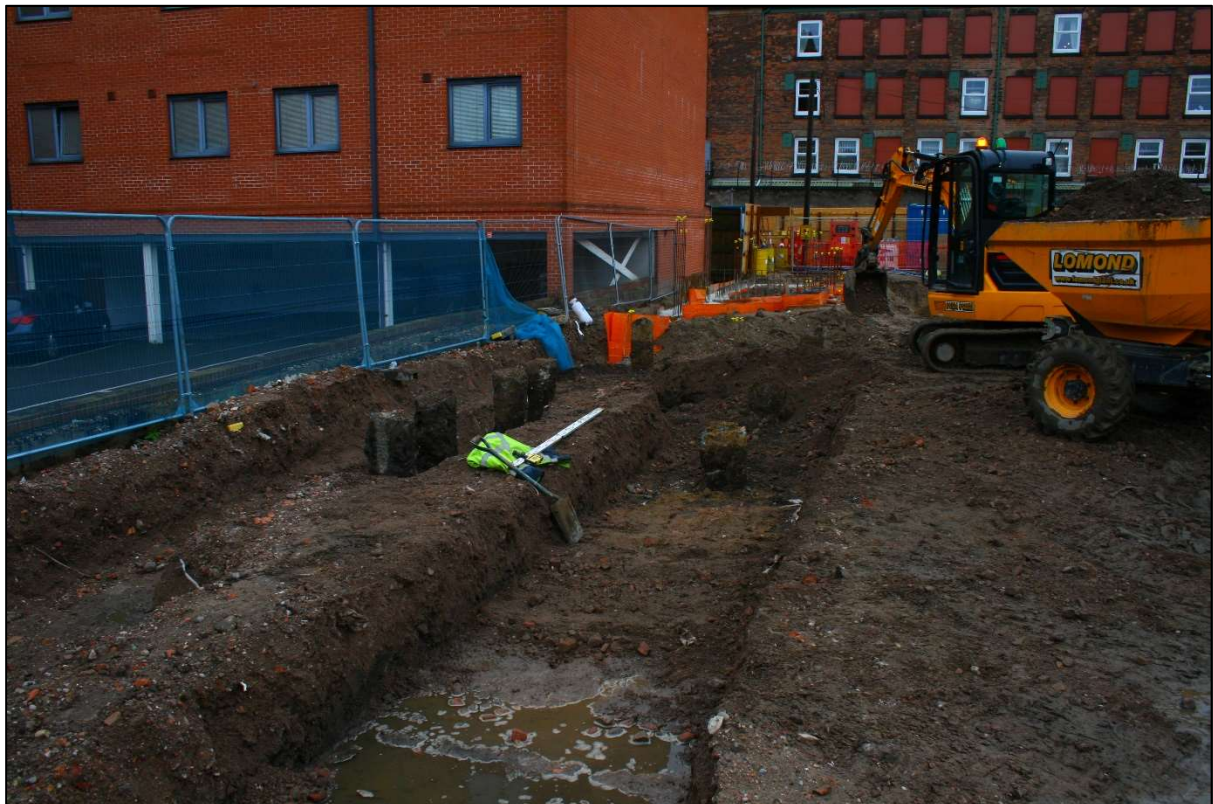
Plate 12: General overview of ground reduction within Blocks C & D. Looking north-east, no scale.

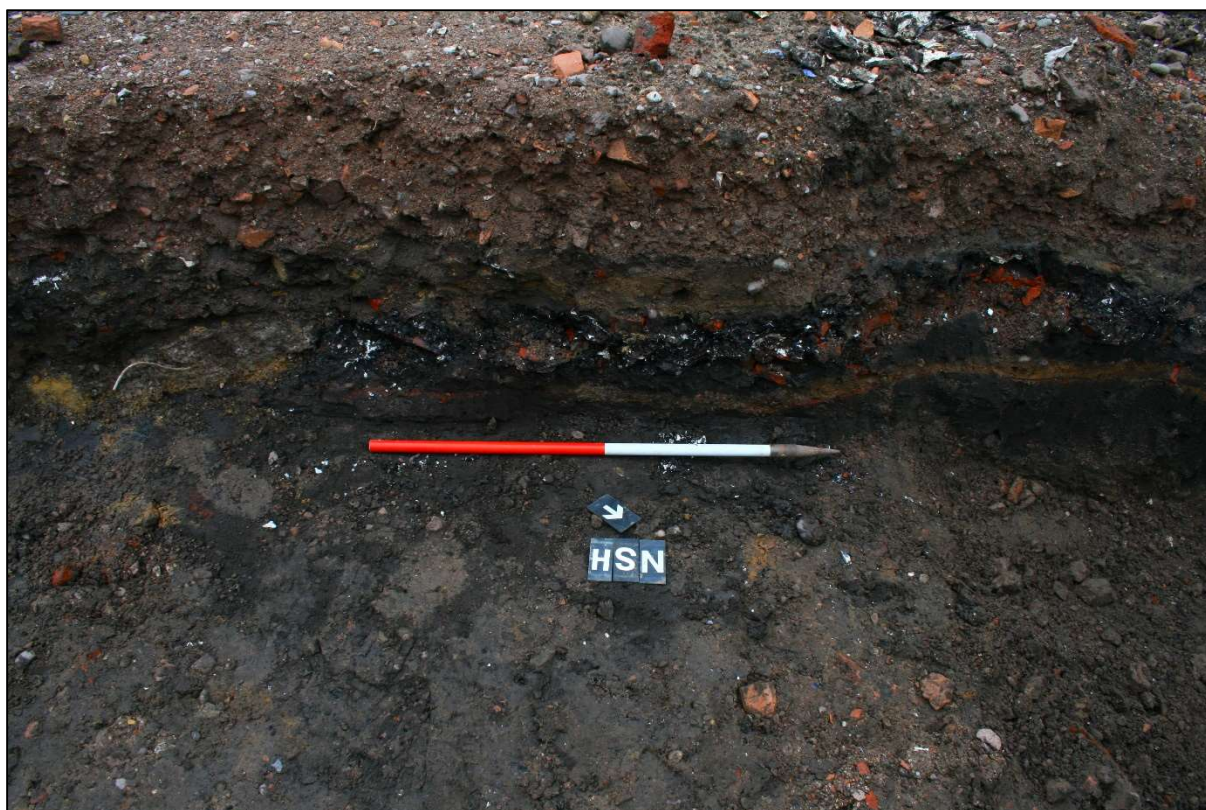
- 8.8 On average the site was sealed by interleaving deposits of ground levelling material and demolition material c 0.2m thick, and gravel hardcore c 0.2-0.3m thick. Tarmac was identified sporadically within the northern portion of the site c 0.1m thick, which had largely been removed prior to archaeological monitoring.

Plate 13: Representative section of ground reduction within Block C & D, showing ground levelling layers and demolition rubble. Looking south-west, scale 1m.

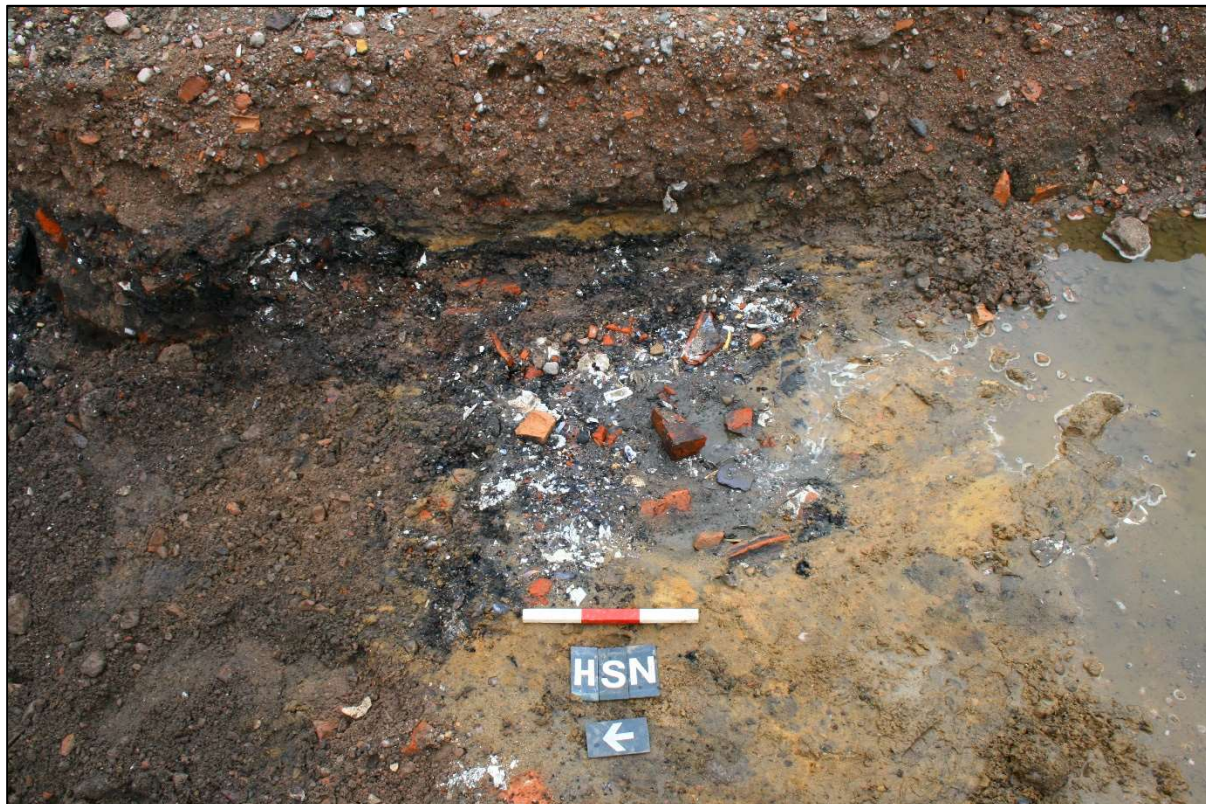
Plate 14: Demolition rubble and ground levelling layers within Blocks C & D. Looking east, scale 0.3m.

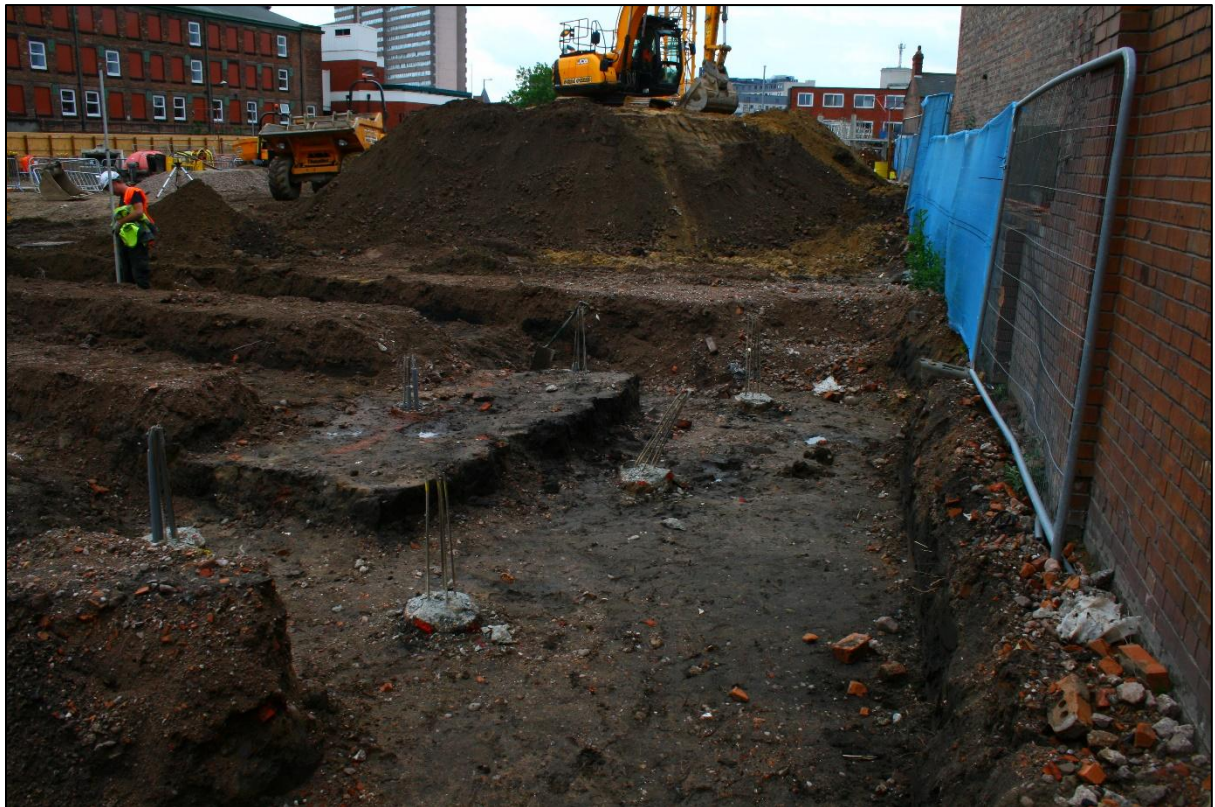
Plate 15: General overview of ground reduction within Block C. No scale.

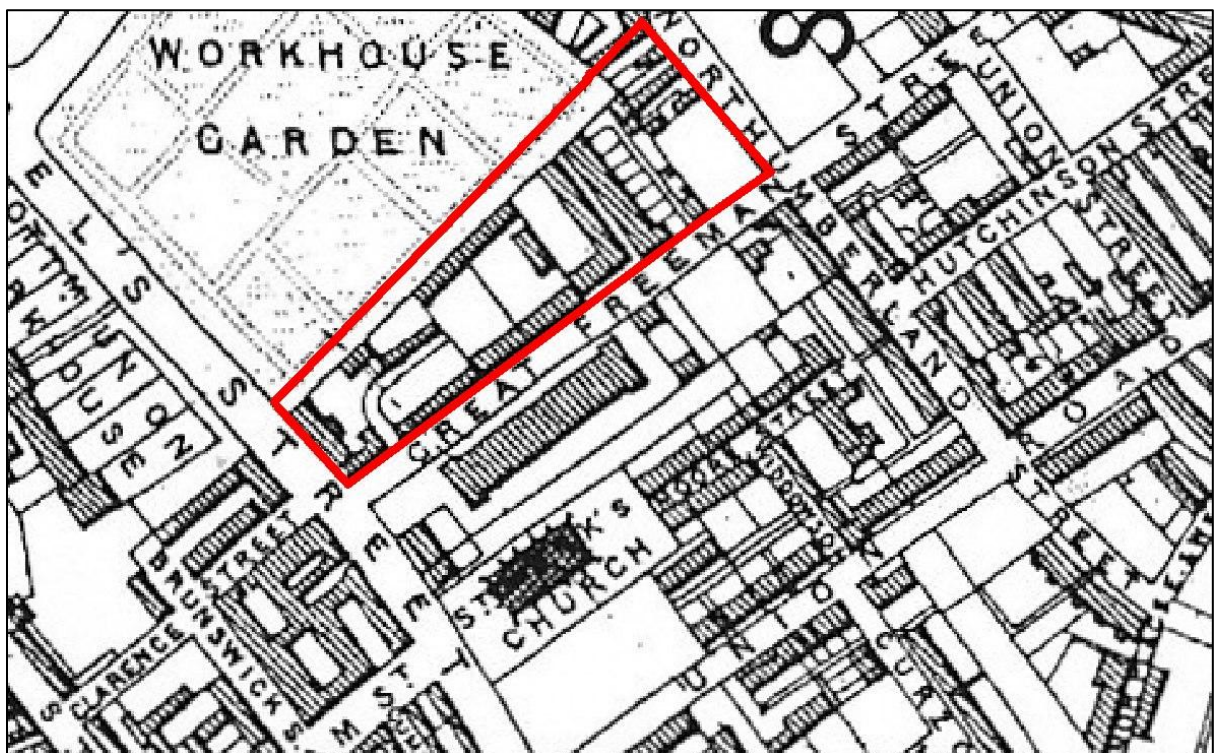
- Intermittent deposits of subsoil and topsoil identified within the northern part of the site likely relate to the former workhouse garden, outlined within the north western corner of the site which is visible in Jacksons Map of Nottingham 1851 (Plate 16).

Plate 16: Jackson's Map of Nottingham 1851. Showing the former workhouse garden to the north-west of the site. Site boundary outlined in red.

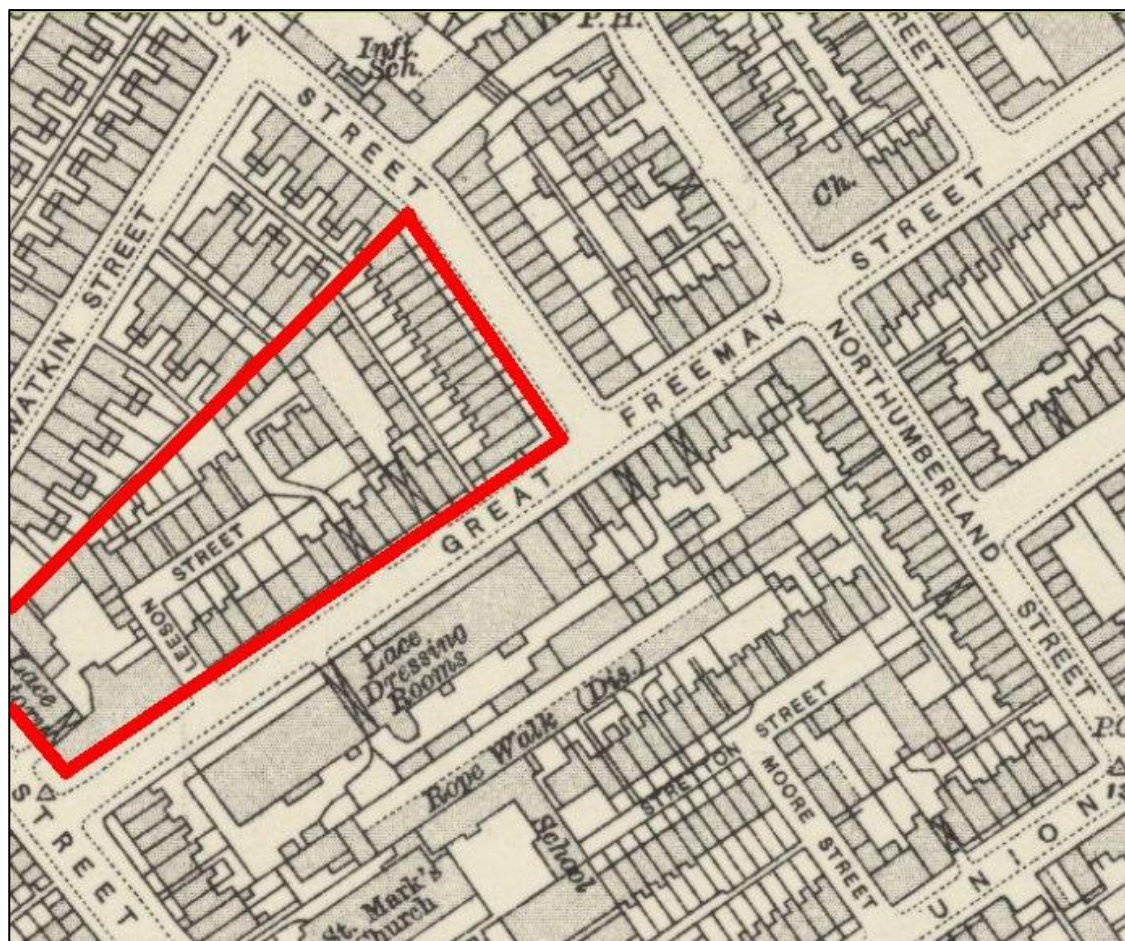
- 8.7 A single brick surface identified within Block A comprised the only identifiable remains of the former lace factory which fronted Huntingdon Street. The floor was identified at a depth of 2.7m below ground level, and comprised a single course of standard sized bricks constructed in Running Stretcher Bond. This was sealed by a 2.5m thick deposit of demolition rubble and mid greyish brown silty sand, and gravel hardcore approximately 0.2m thick. The position of the former lace factory is visible in historic mapping from 1913 (Plate 17)

Plate 17: OS map c 1913, showing the position of the lace factory and workers houses. Site boundary outlined in red
