**AN HISTORIC BUILDING SURVEY
OF INDUSTRIAL BUILDINGS AT THE
CORNER OF EASTERN BOULEVARD
AND RYDAL STREET, LEICESTER, 2007**

A report for The Developments Factory

OS Grid Ref. SK 5816 0366
TPA Project Code: EBL.1
November 2007

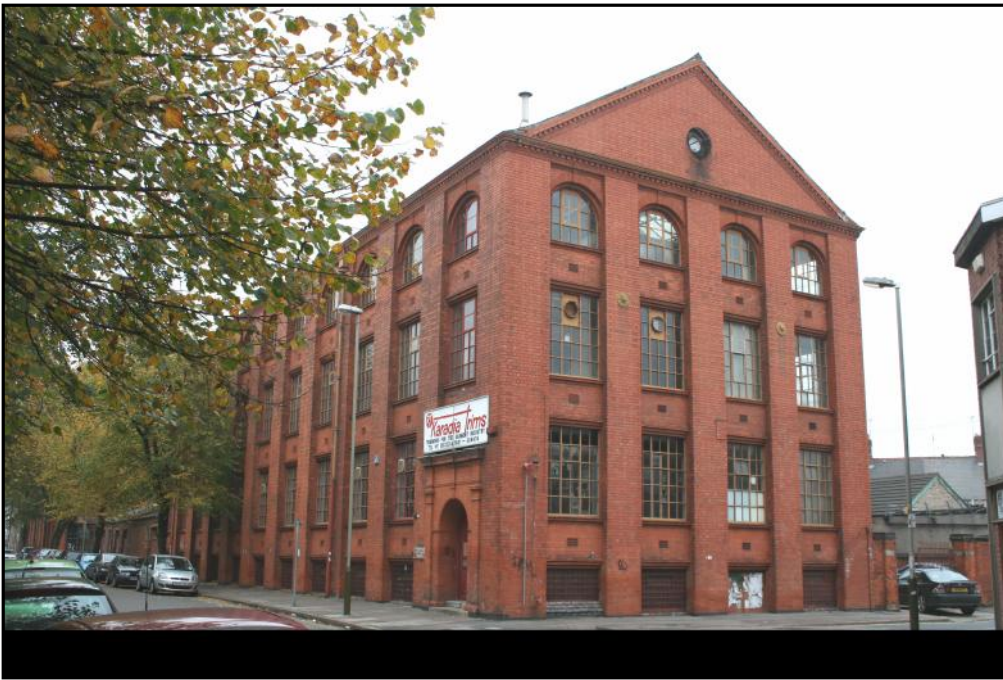
PLATE 1 (DAP 1)

The original part of the building (A on Fig. 3) is 11 window bays long and four wide, built in pier and panel style, and with a gabled slated roof (Plates 1). It has a high basement and three storeys above this, the top one being open to the roof timbers and to skylights. The structure is built of red and blue brick, laid in English bond on the main street frontage and a mixture of English and Sussex bonds to the rear; there is little evidence for stone being used on the exterior. Finer reddish brick is used on the public west and south frontages, and a more

Plates of the exterior of the Karadia Trims building in Leicester. 1: view of the south-west corner; **2:** the east side showing the extended part and an office bay window; **3:** the single-storey north warehouse extension.
DAP: Digital Archive Photo. number

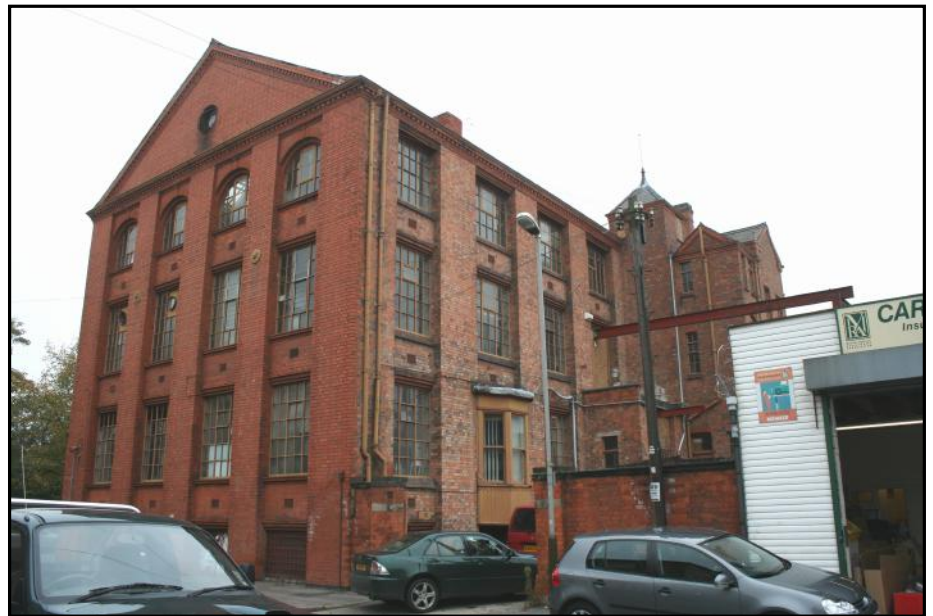
PLATE 3 (DAP 21)

The north extension is also 11 bays long and 4 wide, although a straight joint showing on the west side suggests it was built in two stages, 5 bays to start with and 6 added later. The structure is brick-built, the first phase in Flemish bond, the second in English bond. The roof is double-gabled with corrugated asbestos covering and the east and south sides of the building are clad with iron sheeting (Plate 7). Two large delivery doors (one since infilled) in the north end

on Ullswater Street (Plate 3) suggest that the north extension was probably the packaging and storage section / warehousing part of the factory. When either phase was added is unknown.

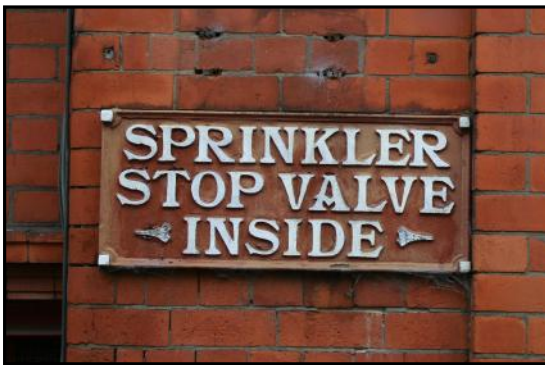
PLATE 5 (DAP 9)

The street frontage has the public entrance in the 11th bay. This is set within a large round arched entry with restrained classical-style surround. The wooden doors and a nearby sign (Plate 5) are probably original and the present signboard above the entrance may mask an original title. The south and north gable ends differ. The south on Rydal Street is similar to the west frontage, whilst the north face (now partly obscured by the later north extension and some large boarding) was probably unbroken apart for exits to an external fire escape staircase.

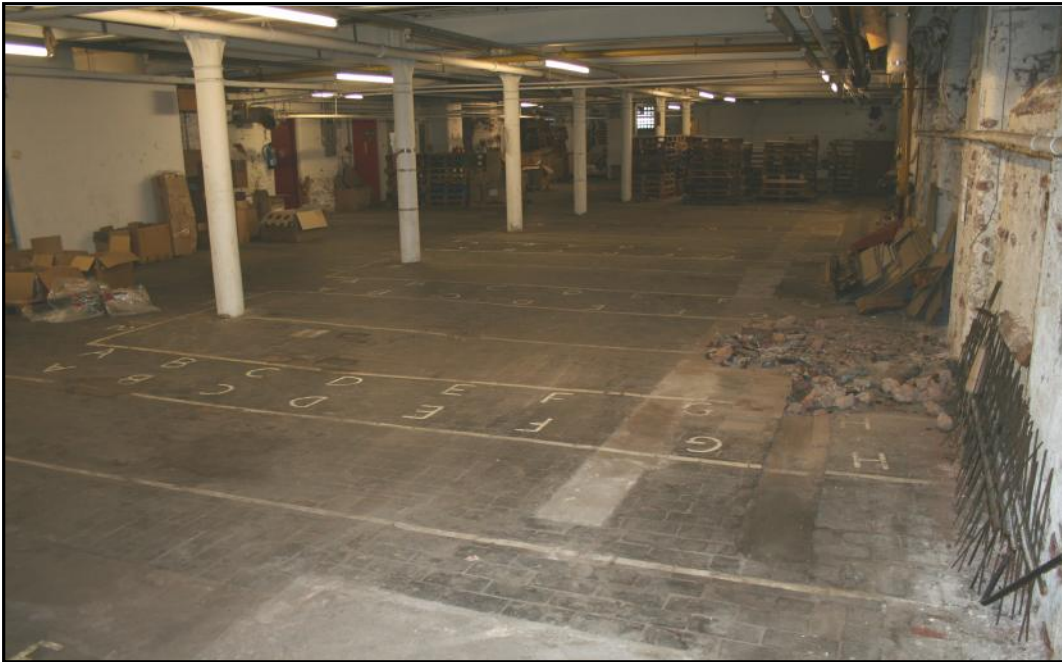
PLATE 8 (DAP 63)

The basement has a brick floor which features parallel lines of timber running most of the length of the west area and part of the east side; in places concrete has replaced some of the timber (Plate 8). These 'trackways' may have carried the weight of the feet of conveyor belts. In other places wooden blocks have either replaced bricks or indicate the positions of light machinery. Heavy machinery was situated in the northernmost bay, as indicated by several concrete slabs in the floor. Although the basement may well have been where the 'rough-stuff' cutters were situated there is little indication of overhead line shafting amongst the pipe-work beneath the ceiling. There are, though, openings in the north-east corner ceiling where lifting and lowering of materials etc may have occurred.

Plates of the basement area of the Karadia Trims building in Leicester. 8: view from the north-west corner showing the open space and a possible trackway on the west side of the floor area; 9: one of the window bays with a reversed relieving arch showing to base; 10: scissor-bracing to the floor joists. *DAP: Digital Archive Photo. number*

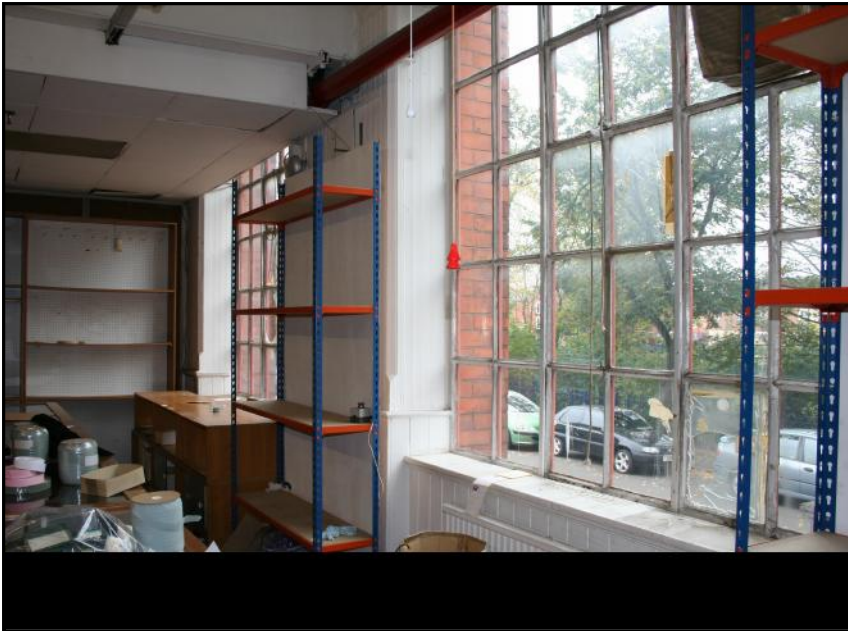
PLATE 11 (DAP 127)

The ground-floor of the original building is raised above the outside surface level and is reached by a flight of stairs off the street entrance on Eastern Boulevard. The first three bays at the south end were used for offices on the east side with probably a showroom / shop opposite, where some wall panelling still survives (Plate 11). The whole floor area was heated by radiators and the indications are that only light industrial duties were carried out here. Metal columns running down the centre of the building support girders and tend to become narrower in girth the higher the floor level (Plate 12). There are indications of a former window in the north wall showing through the paintwork.

Plates of the ground floor area of the Karadia Trims building in Leicester. 11: panelling in the south-west corner of the main building, indicating the former office area above the street entrance; **12:** one of the cast-iron columns holding the girders that support the next floor; **13:** view of the interior of the north warehouse extension. *DAP: Digital Archive Photo. number*

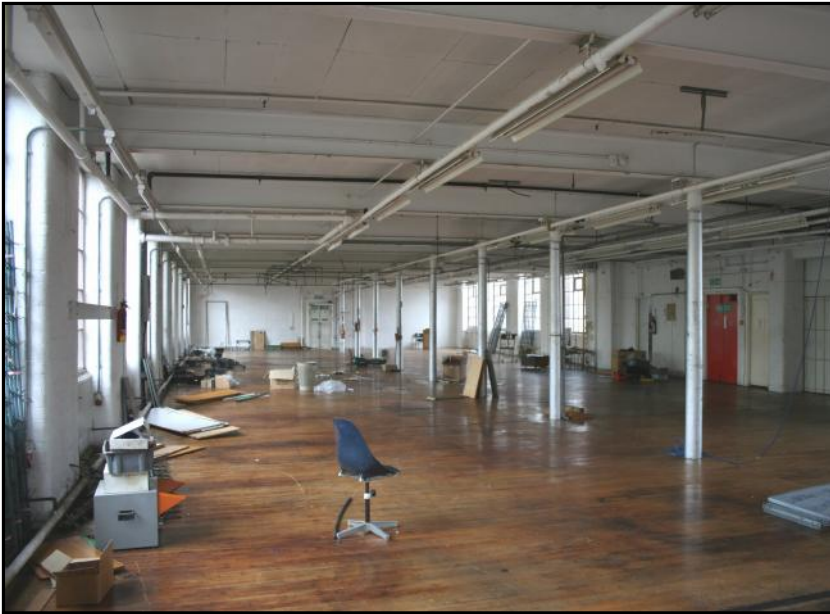
PLATE 14 (DAP 130)

This floor has an oak board floor and a modern ceiling. There are modern partitions at the south end but there are indications in the floor and on the wall of a former supervisor's office in the north-east corner. The floor area is otherwise open (Plate 14) with little evidence from the floor that there may have been machinery or presses used in the 'clicking' process (the cutting of uppers, linings etc), a procedure usually carried out at mid-floor level. The original flooring may have been replaced. A doorway above the east-side loading bay may also be a later addition, with part of a gantry projecting into the room to take a mechanised travelling hoist (Plate 15).

Plates of the first floor and attic areas of the Karadia Trims building in Leicester. 14: view of the first floor working area; **15:** high-level doorway and west end of gantry; **16:** remaining weighing machine on attic wall; **17:** view of roof structure and raised platform in attic. *DAP: Digital Archive Photo. number*

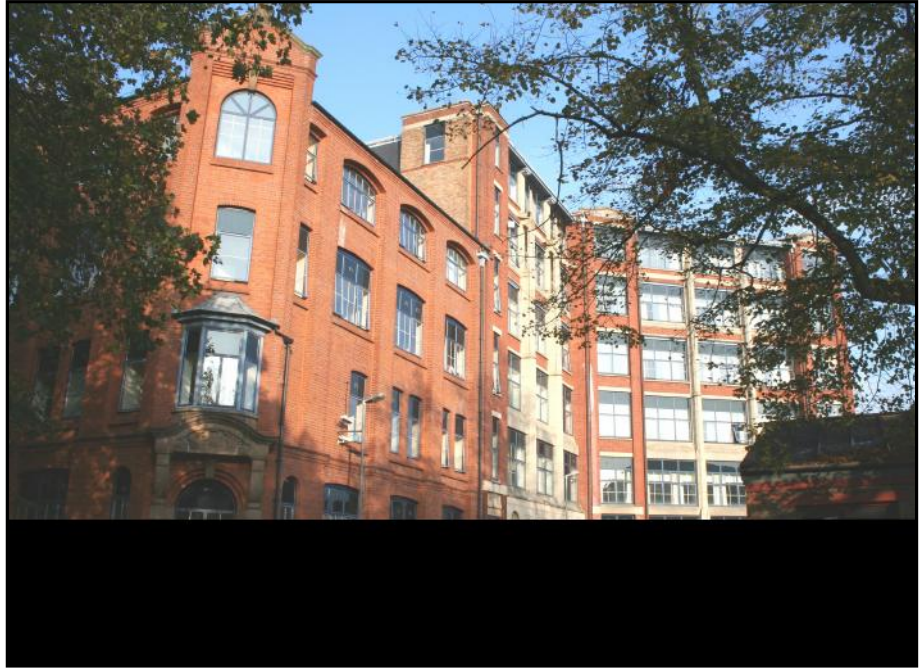
PLATE 18

Other buildings in the vicinity of the Karadia Trims building: **18:** the Benjamin Russell & Son hosiery complex of 1910 and 1924-25; **19 and 20:** the former Liberty Shoes Factory, built 1918-19; **21:** Rydal Cottages built 1897.

At the position of Eastern Boulevard by Mill Lane, Kelly's 1908 Directory lists W. A. Thompson & Co. shoe manufacturers. Earlier, a certain William Thompson, bootmaker, had been based in Leamington Street (Kelly 1891); this may have been the same individual or a relative. A later directory of 1916 lists W. A. Thompson & Co. on Eastern Boulevard at the corner of Ullswater Street, and Russell Benjamin & Sons, hosiery manufacturer, at the corner with Mill Lane (Kelly's Directory for Leicestershire and Rutland 1916). As the latter building, opened in 1911, still stands between Mill Lane and Ullswater Street (Plate 18), the Karadia Trims building must therefore have started as Thompson's shoe factory.
