Broadmarsh Bus Station and Car Park, Nottingham: Archaeological Monitoring and Recording

Report Number: 003/2020

Document Title: Broadmarsh Bus Station, Nottingham: Archaeological Monitoring and Recording.

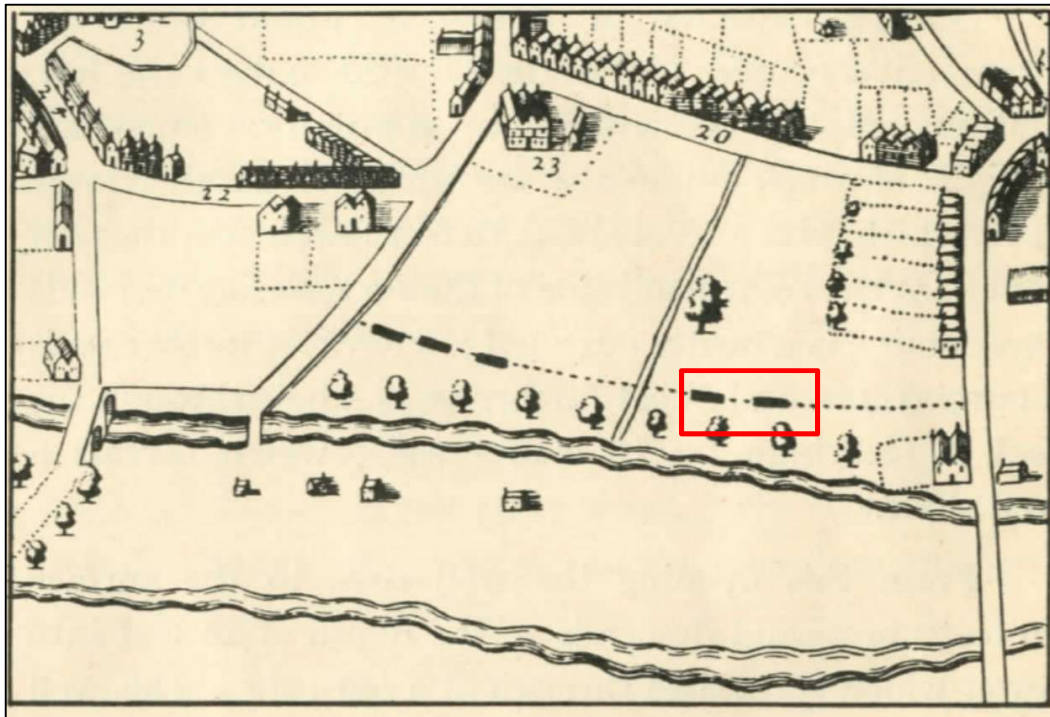
Excerpt from the Thoroton Society of Nottinghamshire Excavation Section: Second Annual Report c. 1937, pp. 18. Segments of the wall which appear to be within the site boundary are outlined.

- 11.3 Probable sections of the wall were thought to have been identified during earlier excavations in the 1930s (pictured below), however the position of these wall segments are no longer securely locatable. Neither the fabric of the wall, nor the dimensions are given as part of the earlier fieldwork descriptions, however the approximate location given on the map (whilst unscaled), lend weight to the suggestion that they represent a part of the same feature or enclosure.

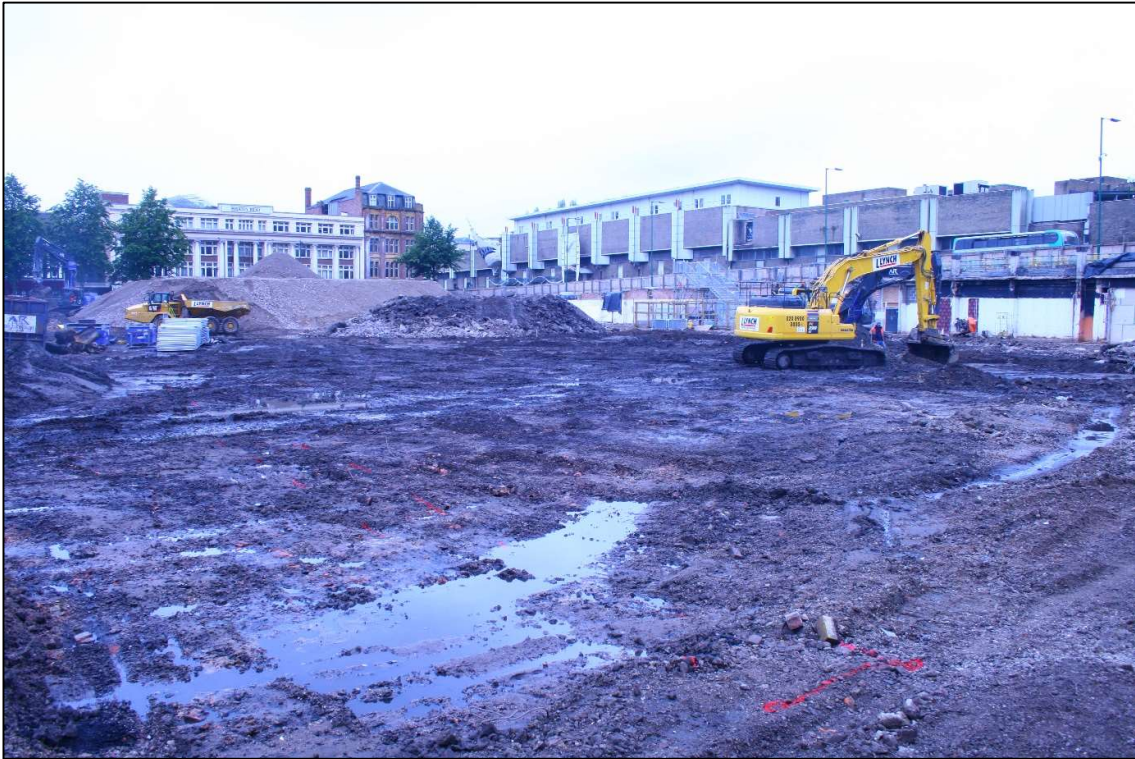
Plate 1: General site view prior to ground truthing. No scale. Looking north-west.

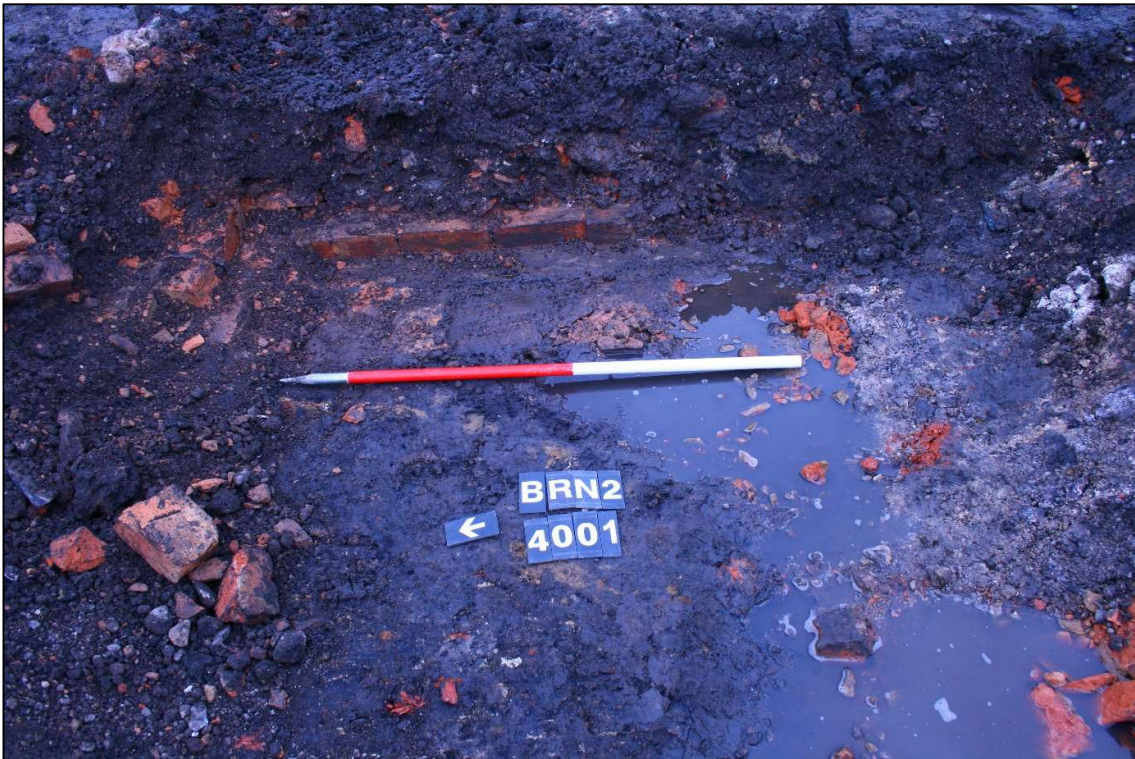
Plate 2: Trench 1, showing 19th century house foundations [4001]. Scale 1m, looking north.

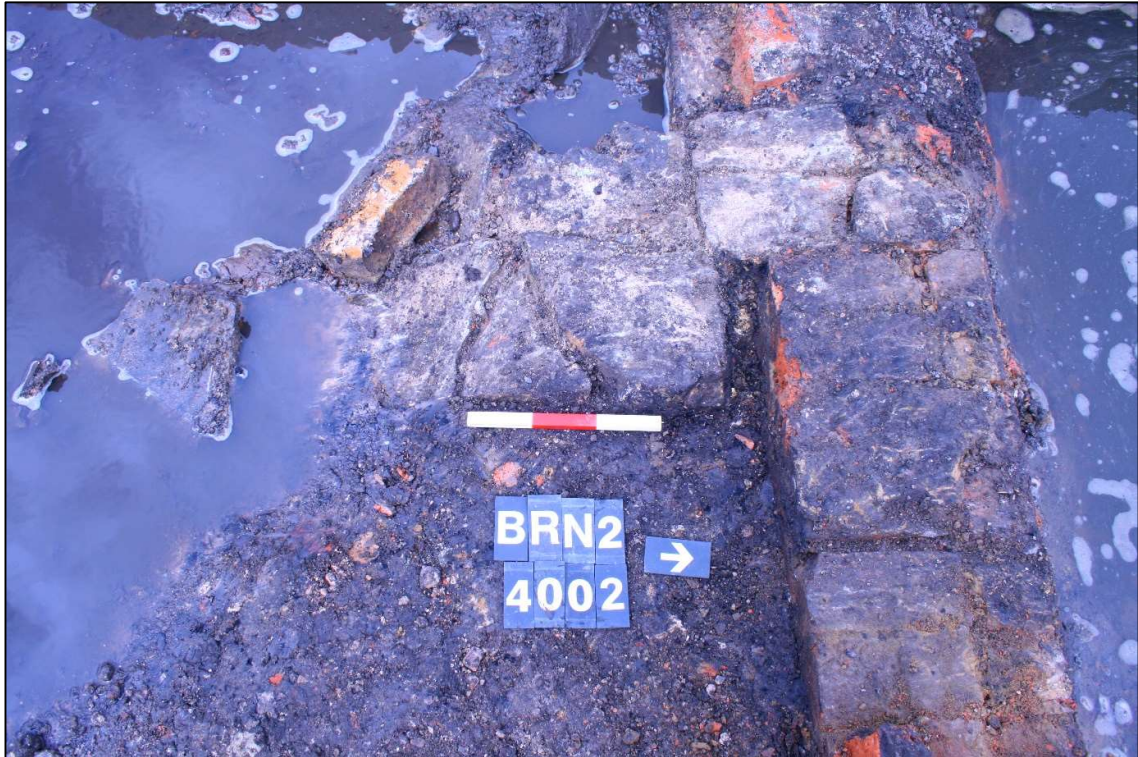
Plate 3: Trench 1, showing 19th century house foundations [4002], which has been keyed into adjacent wall [4003] to the north. Scale 0.3m. Looking west.

- 7.2.6 An intercutting group of mixed sandstone and brick wall foundations, made up of structures [4002, 4007 and 4008] were identified within the central and southern portion of the trench. Each measured approximately 0.5m in width, however the depth remains uncertain due to the ingress of ground water. Each comprised at least one course of irregularly bonded rubble sandstone or brick, with no obvious mortar bonding material. Part of the sandstone structure of [4002] had been keyed into wall [4003] at its northern most edge, suggesting that the group of structures are broadly contemporary in date. It is possible that earlier building debris was reused in the construction of the group of structures, however the lack of securely datable material makes this difficult to ascertain.

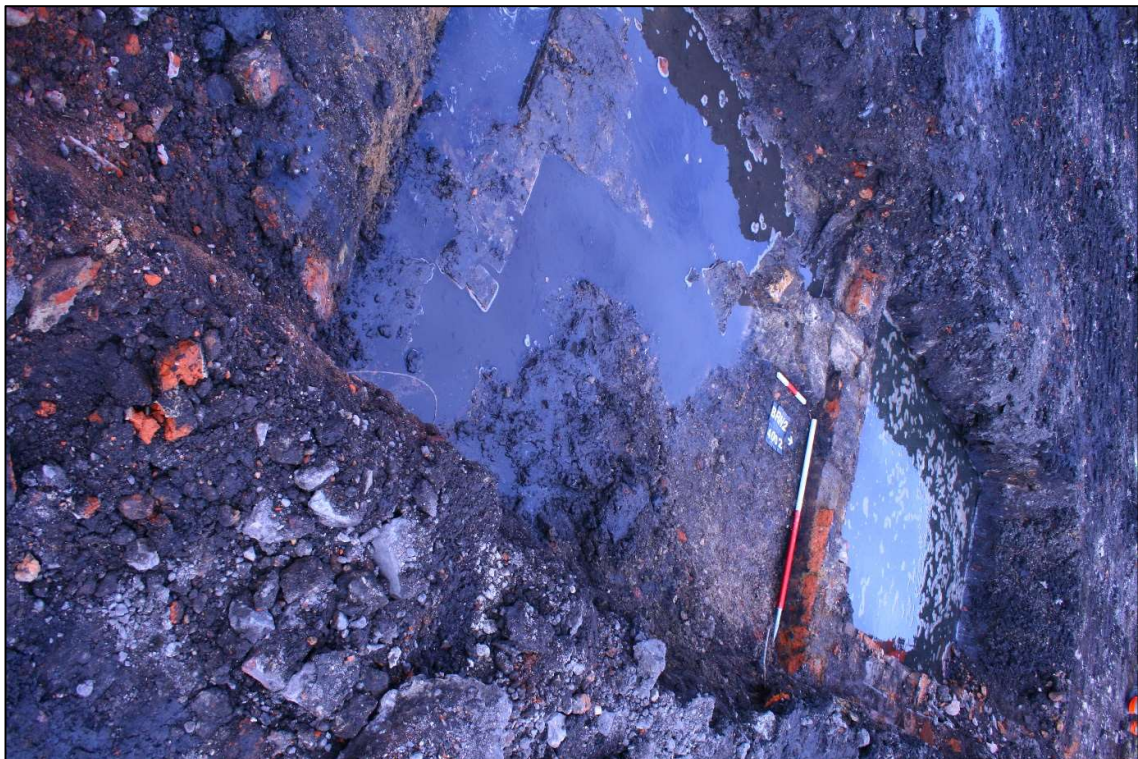
Plate 4: Trench 1, overview. Showing probable former house foundations [4001, 4002, 4003, 4007 and 4008]. Scale 1m x 0.3m. Looking north-west.

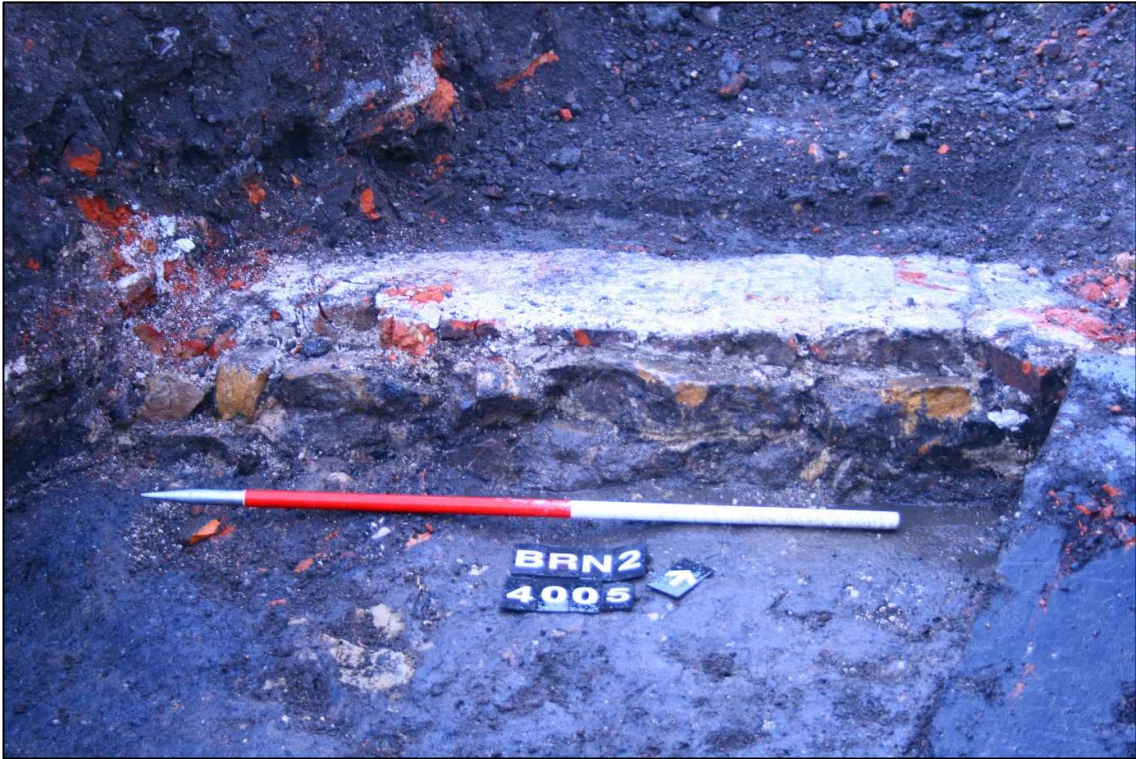
Plate 5: Trench 2, showing the remains of the probable medieval sandstone wall [4005], underlying 19th century housing foundations [4006]. Scale 1m. Looking north.

- 7.2.10 Wall [4005] was aligned west-south-west by east-north-east, and directly overlay wall [4006]. The structure composed a single remaining course of unfrogged, red brick (measuring c 230mm x 110 x 70mm) arranged in English Garden Wall bond, which had a total width of 0.36m. The structure was bonded with a modern, very light pinkish white mortar, though some areas to the north-west appeared to have been repaired at a later date with cement. The wall roughly corresponds to rear property boundaries identified on historic mapping (Jackson 1851; Fig 9), and appears to have reused the earlier sandstone foundation [4005] as structural support.

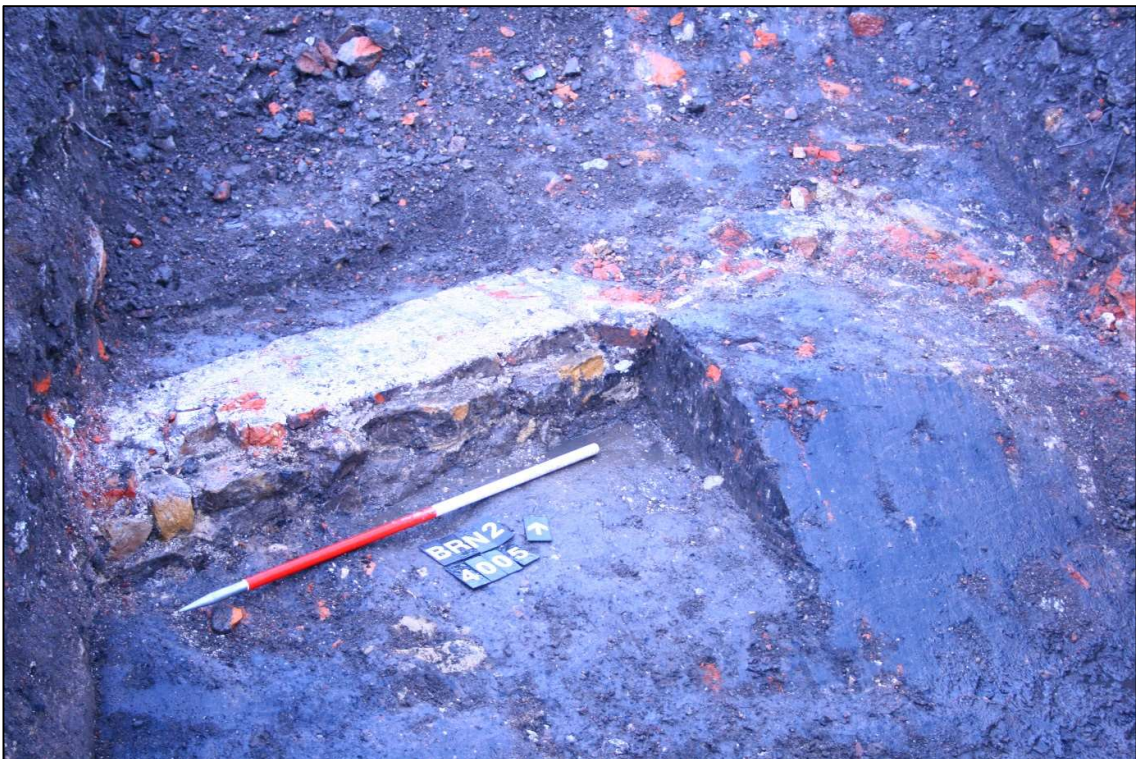
Plate 6: Trench 2, oblique view of probable medieval sandstone wall [4005], overlain by later 19th century foundations [4006]. Scale 1m. Looking north.

*Medieval**Possible wall foundation [4006] (Plate 6; Figs 4)*

- 7.2.9 Two courses of sandstone rubble [4006] were identified at approximately 0.4m below ground level within the northern third of the trench, aligned west-south-west by east-north-east, measuring approximately 0.44m in width. The structure was formed of roughly hewn sandstone rubble, bonded with a yellowish white sandy mortar with shell and stone inclusions. Wall foundation [4006] shares many of the same attributes (alignment, construction materials, and depth of discovery) as the section of Friary wall uncovered in the Phase 1 evaluation (Poole *et al* 2018, 19-20) and may represent a continuation of this structure. As with Trench 1, the wall foundation appears to have been re-used as part of a later brick-built structure (discussed below 7.2.10).

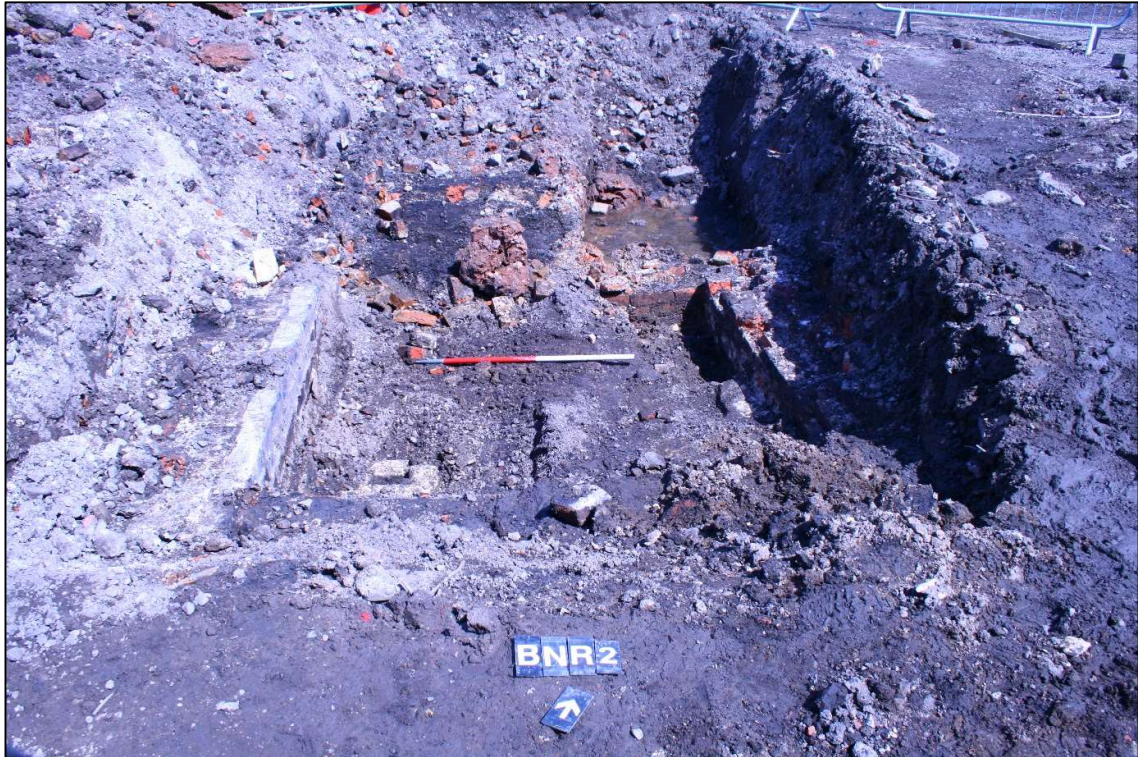
Plate 7: Trench 3, overview. Sale 1m. Looking north north-west.

Trench 3 (7.2m x 3.3m) (Plate 7; Figs 4)

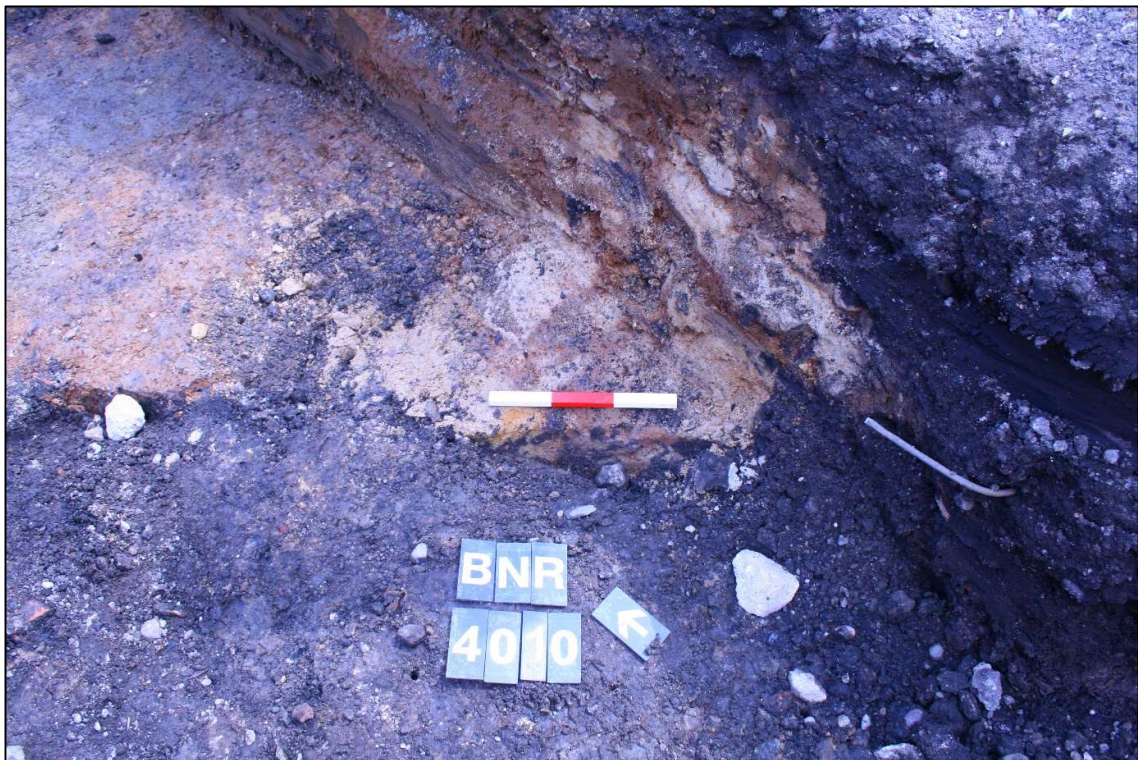
Plate 8: Trench 4, showing the remains of truncated medieval sandstone wall [4010], within the earlier BRN1 Trench 3 footprint. Scale 0.3m. Looking north.

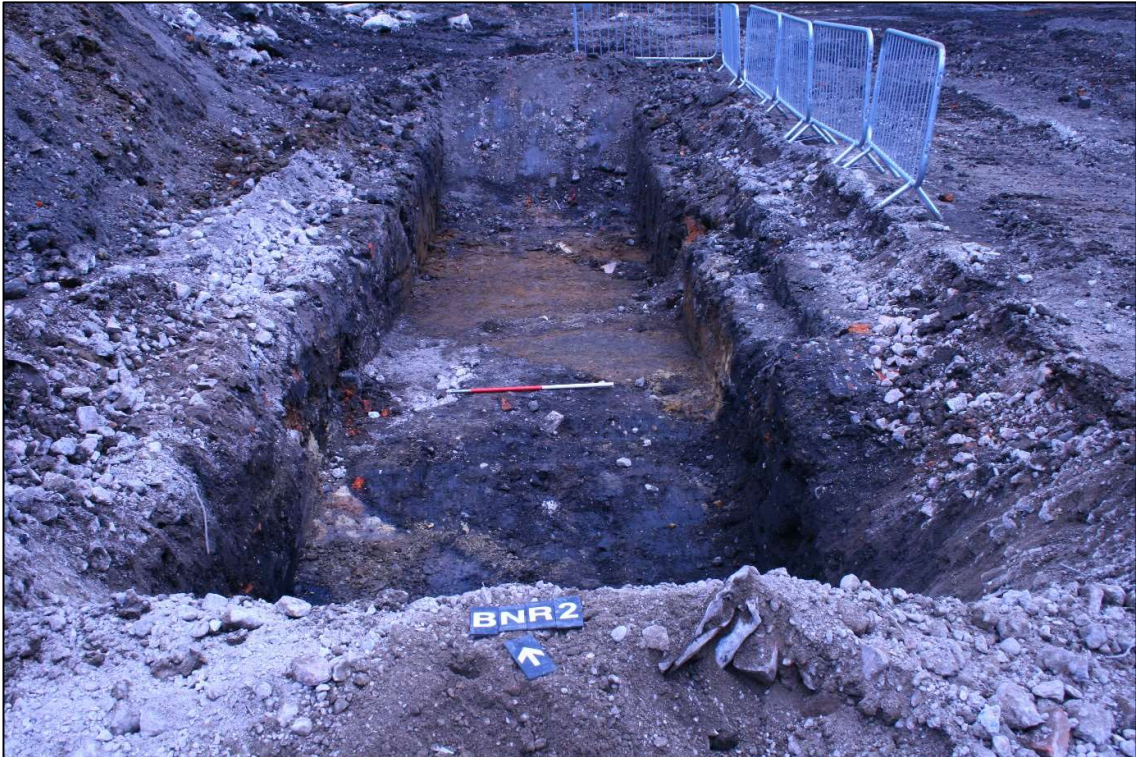
Plate 9: Trench 4 overview. Showing the base of wall [4010] in the background. Scale 1m. Looking north north-west.

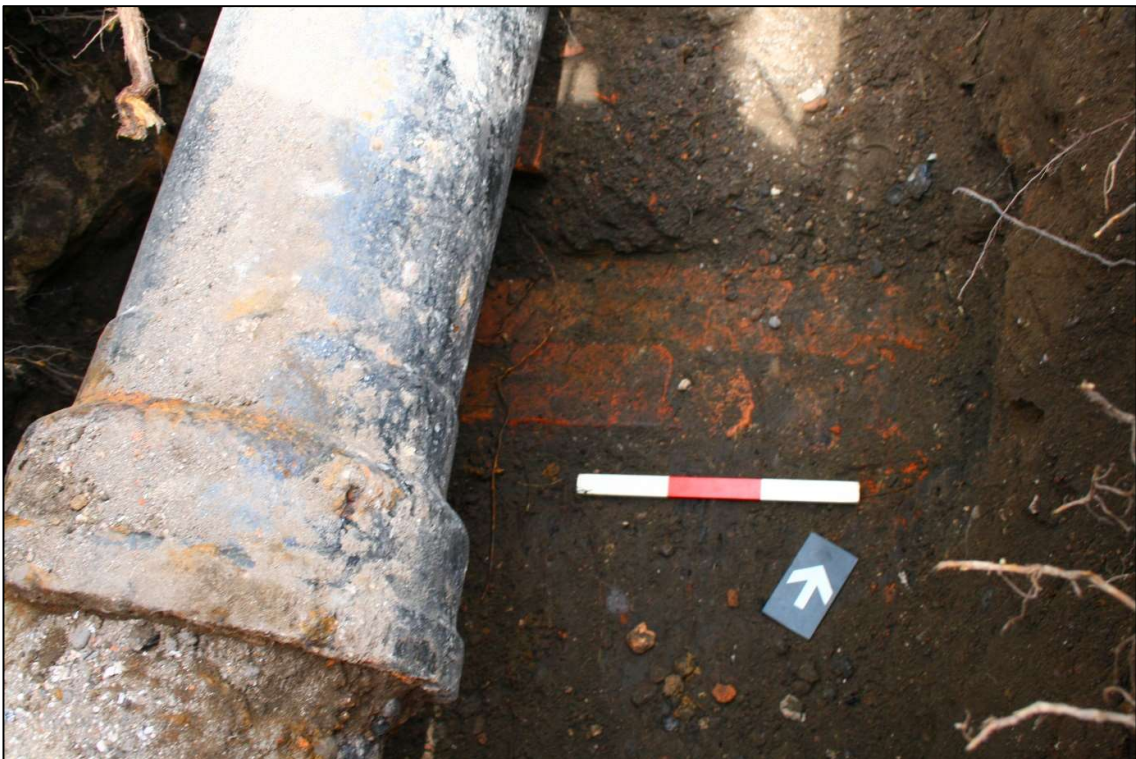
Plate 10: Trench 5, Probable 19th century foundations [4023], identified within the base of the trench. Scale 0.3m. Looking north.

- 7.2.14 An east by west aligned partial surface of an unfrosted, red brick wall [4023] was identified within the central portion of the trench. The structure measured 0.4m in width and was arranged in English garden wall bond which extended beyond the limits of the trench on the east and west. No other characteristics were recorded for this feature.

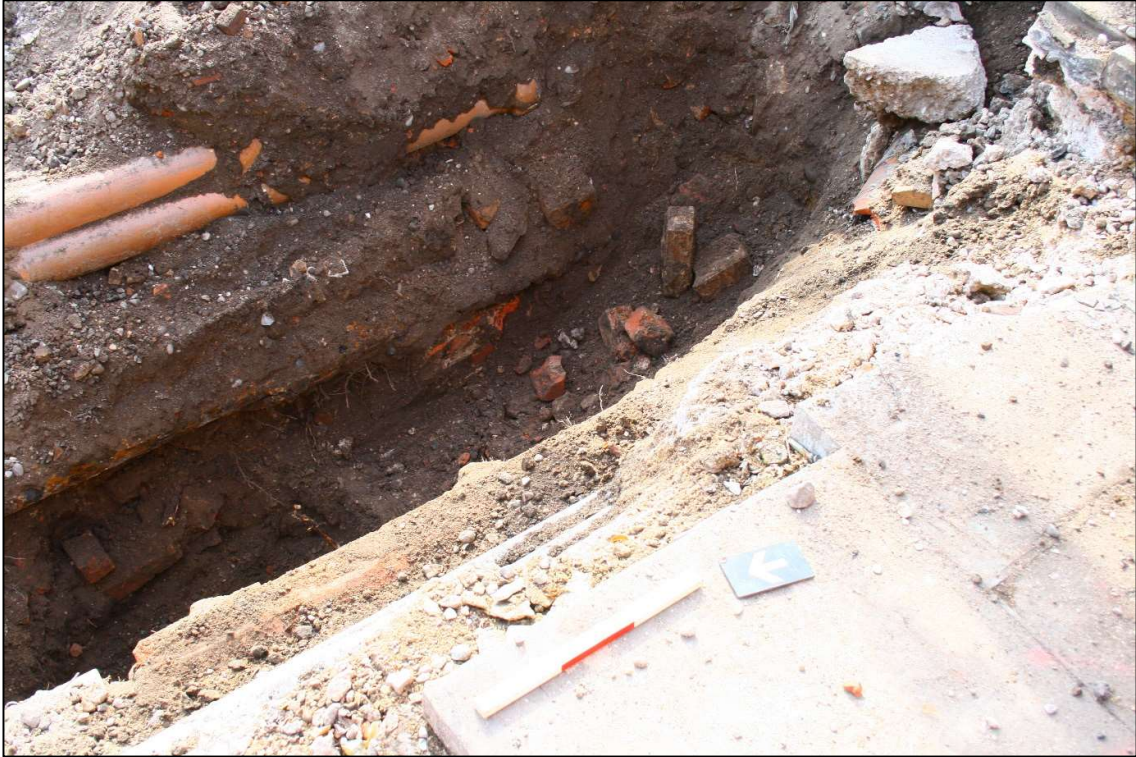
Plate 11: Trench 5, Remains of a partial brick cellar vault, aligned north by south within the eastern section of trench 5. Scale 0.3m. Looking east.

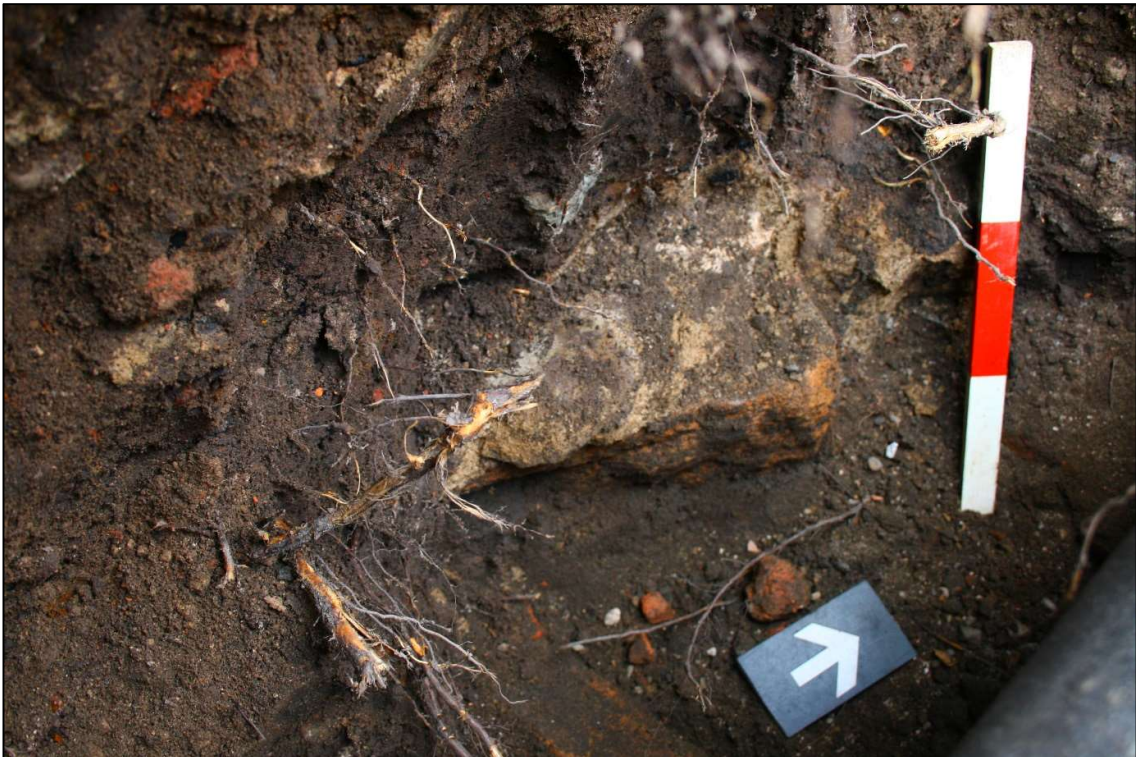
Plate 12: Trench 5, Sandstone rubble debris identified within demolition layers. Scale 0.3m. Looking west.

Trench 5 (7m x 3.4m) (Plates 10-12; Fig 6)

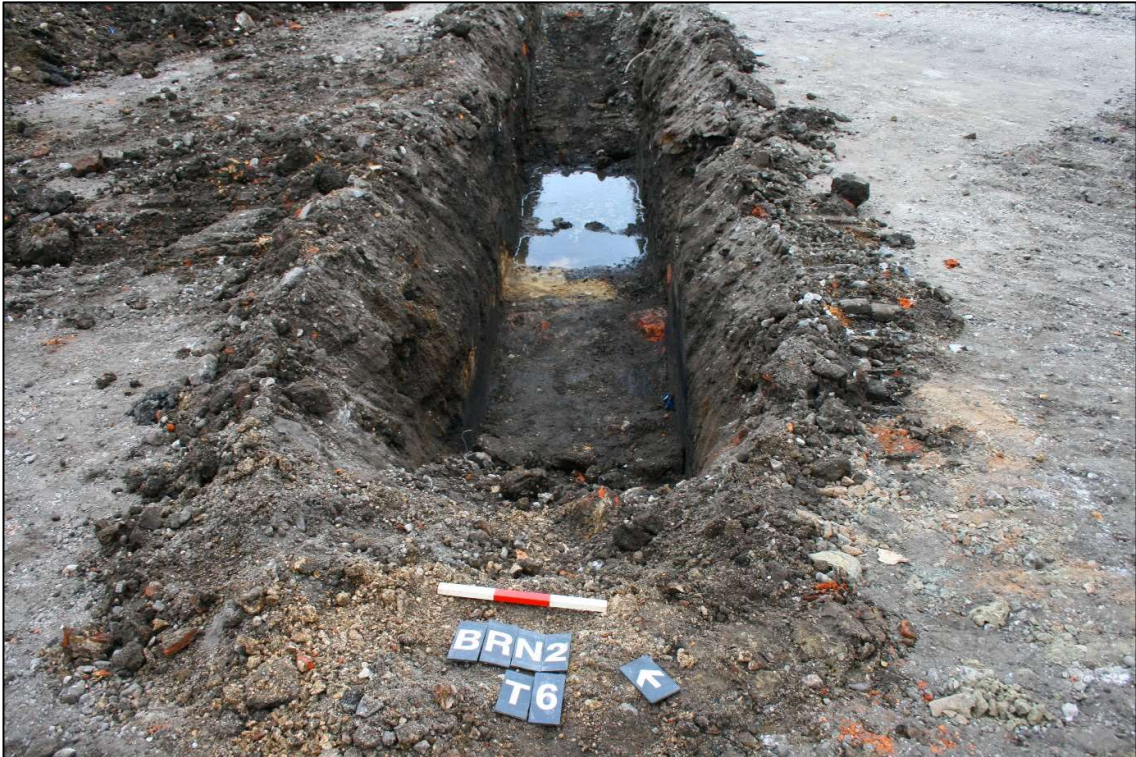
Plate 13: Trench 6 overview, showing probable sandstone wall [4025], and adjacent brick structure [4026] in the foreground. Scale 0.3m. Looking north-east.

- 7.2.17 Machine excavation revealed a probable degraded upper sandstone layer [4025] of Greyfriar's wall, aligned east by west within the central portion of the trench at a depth of 0.8m below ground level. The feature measured approximately 1.26m in width and extended into the trench edges on the east and west. The remaining feature comprised at least one visible course of irregularly sized sandstone rubble, however the feature was not examined further.

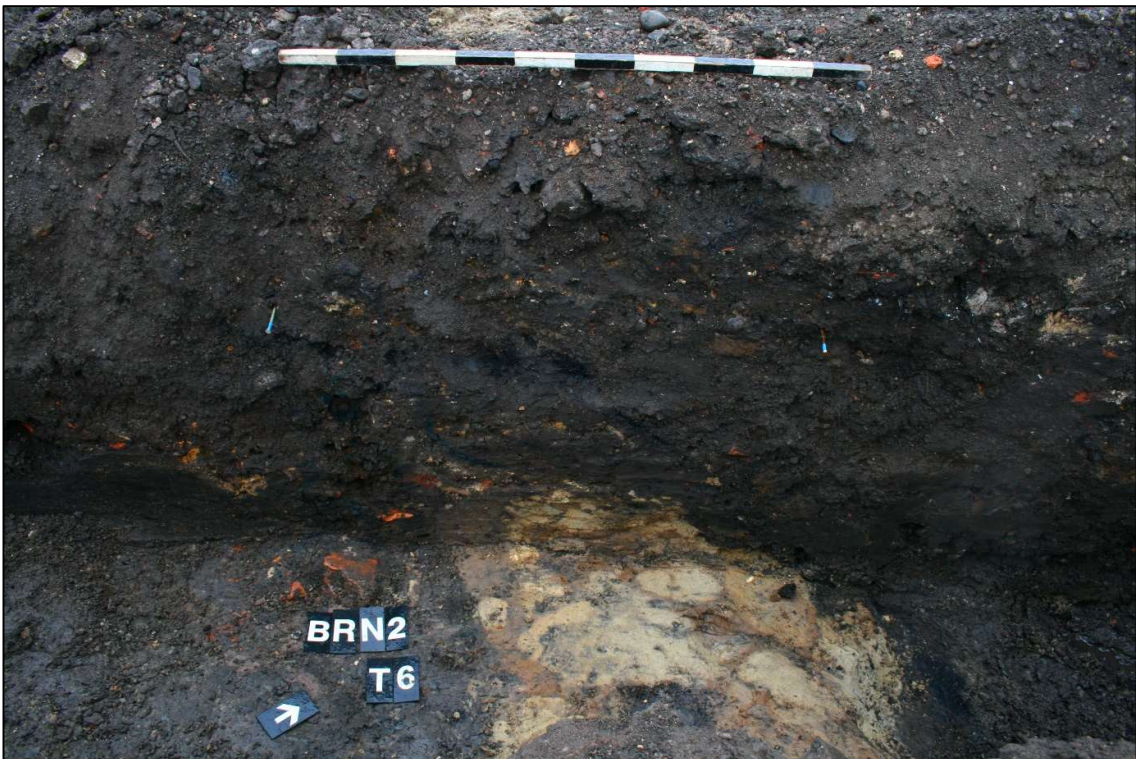
Plate 14: Trench 6, showing the upper sandstone surface of probable medieval wall [4025], partially truncated by machining. Scale 1m. Looking west.

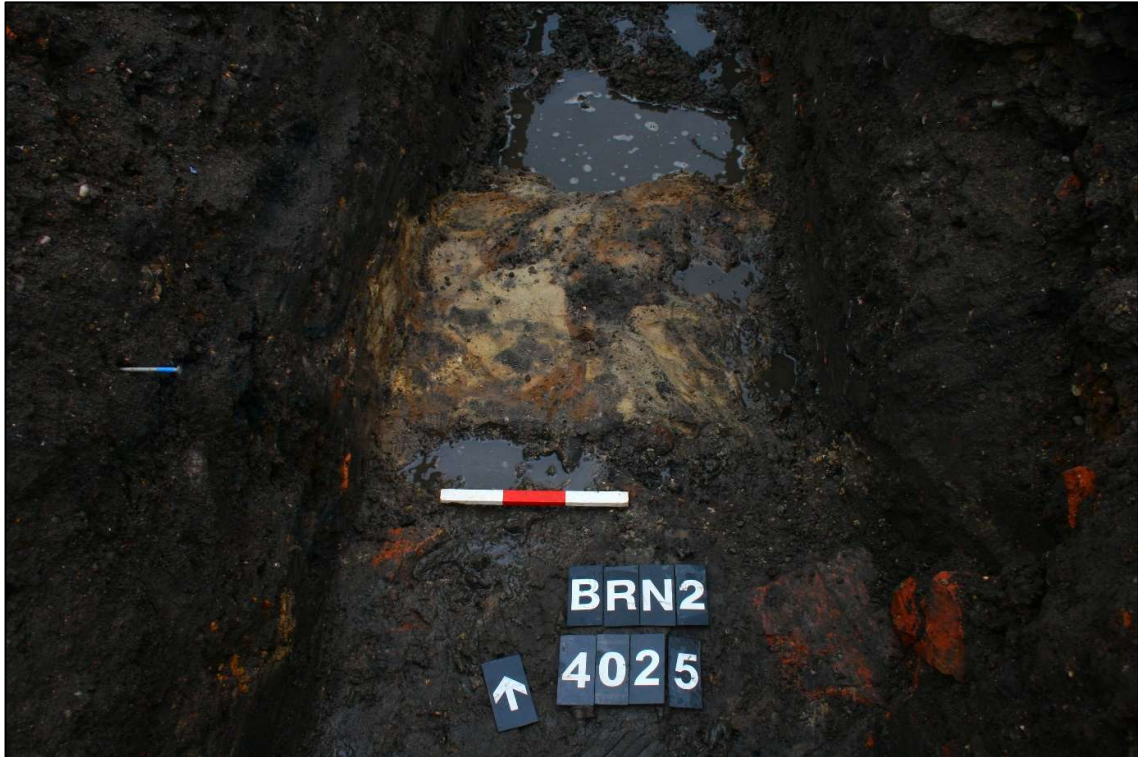
Plate 15: View of the upper sandstone surface of wall [4025], showing adjacent brick structure [4026] in the foreground. Scale 0.3m. Looking north.

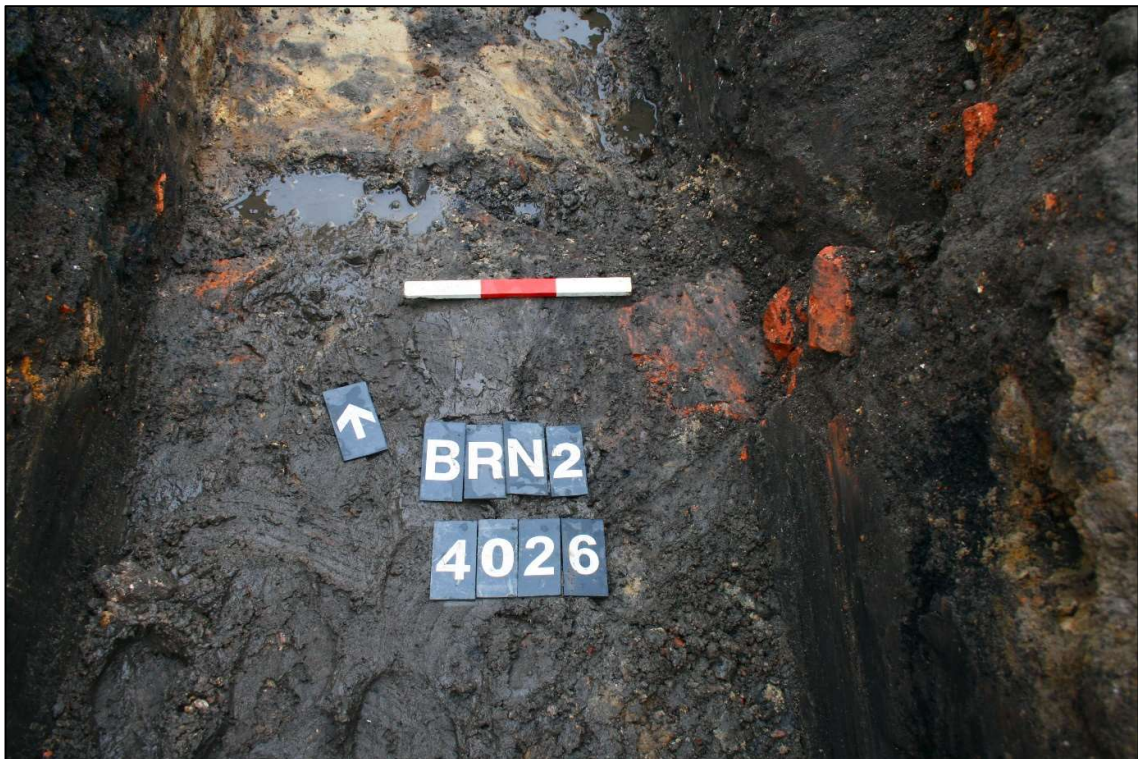
Plate 16: Exposed surface of a probable brick structure [4025] within trench 6, showing sandstone wall [4025] to the rear. Scale 0.3m. Looking north.

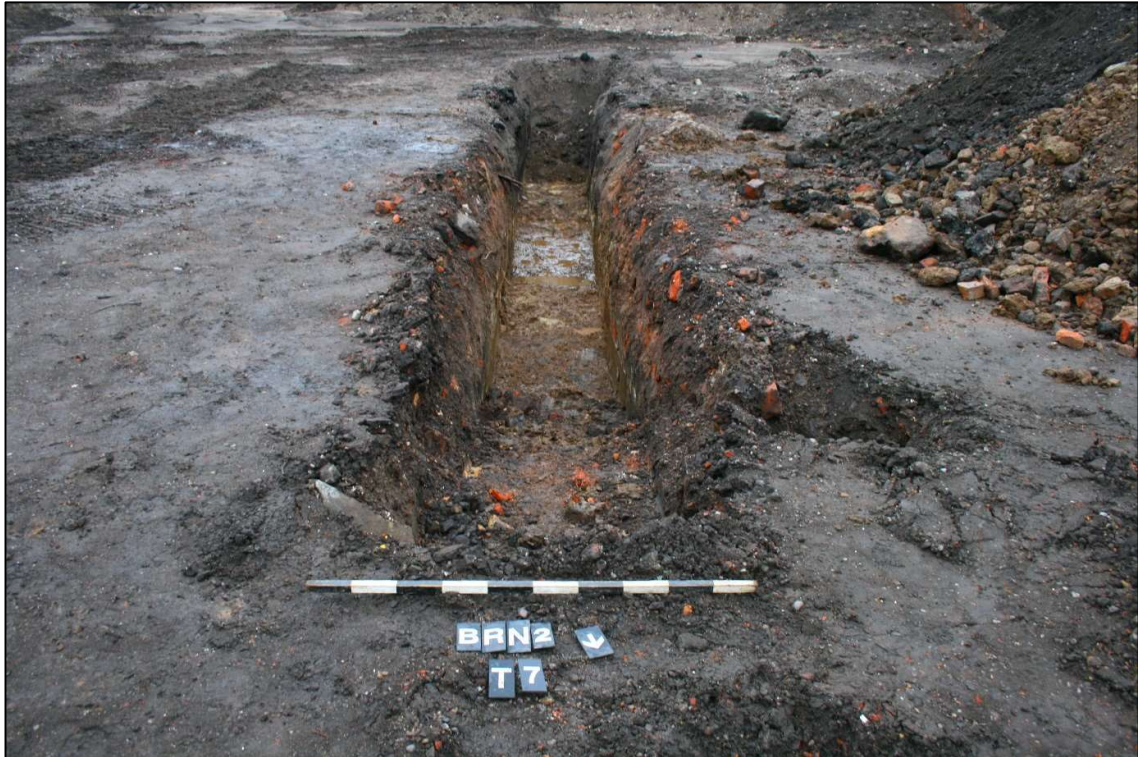
Plate 17: Trench 7, overview. Scale 1m. Looking south.

Deposits (4033, 4034) (Plates 17-19; Fig 7 Dr# 02-03)

Demolition deposit (4038) (Plate 17; Fig 5)

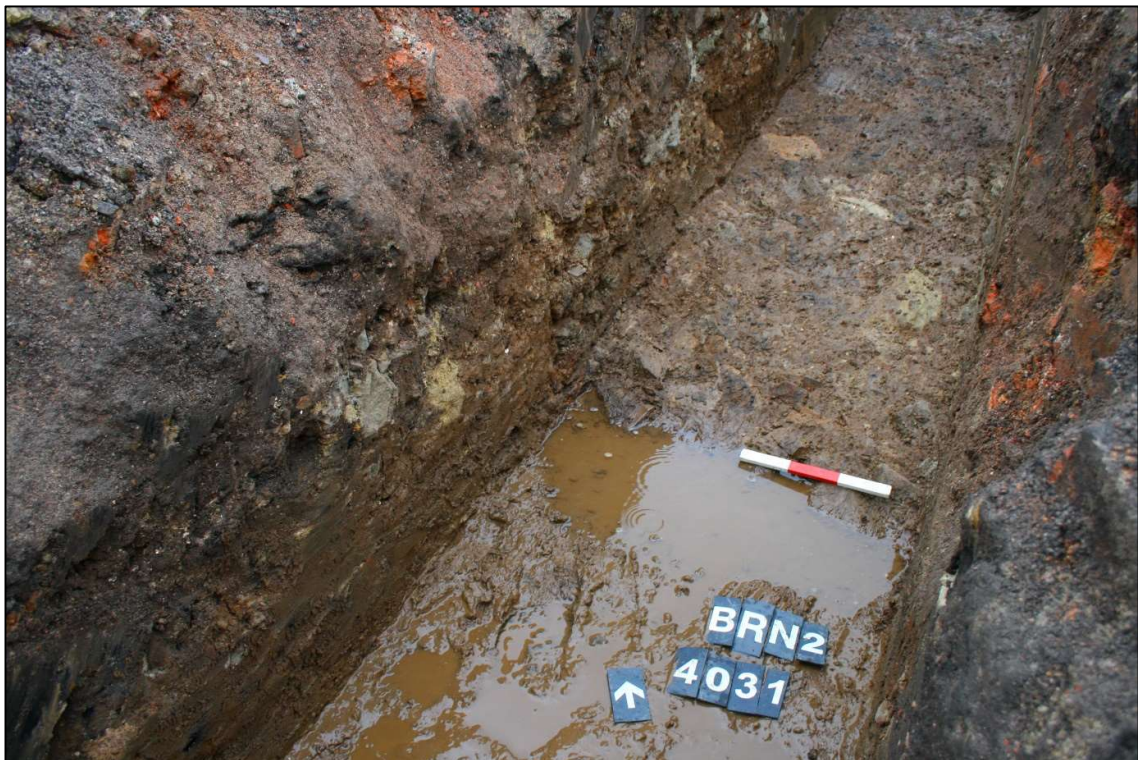
Plate 18: Trench 7, showing a degraded sandstone surface of wall [4031]. Scale 0.3m. Looking north.

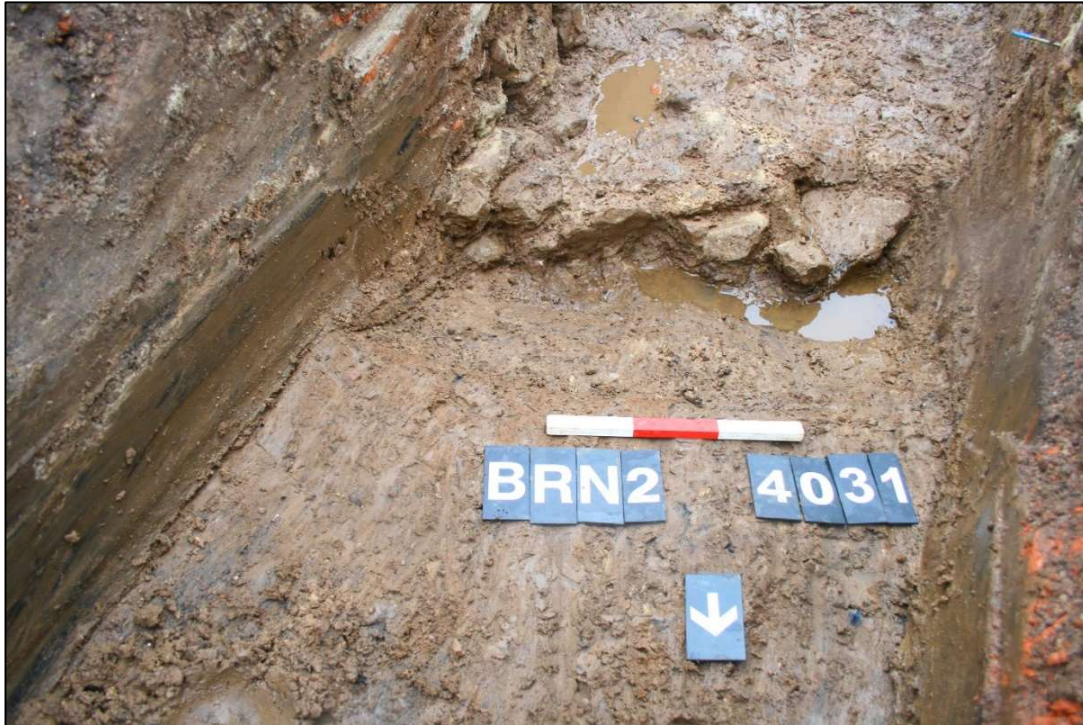
Plate 19: Trench 7, showing a partial elevation of the degraded sandstone wall [4031]. Scale 0.3m. Looking south.

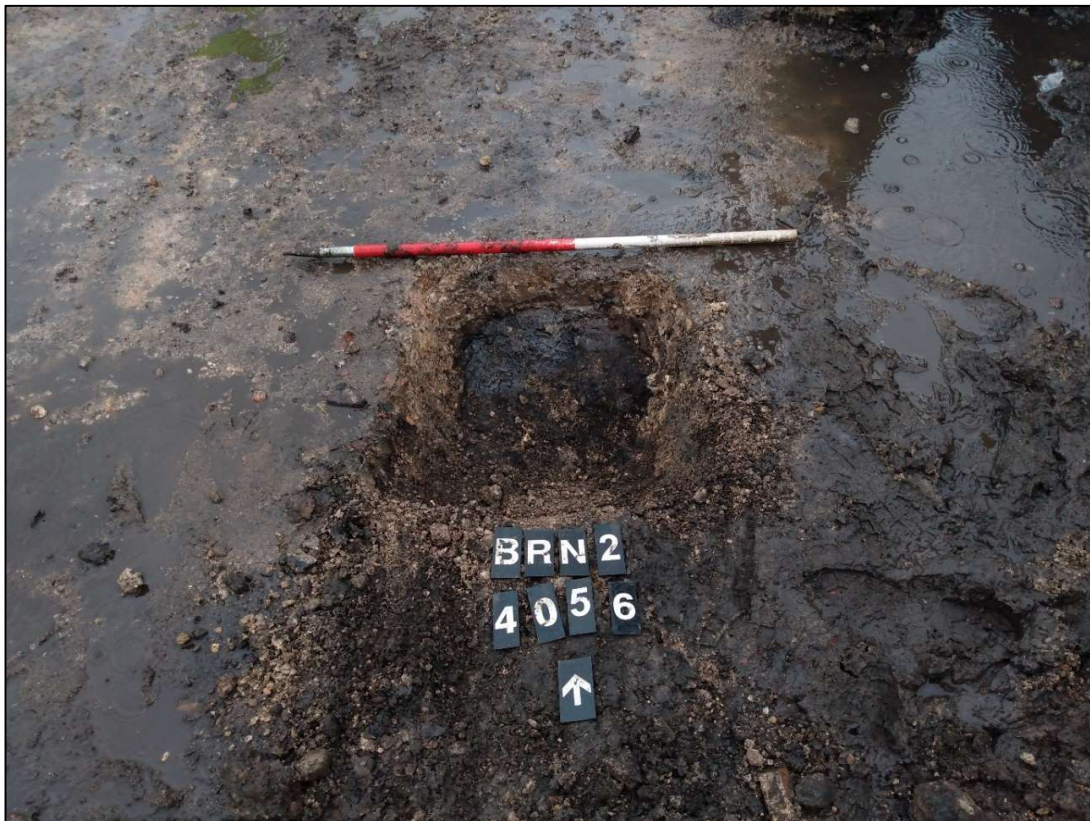
Plate 20: Watching brief: Piling phase. Example of below ground stratigraphy, showing demolition deposits within piling locations to the west of the site. Scale 1m. Looking north.

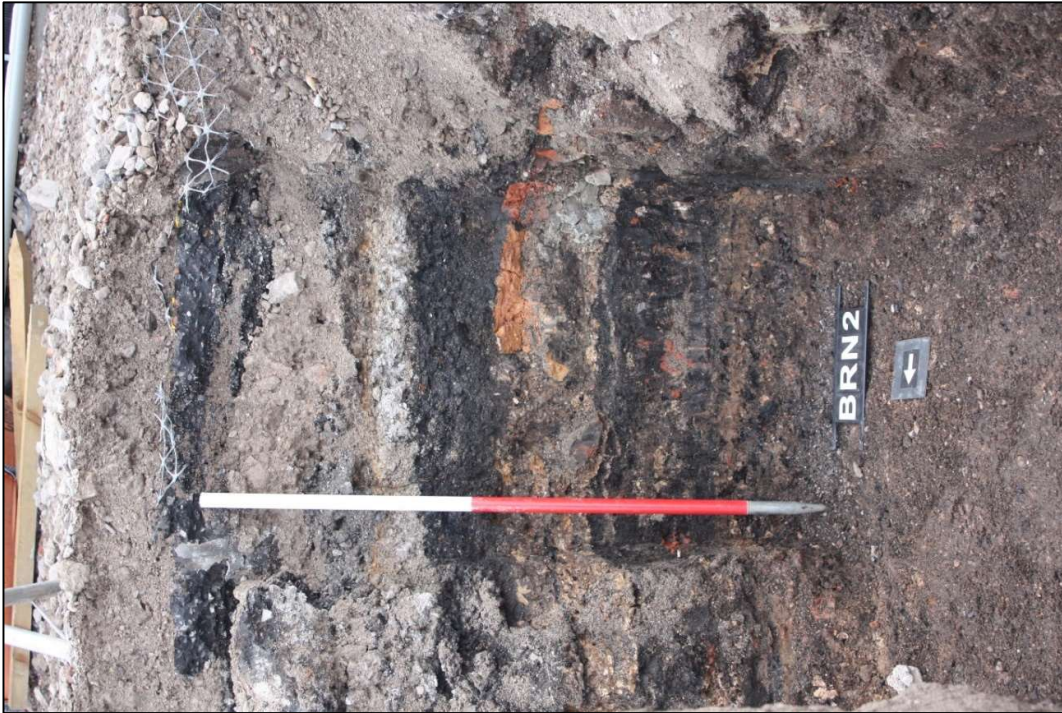
Plate 21: Watching brief: piling phase. Example of below ground stratigraphy, showing the average depth of ground disturbance across the site (between 1-1.5m depth), and ground levelling layers. Scale 1m. Looking east.

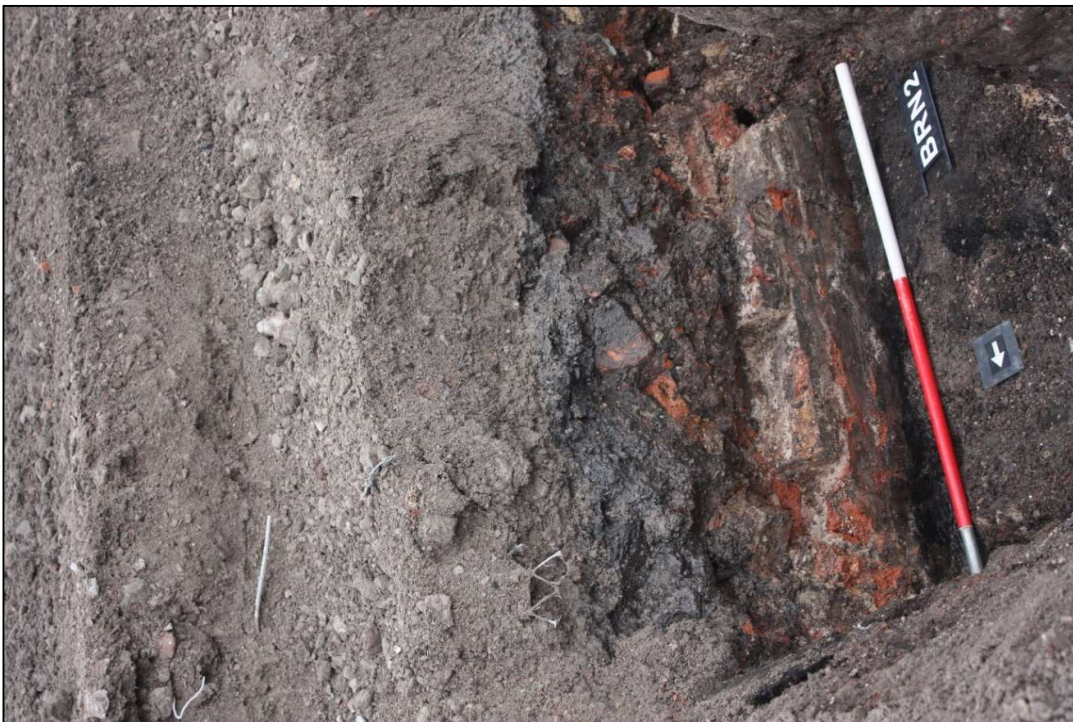
Plate 22: Watching brief: Piling phase. Partially demolished cellar vault identified within piling locations to the south of the site. These correspond to former housing identified on historic mapping. Scale 1m. Looking east.

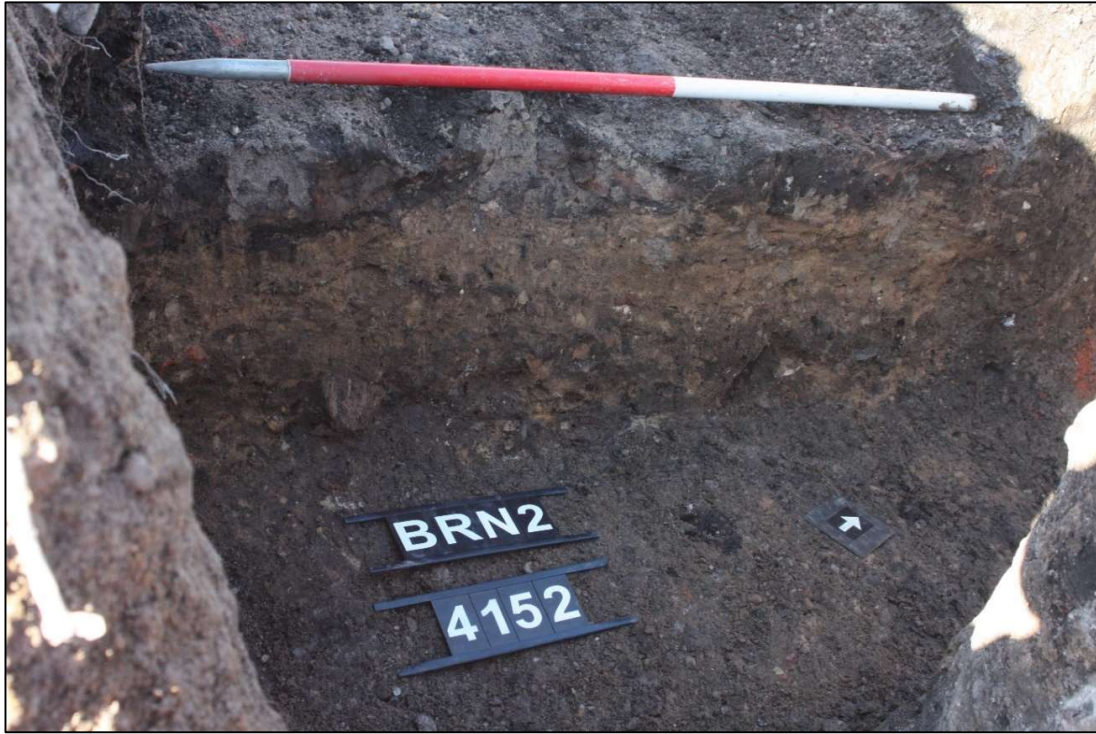
Plate 23: Watching brief: Piling phase P9. Example of below ground stratigraphy across the site. Showing varied levelling deposits within the south-western portion of the site. Scale 1m. Looking west.

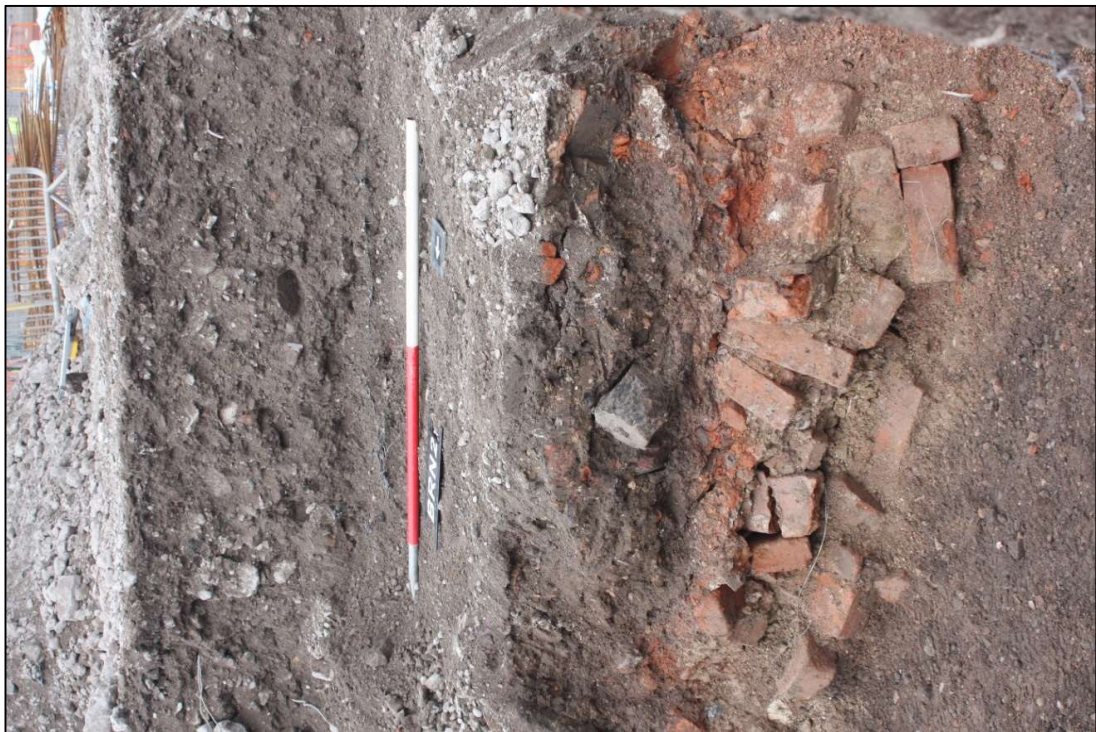
Plate 24: Watching brief. Piling phase. Example of below ground stratigraphy to the north and east of the site, showing brick rubble relating to the demolition of former 19th century housing, visible on historic mapping. Scale 1m. Looking north.
