Broadmarsh Bus Station and Car Park, Nottingham: Archaeological Monitoring and Recording

Report Number: 003/2020

Document Title: Broadmarsh Bus Station, Nottingham: Archaeological Monitoring and Recording.

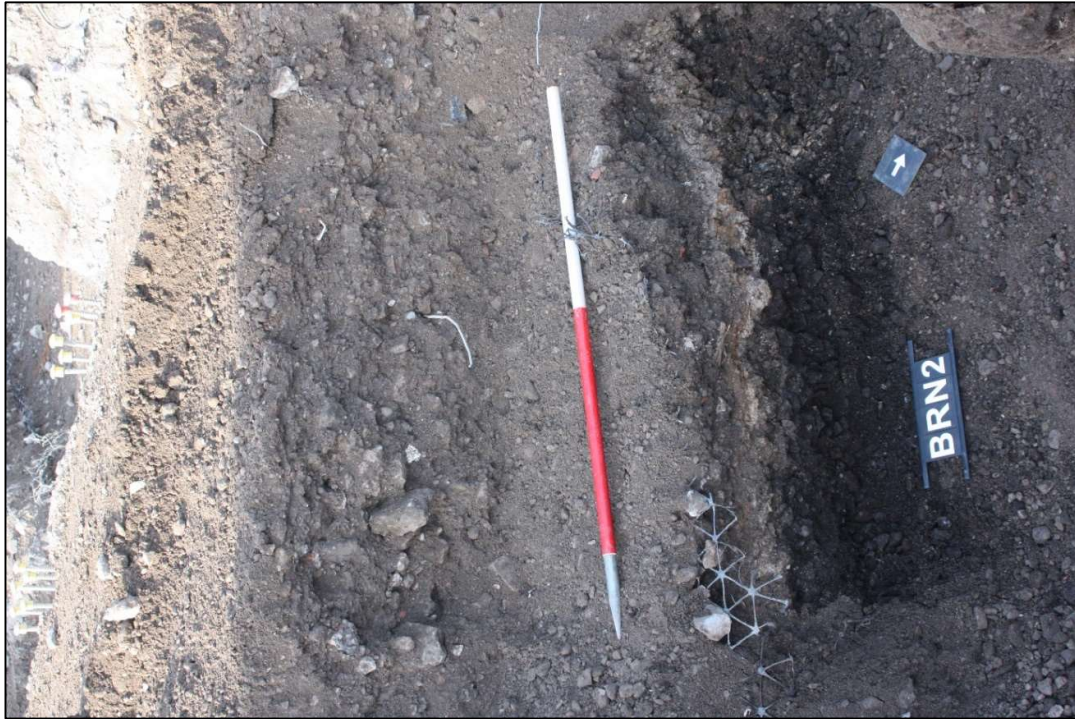
Plate 25: Watching brief: Piling phase. Example of below ground stratigraphy within the central portion of the site. Showing demolition and ground levelling material with a depth of c 1.8m. Scale 1m. Looking south-east.
