Harby Flood Alleviation Scheme

By Dr. Peter Inker

AN ARCHAEOLOGICAL WATCHING BRIEF UNDERTAKEN
BETWEEN FEBRUARY AND MARCH 2005

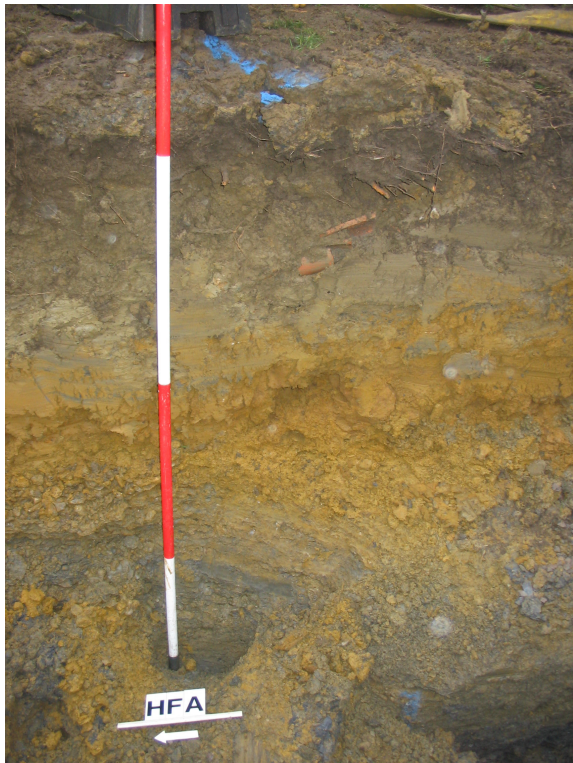
Fig. 1.
Cross-section through pipe trench showing Ferruginous character of clay (Area 03).

The Ferruginous Limestone outcrop was clearly evident in the bright orange character of many of the clays observed during excavation (0115) (Fig.1). A layer of stratified conglomerate limestone with a dense fossil matrix was identified within this orange clay in areas to the west of Nether Street. Outcrops of this conglomerate were visible on the surface of the fields to the west of Areas 02, 03 and 04. The remaining deposits uncovered during excavation consisted of oxidised and unoxidised clays with varying sandy compositions (Grey clays, contexts 0118, 0124, 0125).

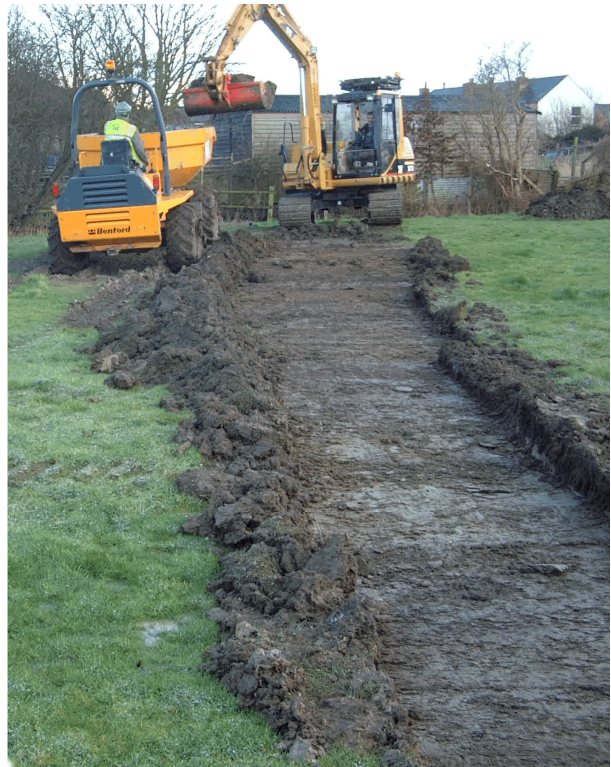
Fig. 2.
Methodology employed in stripping the easement through ridge and furrow (Area 04).

In Areas 02, 03 and 04 topsoil was machine stripped from an easement c.14m wide. However, the contractor limited the depth of the stripping to c.0.15-0.2m, removing only the turf and root-mat. A substantial covering of topsoil was left *in situ*, over which a spread of coarse gravel was laid to provide an access track. Where this easement cut through ridge and furrow, slight adjustments in depth took place to provide a levelling of the area. Excavation of the easement was undertaken using a 360° mechanical excavator and a dumper (Fig.2). This provided a restricted window of opportunity for archaeological assessment, although the potential for the identification of features was nullified by the contractors preferred method of stripping.

Before the watching brief had begun ground-works had already taken place in Area 02. An easement 14m wide had been partially stripped of topsoil, running on a north-south alignment through the centre of the field (Fig.2). This strip was mettled with gravel to enable trafficking by machinery. Approximately 8.5m from the western edge of the easement, a 1m wide and 1.5m deep trench had been cut. Two Large 2m square manholes had been placed at the northern and southern end of this trench. The entire trench was backfilled with a gravel mix, apart from the northern corner where pipe was still being fitted. A section of the stratigraphy in the northern corner of the trench was still visible, showing possible colluvial deposition at the base of the slope.

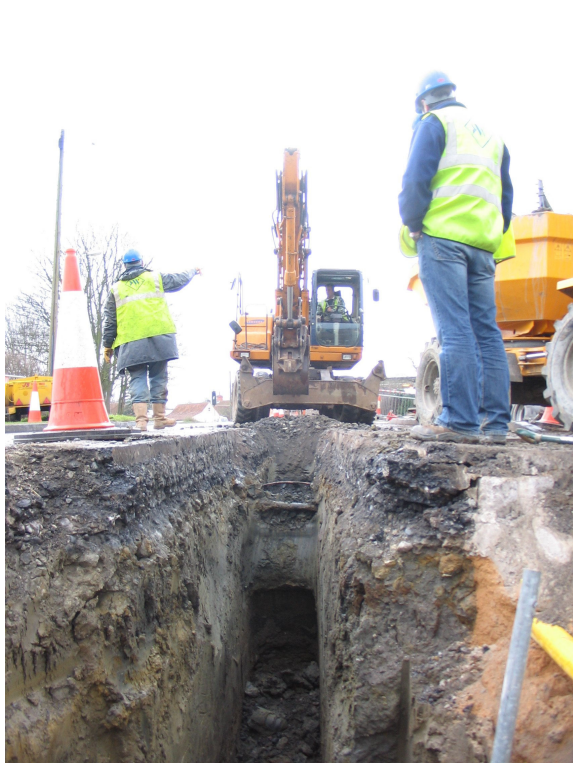
Fig 3.
Photo of pipe trench showing level of visibility and technique of excavation of pipe trench through road (Area 06).

In Areas 05 and 06, the pipeline was initially excavated with a road drill to a depth of approximately 0.2m, then excavated deeper (c.2.5m+) by 360° mechanical excavator. In places the discovery of previous services in the road and roadside verge necessitated the use of trench boxes. These comprised 3m x 2m metal sheets braced 1m apart, and obviously hindered access and observation of the trench sides. Once excavated a basal layer of gravel was deposited onto which the pipe was laid. Prior to backfilling there was a limited window of opportunity to record and

analyse the stratigraphy and its archaeological potential (Fig.3).

Where access permitted representative sections were hand-cleaned and recorded by photography and scale drawing. Examination of the sections of the pipeline trench in Areas 05 and 06 (exceeding 2.5m deep) was constrained by safety considerations which limited observation to ground level (Fig.3). The location of all observed areas, features and recorded sections was annotated on 1:1000 site plans, supplemented by EDM survey where necessary.

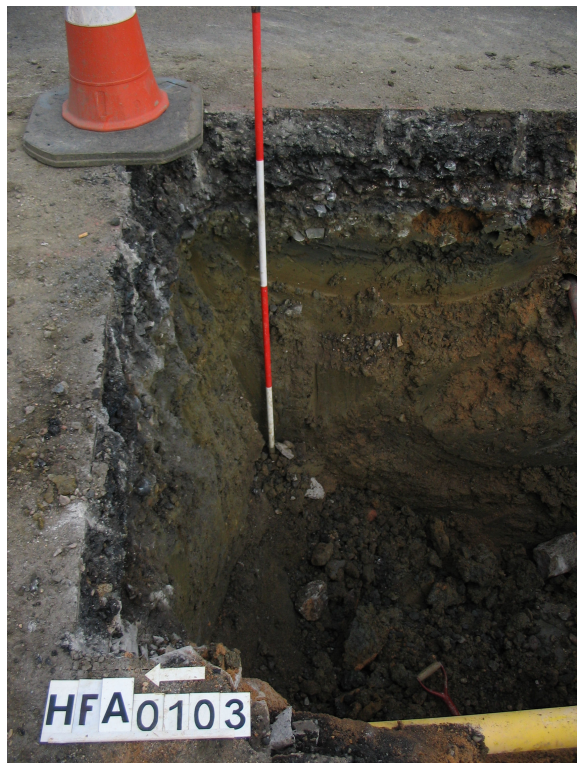
Fig. 4.
Photo of pipe trench showing level of visibility of stratigraphy in wider parts of Area 06.

Area 06 contained a number of gas and electrical services that hampered initial excavation (Fig.4). Work was also hindered in this area by a hard layer of compacted stone chippings over an orange sand base (0129) 0.4m below the modern Tarmac road surface. This could conceivably represent an earlier road surfacing, however opportunity for investigation was limited and so no firm conclusions can be made as to its origin.

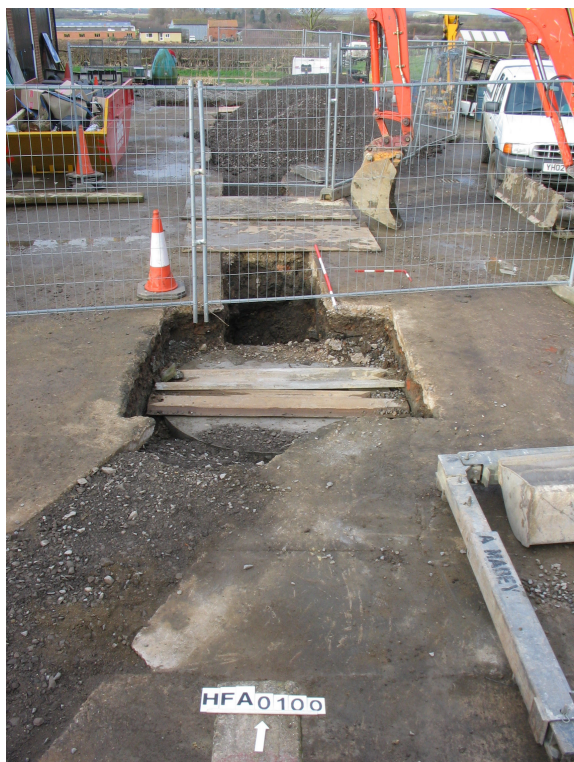
Fig. 5.
Location of well in Area 01 (centre marked by 'L' shaped scale bars).

Excavation had already taken place within the compound of British Waterways' Harby maintenance yard when the watching brief was begun. Inside the maintenance yard a 1m wide and 1.5m deep trench had been cut on a north-south alignment (Fig.5). The trench extended from the northern edge of the compound, 5m from the Grantham canal, to the southern compound wall, a distance of 25 metres. Two 2m diameter manholes had been placed in 2.5m square extensions in the trench. At a point 5m from the southern compound wall the trench turned in a westerly direction, at a bearing of approximately 22° off north. The entire trench had been backfilled with a gravel mix, apart from a 5m stretch where a well had been exposed.

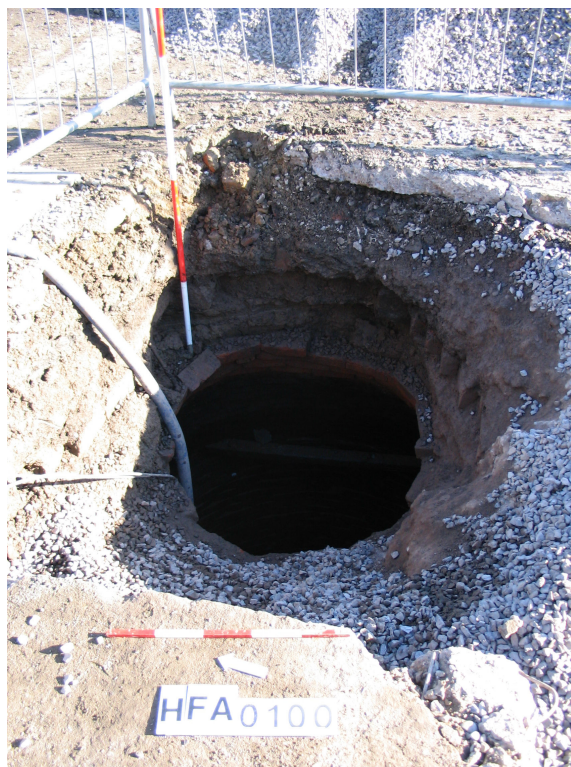
Fig. 6.
Well in Area 01 uncovered.

A well was uncovered during excavation of the pipe trench in Area 01. The well was brick lined, 2m diameter and 8m deep. The pipe trench had cut through a section of the side of the well leaving about 90% of the well intact under the concrete surface of the compound (Fig.6). From the limited amount of stratigraphy visible it could be seen that the top 0.9m of deposit was made up of a concrete hardstand, over mixed deposits of brick and rubble. Beneath this a redeposited layer of grey-brown clay was visible (0112). The bricks making up the well were 23cm x 10.5cm x 7cm in size and constructed with little or no mortar. This building technique is compatible with post-medieval techniques of construction and from subsequent examination of the area there was no indication of earlier, pre-modern activity. The approximate centre of the well was 7.8m from the south wall of the depot (marked where the scales cross in Fig.5). It is possible that the well was a source of water for the Vale Brewery, which previously occupied this site.

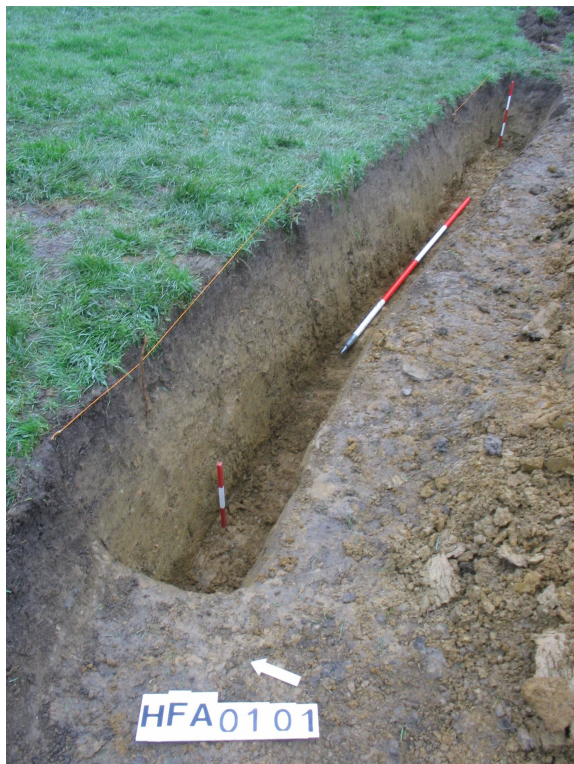
Fig. 7.
Sections 2 and 3 joined: 5m section through ridge and furrow Area 02.

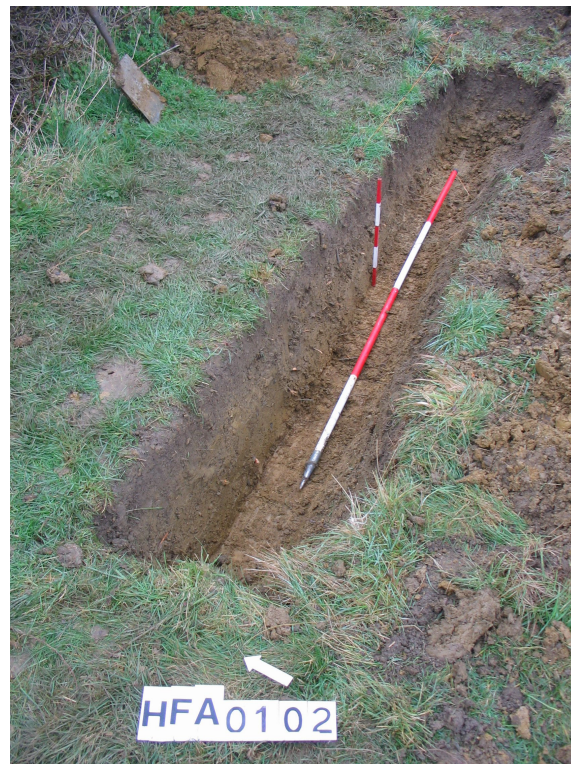
Fig. 8.
Sections 4 and 5 joined: 3.5m section through ridge and furrow Area 03.

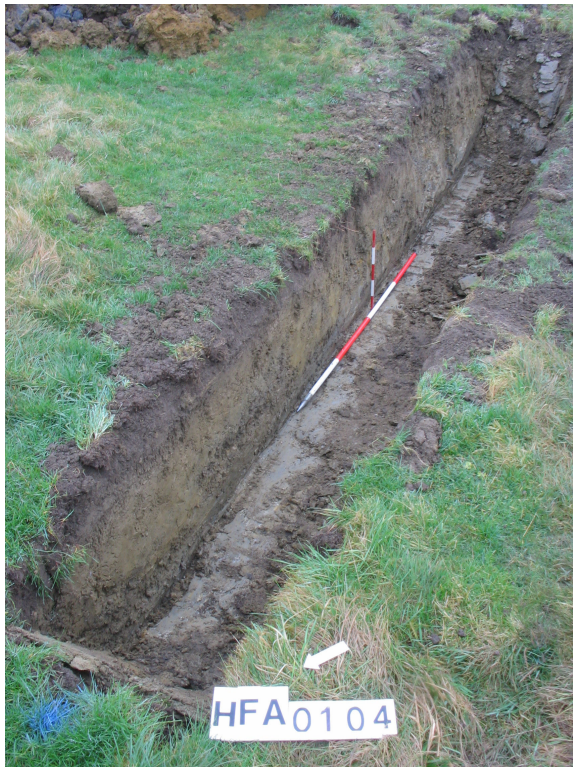
Fig. 9.
Section 6: 5m section through ridge and furrow
Area 03.

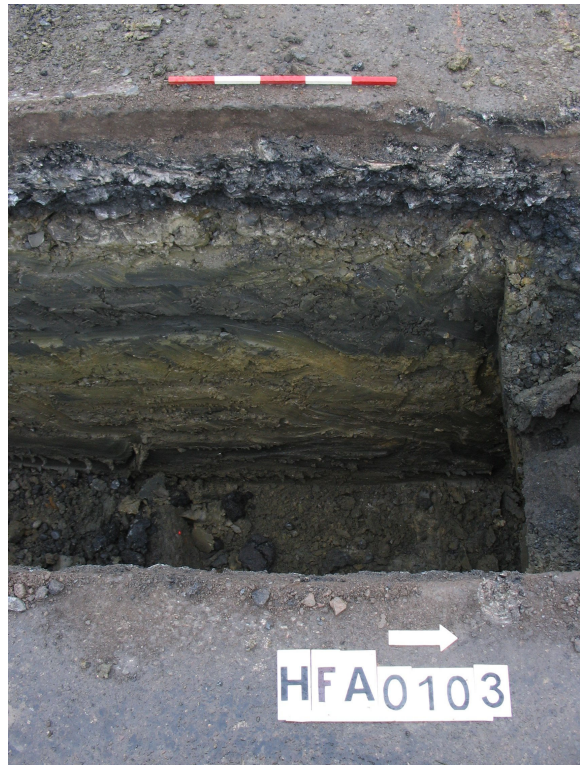
Fig. 10.
Pipe trench 0103 showing section through road
Area 06.

In Areas 05 and 06 the pipe trench was excavated through modern concrete and road surfaces (Figs. 3, 4 & 10).

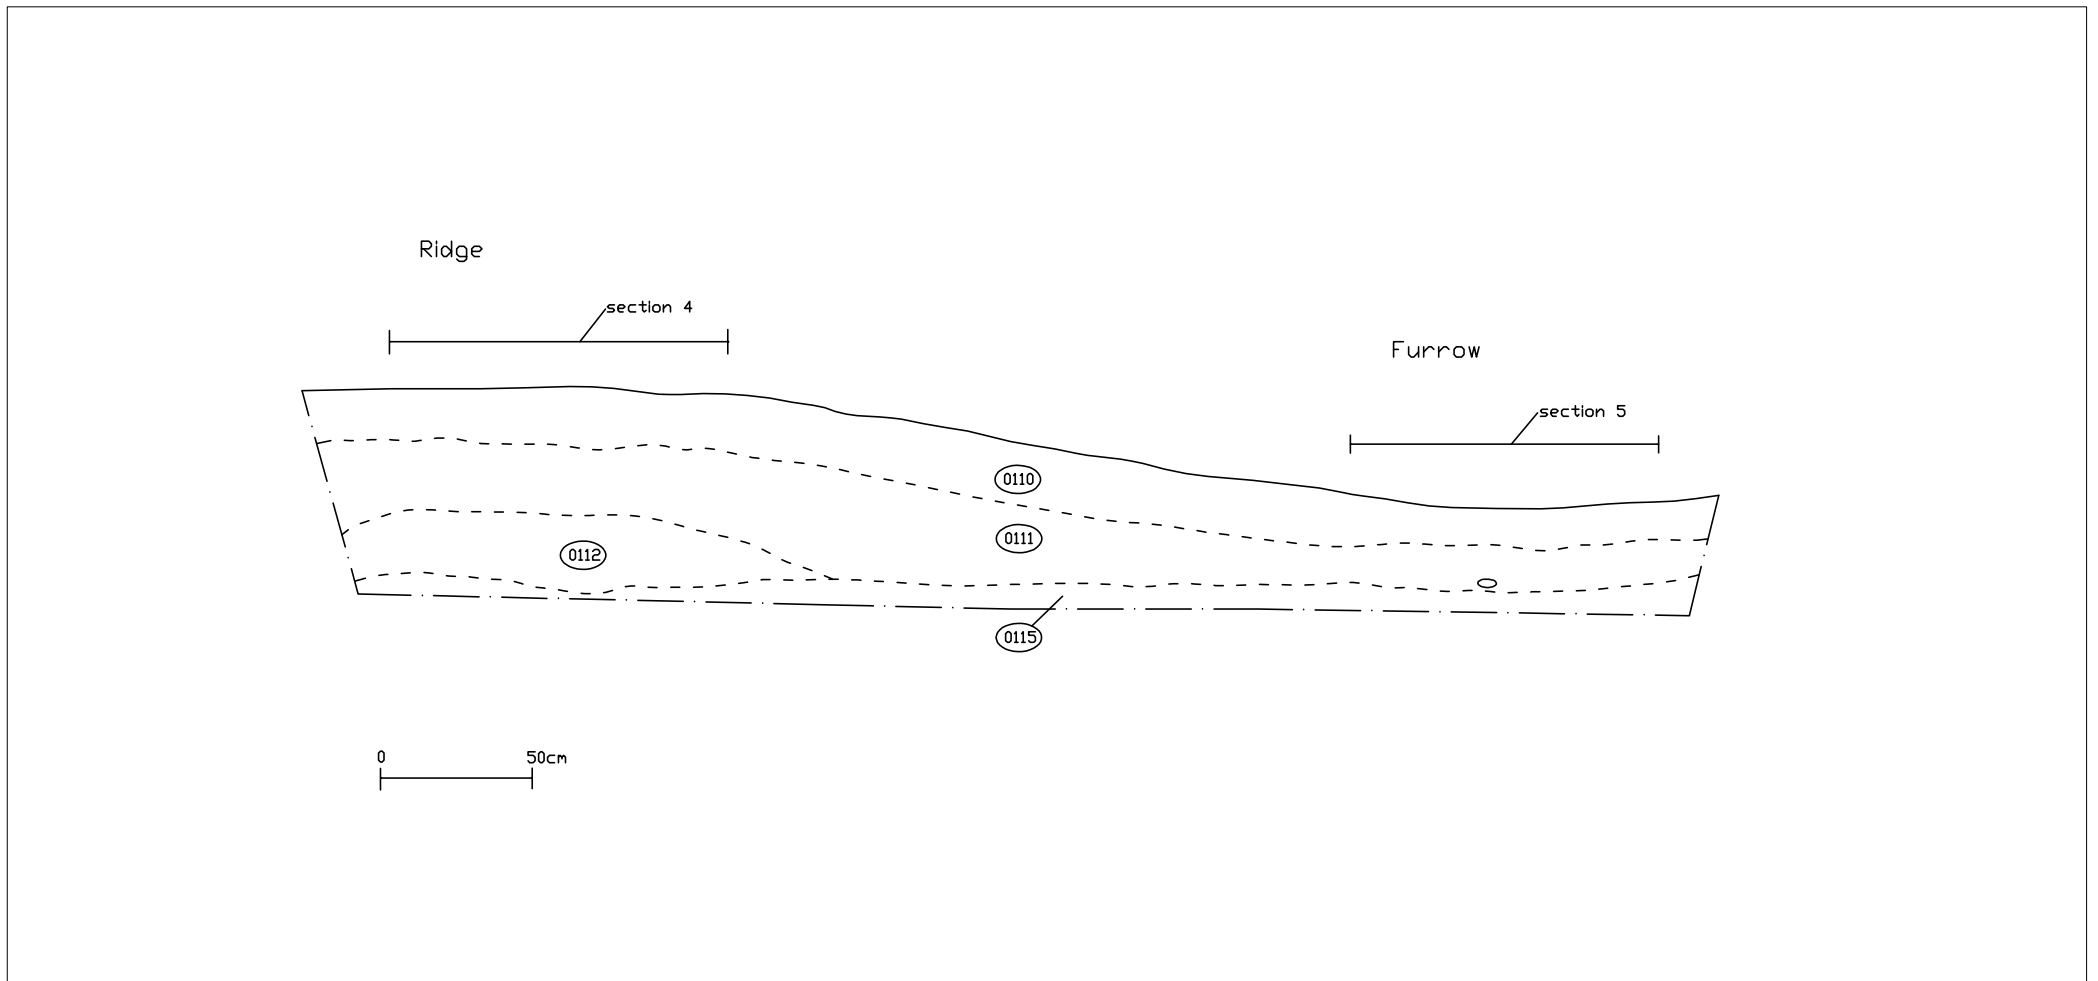
Fig. 14 . South Facing Sections 4 & 5 through Area 03, showing stratigraphy of ridge and furrow. Scale 1:25
Accession Number: X.A145.2005

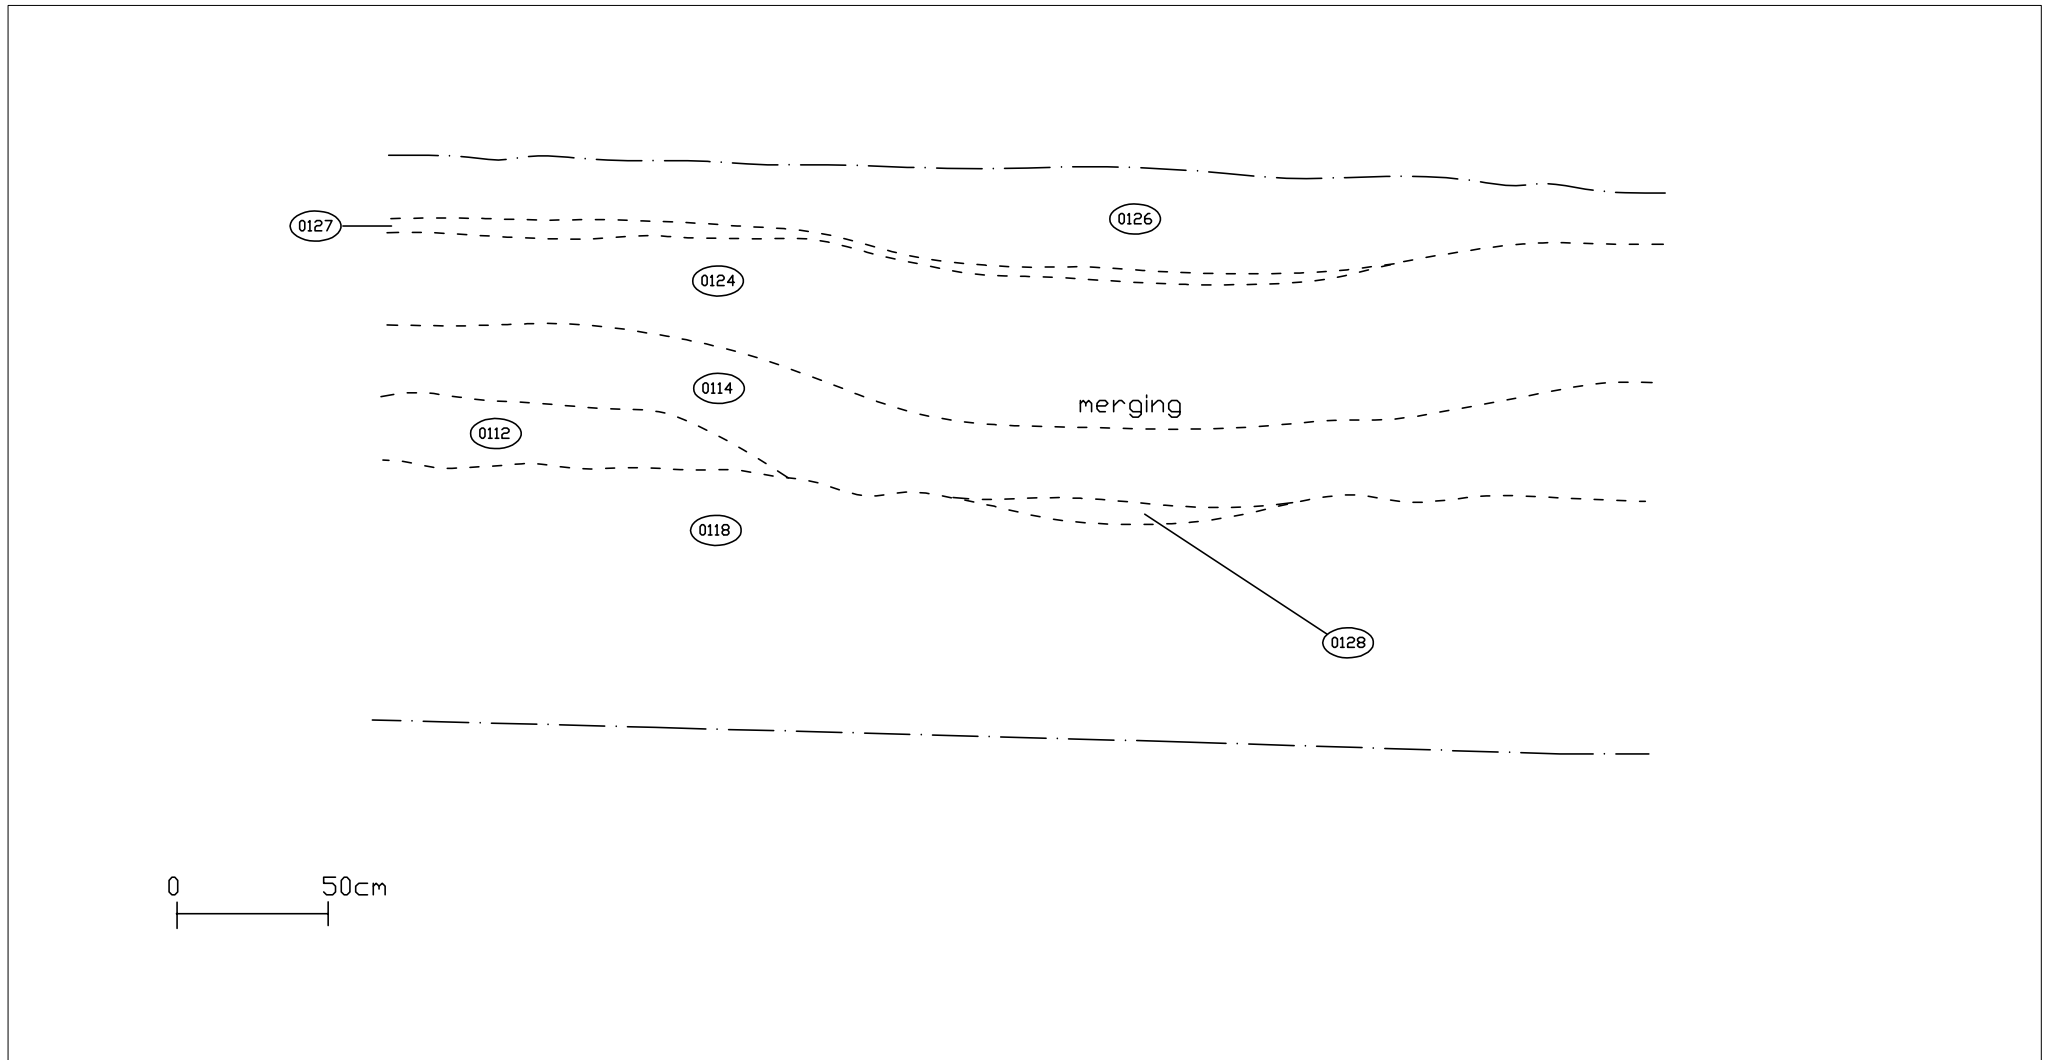
Fig. 16 . West Facing Section 14 through Area 06, showing possible ridge and furrow under road surface.
Scale 1:25.
Accession Number: X.A145.2005

The northern end of the pipe trench in Area 06 showed little sign of archaeology within the series of clay layers. Further to the south however, undulations in the thickness of the road surface and stratigraphy of the trench wall raised the possibility that ridge and furrow were present in this area (Fig.16). The stratigraphy in Area 06 typically consisted of a 0.2-0.3m layer of compacted tarmac (0126) over the hard compacted stone and sand layers already mentioned (0127). Underneath this, lay a series of undulating layers of clay c.0.5m thick. The top layer was a mid-dark grey sandy clay (0125) which merged with the grey-green clay that lay underneath (0124). Beneath this

was an orange-green clay (0114) which overlies a firmer mid grey clay (0118). Towards the south of the pipe route the undulations in these layers became somewhat pronounced. A patch of yellow-white gravel (0112) could be identified between layers 0114 and 0118. This patch corresponded with a slight rise in the layers above it. Similarly, a patch of more dirty looking redeposited yellow-white gravel (0128) could be identified between the same layers in a corresponding depression. Comparison with the stratigraphic sequence recorded in Areas 02 and 03 (Figs 13-16) suggests that the stratigraphy of Area 06 could be compatible with remnants of ridge and furrow cultivation prior to road building.
