WE DIG WOLLATON PARK

A TRAINING EXCAVATION AT WOLLATON PARK NOTTINGHAM

REPORT ON AN ARCHAEOLOGICAL EVALUATION

Report Number: 011/2021

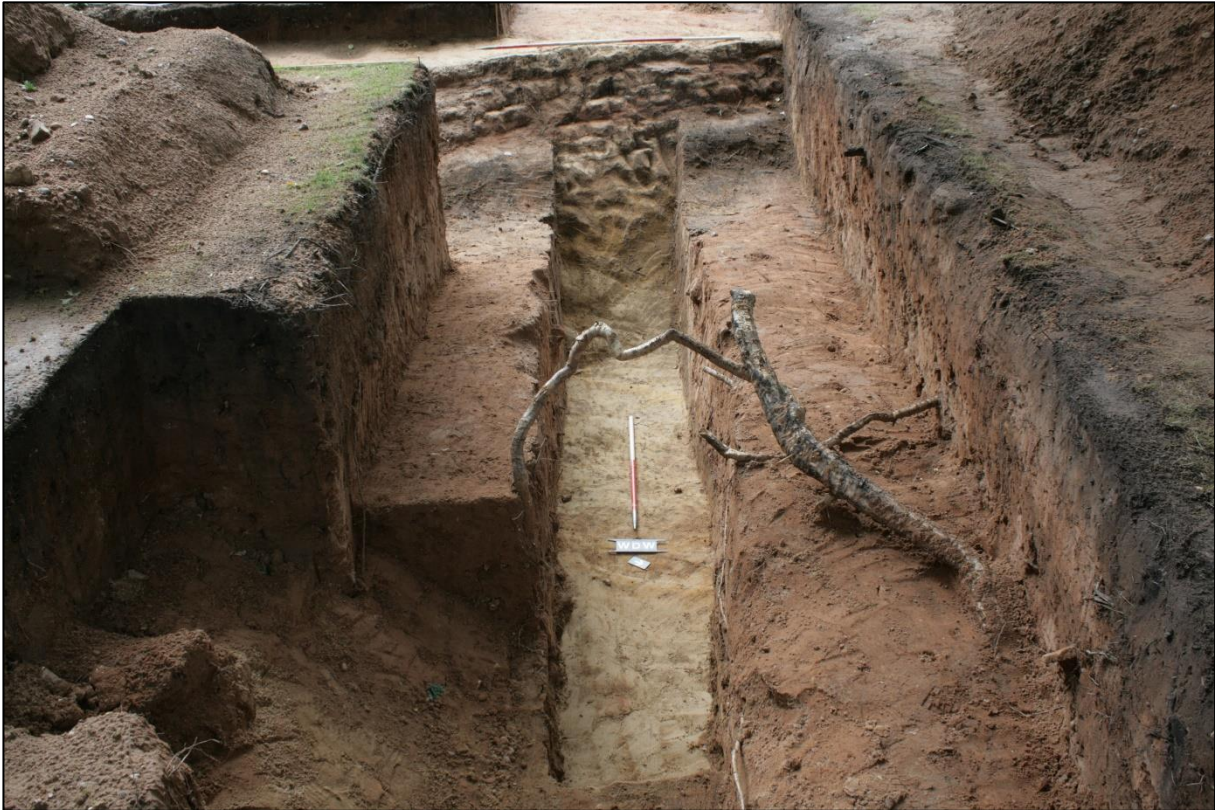
Plate 1: Terrace edge and base [0016] revealed in the north-western trench. Scales = 1m and 2m. Looking south west.

- 7.2.1 A large and deep linear cut [0016] was located within the excavation area, cutting into bedrock [0019] and through degraded sand (0046). It was steep yet even sloping, with a flattish base, measuring at least 7.5m wide within the north-western trench (Plates 01–05). Continuing beyond the edges of the excavation area, a 7.5m long section of linear cut [0016] was revealed in the north-western and central trenches and a further 2m were revealed in the south-eastern trench (Plates 10–11). It is believed that these two sections were parts of the same feature as they were both orientated east to west, and therefore the linear cut would have measured a minimum of 21m long if the central trench had been widened (Figure 03–05). The toolmarks were still visible on the slope within the north-western trench. The length and width of this feature suggested cut [0016] to be the terrace edge pictured in the foreground of Jan Siberechts' 17th-century painting of Wollaton Park (Plate 38). The terrace measured 1.7m deep within the north-western trench, and 1.4m deep in the south-eastern trench. It was filled with terrace bank material deposits described below.

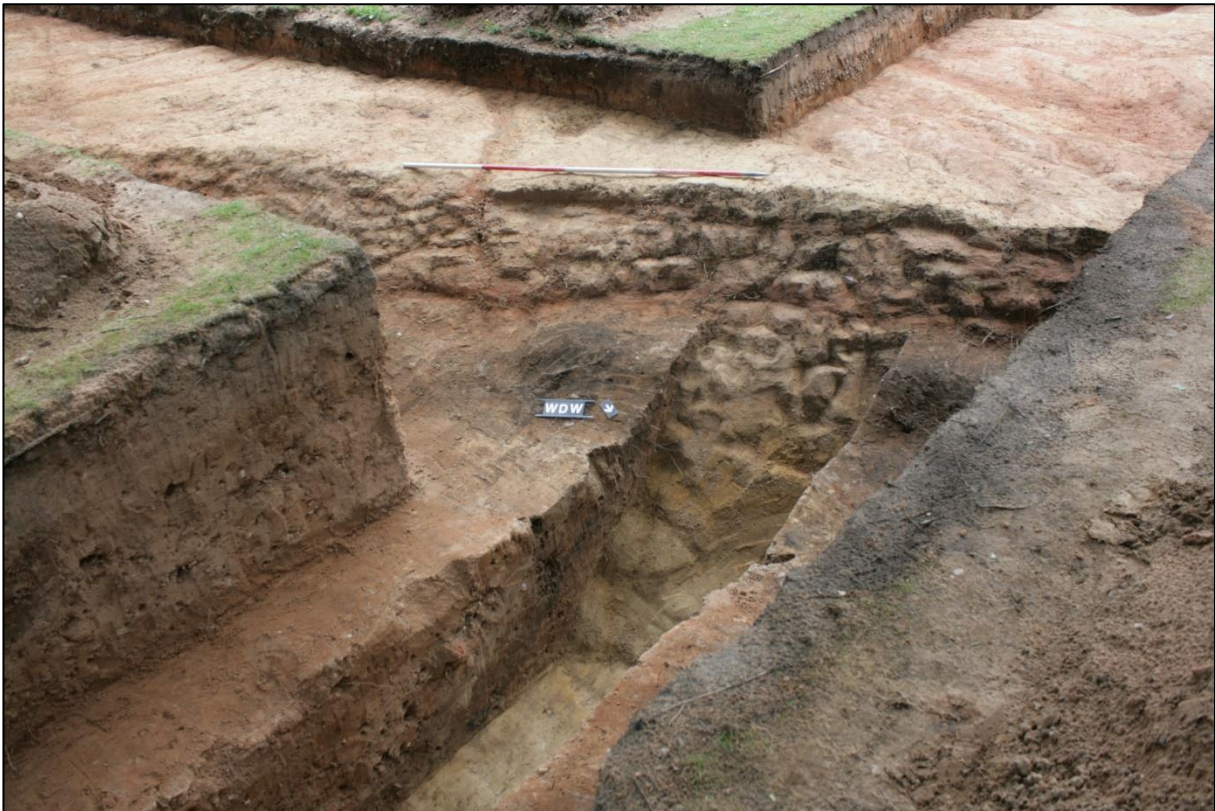
Plate 2: Terrace edge and base [0016] revealed in the north-western trench, section showing terrace edge backfill (0017). Scale = 2m. Looking south-west.

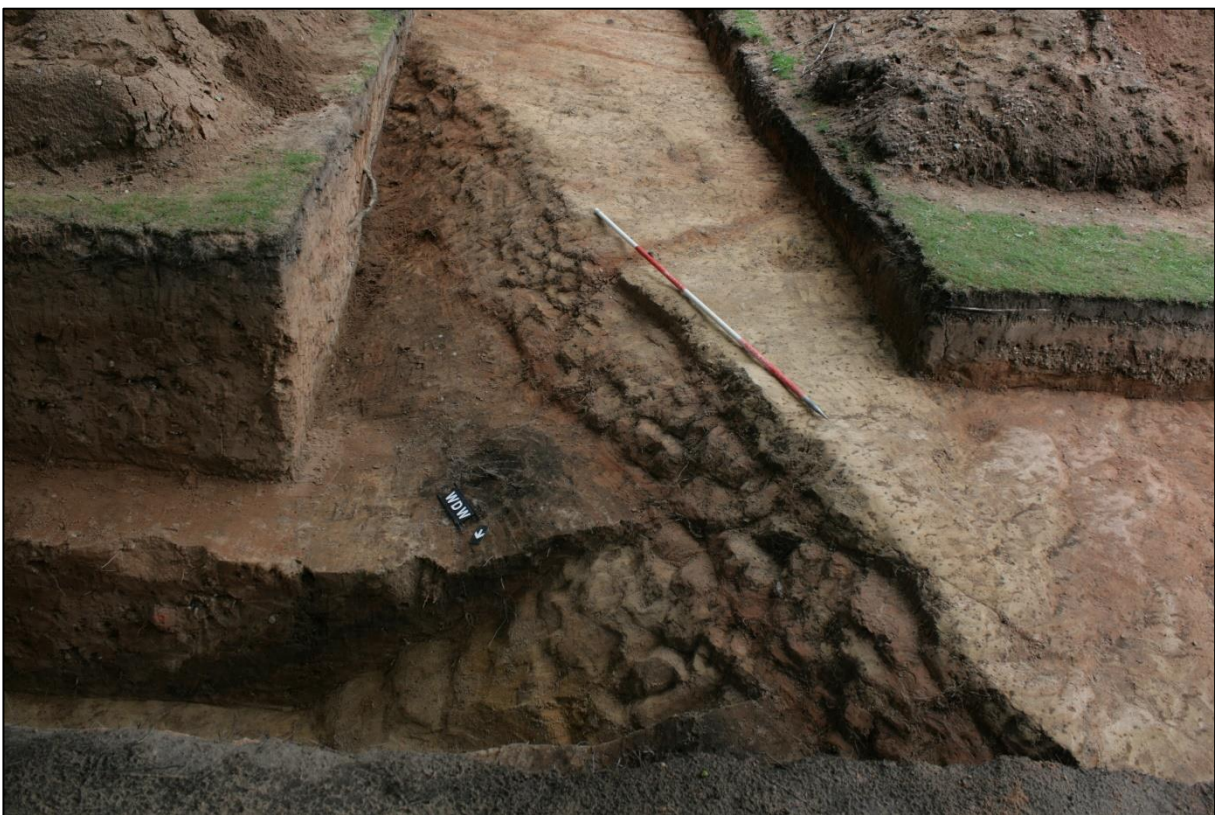
Plate 3: Terrace edge and base [0016] revealed in the north-western trench and running into the central Trench. Scale 2m. Looking south.

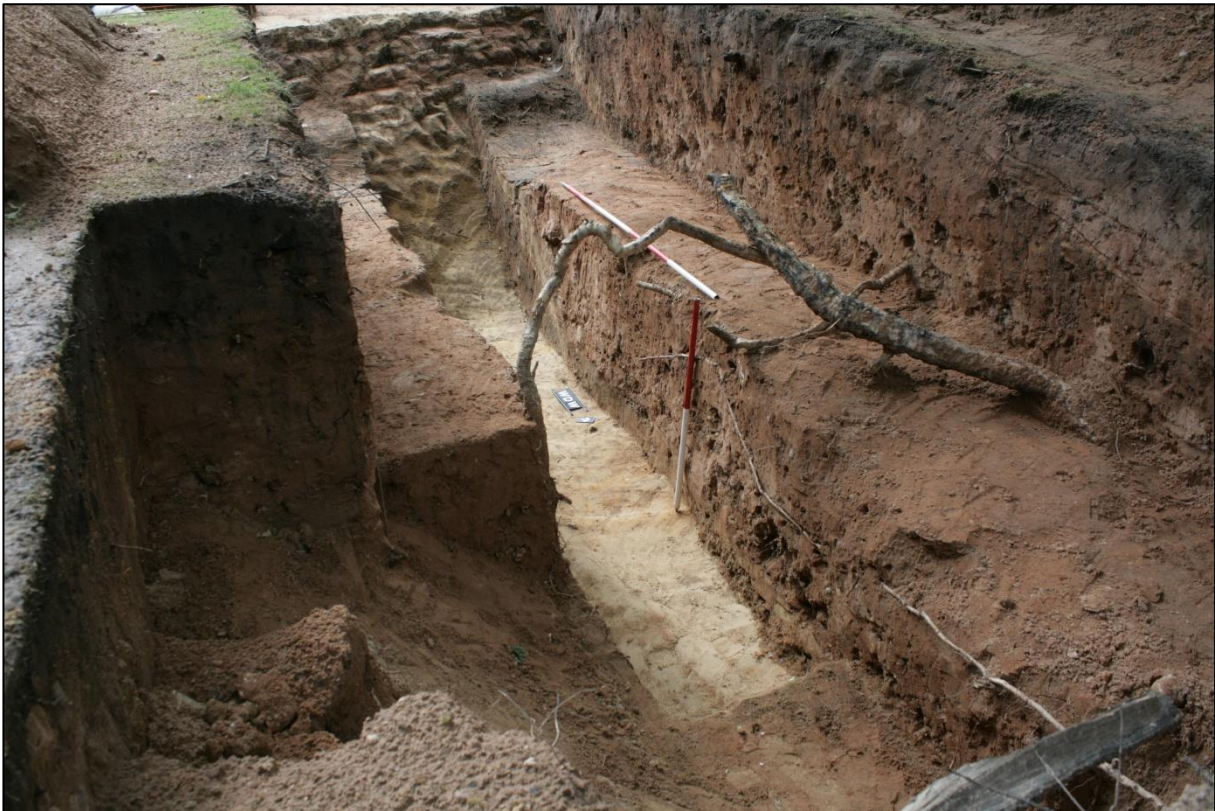
Plate 4: Terrace edge and base [0016] revealed in the north-western trench, section showing terrace edge backfill (0017). Scales = 1m and 2m. Looking west.

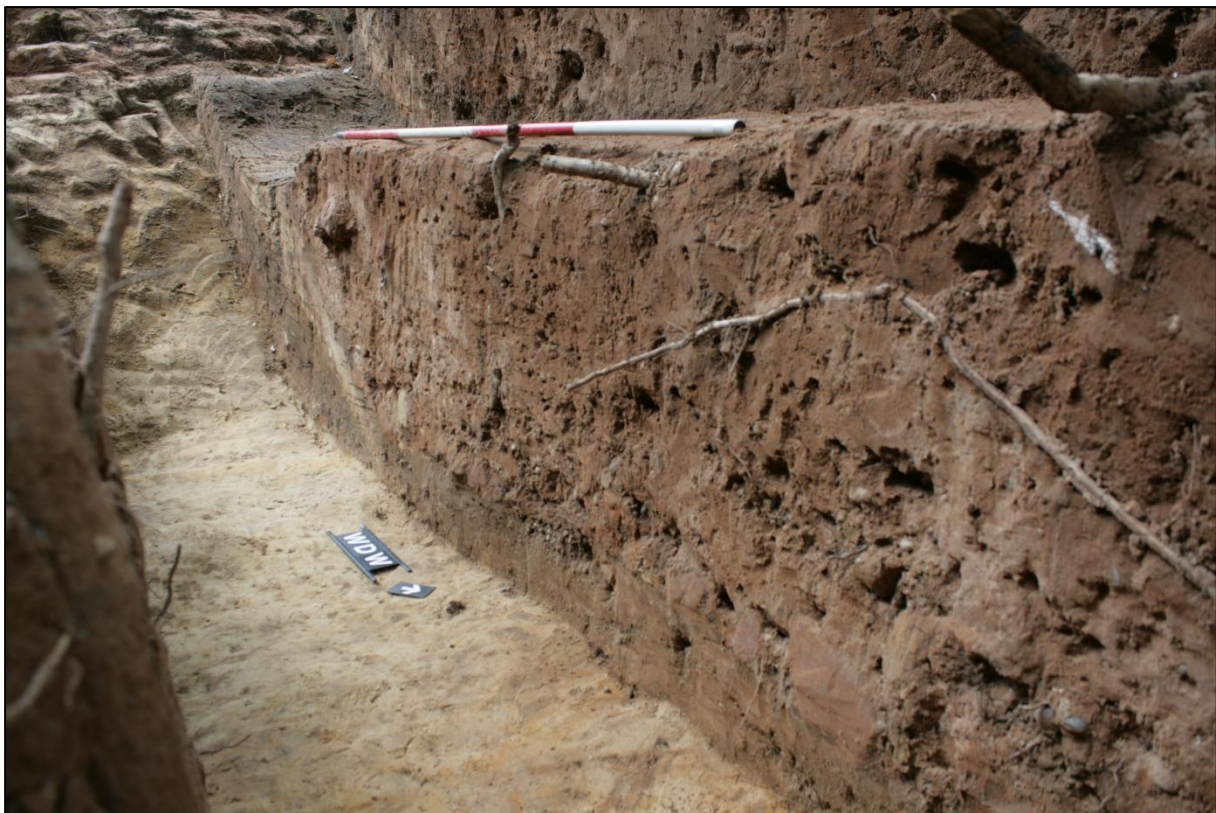
Plate 5: Terrace edge and base [0016] in the north-western trench, section showing terrace edge backfill (0017) and bank material. Scale = 2m. Looking west

- 7.2.4 The fills within terrace edge [0016] observed in the north-western trench consisted of seven fills (0050), (0043), (0051), (0069), (0052), (0068). These fills ranged in colour and composition from compacted yellowy orange mottled coarse sand, to friable dark to mid brown sand silt in. These fills measured a full depth of 0.7m from the edge of the terrace (Plates 5–7).

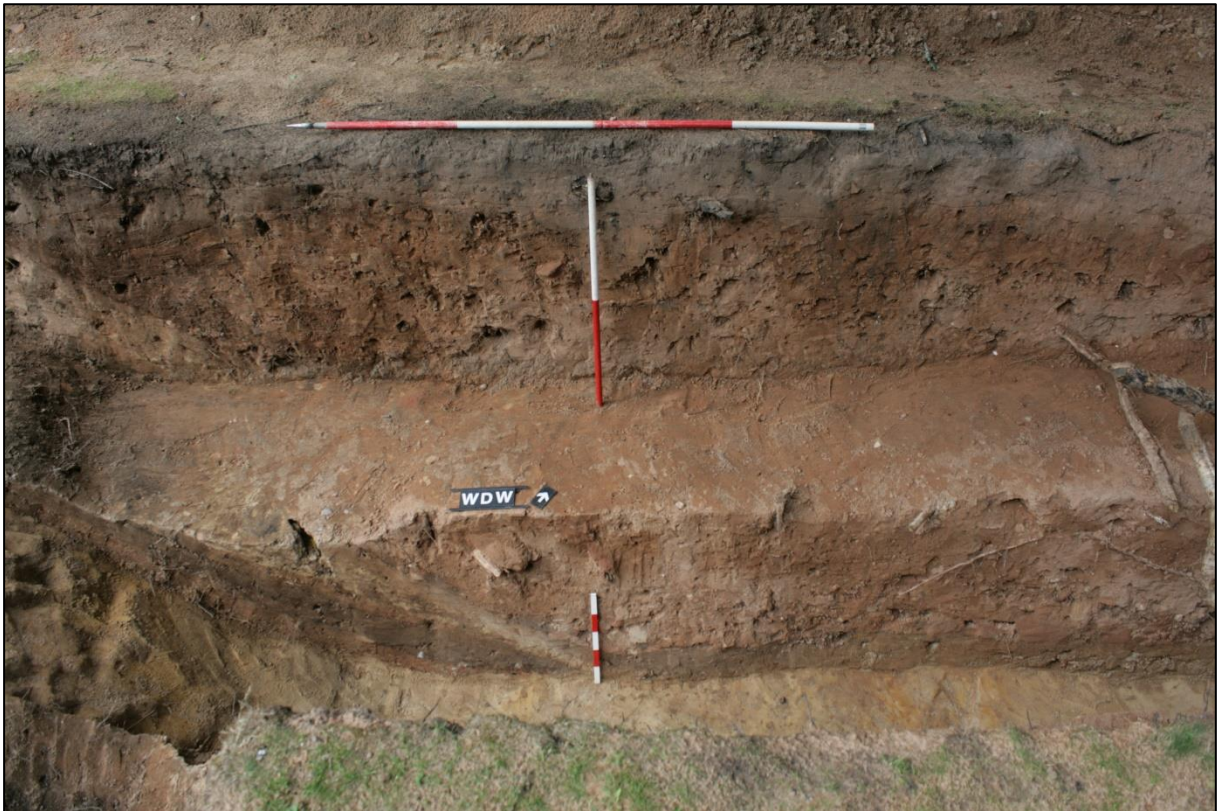
Plate 6: South-east facing section of terrace edge backfill (0017) and bank material in the north-western trench. Scales = 0.5m, 1m and 2m. Looking northwest

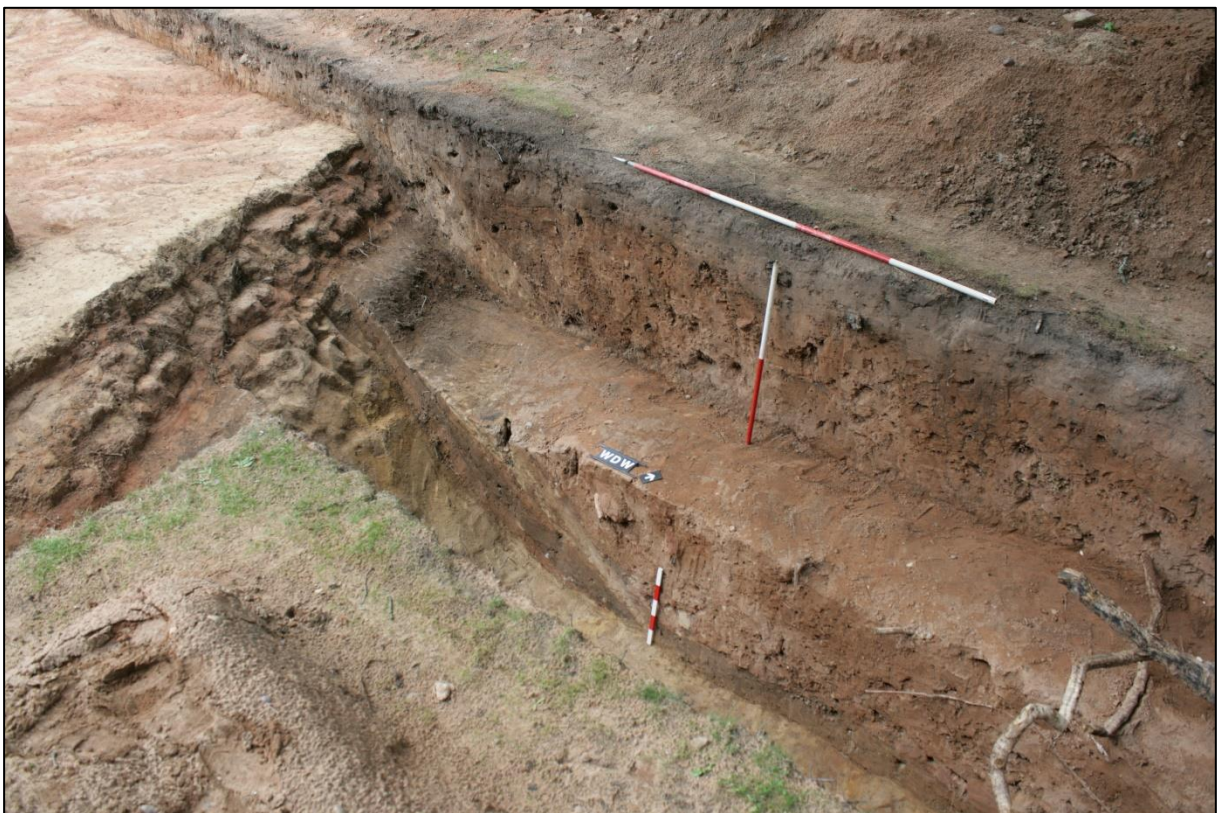
Plate 7: South-east facing section of terrace edge backfill (0017) and bank material in the north-western trench. Scales = 0.5m, 1m and 2m. Looking west.

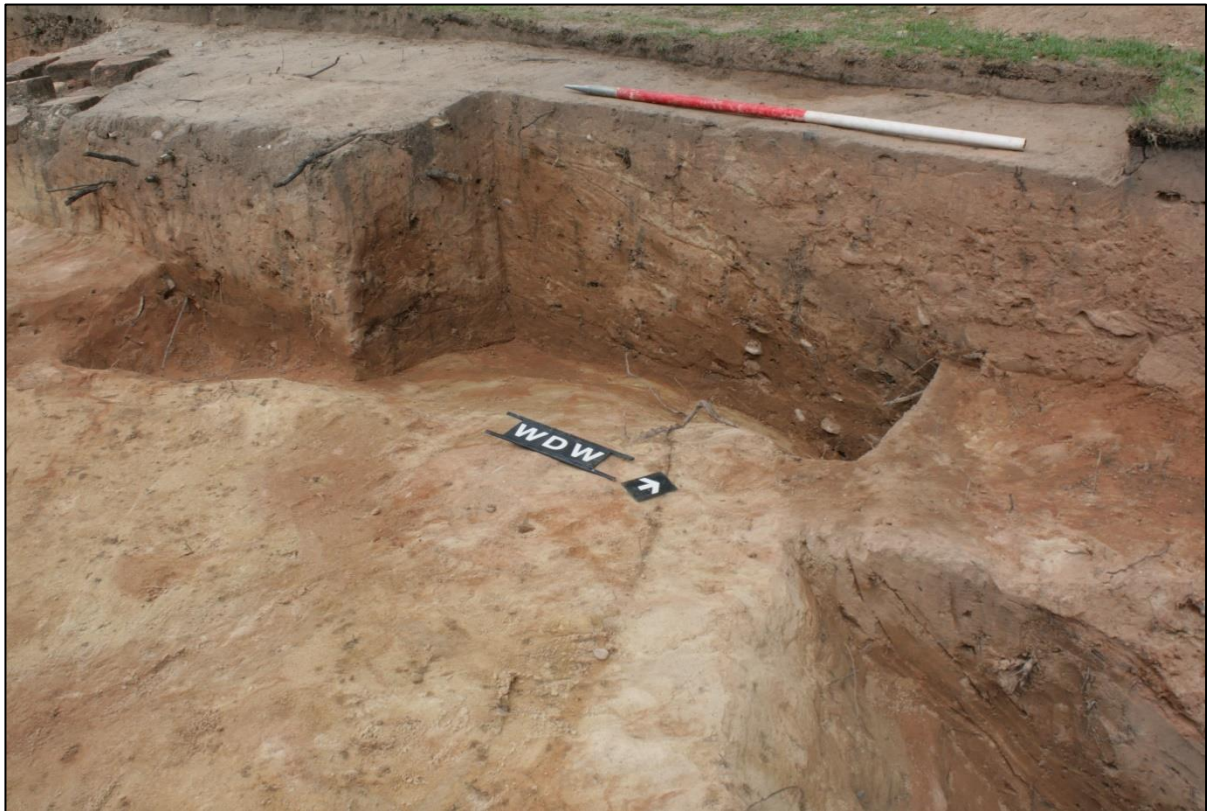
Plate 8: Feature [0072] revealed in south eastern trench, possibly associated with terrace edge cut [0016]. Scale 1m. Looking northwest.

- 7.2.7 The fills within terrace edge [0016] observed in the south-eastern trench and feature [0072] consisted of five fills; loose light brown sand (0063), light yellow brown silt sand (0032), dark orange-brown silt sand (0062), light brown silt sand (0061) and mid-dark brown silt sand with yellow mottles (0060). These fills measured 0.24m deep at the base, 0.5m deep on the terrace edge and 0.7m deep within feature [0072] (Plates 08–11).

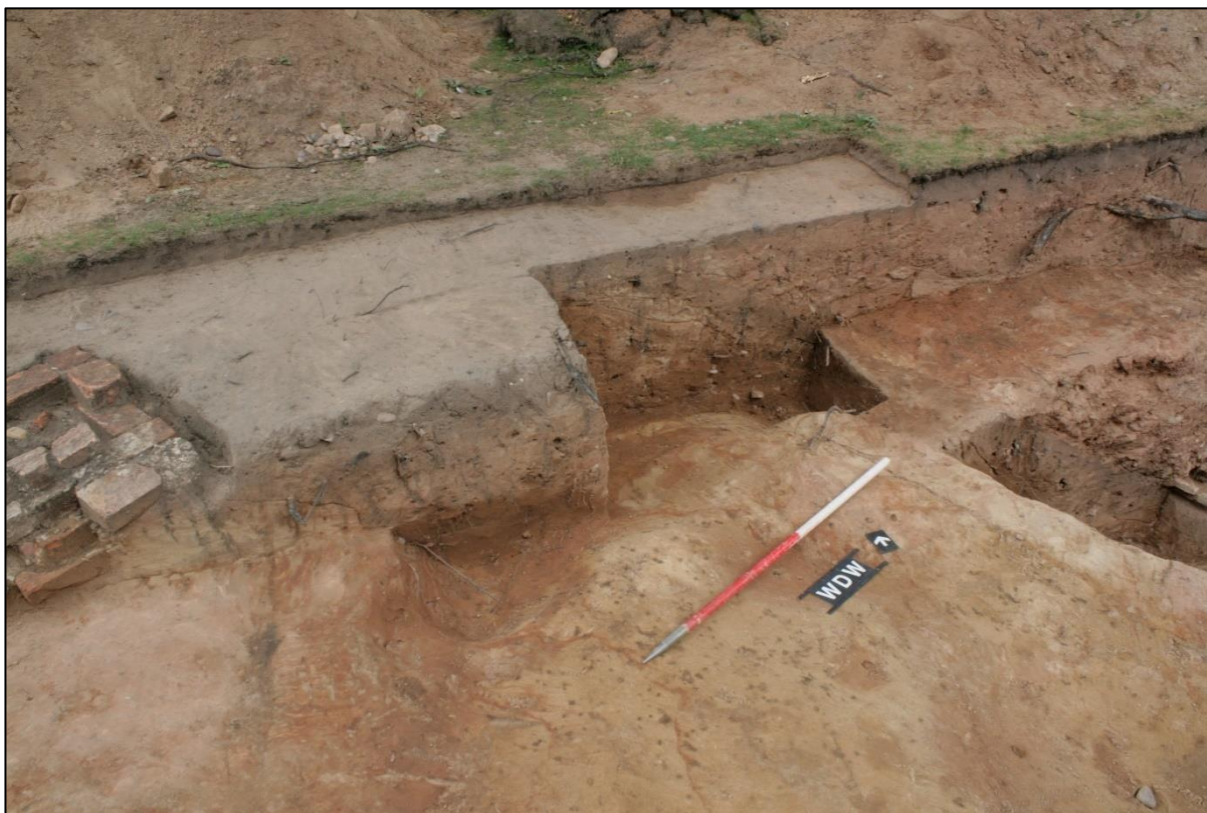
Plate 9: Feature [0072] revealed in south eastern trench, oblique view showing possible association with terrace edge cut [0016]. Scale = 1m. Looking north.

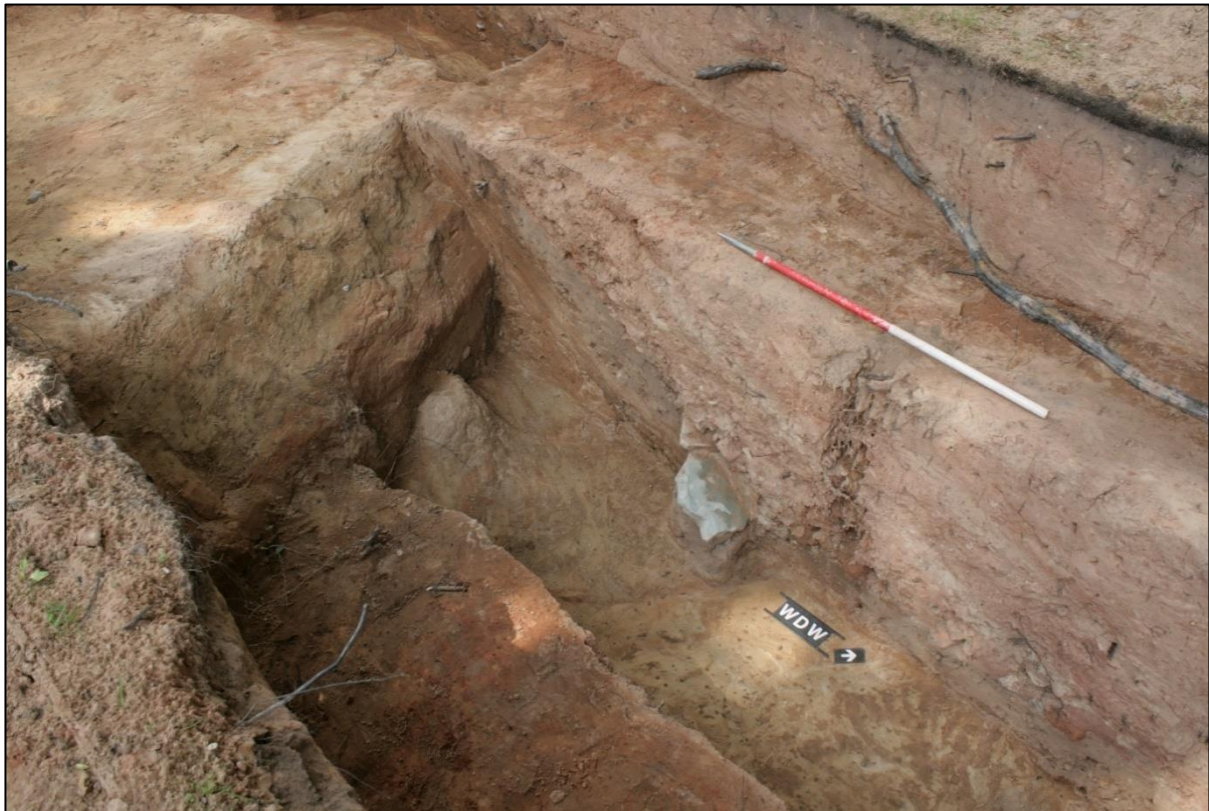
Plate 10: Terrace edge and base [0016] in the south-eastern trench, section showing terrace edge backfill (0015) and bank material. Scale = 1m. Looking west

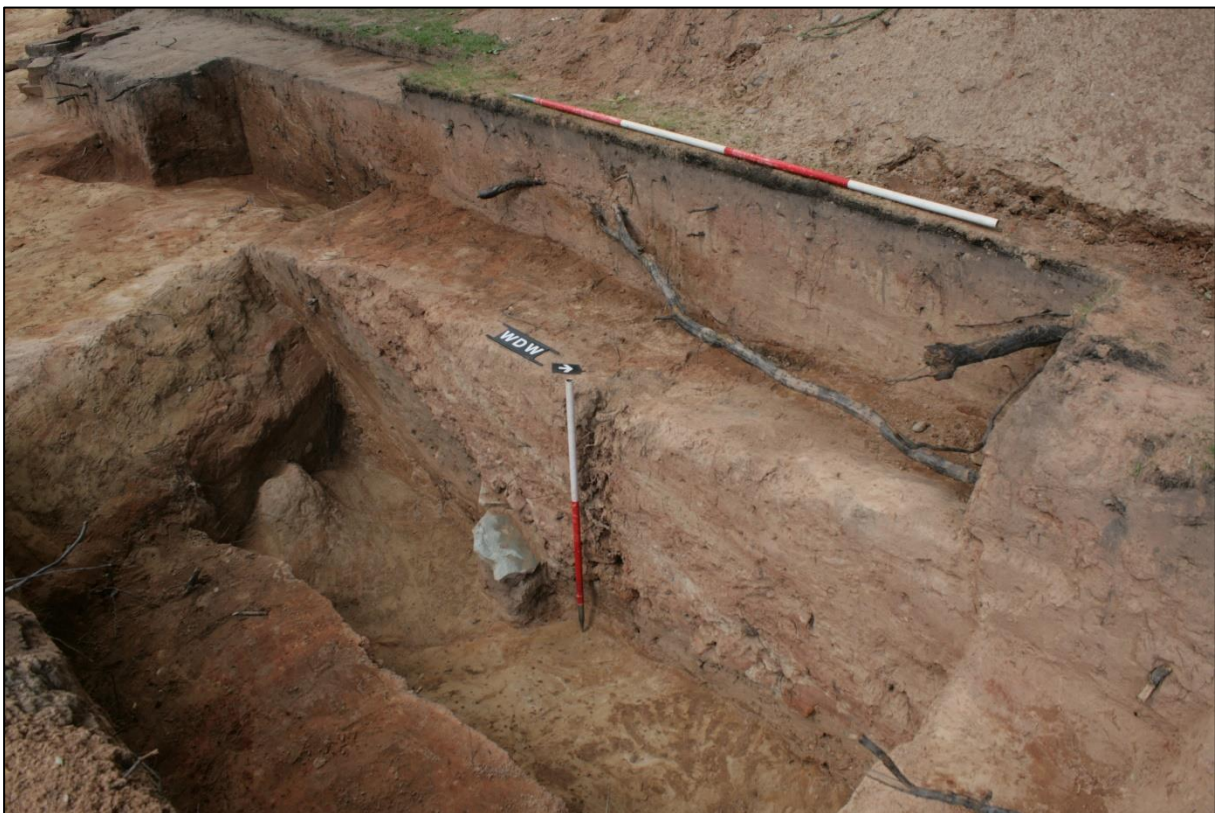
Plate 11: Terrace edge and base [0016] in the south-eastern trench, showing terrace edge backfill (0015) and bank material, and feature [0072]. Scales = 1m and 2m. Looking west

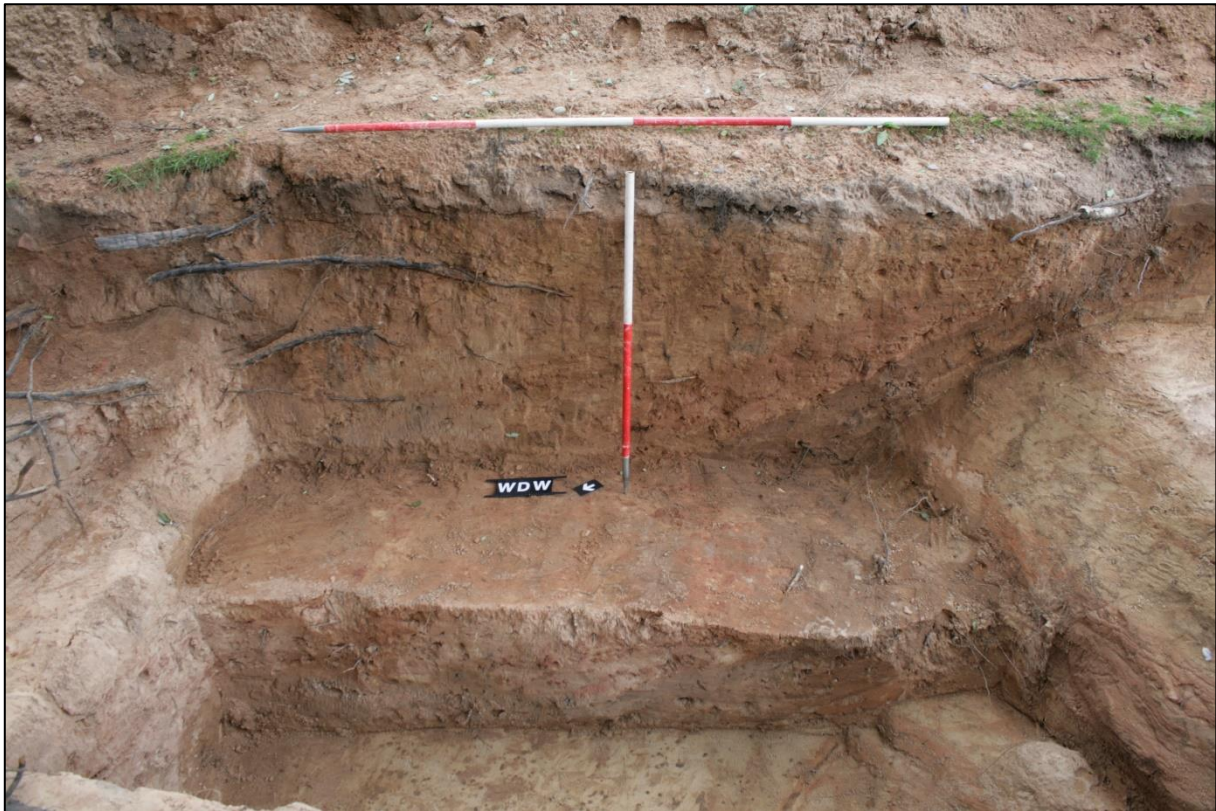
Plate 12: North-west facing section of terrace edge backfill (0015) and bank material in the south-eastern trench. Scales = 1m and 2m. Looking south-east.

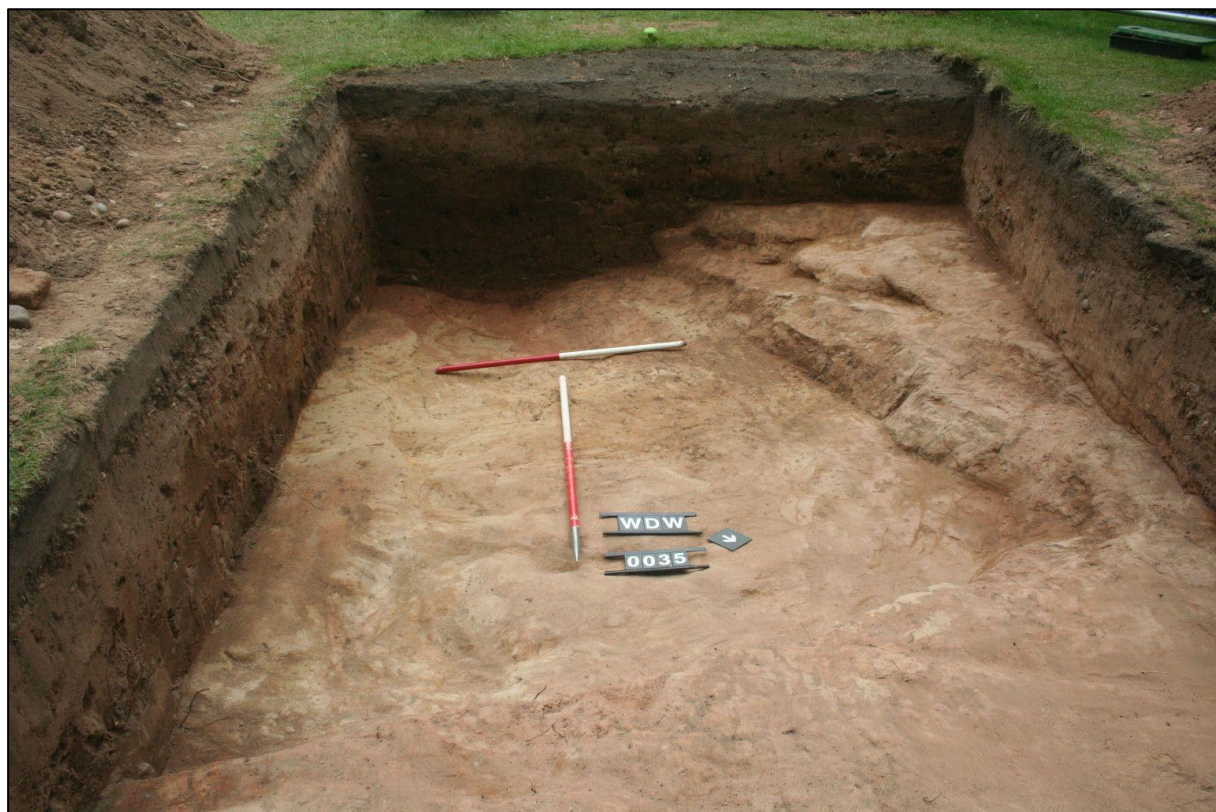
Plate 13: Garden feature [0035] within the north-western trench. Scale 1m. Looking south-west.

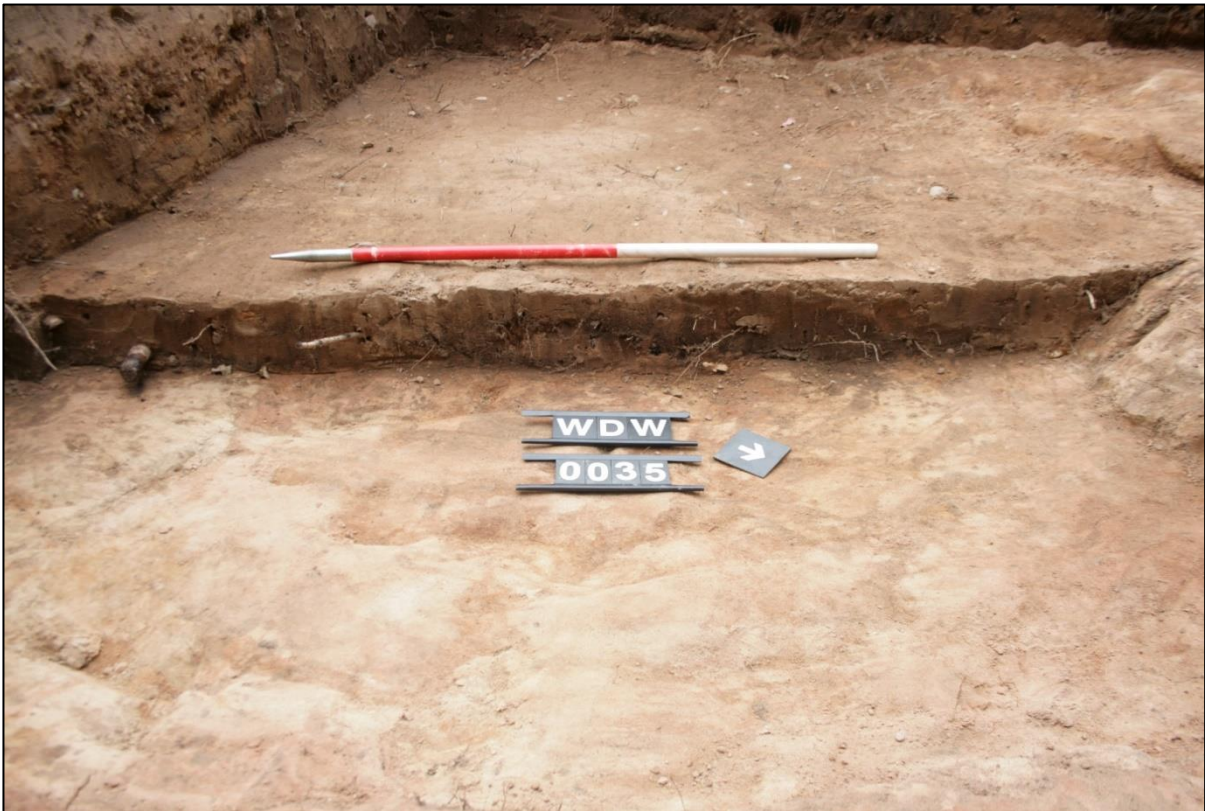
Plate 14: North-east facing section of garden feature [0035] within the north-western trench. Scale = 1m. Looking south-west.

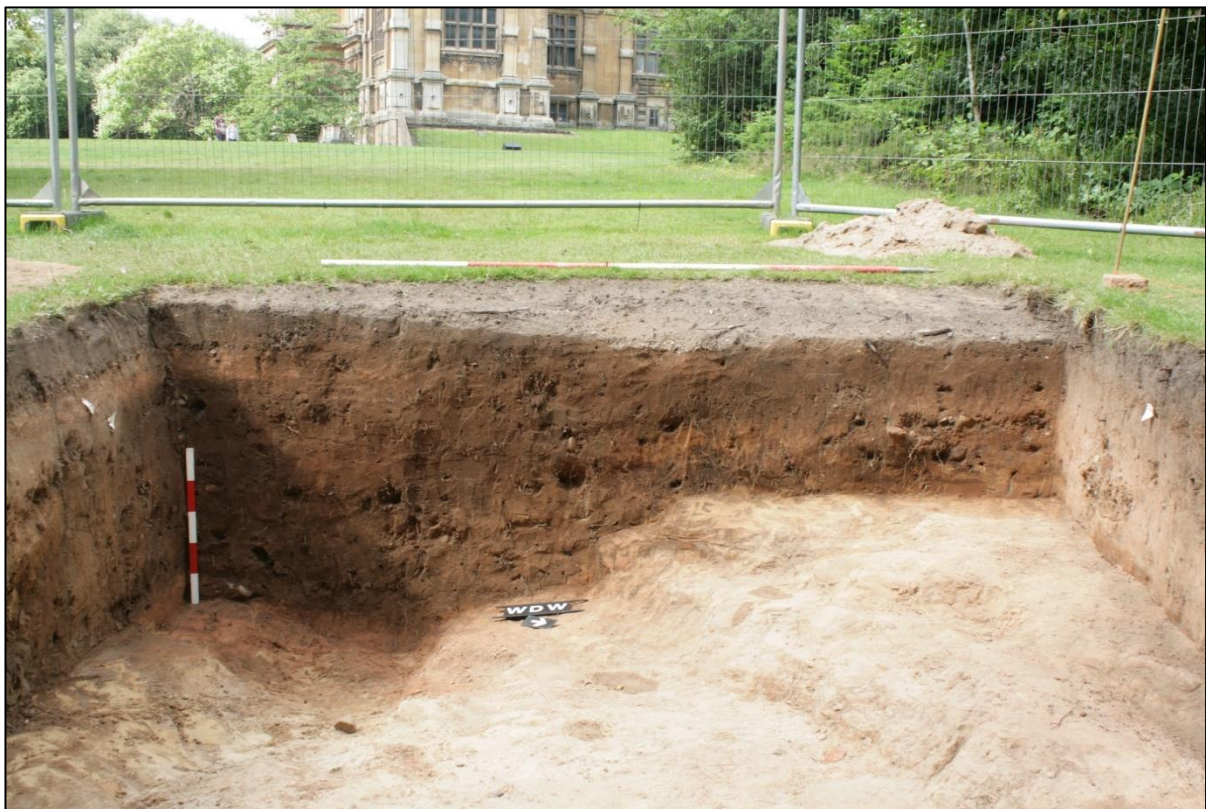
Plate 15: North-east facing section of north-western trench including garden feature [0035]. Scales = 0.5m and 2m. Looking south-west.

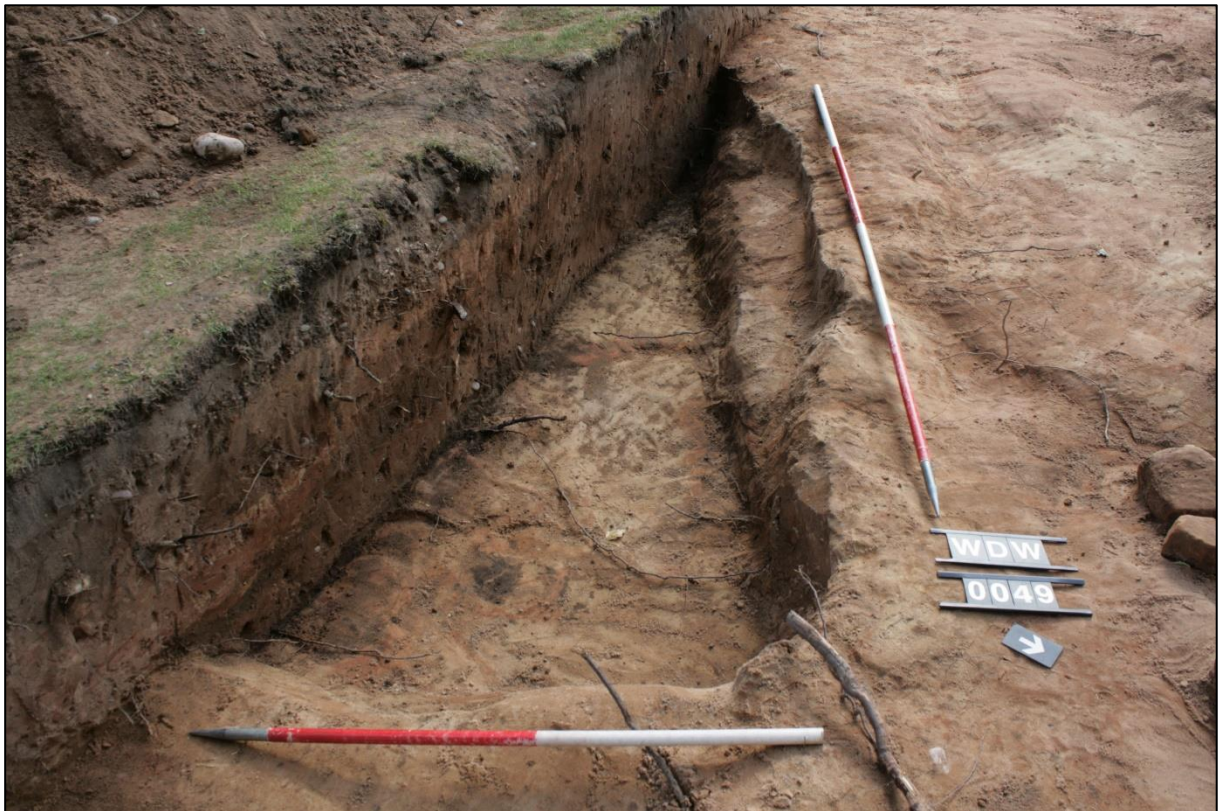
Plate 16: Garden feature [0049] in south-eastern trench. Scales = 1m and 2m. Looking south-

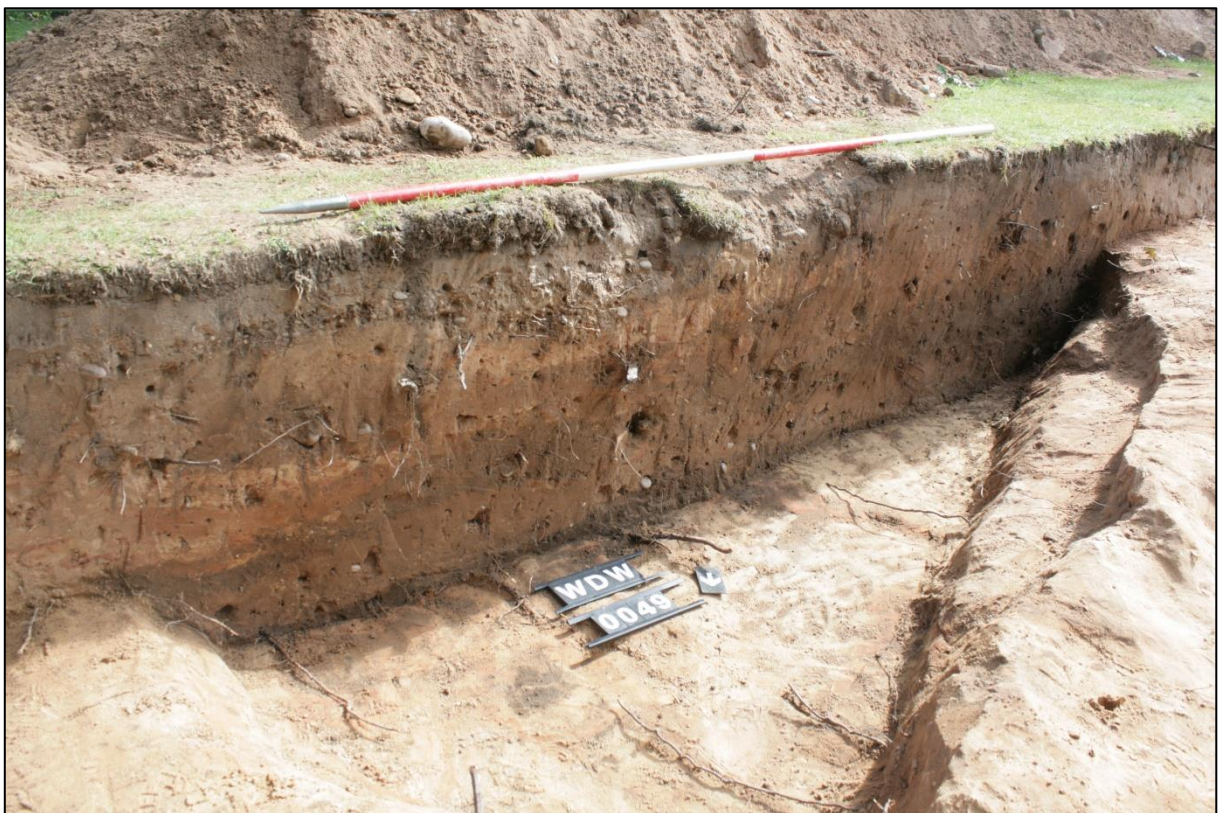
Plate 17: North-west facing section of garden feature [0049] in south-eastern trench. Scale = 2m. Looking south.

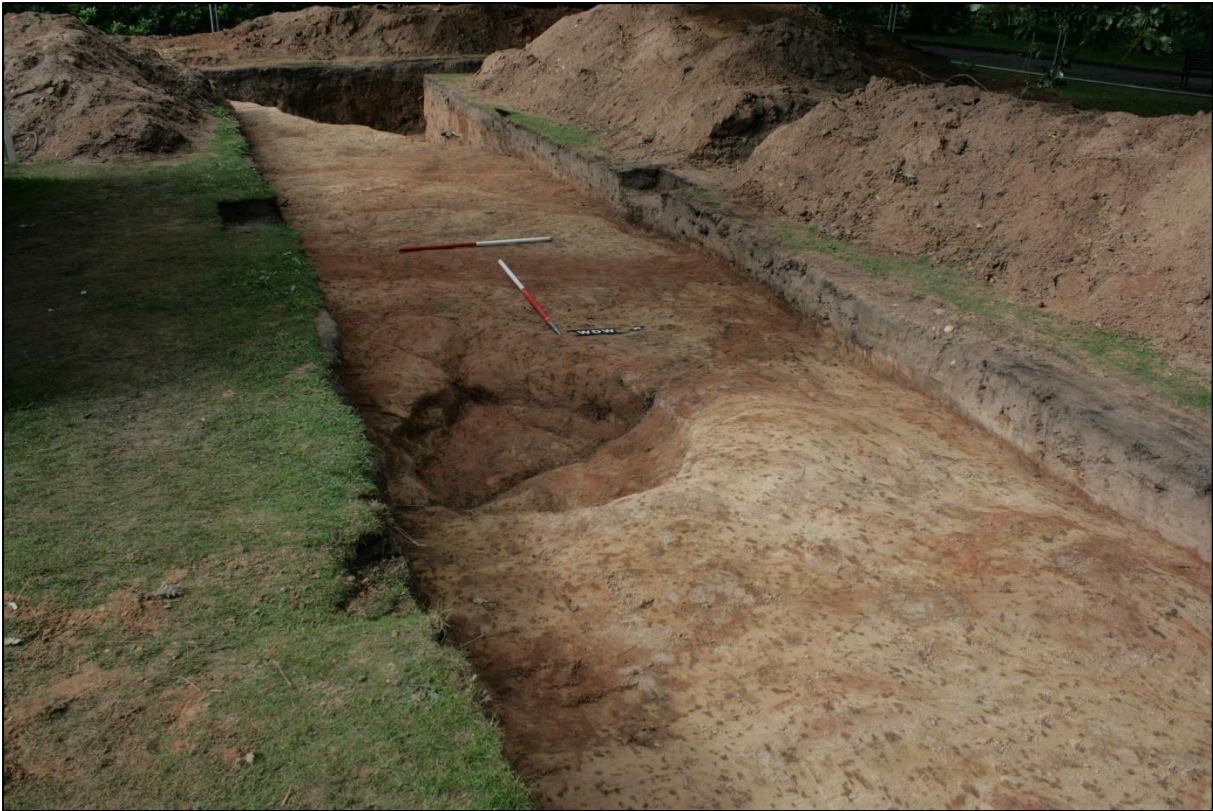
Plate 18: Central trench with round garden feature [0039] in the foreground. Scales = 1m. Looking north.

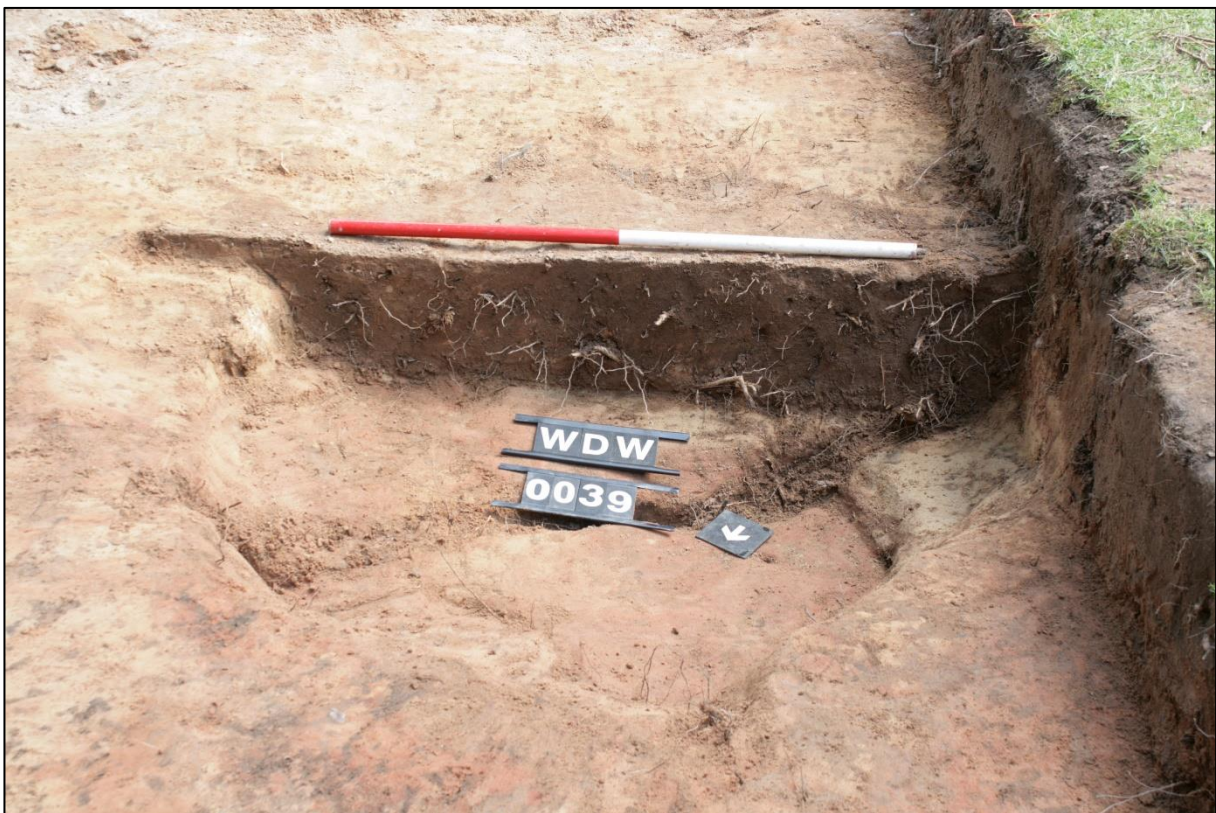
Plate 19: North-west facing section of round garden feature [0039]. Scale = 1m. Looking south-east

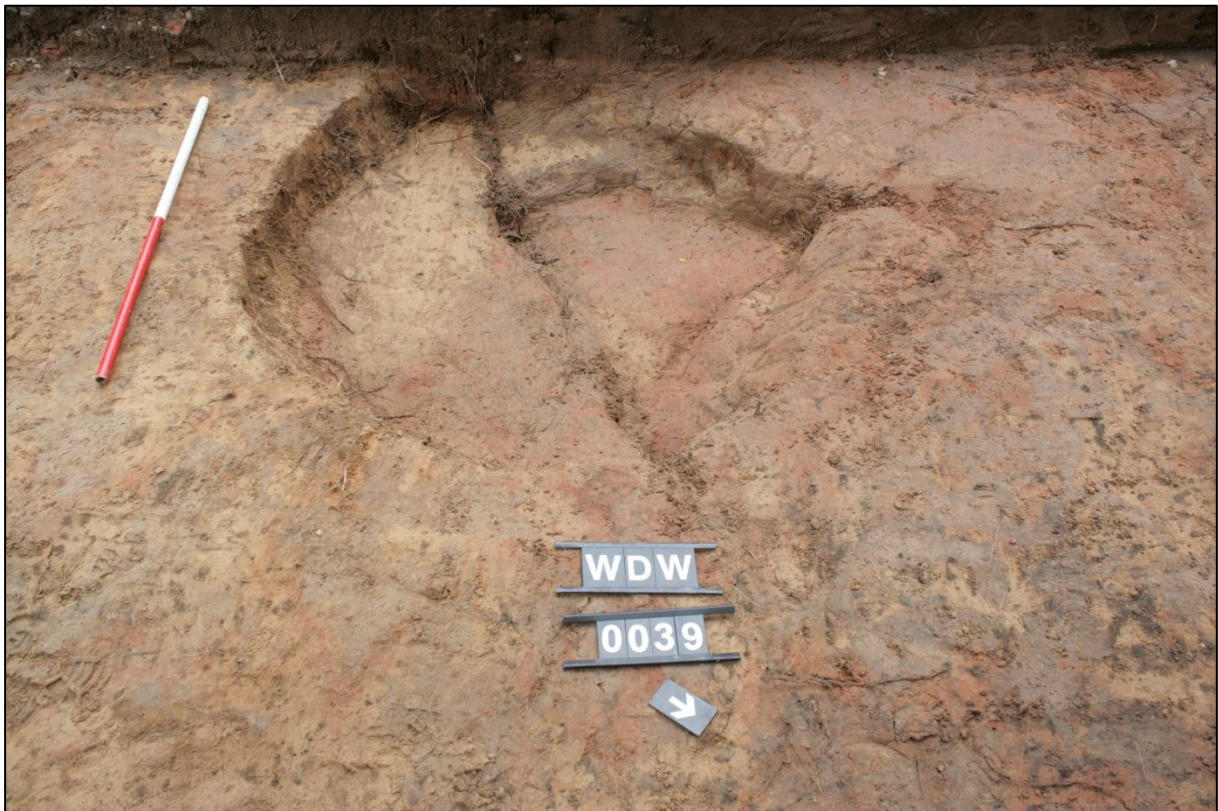
Plate 20: Round garden feature [0039] in central trench. Scale = 1m. Looking south-west.

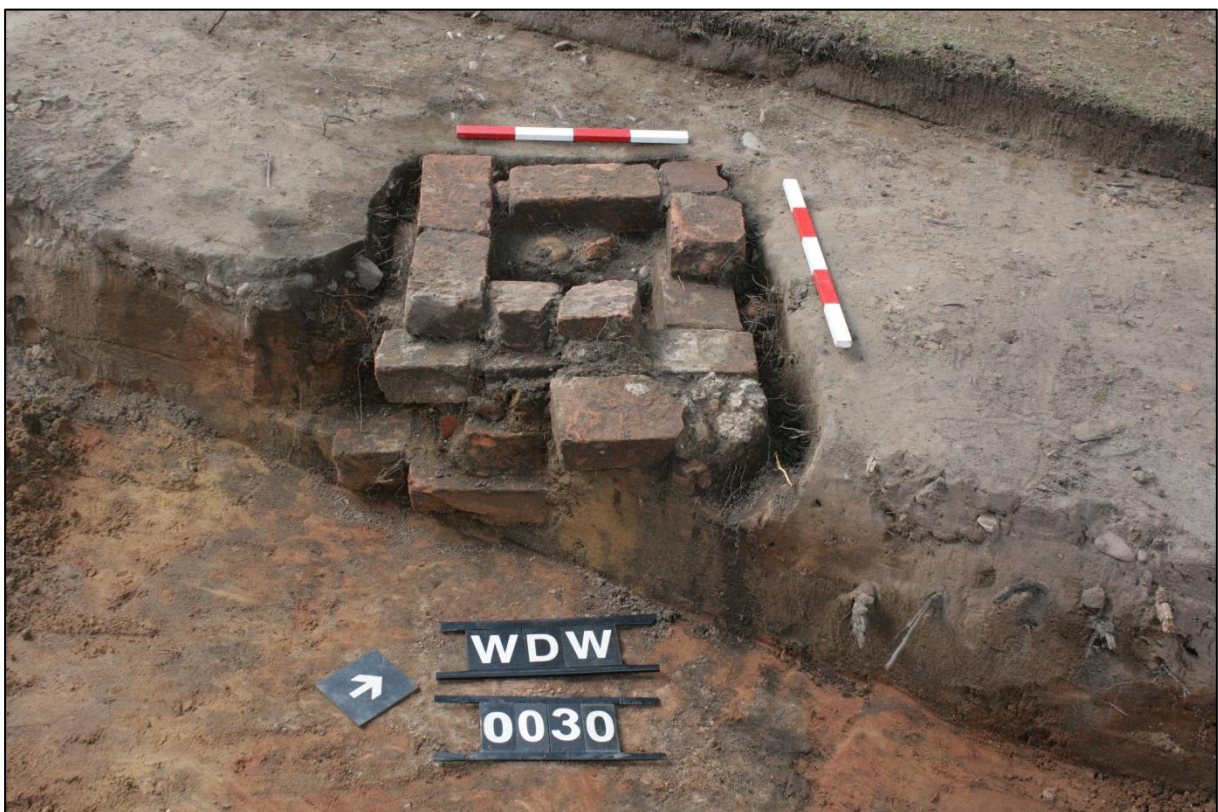
Plate 21: Square brick plinth [0030] showing the excavated construction cut [0033] on the south-west side and the excavated robber cut [0037] on the north-east and north-west facing edges of plinth [0030]. Scale = 0.5m. Looking north-west.

- 7.2.12 Square brick plinth [0030] was exposed at first within the south-east facing section of the south-eastern trench, before turf was removed to expose the entire feature (Plates 21–24, Figures 14 and 15). The brick plinth measures 0.5m x 0.5m in plan and 0.34m in depth. It consists of four loose courses of bricks and each course steps out a further 60mm forming a pyramidal shape with a hollow measuring at least 0.3m x 0.3m in the centre. The individual bricks measure up to 240mm x 115mm x 75mm and are loosely mortared with a white grey mortar. Plinth [0030] is backfilled with a primary fill of dark yellowish brown silty sand (0042) measuring 0.15m deep and a secondary fill of dark brown sandy silt (0041).
