WE DIG WOLLATON PARK

A TRAINING EXCAVATION AT WOLLATON PARK NOTTINGHAM

REPORT ON AN ARCHAEOLOGICAL EVALUATION

Report Number: 011/2021

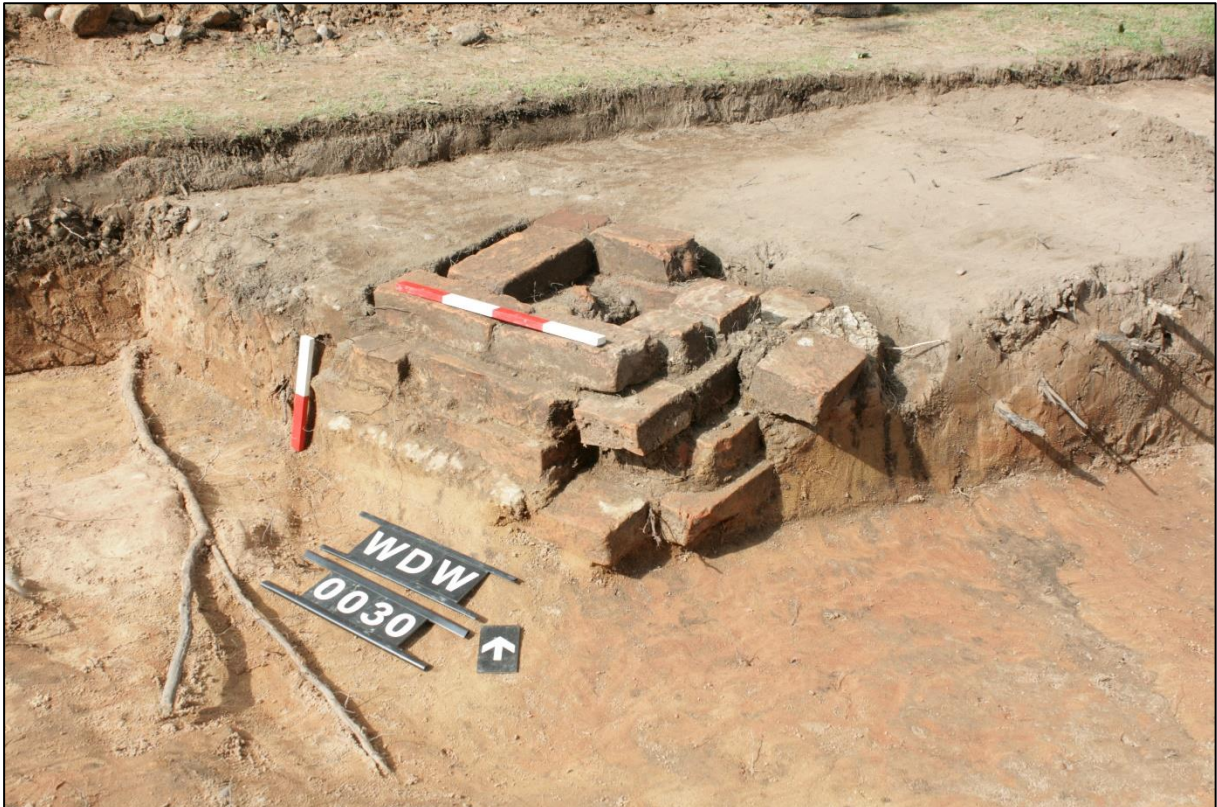
Plate 22: Square brick plinth [0030] oblique view in south-eastern trench. Scales = 0.2m and 0.5m. Looking north.

- 7.2.12 Square brick plinth [0030] was exposed at first within the south-east facing section of the south-eastern trench, before turf was removed to expose the entire feature (Plates 21–24, Figures 14 and 15). The brick plinth measures 0.5m x 0.5m in plan and 0.34m in depth. It consists of four loose courses of bricks and each course steps out a further 60mm forming a pyramidal shape with a hollow measuring at least 0.3m x 0.3m in the centre. The individual bricks measure up to 240mm x 115mm x 75mm and are loosely mortared with a white grey mortar. Plinth [0030] is backfilled with a primary fill of dark yellowish brown silty sand (0042) measuring 0.15m deep and a secondary fill of dark brown sandy silt (0041).

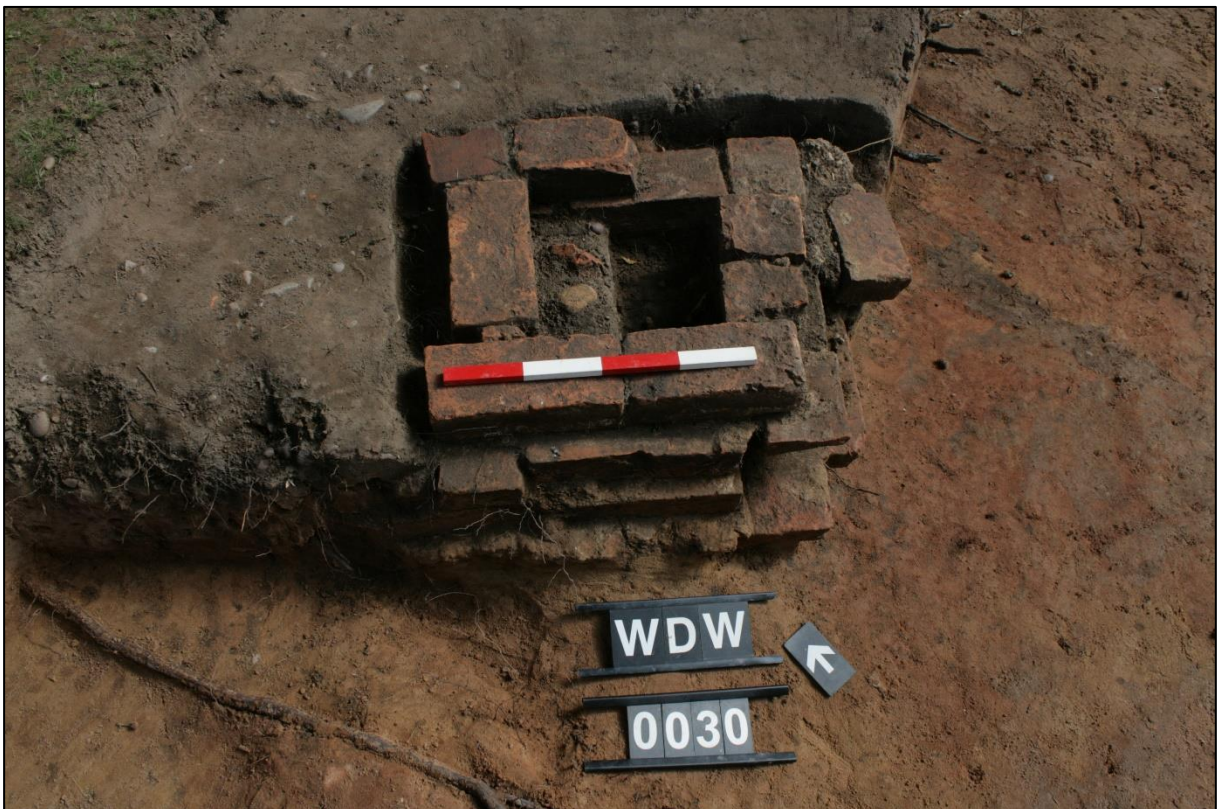
Plate 23: Square brick plinth [0030] plan view. Scale 0.5m. Looking north-east.

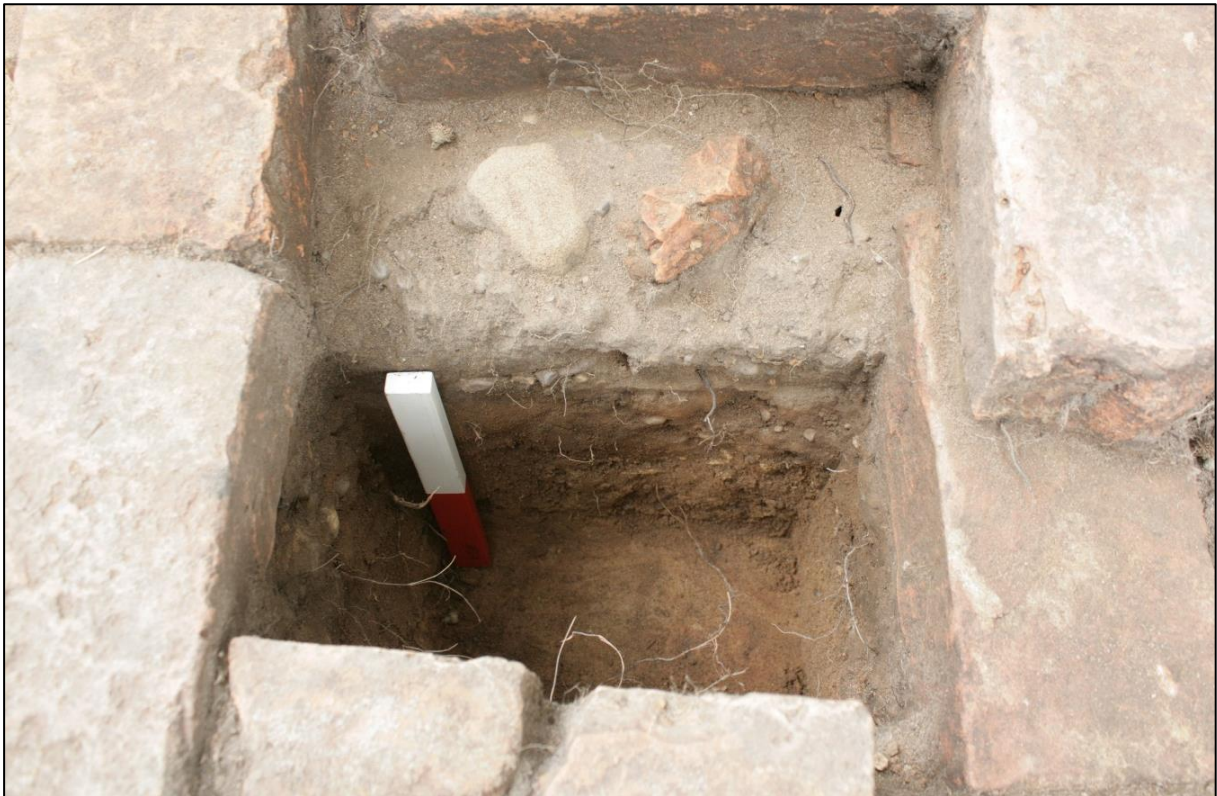
Plate 24: Square brick plinth [0030] and south-east facing section through internal backfill deposits. Scale = 0.2m. Looking north-west.

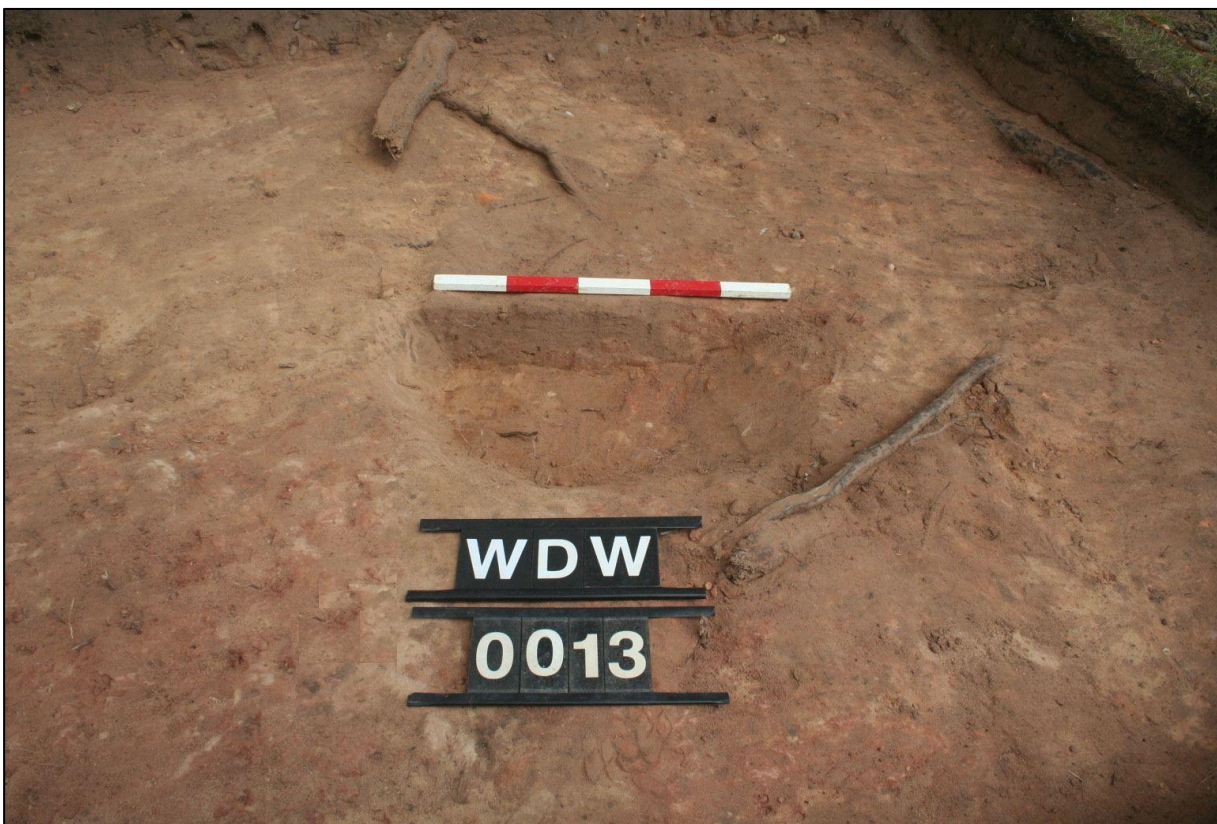
Plate 25: Pit [0013] cutting through terrace backfill (0015) in south-eastern trench. Scale = 0.5m. Looking south-east.

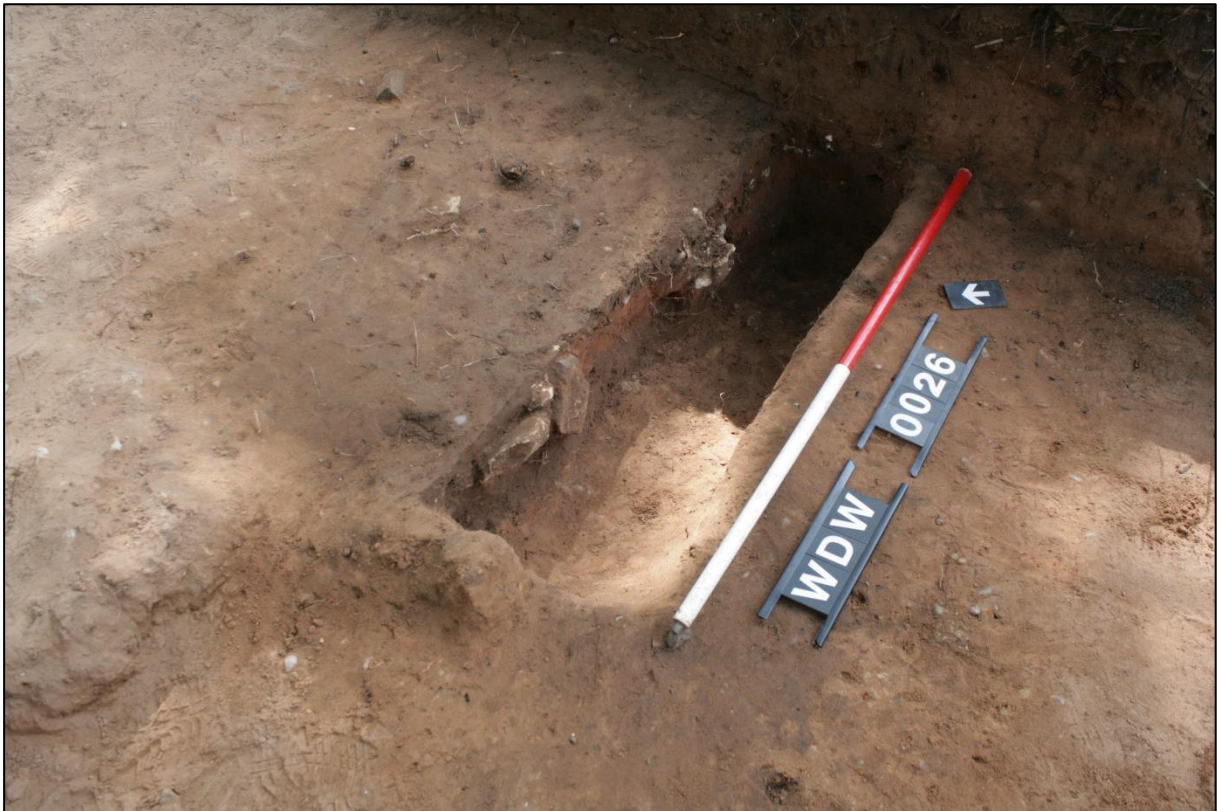
Plate 26: Sub-rectangular pit or linear feature [0026] in north-western trench. Scale = 1m. Looking south-east.

- 7.2.16 Located within the north-western trench, sub-rectangular pit or linear feature [0026] was also found cutting into terrace backfill deposit (0017) and continuing beyond the trench section (Plates 26–28). It measured an observed length of 1.1m, 1m wide and 0.4m deep (Figure 07). The edges and base were concave in shape. Feature [0026] was filled by a primary fill of friable dark brown silt sand (0027) containing mortar and charcoal flecks and measuring 0.18m deep. Above the primary fill was a compacted orange-brown sand (0028) containing large flattish fragments of stone and bricks, measuring a maximum depth of 0.12m. Above this, light brown sand (0029) filled the final 0.07m of feature [0026]. It contained inclusions of charcoal and rounded pebbles. The purpose of feature [0026] is unknown but post-dates the backfilling event of terrace edge [0016].

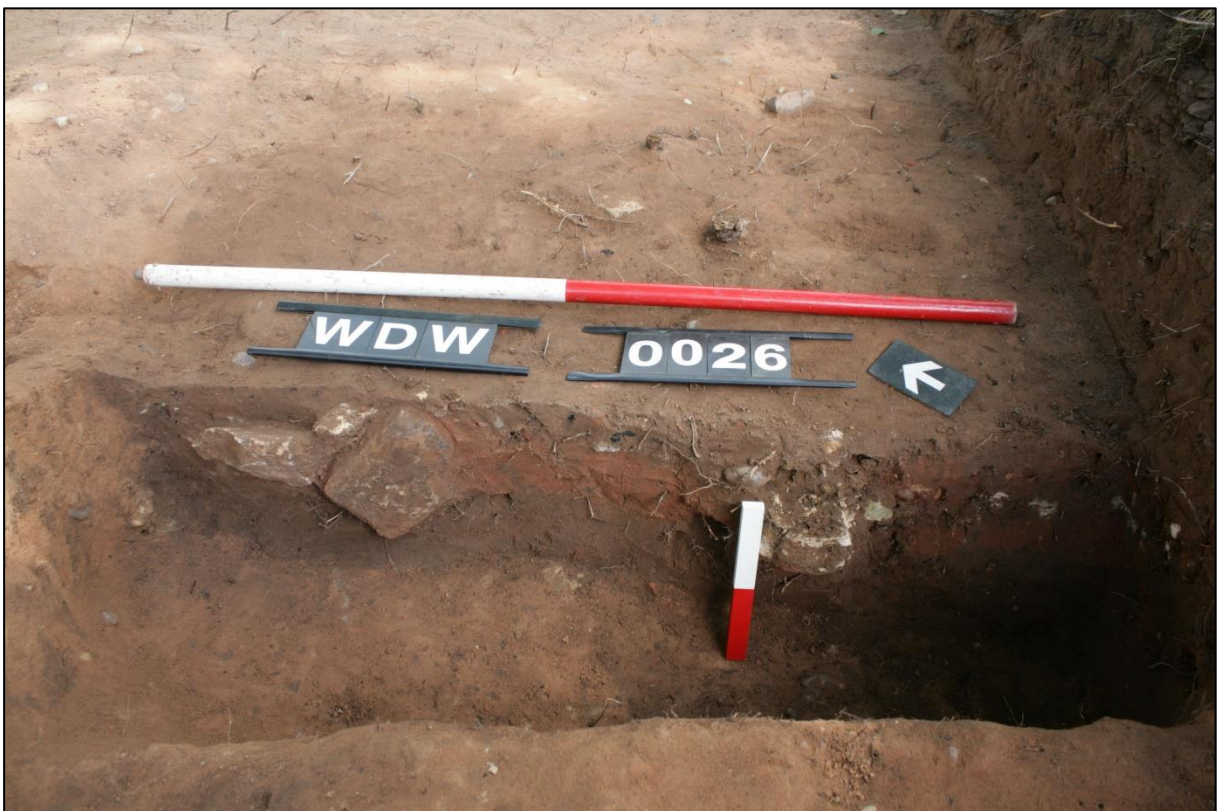
Plate 27: South-west facing section of pit or linear feature [0026] north-western trench. Scales = 0.2m and 1m. Looking north-east.

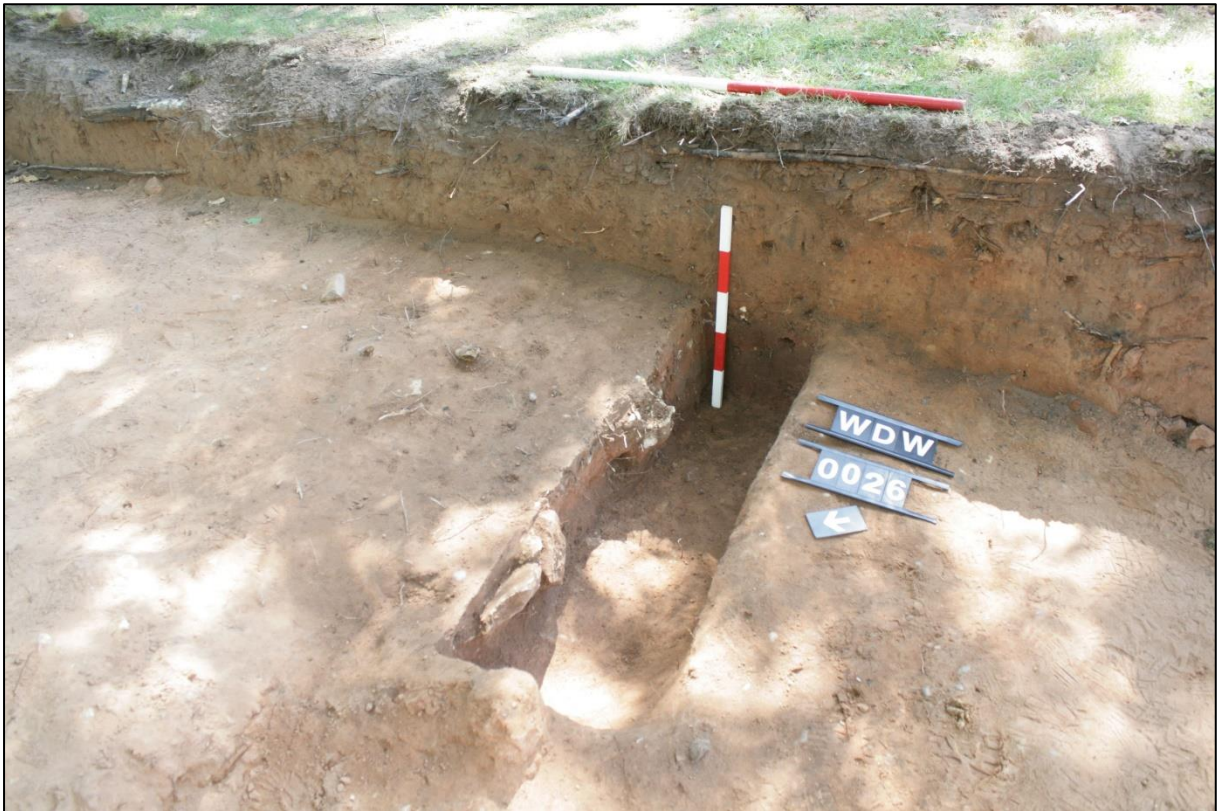
Plate 28: North-west facing section of sub-rectangular pit or linear feature [0026] in north-western Trench. Scales = 0.5m and 1m. Looking south-east.

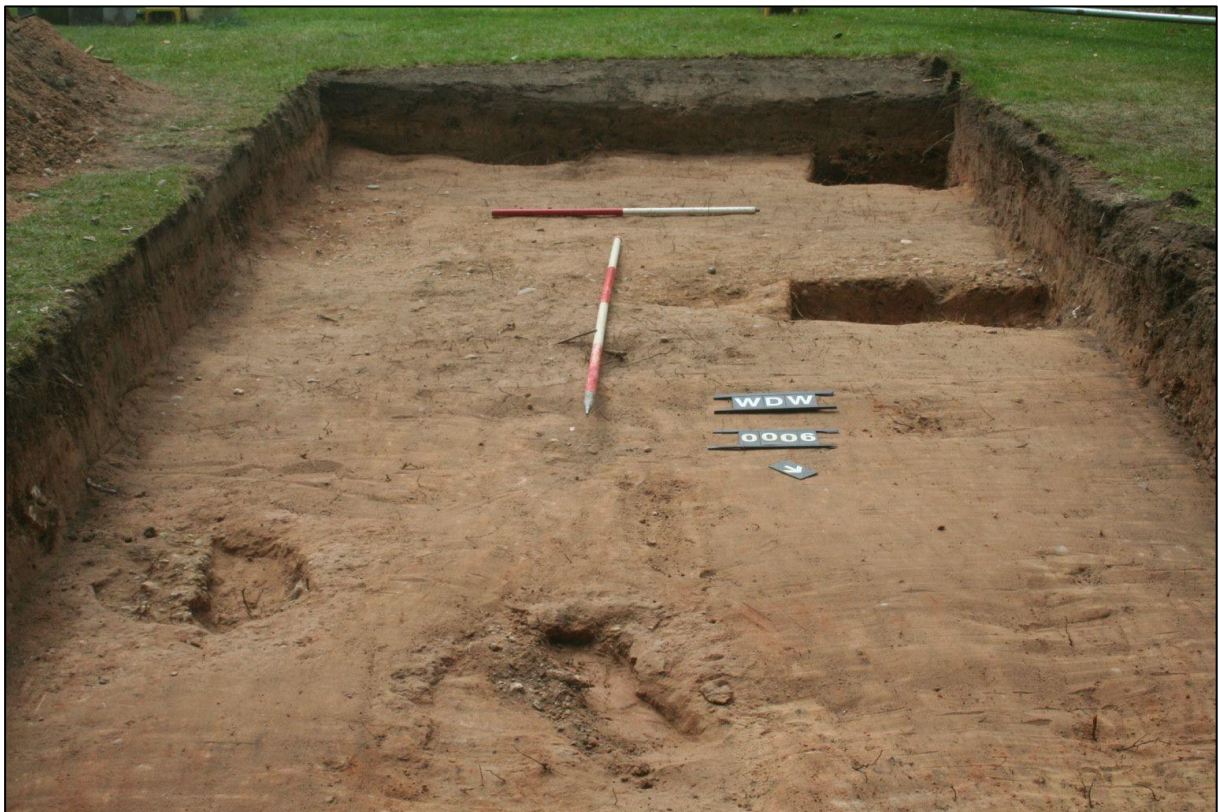
Plate 29: Western end of north-western trench, pits [0007] and [0009] in the foreground, sondage through (0011) and (0006) in the background. Scales = 1m and 2m. Looking south-west.

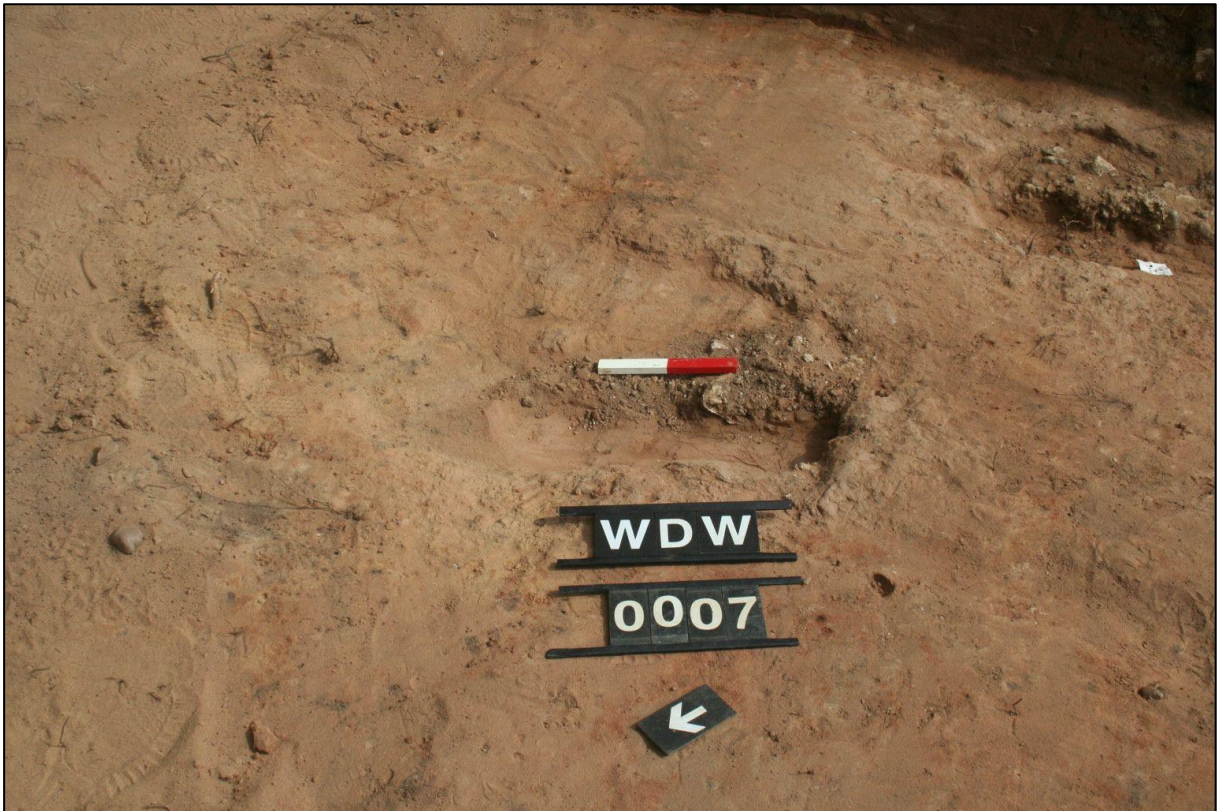
Plate 30: Pit [0007] in western end of north-western trench. Scale = 0.2m. Looking south-east.

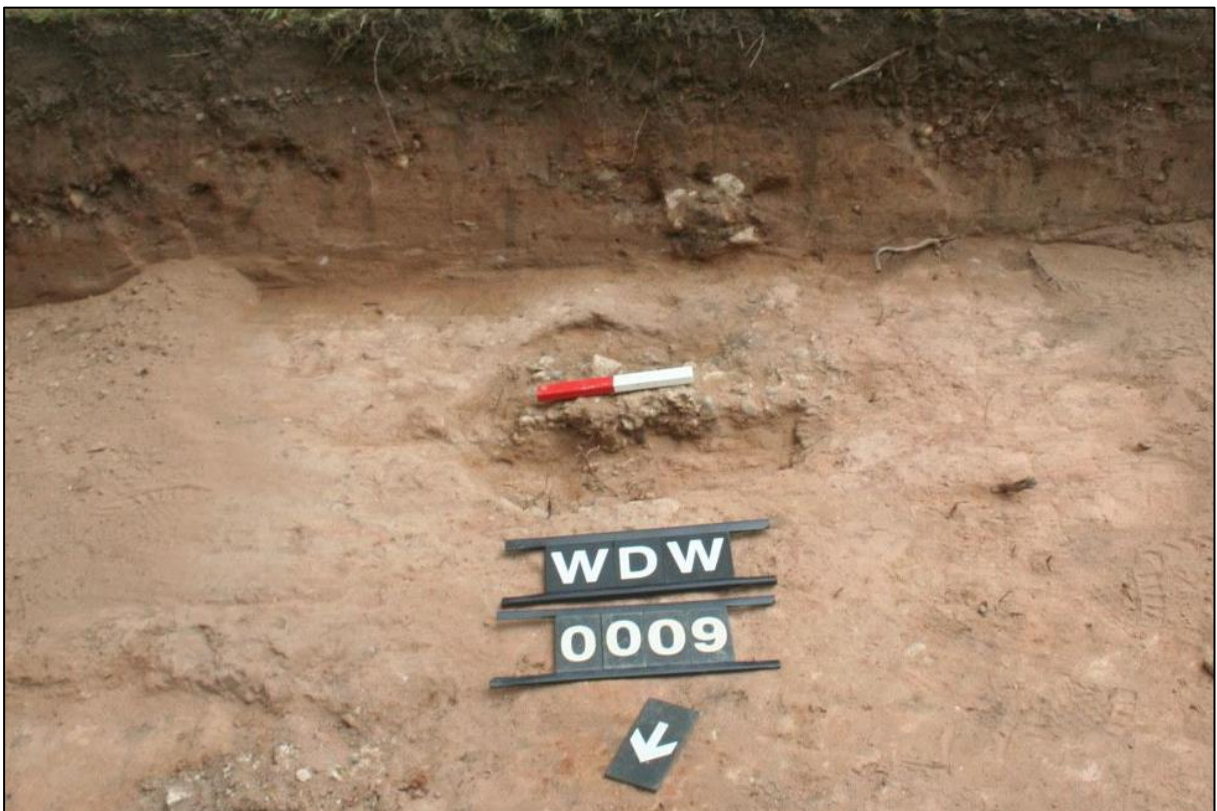
Plate 31: Pit [0009] in western end of north-western trench. Scale = 0.2m. Looking south-east.

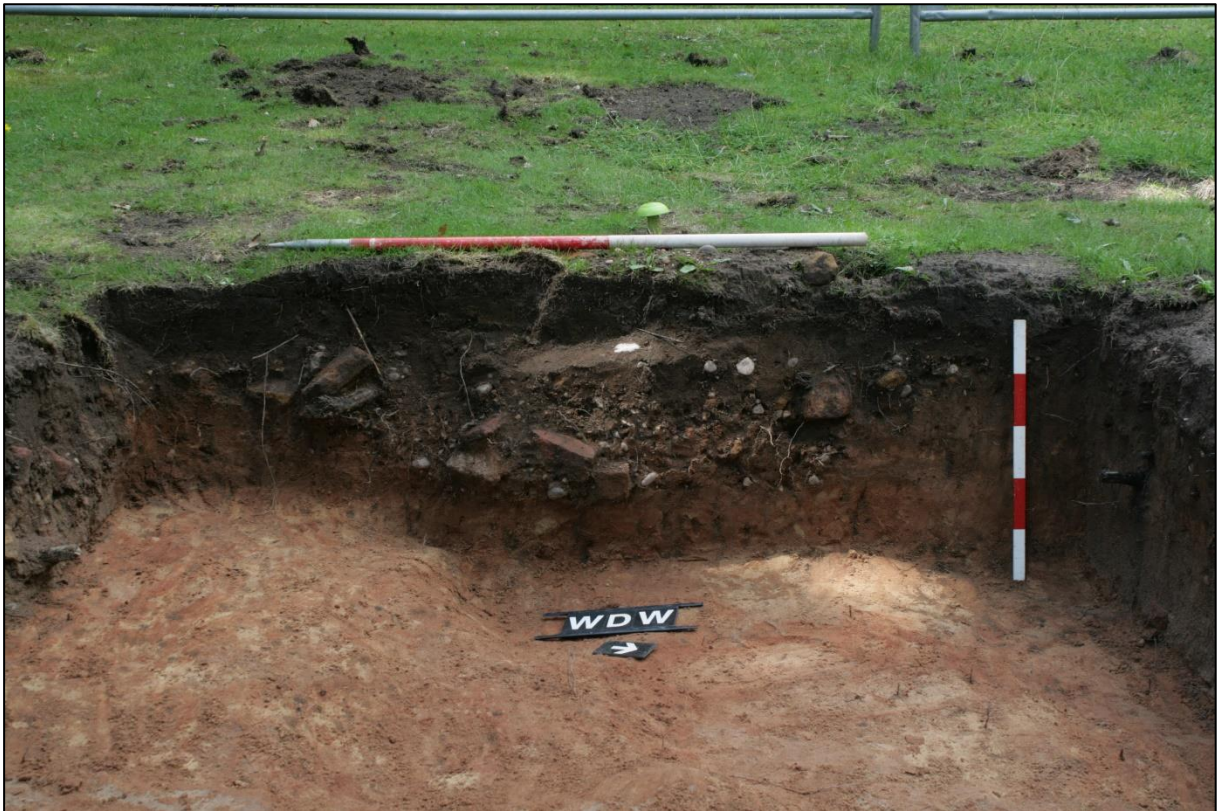
Plate 32: Pit [0044] in the northeast facing section of the south-eastern trench. Scales = 0.5m and 1m. Looking south-west

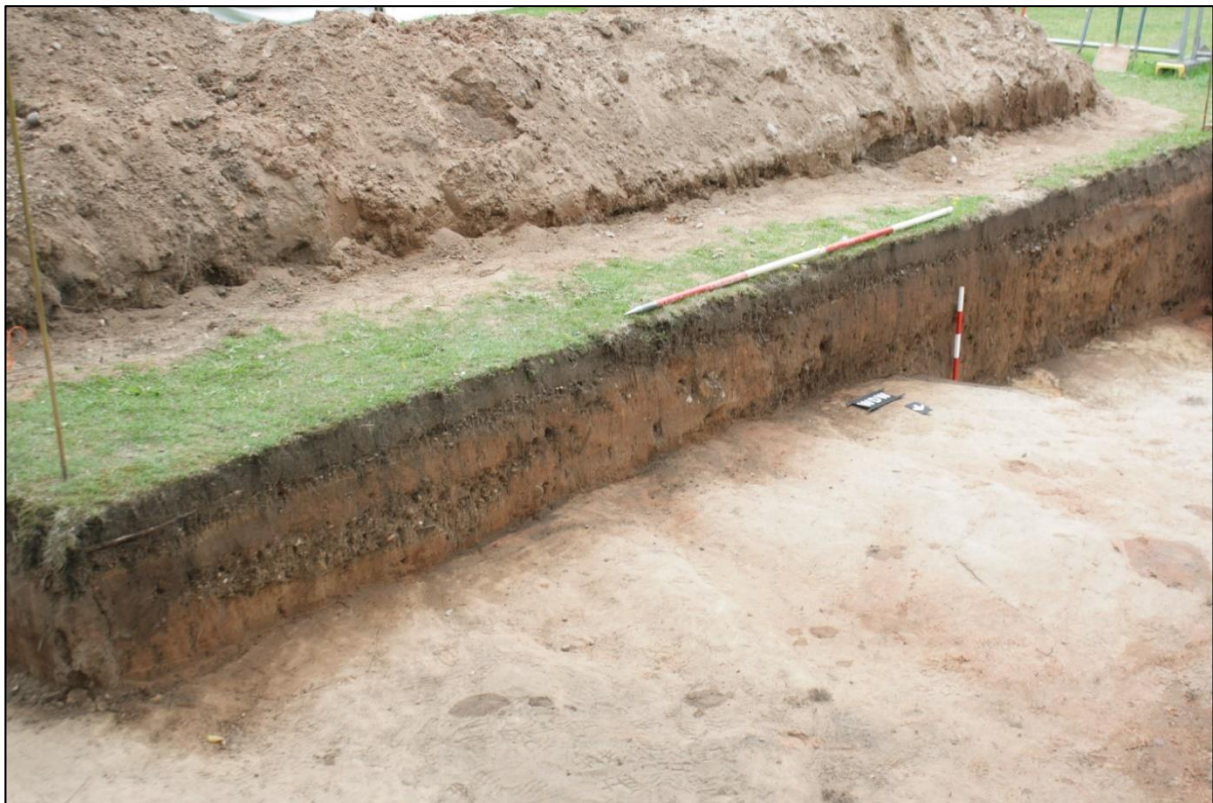
Plate 33: North-west facing section in north-western trench showing levelling and gravel deposits. Scales = 1m and 2m. Looking south.

- 7.2.22 Landscaping or levelling deposits were revealed in the north-western trench above garden feature [0035] and terrace edge [0016]. They measured up to 0.5m deep in total and were revealed in section to be at least 3m wide (Figure 10). They range in composition from friable dark-brown medium silt to orange-brown sand. These deposits are likely to have been used to fill in a recurring hollow or dip in the landscape caused by the presence of garden feature [0035] below ground level (Plates 33–37).

- 7.2.23 A number of gravel deposits were recorded in plan but mostly in section (Plates 33–37). Deposits (0021) and (0024) consisted of intermittent pockets of compact rubble, pebbles and grey-brown sand measuring up to 1m wide and 0.1m deep in section (Figures 09–11 and 17). Deposit (0011) was an uneven yet continuous spread of sandy silt with pebbles, CBM and chalk inclusions observed both in plan and in section. It measured at least 2.6m long and 0.1m deep with its width undulating between 0.2 and 0.6m. Deposits (0003) and (0025) were thin yet consistent fine gravelly layers above sand deposit (0006) and above terrace backfill (0017). These deposits were even and long, with (0003) observed in section for 9.3m. Both deposits measured 0.05m deep. All of these gravel deposits are interpreted as levelling deposits from a later phase of landscaping, possibly into the 20th century.

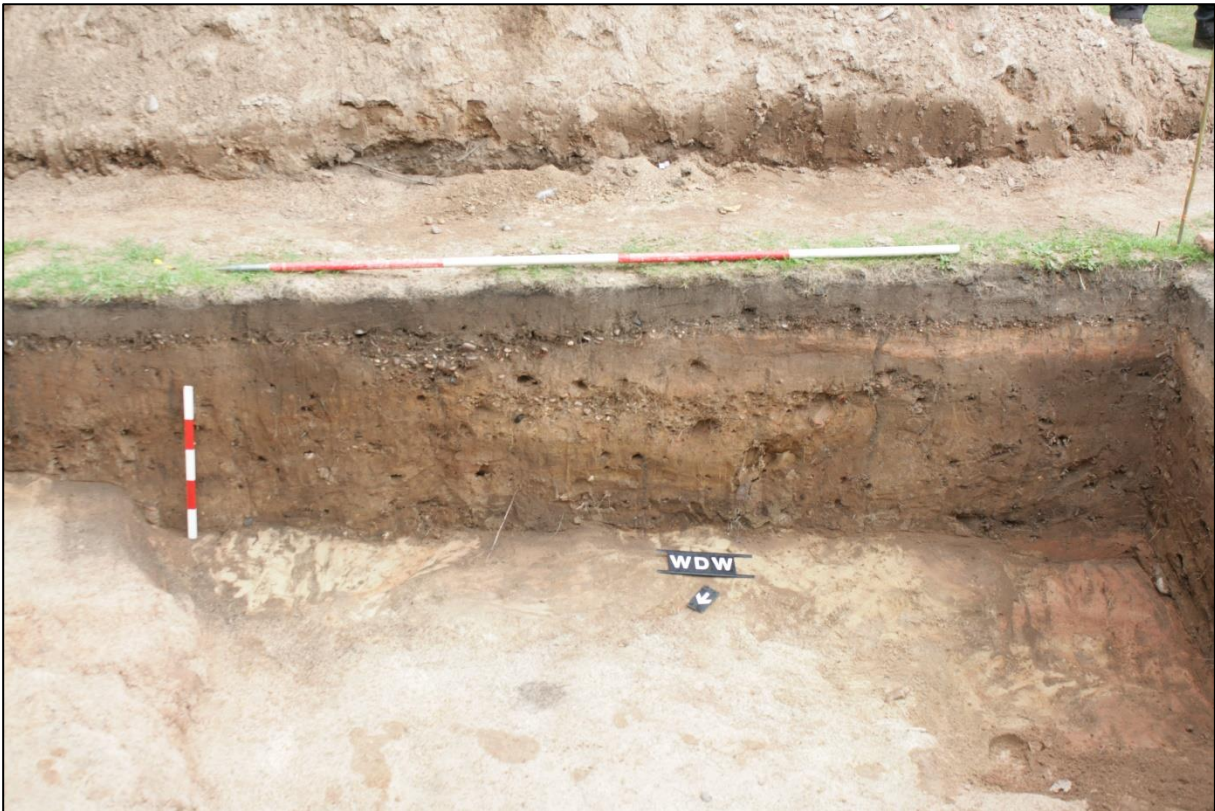
Plate 34: North-west facing section of garden feature [0035] in north-western trench showing levelling deposits and pit [0005] above [0035]. Scales = 0.5m and 2m. Looking south-west.

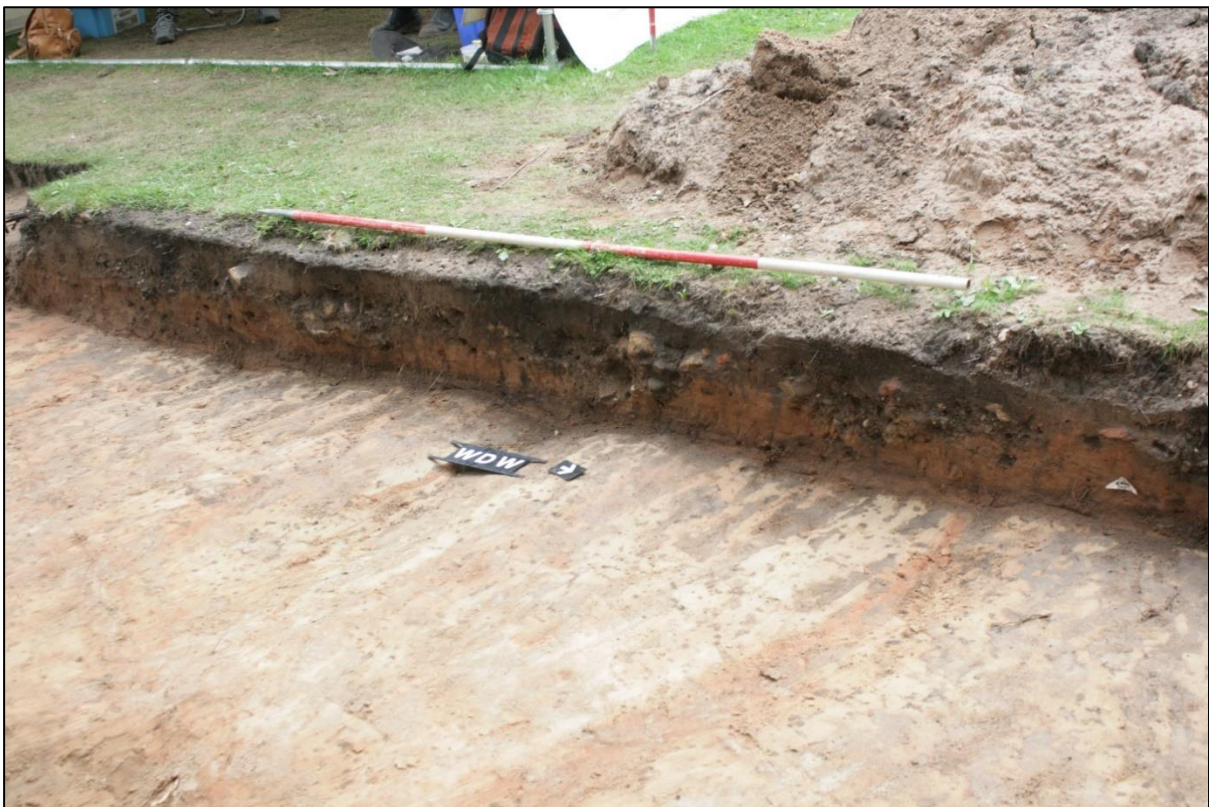
Plate 35: North-east facing section in central trench showing gravel and levelling deposits. Scale = 2m. Looking south-west.

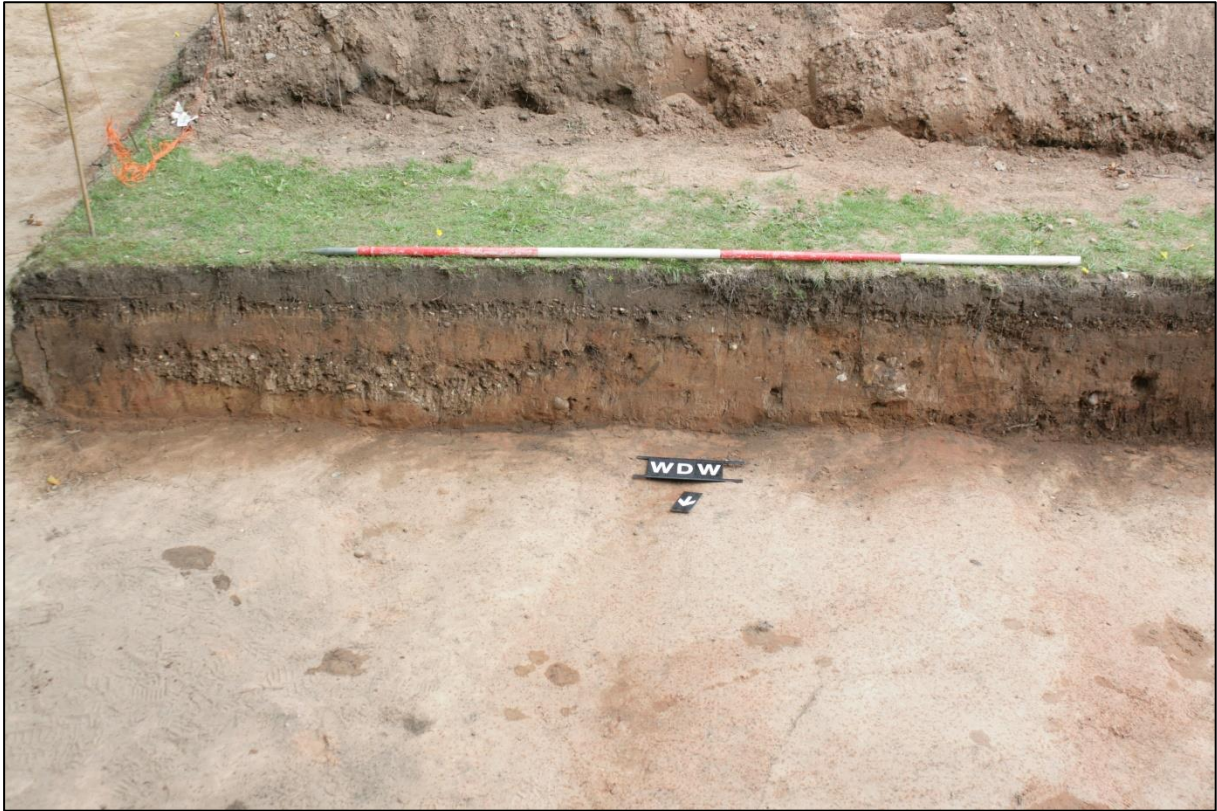
Plate 36: End of north-west facing section in north-western trench showing gravel deposits. Scale = 2m. Looking south-east.

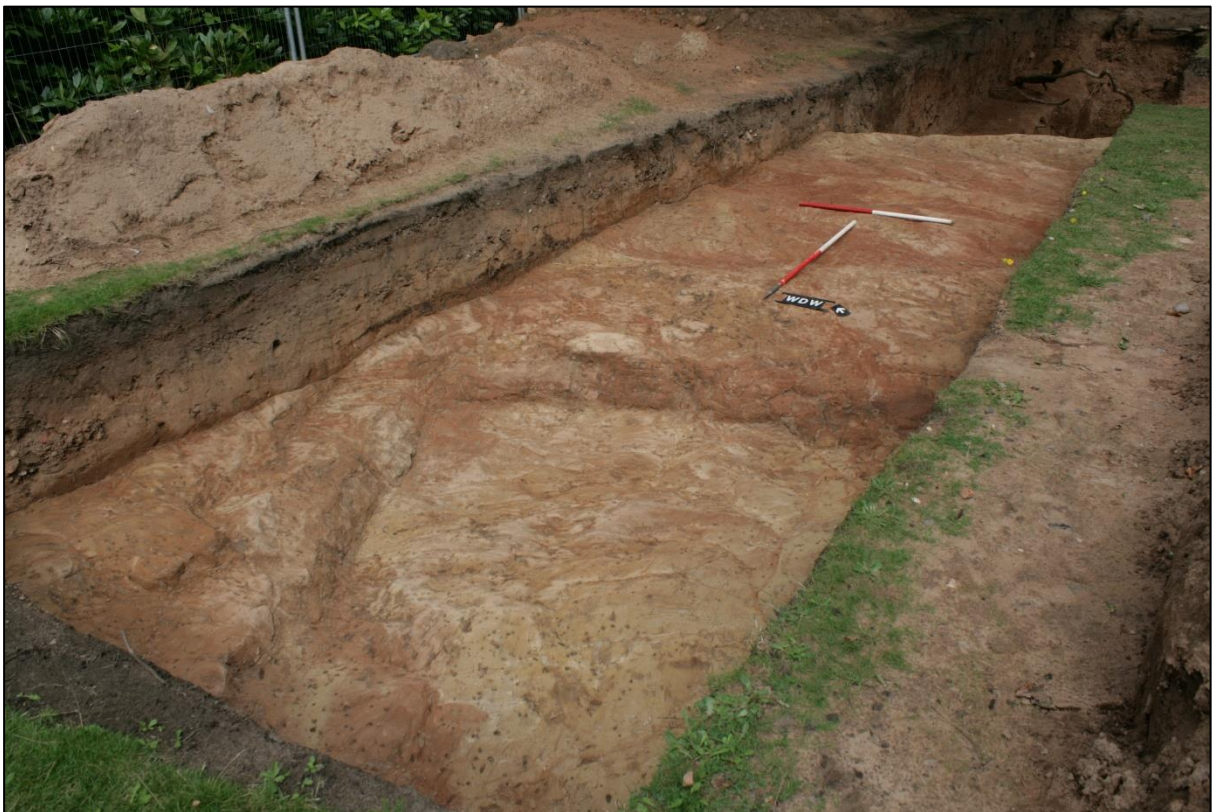
Plate 37: South-east facing section of north-western trench showing redeposited sand, levelling deposits and shallowness of bedrock. Scales = 1m. Looking north.

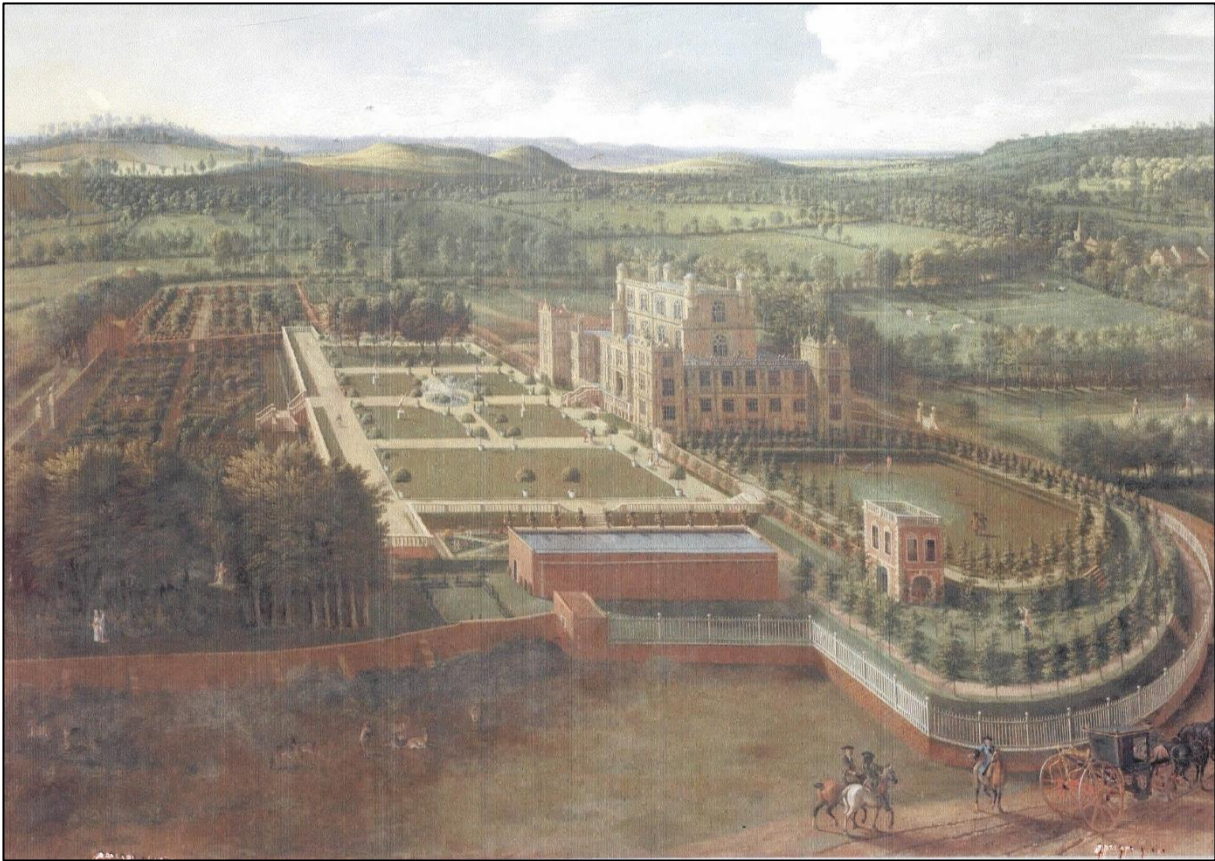
Plate 38: Jan Siberechts painting of Wollaton Hall from the East, 1697. Showing the Orangery in the foreground. (Paul Mellon Collection, Yale Center for British Art, Connecticut)

- 3.1.9 The improvements made by the siblings were commemorated in a series of paintings and illustrations, the first three of which were painted by Jan Siberechts in 1695 and 1697 (Plate 38). The paintings present the formal gardens divided into compartments with differing functions and characteristics. A bowling green is depicted on the north-eastern side of the Hall, with a set of terraces and young trees, and a summerhouse with a roof terrace for viewing the landscape. In the foreground, an outbuilding believed to be an Orangery is depicted, leading onto an area of informal planting. This area is bounded by walls, and railings. The area immediately to the south west of the Hall is the site of the formal gardens, studded with statues and the fountain as the centrepiece, in keeping with Smythson's original designs. Beyond the gardens the park is divided into grazing enclosures with tree lined avenues to the west and a lake is visible in the south-west (Daniels *et al.* 1999). An engraving was also produced by Kip and Kniff in 1707, reflecting the continuation of this layout into the beginning of the 18th Century (Plate 39).
