Land on the corner of Union Road and Curzon Street, Nottingham: an Archaeological Trial Trench Evaluation

Report Number: 191/2019

Document Type: Evaluation Report

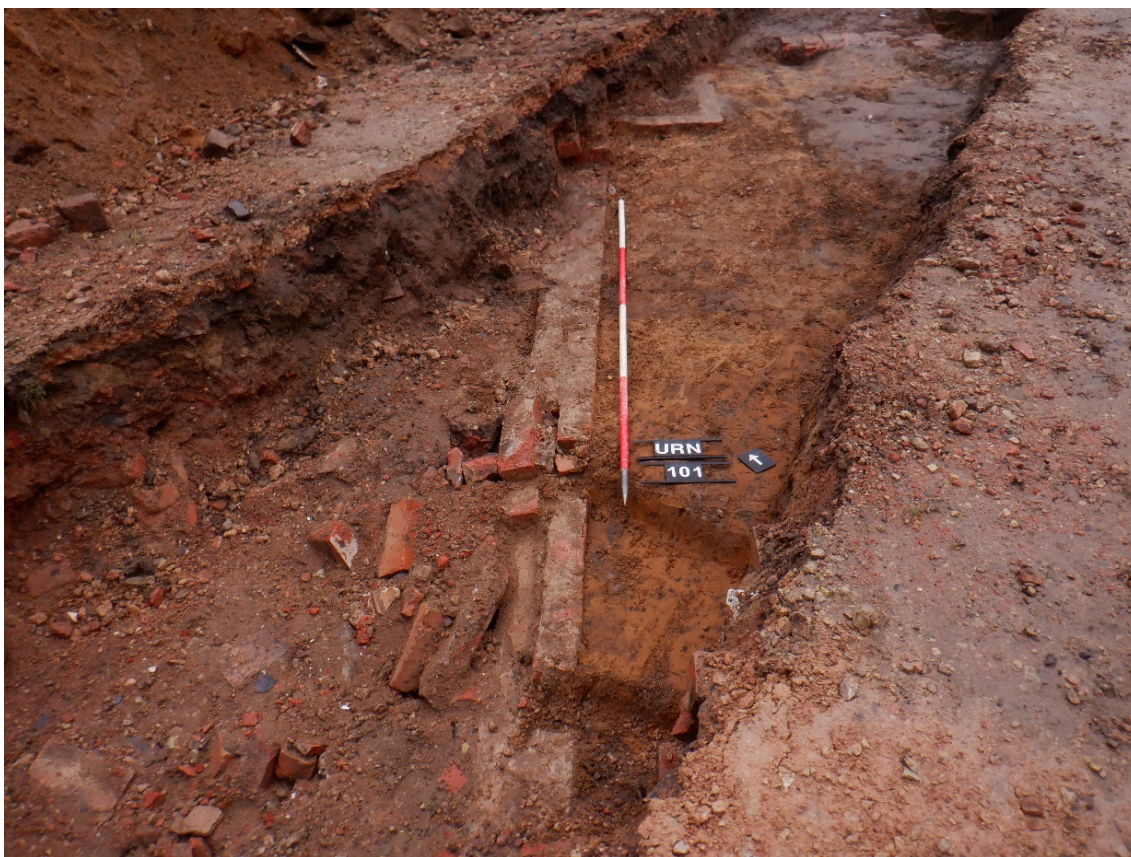
Plate 1: Culvert 0101

- 7.1.2 Structure **0101** was recorded in the western half of the trench and was aligned north-east to south-west, perpendicular with the row of Victorian housing and parallel to Union Road. The structure was recorded cutting through a layer of made-ground (0115) which may be the remnants of an earlier floor surface associated with the Victorian row of houses. To the north-west, the structure was infilled by a deep rubble deposit (0119 and 0120), which probably represented a collapsed culvert arch. The surviving brick-work of the structure was laid on beds, two skins wide, and were laid on an angle which suggested that they probably formed the base of a brick archway.

- 7.1.3 It is unlikely that structure **0101** related to the Victorian buildings on the site as it was recorded cutting through earlier made-ground deposits, which was probably related to this period. The structure crossed the line of several north-west to south-east aligned walls depicted on historic mapping, none of which were visible in the trench, which is a good indication that the earlier Victorian walls have been removed by the construction of the later culvert.

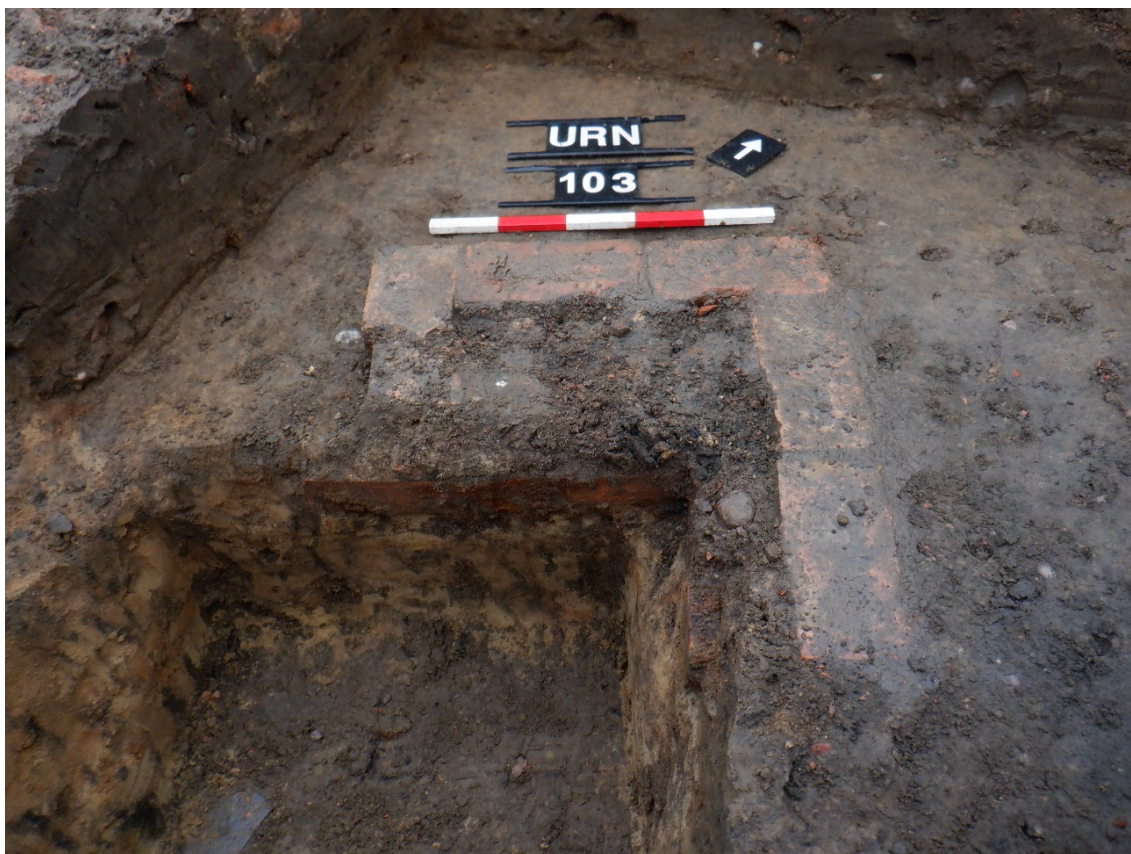
Plate 2: Structure 0103

- 7.1.5 To the north-east of floor surface **0102** were the remains of a small square brick structure (**0103**) which measured 0.65m by 0.65m. The function of this structure is not obvious, but seems to have survived two courses high and was truncated by a later rectangular cut (**0104**). The interior of the structure was filled by a mixed rubble and coal deposit and was located roughly in the centre of a Victorian building depicted on historic OS mapping. The location and infilling of the structure may be indicative of a hearth or chimney.

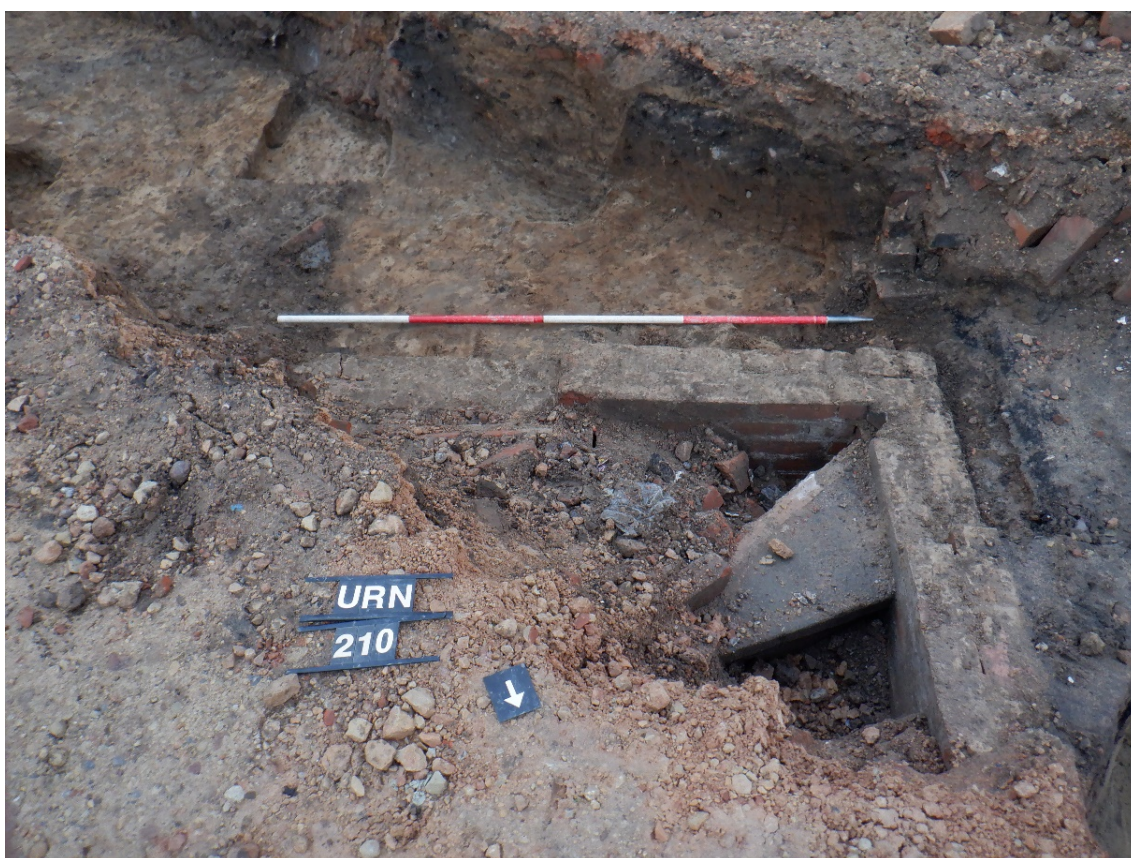
Plate 3: Structure 0210 showing possible staircase

- 7.2.2 The corner of a brick-built structure (**0210**) was recorded at the northern end of the trench aligned north-east to south-west and north-west to south-east. A large stone step was built into the wall of the brick structure which indicates the presence of a cellar one of the row of terrace housing to the north-west which fronted onto Union Street..

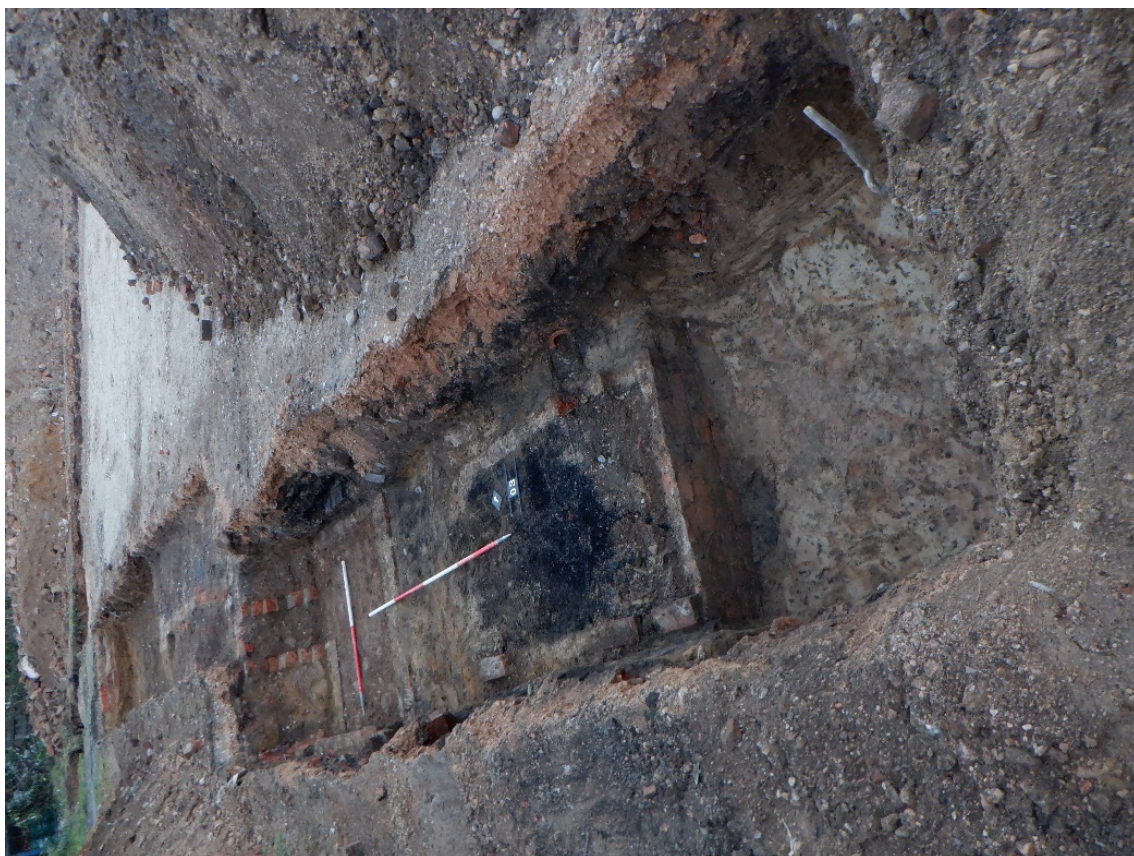
Plate 4: Overview of Trench 3

- 7.3.1 Trench 3 was located to the west of Trench 2 and was aligned north-west to south-east, parallel with a range of Victorian terraced housing fronting onto Union Street. The trench measured 15m long and was positioned to investigate a backyard plot.

- 7.3.2 Towards the central part of the trench, multiple walls were recorded: (333); (334); (335); and (336). The relationship between these structures indicates multiple phases of foundation. It is thought that (333) is later than (341), with (336) possibly contemporary with (333), but that structure (334) is the latest addition as it sits on top of (336). The alignment of these foundations corresponds well with the position of square like features seen on historic mapping.

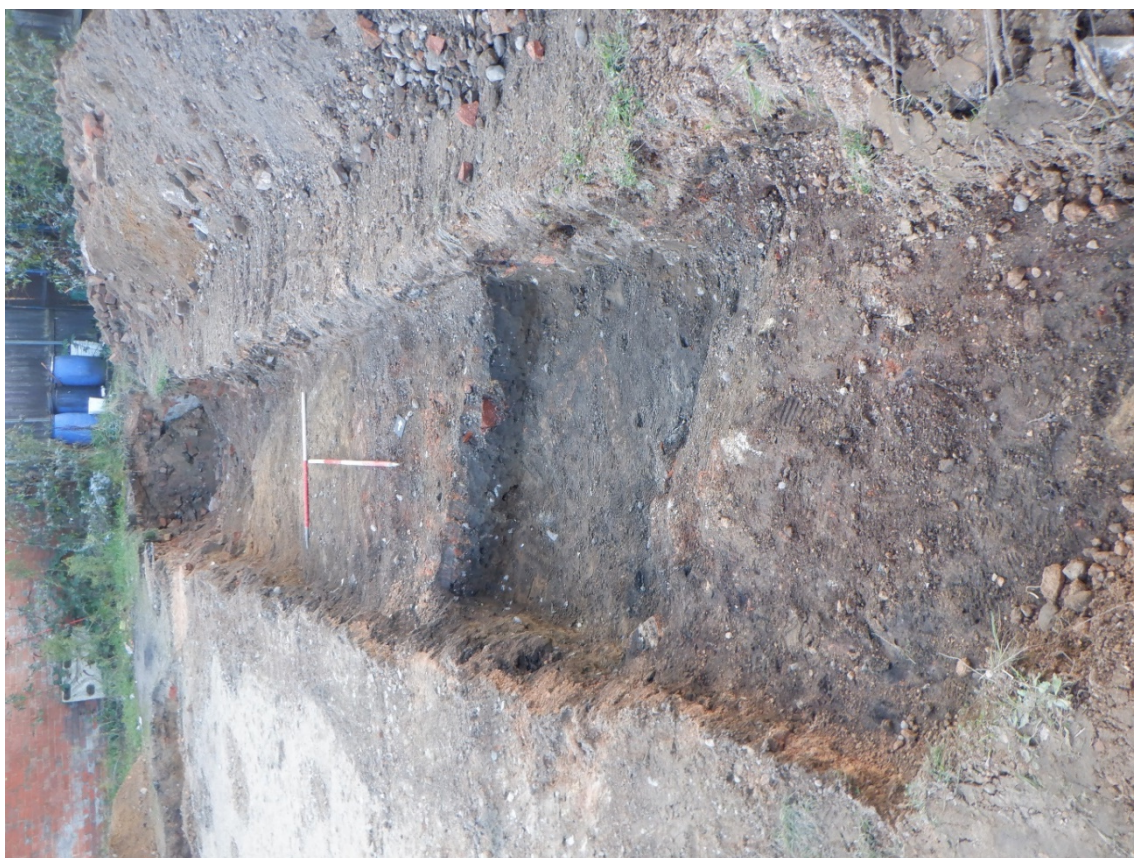
Plate 5: Overview of Trench 1

- 7.1.1 Trench 1 was located at the north-western end of the site boundary, was aligned ENE to WSW and was located to investigate a row of north-west to south-east aligned buildings depicted on 1st edition OS mapping of the site. In total, the trench measured 15m long by 1.8m wide. Three structures were recorded within Trench 1 which related to the row of Victorian terracing and later drainage.

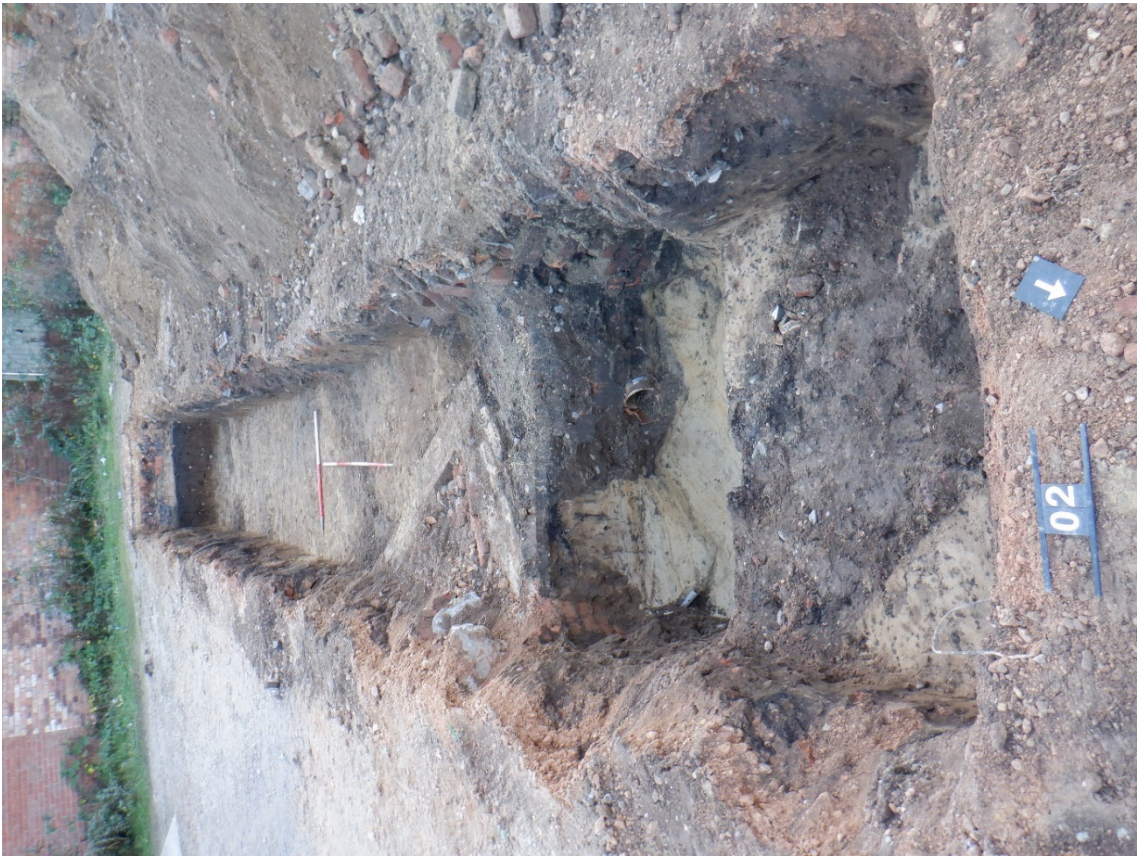
Plate 6: Overview of Trench 2

- 7.2.1 Trench 2 was located to the south-east of Trench 1 and was aligned north to south to investigate a series of backyard plots and buildings depicted on historic OS mapping.
