The Old Rectory, Clifton, Nottinghamshire

Report on the Results of an Archaeological Watching Brief

Produced for: Tomlinson Building Ltd
Prepared by: T. Cousins and A. Douthwaite
Report Number: 194/2018
TPA Project Code: ORC

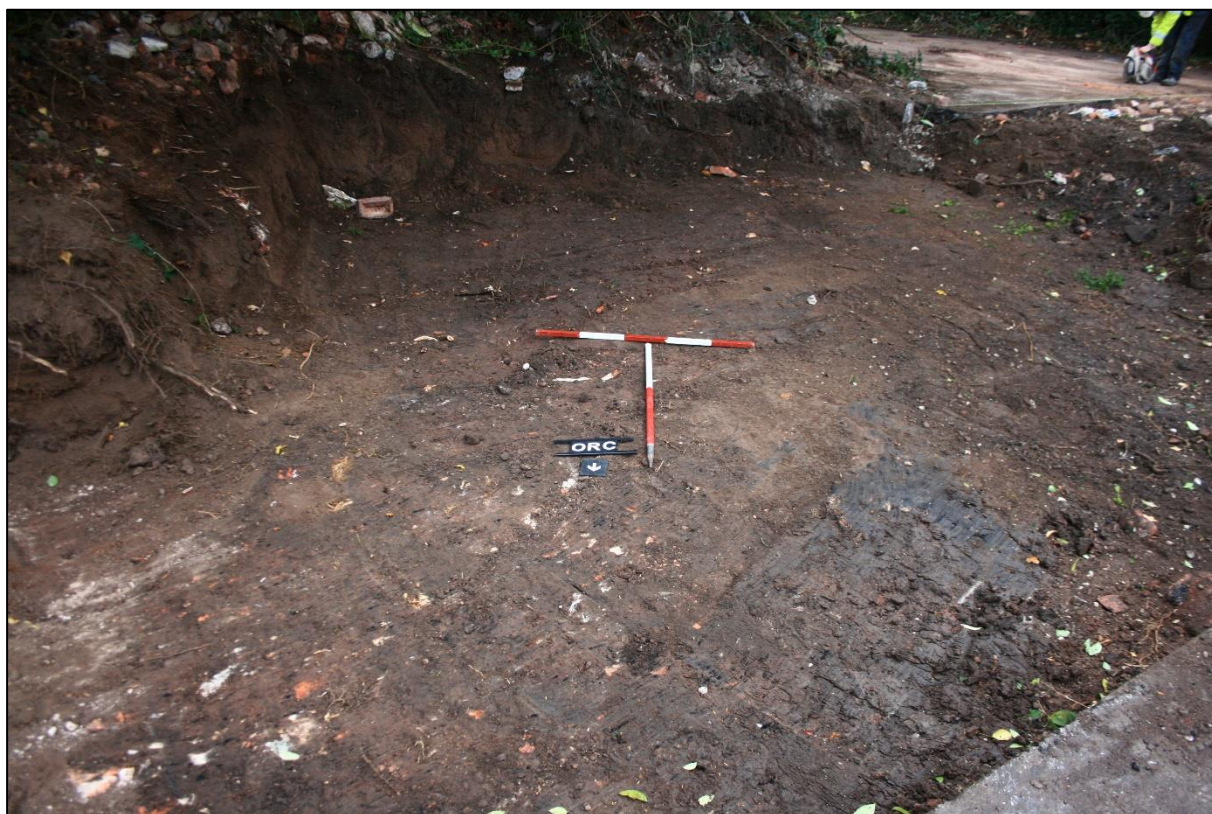
Plate 1: Driveway area overview shot. Scale = 2 x 1m

- 7.1.1 Area 1 consisted of an irregularly-shaped area located south-east of the house (Plate 1, Figure 02). The area was stripped prior to the archaeologist's arrival, exposing at the base a deposit of friable red clay and mudstone with frequent ceramic building material (CBM), sandstone and charcoal inclusions (1007). This was likely to be a mixture of redeposited or imported material mixed with hardcore, in order to provide a hard base-layer for the driveway area.

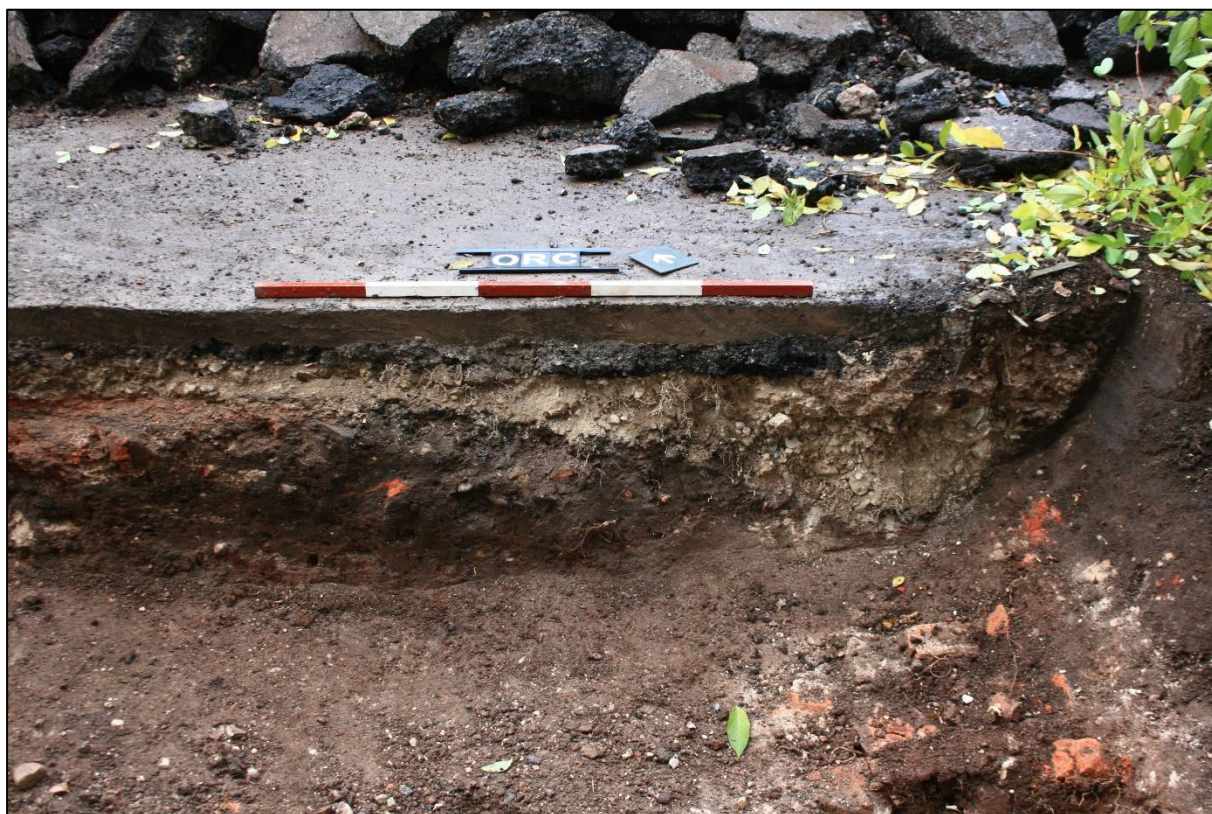
Plate 2: South-east facing representative section, north-east of Area 1. Scale = 1 x 1m

- 7.1.6 Further to the south (106) was sealed by a series of modern concrete and tarmac driveway layers (1005), (1004) and (1003), which collectively totalled no more than 0.42m in depth (Plate 2).

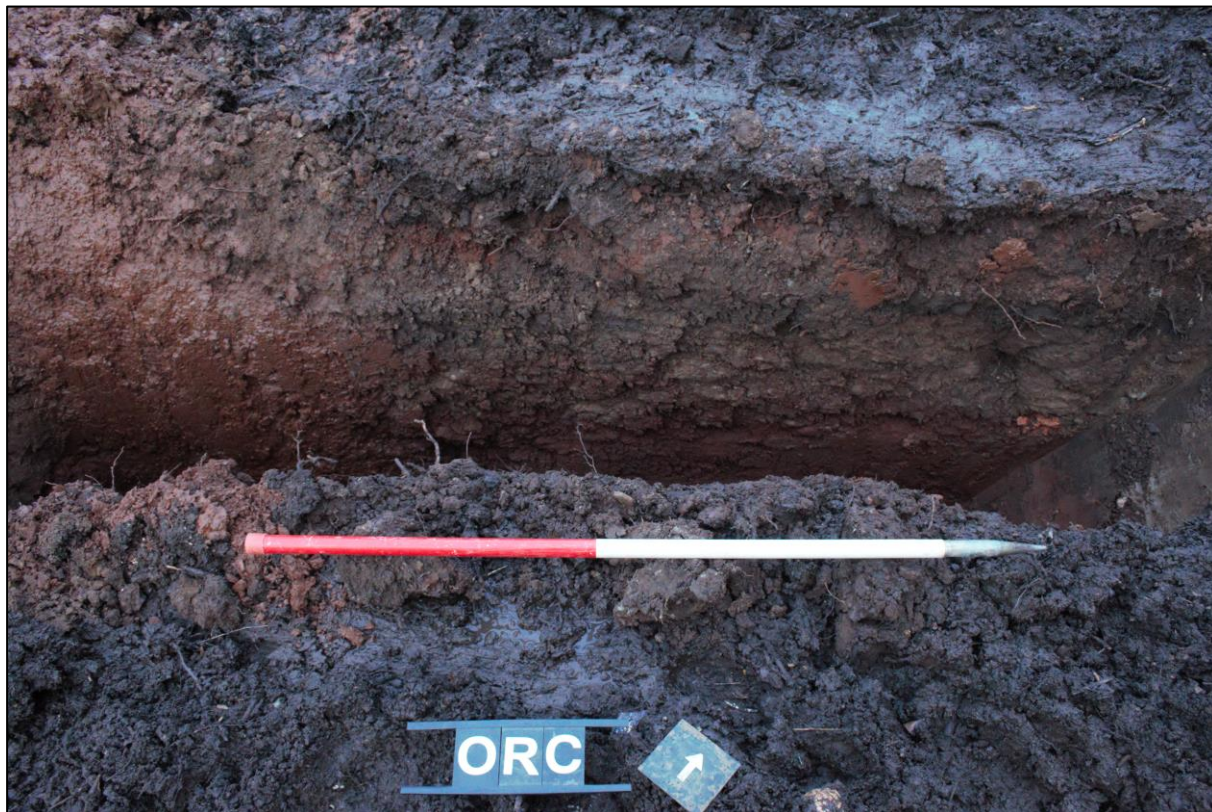
Plate 3: Plot 5. South-east facing section showing made ground (1018). Scale = 1 x 1m

- 7.2.3 (1030) was sealed by (1019), a layer of made ground associated with the landscaping of the Rectory gardens 0.3m deep (Plate 3). This consisted of a firm greyish-brown sandy silt. This deposit was cut by several modern or late post-medieval ceramic drains, along with a red

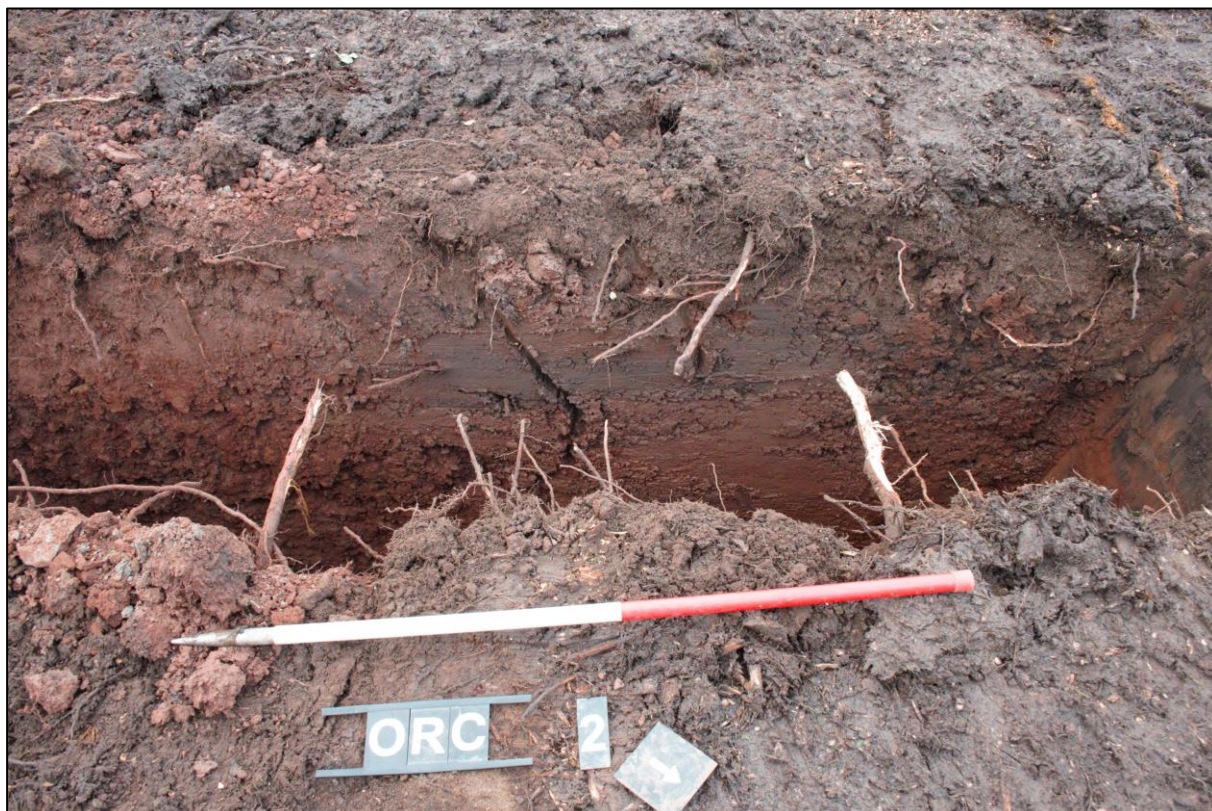
Plate 4: Plot 6. North-east facing section showing made ground (1019). Scale = 1 x 1m

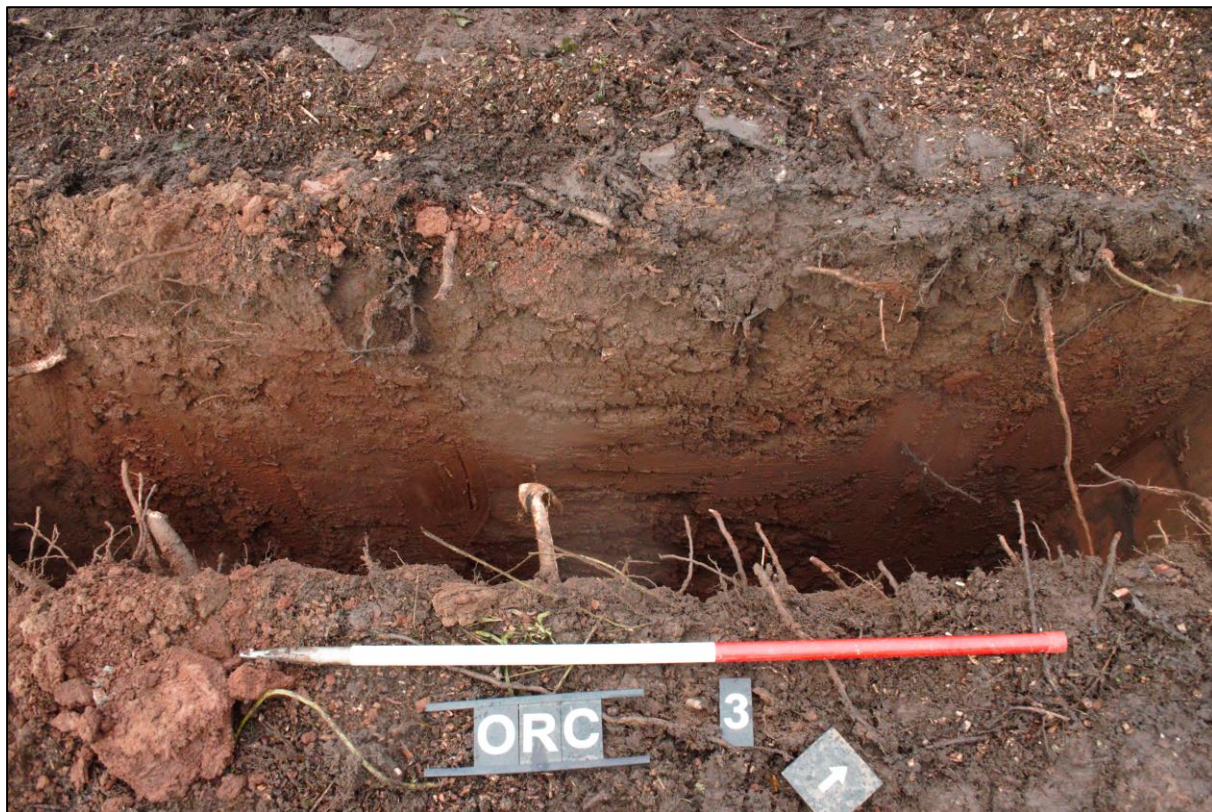
Plate 5: Plot 7. South-east facing section showing subsoil/made ground (1021). Scale = 1 x 1m

7.2.8 Plot 7 was reduced to a depth of approximately 1.5m. The natural substratum (1017) was encountered within Plot 7 at a depth of 0.65m BGL. This was overlain by landscaping deposit (1021) which had a thickness of 0.60m (Plate 5) and was composed of light yellowish-brown sandy silt. The depth of this deposit is double the thickness seen in the other plots, which may be due to the building up of a lower area of ground to form the garden landscape.

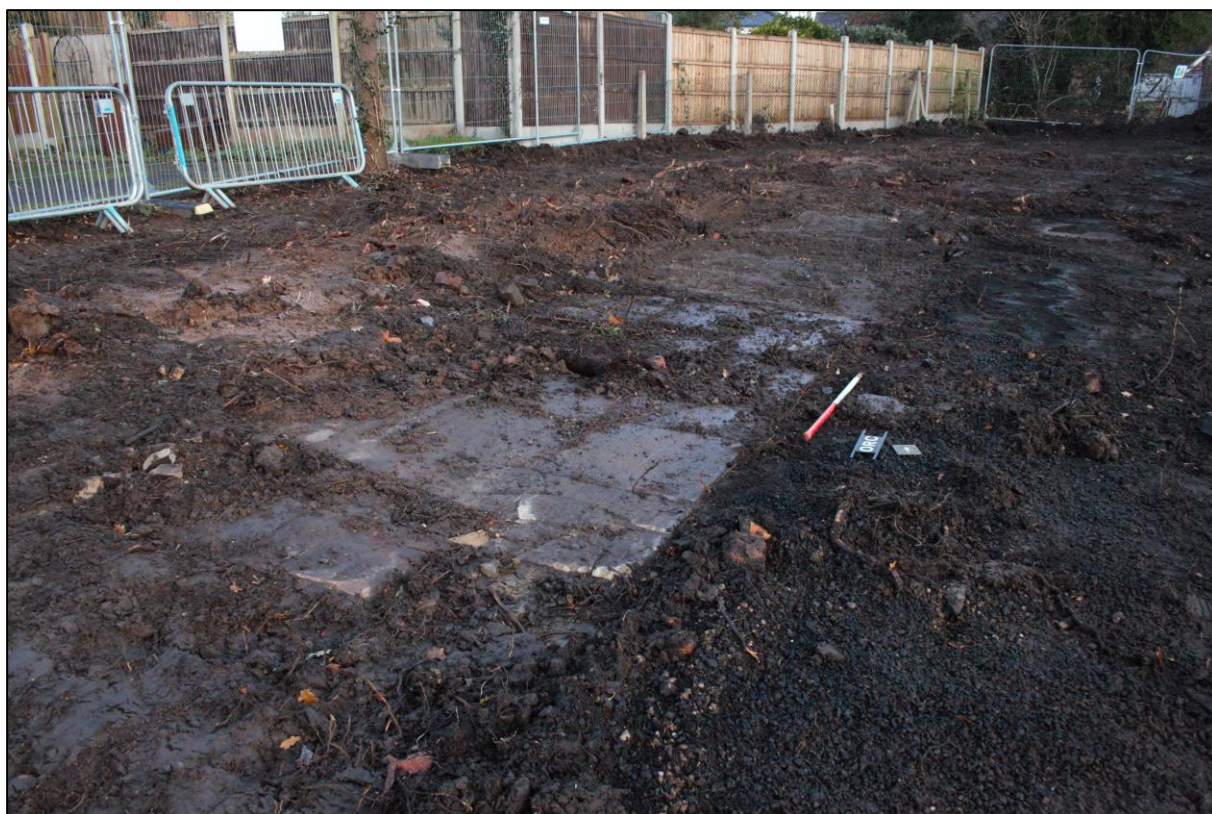
Plate 6: Sandstone slab surface [1022]. Oblique view looking north. Scale = 1 x 1m

7.2.9 A yellow sandstone patio surface [1022] was situated directly above (1021), which was 4.4m x 1.75m in size [Plate 6]. Prior to excavation this area was covered by vegetation.

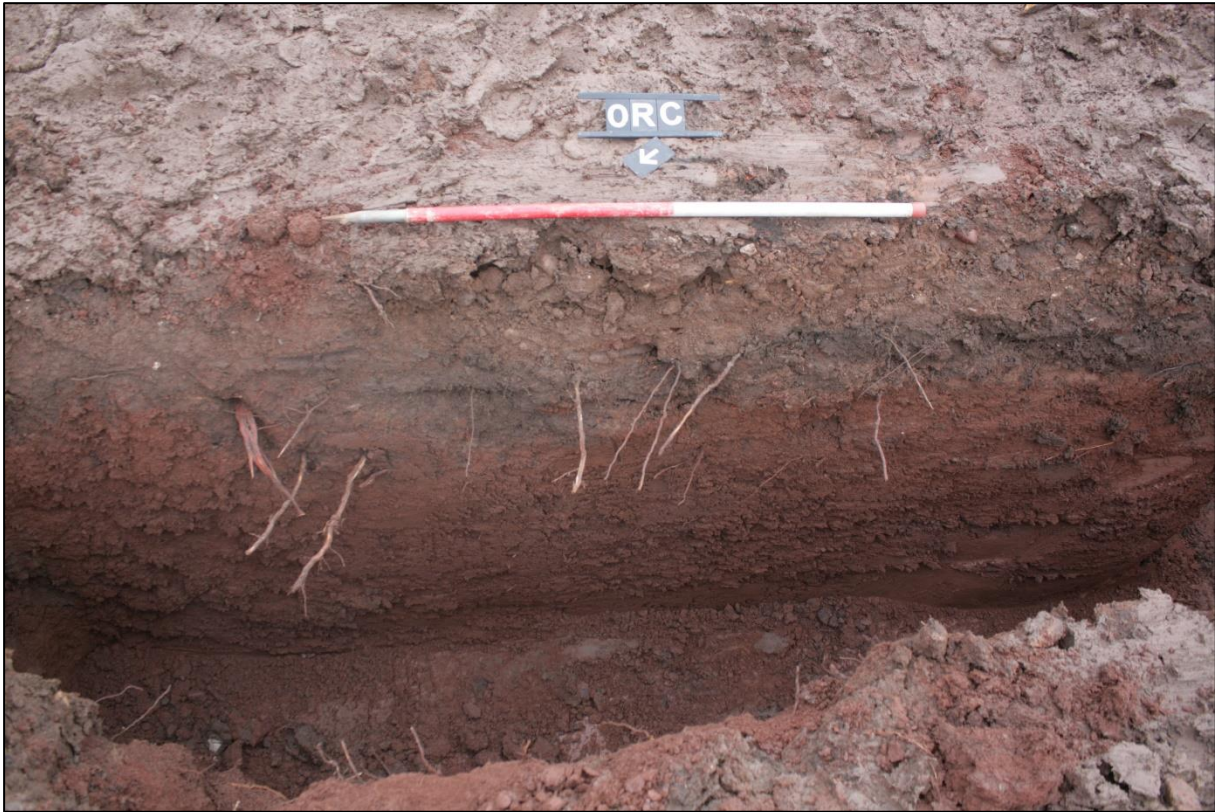
Plate 8: Plot 6 north-west facing representative section. Scale = 1 x 1m

7.2.6 The footings for Plot 6 were excavated to a maximum depth of 1.4m. The natural substratum (1017) was encountered at a depth of 0.45m below ground level (BGL). As with Plot 5, this was overlain by (1019) (Plate 8).

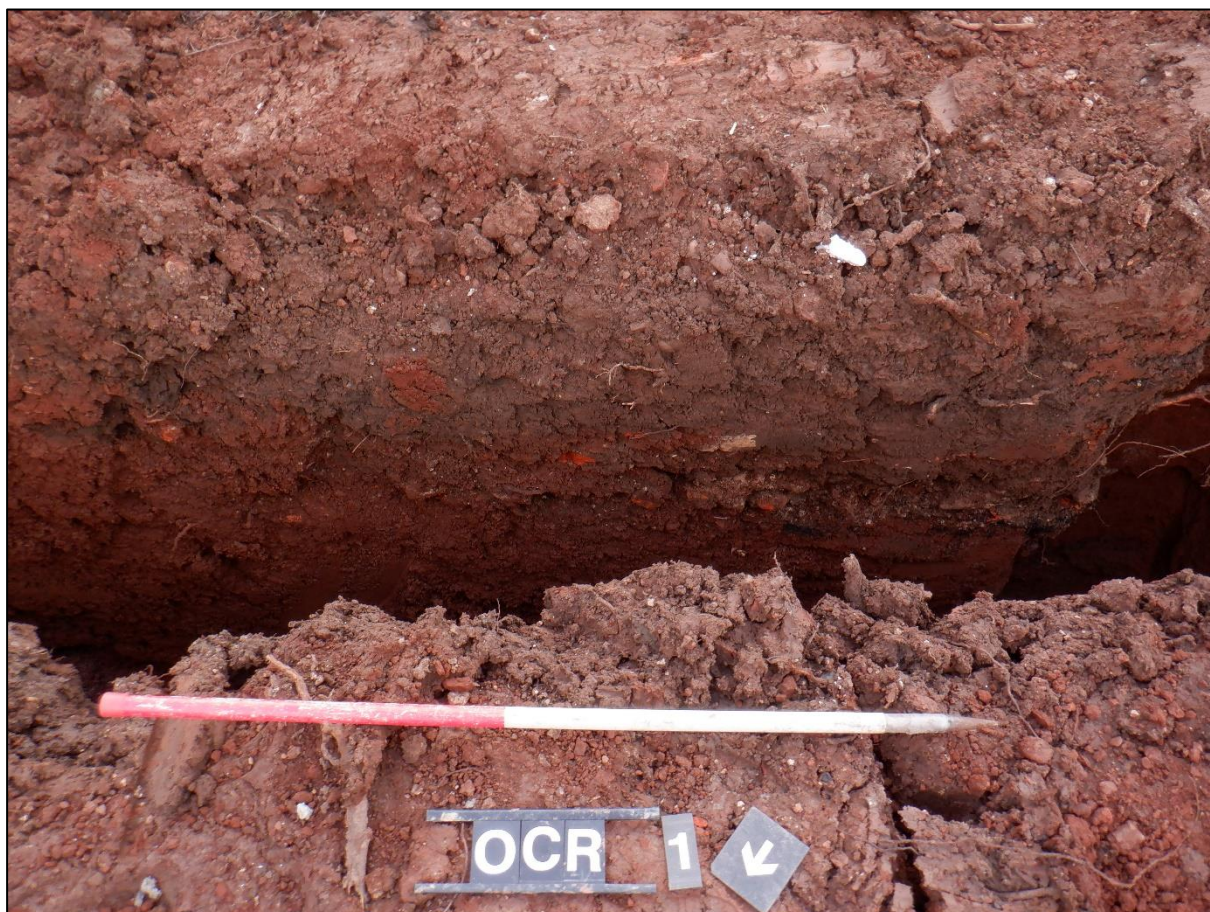
Plate 9: Plot 5 north-west facing representative section. Scale = 1 x 1m

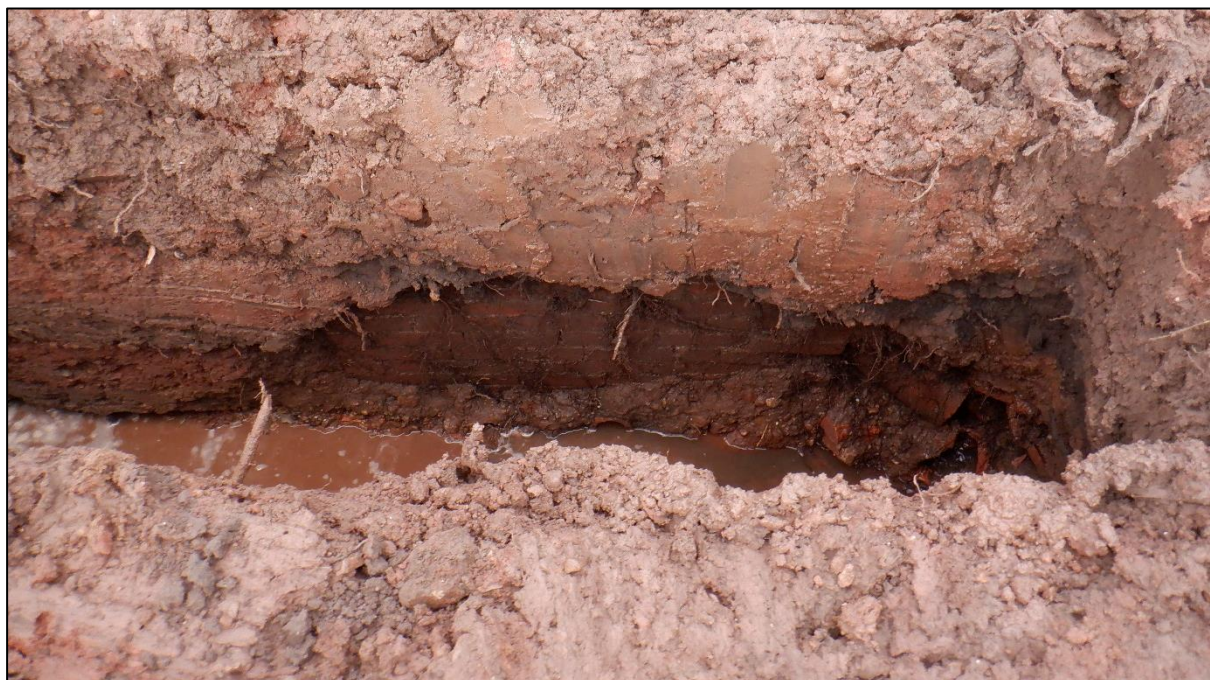
Plate 10: Plot 5 working shot. [1029] Red Brick Manhole uncovered by trench collapse of south east facing trench wall. No scale

brick manhole [1029], which appear to form part of the original drainage system for the Old Rectory (Plate 10). Due to the depth of the trench and the instability of the trench sides it was not possible to investigate this feature further.

7.2.13 It is likely that culvert [1031] is part of the same drainage system as the red brick manhole uncovered in Plot 5.

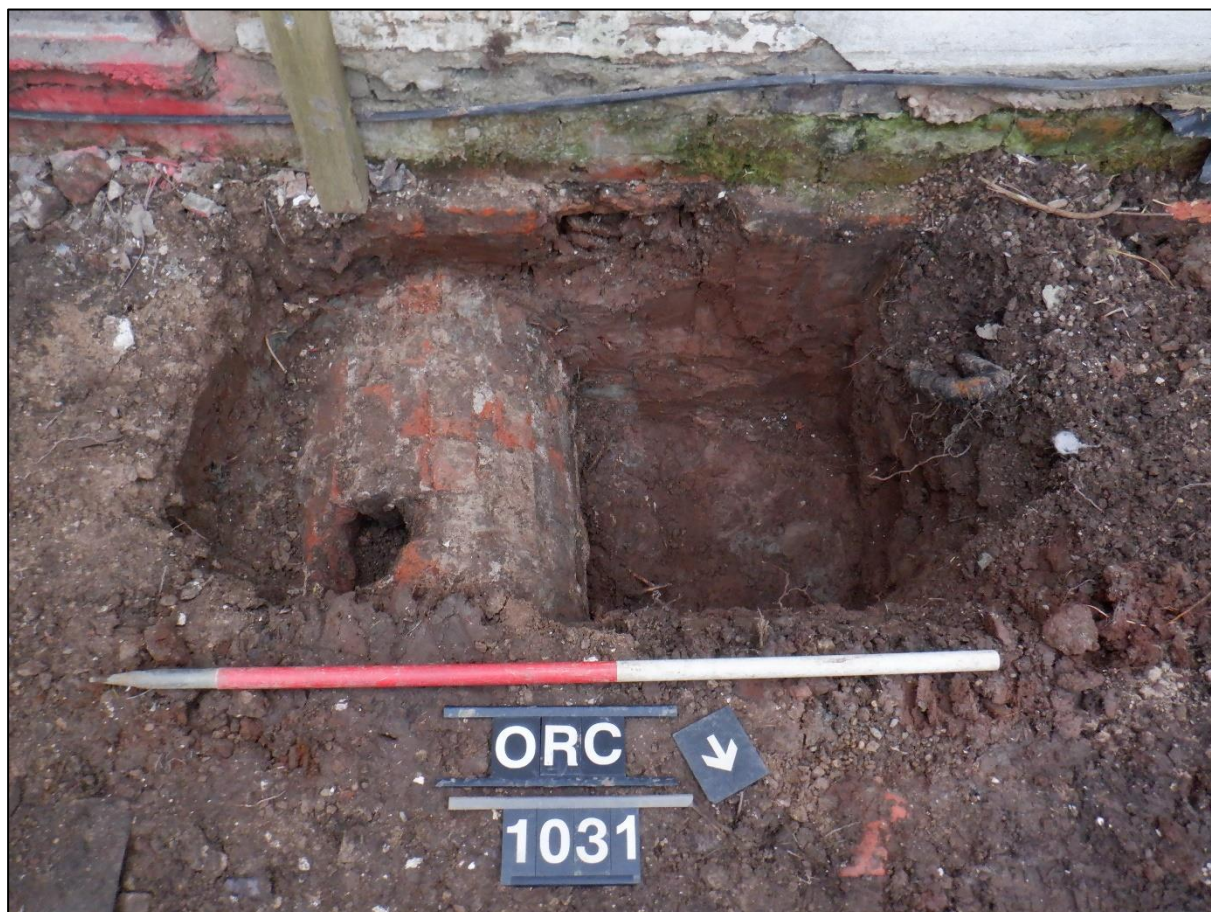
Plate 11: Brick Culvert [1031] uncovered by trial pit in courtyard. Scale = 1 x 1m

7.2.11 Truncating the redeposited clay (1034) was a construction cut [1032] for a brick culvert likely to be of late post-medieval or early modern date [1031] (Figure 02 inset; Figure 03, DR. 05). The culvert was constructed of red bricks 240mm x 100mm x 60mm in size and bonded with mortar and had a semi-circular shape. The construction cut was filled by (1033), a mixed backfill deposit of reddish-brown clay with CBM inclusions (Plate 11)

7.2.12 At some point after the culvert was built, a hole was knocked through the eastern portion of the curved top for a clay pipe to join the drainage system.
