LAND TO THE REAR OF 39 to 41 FRIAR LANE, LEICESTER

A Report on an Archaeological Watching Brief and Trial Trench Evaluation

Report Number: 077/2019

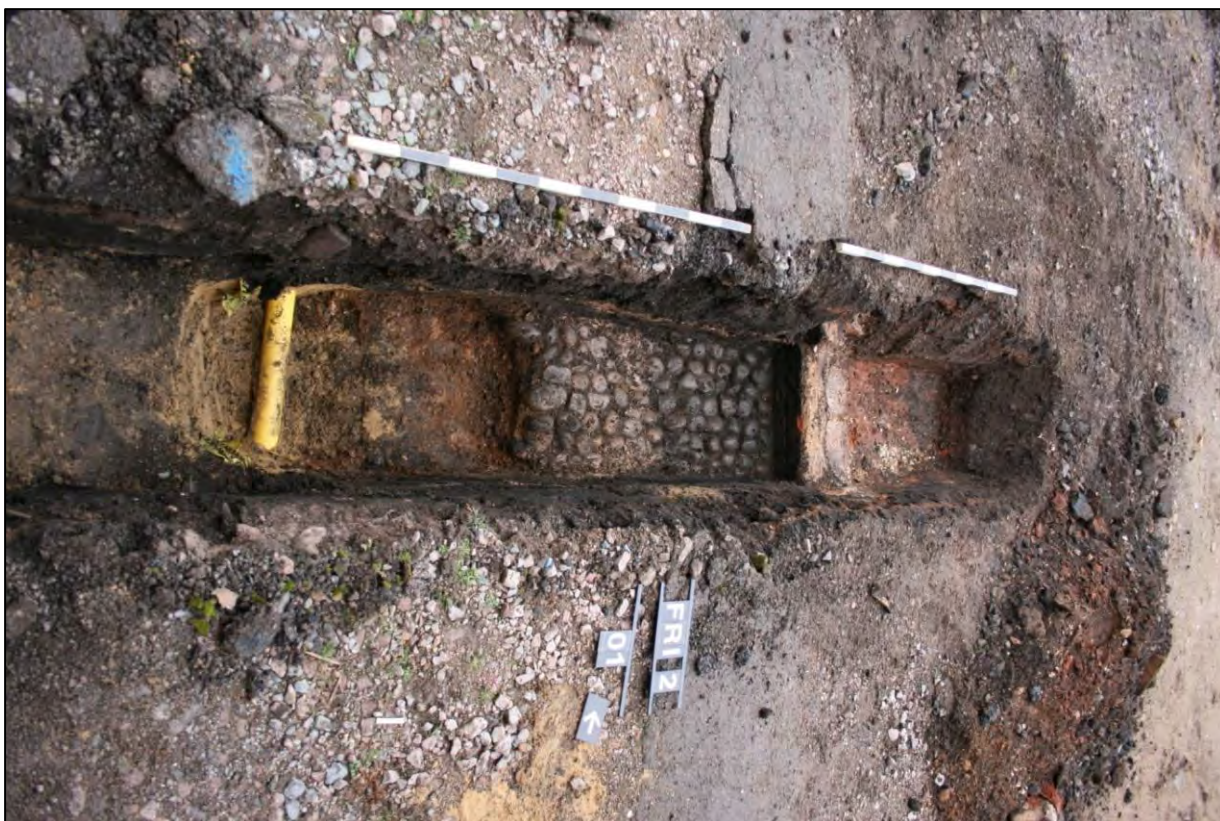
Plate 5: Showing cobbled surface [2011] and 18th/19th century western side rear boundary wall for 41 Friar Lane and gas main. Scale 2 x 1m, looking east.

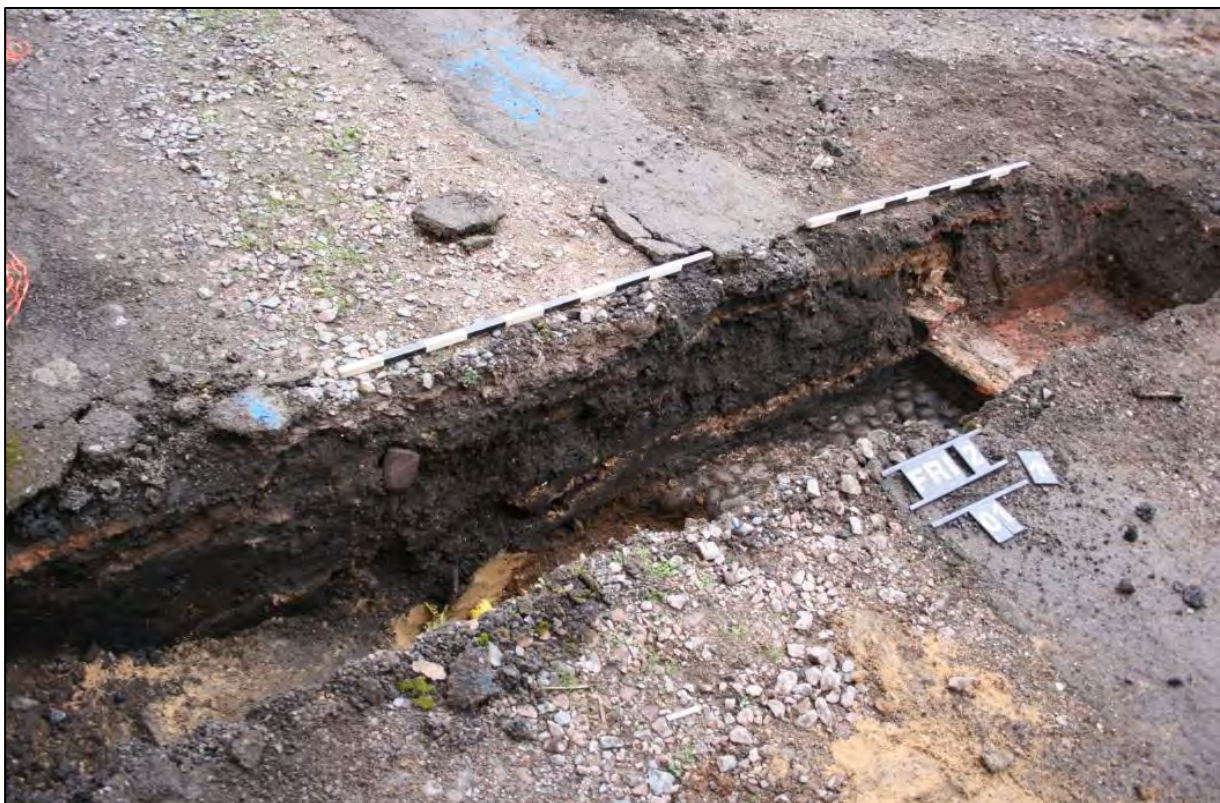
Plate 6: South facing section of deposits overlying [2011]. Scale 2 x 1m, looking northeast.

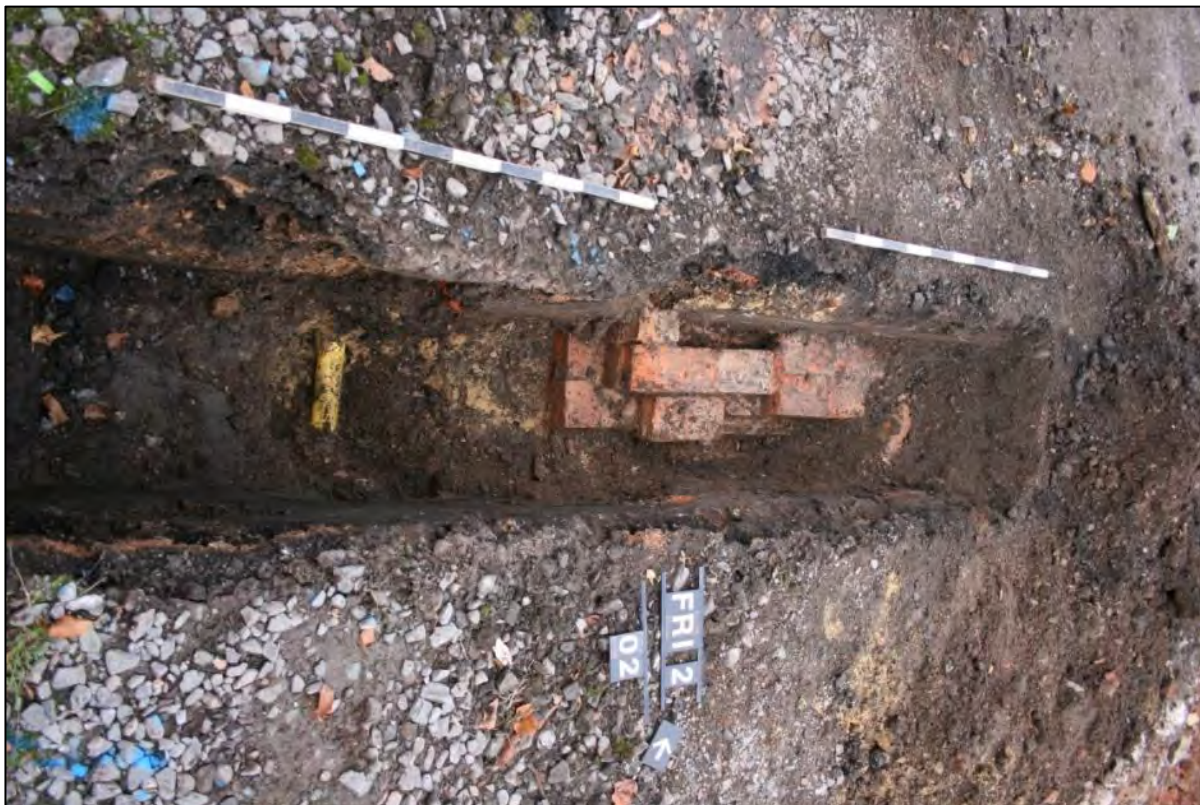
Plate 7: Showing 20th century brick work possibly relating to drainage and gas pipe within the western portion of the site. Scale 2 x 1m, looking northeast

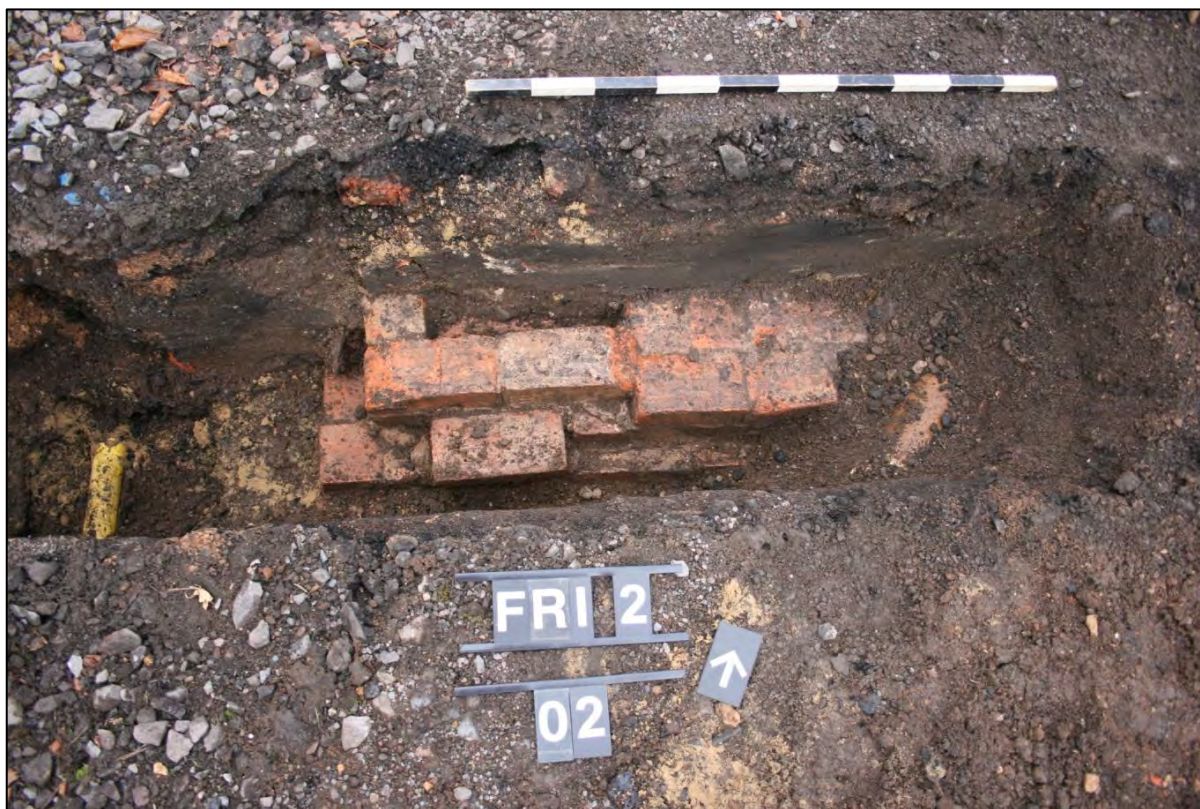
Plate 8: Showing 20th century brick work possibly relating to drainage within the western portion of the site. Scale 1m, looking north

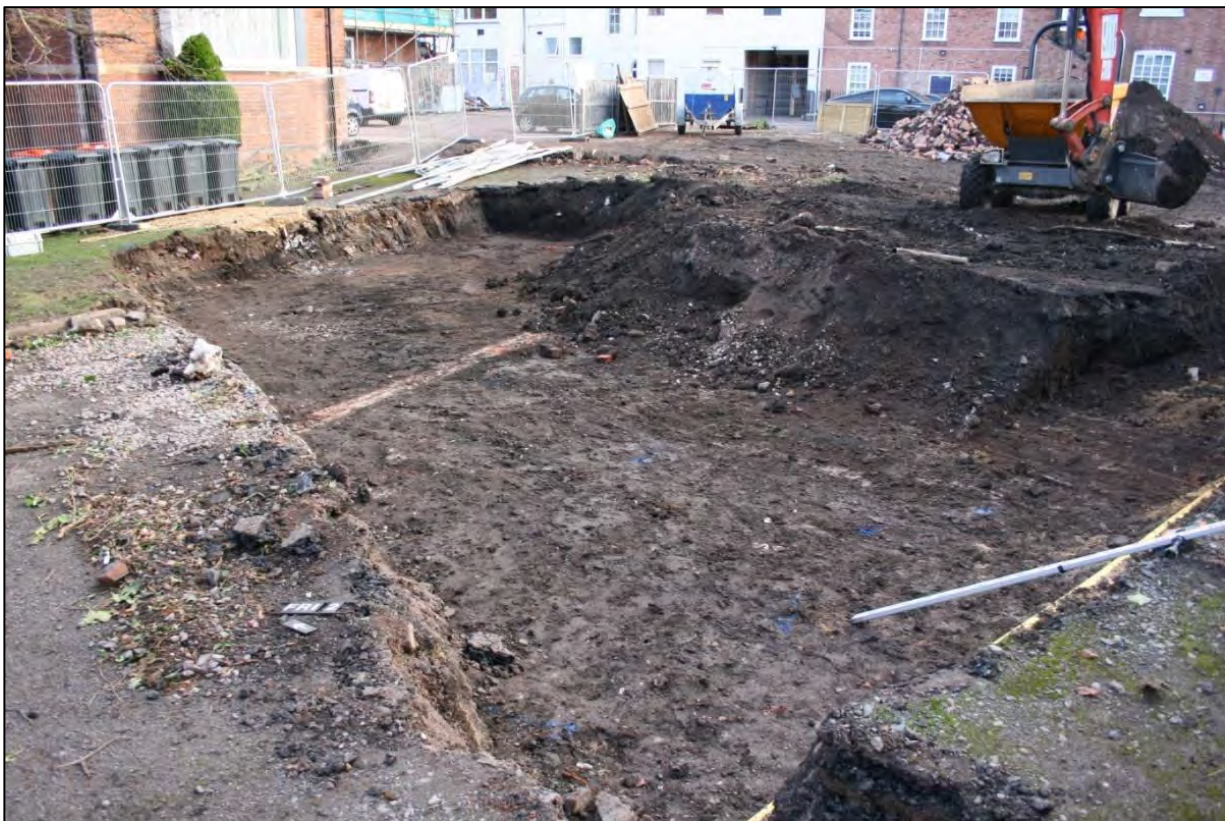
Plate 5: General site overview showing housing foundations within the northern portion of the site. looking northeast.

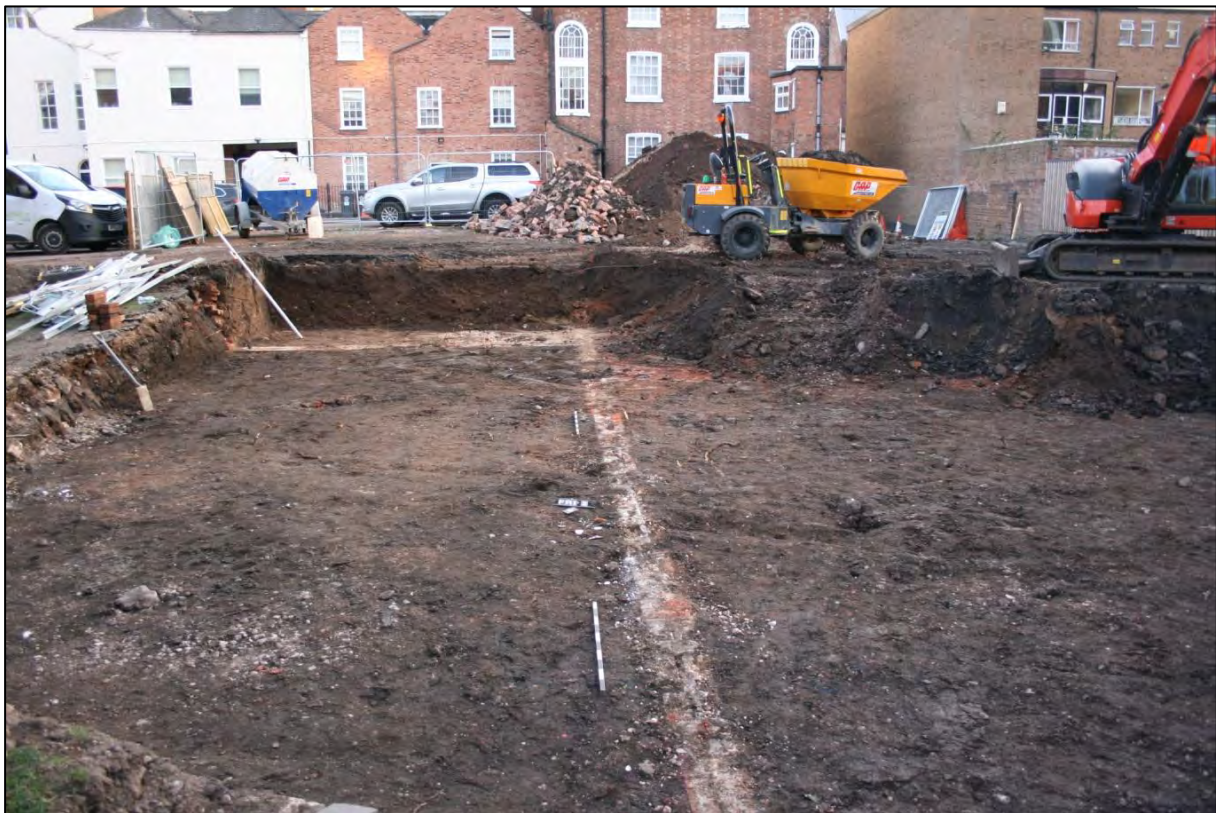
Plate 6: General site view from the central portion of the site, revealing boundary wall aligned to the eastern side of 39 Friar Lane (side of arched window). Scale 2 x 1m, looking northwest

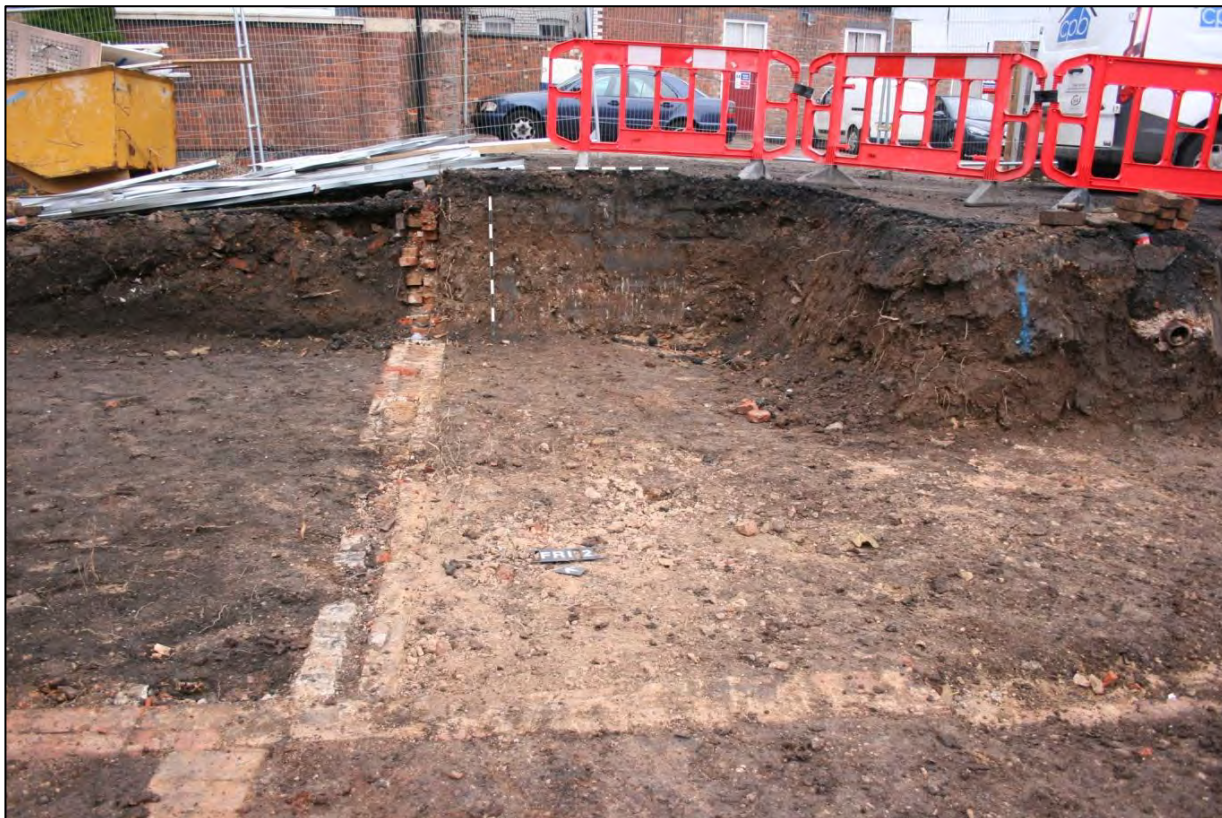
Plate 7: East-west boundary wall (2040) leading to side of Victorian villa immediately to the west. Scale 2 x 1m, looking northeast.

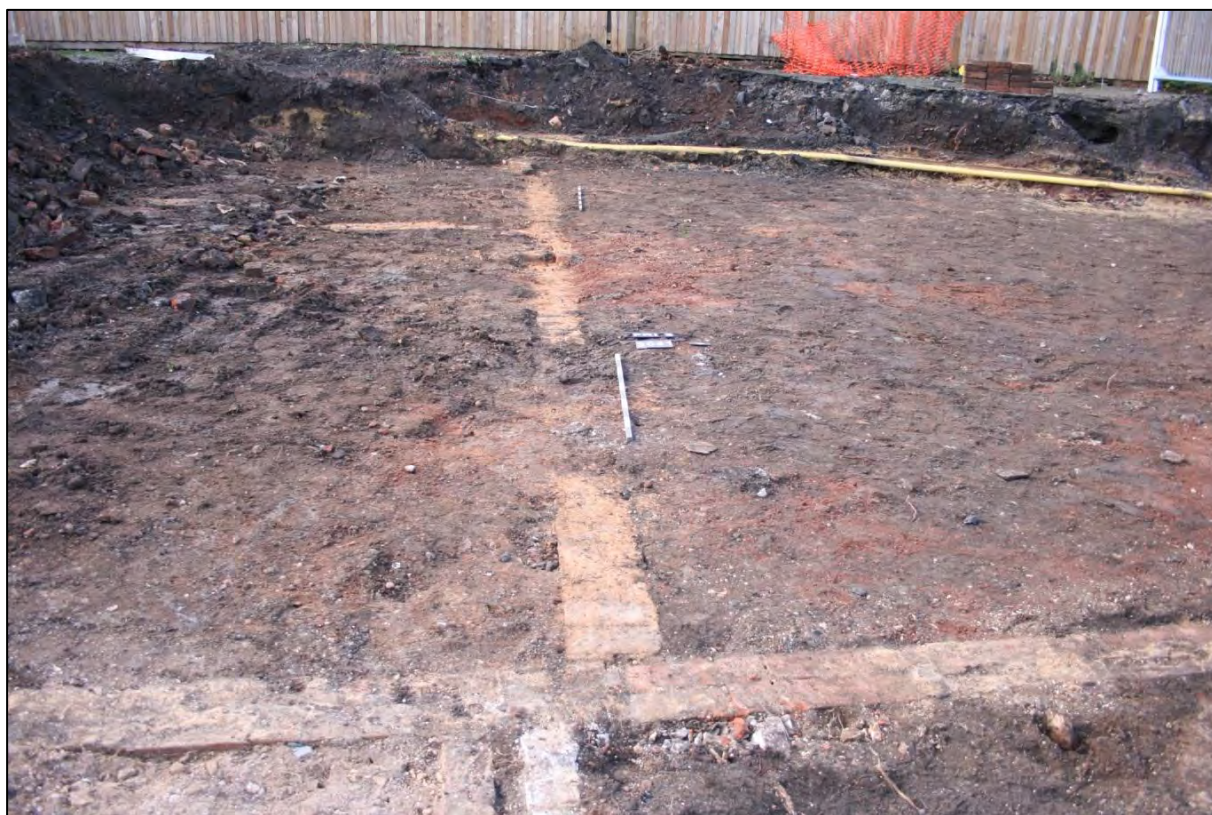
Plate 8: East-west Georgian brick wall (2041) leading off (2039) on its western side. Scale 2 x 1m, looking east.

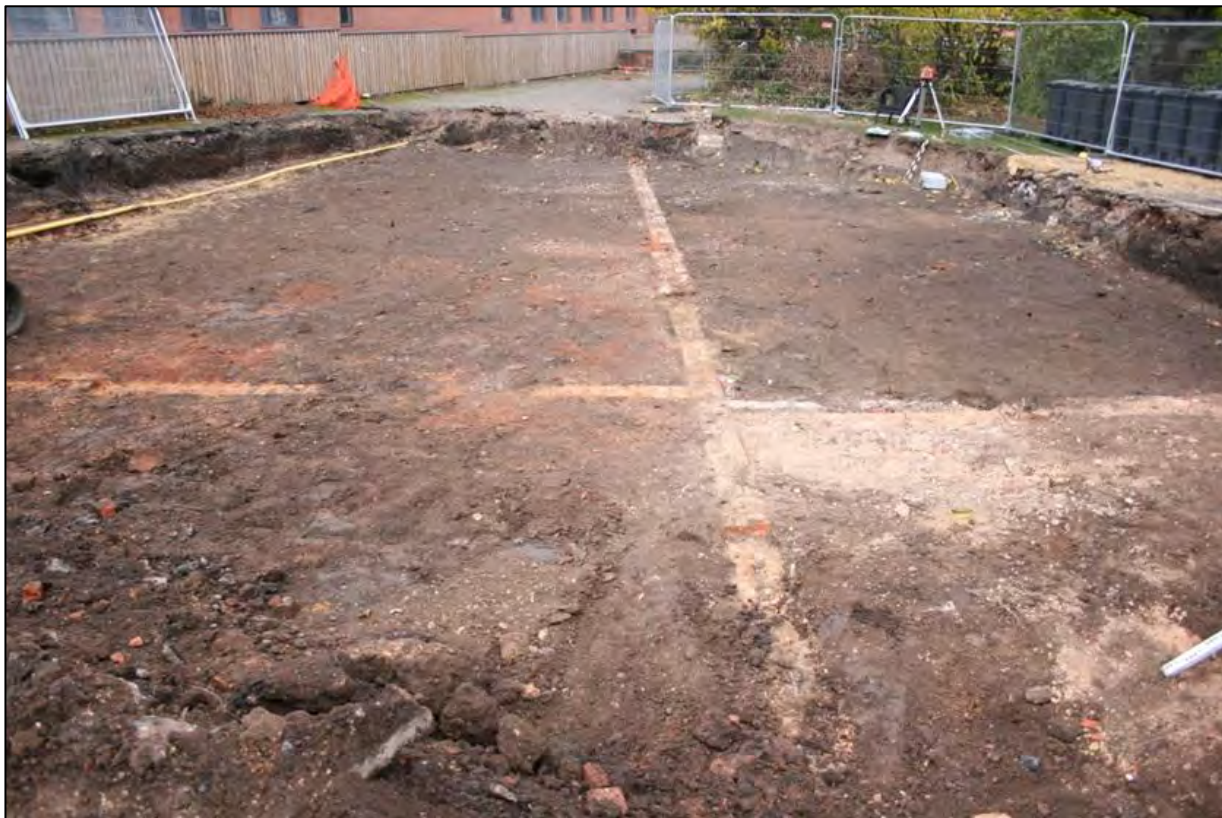
Plate 9: View of stripped northern end of area showing north-south brick wall (2039), east-west wall (2040) and east-west wall (2041)

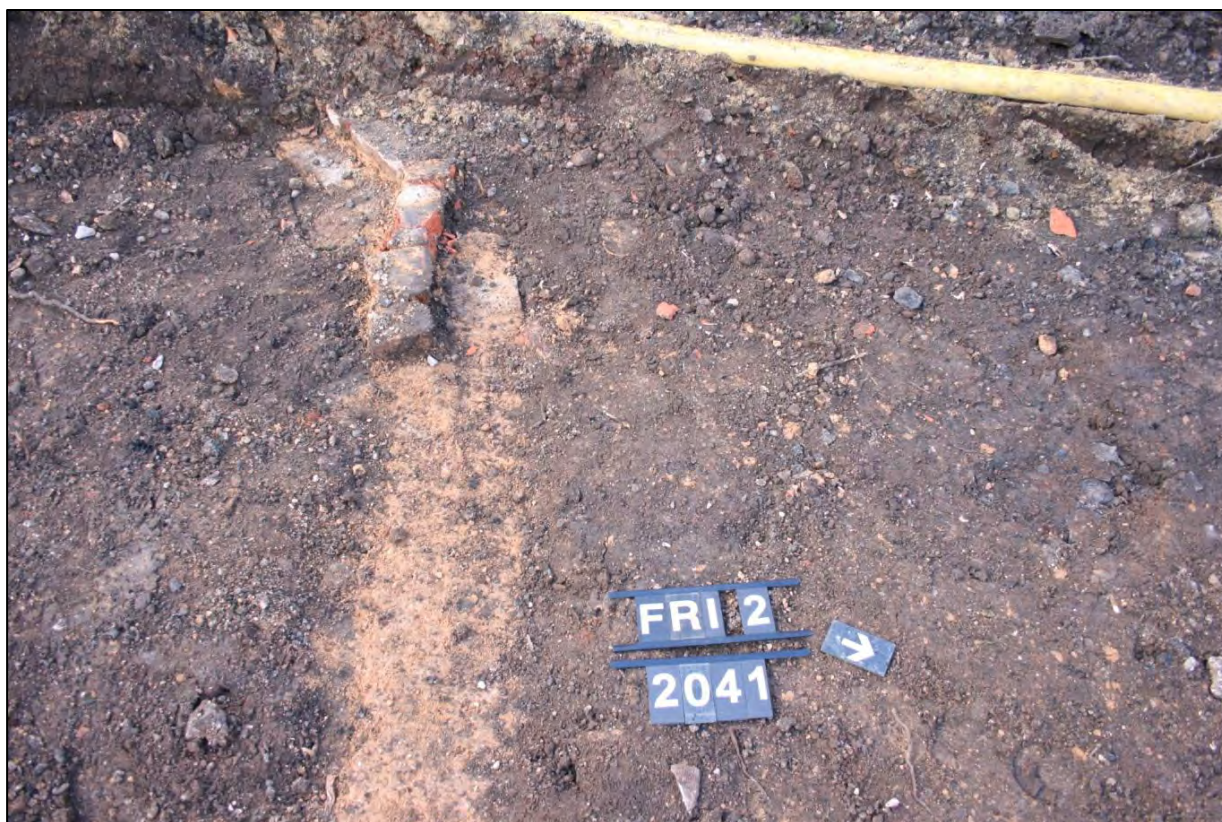
Plate 10: East-west wall (2041) showing a change in direction to the south-west. Looking southwest

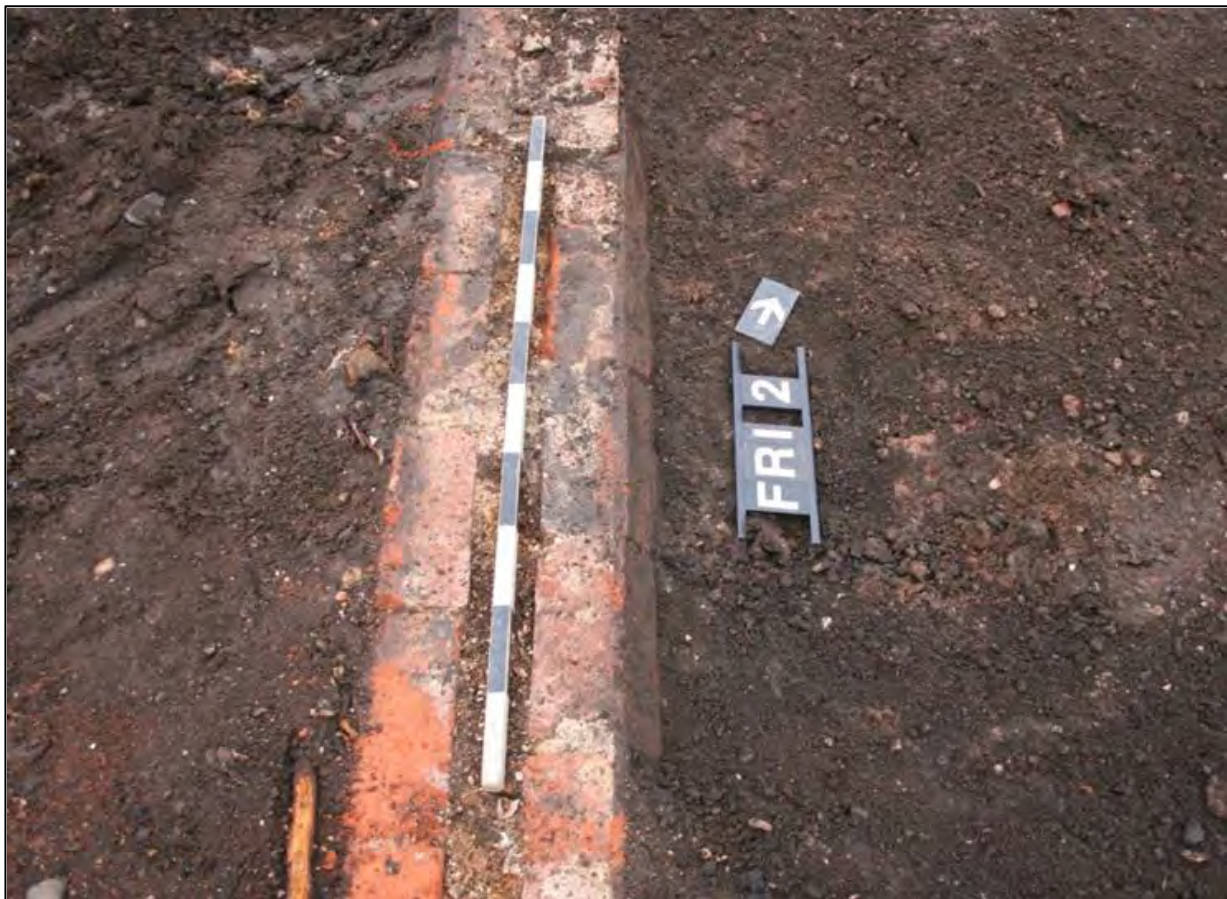
Plate 11: North-south wall (2039) showing chamfered edging, a feature which normally stands clear of the ground level at least 200mm. Scale 1m, looking northeast

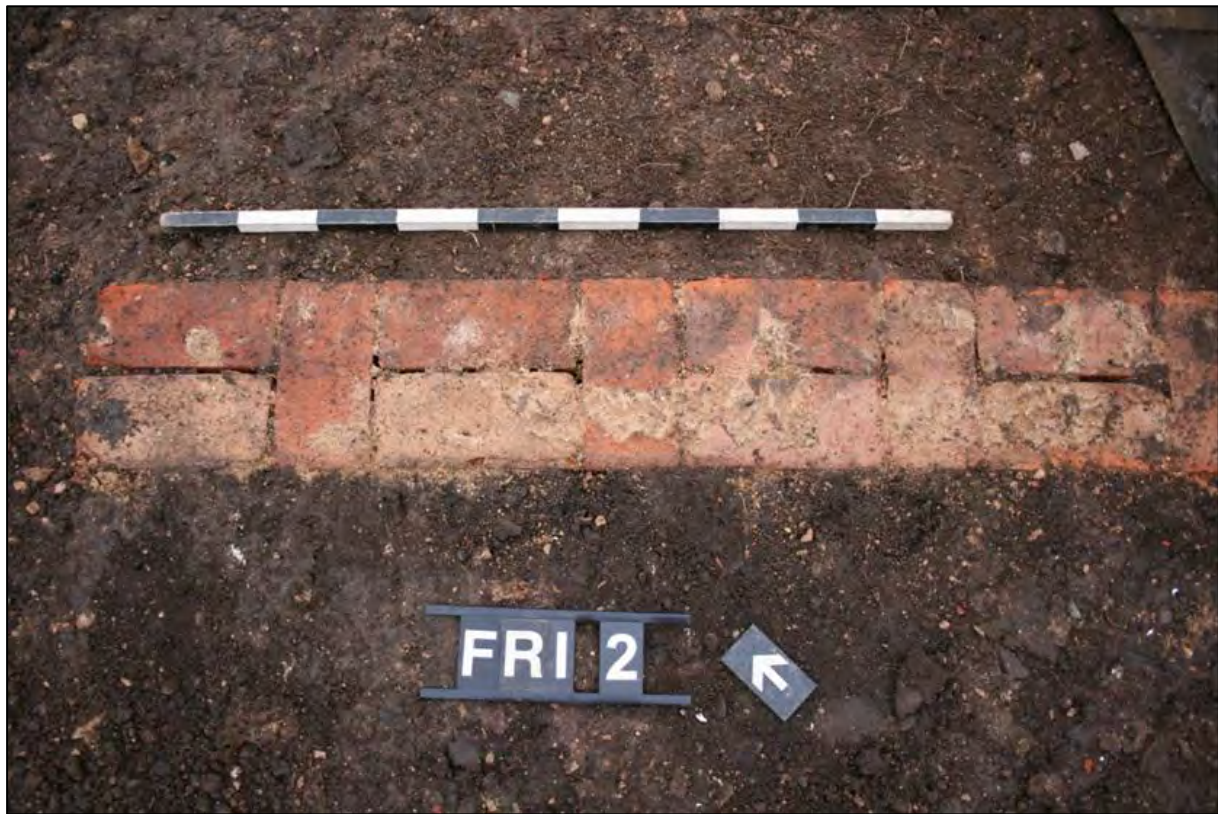
Plate 12: North-south wall (2039) showing bricks laid in the 'Flemish' style. Scale 1m, looking northeast

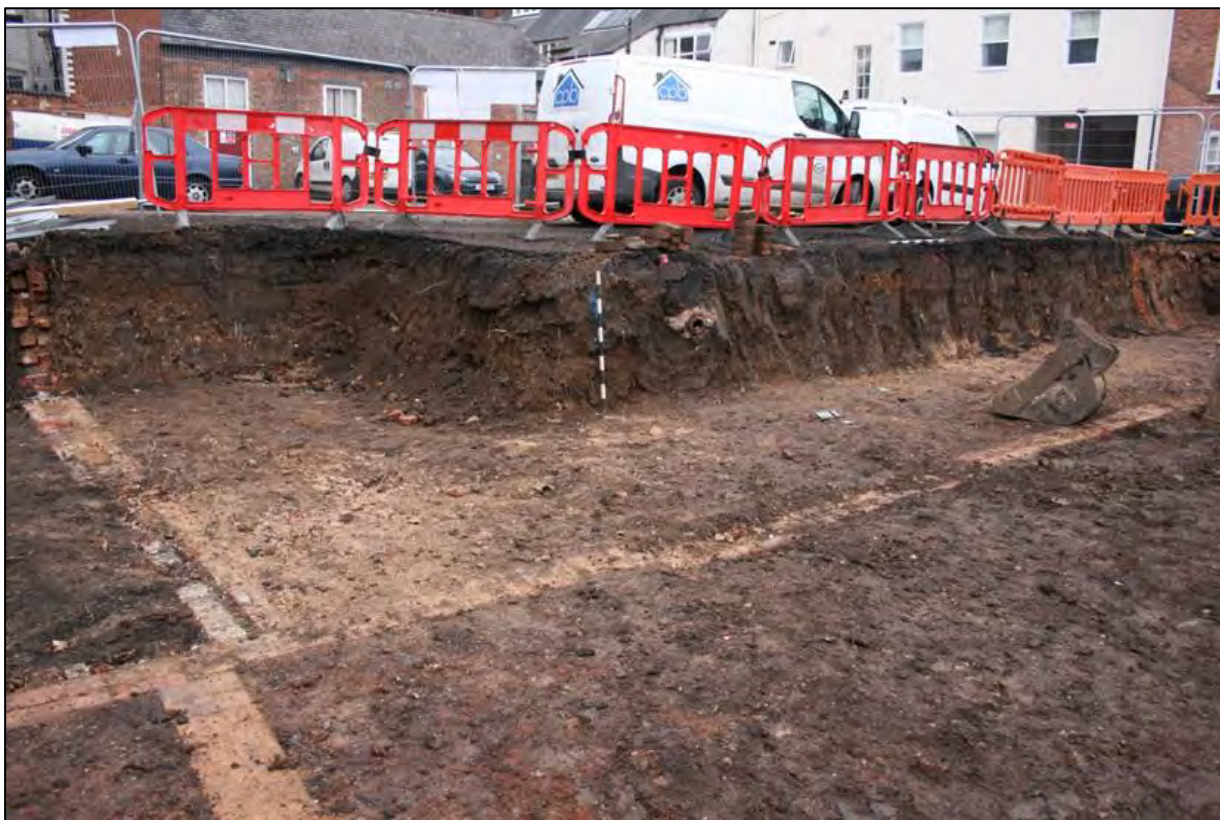
Plate 13: Showing late 19th/early 20th century made ground overlying early 19th century demolition/construction layers. Scale 2 x 1m

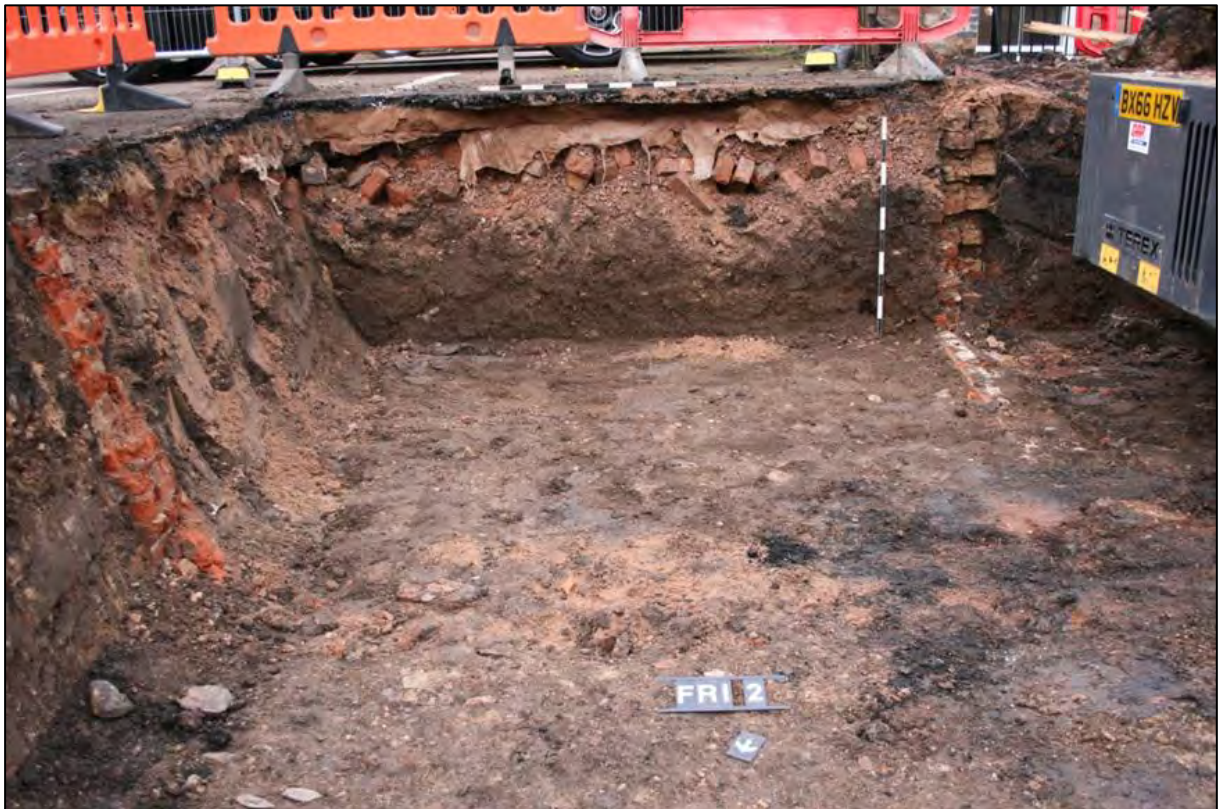
Plate 14: Showing north-south wall (2039) in section and east-west wall (2107) within modern made ground. Scale 2 x 1m, looking southeast

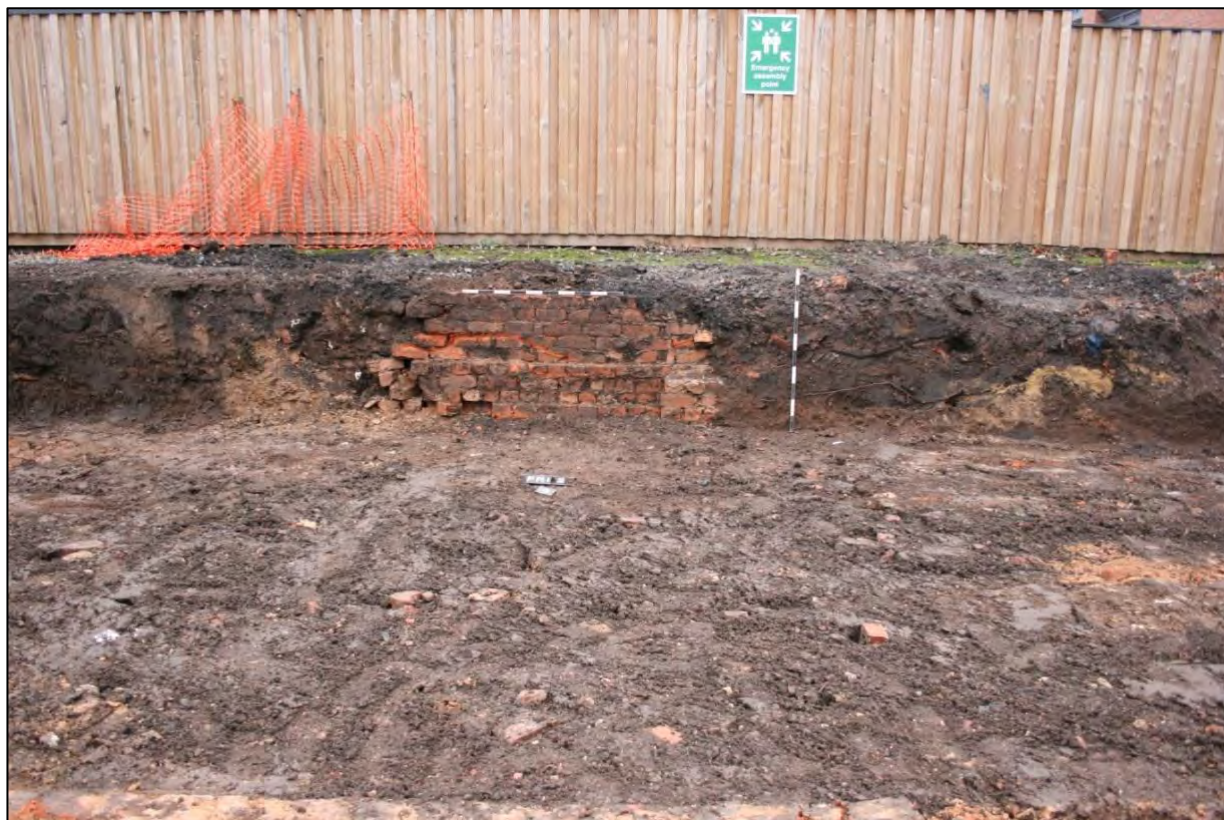
Plate 15: East facing section showing remnants of a wall (2077). Scale 2 x 1m, looking west

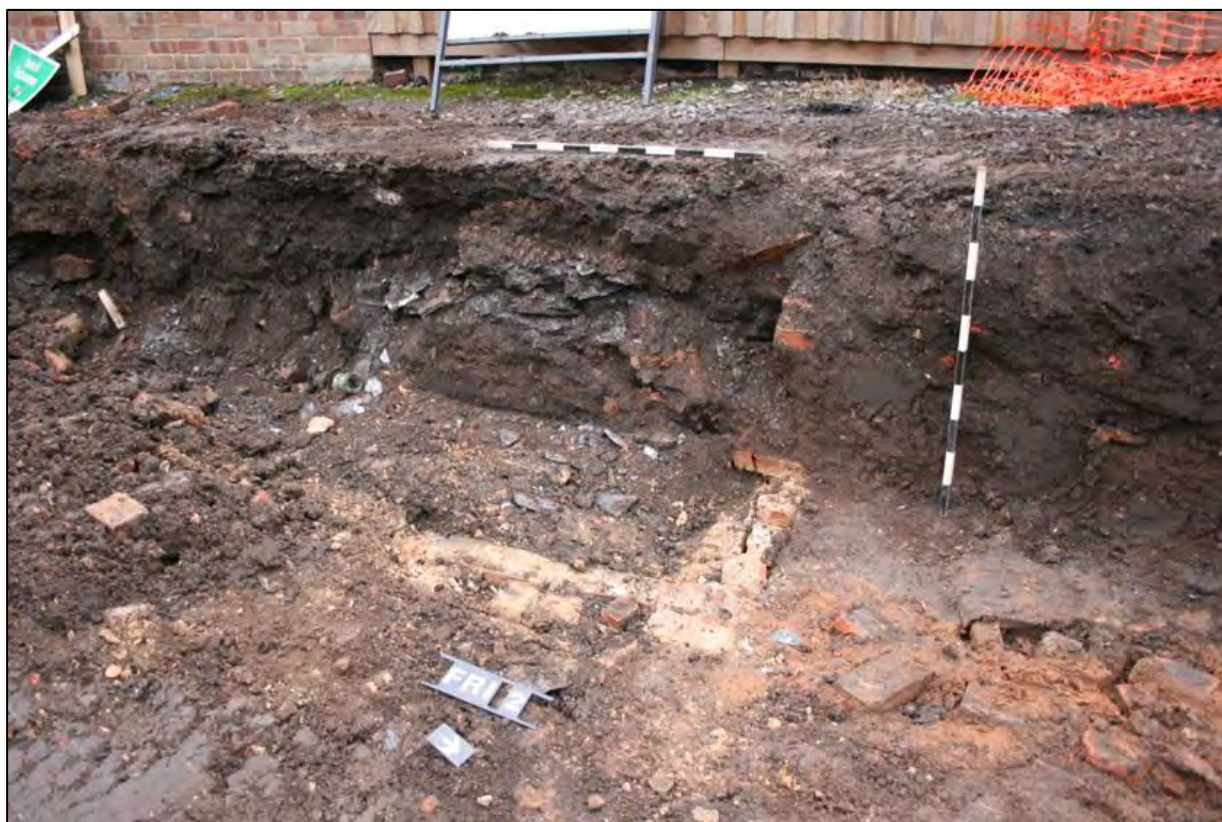
Plate 16: East facing section located in the southwest corner of the site showing brickwork [2076] and demolition material. Brickwork is possibly an outbuilding relating to 41 Friar Lane. Scale 2 x 1m, looking southwest

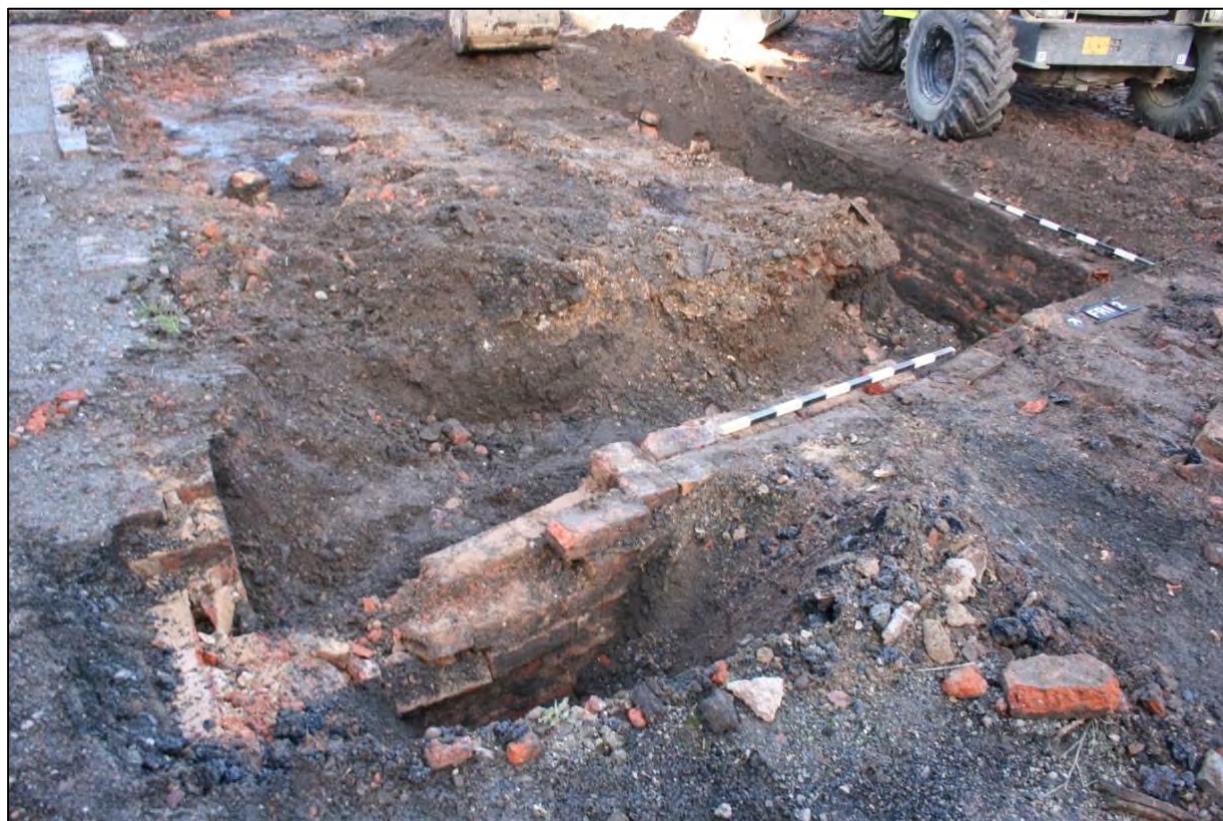
Plate 17: Early 19th century foundations [2108, 2106, 2107] revealed at southern end of site within footprint of proposed development Scale 2 x 1m, looking north

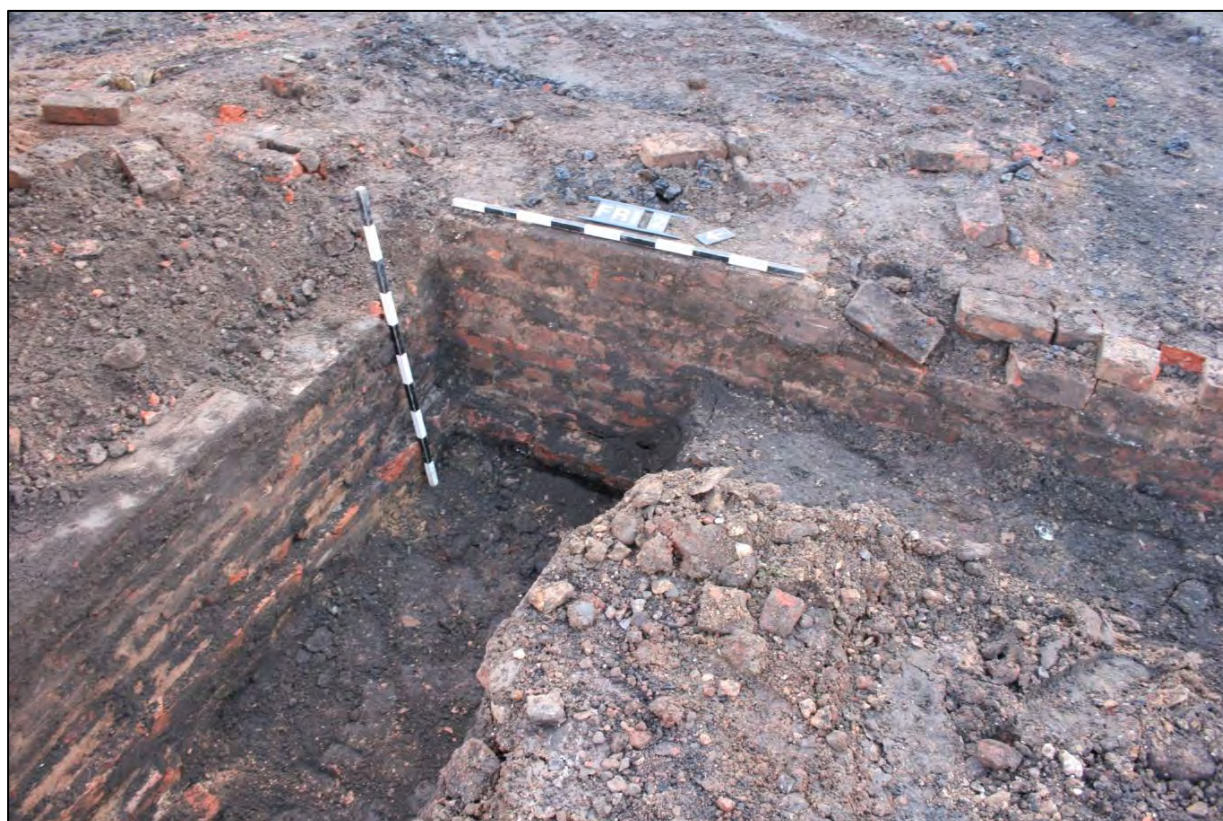
Plate 18: Early 19th century foundations [2108, 2107] revealed at southern end of site within footprint of proposed development. Scale 2 x 1m, looking southeast

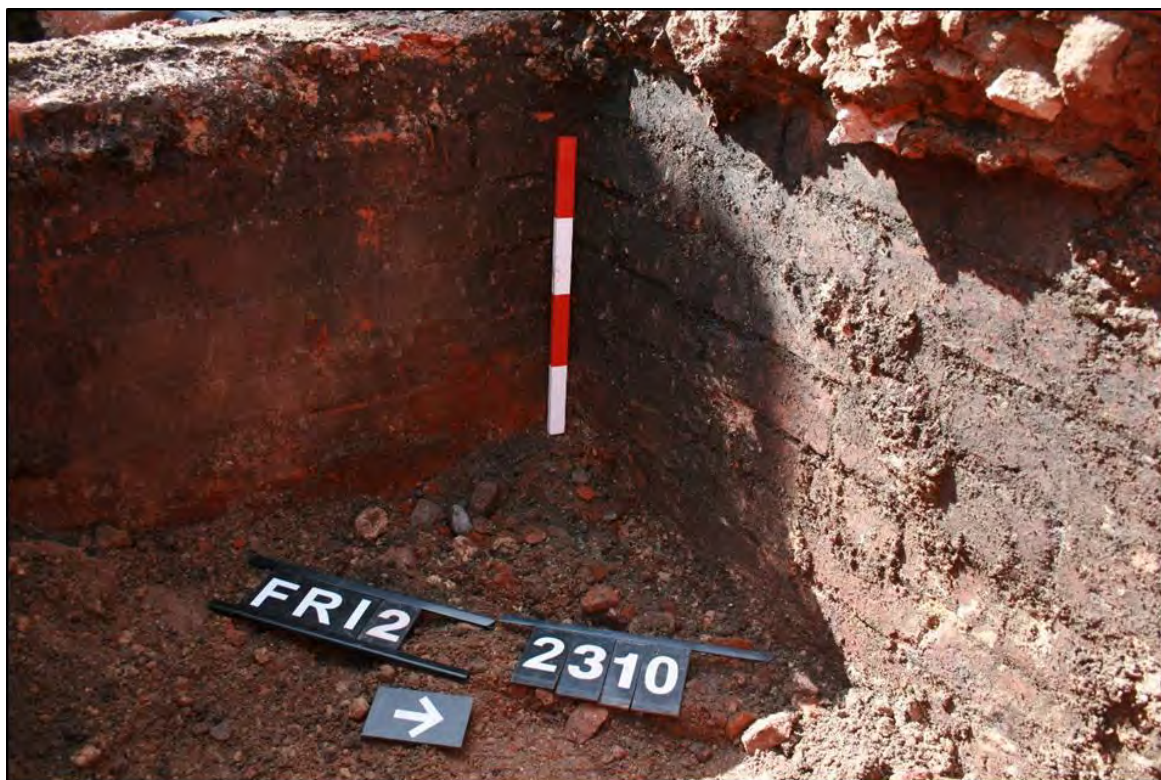
Plate 19: Detail shot of brickwork [2310] within the southeastern portion of the site. Scale 0.4m, looking west

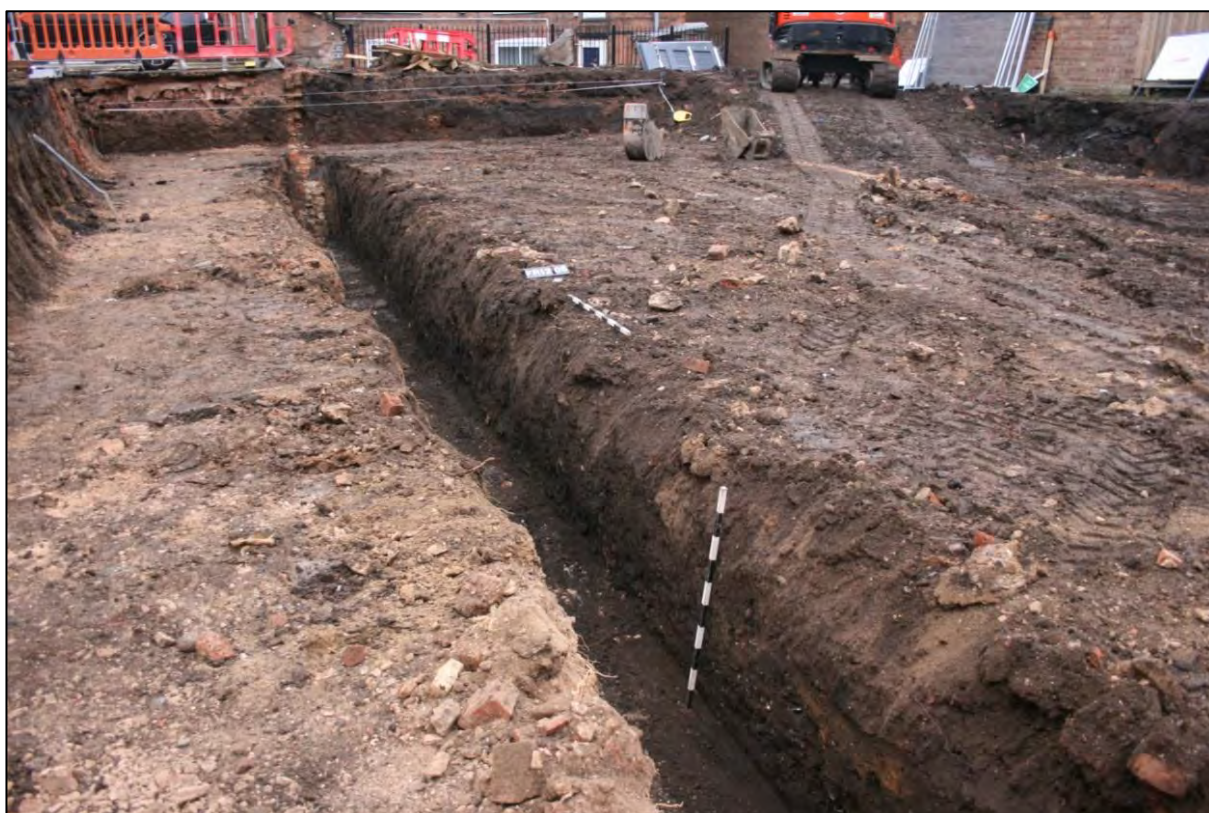
Plate 20: Located within the central portion of the site, after removal of early 19th c garden wall (2039). East facing section showing c.300mm of mixed 18th/19th c. construction/demolition material overlying a black silty soil (actual 18th ground level). Scale 2 x 1m

- 6.3.4 Within the central portion of the site, the remains of a north by south -aligned wall was removed as part of piling works. This revealed a number of vertical sided, flat based robber trenches within the section edges of the trench, relating to abutting walls which were removed during a prior demolition. These were between 0.8m and 1.2m in width, and had an average depth of 0.8m. Each were infilled by a single deposit of demolition material comprised of loose lime mortar that yielded no other datable material.

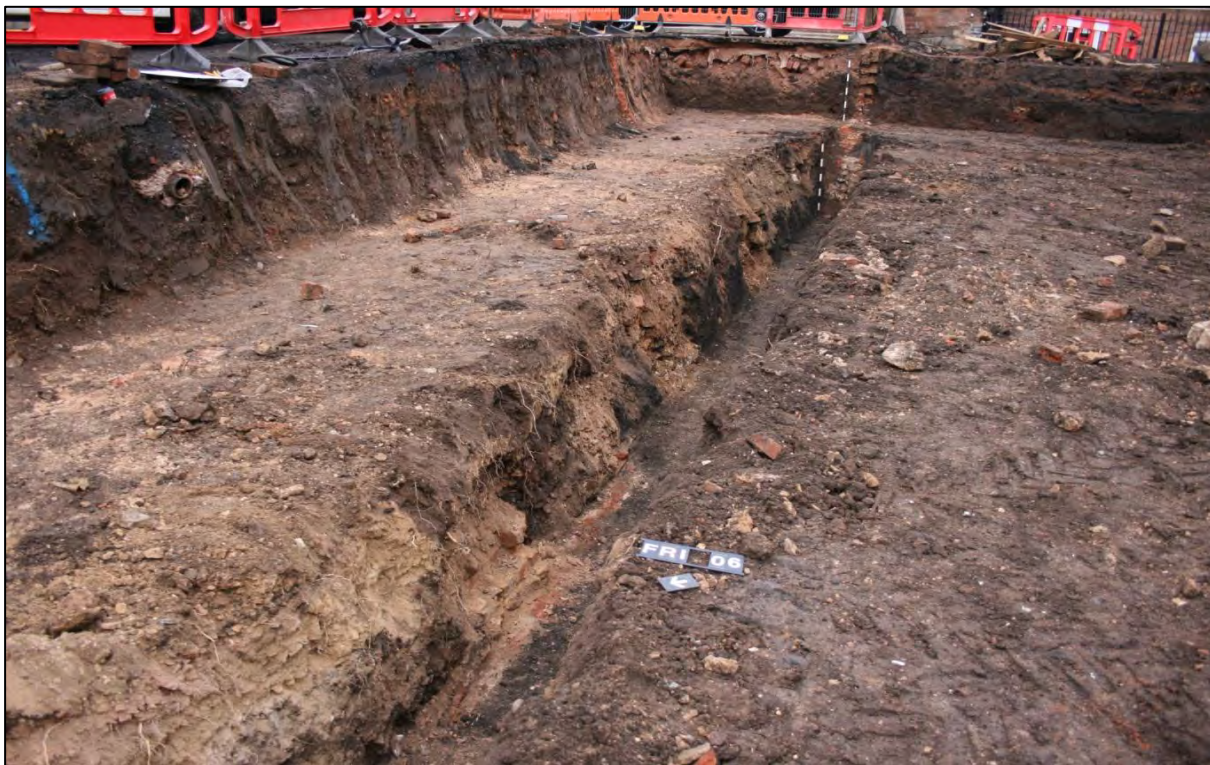
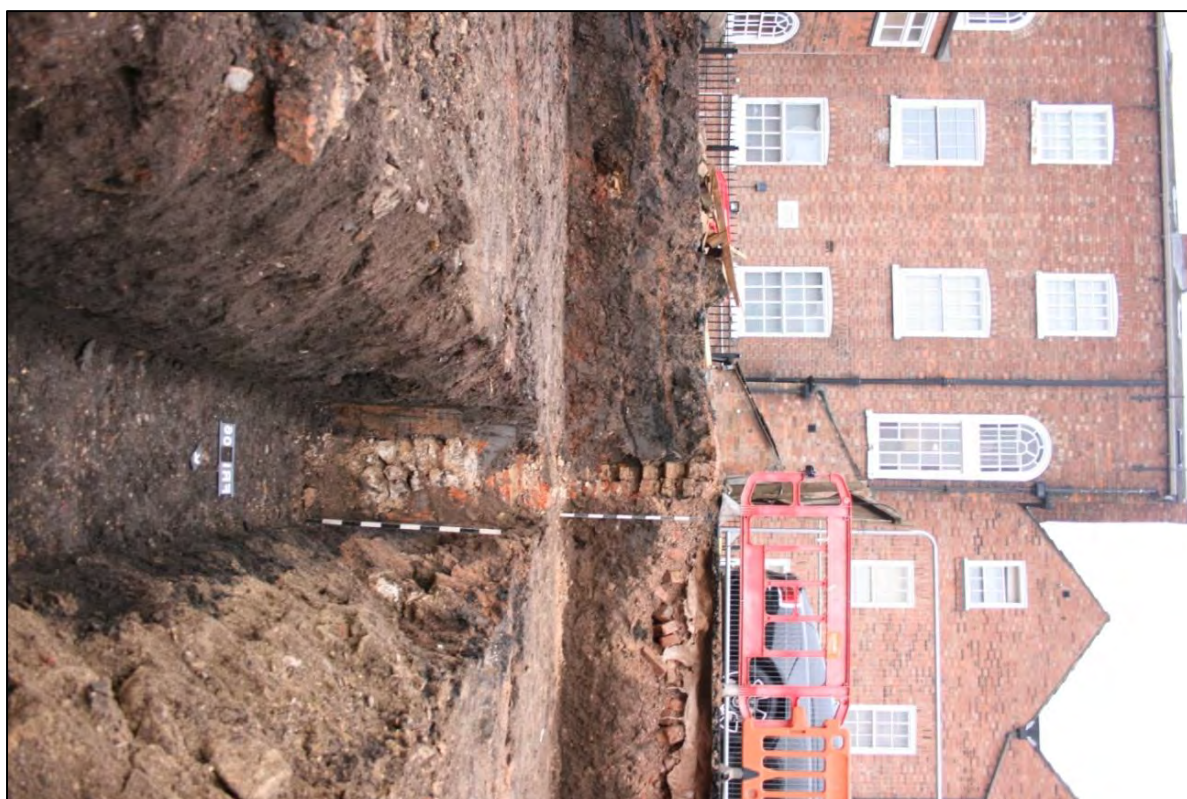
Plate 21: General site view showing removed wall foundations in the near foreground and several 'Robber' trenches visible cut

through pre 18th century black layers. Scale 2 x 1m, looking southeast
