LAND TO THE REAR OF 39 to 41 FRIAR LANE, LEICESTER

A Report on an Archaeological Watching Brief and Trial Trench Evaluation

Report Number: 077/2019

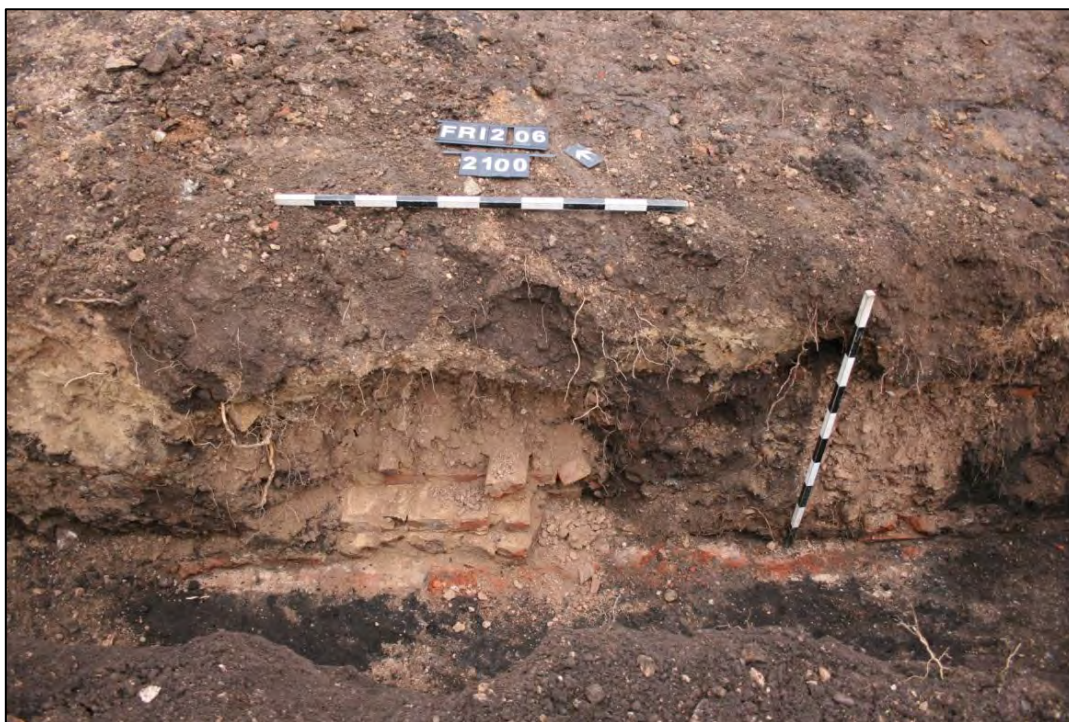
Plate 23: Representative brick foundation (2100). Scale 2 x 1m, looking northeast

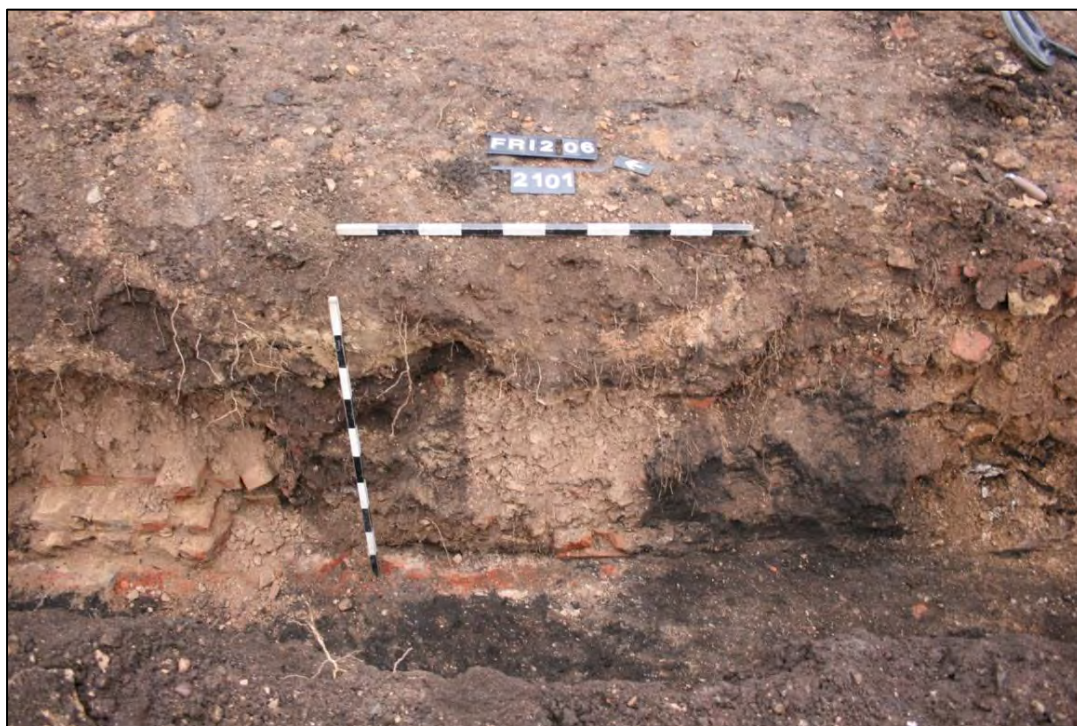
Plate 24: Trench 06 west facing section showing brick foundation and 'robber trench cut' (2101). Scale 2 x 1m, looking northeast

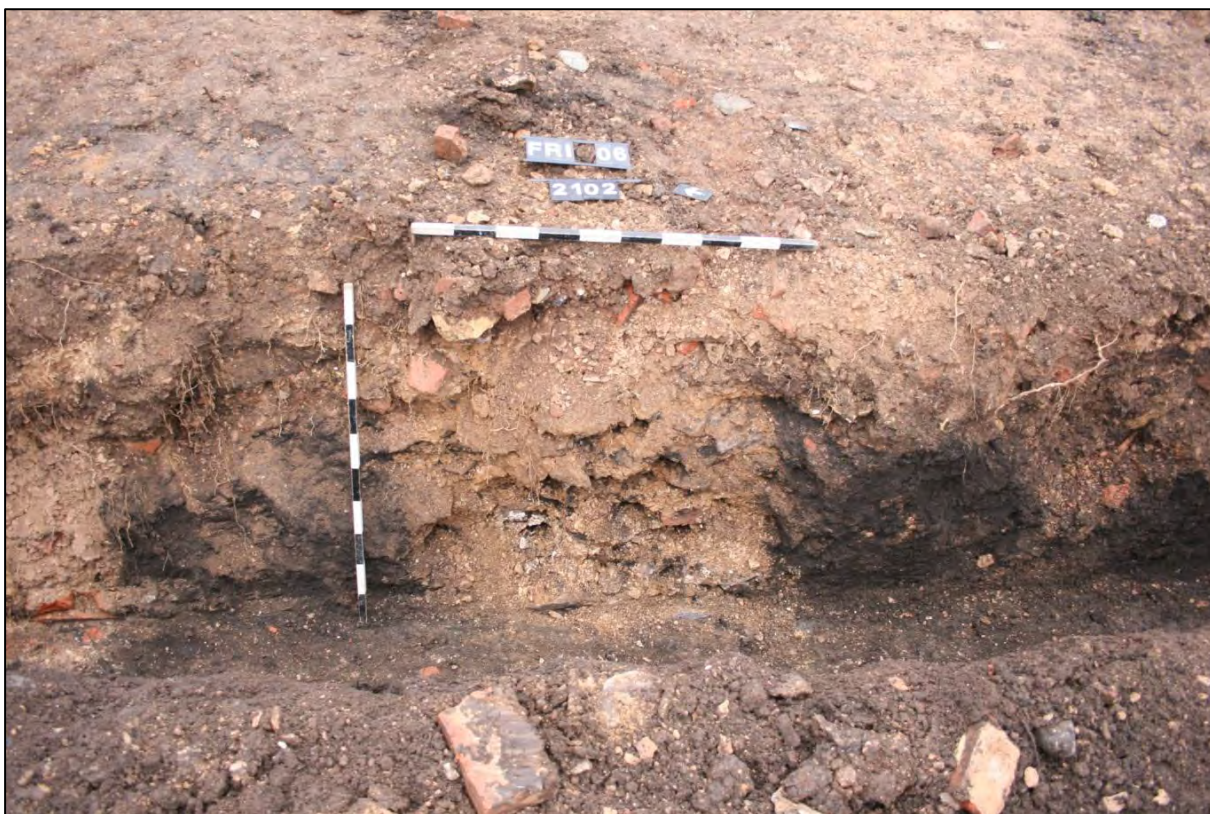
Plate 25: Showing 'robber trench cut' [2102]. Scale 2 x 1m, looking northeast

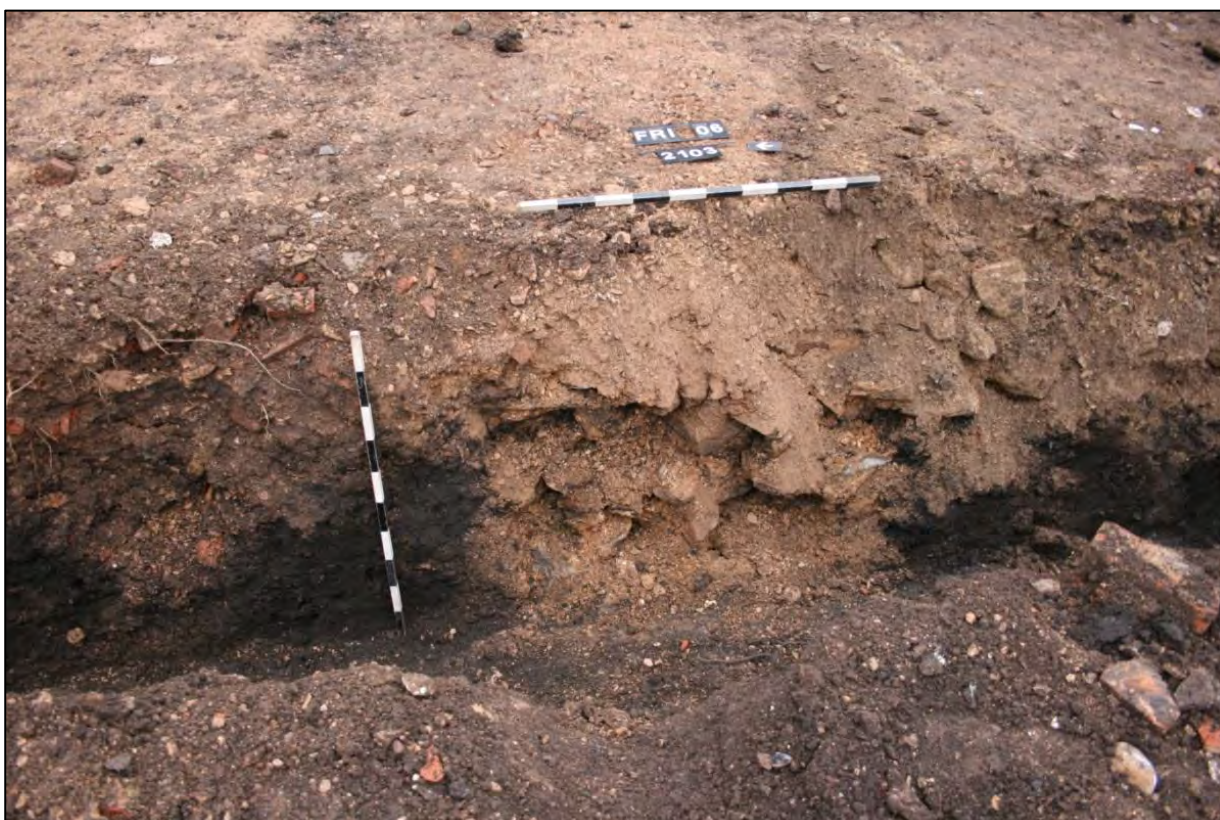
Plate 26: Trench 06 west facing section showing 'robber trench cut' (2103). Scale 2 x 1m, looking east

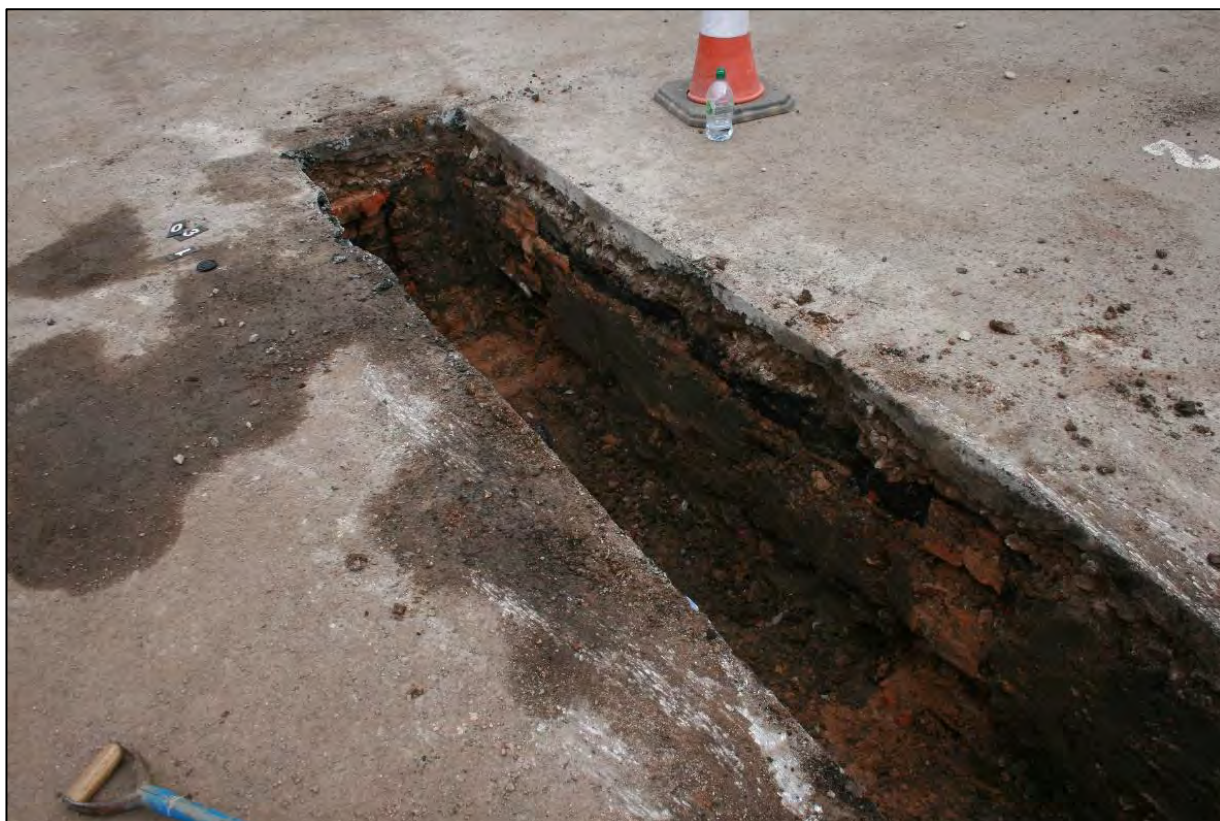
Plate 27: Lowering of the level through Trench 09

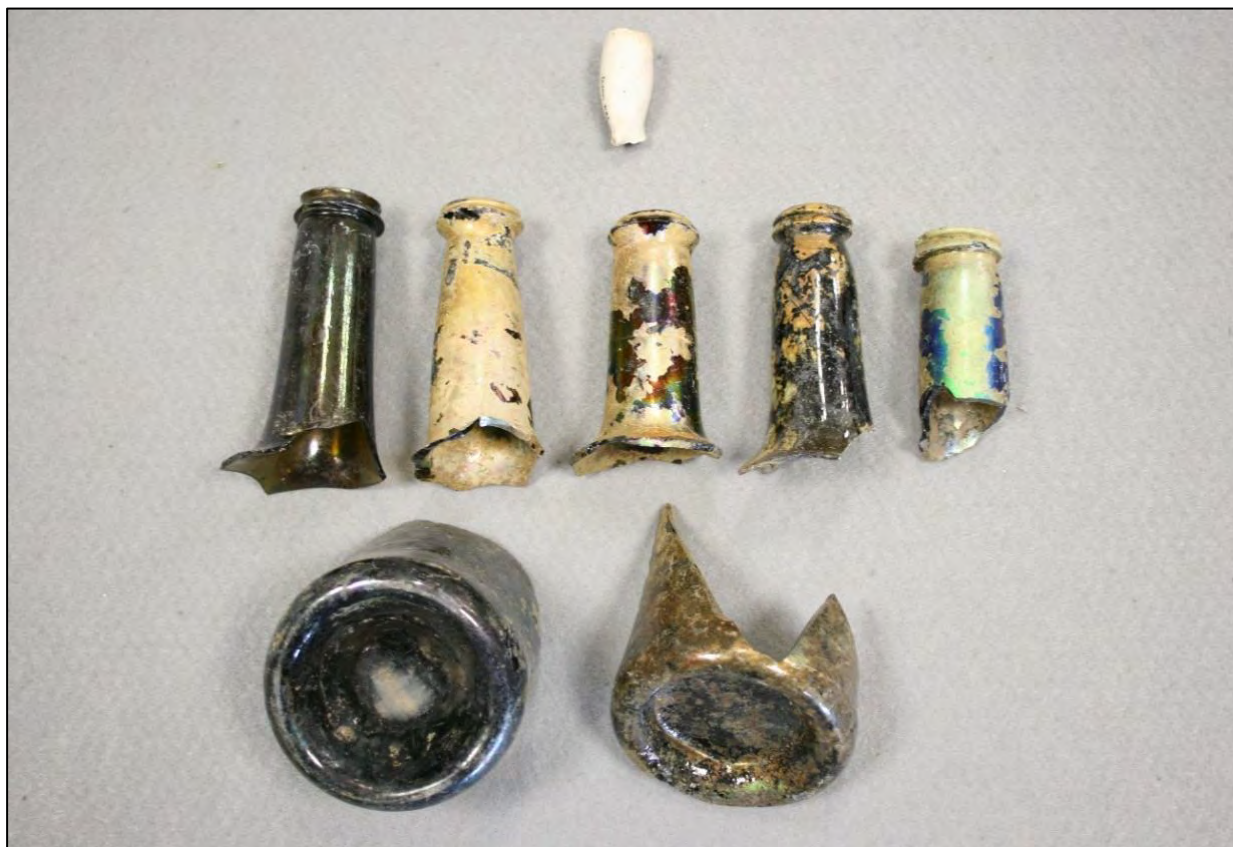
Plate 28: 18th/early 19th c wine bottle necks and clay pipe bowl

7.3.1 Two fragments of clay tobacco pipe were recovered from demolition layer (2059). These consisted of two bowls, one with a long section of stem still attached. The earliest bowl was long with straight sides and a spur although this was broken off, the rim was milled and bottered and the borehole 3mm in diameter. These features place the manufacture of the pipe to c.1690 – 1710. The remaining bowl with stem was large, with a long spur and cut and bottered rim. The stem bore diameter was 1.5mm with a manufacturing date of c. 1730 – 80.

7.4.1 Seven fragments of post-medieval bottle glass were recovered from demolition layer (2059). These consisted of 2 kick up bases, 4 bottle necks and a body fragment. The fragments were large but with the beginnings of degradation of the glass.

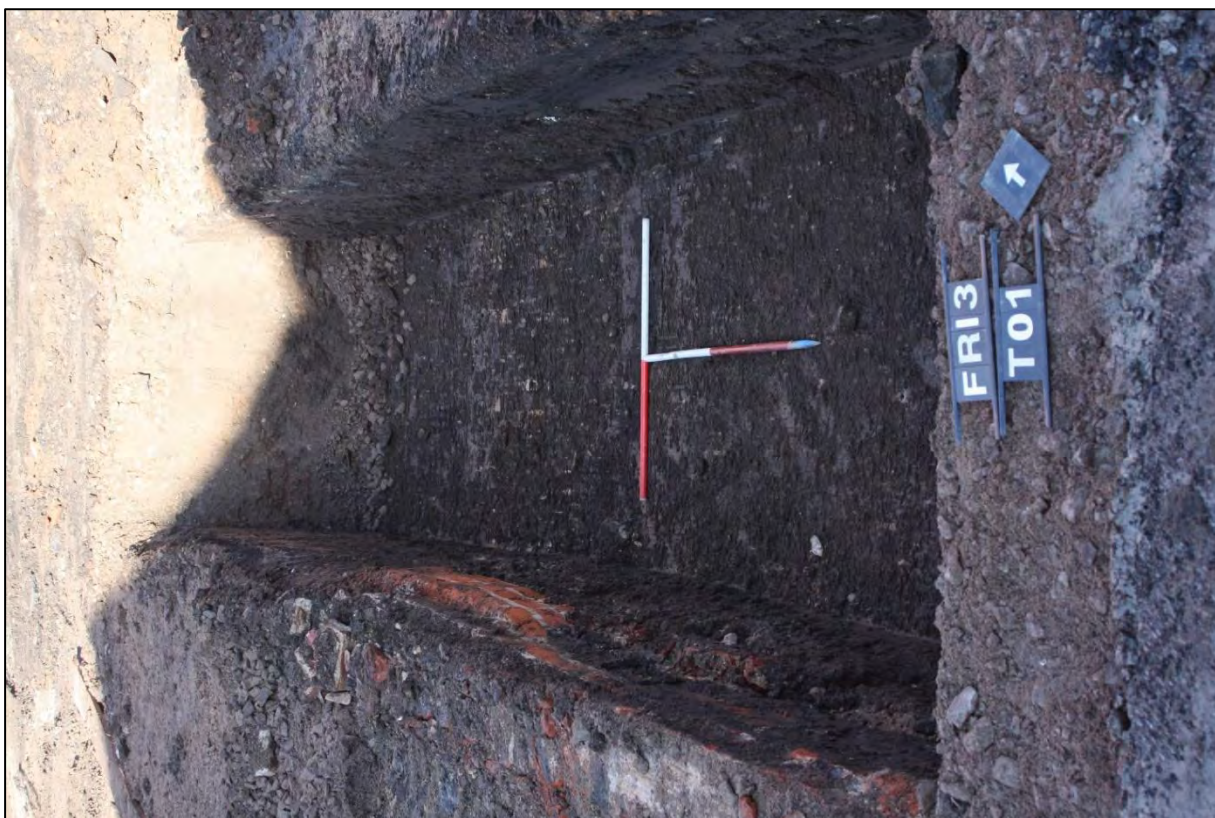
Plate 29: FRI 3, watching brief. Trench 01, looking north-west. Scale 2 x 1m

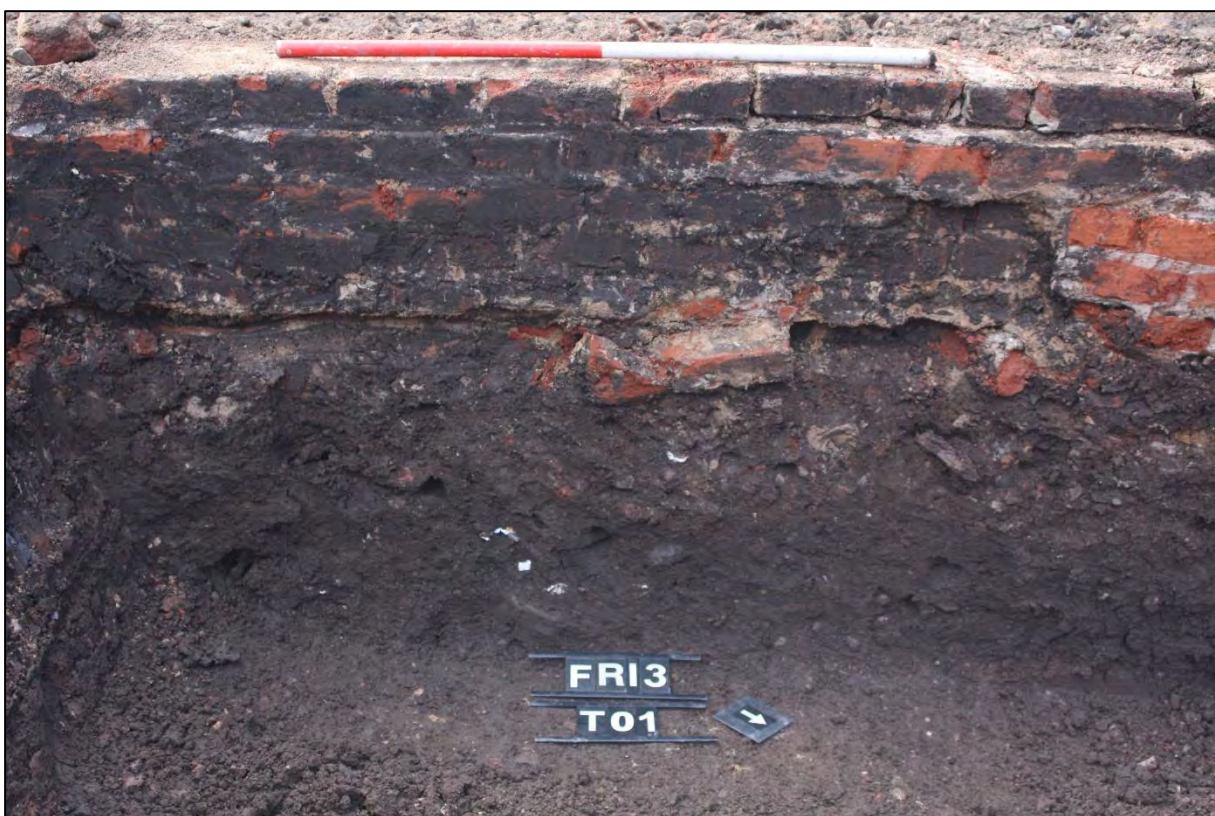
Plate 30: FRI 3, North-east facing representative section trench 01. Showing garden wall footings [2314]. Scale 1 x 1m

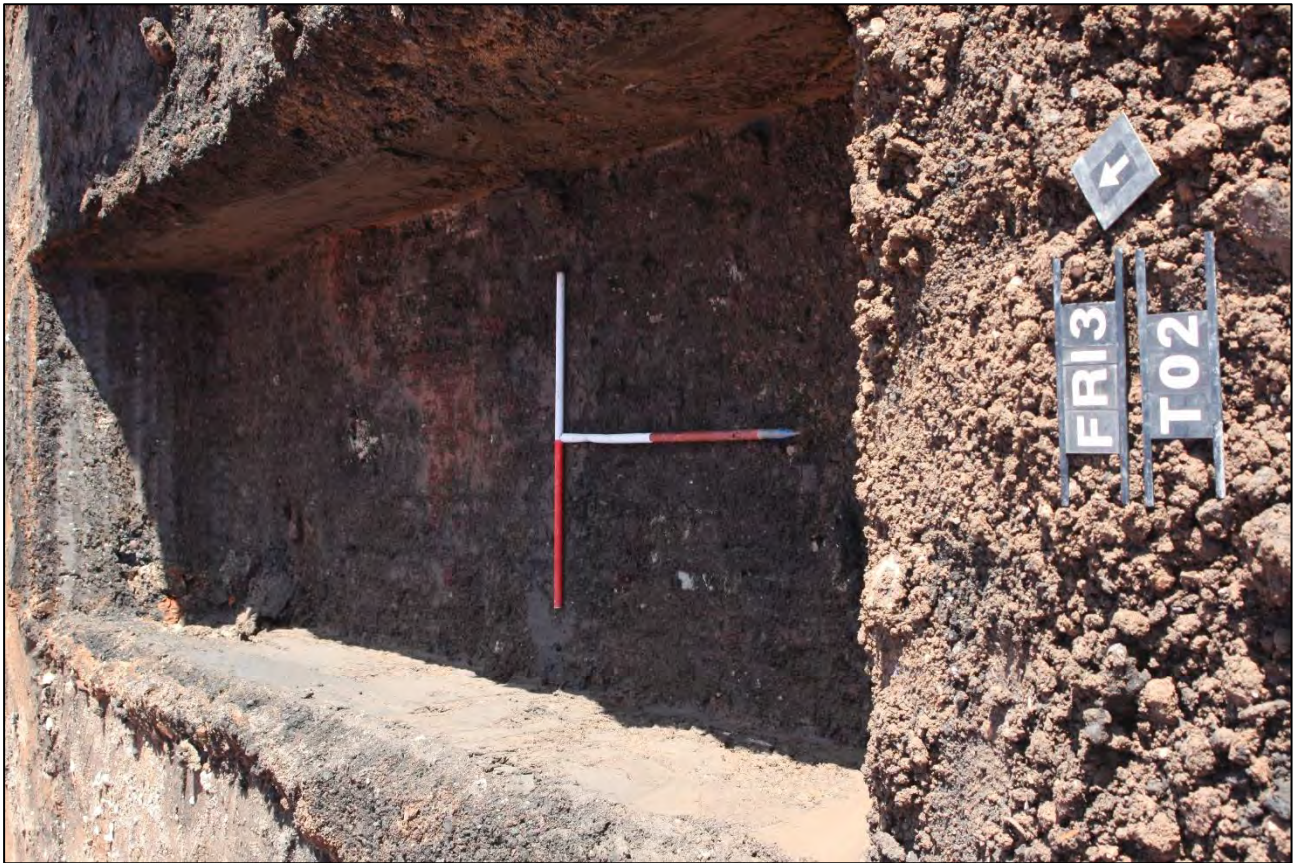
Plate 31: FRI 3, Trench 02, looking north-east. Scale 2 x 2m

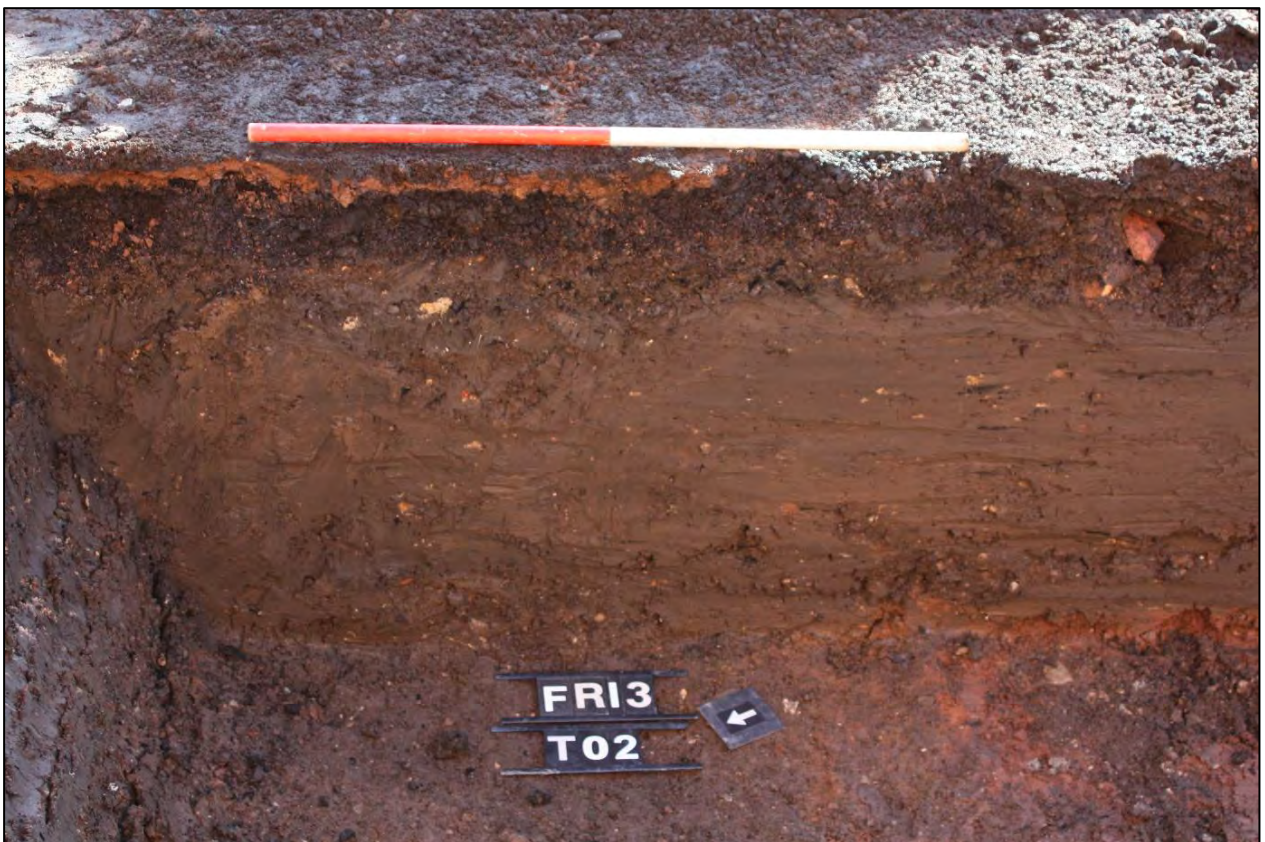
Plate 32: FRI 3, North-west facing representative section trench 02. Scale 1 x 1m
