Garmston Street, Lincoln: Report on the Results of an Archaeological Watching Brief

Report Number: 063/2020

Trent & Peak Archaeology was commissioned by Anglian Water to undertake an archaeological watching brief on land immediately to the south of No. 10 Garmston Street, Lincoln (SK 97548 71536) during contractor-led emergency groundworks to locate and repair a residential water main. The work was conducted on the 5th March 2020.

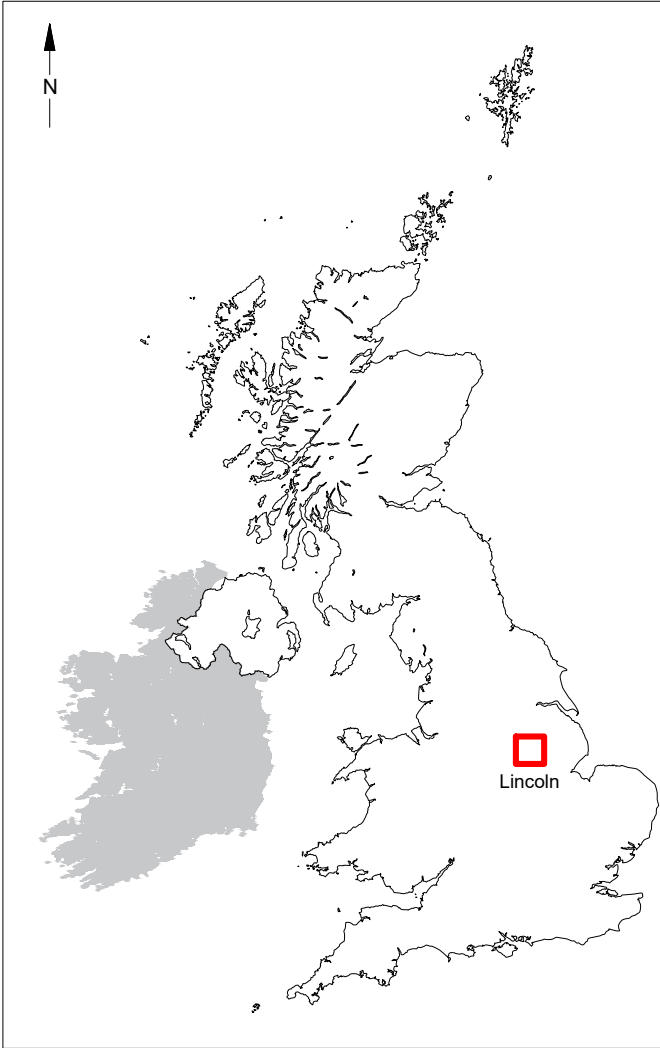
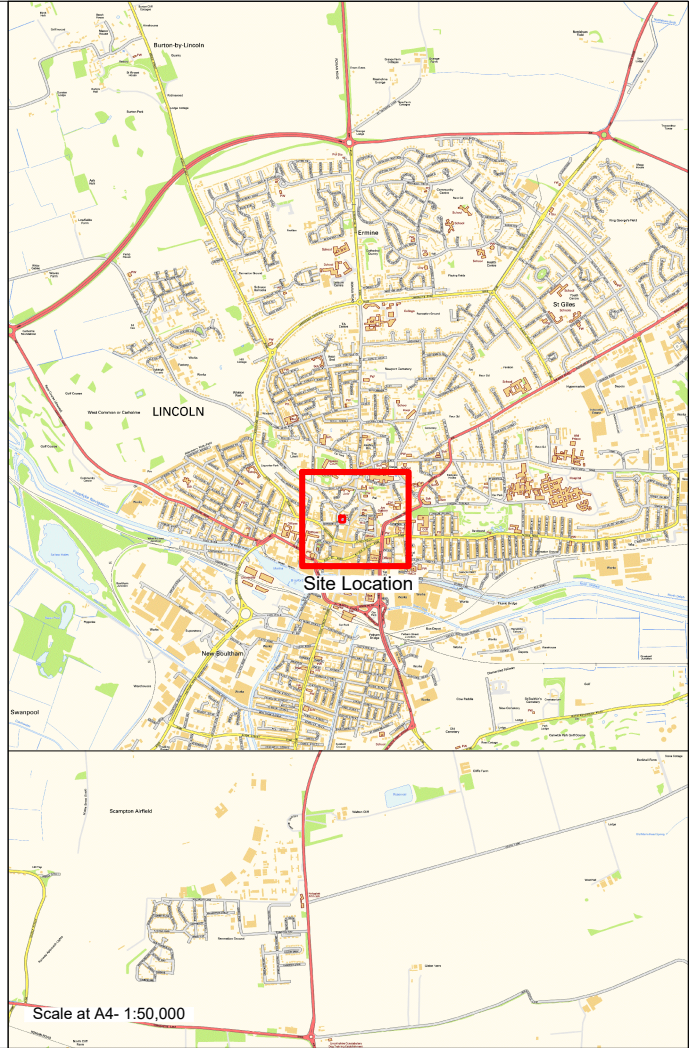
DR#01
East Facing Section of Emergency Water Works Trench

- Figure 1:** Site location plan
- Figure 2:** Section Drawing 01. Scale @A4 1:20

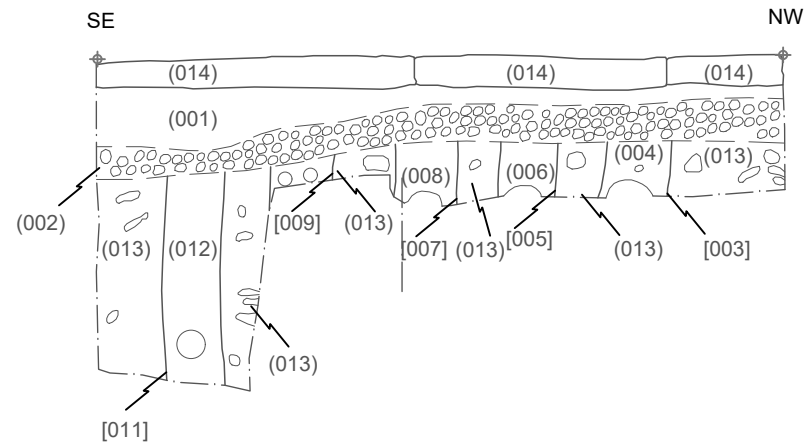
- 6.2 The earliest deposit identified was a friable dark greyish brown clayey silt made ground (013), which was identified at a depth of 0.3m below ground level. The deposit constitutes the build-up of the roadway for the construction of the road and pavement in the 19th century, and continued in depth beyond the limit of excavation. Into this deposit, a number of cuts for modern service pipes leading to the No. 10 property were recorded: [003], [005], [007], [009] and [011] respectively. These are detailed on figure 2.

- 6.3 Above these deposits were a ground levelling material (002) *c* 0.1m thick, concrete underlay (001) *c* 0.1-0.16m thick, and modern paving stones (014) that constitute the current ground surface.

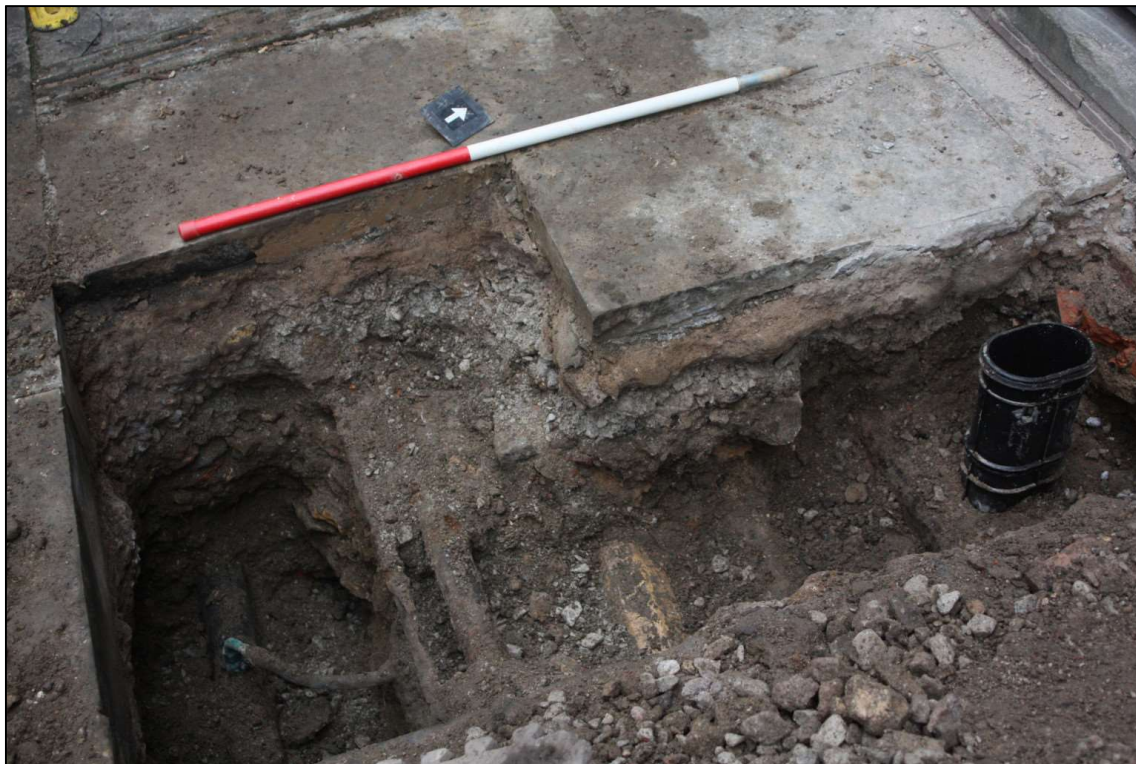
Plate 1: Area of excavation showing east facing section and service pipes in plan, oblique view. Scale 1m, looking north-west.
