NOTTINGHAM CASTLE REDEVELOPMENT PROJECT

Archaeological Excavation and Monitoring in Advance of Interpretation Installation

Document Title: Nottingham Castle Redevelopment Project: Archaeological Excavation and Monitoring in Advance of Interpretation Installation

Report No. 114/2020

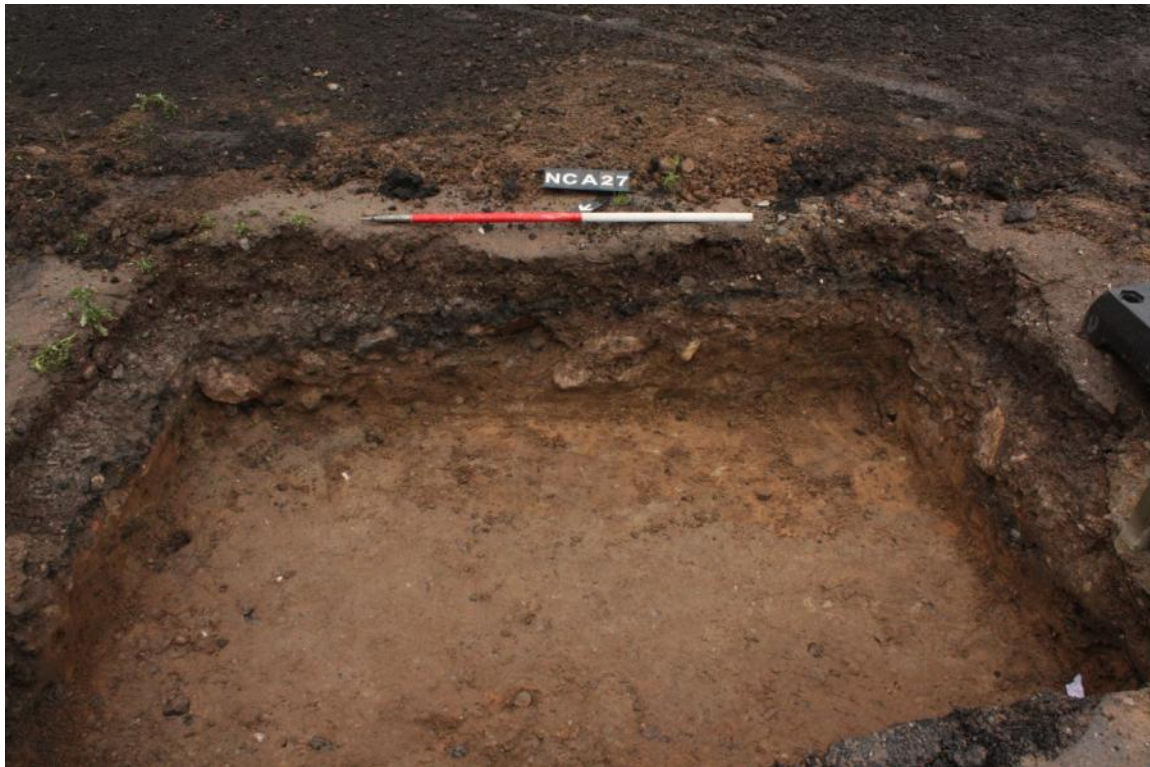
Plate 01: Foundation Trench 2.1.2. Northeast facing section. Scale 1m

- 8.2.1. Foundation 2.1.2 measured 2.1m x 1.5m x 0.55m and comprised five modern landscaping contexts deposited atop a post-medieval sand layer, (27069) located southwest of the castle gatehouse (figure 03). No finds were recorded from any of the contexts recorded in this monitored excavation.

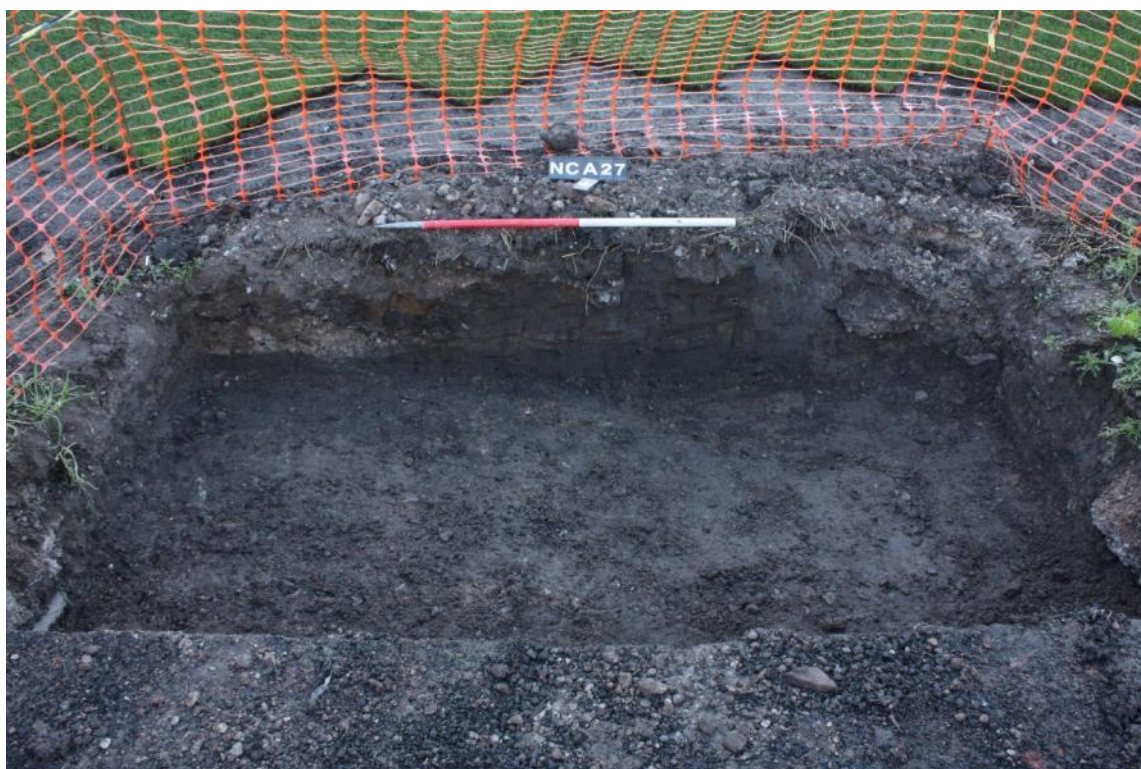
Plate 02: Foundation Trench 2.1.3. Northwest facing section. Scale 1m

8.3.1. Foundation 2.1.3 measured 2.8m x 1.5m x 0.57m and comprised entirely of modern contexts which included a northeast to southwest aligned service [27097] installed in 2020 as part of the Nottingham Castle Redevelopment Project. The Dark greyish brown layer that [27094] truncates, (27098), was likewise deposited as part of the castle redevelopment project during an earlier phase of works 2019. The foundation is located southwest of the castle Gatehouse (Figure 03) and no finds were recorded from any of the contexts observed during this monitored excavation.

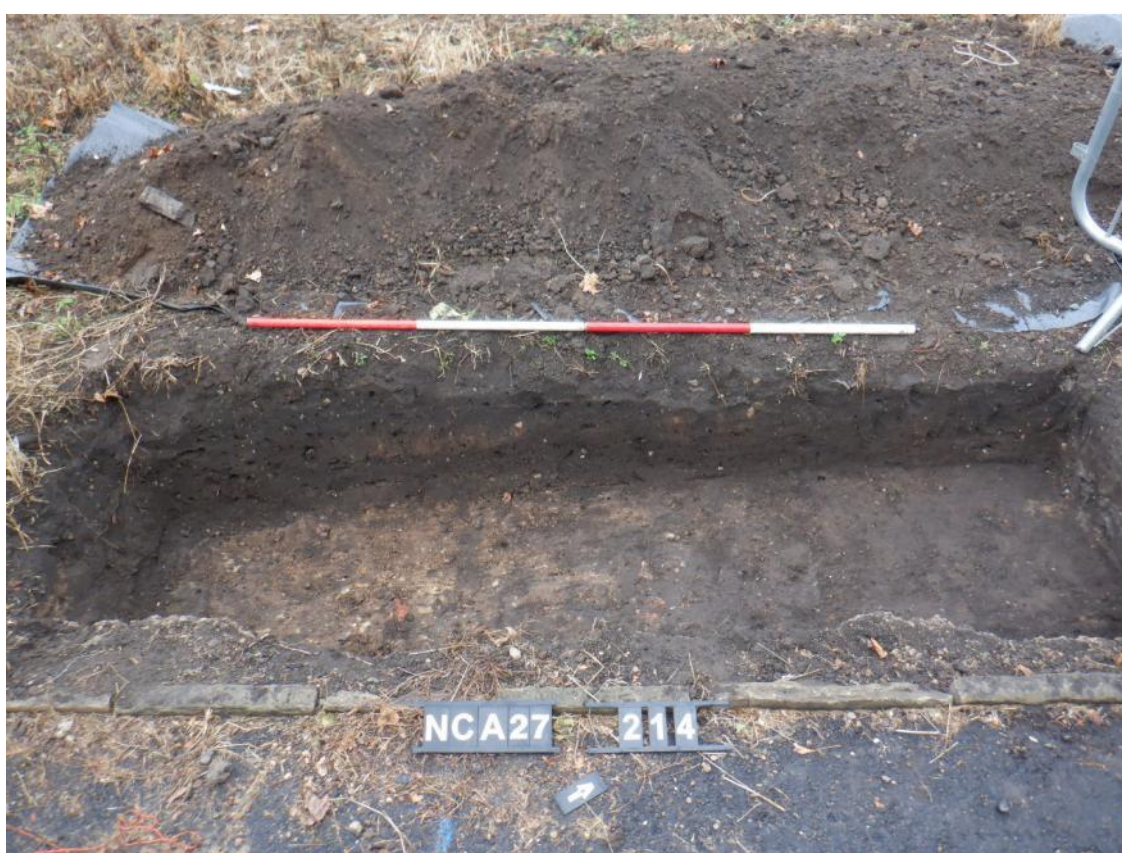
Plate 03: Foundation Trench 2.1.4. Southeast Facing Section. Scale 2m

- 8.4.1. Foundation 2.1.4 measured 2.2m long x 1m wide and 0.5m deep at its north-eastern end, but was slightly deeper at the south-western end due to the sloping ground. It was located northwest of the statue of Captain Albert Ball and northeast of the medieval bridge in the Outer Bailey (Figure 03). This was slightly deeper It comprised a single layer of modern topsoil with moderate inclusions of small to middling sized rounded stone. No finds were recovered from this monitored foundation excavation.

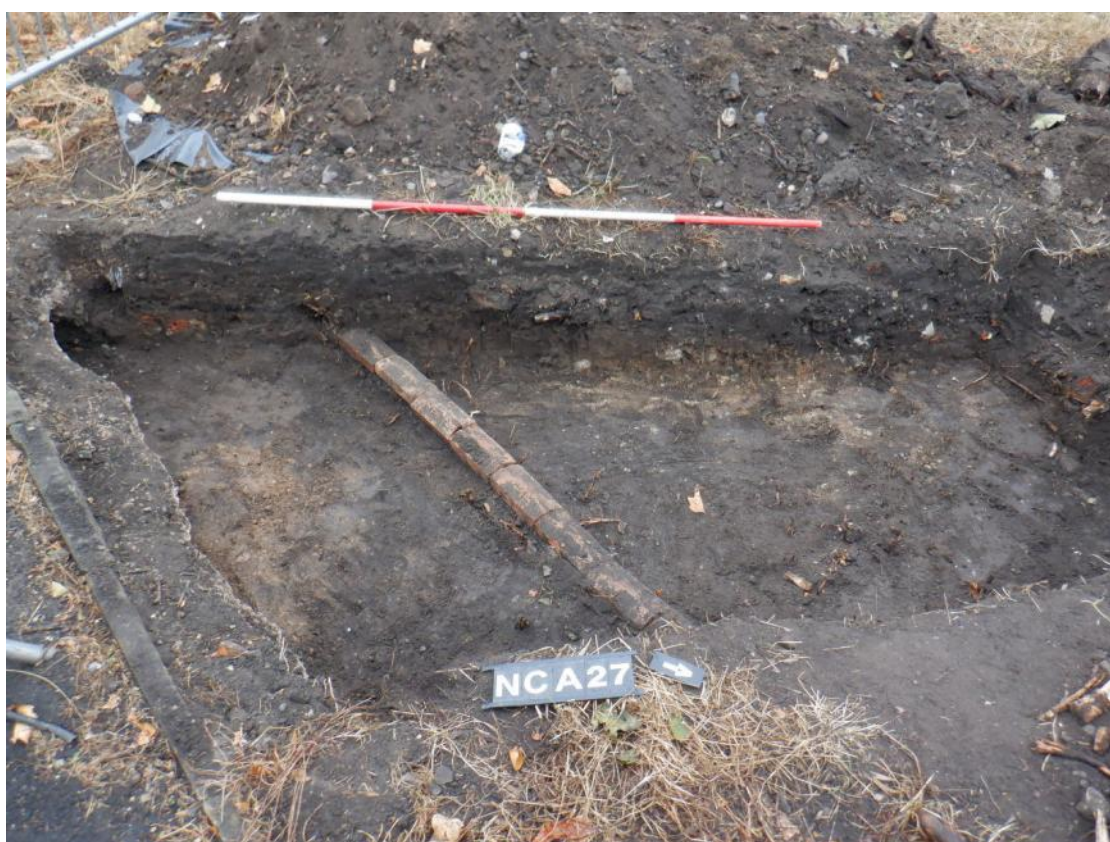
Plate 04: Foundation Trench 2.1.5. Northeast facing section. Scale 2m

8.5.1. Foundation 2.1.5 measured 3.4m x 1.5m x 0.5m and is located west of the Captain Albert Ball statue and northeast of the medieval bridge in the Outer Bailey (Figure 03). Three modern contexts were recorded during this monitored excavation and consisted of sandy topsoil and the cut and fill of an electrical service cable. No finds were recorded from this excavation.

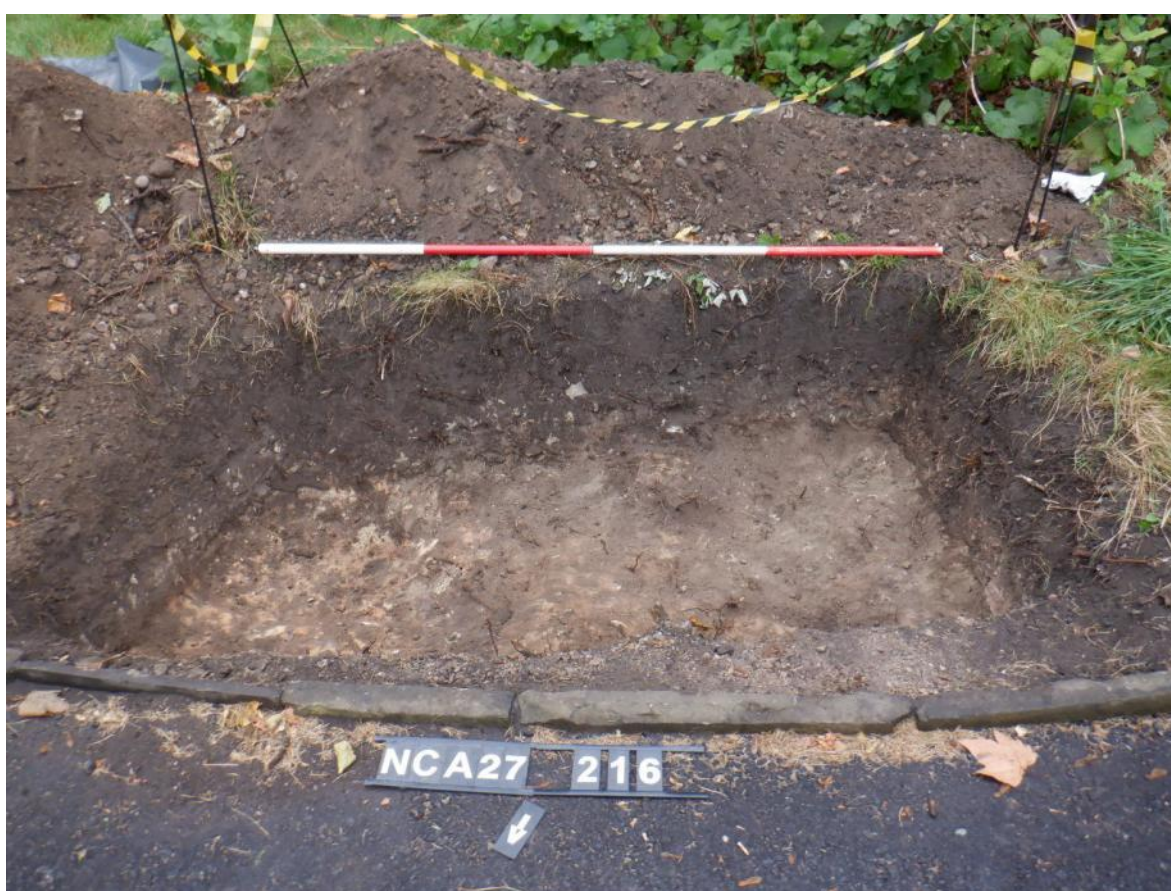
Plate 05: Foundation Trench 2.1.6. Northwest facing section. Scale 2m

8.6.1. Foundation 2.1.6 measured 2.2m x 1.5m x 0.5m and is located East of the medieval bridge and west of the statue of Captain Albert Ball in the Outer Bailey (Figure 04). Three contexts consisting of a modern topsoil, a post-medieval subsoil and an undated sandy natural were recorded from this monitored excavation. No finds were recorded from any of the contexts.

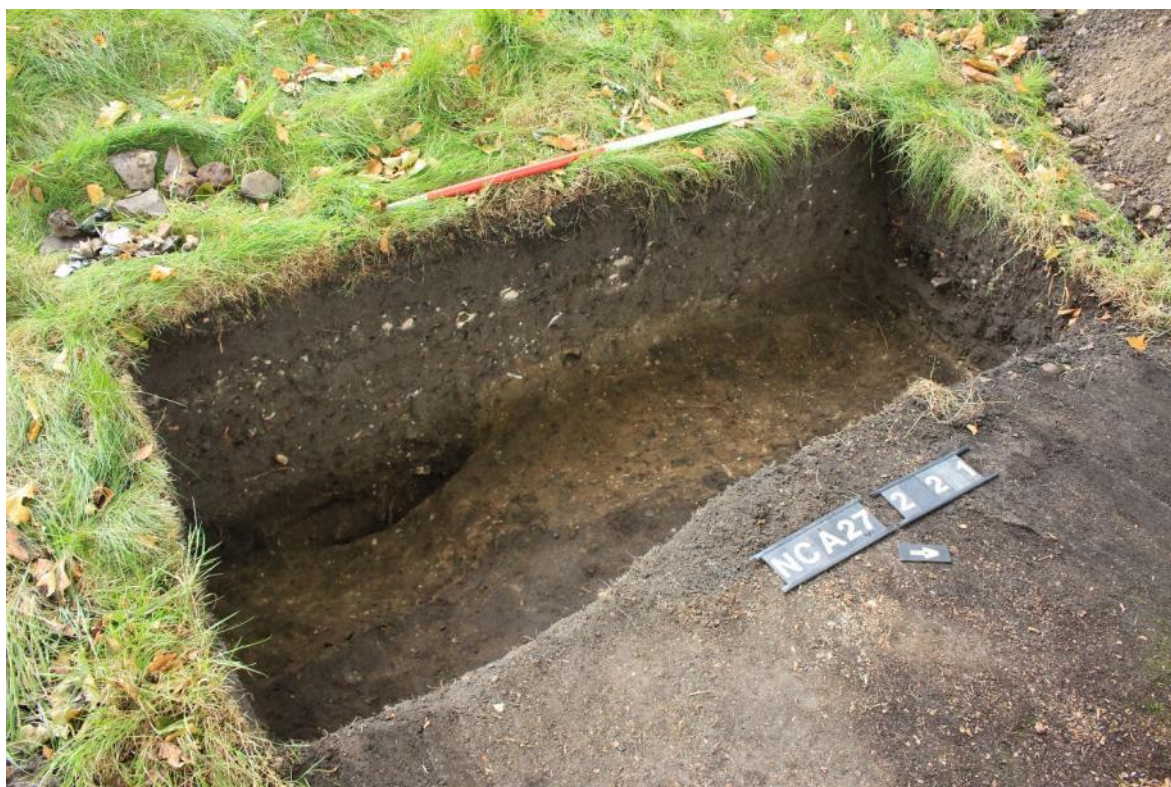
Plate 06: Foundation Trench 2.2.1 Northeast facing section, oblique. Scale 1m

8.7.1. Foundation 2.2.1 measured 2.2m x 1.5m x 0.64m and was located adjacent to the Outer Bailey Curtain wall, northeast of the 1908 bandstand (Figure 4). This was slightly deeper than the 0.5m depth for most foundation trenches, due to the presence of pit [27070] at the south-eastern end of the trench. A total of ten contexts were recorded from this monitored foundation excavation, five post-medieval landscaping contexts and five modern surfacing and bioturbation related contexts. Finds of animal bone and glass were recorded from the modern tree-bole contexts, [27072] and (27073), but no features or deposits of note were identified during this excavation.

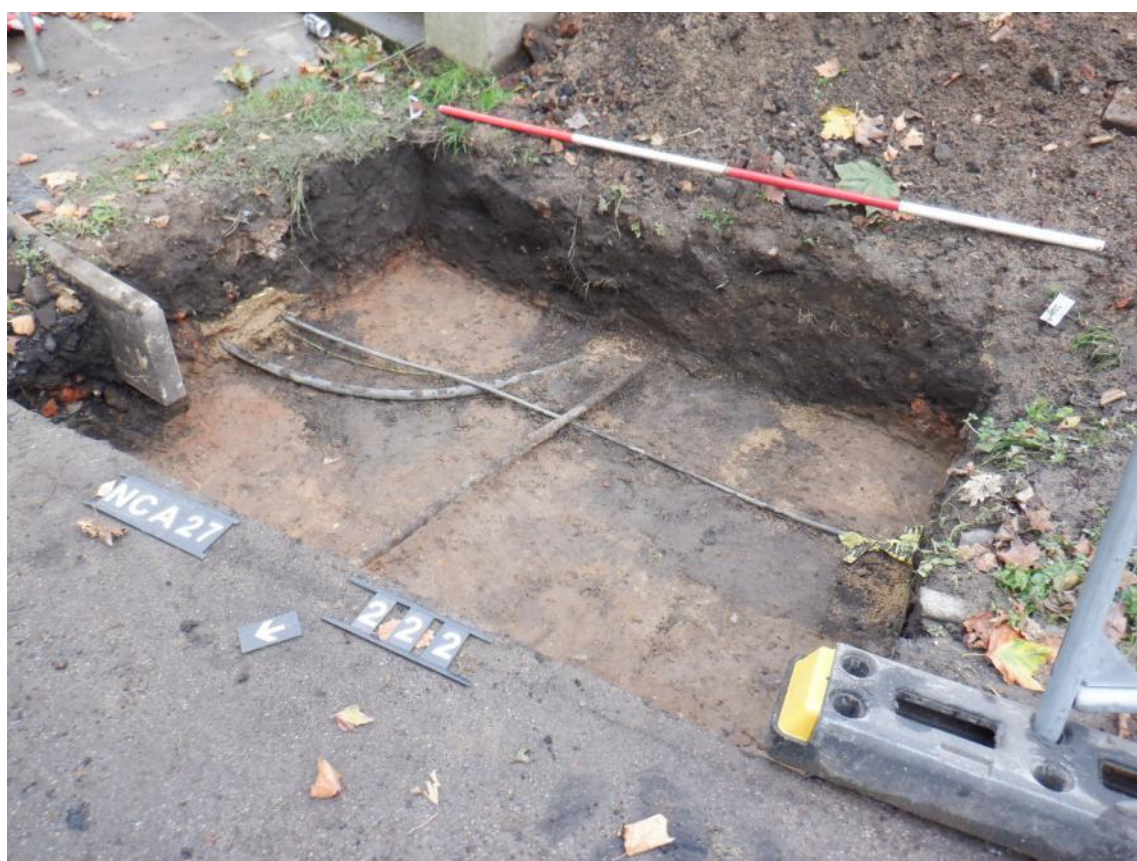
Plate 07: Foundation trench 2.2.2 Northwest facing section, oblique. Scale 2m

8.8.1. Foundation 2.2.2 measured 2m x 1.5m x 0.56m and was located adjacent to the 1908 bandstand in the Outer Bailey (Figure 04). Eight modern contexts were recorded during this monitored excavation including two low voltage electrical services, [27058] and [27059], installed in 2020 as part of the Castle Redevelopment Project and a deliberately formed silty sand layer with frequent charcoal inclusions, (27056), which could be associated with the construction of the bandstand in 1908.

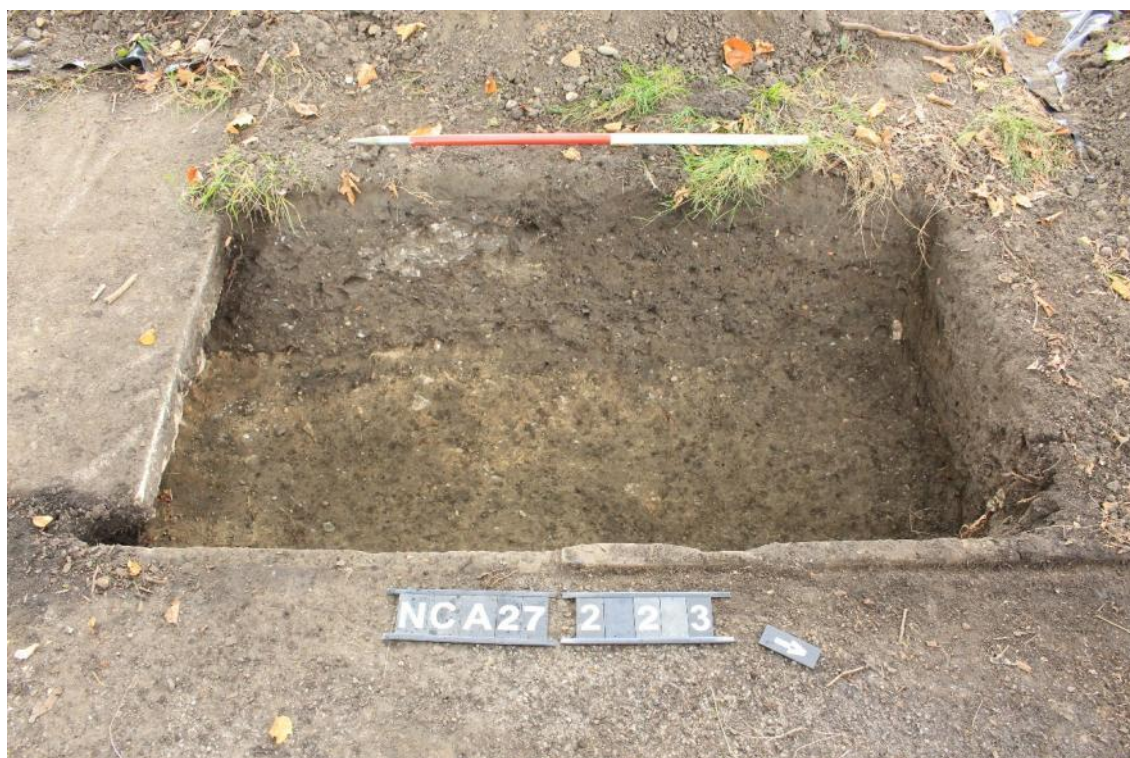
Plate 08: Foundation Trench 2.2.3. Northeast facing section. Scale 1m

8.9.1. Foundation 2.2.3 measured 1.6m x 0.9 x 0.56m and was located adjacent to the statue of Captain Albert Ball in the Outer Bailey (Figure 04). Nine contexts were recorded from this monitored excavation, seven modern surfacing and service contexts and two post-medieval landscaping contexts. No finds were recorded from this excavation.

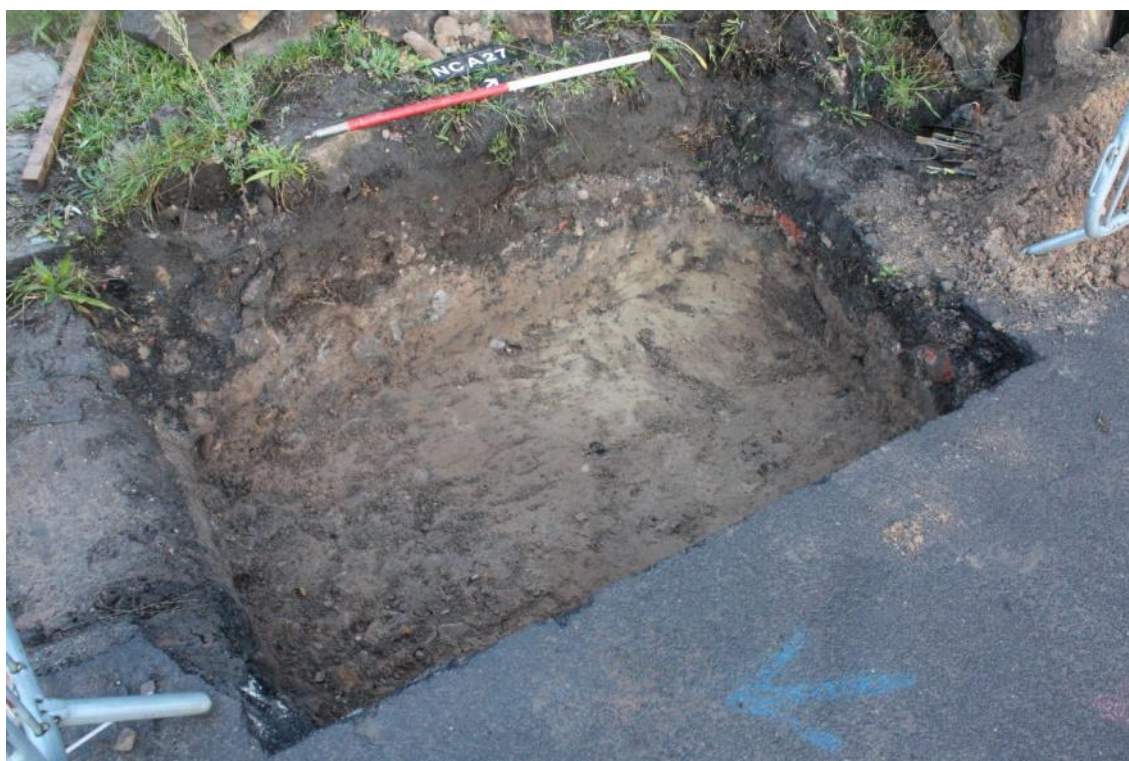
Plate 09: Foundation Trench 2.2.4. Southeast facing section, Oblique. Scale 1m

8.10.1. Foundation 2.2.4 measured 2.2m x 1.5m x 0.9m (deeper than stated in the WSI, due to the sloping ground surface) and was located west of the castle Gatehouse and east of the Afghan war memorial in the Outer Bailey (Figure 03). Six modern landscaping layers were identified in this monitored excavation and no finds were recorded.

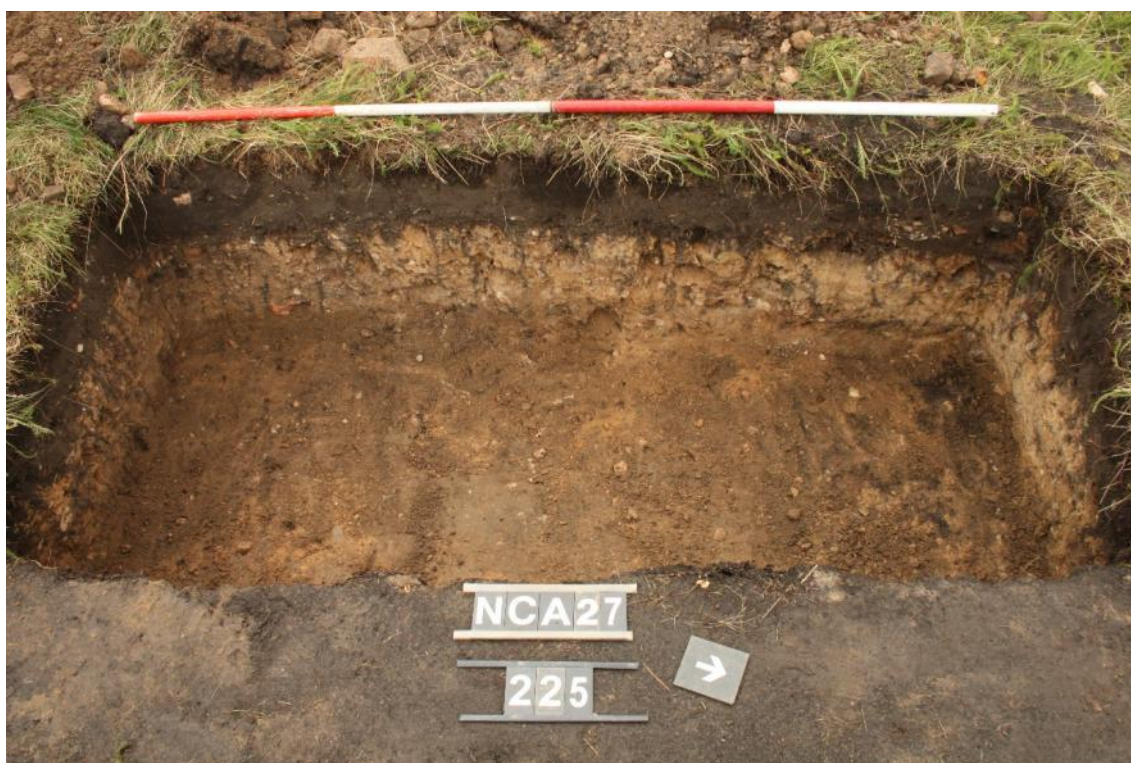
Plate 10: Foundation Trench 2.2.5. East facing Section. Scale 2m

8.11.1. Foundation 2.2.5 measured 2.04m x 0.84m x 0.68m and was located adjacent to the Afghan war memoria, which was unveiled in 1884, and south of the bothy in the Outer Bailey (Figure 02). Three landscaping layers of modern and late 19th century date were recorded during this monitored excavation. No finds were recovered.

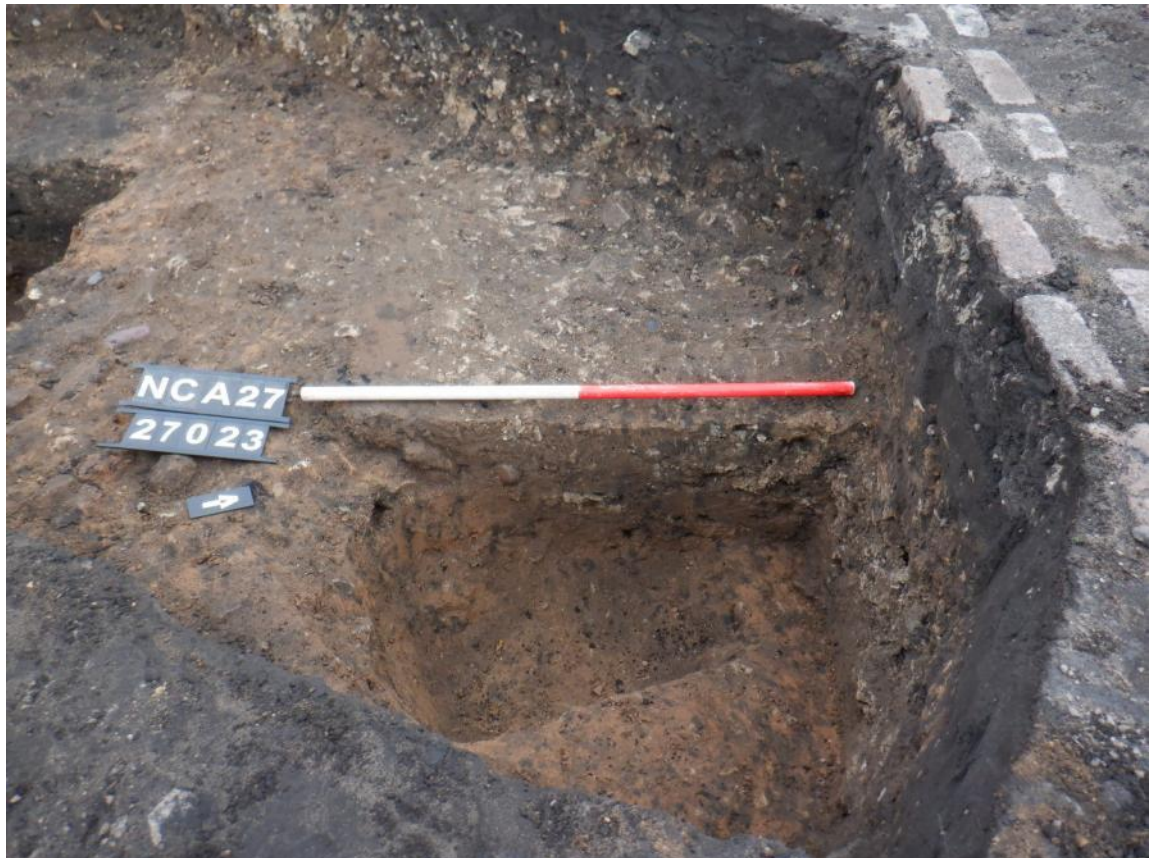
Plate 14: [27023] & [27025] mid-excavation southeast facing section. 2.1.8. Scale 1m

[27025]	Post-medieval – Cut of sub-squared pit possibly associated with post-medieval carriageway.	0.8x0.5x0.44m
(27026)	Post-medieval – Friable greyish brown silty backfill of [27025]	0.8x0.5x0.44m
[27076]	Modern – Cobblestone outline of Medieval castle wall	>0.92x0.16x0.08m
(27077)	Modern – Light grey concrete foundation of [27076]	>0.92x0.2x0.16m
(27078)	Modern – same as (27018)	>2.4x>1.5x0.32m
(27079)	Modern – Compact orange and brown mottled landscaping layer of very silty sand and CBM	>1.18x>1.5x0.26m
(27080)	Modern – same as (27019)	>2.2x>1.5x0.22m
(27081)	Post-medieval – same as (27024)	>1.72x>1.04x>0.4m
(27082)	Post-medieval – light orange compacted sandy silt fill of [27023]	>0.4x>1.5x>0.1m
(27083)	Modern – Lose dark grey brown silty sand layer	>0.84x>0.62x0.18m
(27084)	Same as (27020)	>2.2x>1.5x>0.44m
[27085]	Modern – same as [27021]	>1.7x0.45x0.78m
(27086)	Modern – same as (27022)	>1.7x0.45x0.78m

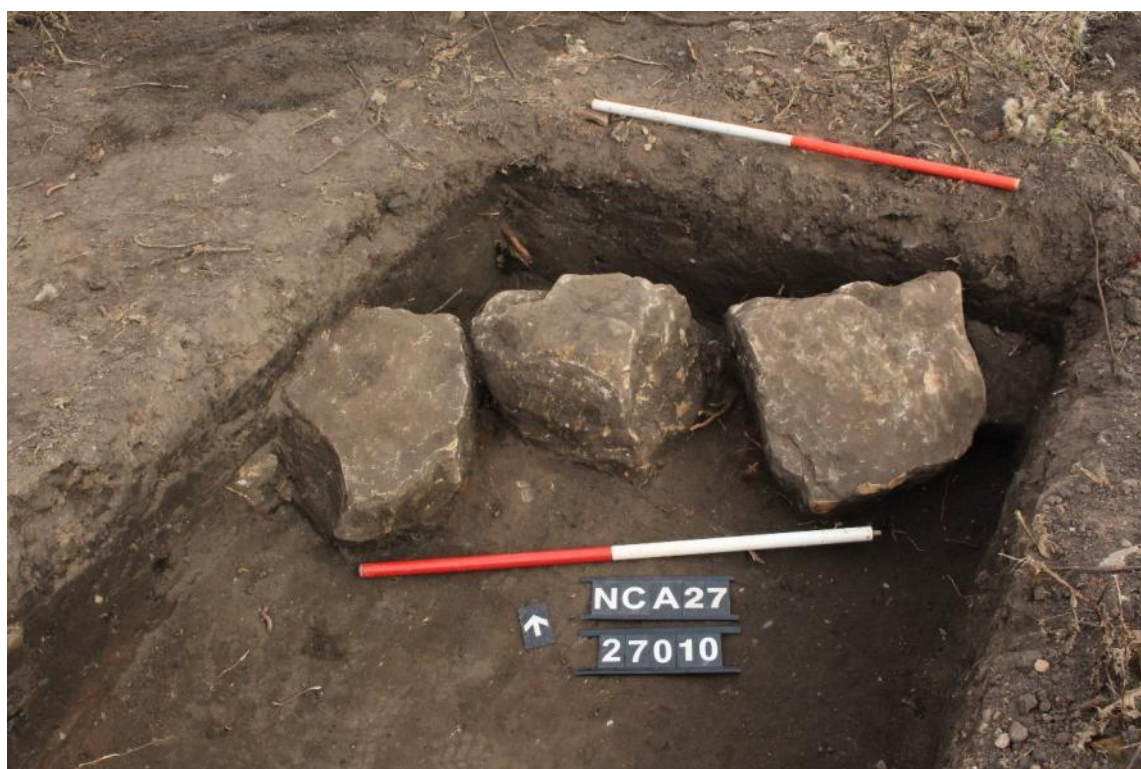
Plate 19: Modern Stone line [27010] in Foundation Trench 2.1.15. Scale 2x1m

Context	Description	Dimensions
(27009)	Modern – Dark Brown friable topsoil	>2.2x>1.5x0.5m
[27010]	Modern – Sandstone gardening rockery. East-west aligned	>1.5x0.5x0.26m
(27099)	Modern – Dark grey brown silty sand layer.	>2.2x>1.5x>0.1m

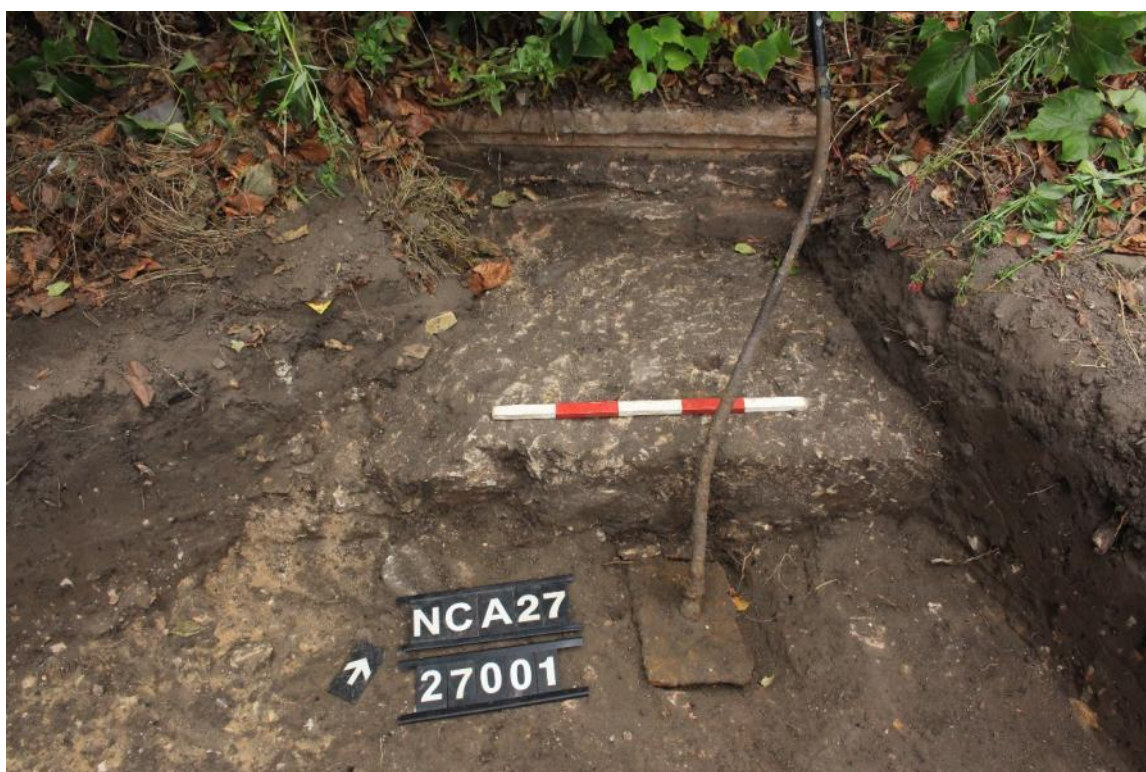
Plate 22: Middle Bailey Retaining Wall Mortar [27001], Foundation Trench 2.1.17, Looking North. Scale 0.5m

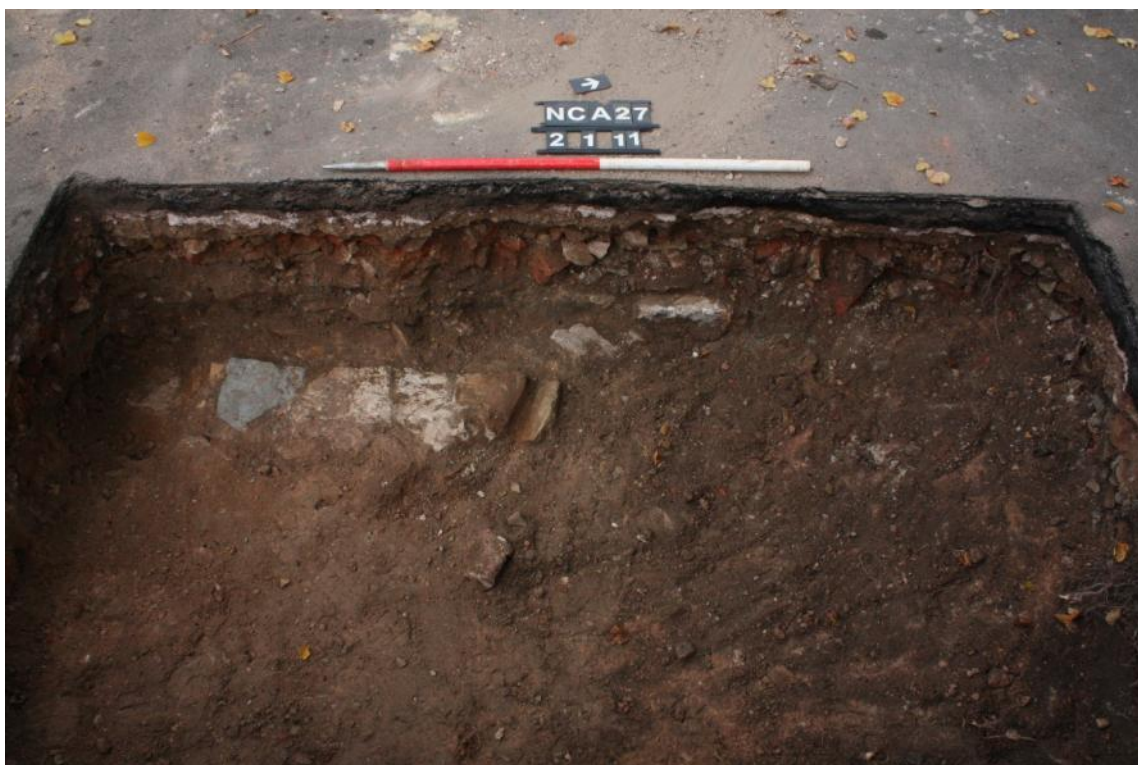
Plate 25: Foundation Trench 2.1.11. Southeast Facing Section with culvert walls [27115] & [27116].
Scale 1m

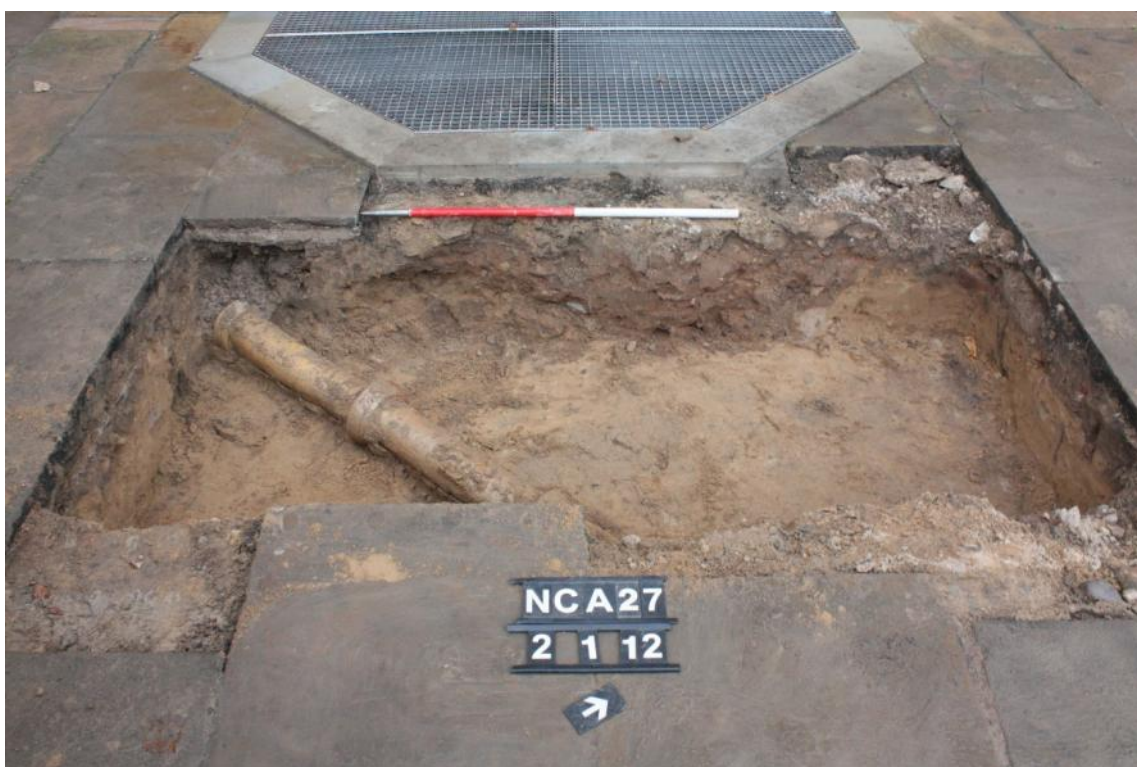
Plate 28: Foundation Trench 2.1.12 Southeast Facing Section with Repair Cut [27123] and Service cut [27120]. Scale 1m
