**AN HISTORIC BUILDING
PHOTOGRAPHIC SURVEY AT
HALL FARM, OFF CHURCH ROAD,
PECKLETON, LEICESTERSHIRE**

**A report for
Peckleton Homes Ltd**

OS Grid Ref. SK 4740 0071
TPA Project Code: HFP.1
March 2009

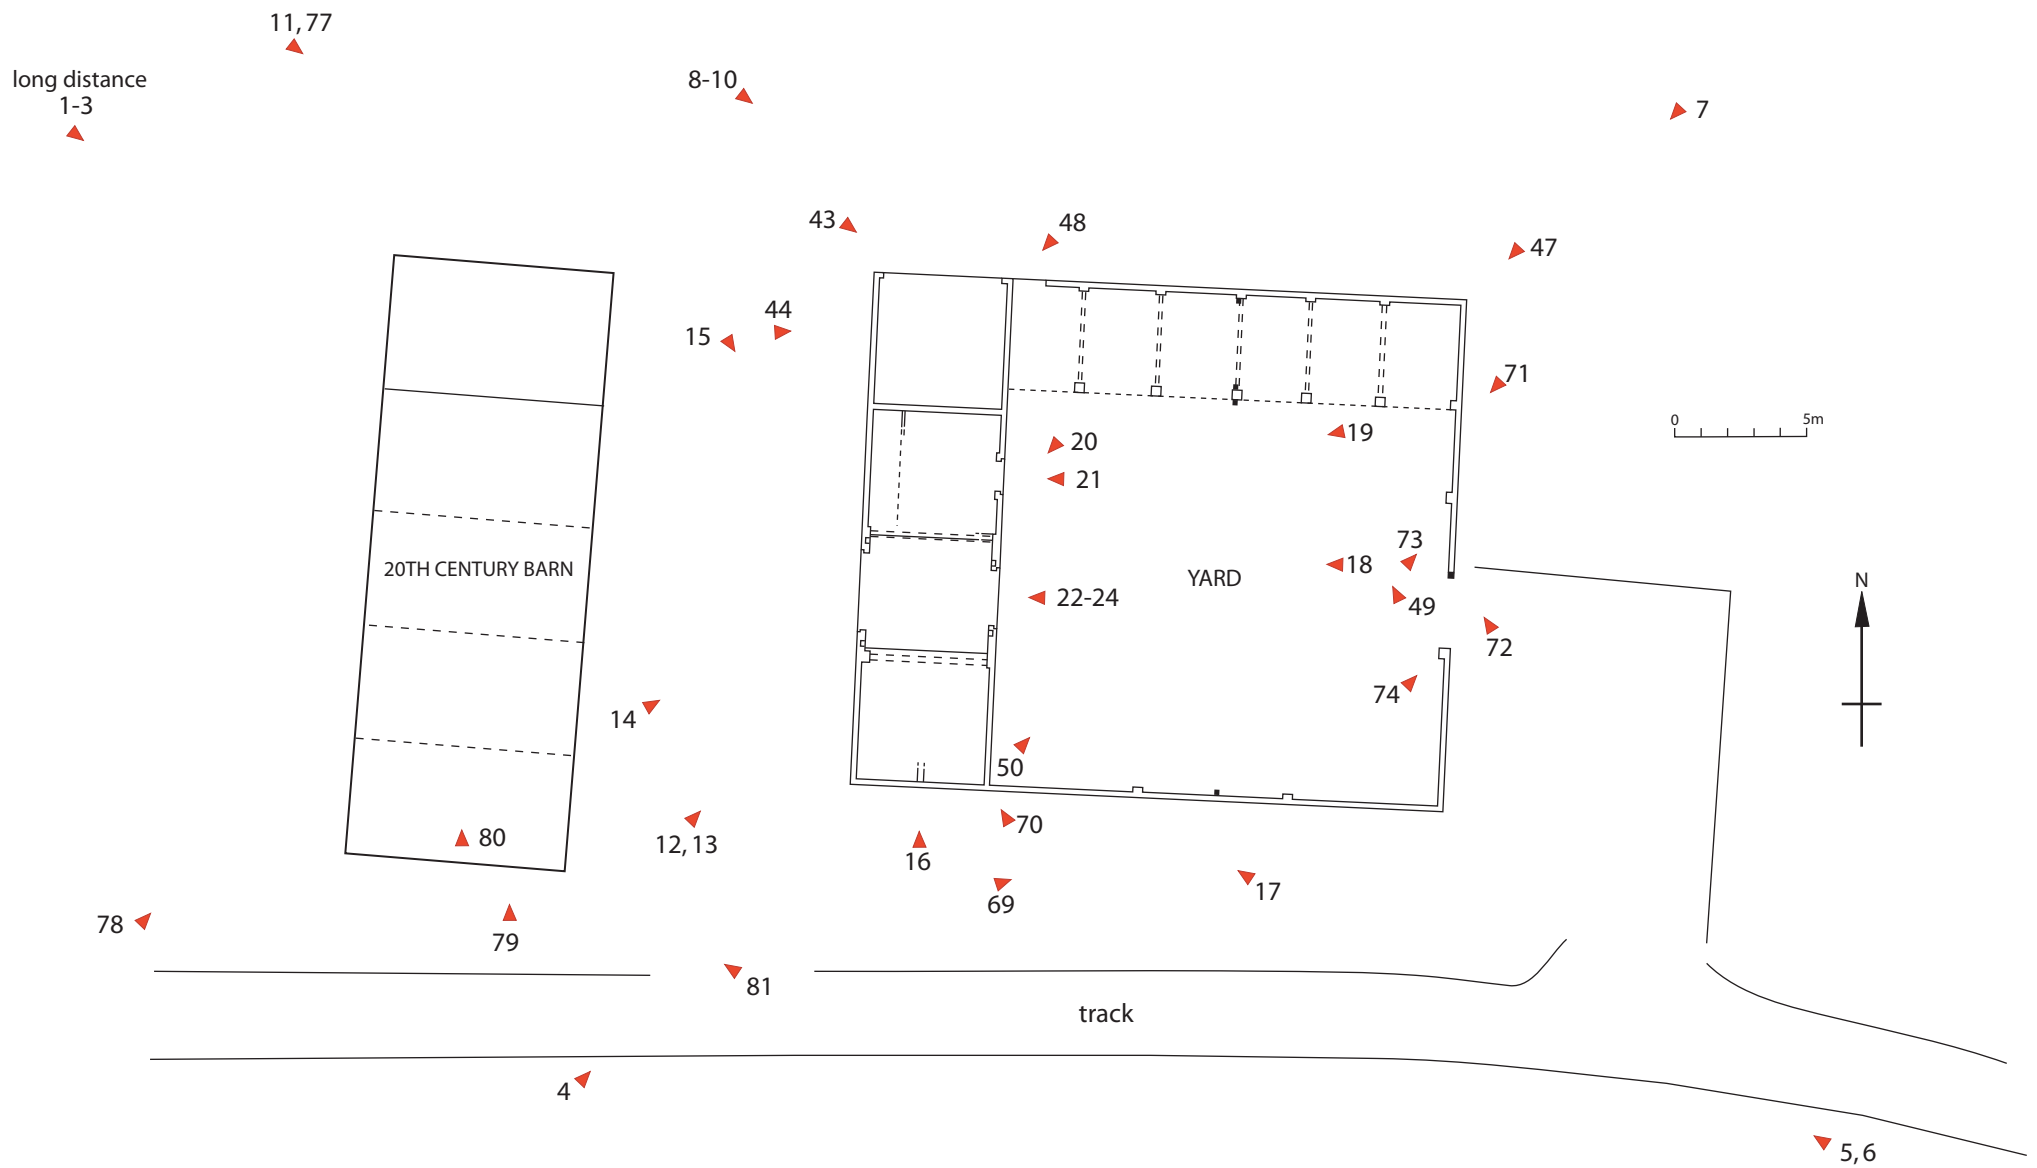
Fig. 3 Plan of the 19th century farm buildings (set around yard, to right) and a 20th century barn belonging to Hall Farm, situated east of Church Road, Peckleton, Leicestershire, and here showing viewpoints of external digital photographs taken February 2009. Not to definite scale.

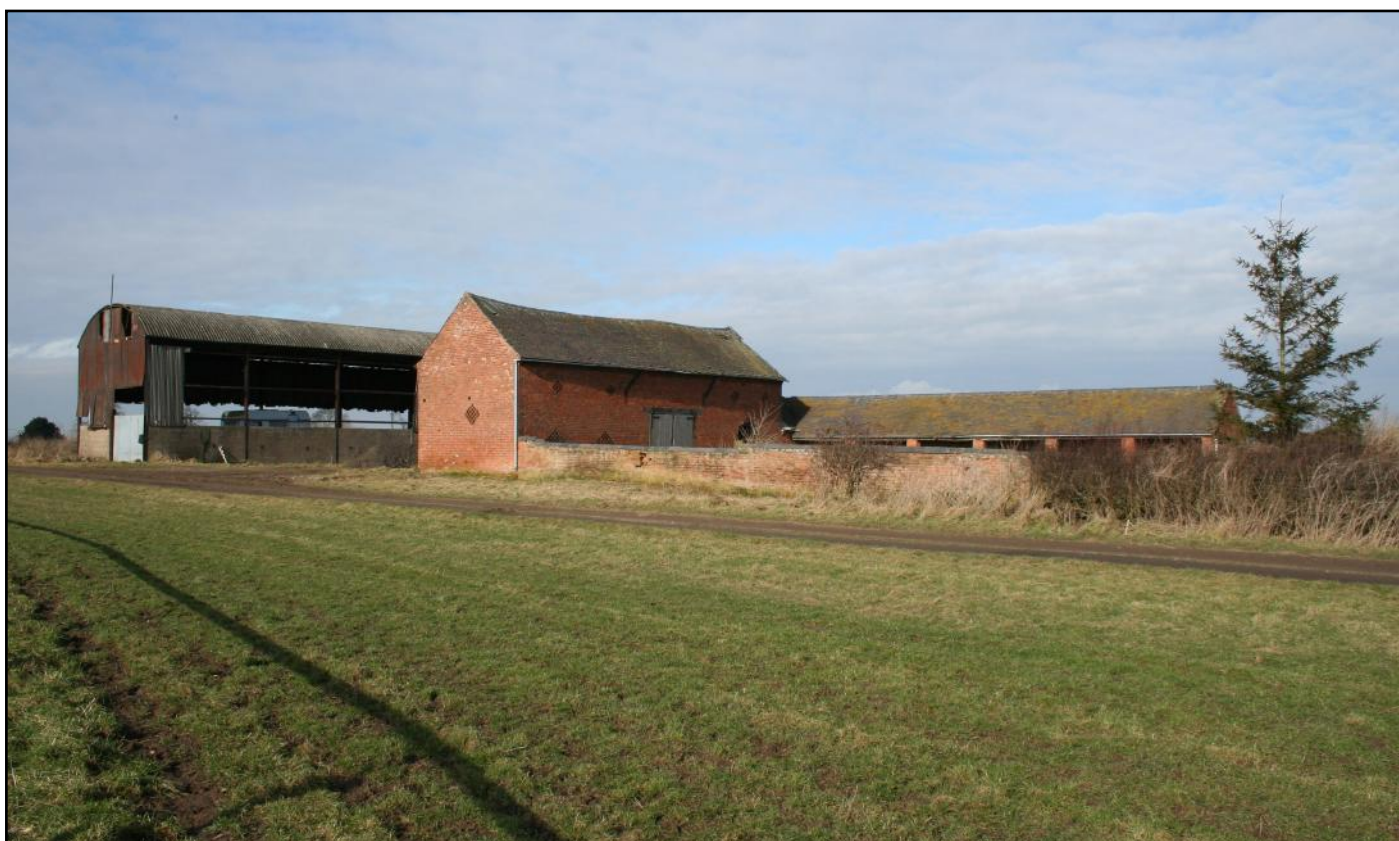
Plates 1, 2 of isolated farm building of Hall Farm, Peckleton, Leicestershire. **1:** distant view showing surrounding landscape, taken from west; **2:** general view from south-east showing track in foreground.

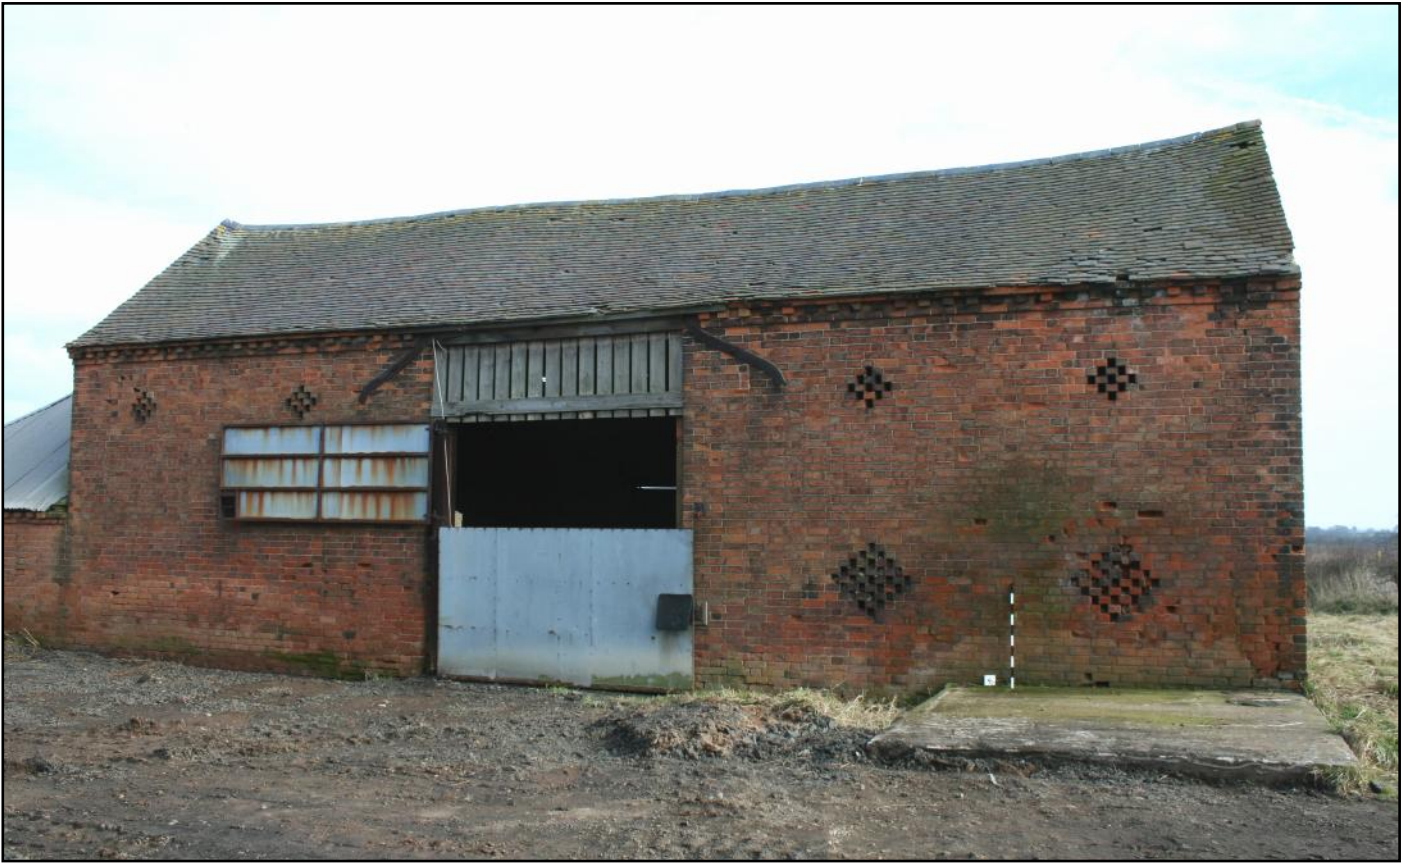
3

Plates 3, 4 of isolated farm building of Hall Farm, Peckleton, Leicestershire. **3:** west side of brick barn showing large central doorway; **4:** east side showing smaller central door and side door.

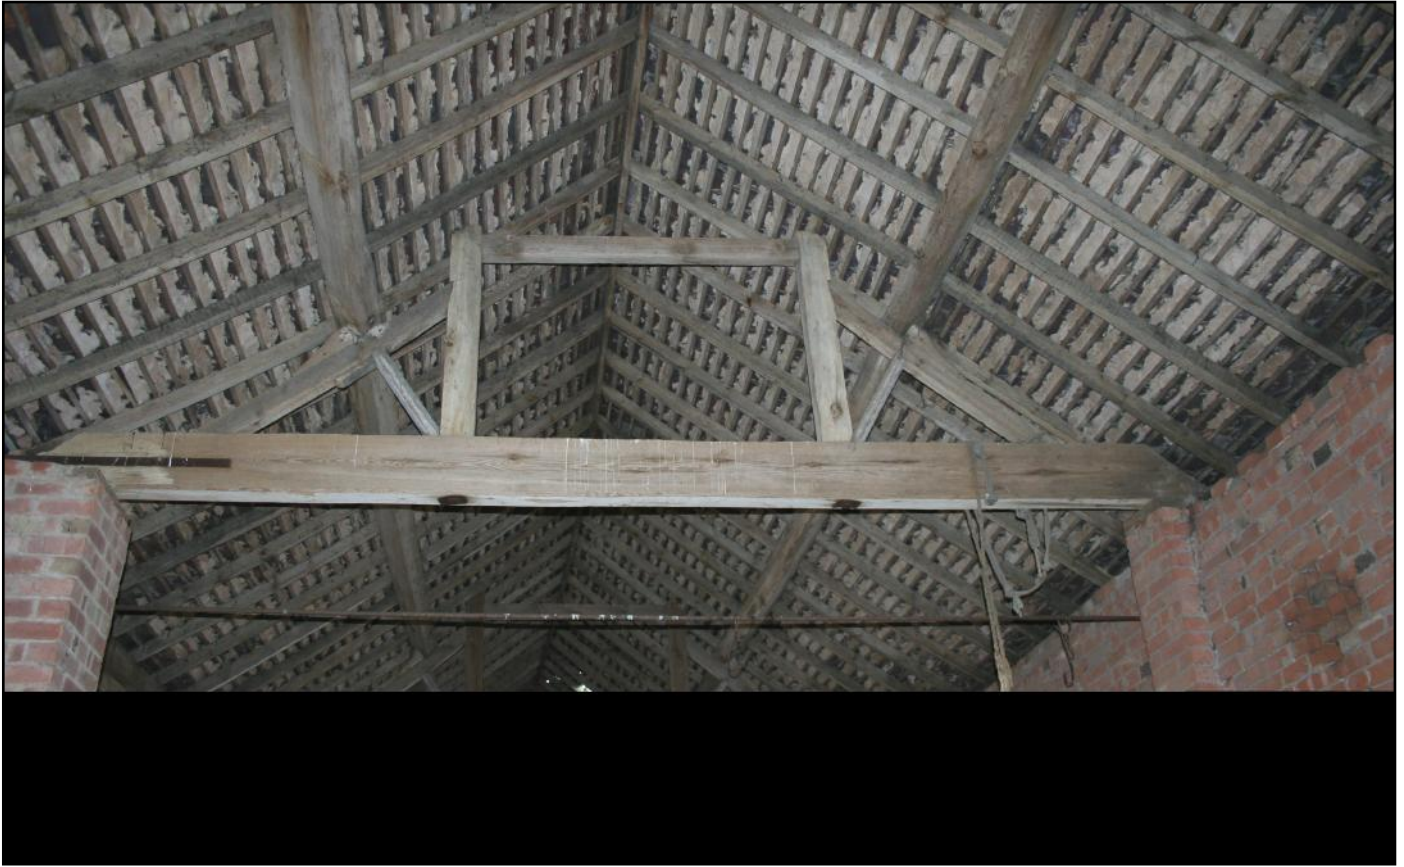
5

Plates 5, 6 of isolated farm building of Hall Farm, Peckleton, Leicestershire. **5:** view of the brick barn's roof structure, looking north; **6:** floor, lower side walling and openings of the brick barn, looking north.

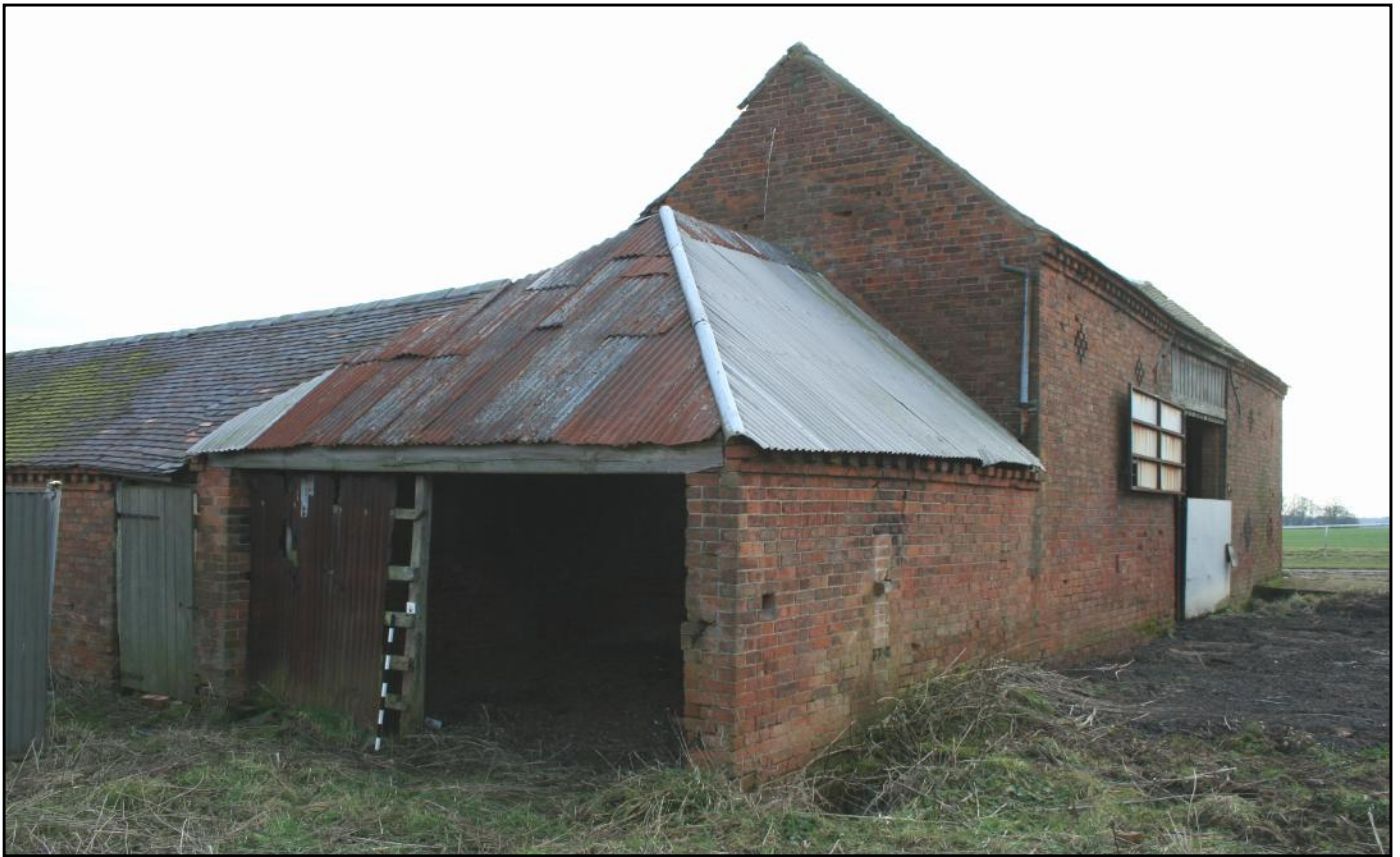
7

Plates 7, 8 of isolated farm building of Hall Farm, Peckleton, Leicestershire. **7:** view of the cart-shed situated in the north-west corner of the 19th century rectilinear farm complex; **8:** internal view of its roof structure.

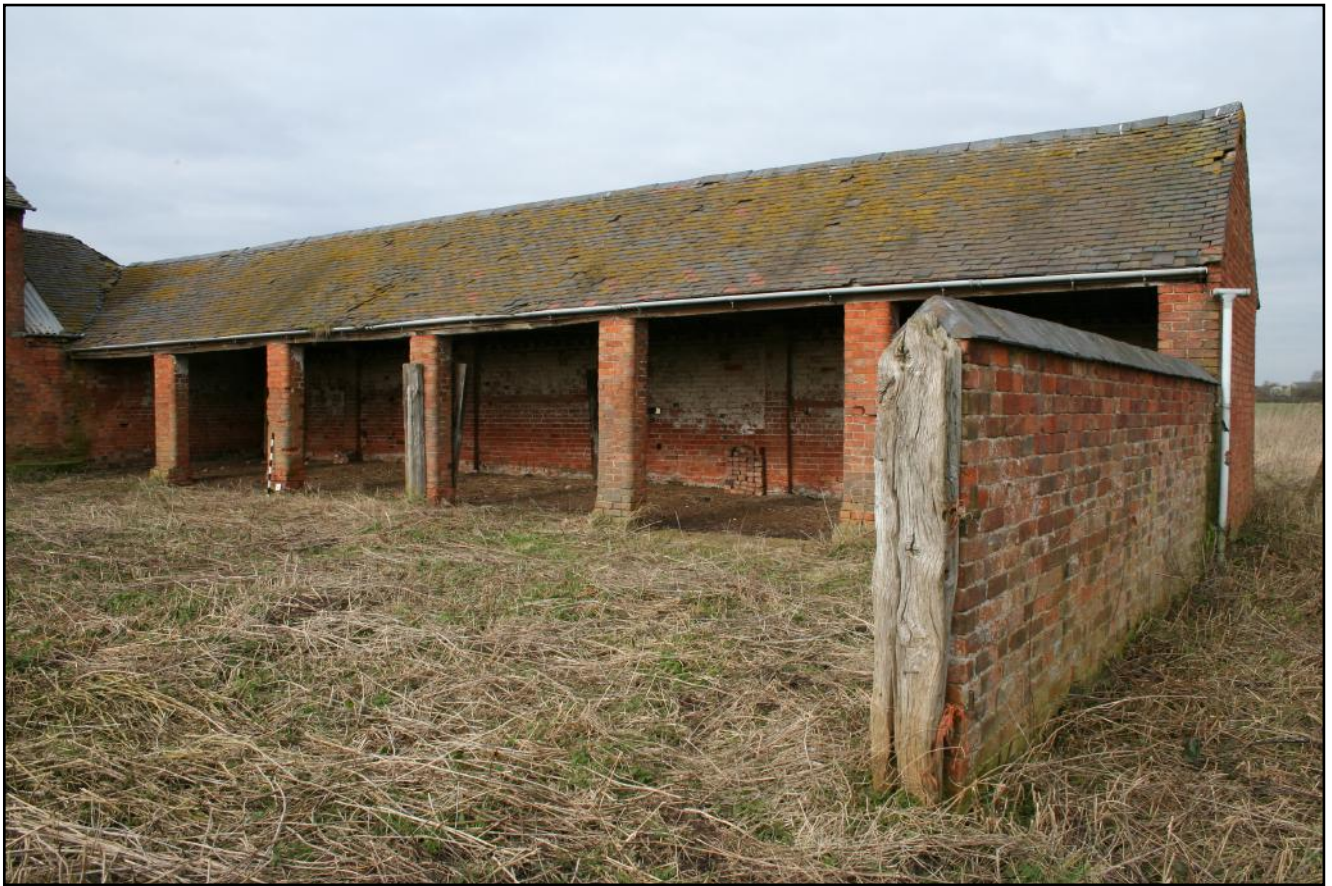
9

Plates 9, 10 of isolated farm building of Hall Farm, Peckleton, Leicestershire. **9:** view of the six-bay open-fronted shed on north side of enclosure; **10:** view of interior looking west.
