**AN ARCHAEOLOGICAL BUILDING  
ASSESSMENT OF A PROPOSED  
DEVELOPMENT AT SMITH'S FARM,  
DONINGTON LE HEATH,  
LEICESTERSHIRE, 2007**

A report for  
Mr P. Elliott

*by  
Richard Sheppard*

OS Grid Ref. SK 418 125 (centred)  
TPA Project Code: SFD.1  
October 2007

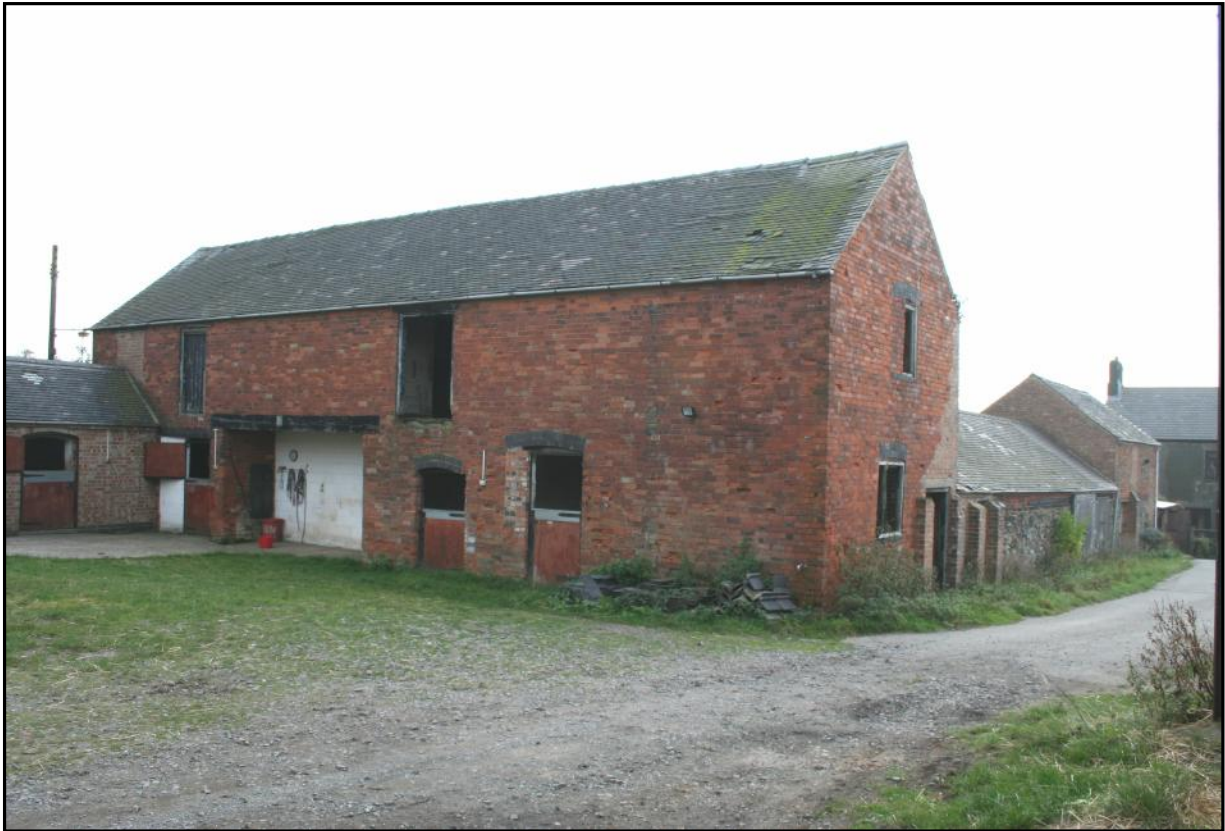
**PLATE 1 (DA 2)**

**Plates 1, 2 of Smith's Farm, Donington le Heath, Leicestershire. 1:** view looking south, with farmhouse bottom right; **2:** view looking north into south courtyard.  
*DA:* Digital archive number.

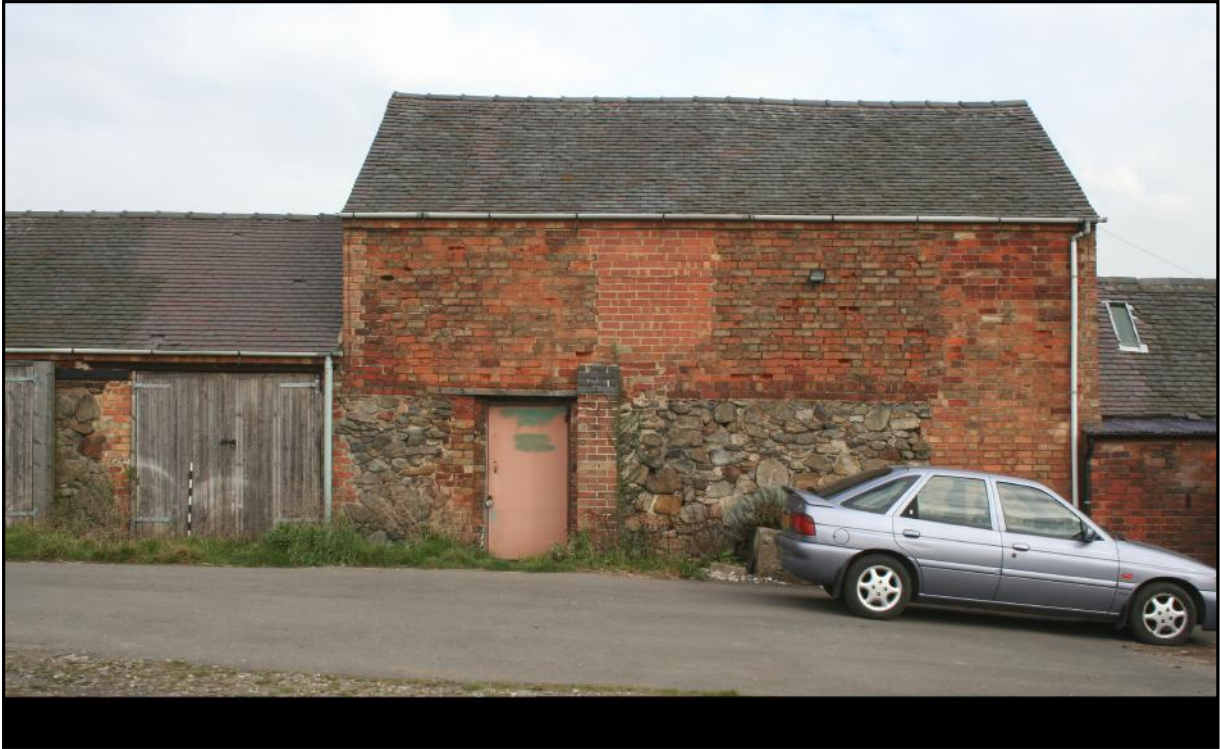
**PLATE 3**  
**DA 40**

**Plates 3, 4 of Smith's Farm, Donington le Heath, Leicestershire. 3:** one of the buildings (6) on the west side of the courtyard with stonework in the external wall; **4:** stone plinth showing on east gable end of Building 8. *DA:* Digital archive number.

The north bay now has a raised concrete floor, whilst the south bay has a brick floor. A wooden stair gives access to an upper floor but the planking here suggests it was not designed to take much weight. The upper level was lit by a window in the south gable end and one on the west side, now blocked off. The west side reveals the evidence of a series of interventions - see Plate 3. What the building was used for is unclear.

The occurrence of stone is also significant as it probably indicates the existence of two yet earlier buildings on the site, one of which was replaced by Building 8. Here, low stonework might point to a low building or a timber-framed structure. The stonework on the west side suggests an earlier range at least 20m long and 5.5m wide. It appears to have an associated brick dividing wall in Building 6, which may date to the early 18<sup>th</sup> century. At the north end (Area B) there is a still largely intact stone wall with an angled top which probably reflects the associated low roofline.

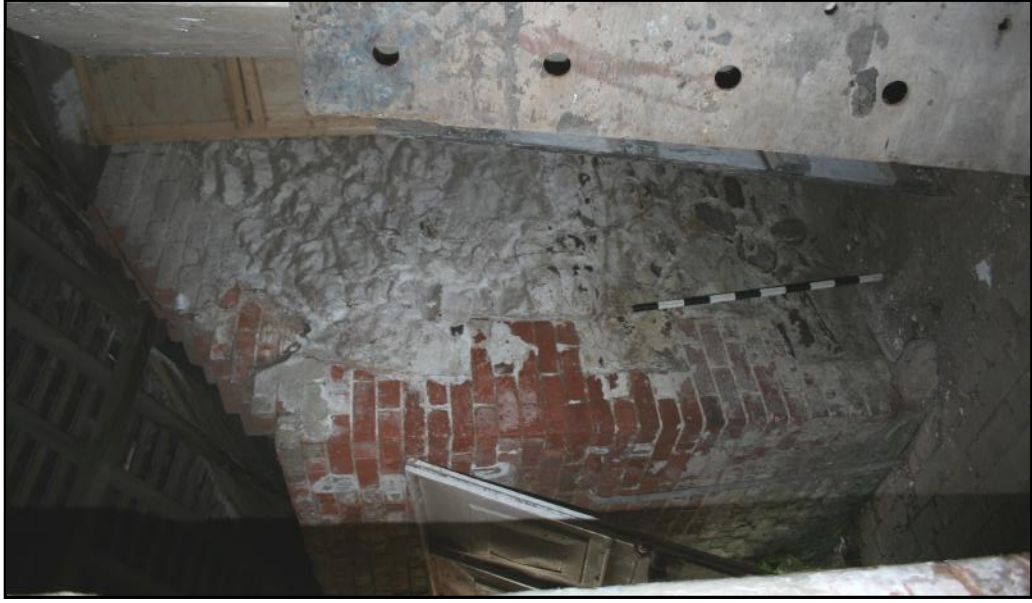
**PLATE 5 (DA 67)**

Plates 5-7 of Smith's Farm, Donington le Heath, Leicestershire. Plate 5: internal stone wall in Building 5, angled at the top  
Plate 6: plank door with pegged and chamfered frame, set in wall between Buildings 5 and 6; Plate 7: upper level and roof structure of Building 8, with timber displaying 'MADE P.O.W.' (arrowed). DA: Digital archive number.

**BUILDING 5:** a 5-bay long single-storey low structure consisting of stone and brick, with a tiled roof. The east brickwork is mainly c.2¾ inch (70mm) thick and about 9 inches long. The west side is principally of stone. A probable combined cart-shed and equipment store, with openings to west and east. Largely open inside but with a modern partition for a separate car standing, and a stone wall separates bays 1 and 2 at the north end (Plate 5). This bay is further divided by an additional brick wall with an angled corner that continues the back passage in Building 4 through to Building 8. The internal stone wall is high and is angled at the top, perhaps reflecting the original roof-line of the earlier building it was evidently part of.
