**AN ARCHAEOLOGICAL  
WATCHING BRIEF AT  
THE OLD RECTORY, HATHERN,  
LEICESTERSHIRE, 2009**

**A report for Mr Martin Collins**

*by  
Richard Sheppard*

OS Grid Ref. SK 5020 2236 (centred)  
TPA Project Code: ORH.1  
March 2010

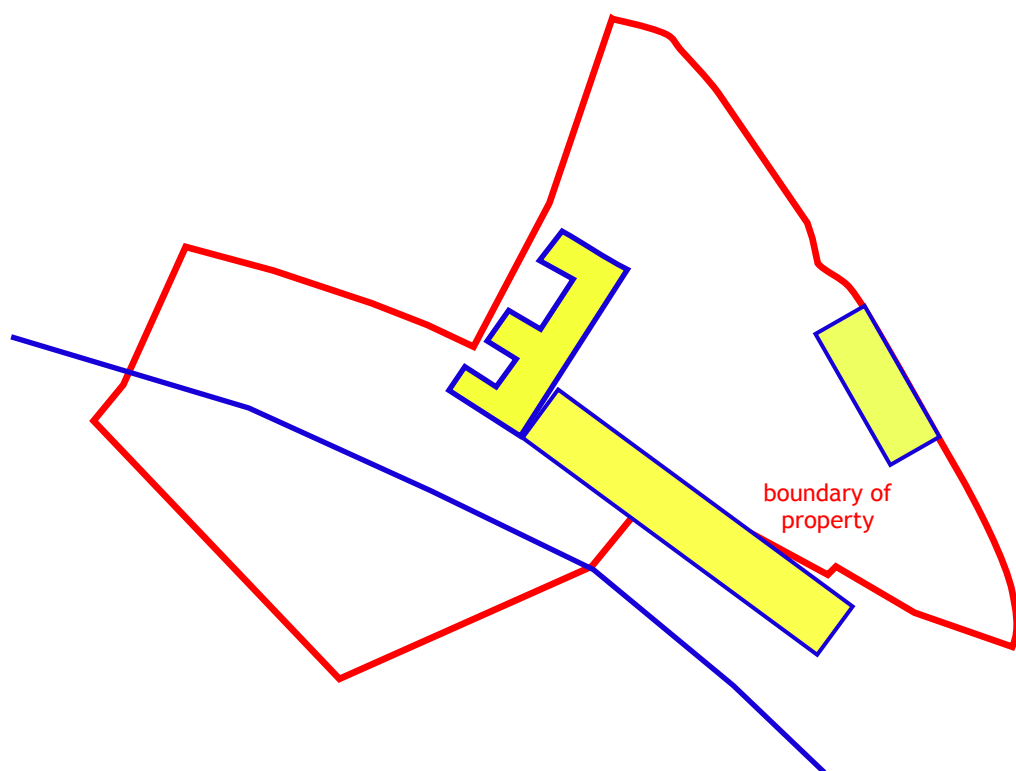
**Figure 6:** Modern plan of the Old Rectory site at Hathern, Leicestershire, overlain with approximate positions and shapes of buildings and a boundary shown within the site on the enclosure map of 1778 (in blue and yellow). Scale here 1:1,000.

Despite a rebuild in c.1700, James Bickham, Archdeacon of Leicester, apparently permitted the rector of Hathern to reconstruct the greater part of his house in the 1770s (Pemberton 1984, 63). The rector at this time was probably William Middleton. Whether works were actually carried out is unclear. An indenture dated 12<sup>th</sup> April 1819 allowed the 'patron of the living at Hathern' (then Edward T. M. Phillips) to borrow money from an ecclesiastical fund (ROLLR ref. DE782). A not inconsiderable sum of £920 was 'to be paid out and expended in repairing and enlarging the Parsonage House and rebuilding the out offices upon the Glebe.' Brickwork on the main, slightly projecting, central part of south-east frontage (Plate 9) and along most of the back wall is 2<sup>5</sup>/<sub>8</sub>-2<sup>3</sup>/<sub>4</sub> inches (67-70mm) thick, 8<sup>3</sup>/<sub>4</sub>-9<sup>1</sup>/<sub>4</sub> (222-235mm) long and laid in Flemish bond. This is consistent with a date between 1810-1825.

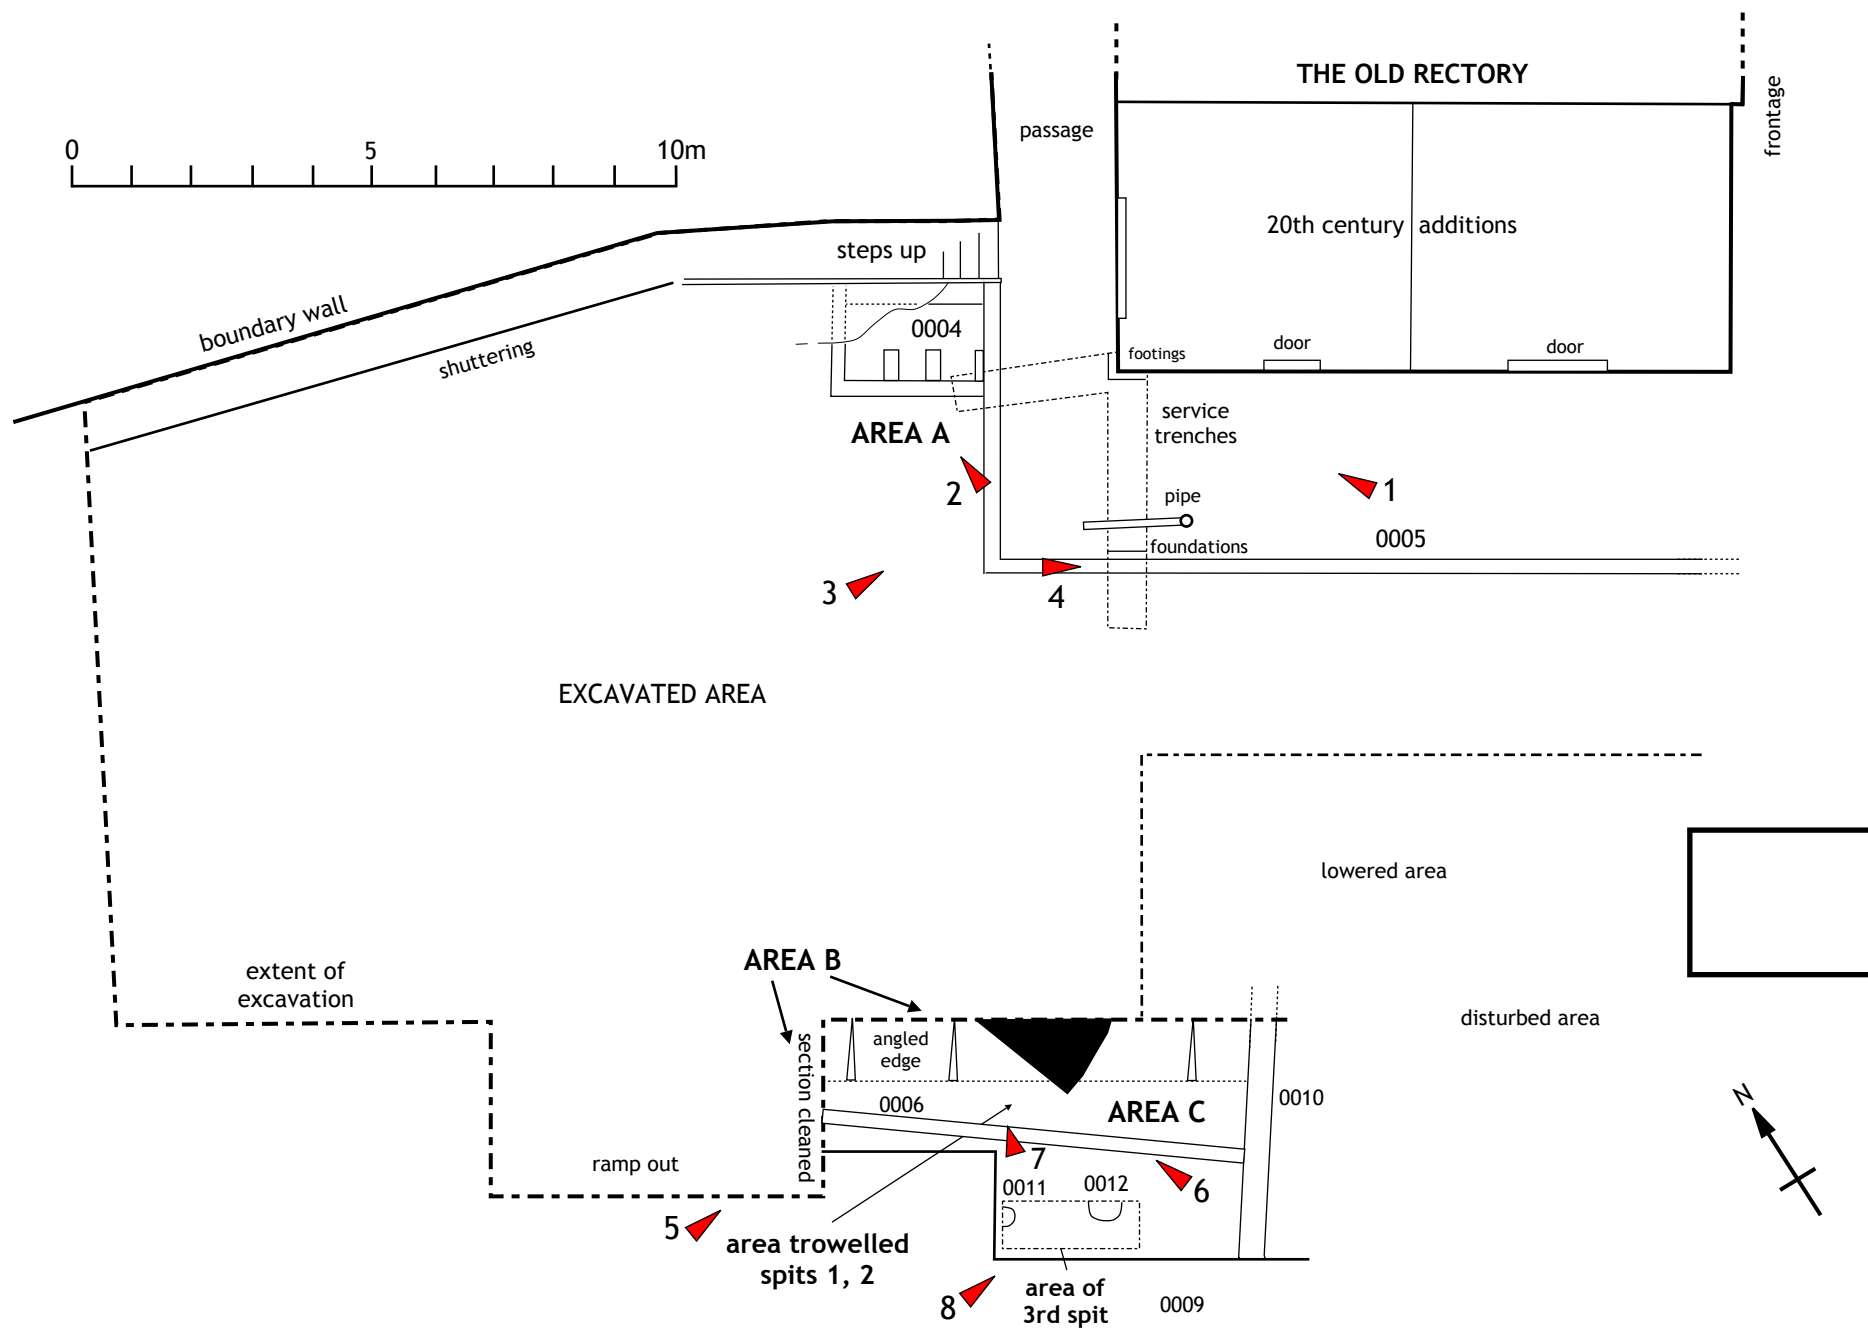
**Figure 7:** Plan showing area excavated to the rear of the Old Rectory, Hathern in 2009 for a new extension, and features recorded and the area trowelled where pottery was recovered. Scale 1:125.

was removed from the main area and steel shuttering installed to help support an adjoining boundary wall. Unfortunately, the speed of the operation was miscalculated so that by the time of the second site visit (14/05/09) the main area had already been speedily excavated out without a record being made. An examination was then made of a brick structure uncovered close to the south-west corner of the building and what appeared to be the base of a brick boundary wall. Sections at the west and south sides of the excavated area were also cleaned by hand for evidence of features cutting through the exposed soils and for finds showing through. Three areas examined in detail are distinguished as A, B and C in Figure 7.

Area C was a level area of about 12m<sup>2</sup>, set back from the section and the north sloping edge, and this was trowel-cleaned in two spits, with a smaller area taken down in a third spit to the base of the subsoil. The area was crossed by two drains (0006, 0010), and cut by a modern pit (0008; Plate 6). A number of late post Medieval pottery sherds and occasional pieces of building debris were found during the trowelling. Although the reason for this was unclear in the first two spits, in the third spit two small features were shown to have penetrated through to the lower level, without having been clear at a higher level (Plate 8). These were post-holes / small pits of late post-medieval date, and probable garden features.

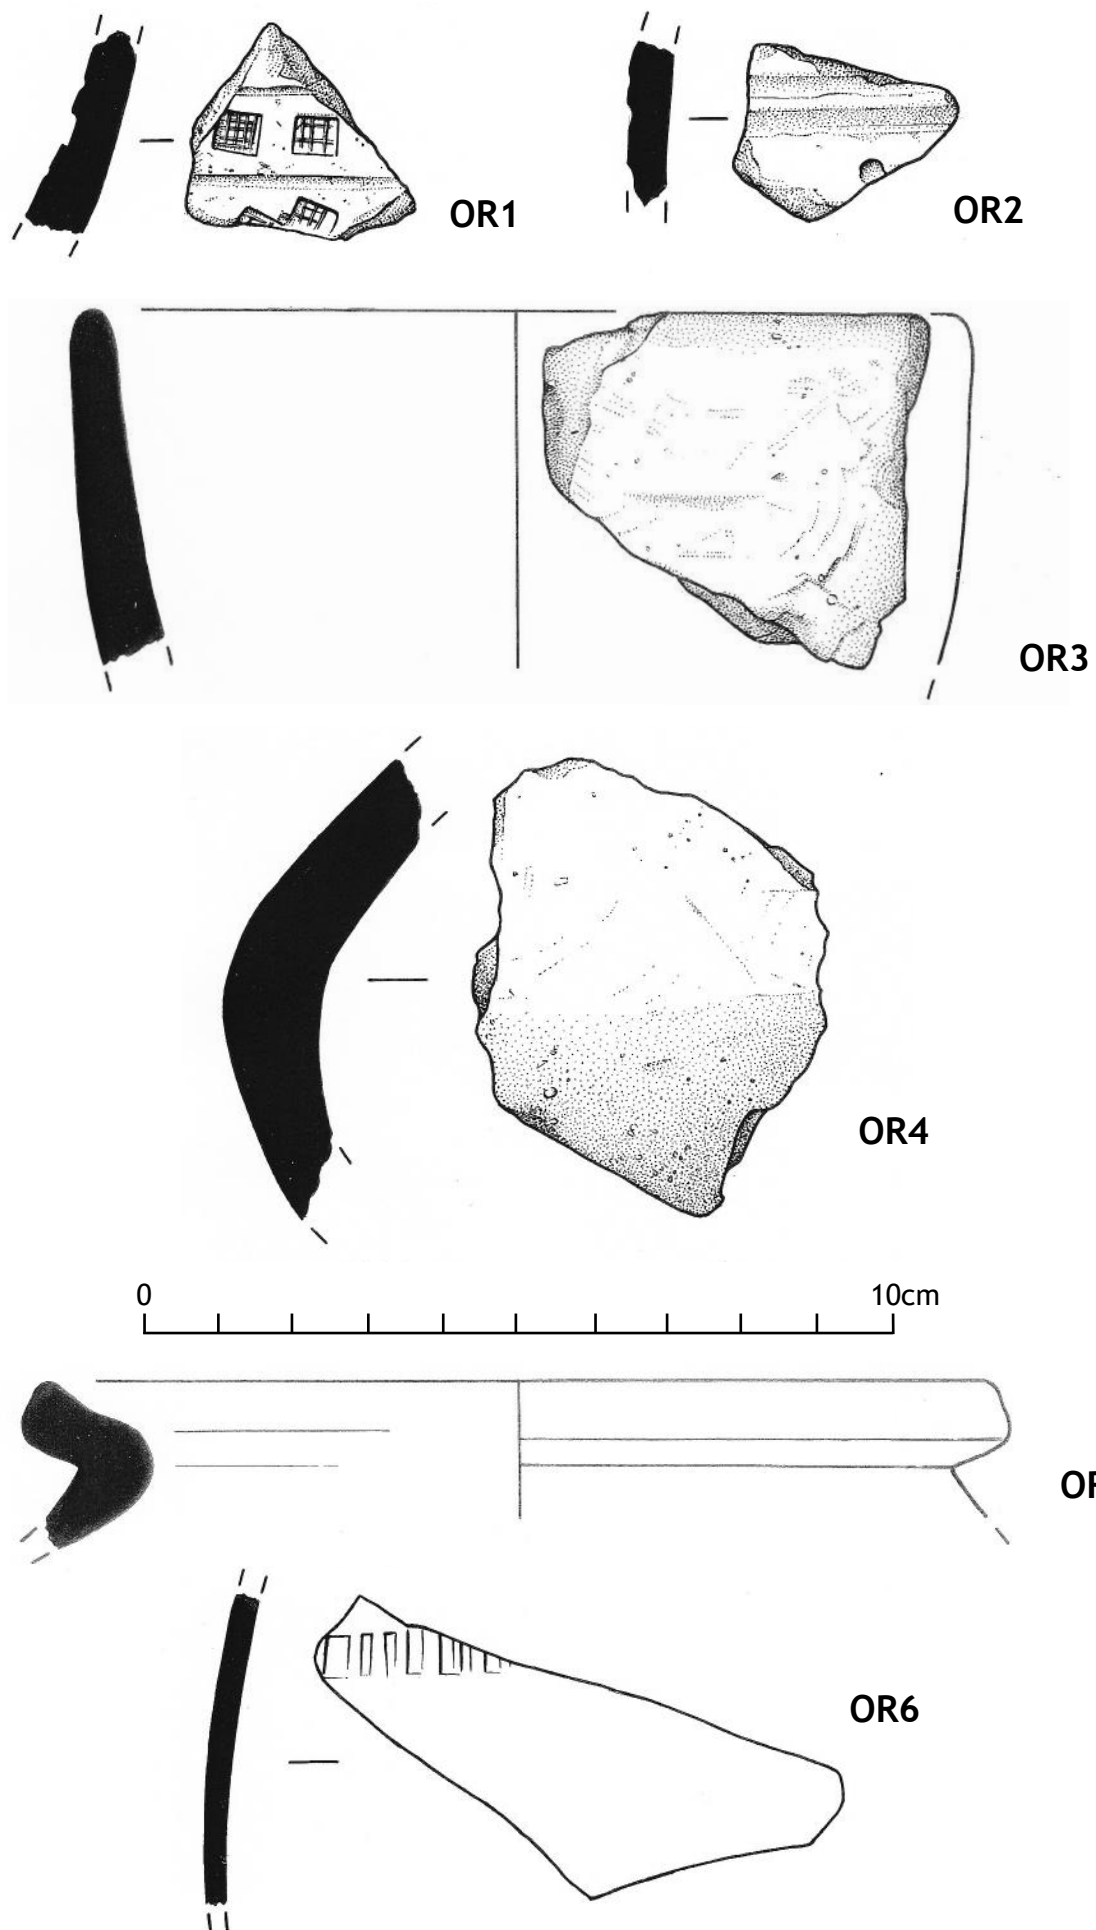
**Figure 8:** Some Saxon and medieval pottery recovered from the Old Rectory site, Hathern. Scale 1:1.

Fig. OR1: Area C, Spit 2. Stamped sherd. Uniform black fabric.

Fig. OR2: Area B. Incised sherd. Uniform black fabric.

Fig. OR3: Area C, Spit 1. Rimsherd from small bowl. Black fabric with brown surfaces. Thick sooting on the inner surface.

Fig. OR4: Area C, Spit 1. Base sherd, possibly from the same vessel as OR3. Black fabric with brownish surfaces, some sooting on both surfaces.

Fig. OR5: Area C, Spit 1. Stamford Ware. White fabric with grey and black patches on the rim and body.

Fig. OR6: Area B. Stamford Ware. Pale grey fabric with dark grey, sooted outer surface, fragment of a rouletted band.

The assemblage from this site appears fairly typical of sites of the period in the region. All the sherds are granite-tempered, almost certainly with Charnwood Forest Granodiorite, a type which has a wide distribution throughout the midlands and beyond. The few feature sherds are from simple vessel forms, with the only rim from a small bowl (Fig. OR3). The decorated sherds, with incised lines (Fig. OR2) and, in one case, stamp impressions (Fig. OR1), are entirely typical, with the latter suggesting a 6<sup>th</sup> century date. Illustrations (Figure 8)

The small assemblage of Stamford ware comprises entirely unglazed small jars (eg. Fig. OR5), with simple, lid-seated rim profiles, some with simple square-notched rouletting. This is entirely typical of the products of the period in the 10<sup>th</sup> century, and perhaps even the late 9<sup>th</sup>. A number of assemblages from Stamford and elsewhere have these characteristics (Kilmurry 1980, 94-100). The small amounts of St. Neots ware could easily be of the same date. The complete lack of dateable 11<sup>th</sup> century pottery suggests that the site was abandoned at that time.

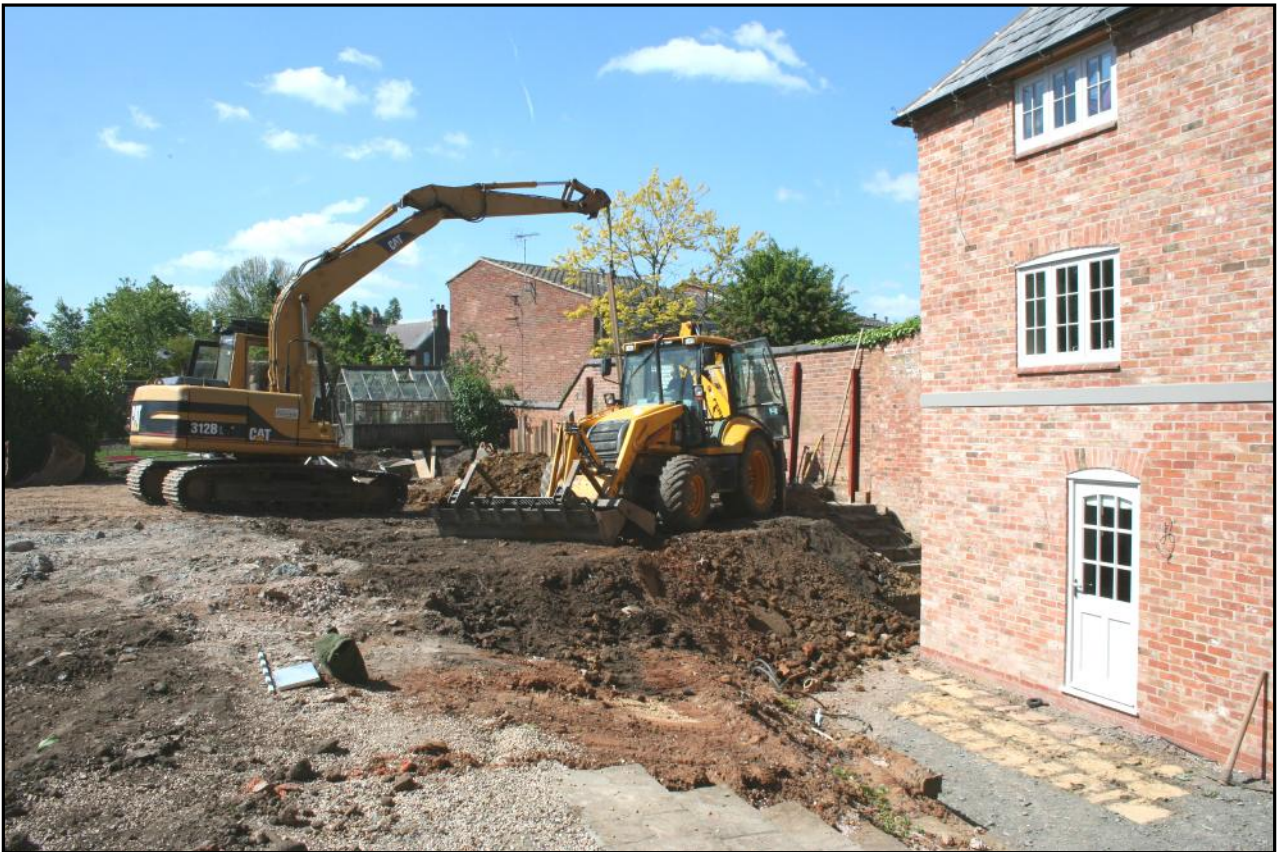
Examination of this area on the first day showed that from a flagged surround to the south end of the rectory building the ground rose c.1.35 – 1.5m to the garden beyond (Plate 1). A series of steps against a boundary wall and another immediately opposite the south end of the building gave access to this higher level garden. A section left against the first steps and west of a brick-built structure showed a soil profile composed of fine dark topsoil (0001), a pebble layer (0002) and subsoil (0003), in total only 0.6m thick, overlying natural clay. At the far west end of the site the build-up was closer to 0.75m above the natural. From this it was concluded that the south part of the rectory had probably been terraced into naturally rising ground.

**Plate 1:** Machine excavations on the first day of the watching brief at the Old Rectory, Hathern. To right is the south-west corner of the house, with steps showing to rear.

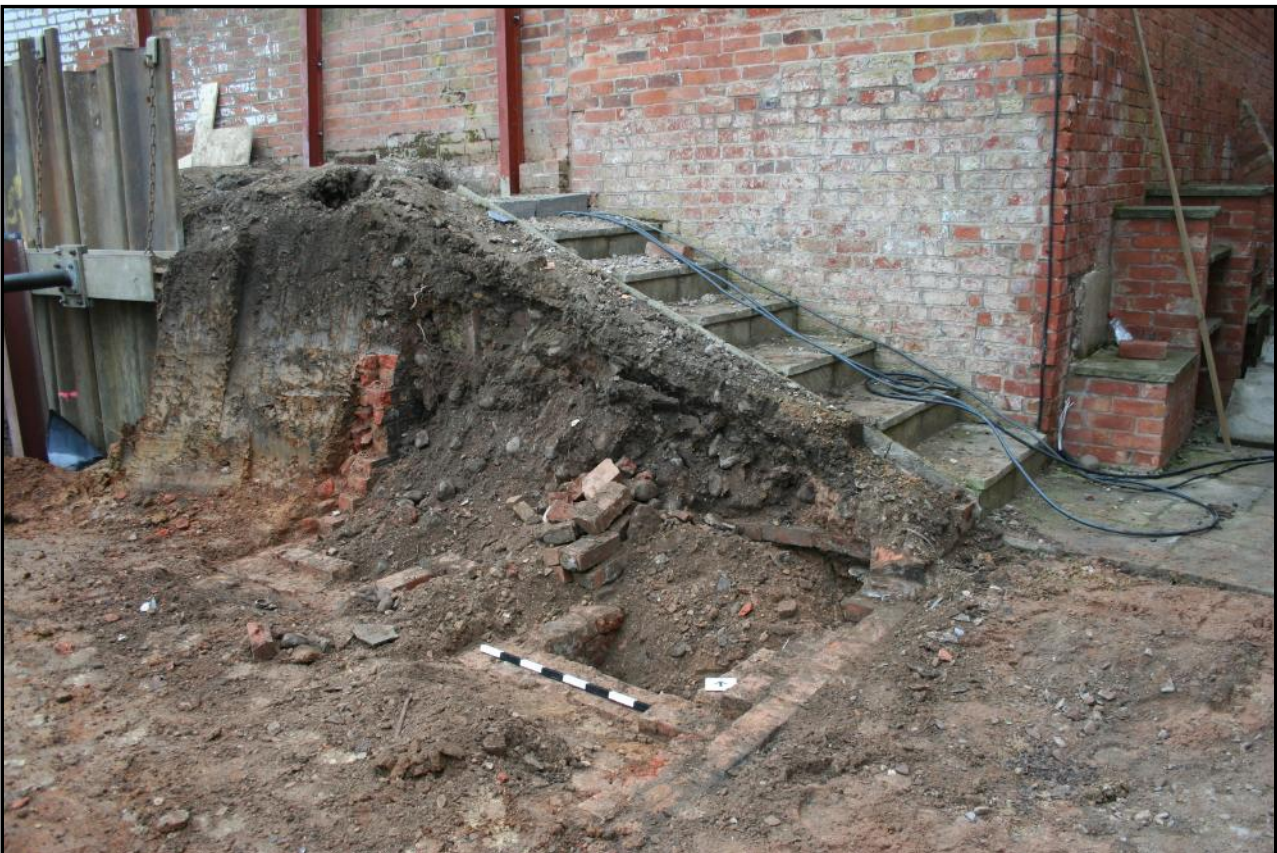
The remains of a small brick structure (0004) at least 1.5m high was found close to the building (Plate 2). It was divided into three small compartments, had a brick floor and had a low rear top where it continued under the steps. If continuing on to the rear boundary wall its estimated overall size would have been c.2.8m square. Its brickwork suggested a mid-19<sup>th</sup> century date and it can be seen on maps from 1884 onwards. It was probably used for storage of coal or something similar.

**Plate 2:** Brick structure 0004 uncovered in front of steps that previously gave access up to the former garden level. To left of this is a section showing the dark topsoil, lighter subsoil and yellow clay natural.

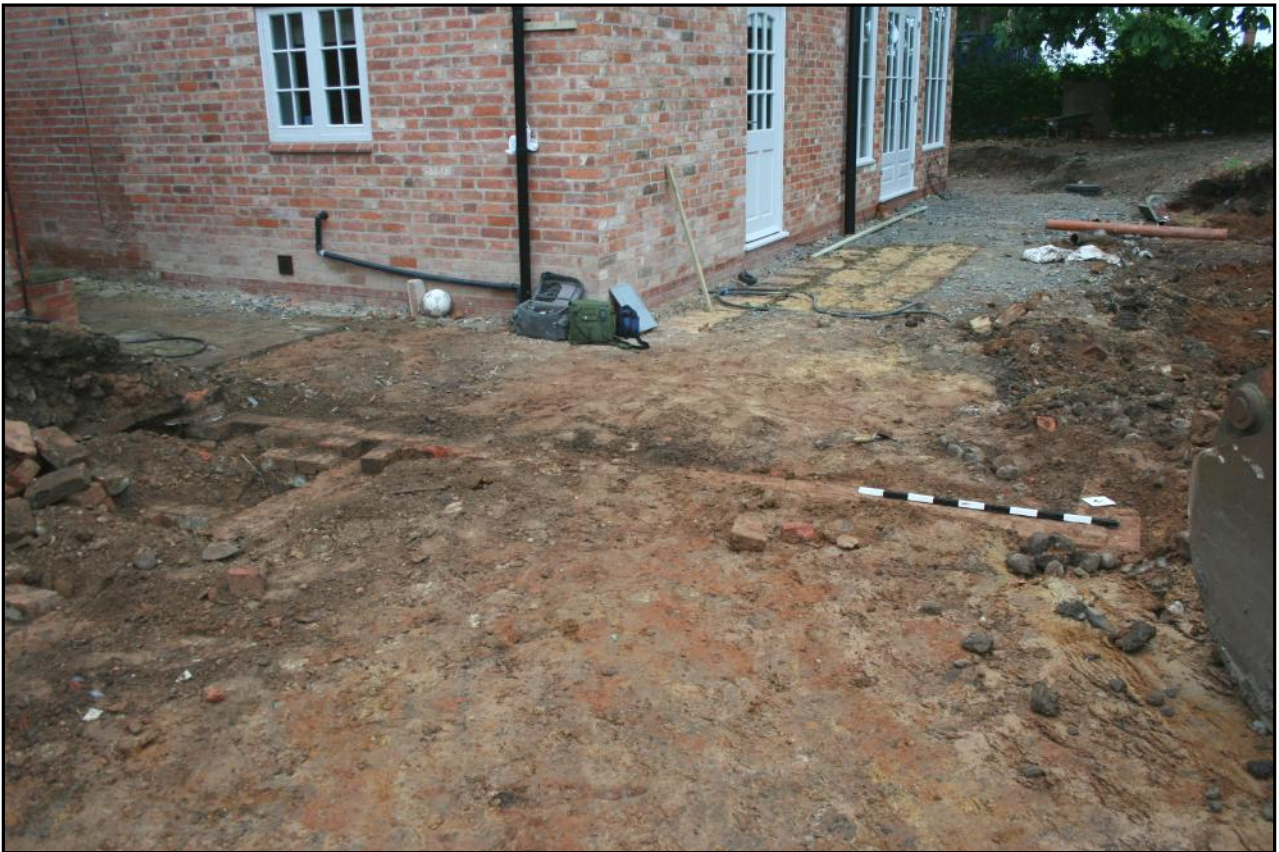
The east wall of the structure continued to the south and turned a right-angle, 3m from the building, and then ran for a minimum length of 8m (Plate 3). This wall (0005) was found to be built of slightly thinner bricks, and with a stepped foundation where revealed in a later trench (Plate 4). The brickwork suggested an early 19<sup>th</sup> century date and that it was not part of the former adjoining south range shown on the enclosure map, despite being in a similar position. Any earlier structure may have been built at a higher level and thus lost when terracing occurred

**Plate 3:** Brick wall 0005 extending across from 0004 and, at the far right, turning to run parallel to the south end of the Old Rectory, Hathern.

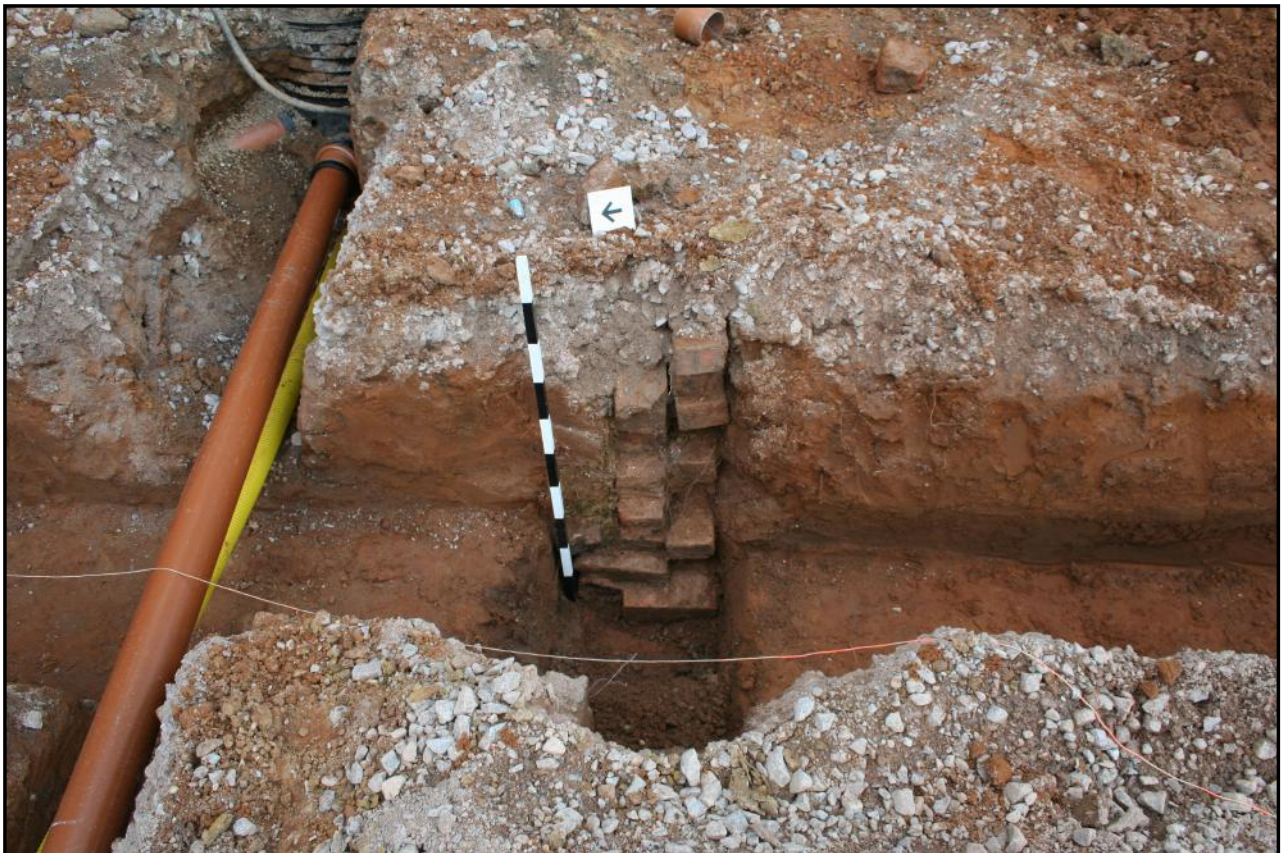
**Plate 4:** Section of wall 0005 showing in a service trench.

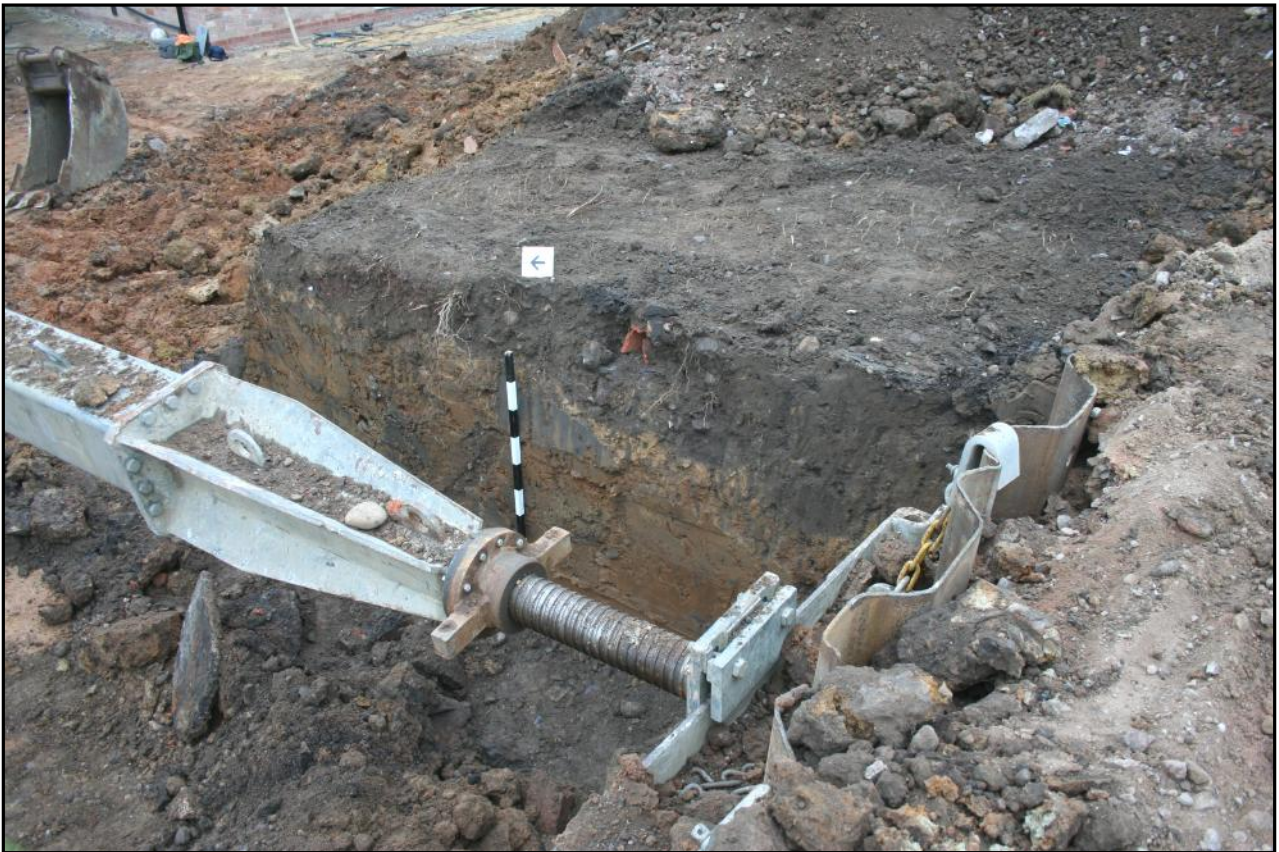
**Plate 5:** A cleaned section south of the fully excavated area for the south-west extension to the Old Rectory, Hathern, showing a ceramic drain 0006 cut through the subsoil.

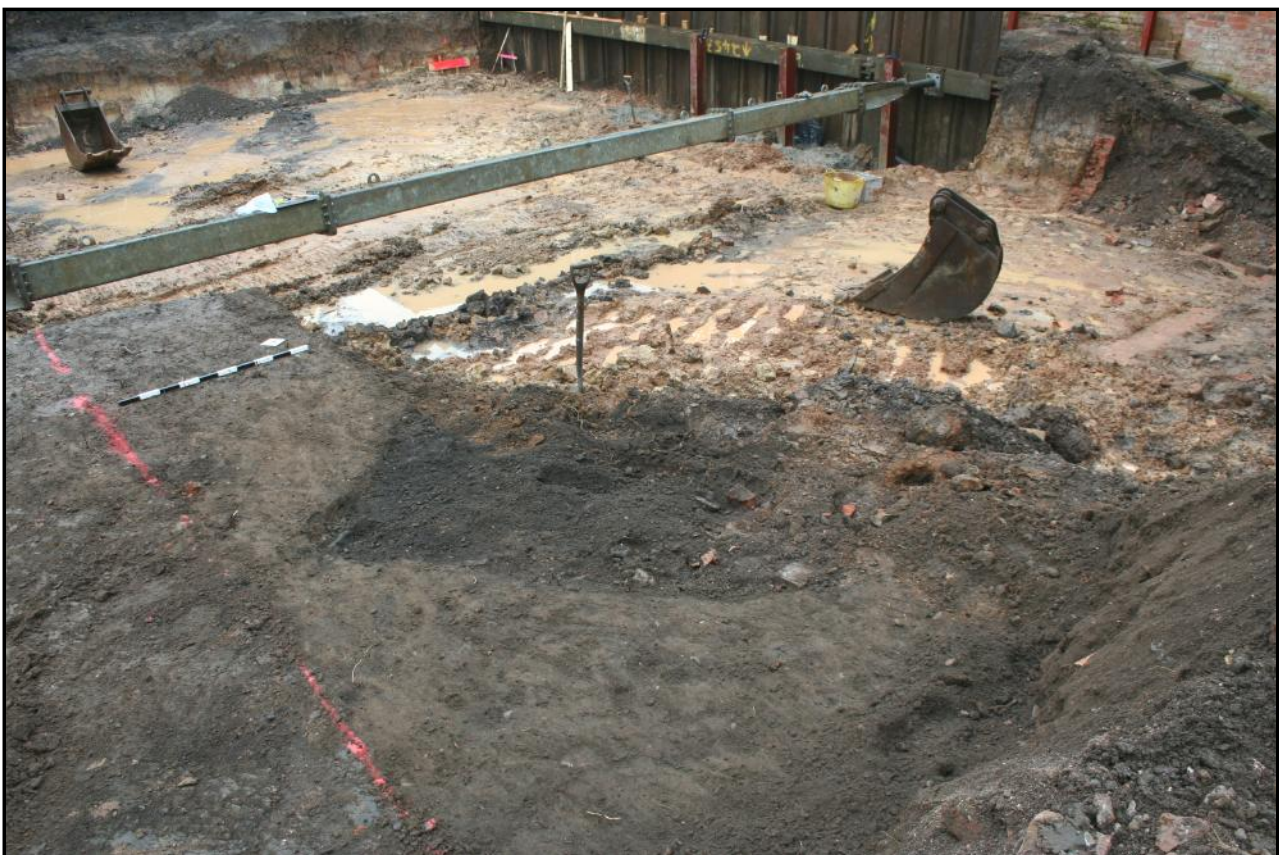
**Plate 6:** Area behind the cleaned section after trowelling of the first spit, showing the line of drain 0006 (pink line) and dark modern feature 0008 (centre). The extent of the cleared area shows in the background.

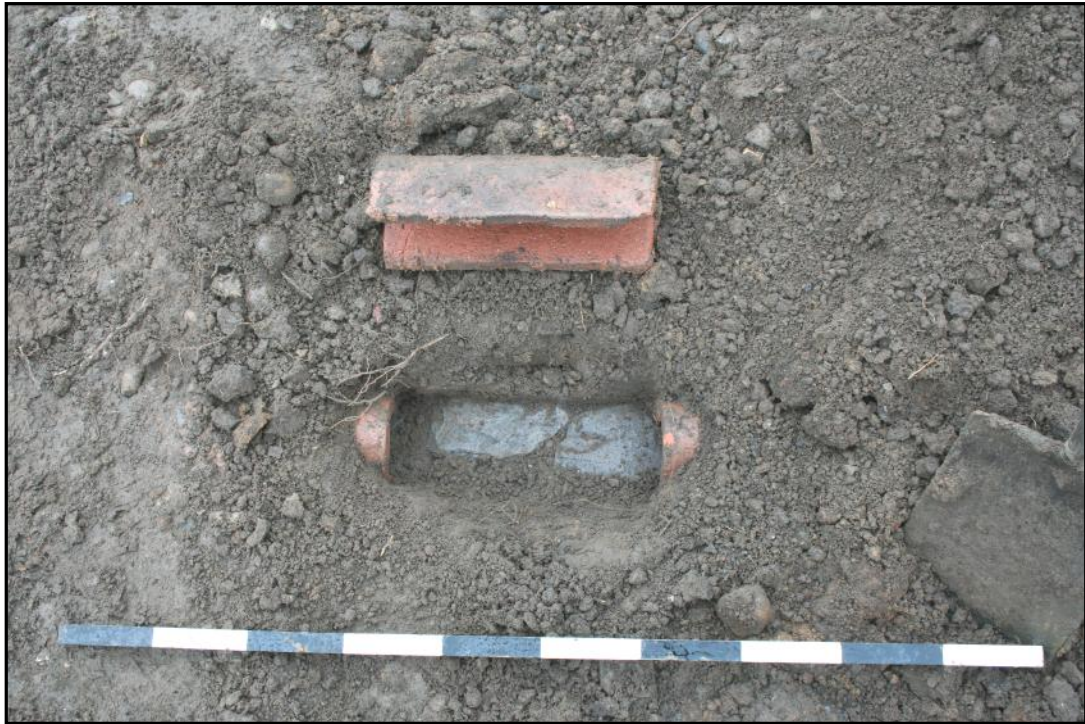
**Plate 7:** Removed section of horse-shoe shaped ceramic drain 0006 from the back garden of the Old Rectory, Hathern.

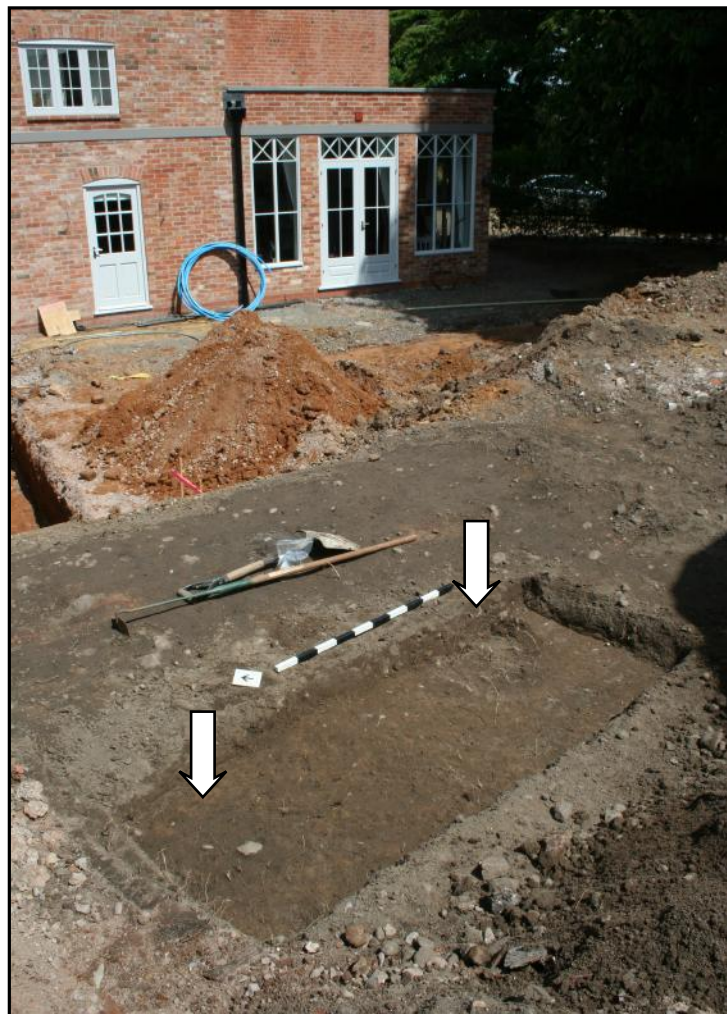
**Plate 8:** Area of spit 3 with slightly darker modern features 0011 and 0012 highlighted.

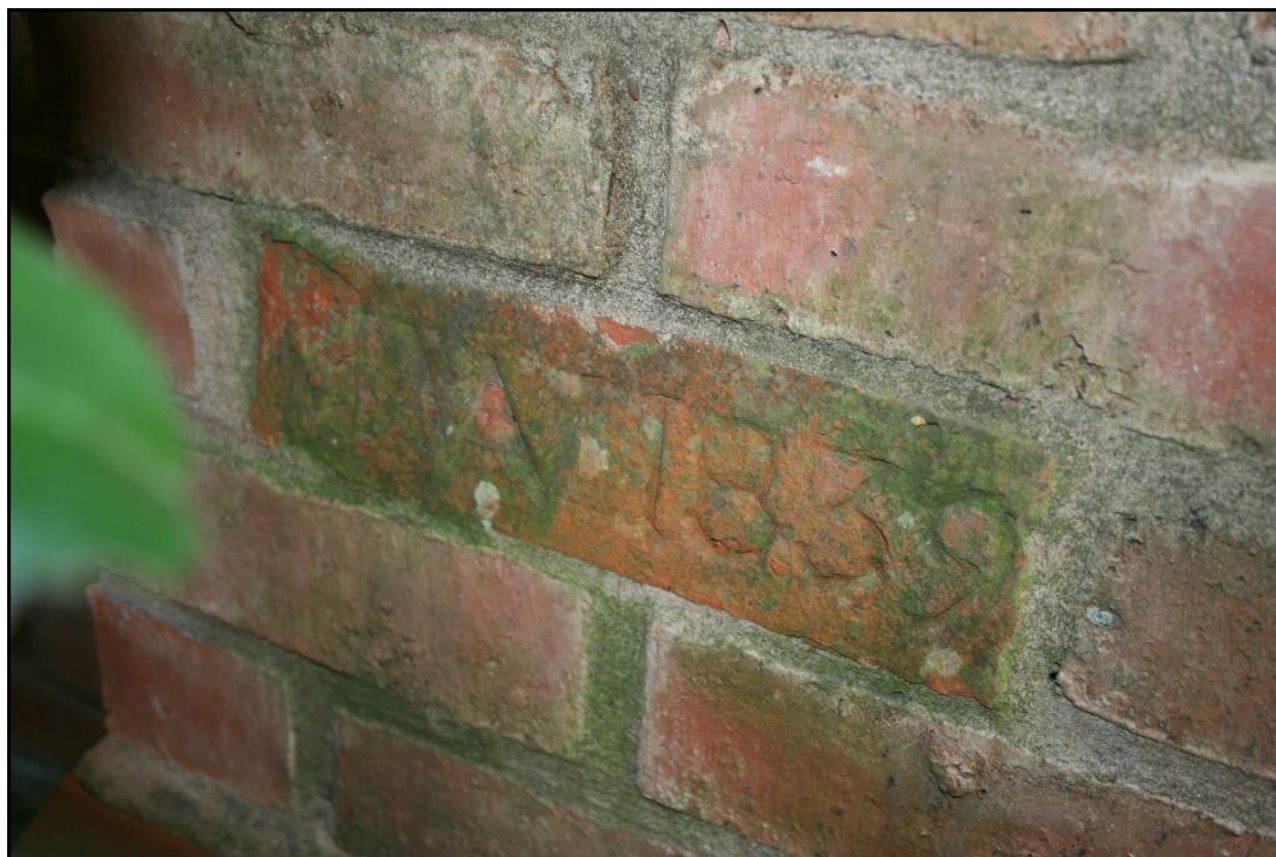
**Plate 10:** Dated brick (1839) built into a garden wall at the back of the Old Rectory, Hathern (position shown of Fig. 2).
