**A DESK-BASED ASSESSMENT  
AND BUILDING APPRAISAL OF  
THE CANLIN CASTINGS LTD SITE,  
LANGLEY MILL, DERBYSHIRE**

**A DESK-BASED ARCHAEOLOGICAL  
ASSESSMENT AND BUILDING APPRAISAL  
OF THE CANLIN CASTINGS LTD SITE AT  
LANGLEY MILL, DERBYSHIRE**

**A report for  
Canlin Castings Ltd**

OS Grid Ref. SK 448 475 (centred)  
TPA Project Code: CCD.1  
February 2010

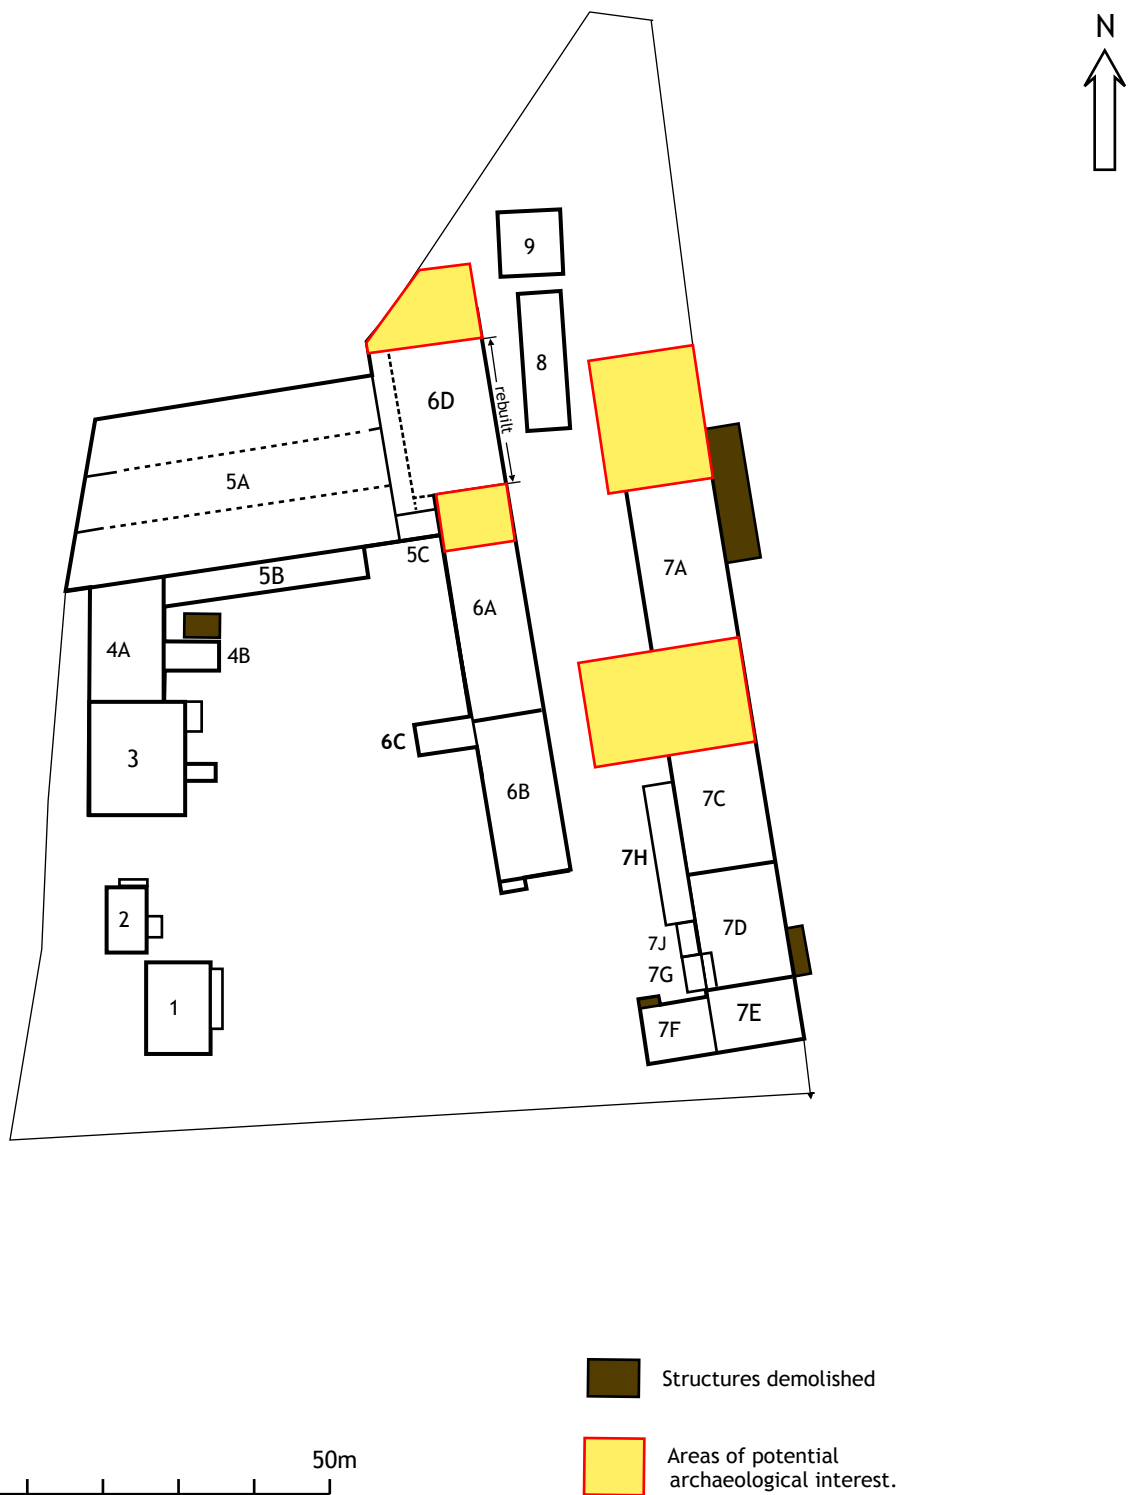
**Figure 11:** Canlin Castings Ltd, Langley Mill, Derbyshire: Suggested areas of possible archaeological survival with potential for adding to the understanding of the site's development. Scale 1:1,000.

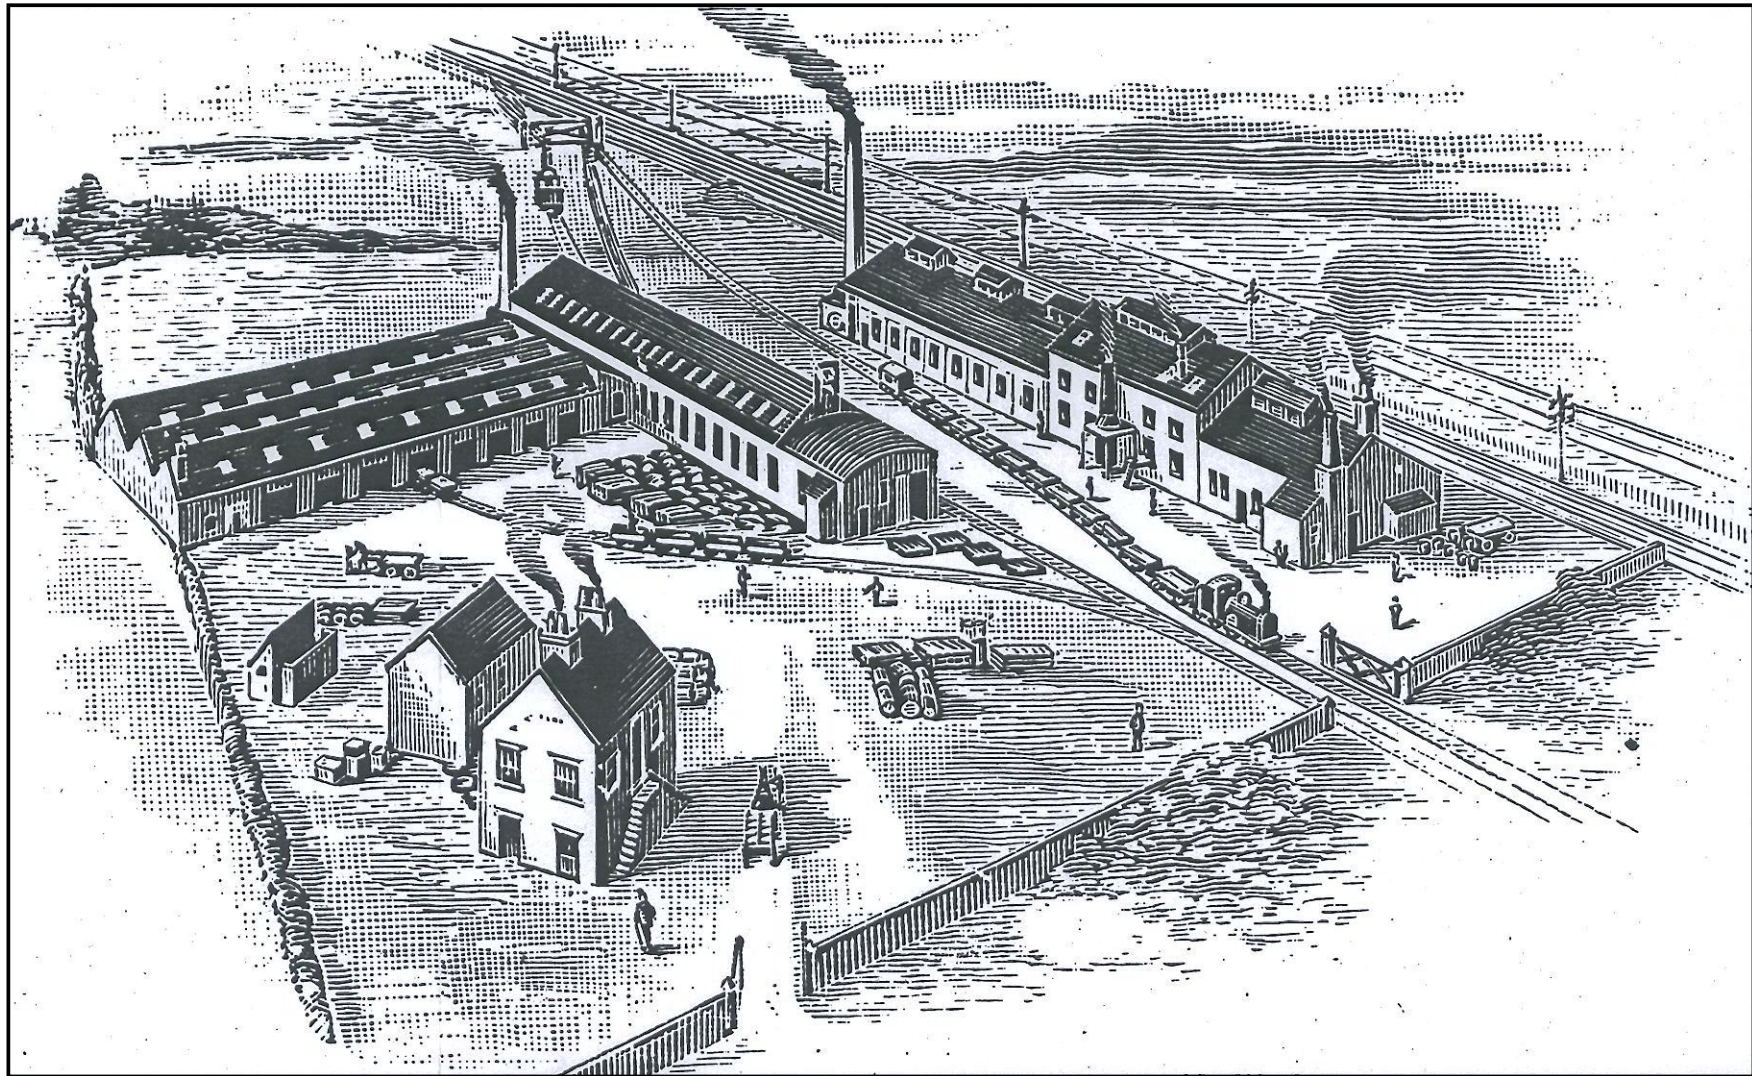
Plate 1: Lithograph portraying a bird's-eye view from the south-west of the Canlin Castings Ltd site drawn before 1900.

Between 1868-1881 the site expanded significantly, despite the fact that one of the founding partners was preoccupied in building up a separate works nearby, one that was probably specializing in steel. A lithograph of the site that perhaps dates to just before 1900 (its source is unclear), as Building 4A does not appear, shows a busy site with the main hot foundry activities still based in or next to the eastern range. There is what looks like a vertical cupola furnace showing outside Building 7C. Stacks show close to this, at the ends of the range and at the north-west corner of the middle range (6D). Because the early buildings appear to have been built with timber trusses there may have been a policy to keep furnaces on the outsides of the main buildings to diminish fire risk. Although part of Buildings 4A and 6D are known to have been partly destroyed by fire, the east range appears not to have suffered such damage, despite the likely risks.

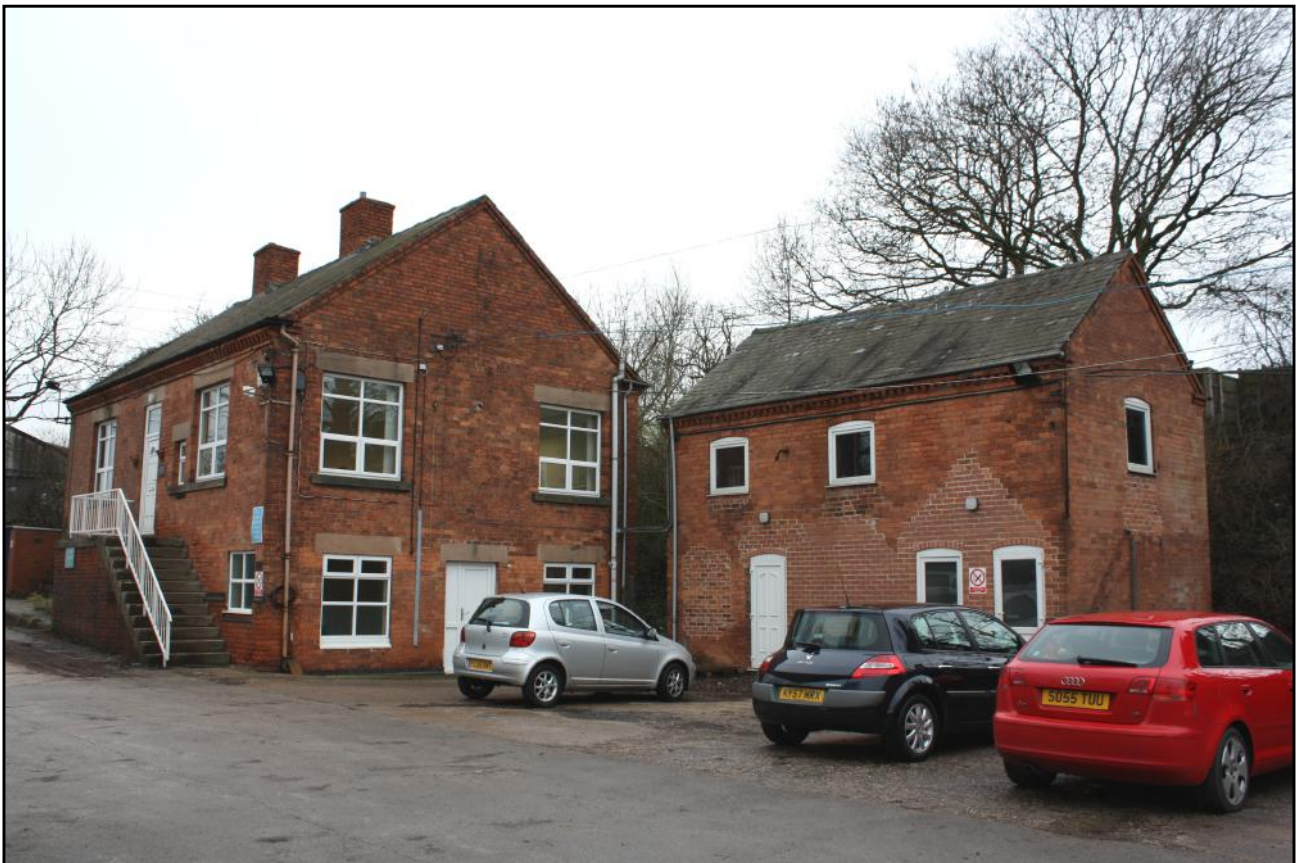
**Plate 3:** Buildings 1 and 2 (offices to left, former stables to right) at the Canlin Castings Ltd site at Langley Mill, Derbyshire.

**Building 1 (Plate 3):** Offices, situated close to the site entrance. Brick-built (Flemish garden bond) with moulded dentilation at eaves level and lower plinth. Slate roof, stacks, modern windows and flat stone lintels. Replaced staircase on east side. The south side has two low level windows that were doorways and the upper walling still bears the title PICKERSGILL & FROST LTD, although now getting obscure. Probably built c.1895 by new owners.

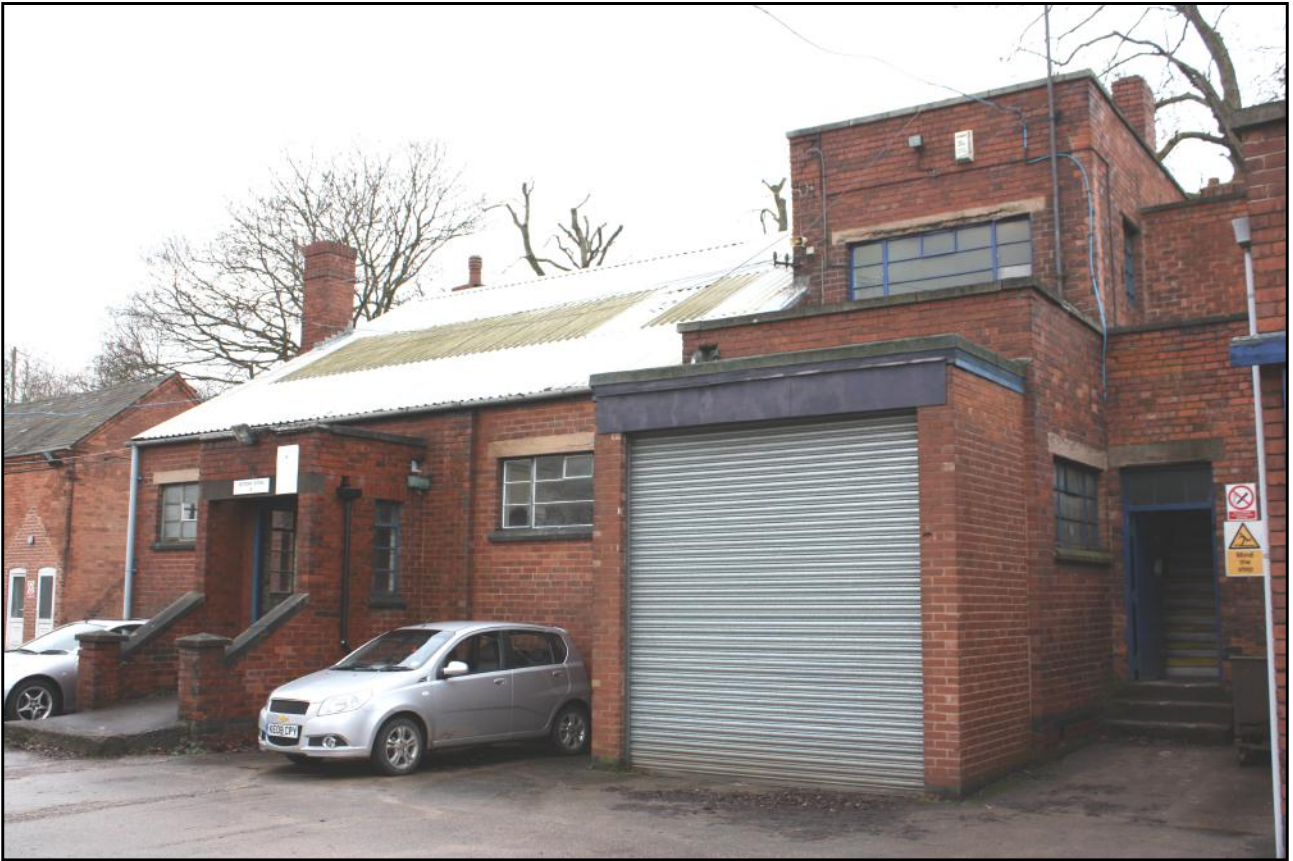
**Plate 4:** The Canlin Castings Ltd site at Langley Mill: the east frontage of Building 3, with an extended loading-bay, and the south end of Building 4 to the far right (stairway entrance).

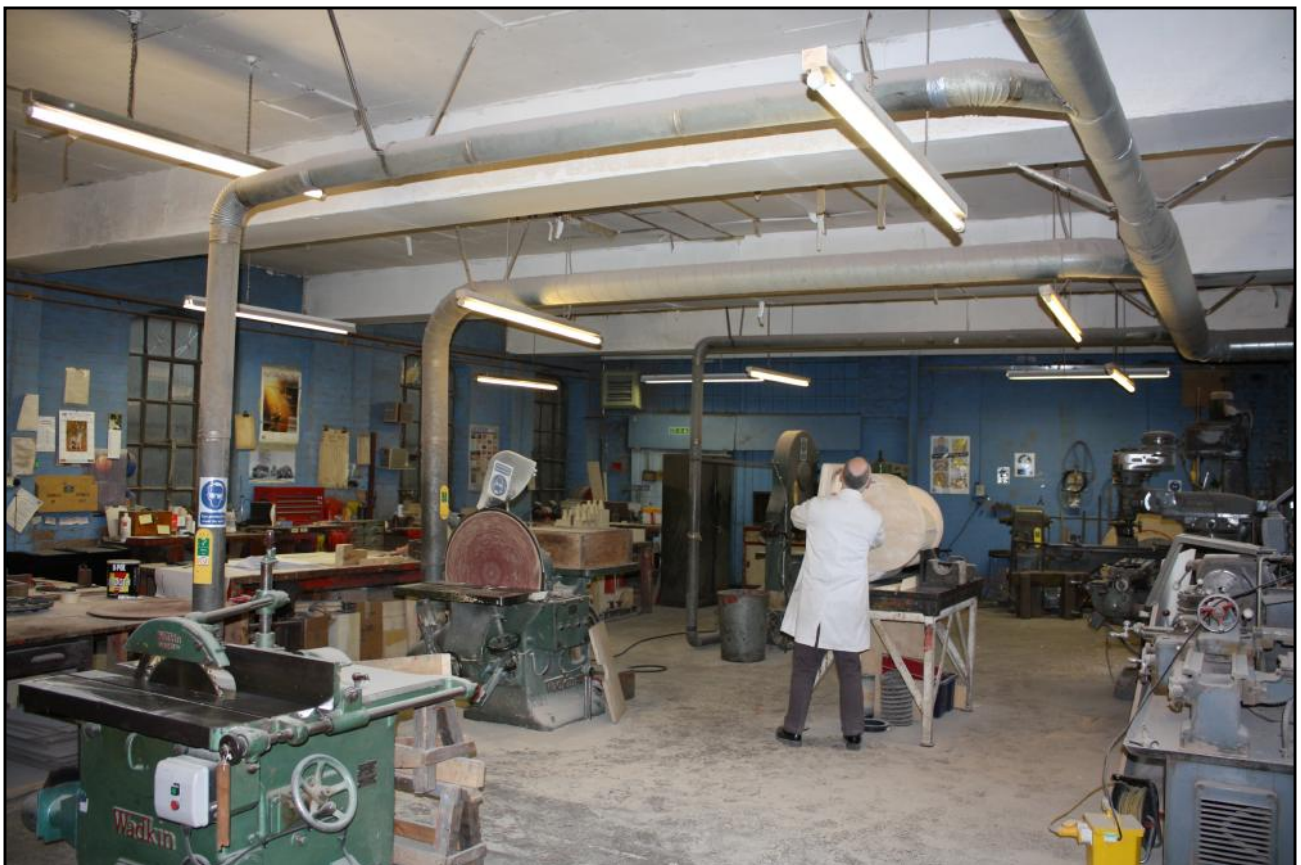
**Plate 5:** The Canlin Castings Ltd site at Langley Mill: interior view of Buildings 4, now used as the Pattern Shop.

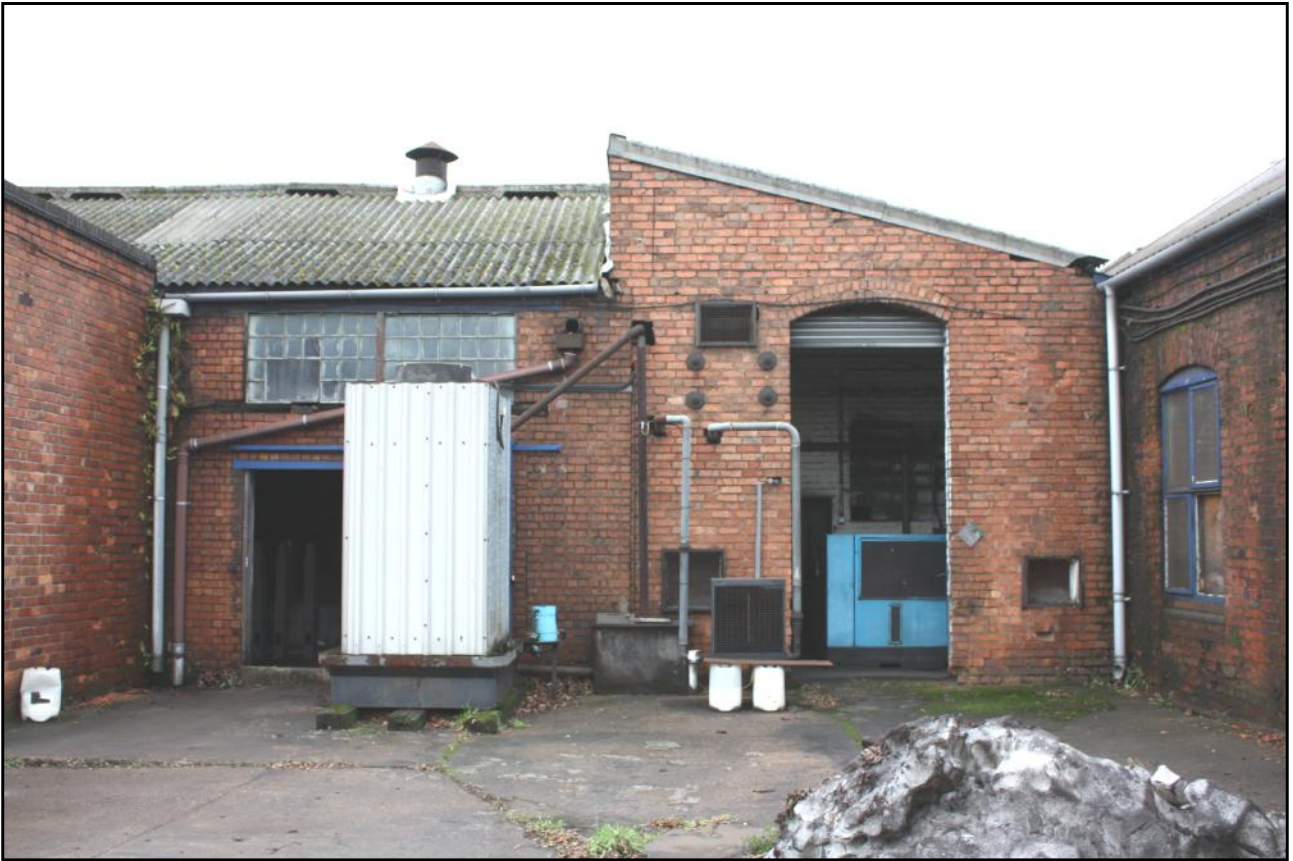
**Plate 6:** The Canlin Castings Ltd site at Langley Mill: the east end of the south frontage of Building 5A (to left, with entry door and windows above, as shown in the 19th century lithograph) and, to right, infill structure 5C with tall entry and sloping roof.

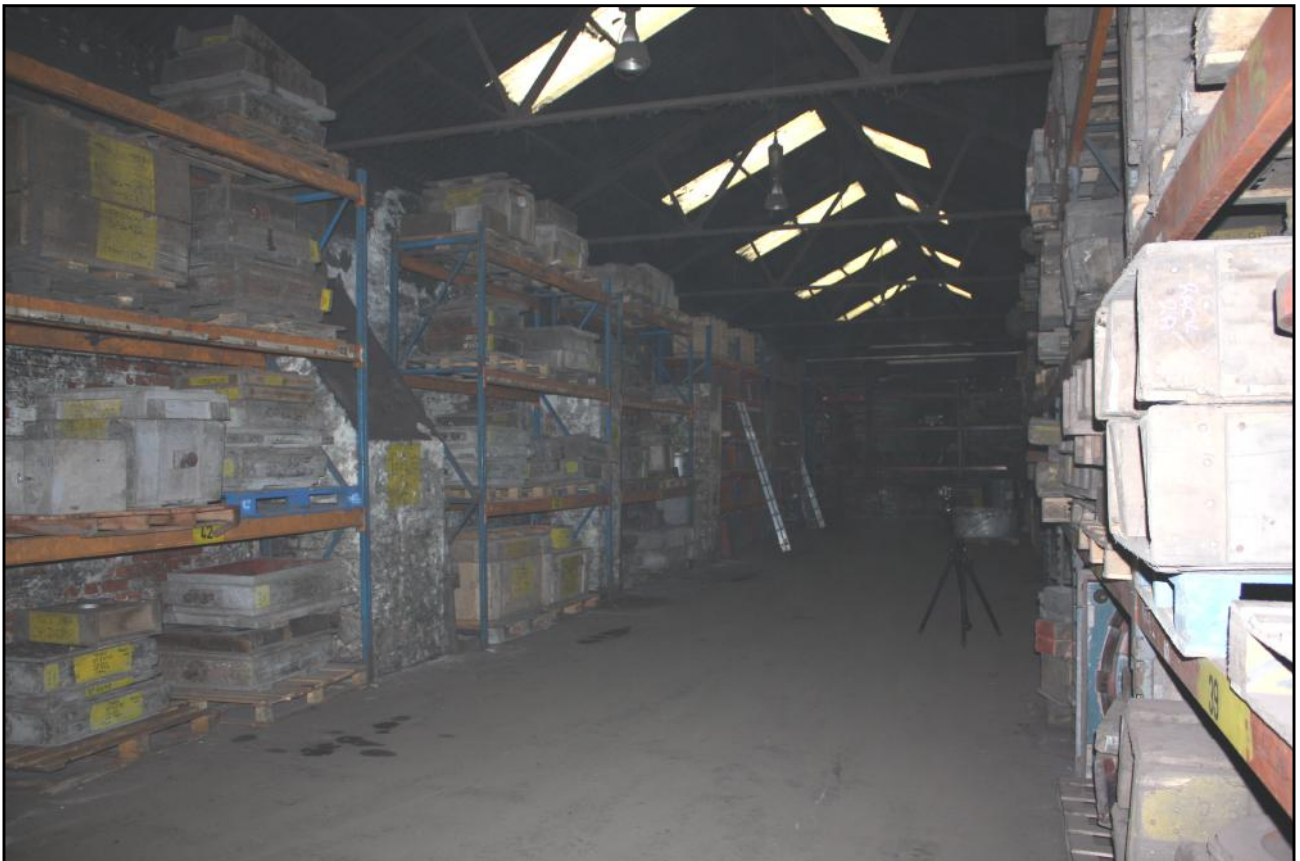
**Plate 7:** The Canlin Castings Ltd site at Langley Mill: interior view of the back of Building 5A, (now used for storing patterns), showing metal-framed roofing and brick buttresses.

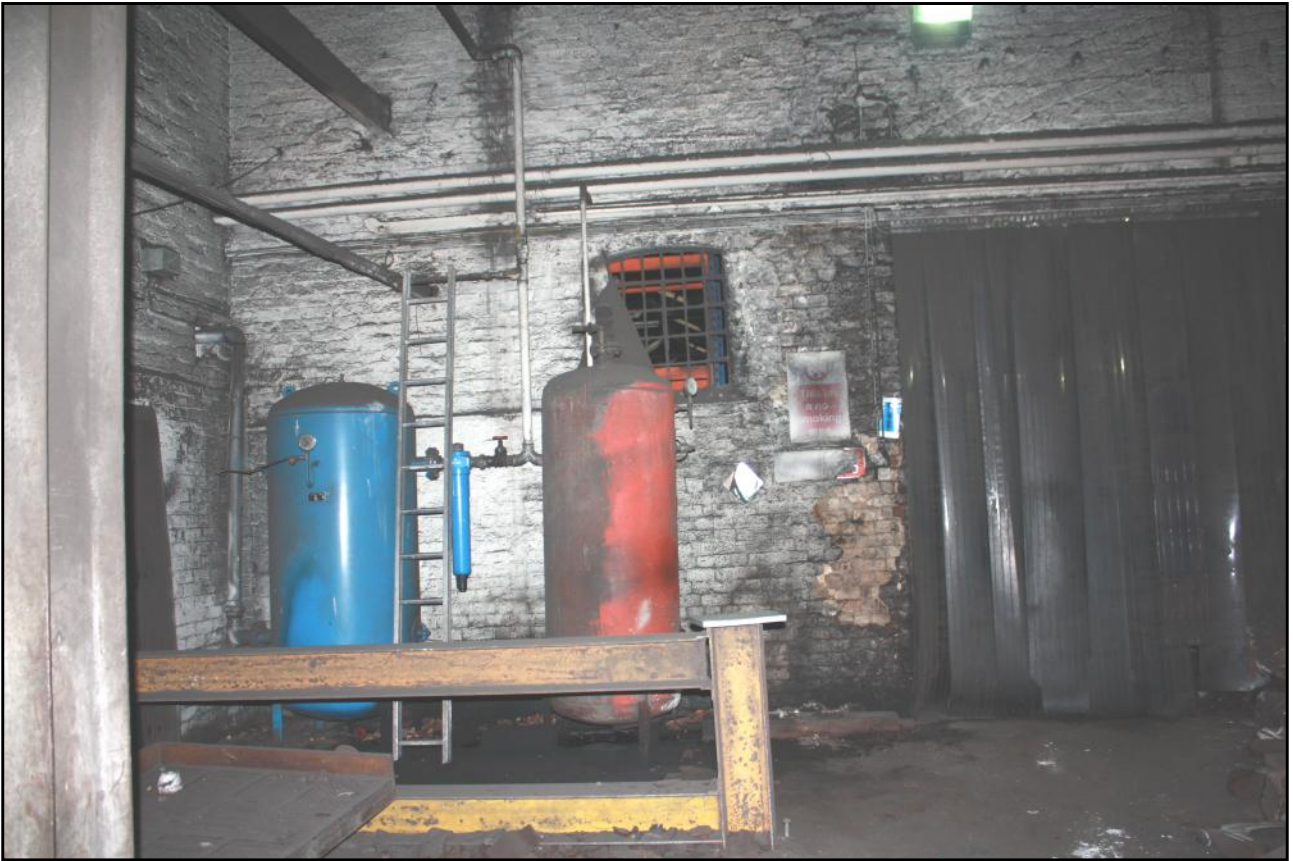
**Plate 8:** The Canlin Castings Ltd site at Langley Mill: part of the now hidden east frontage of Building 5A, showing an original window frame and, to right, an opening with part of a large relieving arch showing above, to top right.

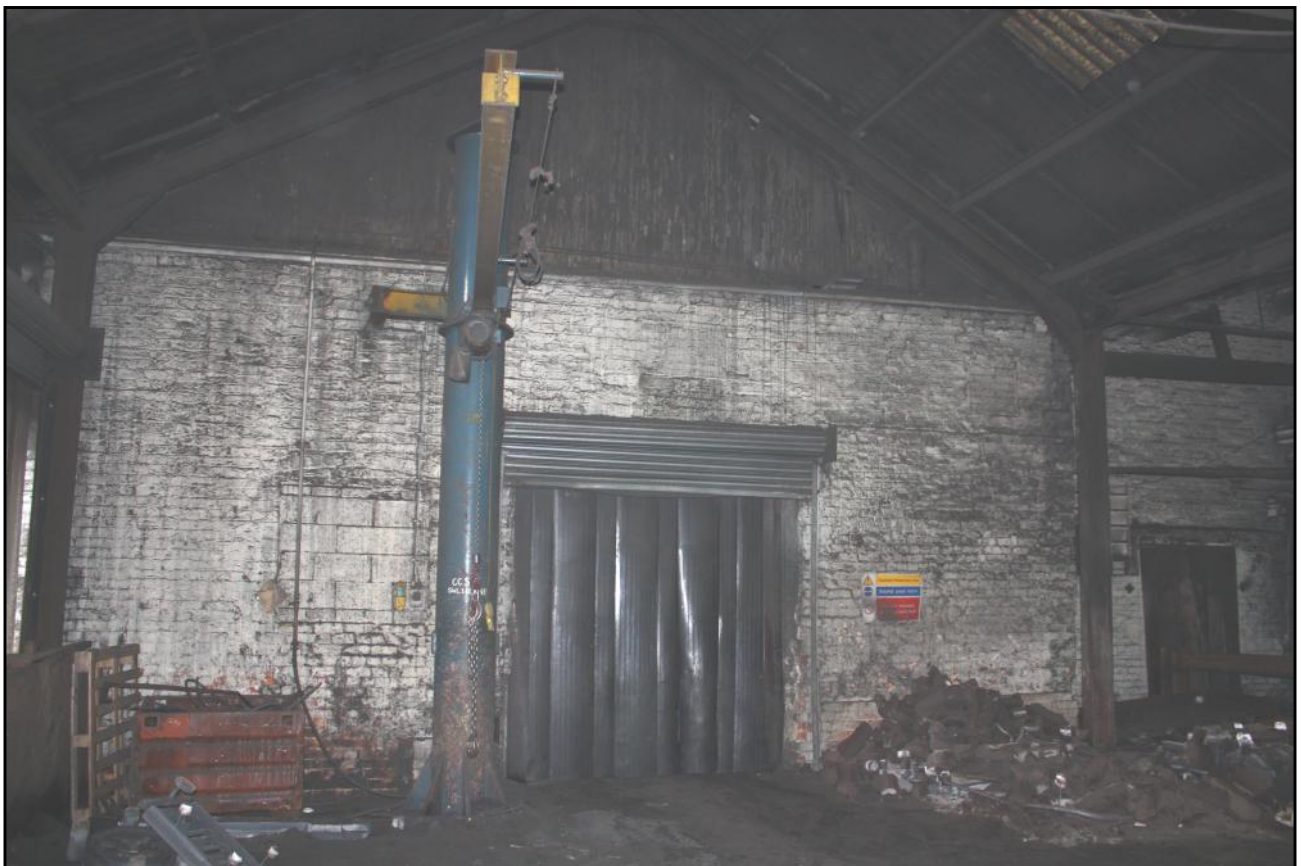
**Plate 9:** The Canlin Castings Ltd site at Langley Mill: north end of Building 6A (with blocked window to left) and metal roof truss of now largely rebuilt Building 6D.

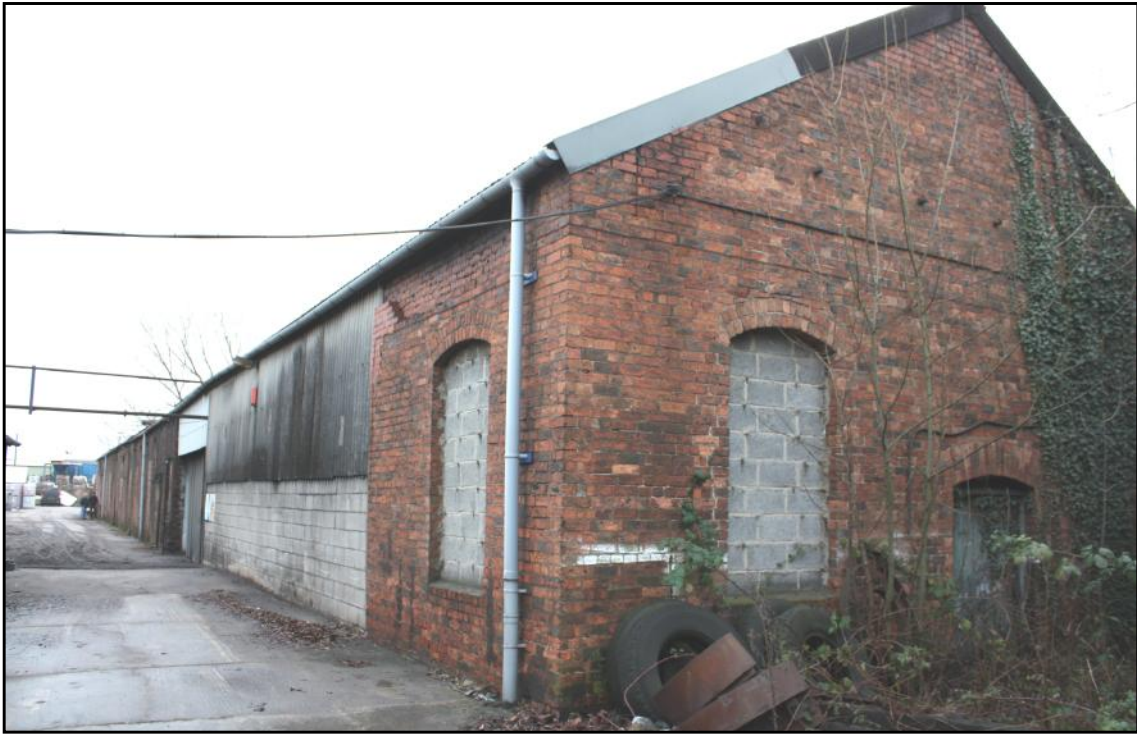
**Plate 10:** The Canlin Castings Ltd site at Langley Mill: view looking from the north-east corner of Building 6D showing the full east side of the middle range.

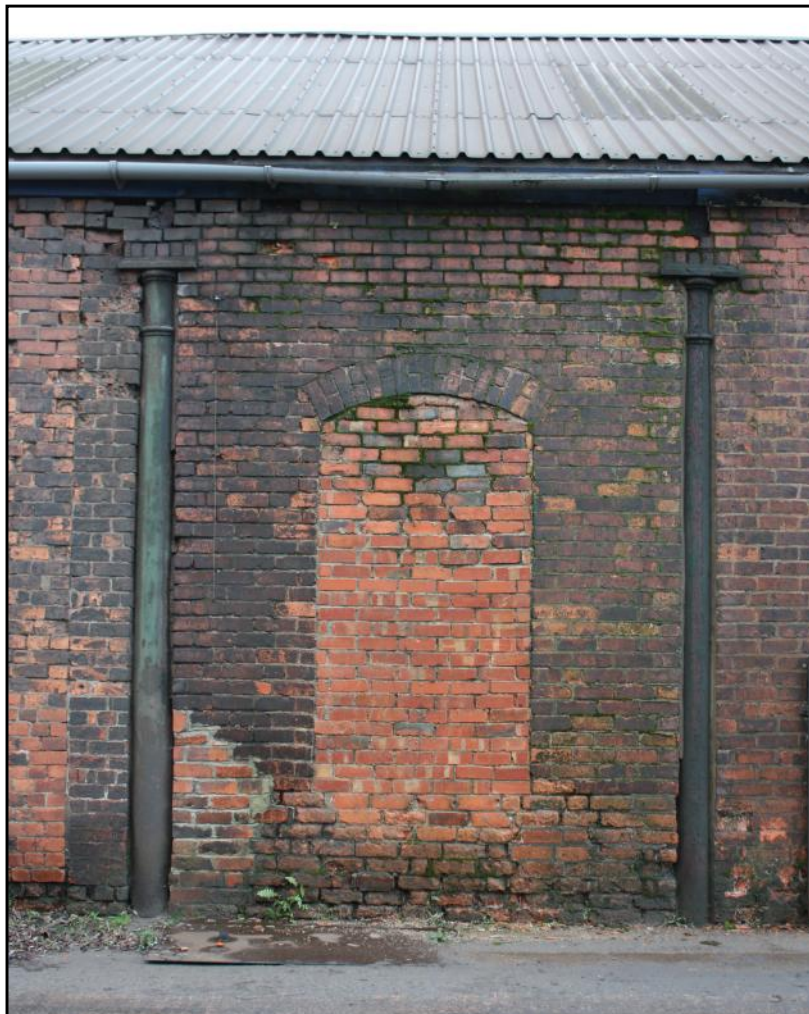
**Plate 11:** The Canlin Castings Ltd site at Langley Mill: exposed cast iron pillars showing in the east external wall of Building 6A, with straight joint to extension 6B showing to far left.

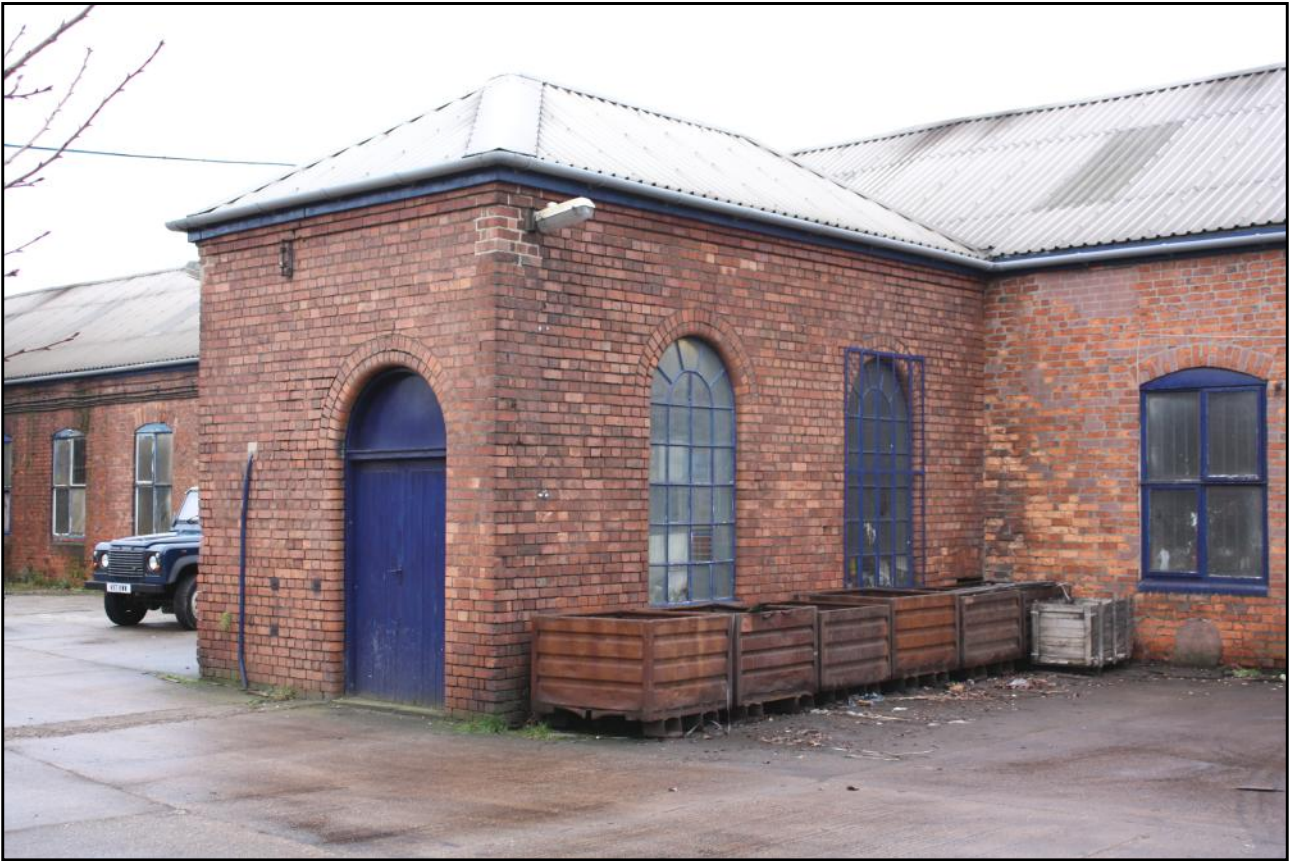
**Plate 12:** The Canlin Castings Ltd site at Langley Mill: west side of the middle range, with Building 6A showing to far left, 6B to right and 6C (Test House) in centre.

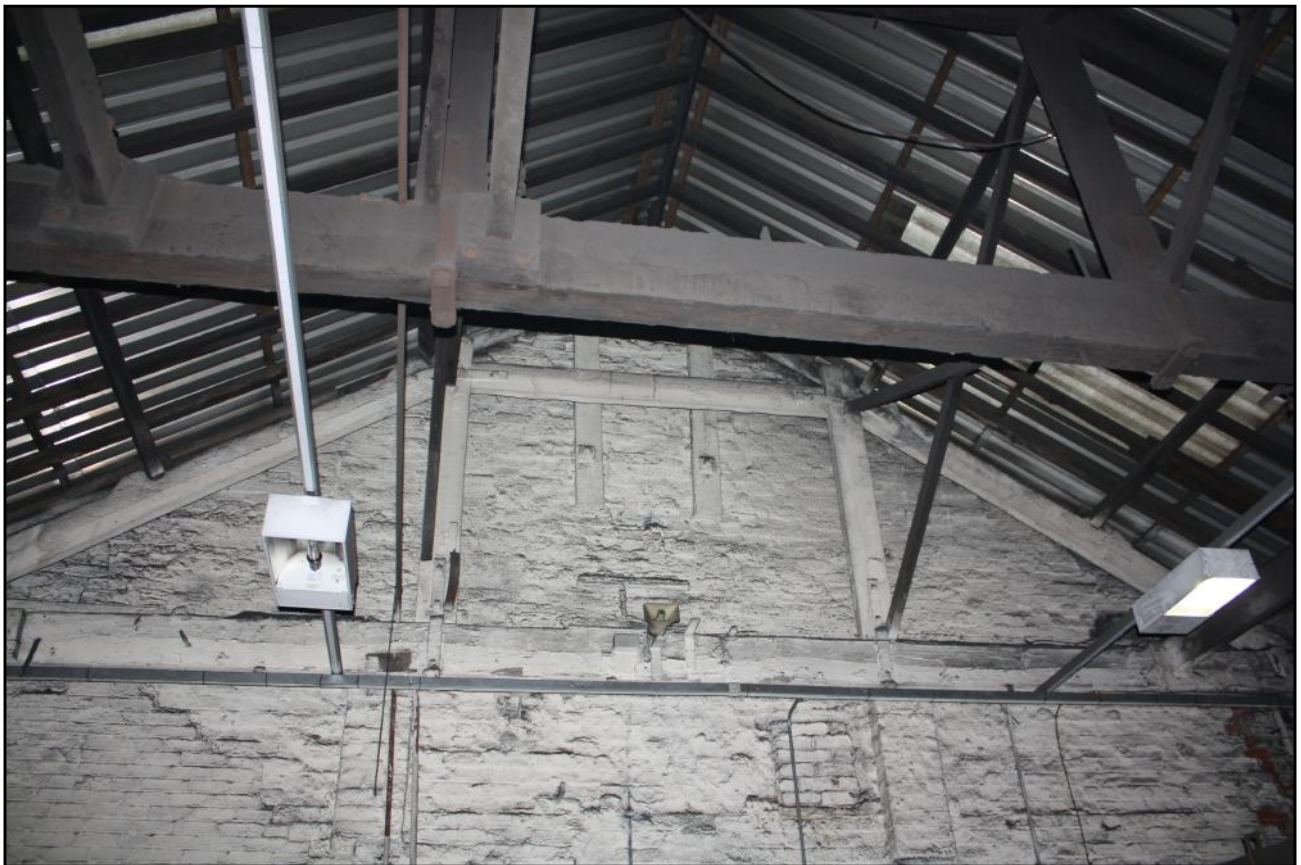
**Plate 13:** The Canlin Castings Ltd site at Langley Mill: queen-post timber trusses in Building 6A, as originally used in all the pre-1900 structures on the site.

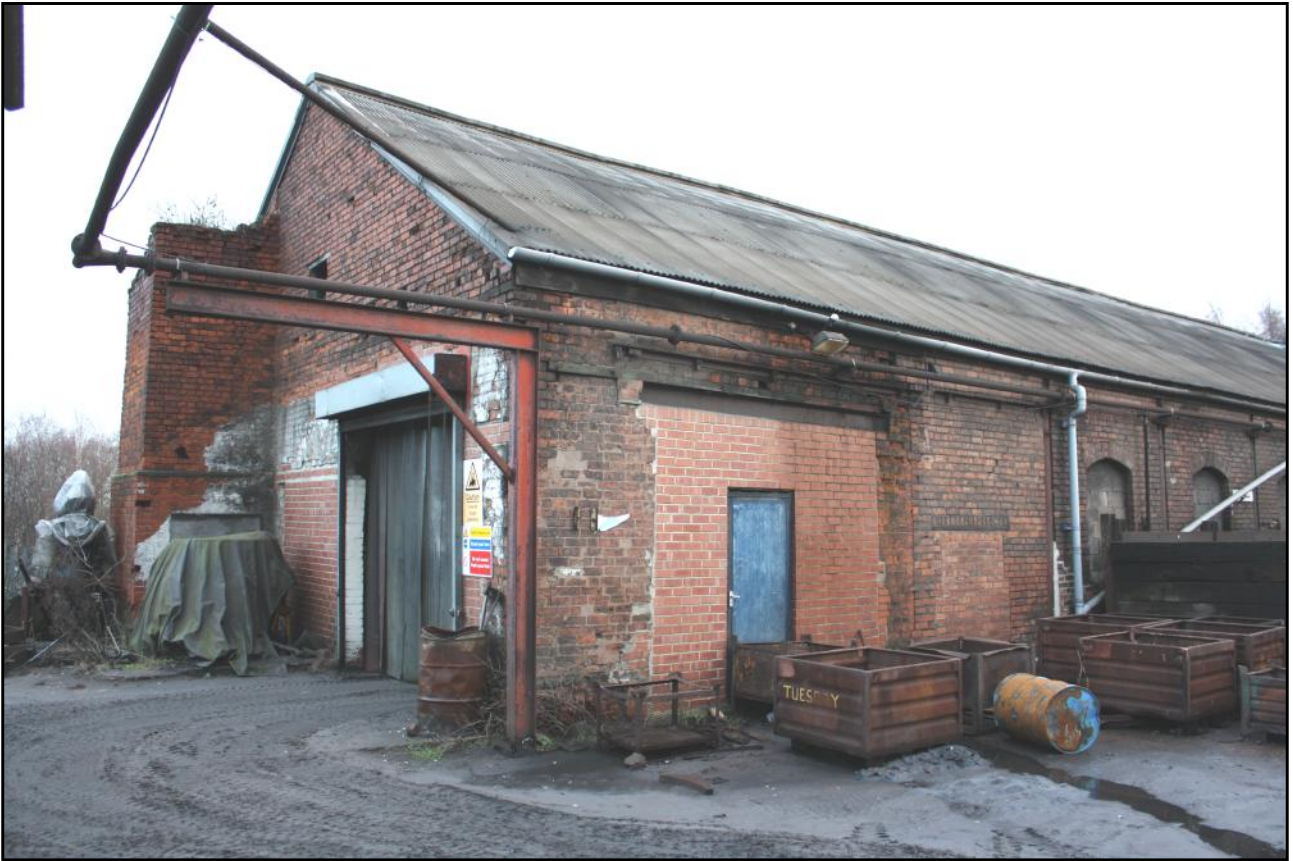
**Plate 14:** The Canlin Castings Ltd site at Langley Mill: north end of Building 7A showing the base of a large chimney, the scar of a former lean-to and, to right, part of the west frontage with infilled former openings and cast iron pillars showing to far right.

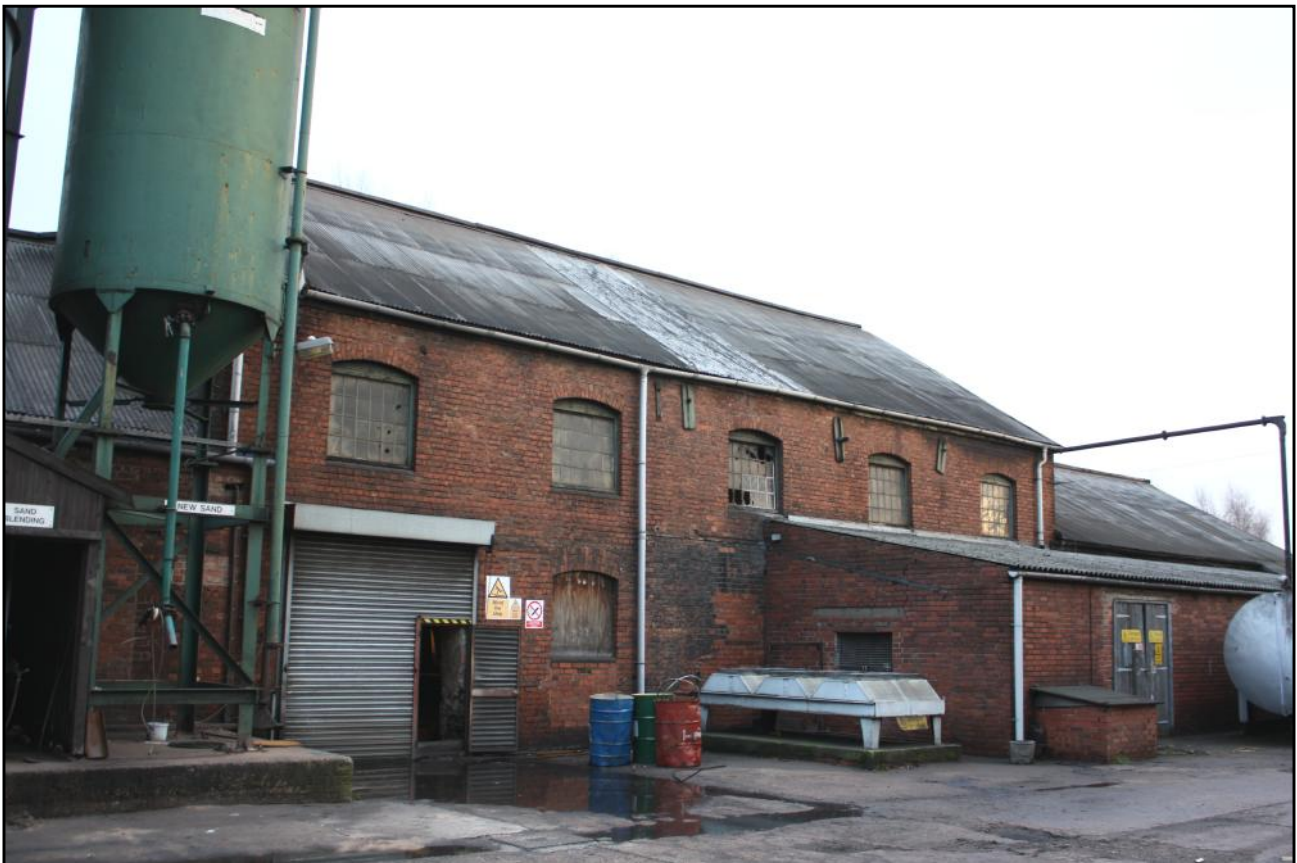
**Plate 15:** The Canlin Castings Ltd site at Langley Mill: two-storey tall Building 7C with, to left, a sand tank (where a cupola furnace once stood) and, to right, additions 7D-E and 7H.

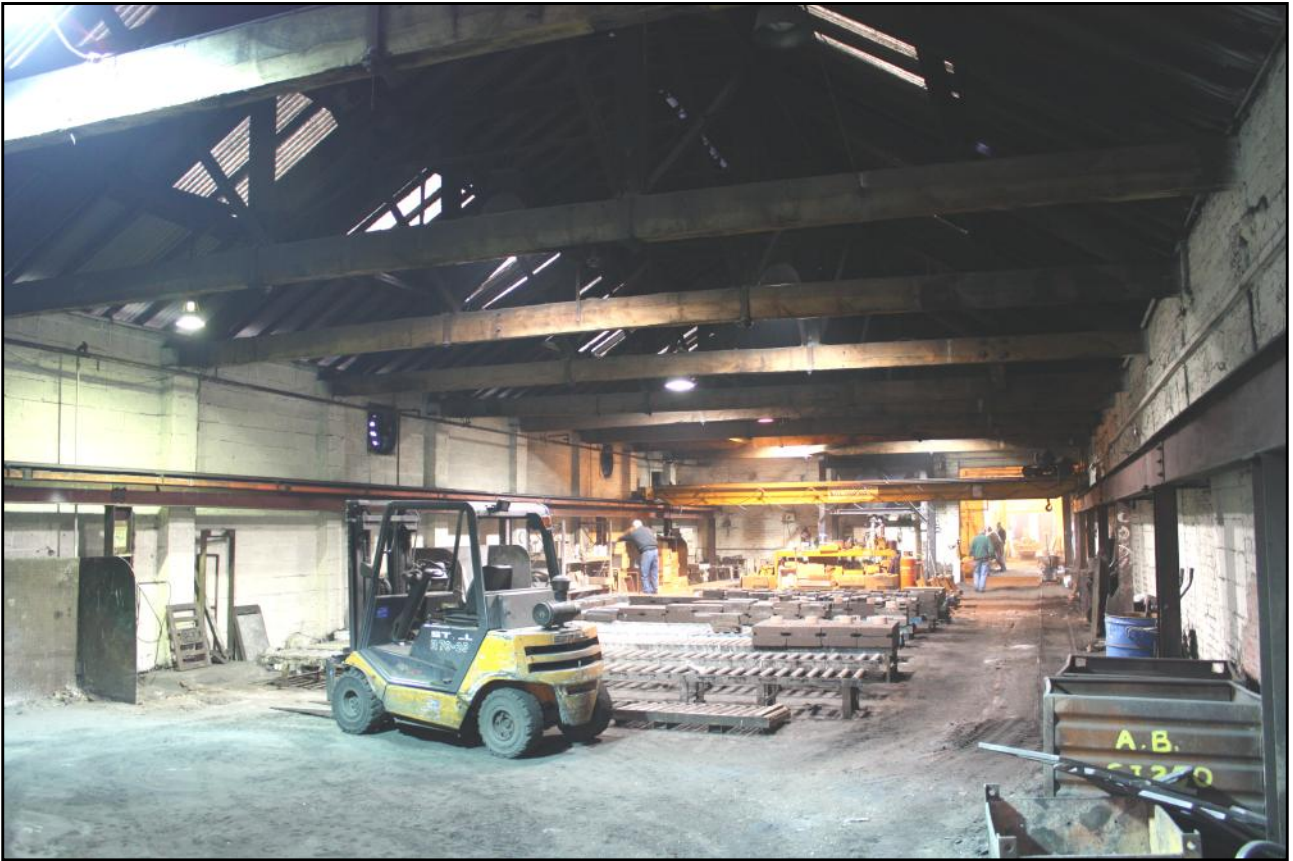
**Plate 16:** The Canlin Castings Ltd site at Langley Mill: interior of Building 7A (small castings floor) showing gantry system, breeze-block walling to left and brick and cast iron pillar walling to right.

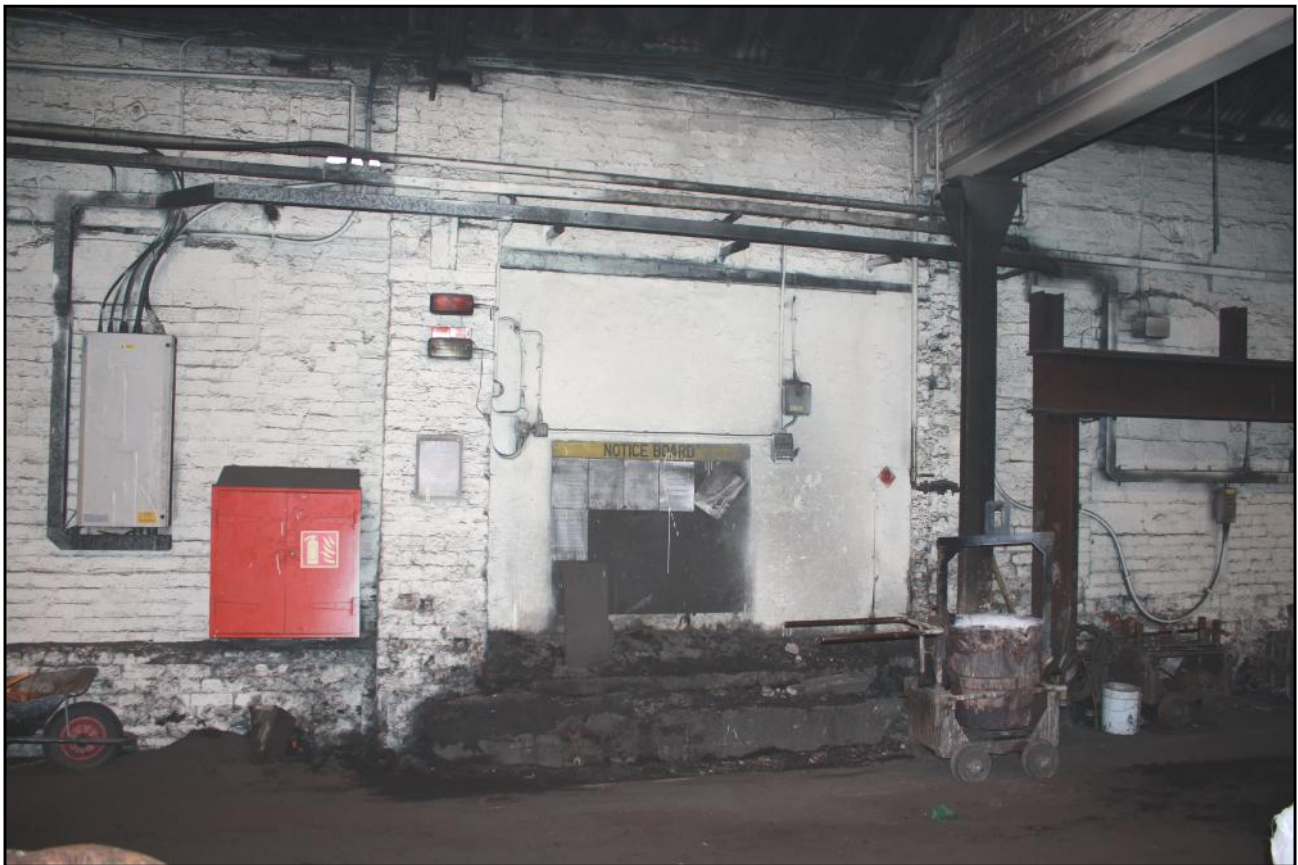
**Plate 17:** The Canlin Castings Ltd site at Langley Mill: base of a former external cupola furnace showing in the west wall of Building 7B.

**Building 7B:** Two bay extension to the south, contemporary with 7C but with dividing wall between the two. This part has been partly open on the west side to a cupola furnace, immediately outside the building, in an area since cleared (but now with a concrete base supporting upright sand blending tanks). Part of the base support for the cupola shows below the infilled lower west wall (Plate 17). The roofing here is of steel but this may have replaced an earlier timber one. Walling on the east side is original brick with windows now infilled. Now used to store materials for use in 7C.

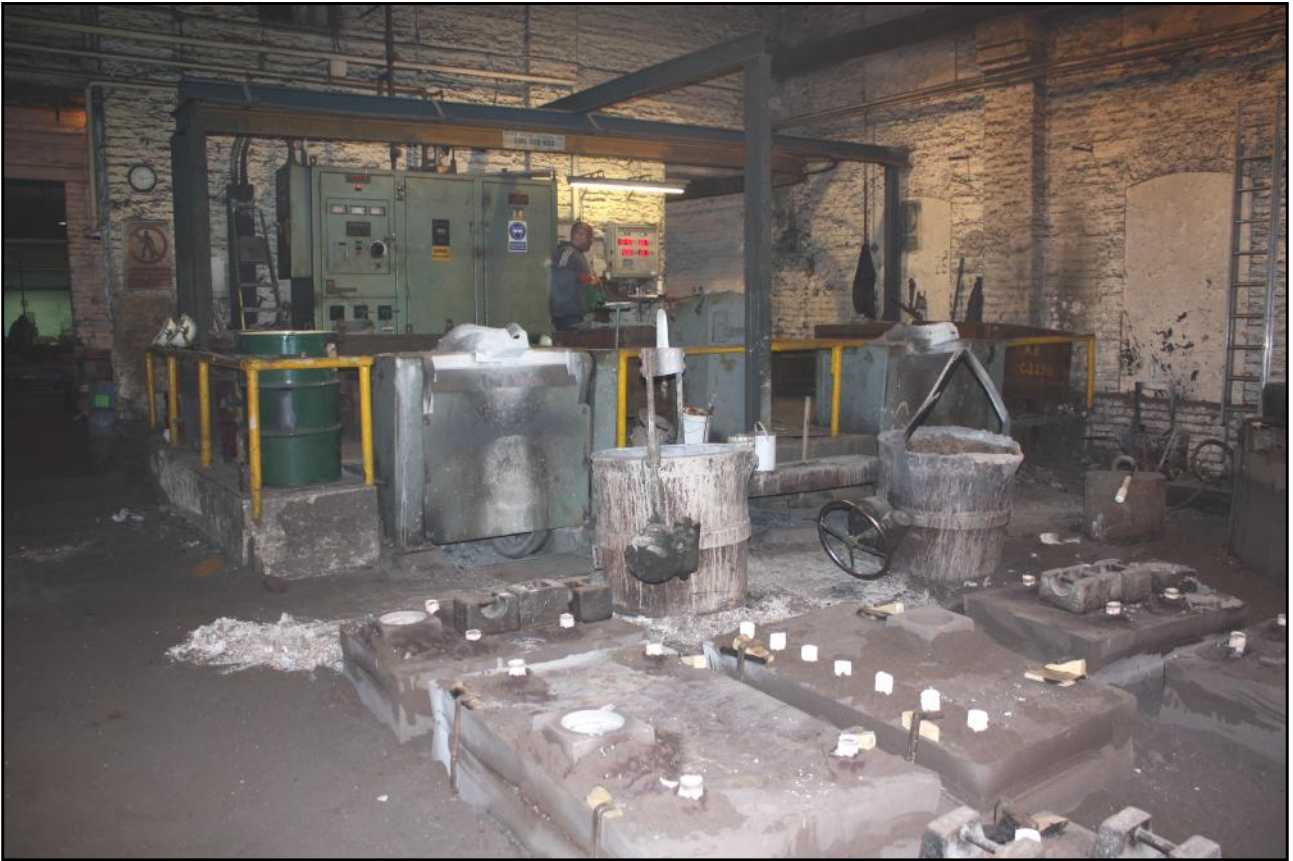
**Plate 18:** The Canlin Castings Ltd site at Langley Mill: present-day furnaces at the north end of the large castings floor in Building 7C.
