**A DESK-BASED ASSESSMENT  
AND BUILDING APPRAISAL OF  
THE CANLIN CASTINGS LTD SITE,  
LANGLEY MILL, DERBYSHIRE**

**A DESK-BASED ARCHAEOLOGICAL  
ASSESSMENT AND BUILDING APPRAISAL  
OF THE CANLIN CASTINGS LTD SITE AT  
LANGLEY MILL, DERBYSHIRE**

**A report for  
Canlin Castings Ltd**

OS Grid Ref. SK 448 475 (centred)  
TPA Project Code: CCD.1  
February 2010

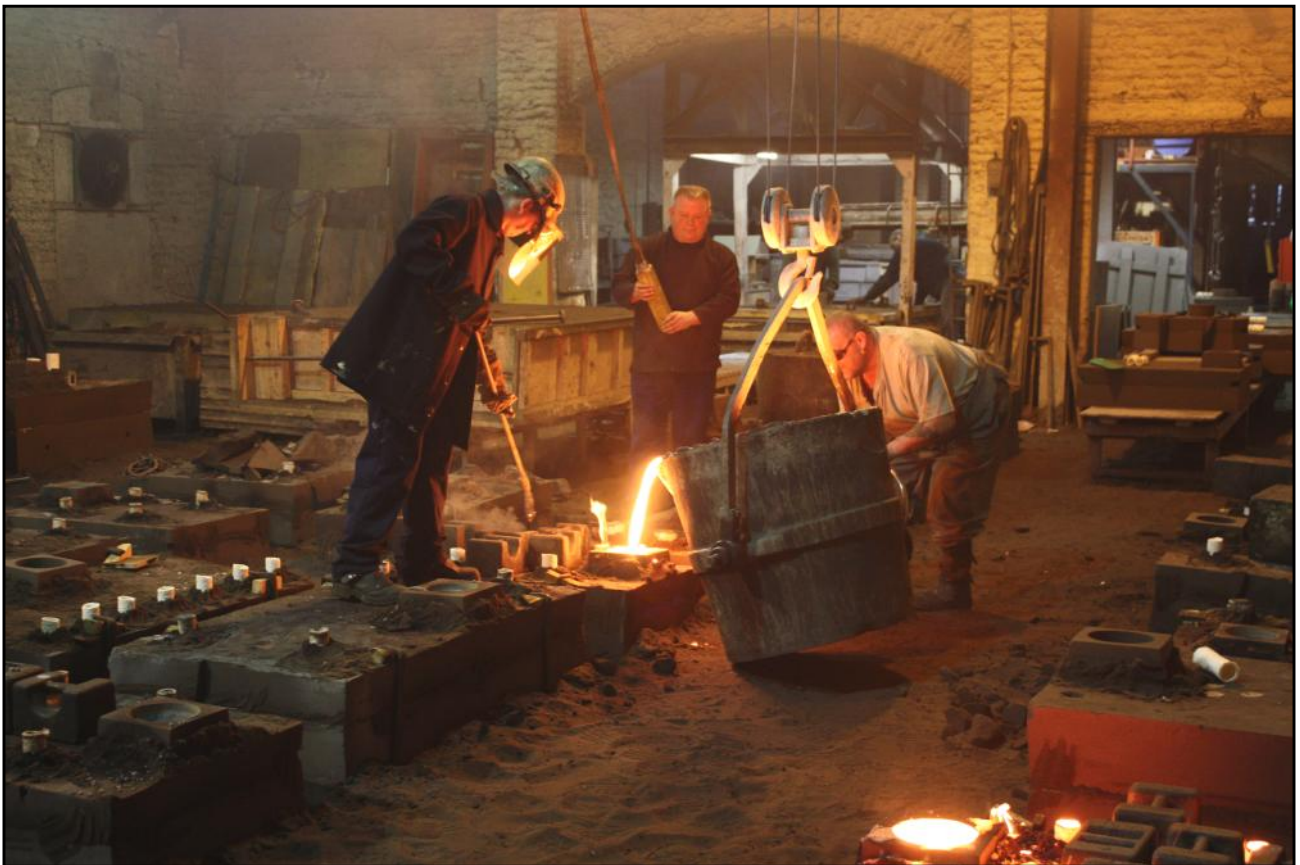
**Plate 19:** The Canlin Castings Ltd site at Langley Mill: molten iron being poured into moulds in the large castings floor in Building 7C.

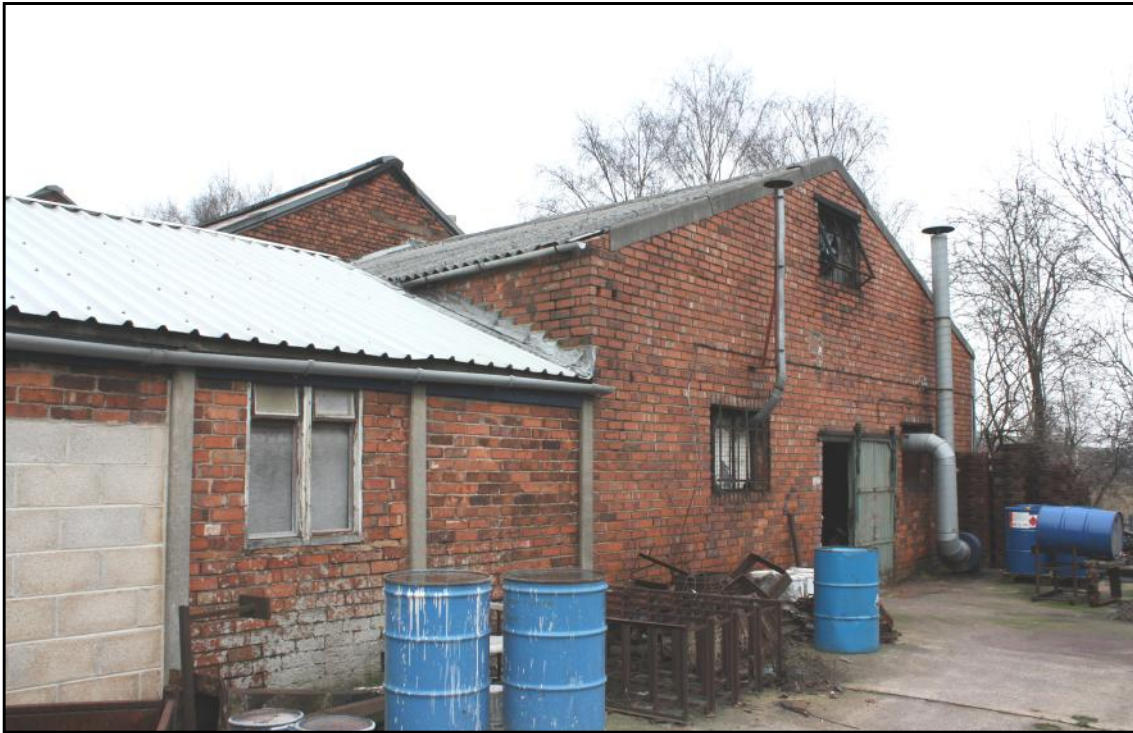
**Plate 20:** The Canlin Castings Ltd site at Langley Mill: south end of Buildings 7E (to right) and 7F (to left).

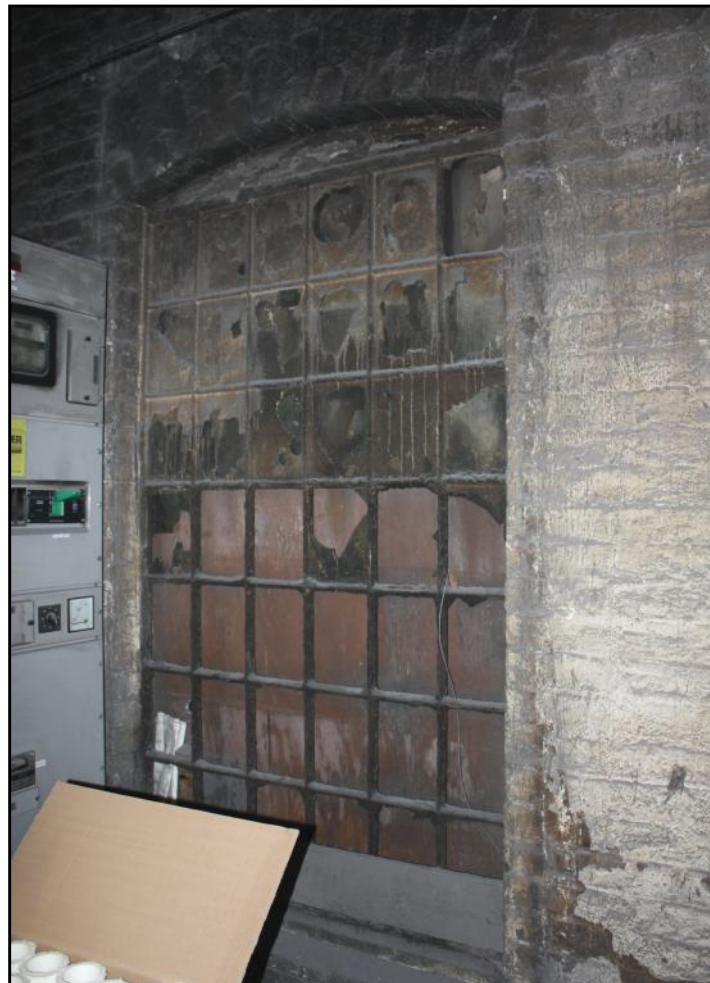
**Plate 21:** The Canlin Castings Ltd site at Langley Mill: cast iron window frame in the west wall of Building 7C now hidden within extension 7H.

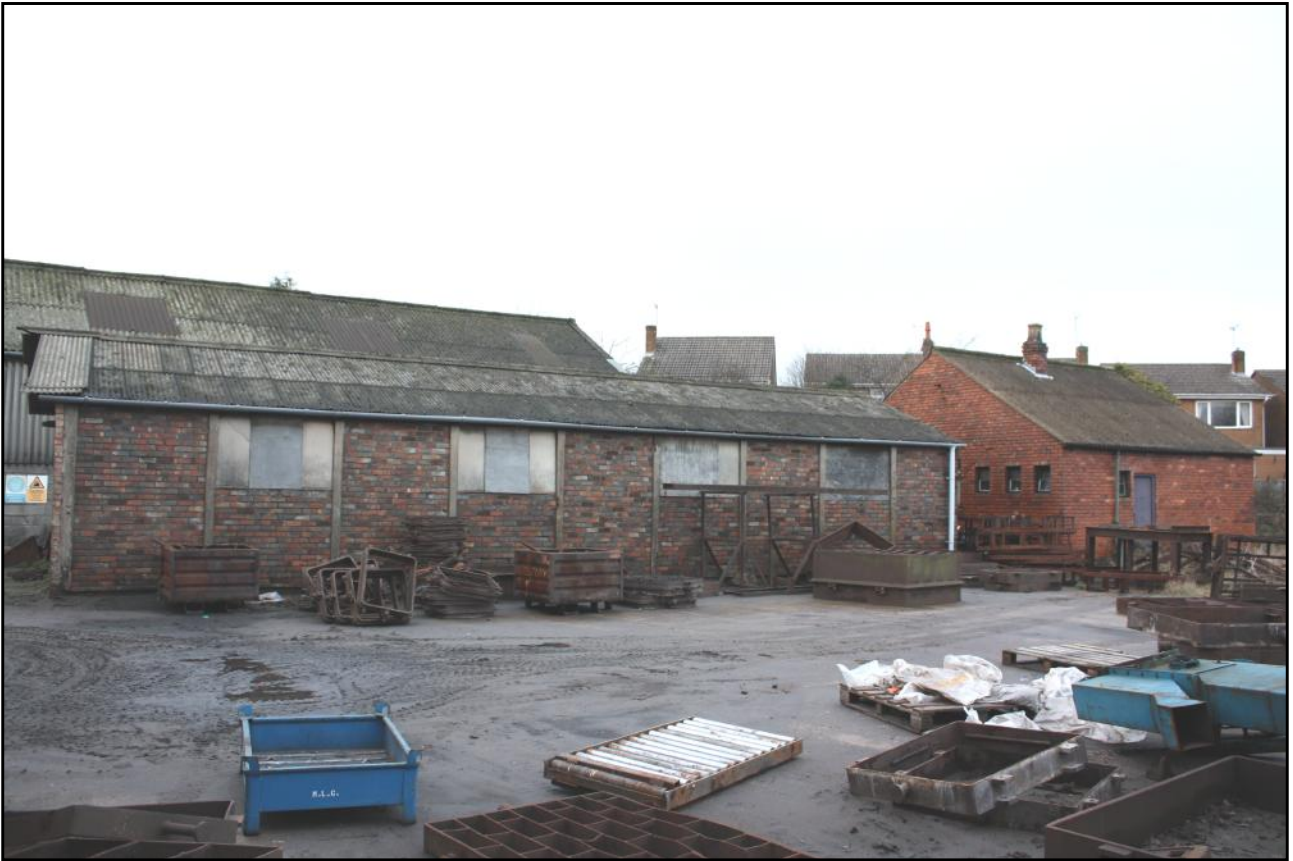
**Plate 22:** The Canlin Castings Ltd site at Langley Mill: Buildings 8 (pattern store) to left, and 9 (former bath-house) to right.

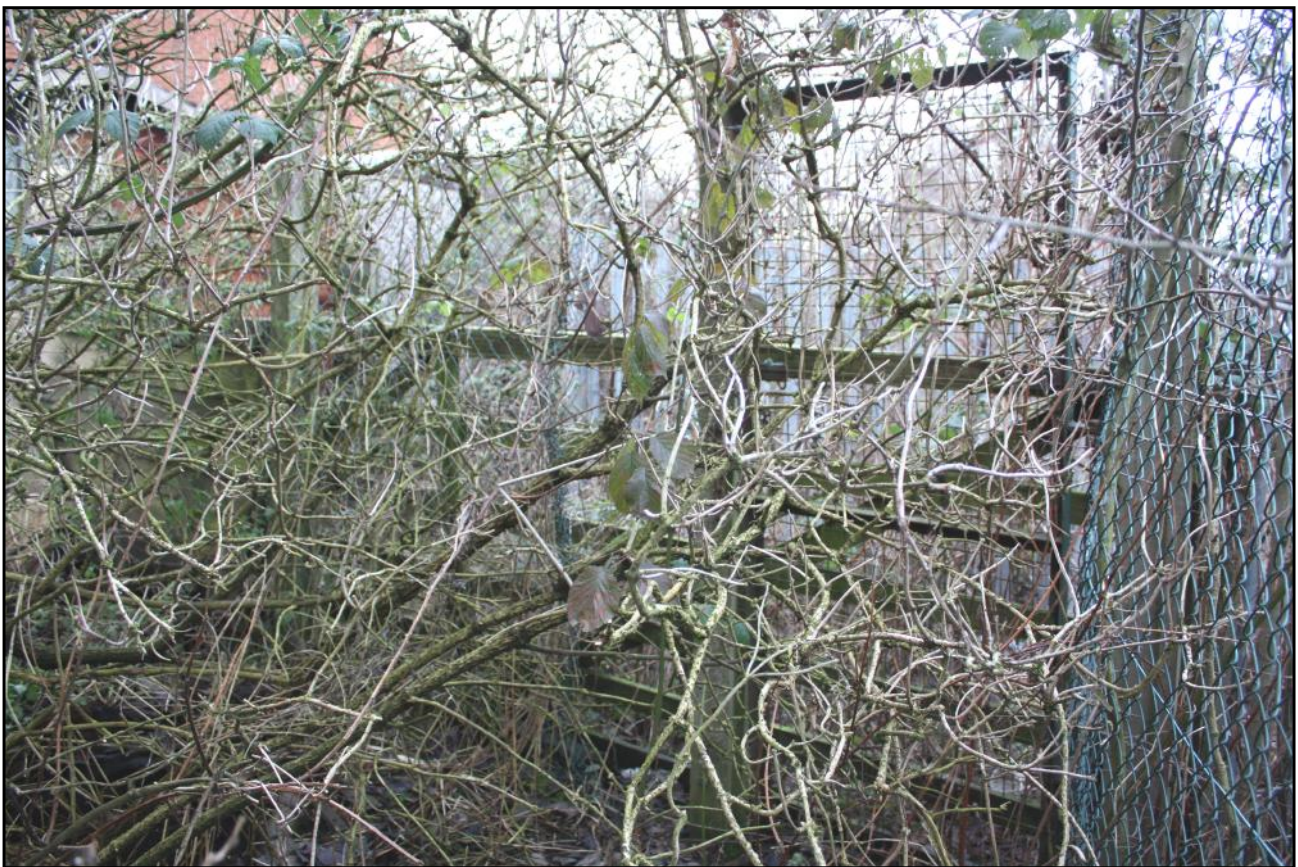
**Plate 23:** The Canlin Castings Ltd site at Langley Mill: remaining wooden gate at the top right corner of the site, where railway sidings from the adjacent Midland Railway once entered the site.
