# AN HISTORIC BUILDING RECORD OF THE BULL'S HEAD INN AT HANFORD, STOKE-ON-TRENT, STAFFORDSHIRE

A report for Avery Healthcare Ltd

by Richard Sheppard

OS Grid Ref. SJ 8680 4201 (centred) TPA Project Code: BHH.1 August 2010

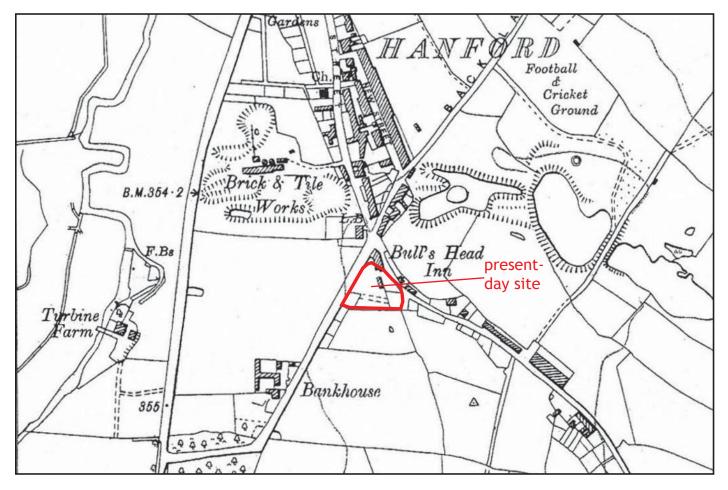
Figure 2: The old Bull's Head public house shown on an Ordnance Survey map of 1925. Scale 1:5,000.

- 3.4 Although a website about the site states that the public house was rebuilt in 1909 no corroborating evidence could be found for this. Ordnance Survey plans from 1890 onwards show that plan of the buildings did not change much between then and 1925 (Fig. 2). However, the site was completely altered by 1938 when the present building was opened by brewers Ind Coope and Allsopp (Fig. 3). The old public house was demolished and some of the former stables retained up until perhaps the 1950s. This new building is now referred to as an inter-war roadhouse. It was an inn, providing both refreshments and accommodation.

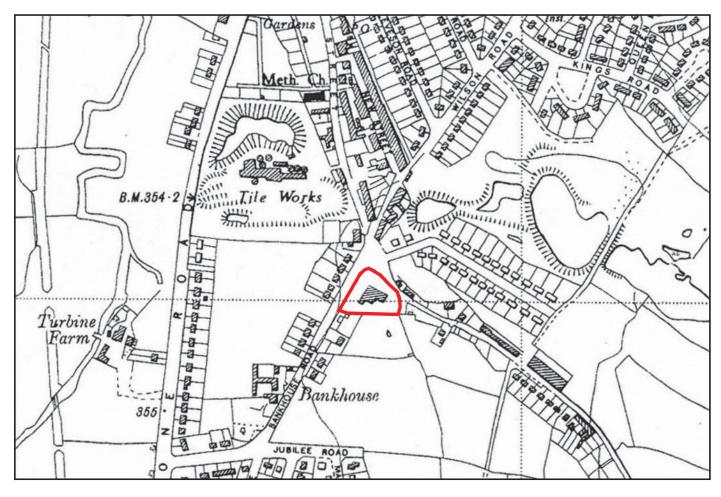
Figure 3: The replacement Bull's Head public house shown on an Ordnance Survey map of 1950. Scale 1:5,000.

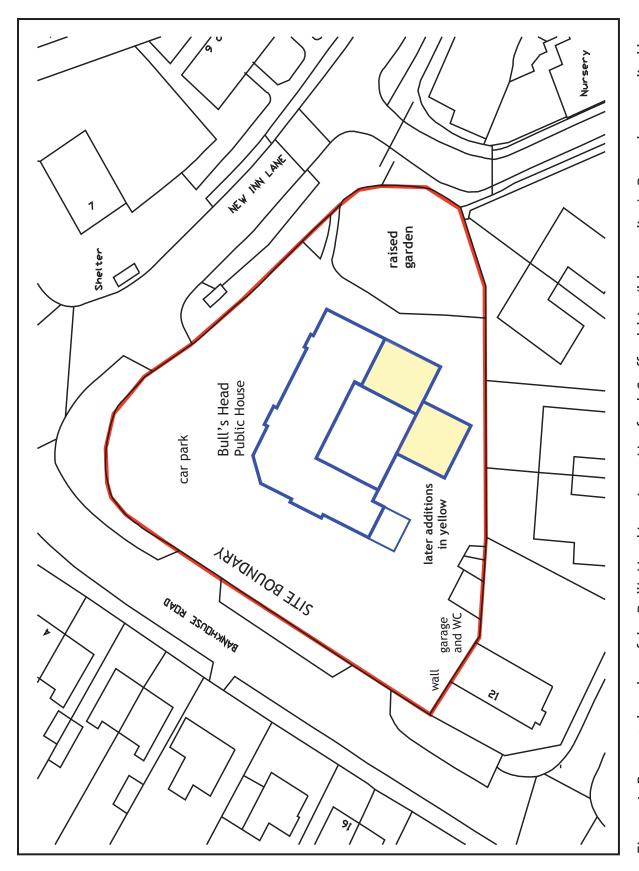
Figure 4: Present-day plan of the Bull's Head Inn site at Hanford, Staffordshire (blue outline). Base plan supplied by client's agent. (Ordnance Survey map reproduced with the permission of Her Majesty's Stationery Office. © Crown Copyright Licence No. AL 100020618).

- 2.1 The building is situated at the south corner of the junction of New Inn Lane and Bankhouse Road at Hanford, south of Stoke-on-Trent in Staffordshire (Figure 1). The overall site is roughly triangular in shape and is occupied by the public house, a small outlying garage and former WC, a raised beer garden area and tarmac-covered car parking areas (Figure 4). The site lies on high ground to the east of the River Trent.
- 2.2 It is currently proposed to demolish the existing structures and use the site for redevelopment. This work will entail intrusive ground-works which will impact upon any surface and below ground archaeology that may exist on the site.

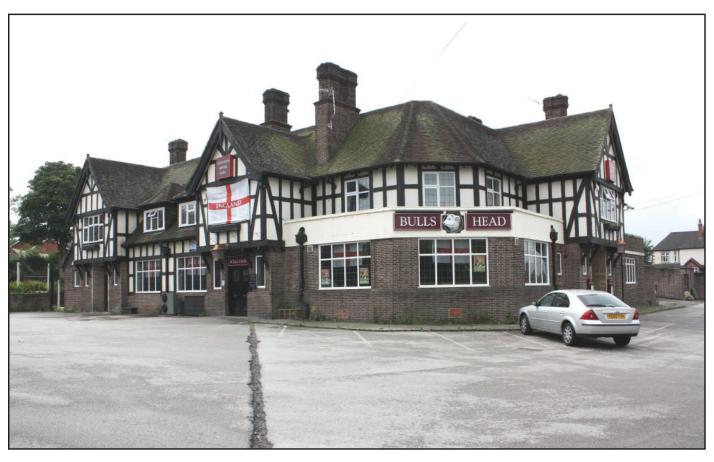
Plate 1: View towards the north corner of the Bull's Head public house, Hanford, Staffordshire.

4.2.1 The Bull's Head is a fine example of a roadhouse of 'brewers' Tudor design.' It is largely two storey in height with single storey sections to the rear and on the south-east side. It faces north-west and north-east with a half-timbered first floor with three gables jettied forward and dormer windows (Plate 1). Tall double chimney stacks rise above the tiled roof. Brickwork consists of reddish-brown narrow 2 inch thick bricks (with the more standard 3 inch brick showing in the cellars); herringbone infill is used at the east end (Plate 2). Further ornamentation shows on the bargeboards (Plate 3), on down-pipes and rainwater heads (Plate 5) and on ashlar flanking the three main entrances. The only remaining original leaded window shows in the attic of the east gable end (Plate 4).

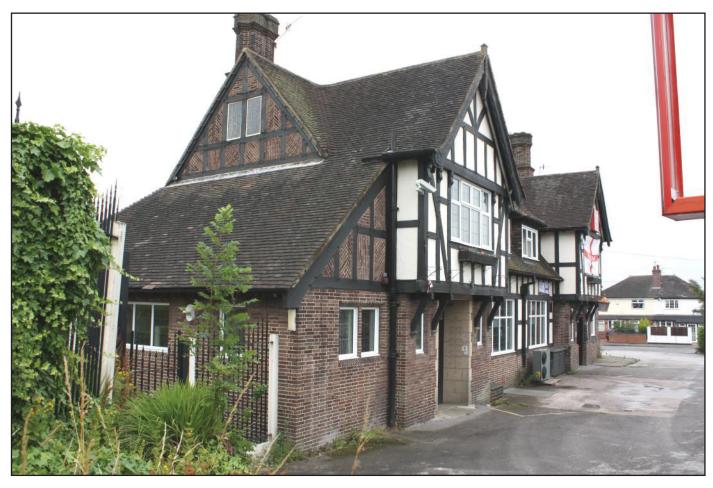
Plate 2: View along the north-east frontage of the Bull's Head public house at Hanford, Staffordshire.

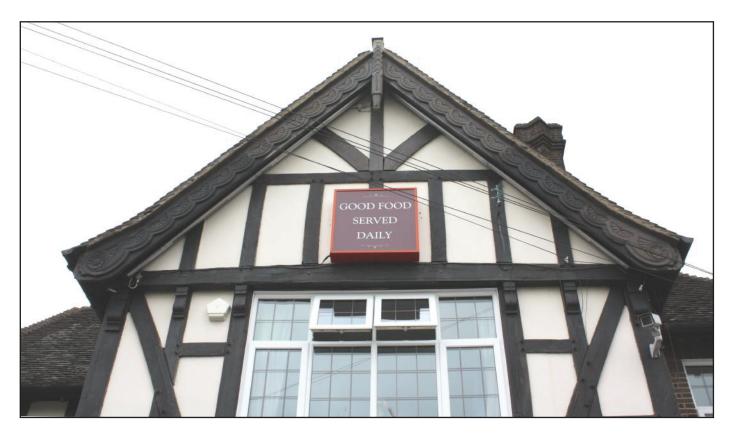
Plate 3: View of timber panels and decorated barge-boards on the north-east facade of the Bull's Head public house, Hanford, Staffordshire.

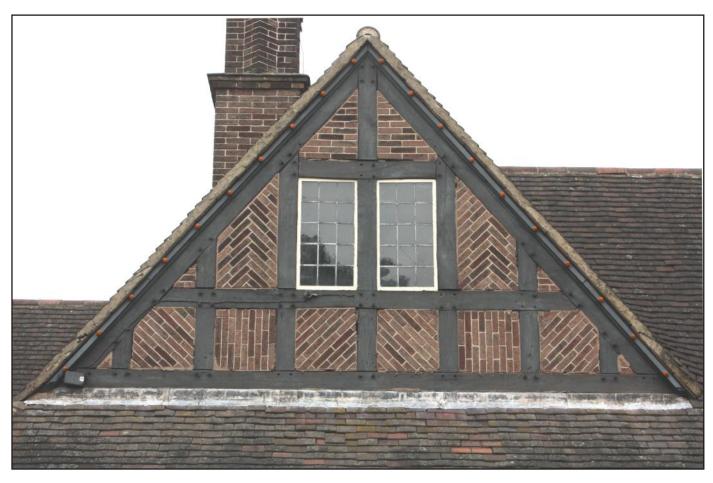
Plate 4: View of brick infill (nogging) to timber panels and the last remaining original leaded lights in an attic window in the south-east gable-end of the Bull's Head public house at Hanford, Staffordshire.

- 3.6 The Bull's Head has been extended to the rear on at least two occasions with what may be deemed architecturally unsympathetic single-storey extensions, for an enlarged function room and modern kitchen and storage facilities. Only a single original leaded window now survive in the attic of the east gable end of the 1938 part of the building. Nevertheless, the rest of the exterior and most of the ground floor area are as originally built and decorated. Although not listed it is sufficiently intact to warrant a status of being a building of local interest.

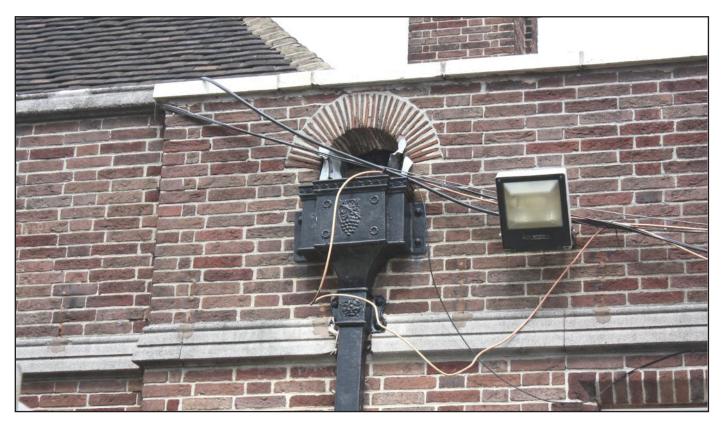
Plate 5: Decorative cast-iron rainwater head on the rear frontage of the Bull's Head public house, Hanford, Staffordshire.

- 4.2.2 At the back of the building there is a single gable roof over a first storey bathroom and an expanse of flat roofing over the bar at the centre of the inn. At the south-west corner of the building an (?)unroofed single storey area gives access to an open stairway that rises to the first floor level; this may have acted as a fire escape, although its now blocked-off entry point is adjacent to the main staircase up from the ground-floor lobby. The building has been further extended at the back to enlarge the function room (Plate 6) and to extend the kitchen facilities.

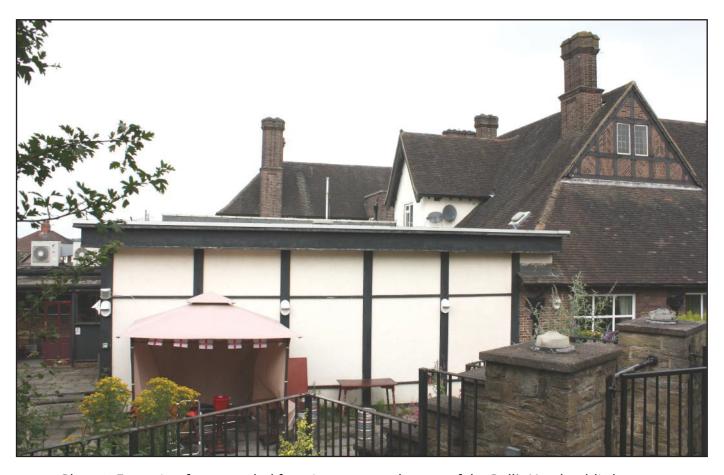
Plate 6: Extension for expanded function room at the rear of the Bull's Head public house, Hanford, Staffordshire.

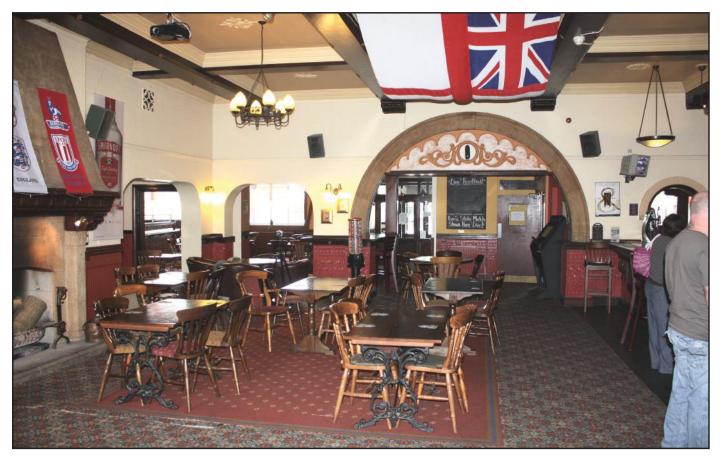
Plate 7: Public bar G2 with high ornamental arch, at the centre of the ground floor of the Bull's Head public house, Hanford, Staffordshire.

- 4.2.3 The ground floor level of the interior was laid out with two large bars (G2 and G8), a lounge (G6), dining room (G7; for paying guests and visitors), a smoking room / function room (G10), kitchens and storage (G12) and toilet facilities. There are many surviving original features although the windows have been replaced, some additional openings made in the walling to open up the interior and parts of the wall decoration altered. There remain some original Tudor-style fireplaces (Plate 7), ornamental woodwork and tiling (Plate 9) and detailed plasterwork, especially within Room G6, the most lavishly-decorated of all the rooms (Plate 10). The Tudor rose features as an emblem in various locations and contexts throughout the ground floor area. The plainer public bar / billiard room G8 on the north side of the building has a typical 1930s fireplace and a rustic-style counter (Plate 8).

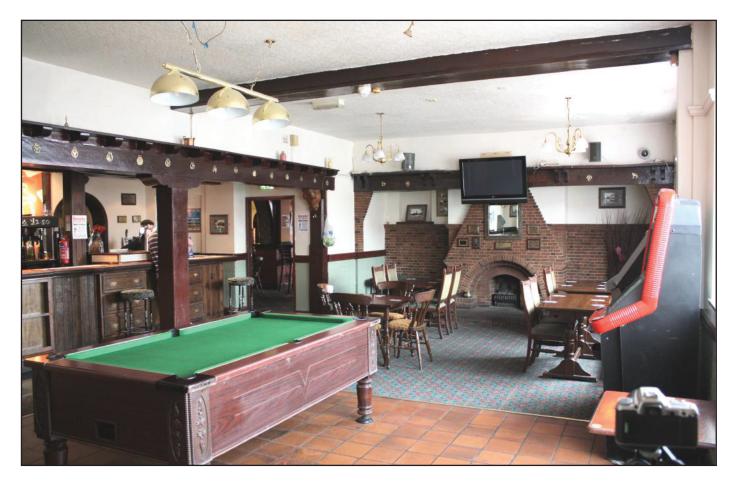
Plate 8: The plainer decorated public bar G8 on the north-east side of the Bull's Head public house, Hanford, Staffordshire.

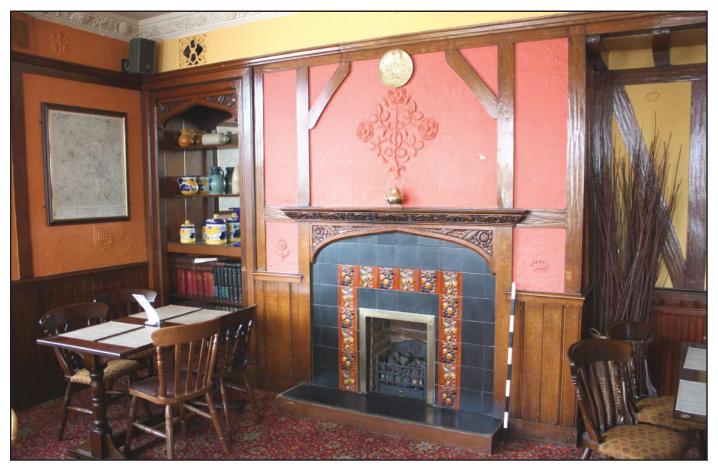
Plate 9: Decorative tiled fireplace and wall panelling in lounge G6 in the angled corner of the Bull's Head public house, Hanford, Staffordshire.

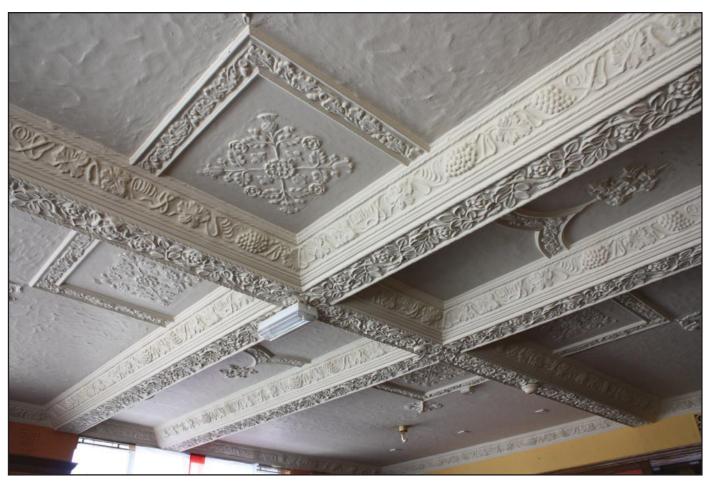
Plate 10: Decorative plasterwork on the ceiling of lounge G6 in the Bull's Head public house at Hanford.

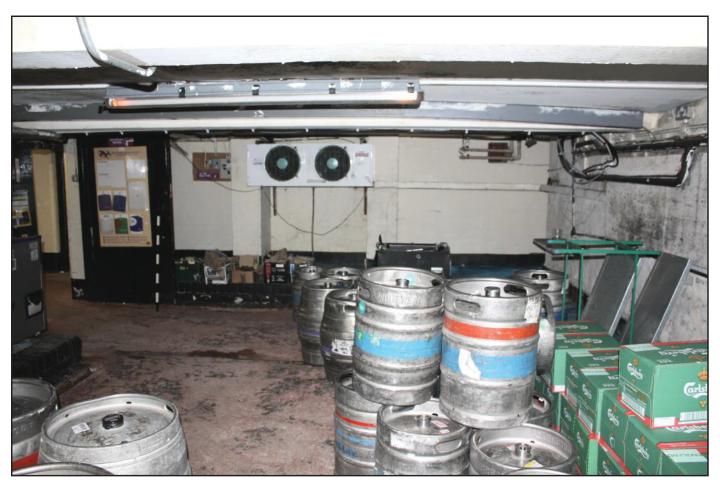
Plate 11: Cellar C8 in the Bull's Head public house, Hanford, Staffordshire.

- 4.2.4 Stairs lead down to a large cellarage area beneath the two-storey high part of the building. This has three delivery entry points, including an added one for a hydraulic lift or hoist; the mechanism of which no longer remains. A series of cellar rooms on the north side have entry doorways which can be locked. One of these (to C6) still has a distinctive number '10' affixed to its outer side. Numbering of individual rooms within a pub was standard practice for Customs & Excise control purposes until the 1960s. This is the only surviving example. Cellars C7 and C8 have low *thralls* (a term commonly used in the Nottingham area for brick or stone benches in pub cellars) for casks to stand on (Plate 11).

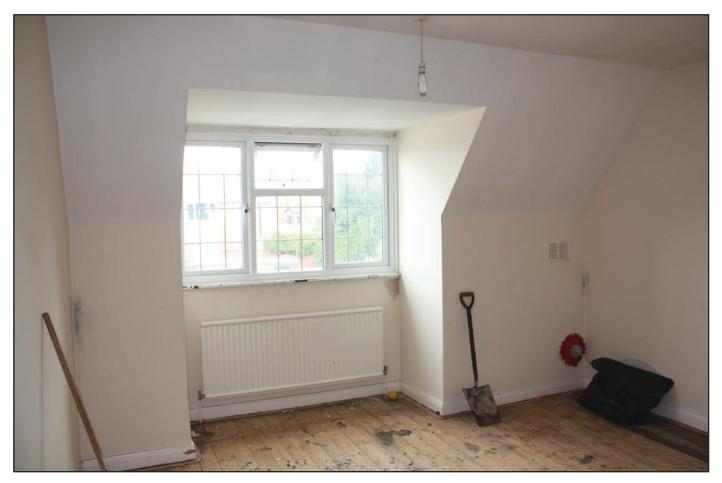
Plate 12: Room F6, one of the now plain and undecorated former hotel rooms on the second floor of the Bull's Head public house, Hanford, Staffordshire.

- 4.2.5 The first floor consists of a series of eight rooms of variable size, set out to the north and west of a continuous corridor. Two small storage rooms and a bathroom / WC are situated on the other side of the corridor. Most of the rooms have blocked off fireplaces (apart from F6) and are lit by large windows set within recesses (Plate 12). Most of these rooms would have been intended for paying guests as the Bull's Head was referred to as an hotel when opened in 1938 (see above). Now though, the rooms are plainly decorated and no original schemes survive.

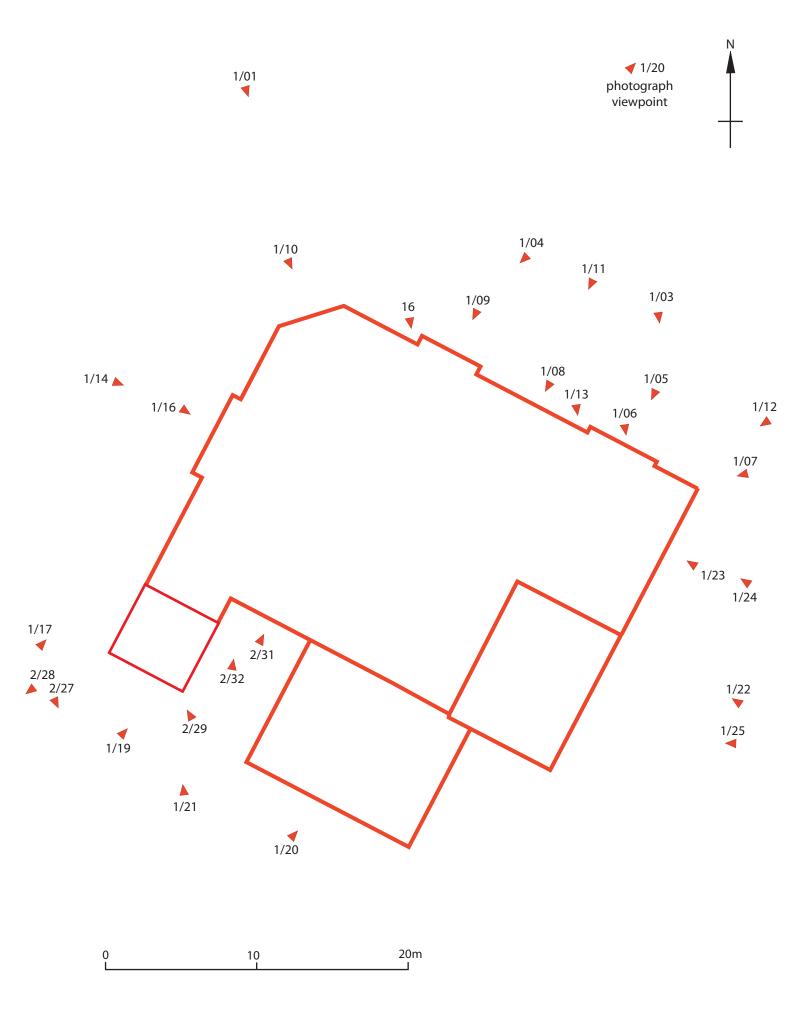
Figure 12: Plan of Bull's Head Inn, Hanford, showing the external film photograph viewpoints (1/01-2/32). Scale 1:250.
