**AN ARCHAEOLOGICAL
WATCHING BRIEF AT
WHITE HOUSE FARM,
SAMWORTH WAY,
MELTON MOWBRAY
LEICESTERSHIRE, 2010**

**A report for
Clegg Food Products Ltd**

OS Grid Ref. SK 7362 1800 (centred)
TPA Project Code: FMF.1
November 2010

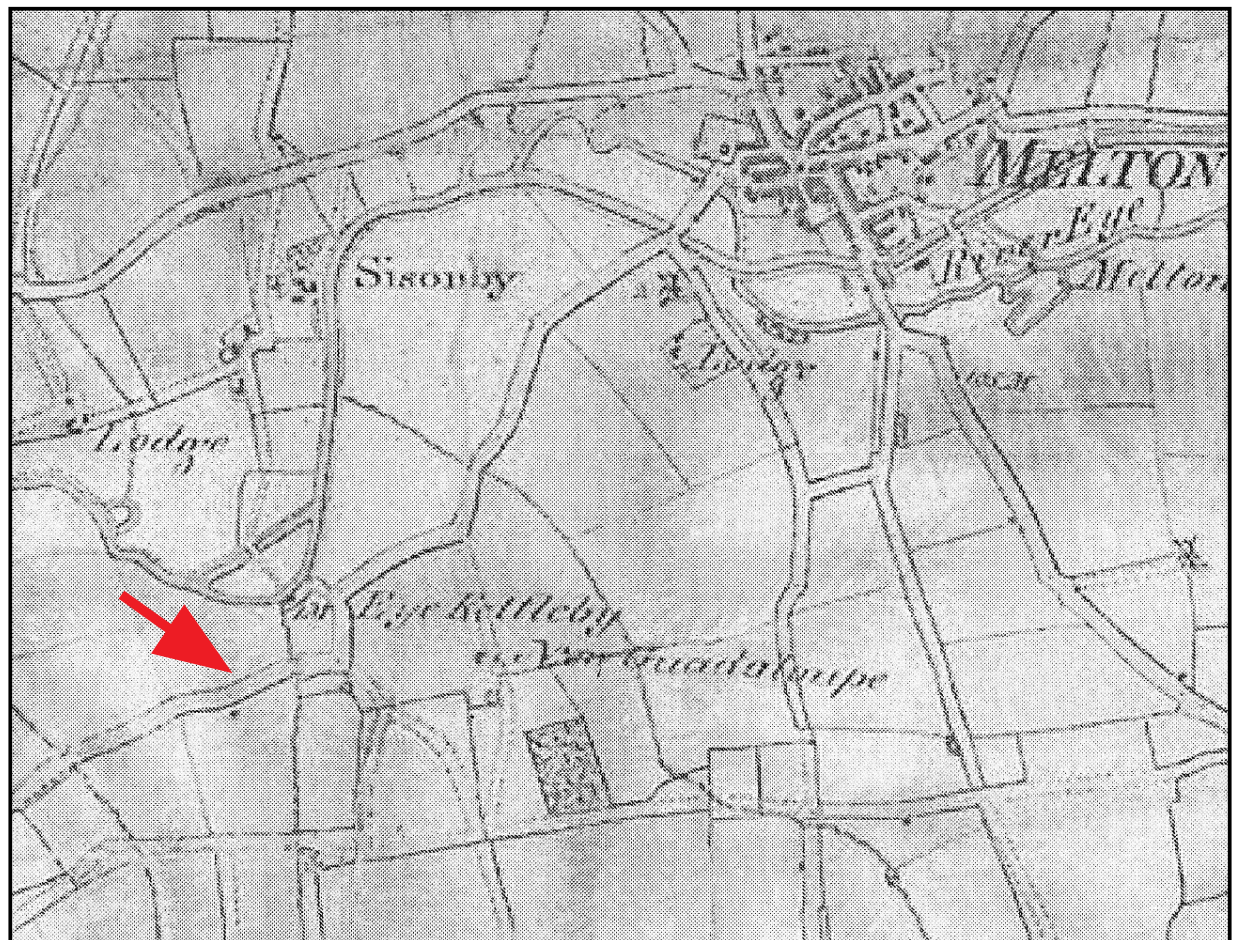
Figure 3: Site location highlighted on an Ordnance Survey drawing of the Melton Mowbray area by Boyce in 1816. Not to regular scale.

Prior's county map of 1777 show the study area open but with the former site of Eye Kettleby Church marked in a position very close to the later farm (Fig. 3). The latter was probably built in the early 19th century, its brickwork suggesting that it was probably built not long after 1816 when it was still not shown on an early drawing for the Ordnance Survey (Fig. 4). The farmhouse was a small two-cell, two storey building with a central entrance opening to a straight flight of steps; it was later extended at the back. Ordnance Survey maps from 1883 show an 'old sand pit' to the north of the farmhouse but this was later reopened and eventually extended to exploit sand (pre-Glacial deposits, Bytham Sands) around three sides of the farmhouse and an adjacent barn, leaving them standing alone on a high point (Plate 1), on what the British Geological Survey map 142 shows as Oadby Till. Now abandoned, the farmhouse is still largely intact, whilst other farm buildings within the study area have decayed.

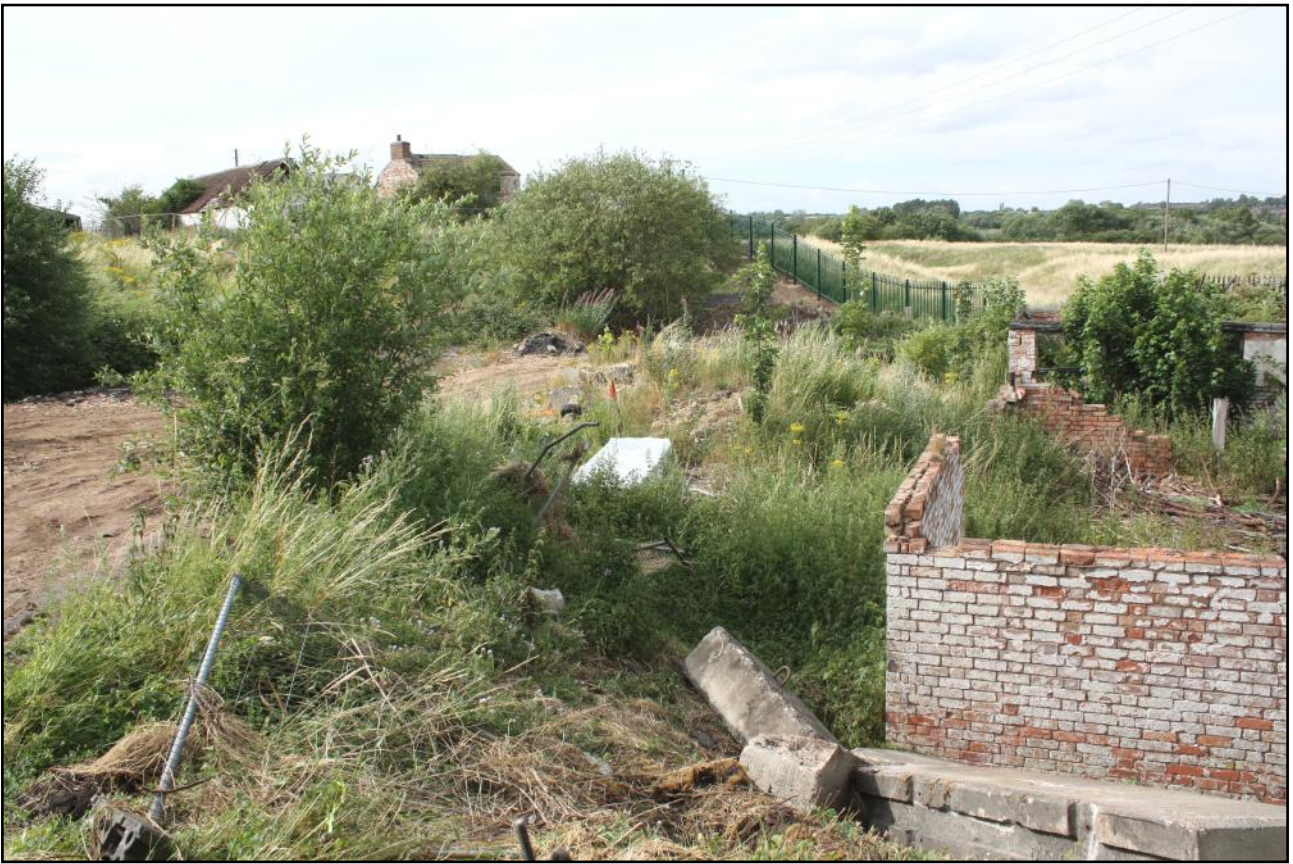
Plate 1: View of the farmhouse, barn (top left) and another derelict farm building at White House Farm, Samworth Way, Melton Mowbray.

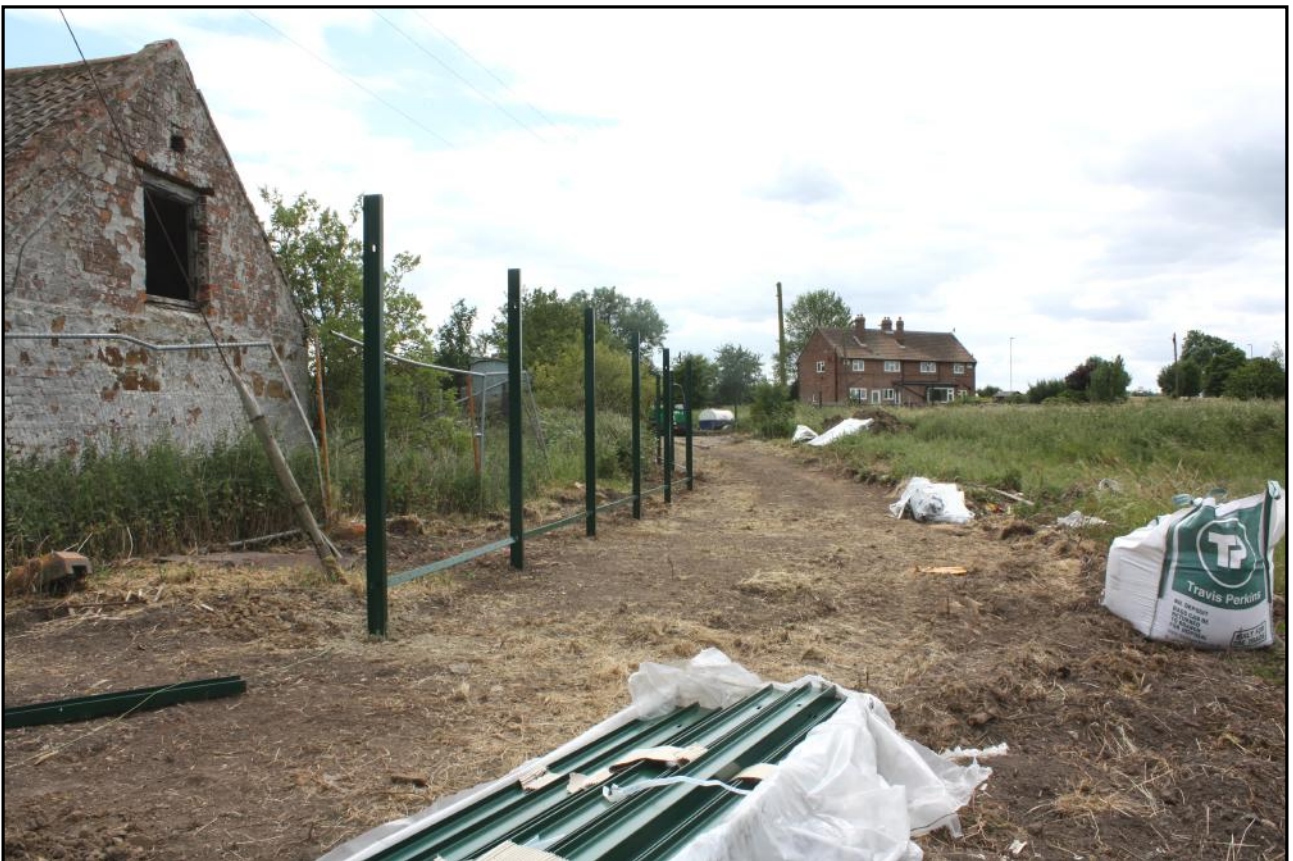
Plate 2: Fence posts in the process of being installed in the west part of the site at White House Farm, Melton Mowbray.

The fenceline was erected to surround most of the study area, with a gap between holes 1 and 111 at the west end bridged by an existing garden boundary. At the east end the fence was extended to an existing brick wall and here was diverted in part from its intended line further to the north because of dense vegetation and awkward banking (Fig. 8). Apart from where entrances were positioned midway within the north and south sides, all postholes were generally excavated to uniform dimensions - 300mm square, 600-700mm deep and set 2.75m apart. Metal posts were then inserted and held in place by concrete (Plate 2). A total of 145 holes were excavated and with the exception of 2 of these, all were recorded.

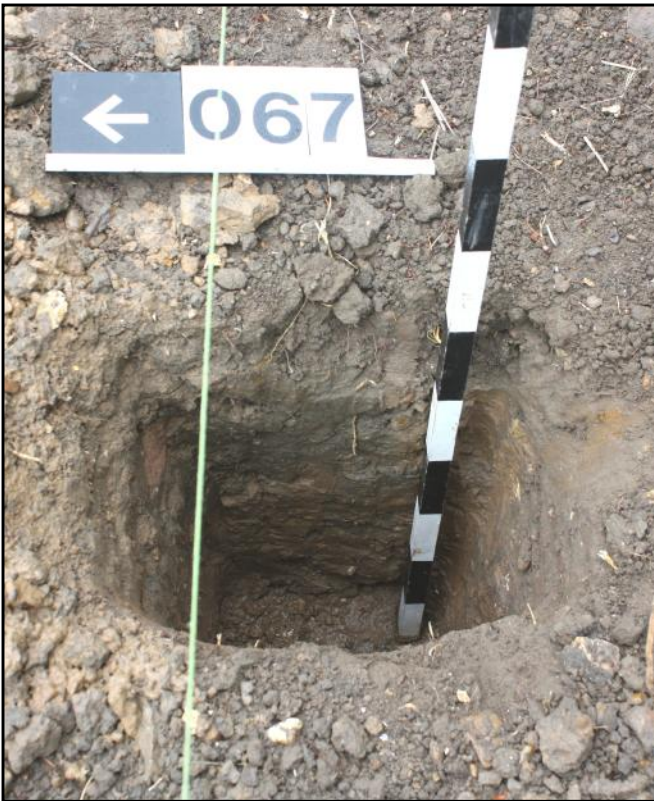
Plate 3: Example of the most typical section of the postholes at White House Farm, showing sequence of remains of topsoil, subsoil and yellow clay natural.

Most of the postholes were of uniform stratigraphy: lower part of the topsoil (the upper part having been removed in an initial stripping of the fenceline); subsoil and then natural silty clay (sometimes with chalk inclusions) or sand. Variations in the content of the subsoil and the makeup of the natural were noted and the removed spoil was checked for finds. A chart of the postholes is included below.

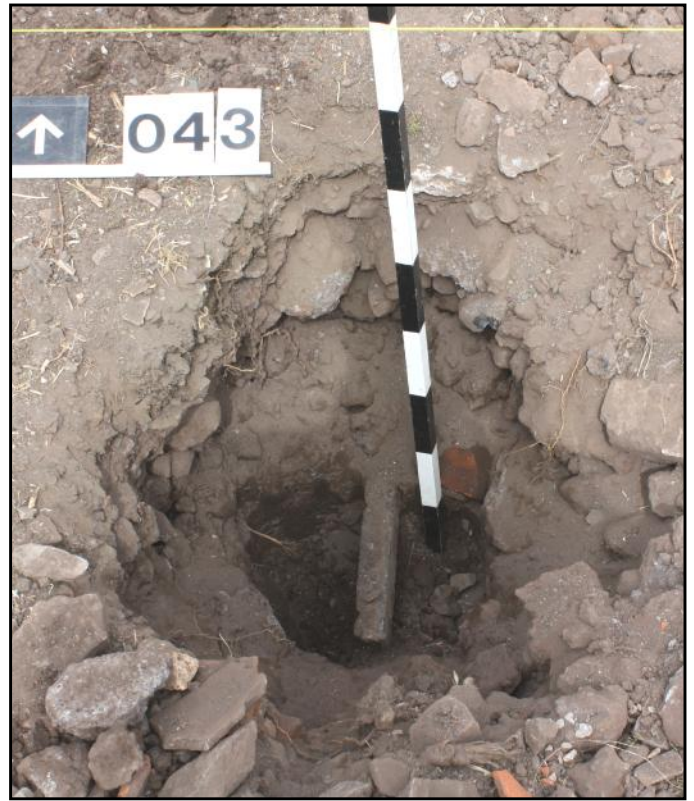
Plate 4: Example of a posthole at the north end of the site, filled with demolition rubble close to the former farmhouse.

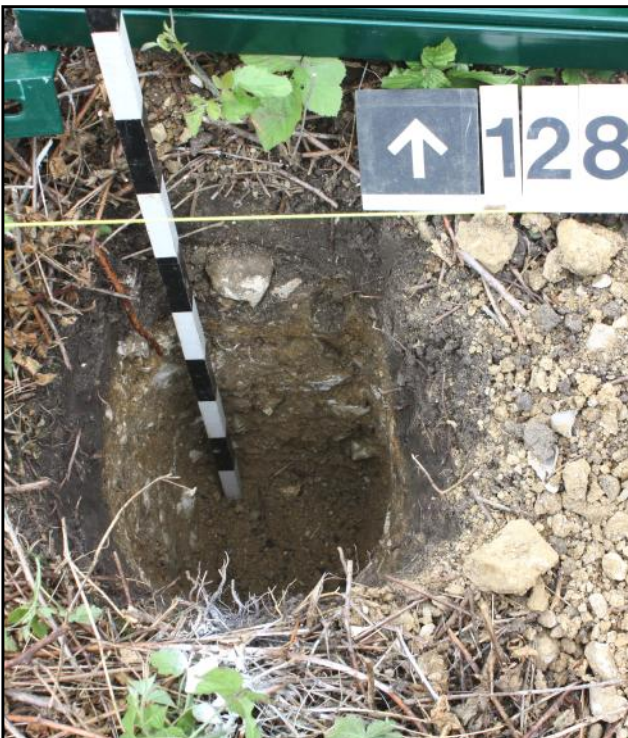
Plate 5: Example of a posthole on the south-west part of the site, with distinct white-flecked clay natural.

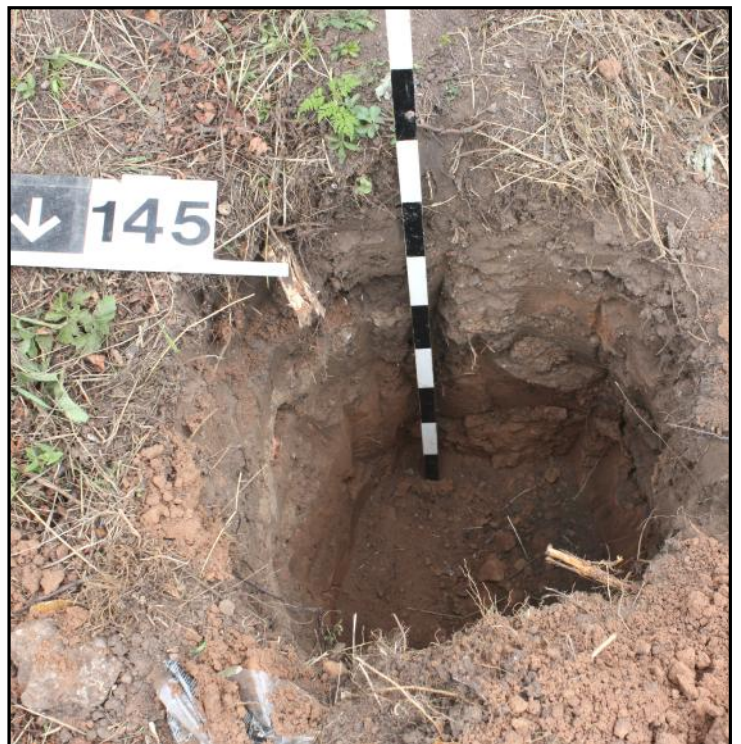
Plate 6: Example of a posthole on the south central part of the site, where a bright orange sand natural can be found.
