**AN ARCHAEOLOGICAL
EVALUATION OF THE
BULL'S HEAD INN SITE
HANFORD, STOKE-ON-TRENT,
STAFFORDSHIRE, 2010**

**An Archaeological Evaluation
at the Bull's Head Inn site,
Hanford, Stoke-on-Trent,
Staffordshire, 2010**

A report for Avery Healthcare Ltd

OS Grid Ref. SJ 86805 42010 (centred)
TPA Project Code: BHH.2
December 2010

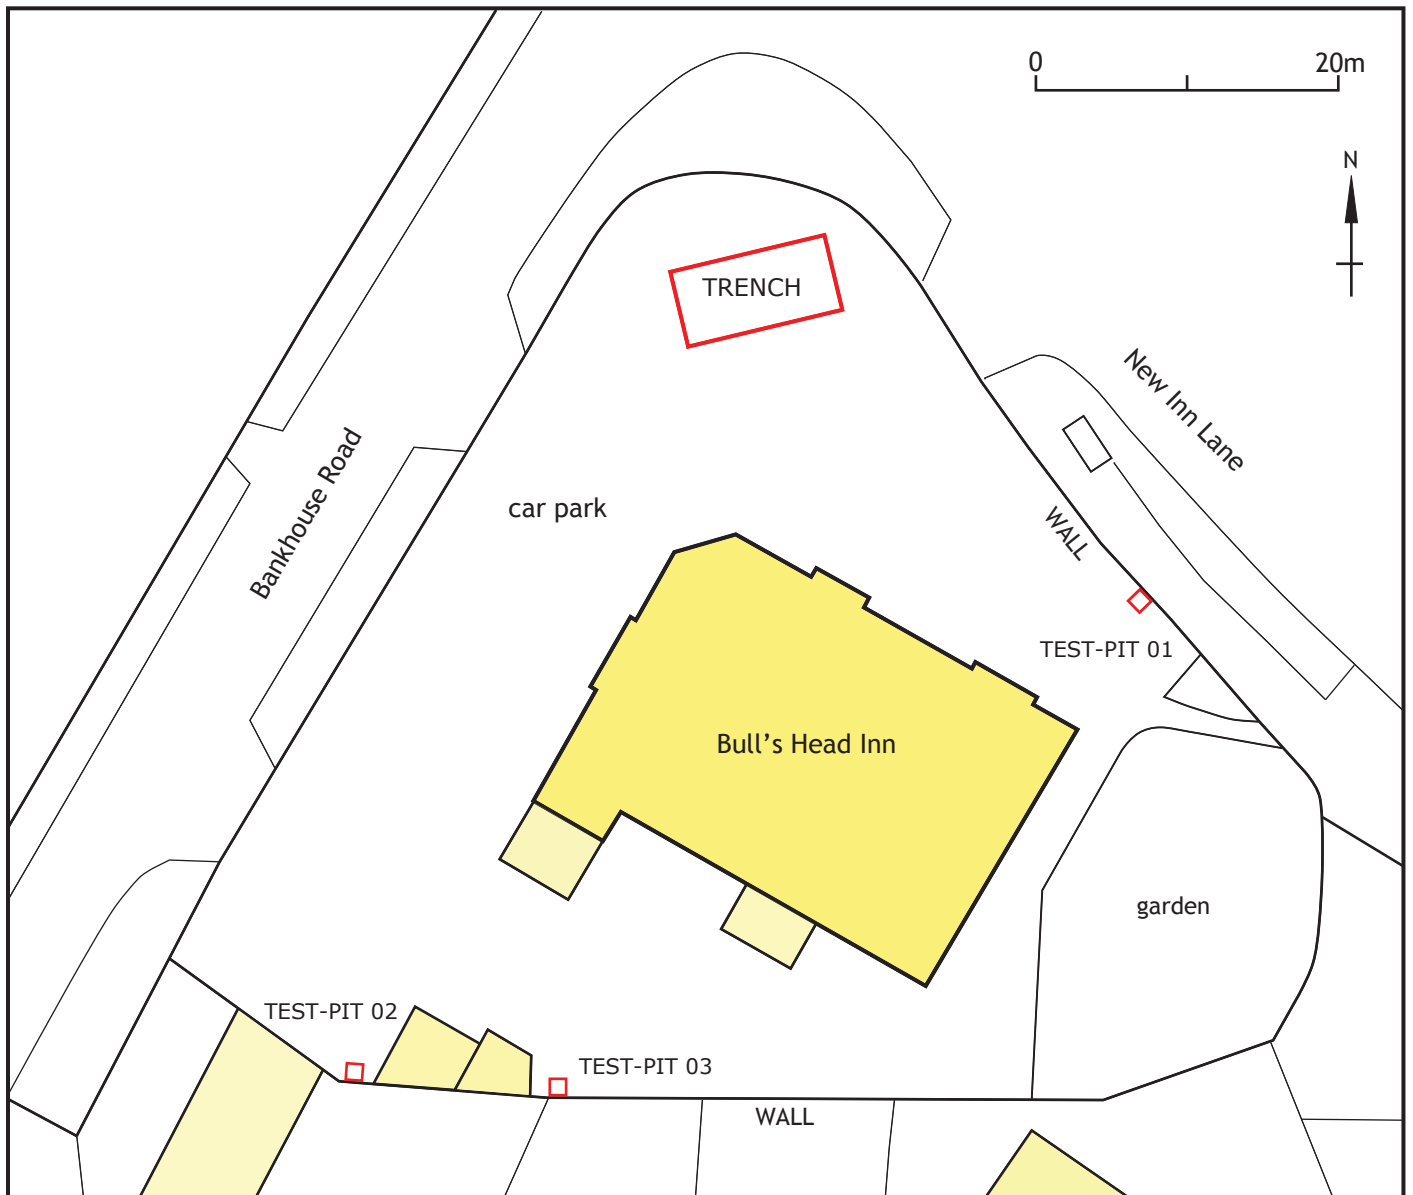
Figure 2: Plan of the Bull's Head Inn site at Hanford, Staffordshire showing the position of the archaeological evaluation trench and three test-pits excavated in December 2010. Scale 1:500.

An evaluation trench measuring 10m x 5m was machine excavated under archaeological supervision to the north of the Bull's Head Inn, within the current car park (Figs 2-4). Beneath the tarmac of the car park (0001) there were two foundation layers, an intermittent layer comprising tile and brick (0002) c.0.10m thick, beneath which there was a layer extending over the entirety of the excavated area consisting of brick and concrete (0003). The base of this was c. 0.30m below the surface of the tarmac. These layers formed the foundation for the car park. Layer (0003) rested upon the underlying natural light red sandy clay geology (0004). The nature of this material was checked by the excavation of a deep sondage or test-pit in the north-

Three test pits measuring 1m x 1m were machine excavated under archaeological supervision (Figs 2, 5). Test Pit 01 was located in the car park to the east of the Bull's Head Inn and Test Pits 2 and 3 to the south and south--west. The test pits were excavated to assess the foundation depth of the walls enclosing the car park.

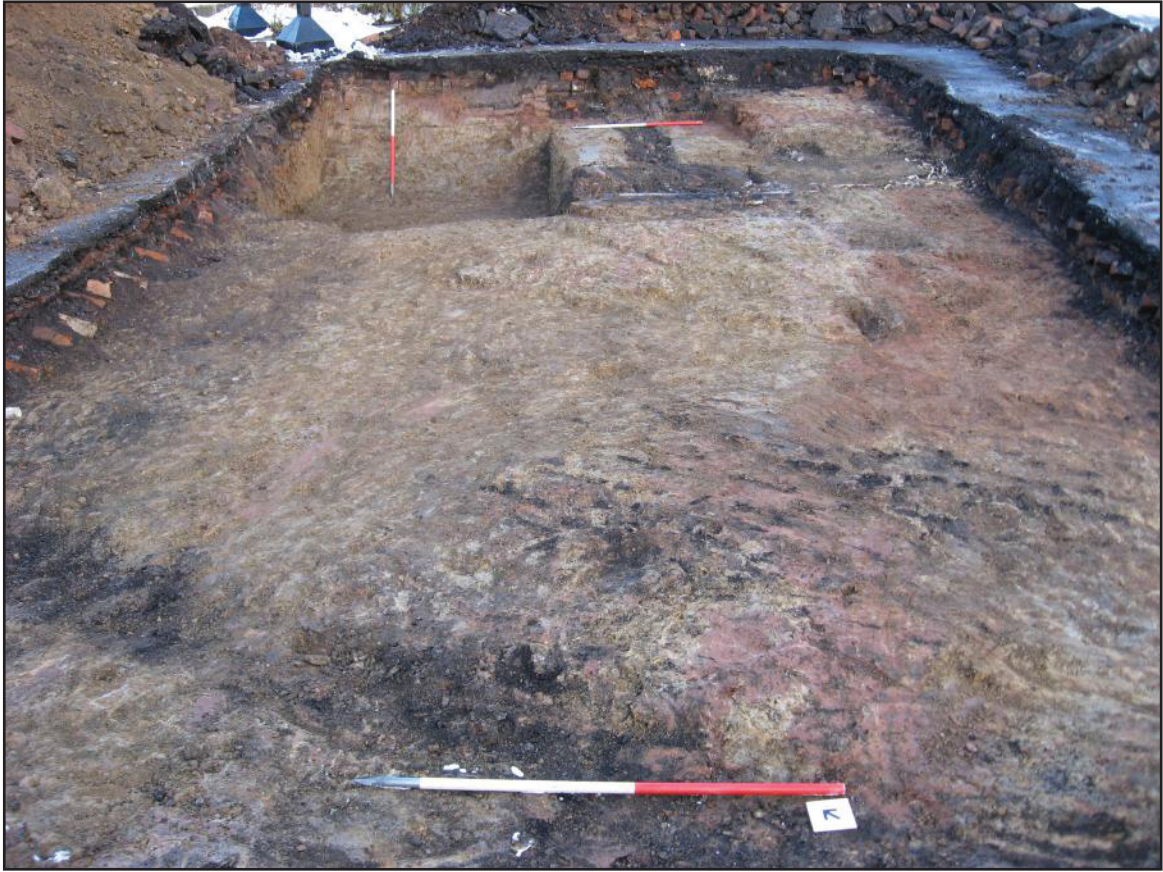
Plate 1: View looking eastwards along the length of the archaeological evaluation trench at the Bull's Head Inn site at Hanford, Staffordshire.

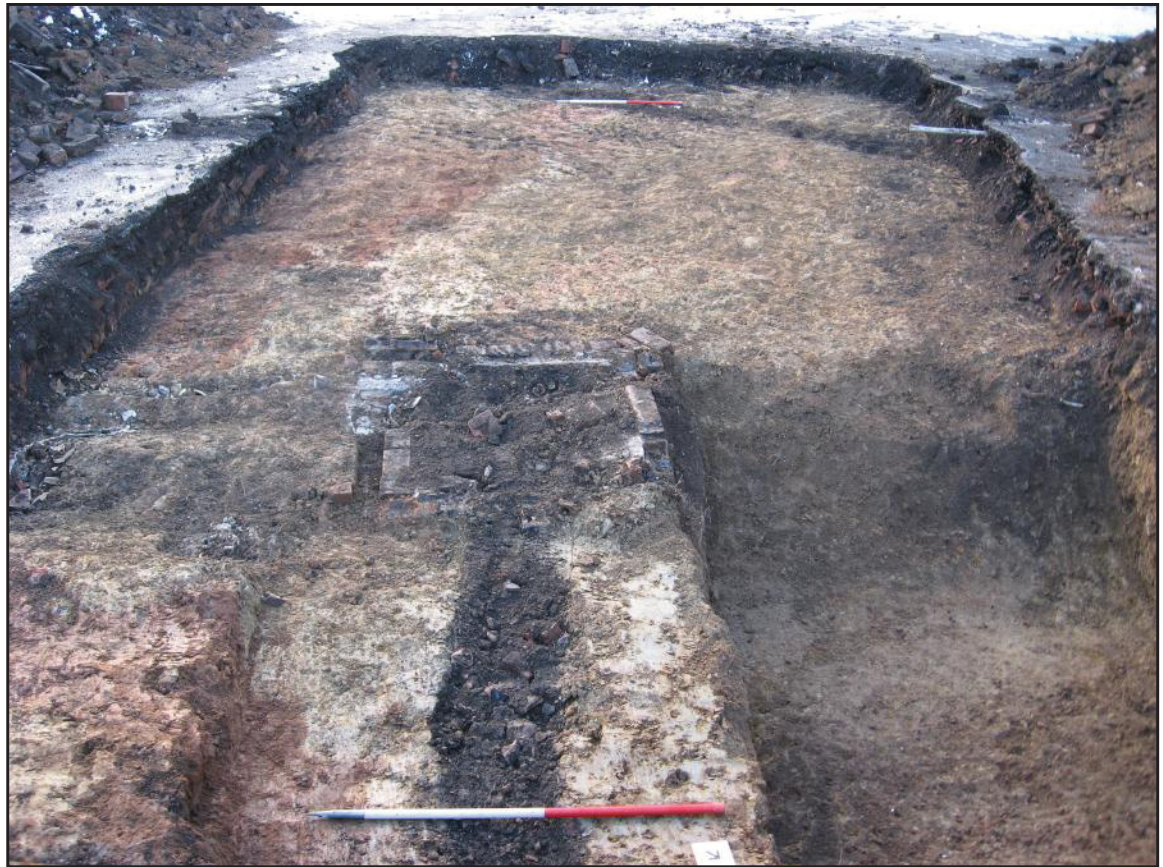
Plate 2: View looking westwards along the length of the archaeological evaluation trench at the Bull's Head Inn site at Hanford, Staffordshire.

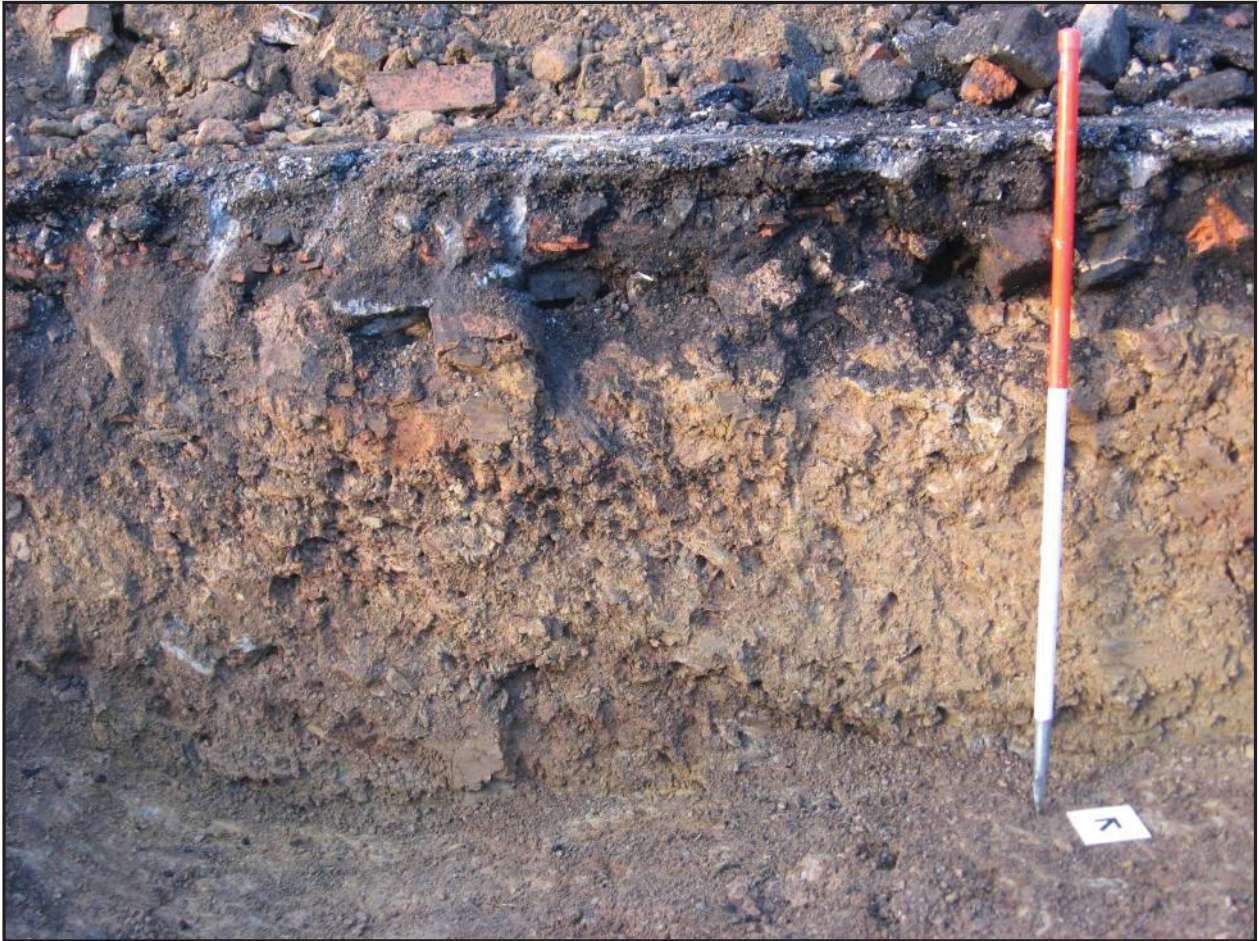
Plate 3: Part of the south-facing section of the sondage in the archaeological }
evaluation trench at the Bull's Head Inn site, Hanford, Staffordshire.
