AN HISTORIC BUILDING SURVEY AT PASTURES FARM, LONG LANE, KIRK LANGLEY, DERBYSHIRE, 2011

by Richard Sheppard

OS Grid Ref. SK 2081 3806 TPA Project Code: PKL.1 March 2011

Trent & Peak Archaeology University Park Nottingham NG7 2RD

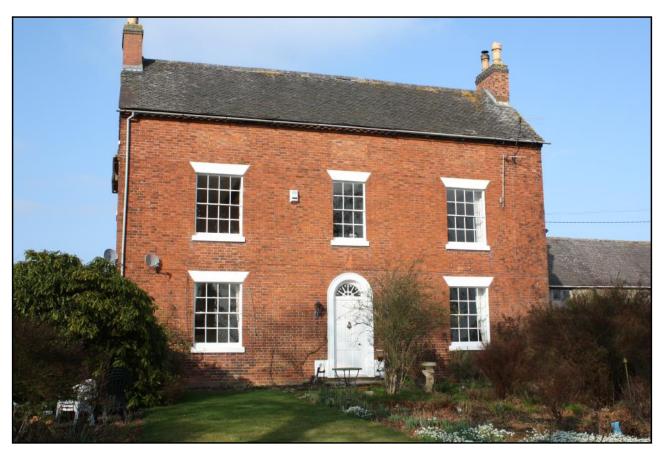
Plate 1: South frontage of the former farmhouse to Pastures Farm, Long Lane, Kirk Langley, Derbyshire.

The farmhouse has a 3-bay frontage onto Long Lane, two storey high with a garret, and at the back there are two adjoining gable extensions, both 2 bays long. A lower two-storey section that adjoins the east side has a large arched entry and this may have been used as a dairy.

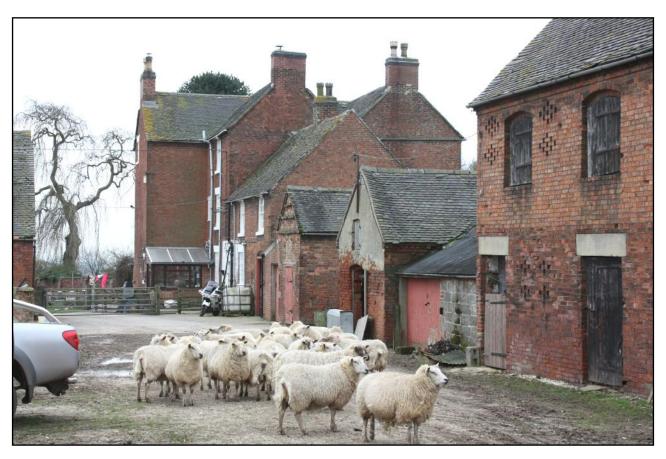
Plate 2: View looking south showing the rear of the former farmhouse, its rear extension and part of the north range (far right) at Pastures Farm, Long Lane, Kirk Langley, Derbyshire.

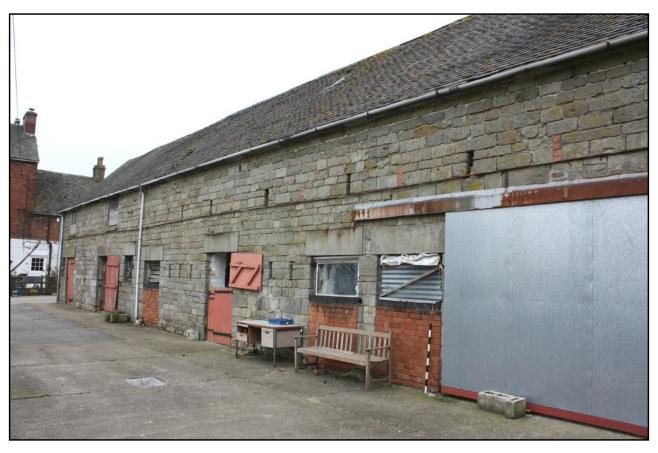
Plate 3: South frontage of the mainly stone-built central range at Pastures Farm, Long Lane, Kirk Langley, Derbyshire.

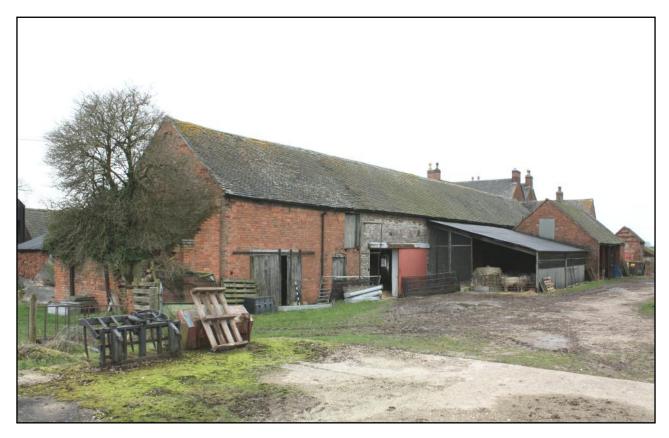
Plate 4: View looking south-west showing the north rear side of the central range, its brick-built eastern extension and the added cartshed and modern shelter shed.

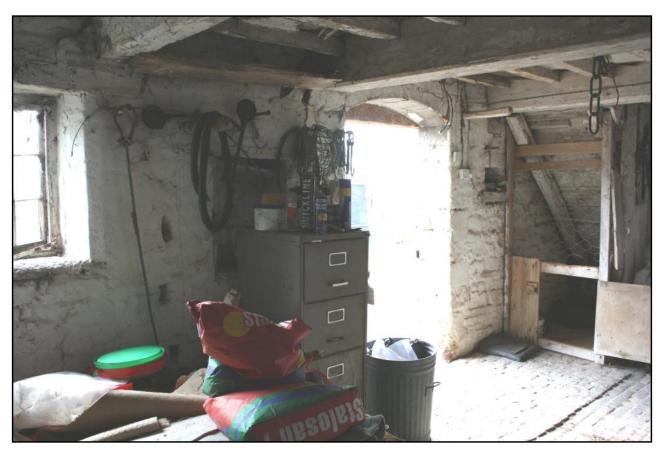
Plate 5: Room 2, a former stable in the central range of Pastures Farm, Long Lane, Kirk Langley, Derbyshire.

The west half of the building still retains its upper floor, with a gypsum plaster floor laid on slats. Rooms 1 and 2 were stables with space for 6 horses facing the back wall, although only Room 1 retains its stalling and trough. Pegs, cupboards and slots in the south wall indicate where harness was kept (Plate 5). Rooms 1 and 2 on the upper floor, reached by an internal staircase, have splayed windows and may have been used by the groom, although there is no evidence of this end ever having been heated.

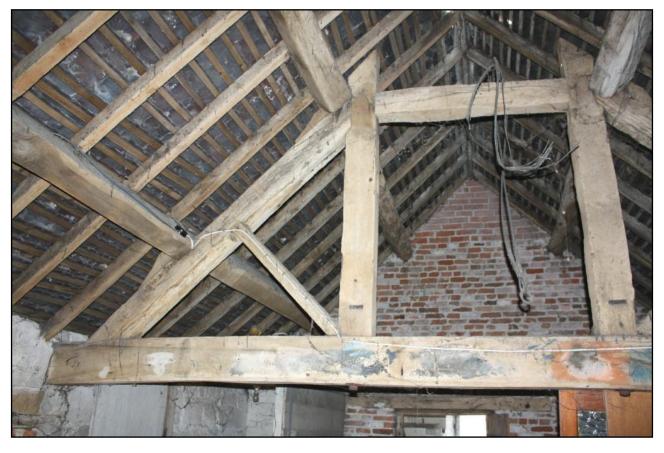
Plate 6: The upper floor of Room 2 showing the staircase (bottom left), a queen-post truss and internal brick walling.

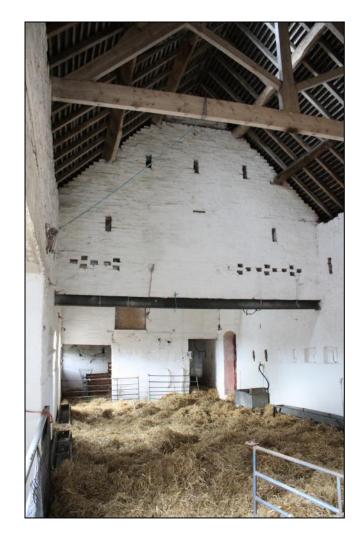
Plate 7: View of Rooms 4 and 5 in the central range of Pastures Farm showing a missing upper floor, vents within an internal wall and a king-post roof structure.

The east end of the building is much altered. Rooms 4-6 are now open to the roof, with the internal walling removed at ground floor level and the upper walling supported on girders (Plate 7). At ground level, opposing doorways in Room 4 suggest that there was a through-passage here and there may have been another within Room 5 (that in the south wall since widened). A doorway in the remaining wall between Rooms 3 and 4, next to the north wall, is consistent with there having been a feeding passage running the length from here to the doorway in the east end wall. This, and side ventilation throughout the east end of the building suggests that there were two through passageways and four compartments for milking and over-wintering cattle within the larger part of the building.

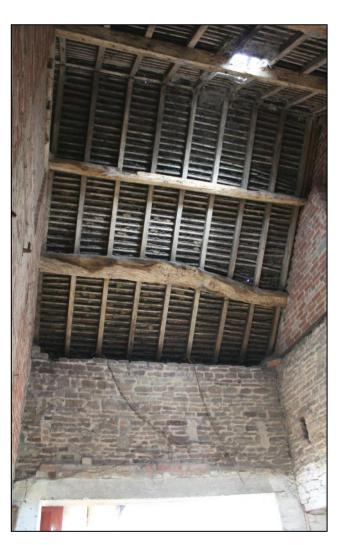
Plate 8: Roof structure above Room 6, the east end room of the original part of the central range.

The original part of the building is 9 bays long and with internal walls that divide it into 6 rooms of varying length (Figure 5). The roof is supported by 5 walls and three trusses, the west end one in Room 2 being of queen-post construction (Plate 6), the other two of later king-post form (Plate 7). A number of purlins are reused timbers with mortices and the roof above Room 6 features a heavy irregular beam on either side (Plate 8). The building has been re-roofed at least once.

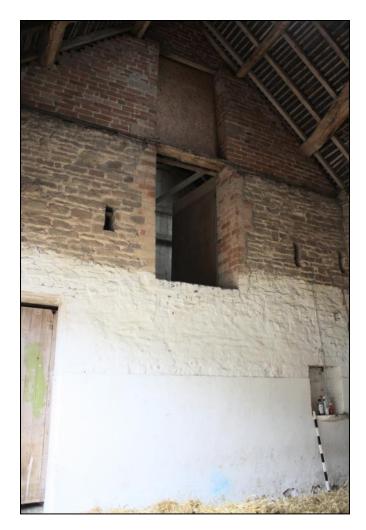
Plate 9: East end wall of the original part of the central range, showing three openings, gable-top brickwork and a cupboard (bottom right).

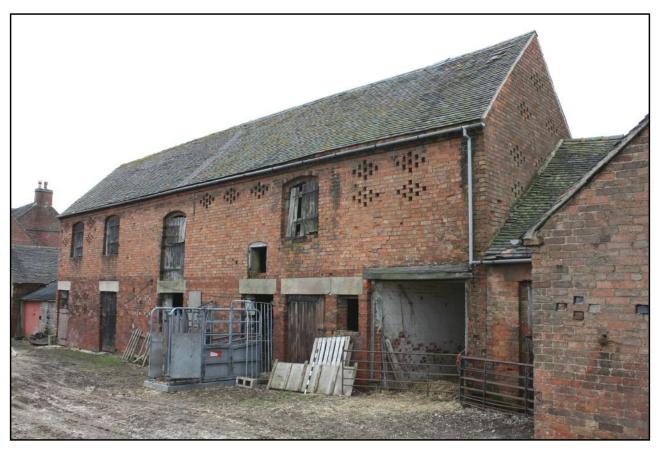
Plate 10: East frontage of the original part of north range at Pastures Farm, Long Lane, Kirk Langley, Derbyshire.

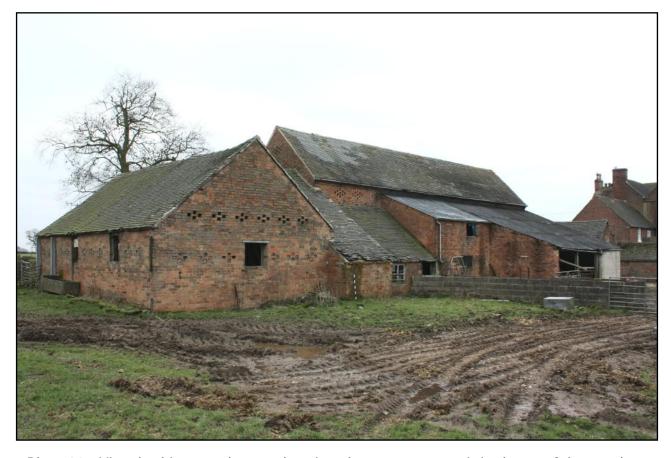
Plate 11: View looking south-east showing the two-storey original part of the north range and other additions on the north and west sides. The former farmhouse shows far right.

The north range originally consisted of a 5-bay long, two-storey block brick-built with a diamond-shaped ventilation pattern, dentilation and stone lintels and stone slabs built into the lower south wall (Plate 10). The brickwork is 2¾ (70mm) thick and 9⅓-9¼ ins. (222-235mm) long, a size of brick used as late as 1850. The range was built both shorter and narrower than the central range but was also divided into a series of rooms or compartments and it still retains a continuous upper floor. Separate detached buildings stood beyond its north and south ends, all now joined together to form a single structure, that has also been extended on its west side (Figure 6; Plate 11).

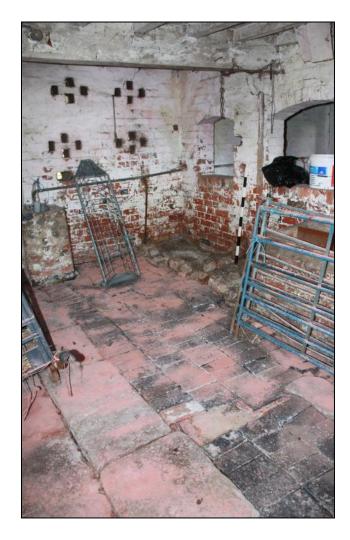
Plate 12: View of Rooms 1 in the north range of Pastures Farm, showing stone flagged floor, arched openings in the internal wall and diamond-shaped vents in back wall.

The south half of the original part of the building consists of two looseboxes (Rooms 1 and 3) separated by a feed area (Room 2), from where animal feed was passed through arched openings in the internal walls to troughs (Plate 12). Both rooms have stone-slabbed floors, dropping in level to drainage channels at the back, with doorways at either end. These rooms were probably for housing and feeding calves. Room 4 houses an internal staircase and may have also contained farm equipment. Room 5 was a stable for two horses (Plate 13) and Room 6 a gig-house. The upper floor is separated into five rooms with only a single truss and short heavy cross-beams supporting the roof (Plate 14). Close-set walling and cross-beams supporting the ground floor ceiling, together with a tall upper doorway and a low opening above the entry into Room 4 suggest that grain was stored on the upper floor. No separate granary exists on the farm.

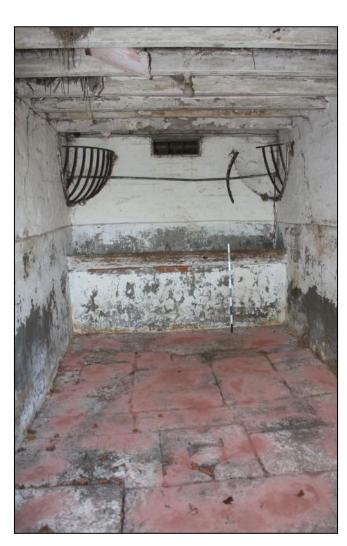
Plate 13: Former stable in Room 4 of the north range, with feed trough and hayracks showing to rear.

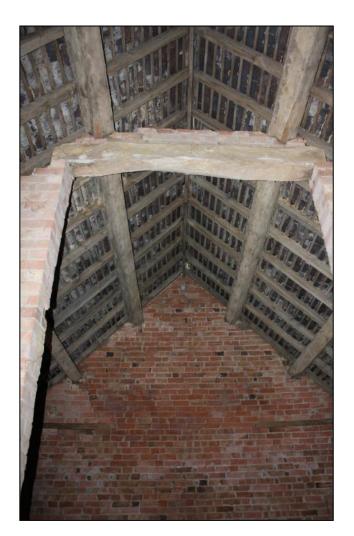
Plate 14: Roof structure and side walls at the south end of the north range (between Rooms 1-2).

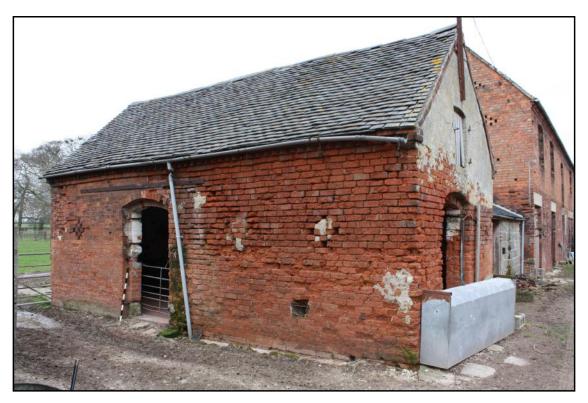
Plate 15: Former isolated building now at the south end of the north range of Pastures Farm, Long Lane, Kirk Langley, Derbyshire.

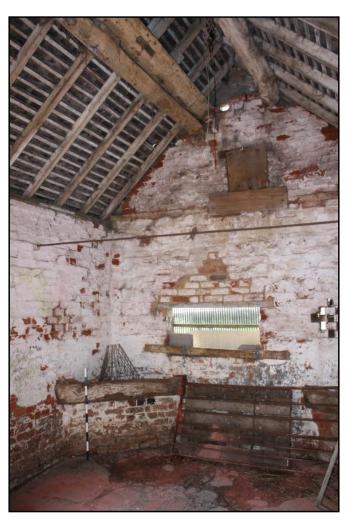
Plate 16: Internal view of the west room, showing corner feed trough, inserted window and roof structure.

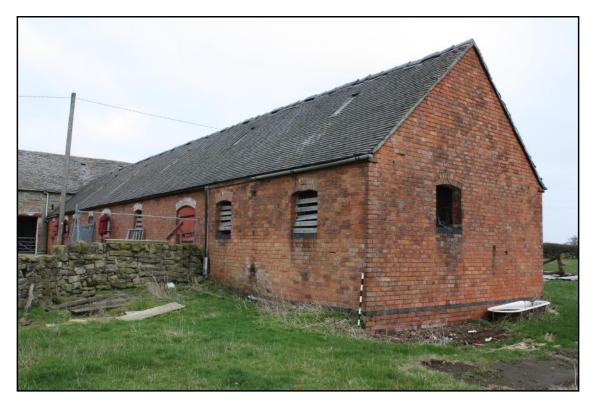
Plate 17: View of the single-storey south range of Pastures Farm, Long Lane, Kirk Langley, Derbyshire.

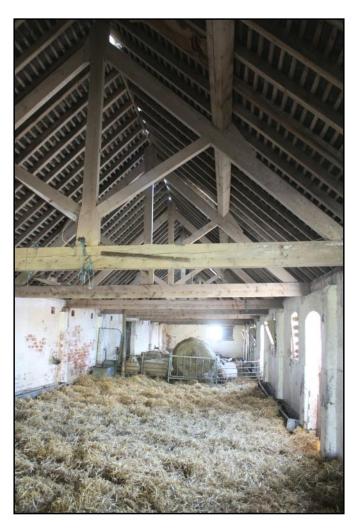
Plate 18: Internal view of the open 9-bay south range showing roof structure and lighting from west (right).
