**ST ANDREW'S HOUSE, NORTHSIDE,  
ST ANDREWS BUSINESS PARK,  
NORWICH NR7 0HT**

**AN ARCHAEOLOGICAL WATCHING  
BRIEF OF GEOTECHNICAL  
INVESTIGATIONS**

**An Archaeological Watching Brief of Geotechnical Investigations at St Andrew's House, Northside, St Andrews Business Park, Norwich NR7 OHT**

**NHER Number: 51597**

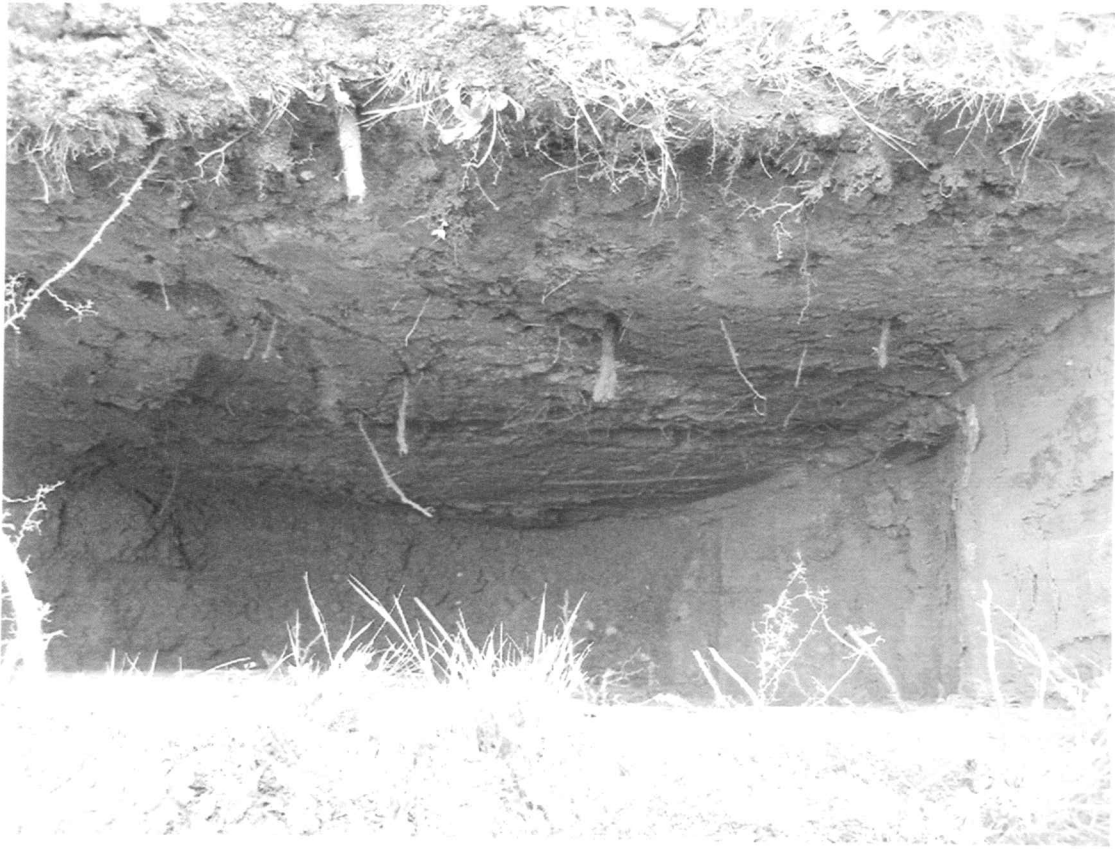
Test-Pit 13

- 4.13 Test Pit 13 (1.50m x 0.60m x 2.50m) was located in front and to south of the northeast wing of the hospital. A loose yellow natural sand with sandy clay lenses occurs 1.30m bgl [44]. This is overlain by a 0.50m thick poorly consolidated yellow silty-sand [43]. This layer was interpreted as weathered or re-deposited natural. The top of this layer occurred 0.60m bgl. Overlying this layer was a 0.25m thick loose yellowish-brown sand with occasional small brick fragments [42]. This is 19<sup>th</sup> or 20<sup>th</sup> century made ground. The top of this layer is 0.30m bgl. On top of this layer is a mid greyish-brown topsoil [41].

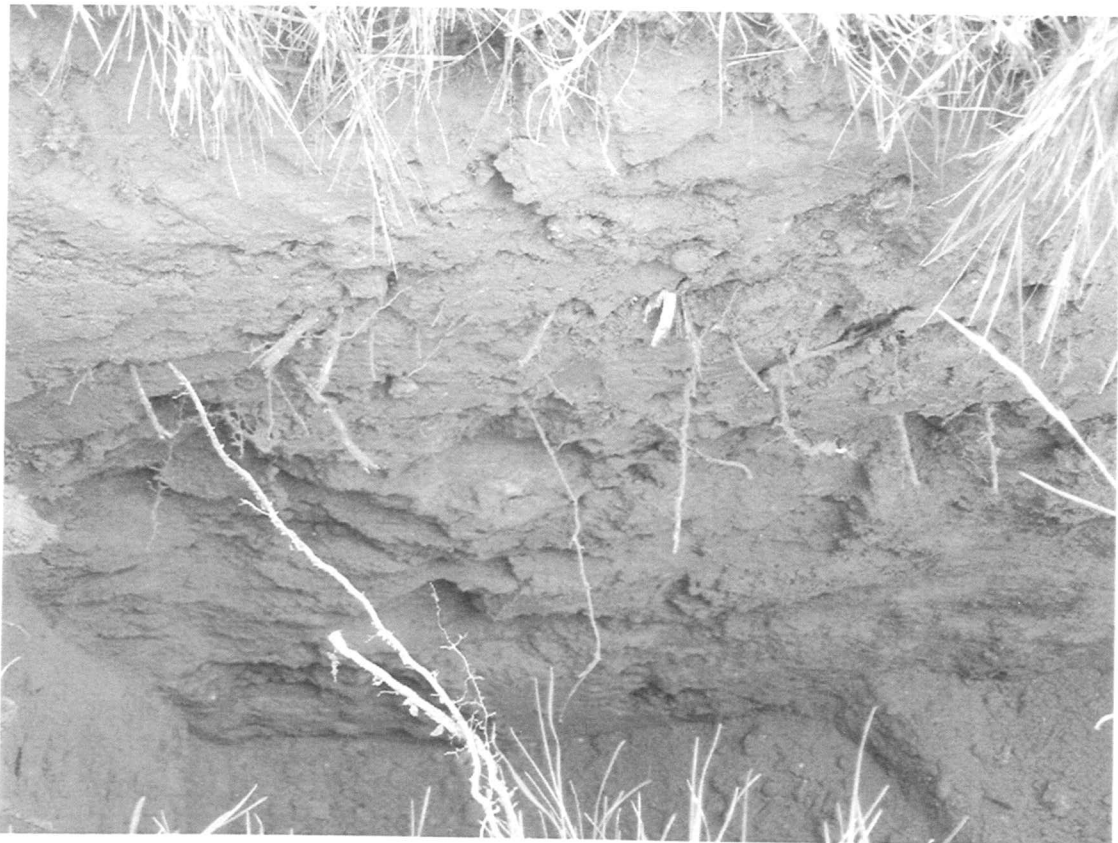
Test-Pit 14

- 4.14 Test Pit 14 (1.50m x 0.60m x 1.90m) was located near the northeast corner of the hospital. A layer of loose yellow and orange sand occurs 1.42m bgl [48]. This natural layer is overlain by a 0.48m thick layer of poorly consolidated orangey-brown sand [47]. Very occasional small modern brick fragments were observed in this deposit suggesting this layer is not a natural deposit. It is probably the result of 19<sup>th</sup> century landscaping. The top of this deposit occurred 0.43m bgl. This layer is overlain by a

0.20m thick, firm yellowish brown clay sand layer with small fragments of brick and lime mortar [46]. The top of this layer was 0.28m bgl. Overlying this layer was a mid brown sandy silt topsoil [45].
