**ARCHAEOLOGICAL BUILDING
RECORDING OF FOLKESTONE AND
HASTINGS GLASSWORKS,
MILL BAY, FOLKESTONE,
KENT**

SITE CODE: KFHG05

SEPTEMBER 2005

**Written and Researched by James Dixon
Pre-Construct Archaeology Limited, September 2005**

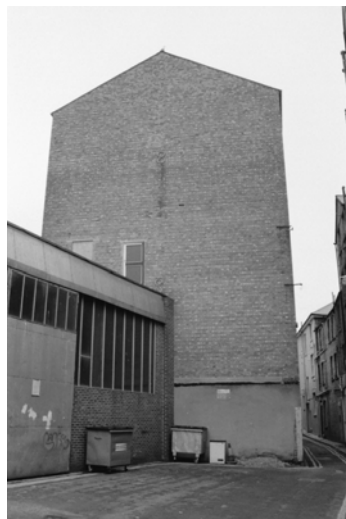
Plate 1: Building 2, South Facing Elevation

5.2.1 Building 2 is a functional, five storey warehouse building, the lowest of the floors being at basement level in relation to the courtyard, but at road level in Mill Bay. The exterior of the building is in Fletton brick laid in English Bond and measuring 235-240mmx118-120mmx68-70mm. The building is divided internally into five bays, but these are not evident from the building's exterior. The courtyard elevation, beginning above Building 4 shows three windows centrally placed on each of the third and fourth floors, these with brick segmental arches and concrete sills. All of the casement windows have iron frames. On the northeast elevation (Fig8a), the windows appear to show two bays, being set in pairs at either end of the building and on all floors, save for the ground floor where the second window from the south is replaced with a doorway. The windows on the ground floor are horizontally proportioned, those of the first floor elongated, and those of the top three floors are of the same proportion as the courtyard elevation. There is a brick stringcourse running around the building beneath the windows of the fourth floor. The southeast elevation is plain, save for a reverse 'S' reinforcing bar and two modern doors leading to the flat roof over Building 5. The northwest elevation holds the flue of a previously adjoining building, but was inaccessible for further analysis. This flue leads to a chimneystack with four pots and another stack rises above the centre of the northeast elevation. The roof of the building is of slate and gable-ended. The tower of the lift shaft breaks the line of the roof in the northern corner of the building.

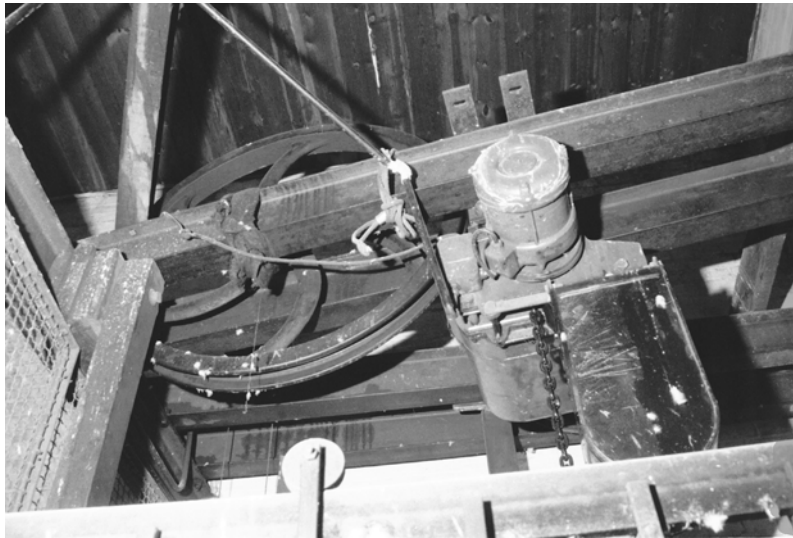
Plate 2: Building 2, Lift Mechanism

5.2.2 The interior of the building appears to have been heavily altered, with a concrete and steel column grid and floors replacing what was probably originally a wooden arrangement. On all of the floors, the only original room division is that between the main room and the stair/lift shaft. This is built in the same brick as the rest of the walls of the building and bonded into the northwest and northeast walls. The central portion of the wall is angled (Fig 8b). The stairs within the shaft/tower are plain wooden return stairs with landings at each floor and at intermediate levels. The lift shaft is built of, and reinforced with, steel 'I' sections and its mechanism remains in situ above the level of the fourth floor.

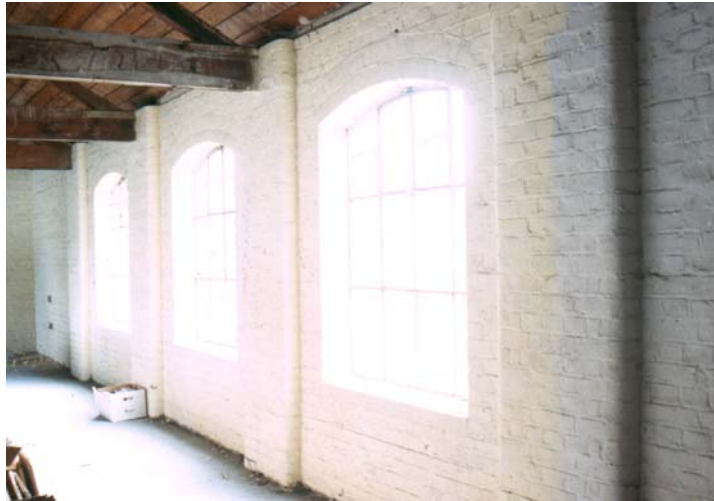
Plate 3: Building 2, Fourth Floor

- 5.2.7 On the fourth floor, the positions of four roof trusses divide the room into five bays and are all that remains of the building's original structural timberwork. These are wide Queen Post trusses, constructed from machine-cut timber and held together with iron ties and straps. The queen-posts themselves have sloping joggles on their outward faces supporting raking braces to the principal rafters. The purlins held by these support a timber-plank roof. As with the rest of the floors in the building, the floor here is of Portland cement, possibly poured over concrete blocks. The angled section of the stair tower in the northern corner of the building corbels to a right-angle as it reaches the roof, creating the square tower visible from the exterior of the building.

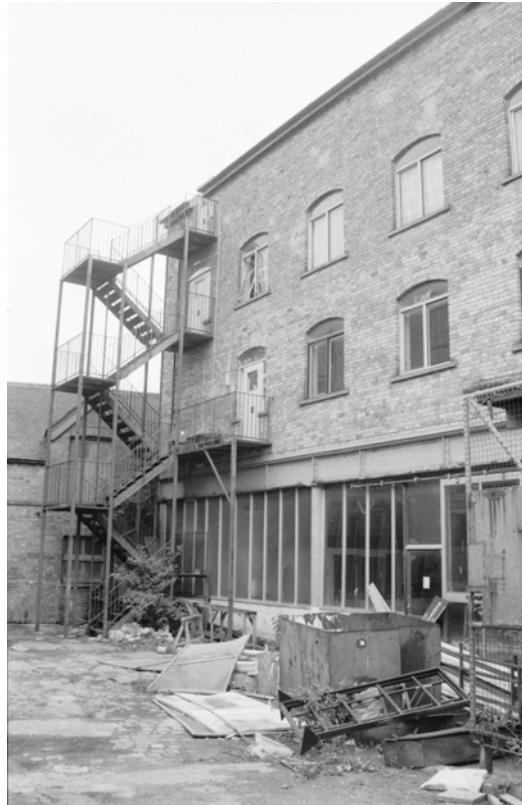
Plate 4: Building 3 From the Courtyard

5.3.1 The exterior of Building 3 is built in yellow brick laid in Flemish bond and measuring 222-232mmx106-115mmx68-70mm. It is of six bays and built in four storeys, the lowest of which is at courtyard level. At this level, the courtyard frontage is built in blue brick and steel. The Ordnance Survey Map depictions of this building show that it was historically open fronted. It has since been in-filled with light steel framing, glass and breeze blocks. To the northern end of this face, a wooden platform rises from the courtyard to provide access to a double door leading to the internal stairwell. The first and second floors of the courtyard façade hold most of the building's fenestration, this consisting of a series of reveals topped with brick segmental arches. The windows currently in place in the reveals are modern replacements. An iron fire escape has been added to this face of the building (as seen in Fig 9a) and a window on each of the first and second floors has been converted into fire escape doors accordingly, with a fire escape door also added at third floor level. This floor has large vertically proportioned windows at its northern and southern ends below a relatively steeply pitched, brown tiled roof. The northwest face of the building has a door providing access from Dover Road at a level intermediate to the internal ground and first floors (internal before the demolition of 18-20 Mill Bay) and the southeast face is similar in appearance, adjoining the southern wing of Building 4 at ground floor level. The southwest face is plain, but has a brick string-course between first and second floor levels.

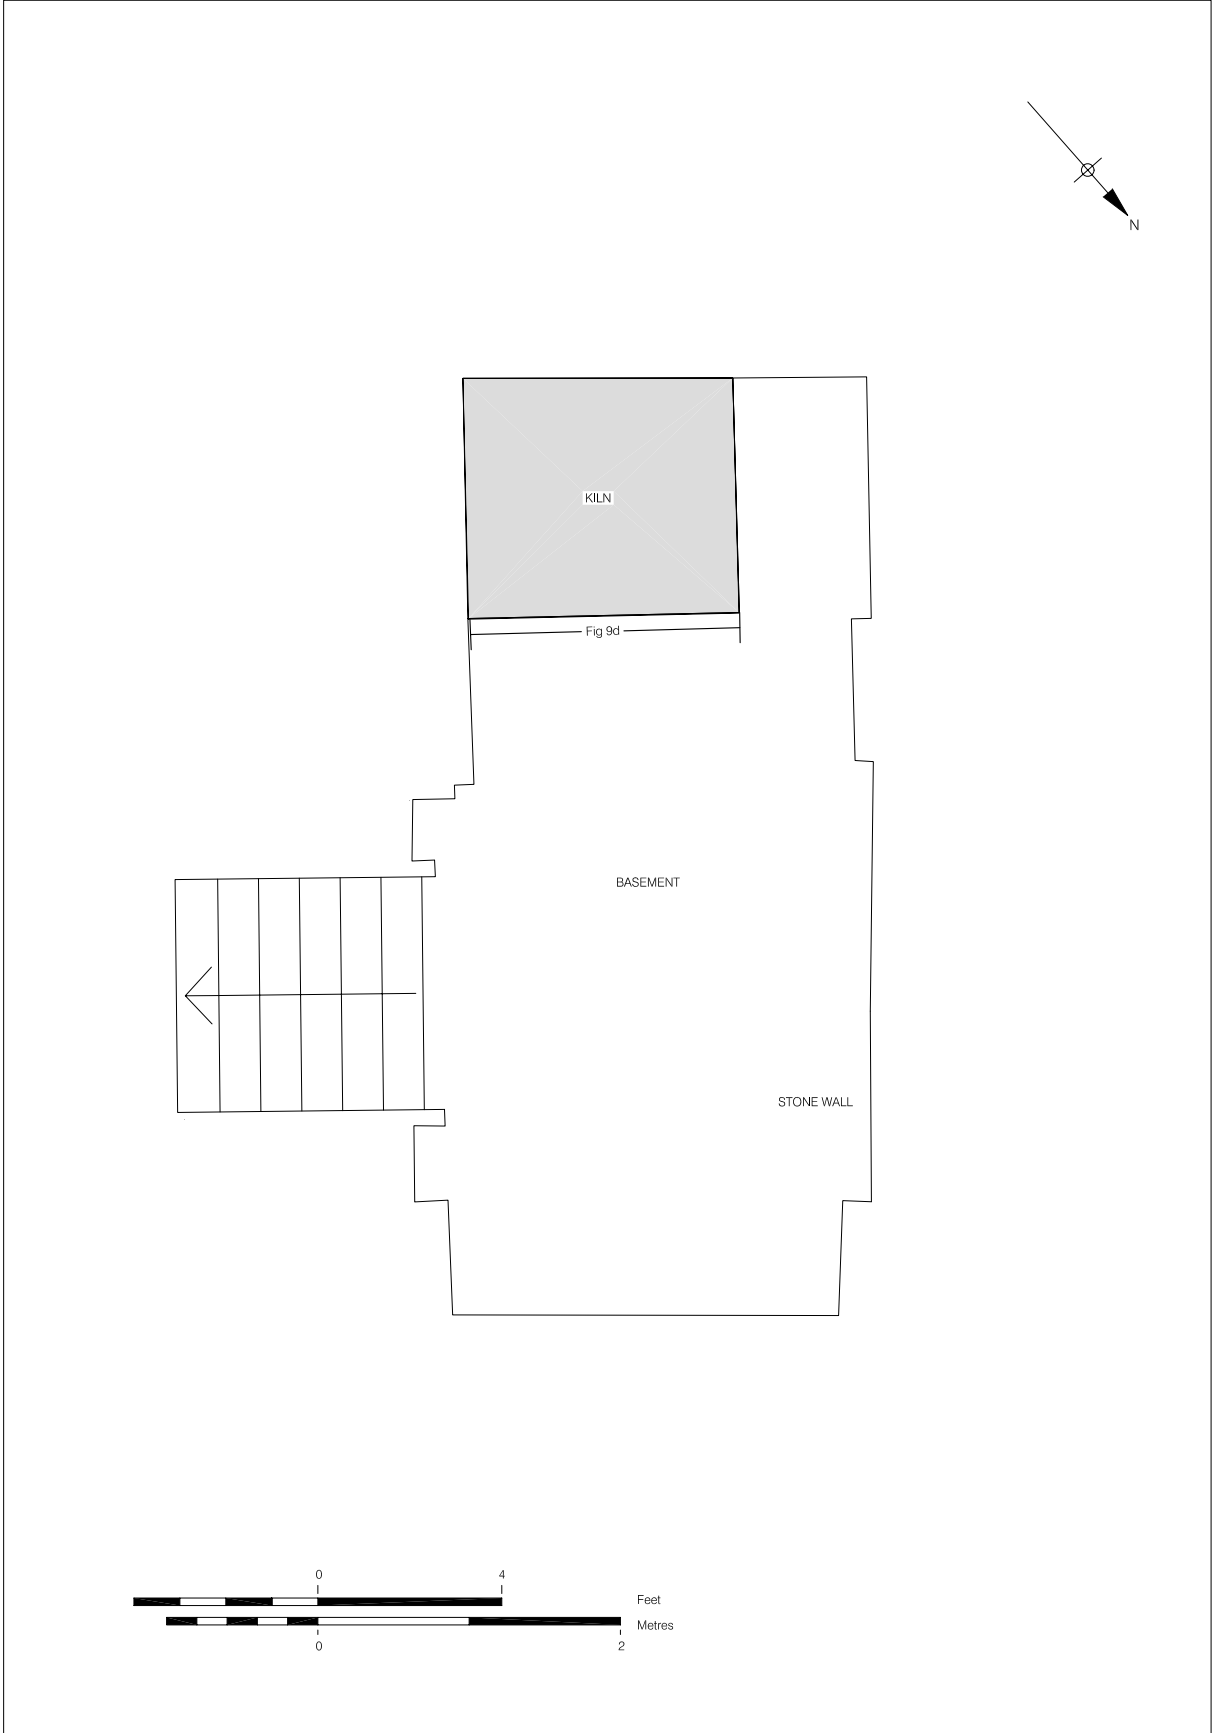
Figure 9c
Building 3: Basement Plan
1:50

5.3.2 Internally, the ground floor of Building 3 appears to retain no fittings relating to any of its previous uses. The floor has been covered with hardboard and the ceiling, of corrugated iron and tile, is held at the southern end of the room by a single cast-iron

pillar. The southeast wall of the room is a previously external wall of Building 4. The southwest wall has a series of recesses built into it, each topped with brick segmental arches. In the northwest wall, a set of double doors, set above the ground lead into the entrance lobby of the stairwell area of the building. Below these a set of steps, previously obscured by the hardboarding of the floor, leads into a small basement (Fig 9c) room. This northern wall of this room has one section built in stone, possibly remaining from a previous building on the site. To the north of this basement room, is a Fletton brick built kiln (Fig 9d), retaining some iron doors and internal fittings. The exact use of this kiln is unknown, but it is too small to be used in glass production and was possibly rather used in the production of glass paint.

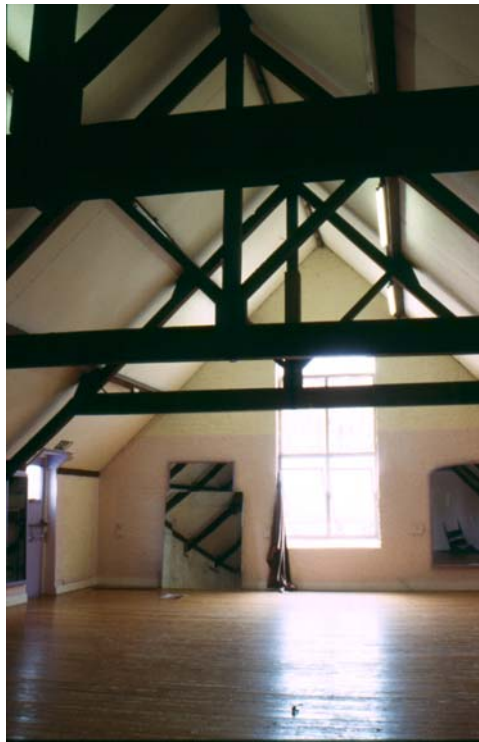
Plate 5: Building 3: Third Floor

- 5.3.6 The third floor is divided internally with plasterboard walling to create one large and one small room, and two WCs. The stairwell itself is divided from the main room by a brick wall. Like the floor beneath, it retains its wooden floor. The roof is held on three tall King post trusses held together with wrought iron ties and resting on sandstone slabs built into the external walls. The tall windows at either end of this floor have the same segmental arches and sloping concrete sills as the smaller windows on the floor below.

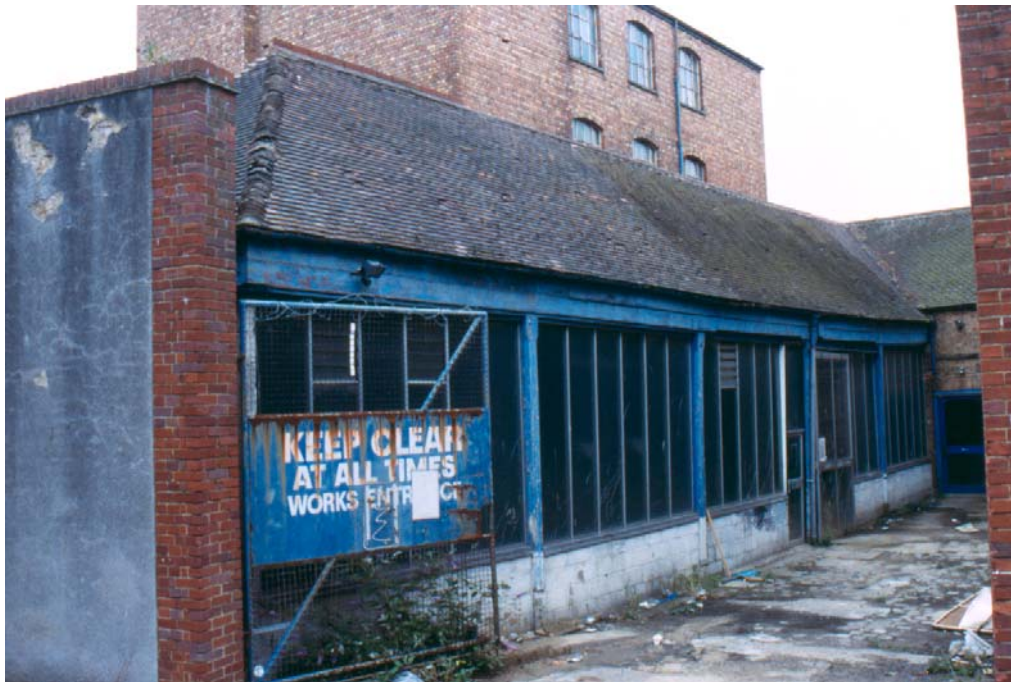
Plate 6: Building 4, West Facing Elevation

- 5.4.1 Building 4 is a functional, single storey building of two wings, one running approximately N/S (south wing) and the other adjoining wing running approximately E/W (north wing). The visible brickwork of the building consists of Fletton brick laid in Flemish bond and measuring 228-235mmx107-109mmx69-71mm.

- 5.4.2 The south wing is externally constructed as above, with two segmentally headed arched windows, a single door to the north and a loading door set into a dormer at roof level. This elevation continues inside the ground floor level of Building 3, this previously external. The building has a red-tiled roof, altered to its southern end by the addition of Building 3.

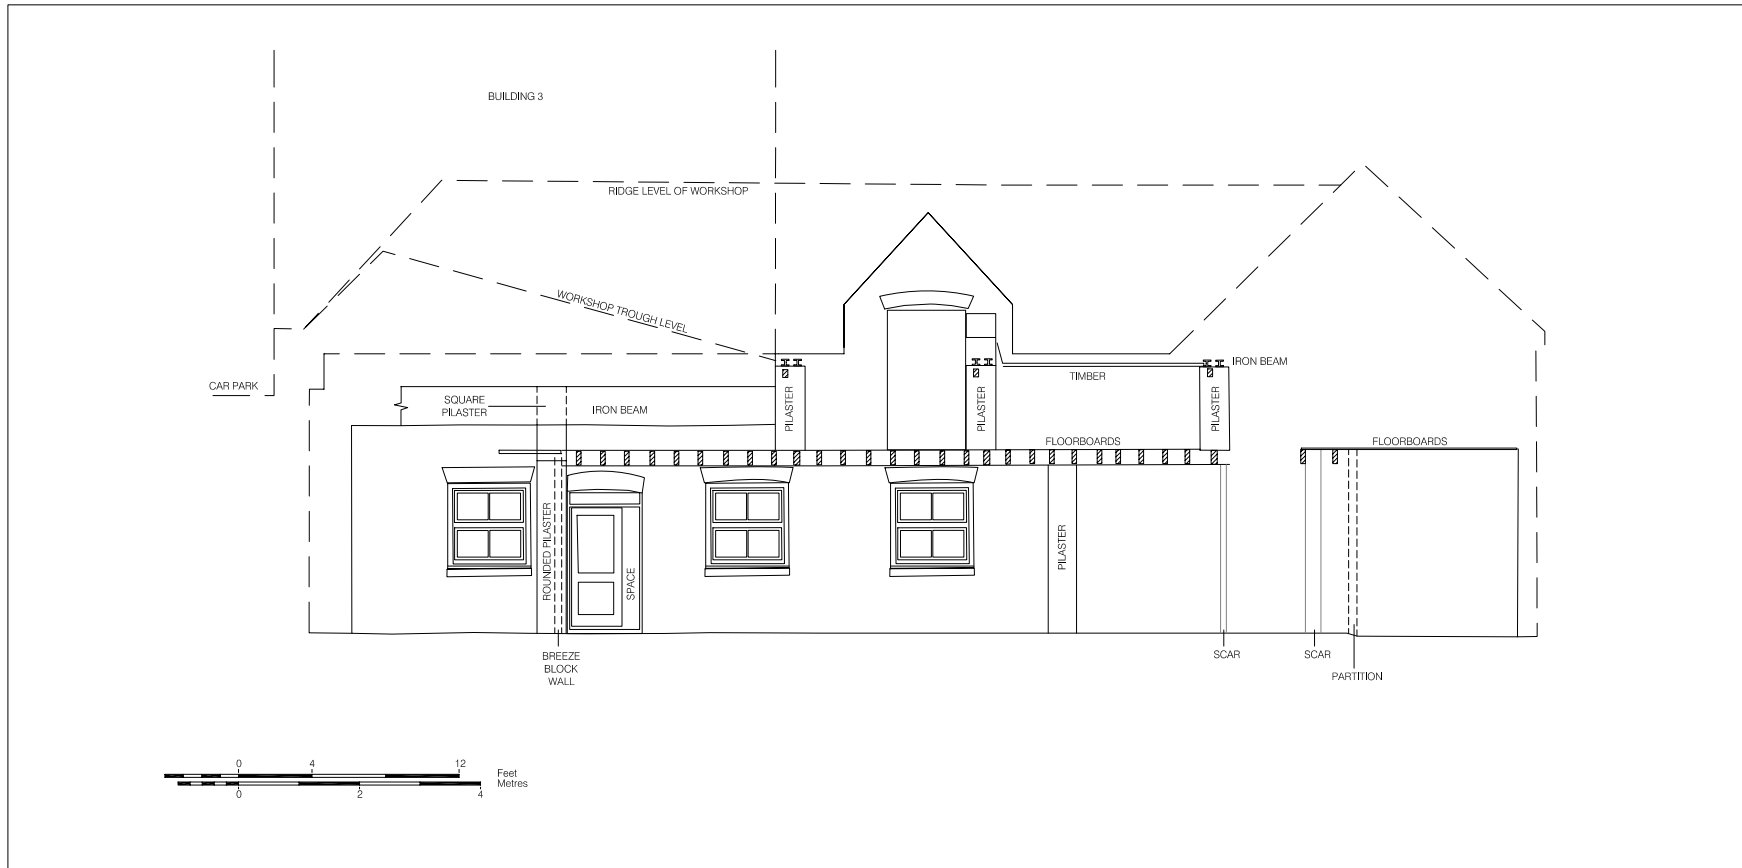
Figure 10
 Building 3 Section
 1:125

sills continue inside the building and it is possible to see in detail the wooden casement windows. The roof is held on Queen post trusses, these recently strengthened with steel 'I' sections to allow them to hold a small travelling crane. Although not wholly clear, the roof level seems to have been altered at some point in the building's use-life. At ground floor level, there are rounded brick pilasters that run up to the level of where a row of mortices reveal an upper floor to have been removed. Above this level, however, the pilasters are square in section and are off-set from the pilasters below (see Fig 10). To the south, a large, horizontal steel beam has been inserted into the building at an angle to support the eastern wall of Building 3. It is possible that the off-setting of the pilasters relates to a wholesale rebuilding of the roof when Building 3 was added, but, due to the lack of evidence that anything else in the roof has been altered, more likely that they were never vertically aligned.

- 5.4.4 The courtyard face of the north wing of Building 4 was historically open-fronted, as demonstrated by both the depiction of it on the Ordnance Survey Maps and its construction as a series of chamfered wooden beams holding the roof, only recently filled in with light metal, glass and breeze blocks. Internally, the building is constructed in brown brick laid in Flemish bond. The floor is of cement. In the northernmost wall, a large double-width sliding door leading to the first floor of Building 2 provides the only surviving fitting from the early uses of the building. The rest of this wall holds large, shallow recesses. In the west of the room, on the courtyard side, there is a brick pilaster that corbels out towards the courtyard to support the wooden frame of both the roof and the open frontage of the building. The east of the room runs into the northern end of the south wing. The roof is held on Queen post trusses with their queen-posts raked, creating a pentagon shape in the truss' centre.

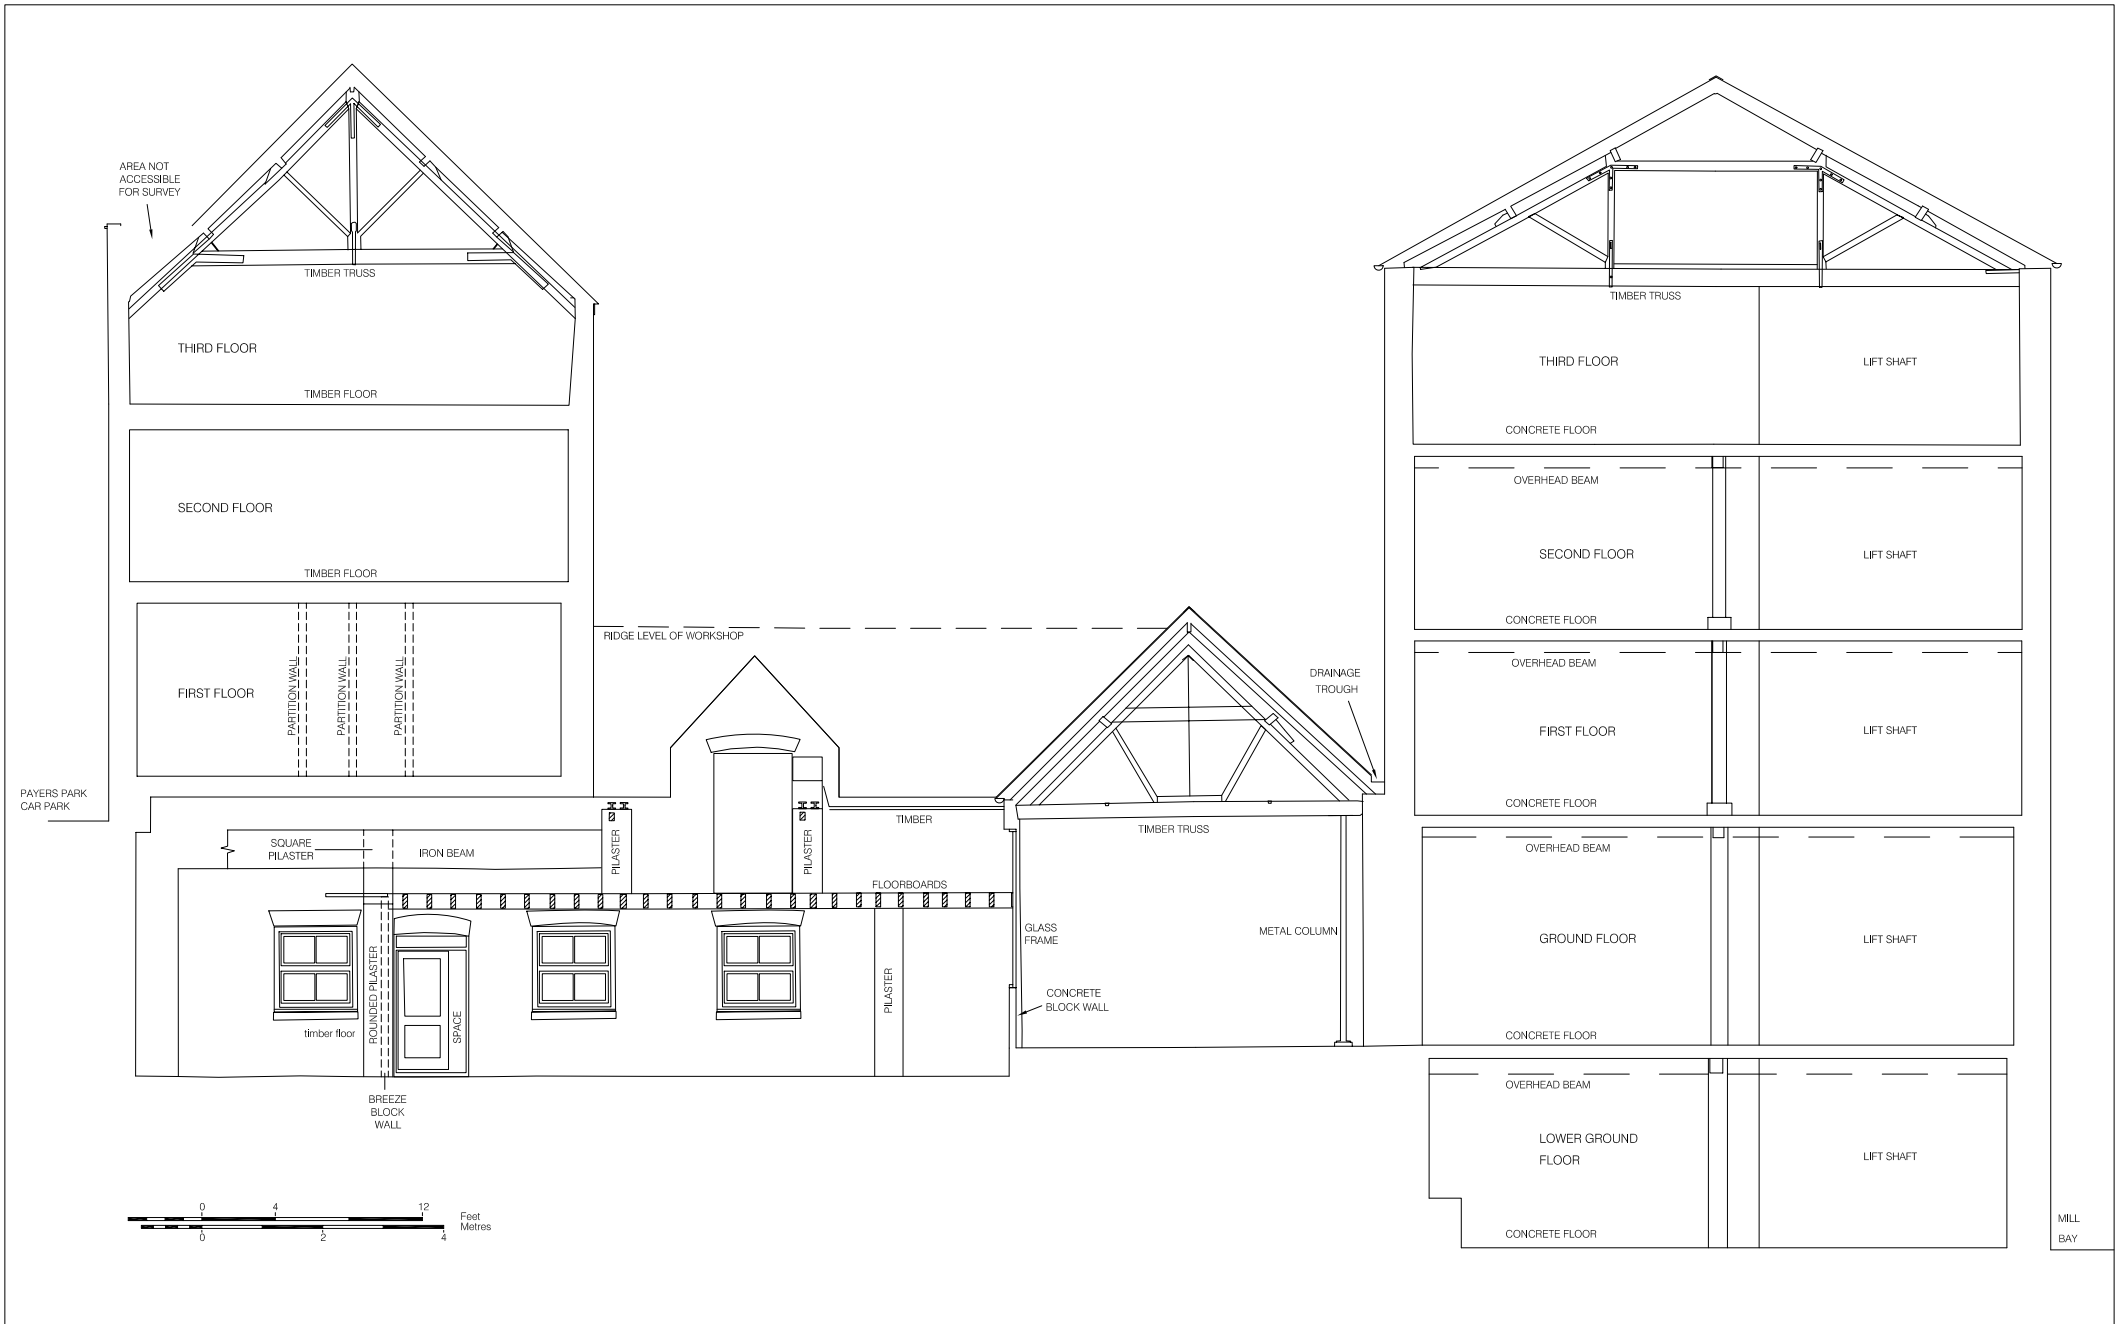
Figure 11
Composite Section
1:125

The first phase of building of the current complex of buildings to take place after 1881 when the low courtyard building, Building 4, was created in open ground behind the offices of *Bridges and Co.*. At this time, the area occupied by Building 2 was taken up by housing on Mill Bay.

In a second phase of construction, sometime before the completion of the 1898 Ordnance Survey, Building 3 was added at an angle to Building 4, creating additional warehouse space. Its upper levels were accessed through the now demolished 18-20 Mill Bay.

By 1907, the housing on Mill Bay had been demolished and Building 2, a tall building with access from both courtyard and lower levels and incorporating a lift-shaft, was constructed in a third construction phase.

In the 1970s, the only other major phase of construction, Phase 4, took place. In this phase, two buildings fronting onto Dover Road were demolished, creating direct access to the courtyard. At this time, Folkestone and Hastings Glassworks took over the site and a number of later developments, including the addition of a small kiln, the internal breeze block division of a number of the rooms, the timber division of the rooms in Building 2 and the covering of the yard can be attributed to this time.
