**AN ARCHAEOLOGICAL WATCHING BRIEF
ON B6318 SIGNING IMPROVEMENTS AT
STANLEY PLANTATION AND EAST WALLHOUSES,
NEAR HALTON SHIELDS,
NORTHUMBERLAND**

**An Archaeological Watching Brief on B6318 Signing Improvements at
Stanley Plantation and East Wallhouses, near Halton Shields, Northumberland**

National Grid Reference: NY 9703 6905 – NZ 0497 6834

Site Code: WHS 11

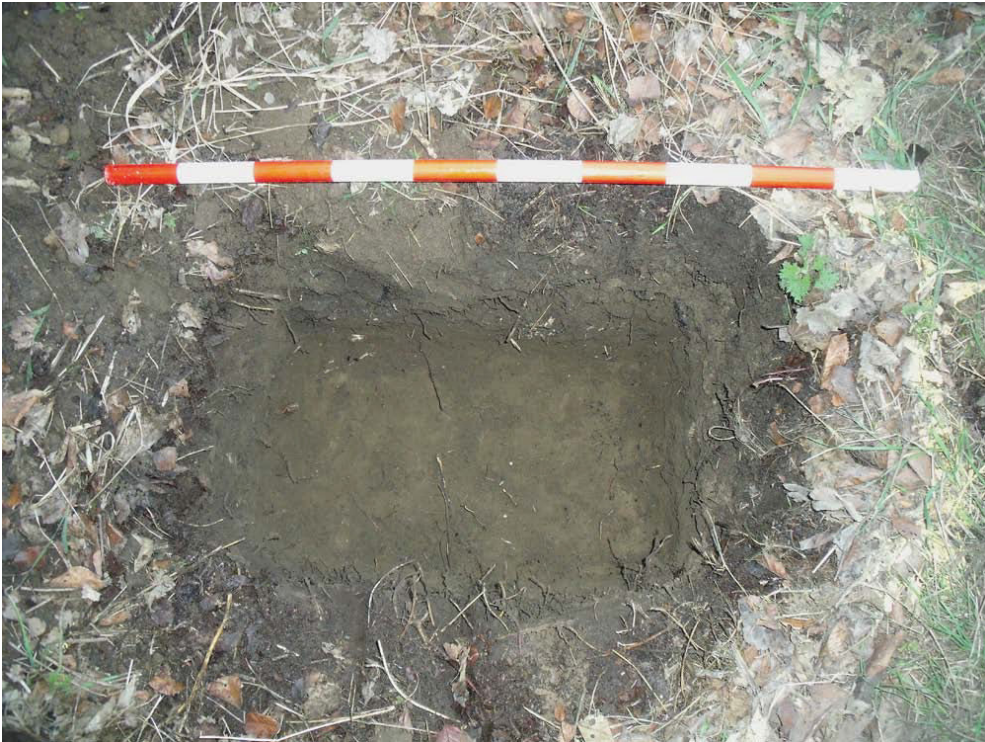
Figure 6 Overview of Foundation Pit 4, looking east (1m scale)

5.2.1 Phase 2 is an undated sub-soil horizon. In FP 5, the sub-soil layer, [11], overlay the aforementioned natural sub-stratum. Up to 0.35m thick, it was encountered at a depth of 0.18m below ground level (Figure 7). In FP 3 and FP 4 (at East Wallhouses and Stanley Plantation, respectively), similar layers, [7] and [9], respectively, were the basal deposits to be exposed (Figures 3, 6 and 7). Layers [7], [9] and [11] generally comprised friable light to mid greyish brown sandy silt. Sub-soil layer [7] was only partially exposed within the base of FP 3. At least 0.32m thick, continuing below the basal limit of excavation, it was encountered at a minimum depth of 0.24m below present ground level (Figures 3 and 5). In FP 4 sub-soil layer [9] was at least 0.10m thick and was encountered at a depth of 0.50m below present ground level (Figure 6).

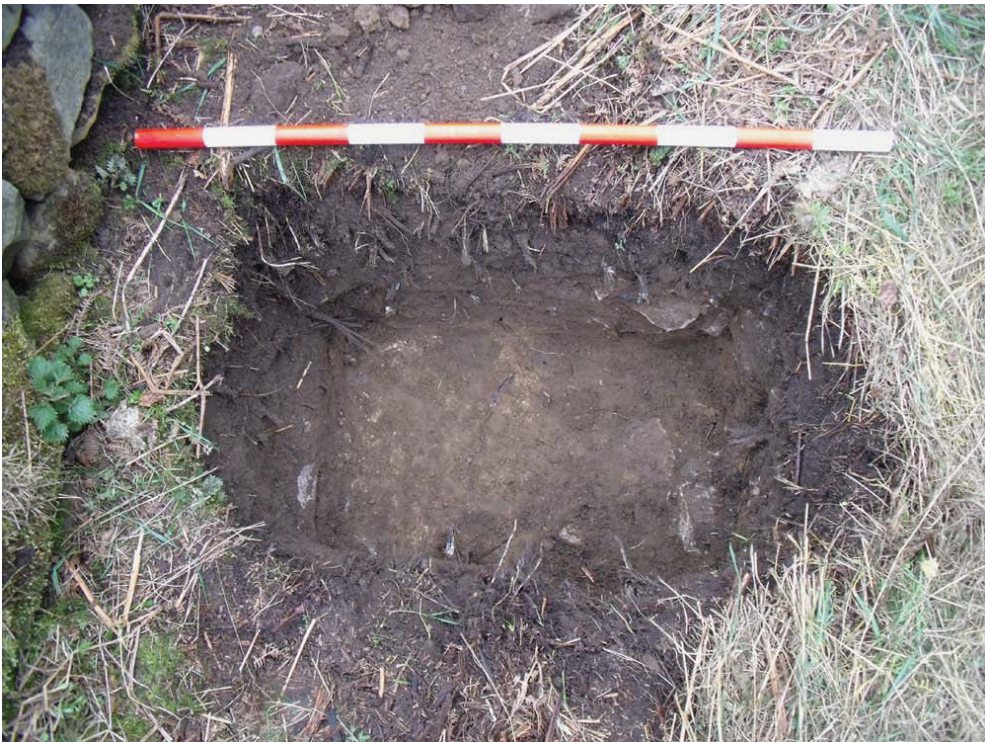
Figure 7 Overview of Foundation Pit 5, looking west (1m scale)

5.1.1 Phase 1 is the natural geological sub-stratum. The earliest deposit encountered within the base of FP 5 (at Stanley Plantation) was a layer, [12] (Figure 7). This comprised firm light yellowish brown silty sand with occasional small angular and rounded stones throughout and likely represents the glacially-derived 'drift' geology of the area. The deposit was encountered at a depth of 0.43m below present ground level. The natural sub-stratum was not encountered within any other foundation pits due to the limited depths of the excavations required.
