**MILL CROFT, ROYSTON ROAD,
BARKWAY, NORTH
HERTFORDSHIRE**

**AN ARCHAEOLOGICAL TRIAL
TRENCH EVALUATION**

PCA REPORT NO: 13243

SITE CODE: HMCB18

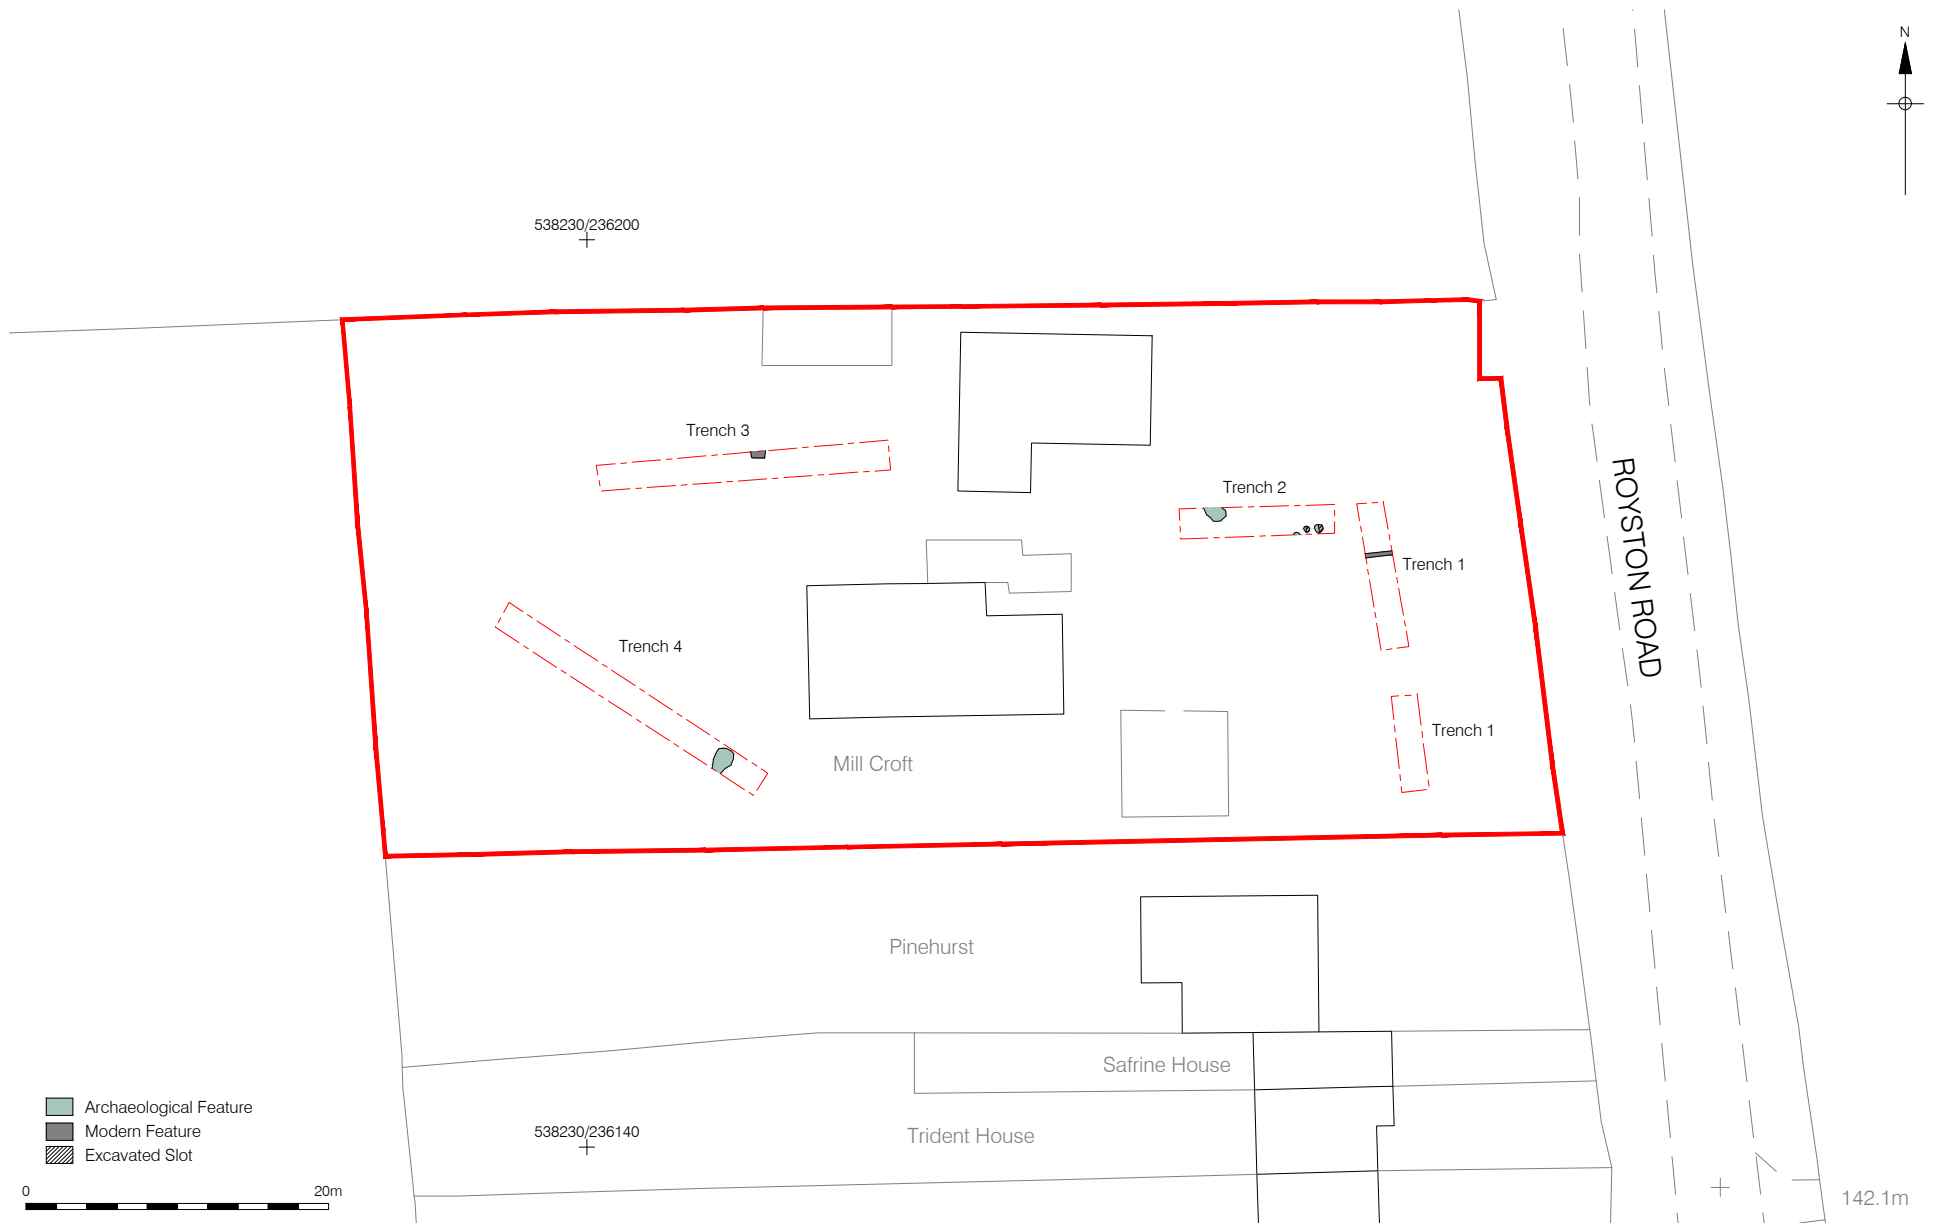
Figure 2
 Trench Location Plan
 1:500 at A4

- 4.1.1 The Written Scheme of Investigation for the evaluation proposed the excavation of four trial trenches (3 x 20m; 1 x 10m), distributed across the site (Figure 2) and providing an overall 5% sample of its area. The trenches were positioned in order to adequately sample the overall area of the site, taking into account constraints caused by the presence of standing buildings and live services.

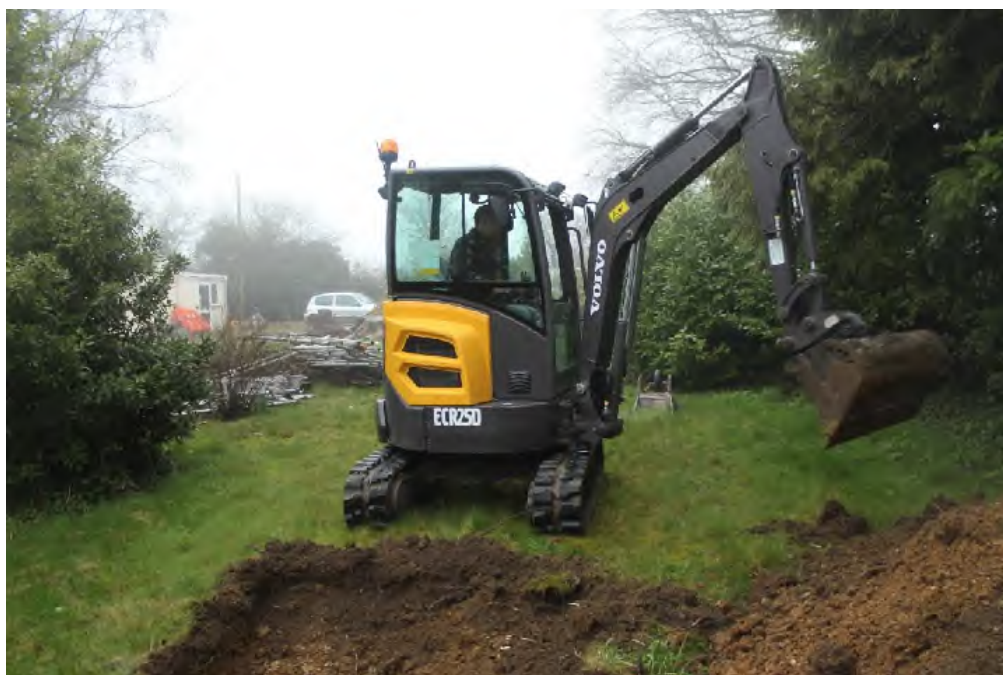
- 4.1.2 Ground reduction was carried out under archaeological supervision using a 5-ton tracked mechanical excavator fitted with a 1m-wide toothless ditching bucket (Plate 1). Trenches were excavated to two bucket widths (i.e. 2m). Due to the presence of two modern services, Trench 1 was excavated in two segments. Topsoil, subsoil and overburden deposits were removed in spits down to the level of the undisturbed natural geological deposits where potential archaeological features could be observed and recorded. With the exception of a modern wall in Trench 3, no archaeological features or deposits were present above the level of the natural geology. Exposed surfaces were cleaned by trowel and hoe as appropriate and all further excavation was undertaken manually using hand tools. Overburden deposits were set aside beside each trench and examined visually and with a metal-detector for finds retrieval.

Plate 1: Trench 1, machining, view north

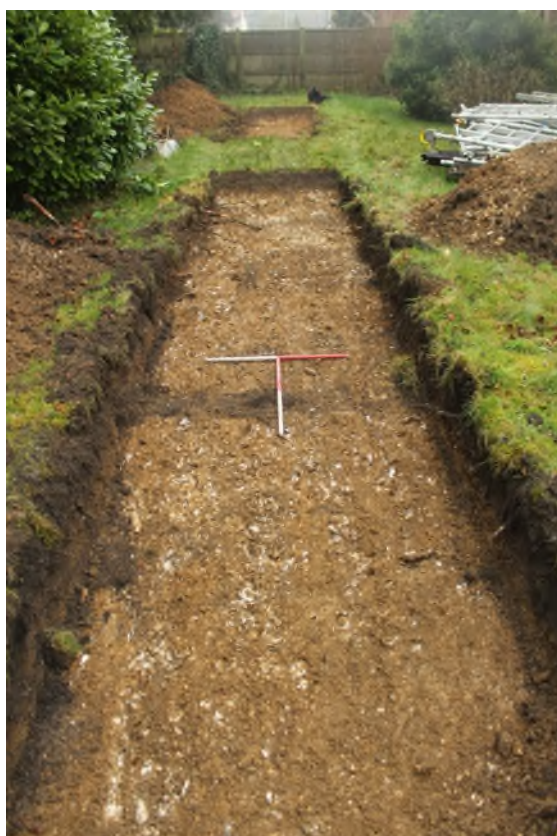
5.2.1 Trench 1 contained two modern services, which were aligned roughly east to west. One of these services was picked up prior to excavation as part of a CATSCAN survey. As such, Trench 1 was split into two segments to avoid the location of this signal.

TRENCH 1	Figure 2	Plate 2	
Trench Alignment: N-S	Length: 19.2m	Max. Machine Depth (m OD): 142.75	
Deposit	Context No.	Average Depth (m)	
		N End	S End
Topsoil	(100)	0.32m	0.31m
Subsoil	(101)	0.41m	0.42m
Natural (max. machined depth)	(102)	0.43m+	0.43m+
Summary			
Trench 1 was located close to the eastern boundary of the site.			
The trench contained two modern services, which resulted in the trench being split into two segments.

Plate 2: Trench 1, view south with pipe trench visible in foreground

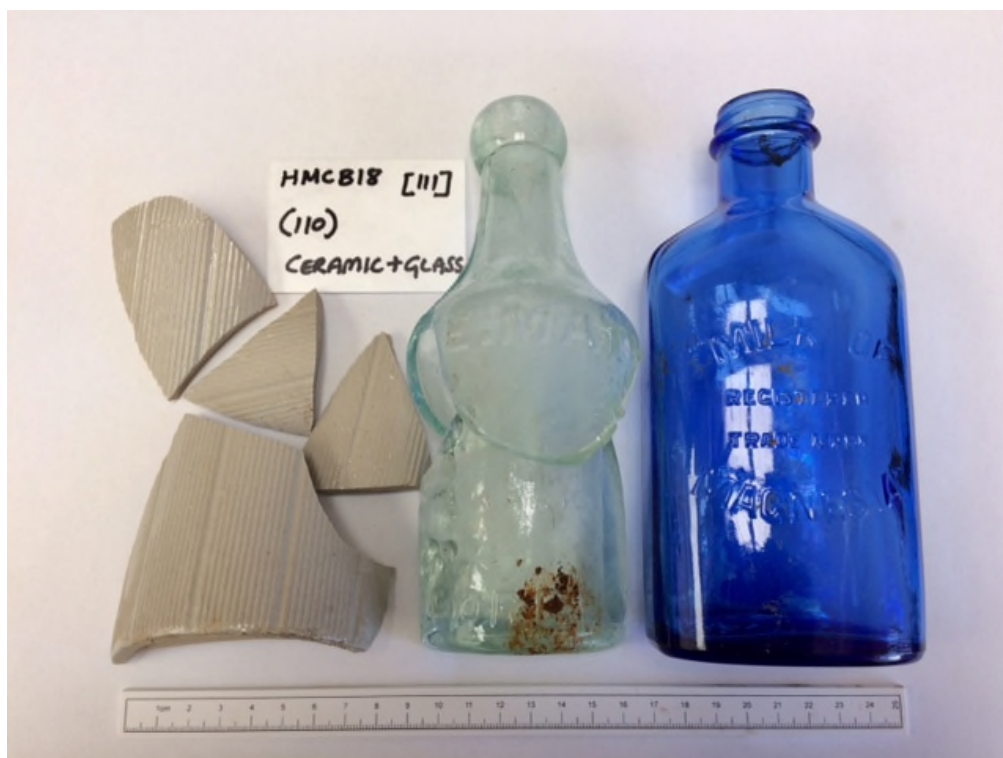
5.3.5 Pit [111] was located towards the west end of the trench and was sub-oval in plan (0.68m wide). It had a single fill (110), a dark grey sandy silt which contained occasional coke and charcoal flecks. The feature was not excavated but fragments of bottle glass and sherds from a ceramic vessel were recovered from its upper levels (Plate 3). All are of modern (late-19th-/20th-century) date.

Plate 3: Trench 2, Pit [111], finds

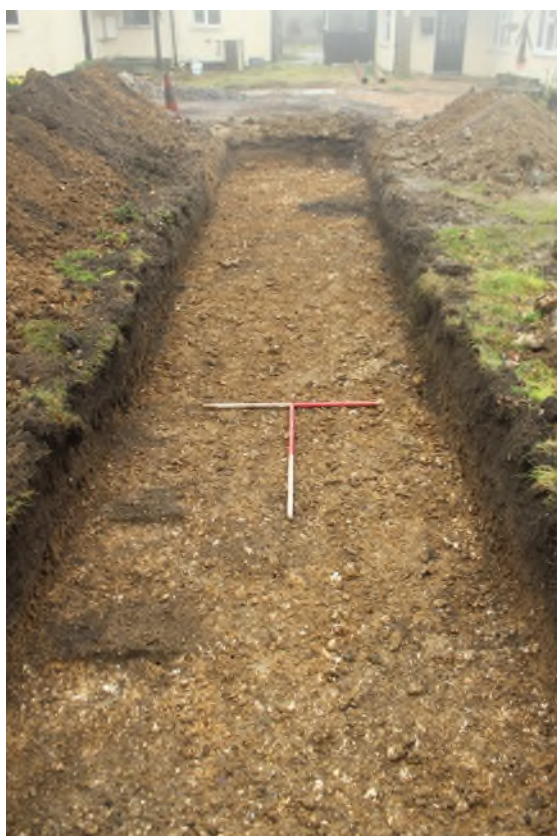
TRENCH 2	Figures 2 & 3		Plates 3 & 4	
Trench Alignment: E–W	Length: 10.3m	Max. Machine Depth (m OD): 143.33		
Deposit	Context No.	Average Depth (m)		
		E End	W End	
Overburden (Tarmac, pea-gravel)	(104)	0.35m	-	
Topsoil	(100)	-	0.33m	
Subsoil	(101)	0.60m	0.51m	
Natural (max. machined depth)	(102)	0.62m+	0.53m+	
Summary				
Trench 2 was located in the eastern part of the site.				
The trench contained three postholes and a single pit; all of the features present were of modern date.

Plate 4: Trench 2, view west

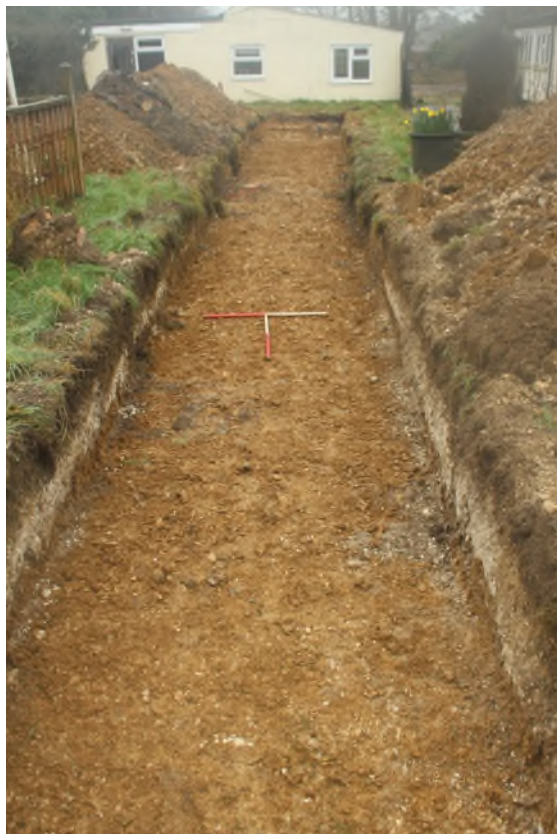
5.4.1 The trench contained a single modern wall foundation [115], which was composed of red brick and breezeblocks with a sandy concrete overlay.

TRENCH 3	Figure 2		Plate 5	
Trench Alignment: E–W	Length: 19.4m	Max. Machine Depth (m OD): 143.72		
Deposit	Context No.	Average Depth (m)		
		E End	W End	
Topsoil	(100)	0.19m	0.29m	
Overburden (Chalk, rubble and tarmac)	(114)	0.43m	0.59m	
Subsoil	(101)	0.51m	0.68m	
Natural (max. machined depth)	(102)	0.52m+	0.70m+	
Summary				
Trench 3 was located in the north-western part of the site.				
The trench contained a single modern wall.

Plate 5: Trench 3, view east

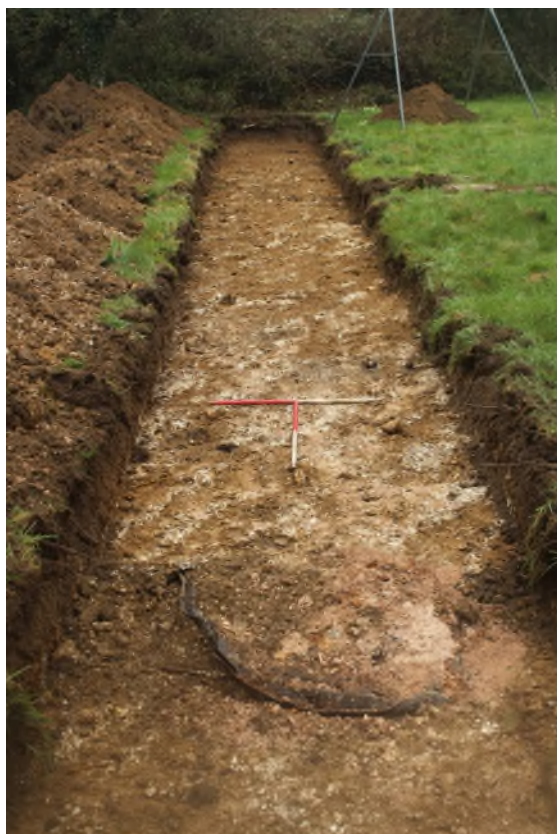
5.5.2 Pit [113] was located towards the south-east end of the trench and was sub-oval in plan (1.28m wide). It had a single fill (112), a light pink sand which contained frequent brick and concrete rubble, corrugated iron and other debris of modern date. The feature was not excavated.

TRENCH 4	Figure 2		Plate 6	
Trench Alignment: NW–SE	Length: 20.5m	Max. Machine Depth (m OD): 143.10		
Deposit	Context No.	Average Depth (m)		
		NW End	SE End	
Topsoil	(100)	0.3m	0.29m	
Subsoil	(101)	0.35m	0.38m	
Natural (max. machined depth)	(102)	0.36m+	0.40m+	
Summary				
Trench 4 was located in the south-western part of the site.				
The trench a single pit, which was of a modern date.

Plate 6: Trench 4, view north-west
