An Archaeological Evaluation on land at Mountwood Horizons, Westerham Rd, Brasted, Kent, TN161HJ

Site Code: KWBR 11

Pre-Construct Archaeology Limited

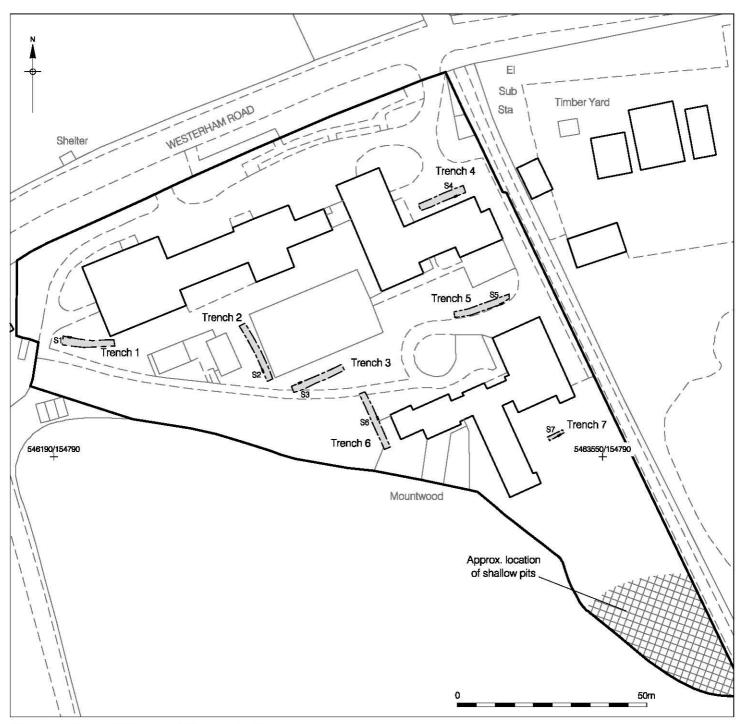
- 6.2 The trench locations and orientations are detailed in Figure 2. They all measured 1.80m wide by 15m in length.
- 6.3 The trenches were opened with a wheeled mechanical excavator, fitted with a flat-bladed ditching bucket, under archaeological supervision. Excavation by machine was undertaken in spits until significant archaeological horizons or natural geology was reached.

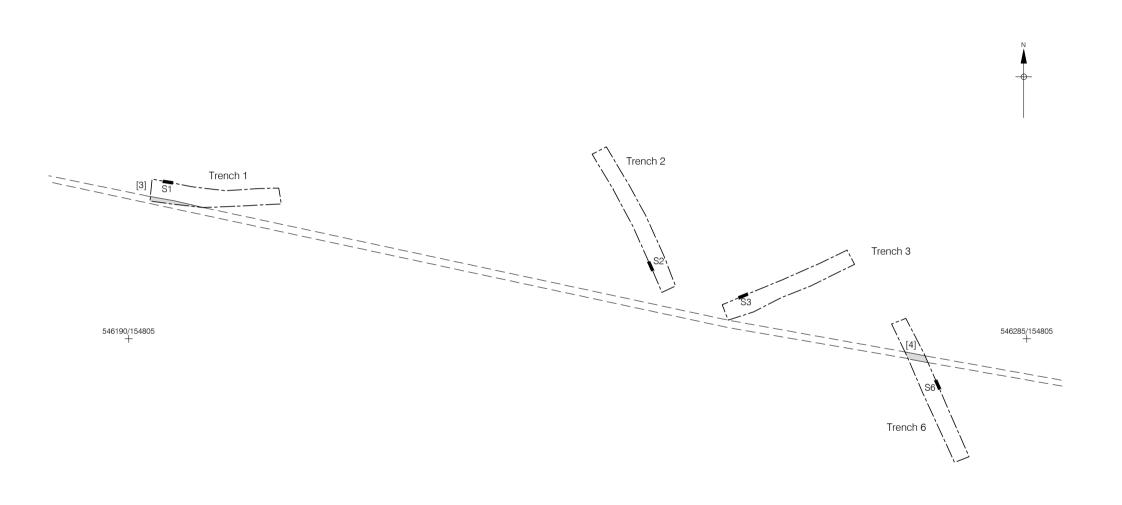
Figure 3
Plan showing the masonry in Trenches 1 & 6
1:400 at A4

7.2.1 The foundations of a wall were discovered in Trenches 1 (recorded as [3]) and 6 (recorded as [4]. It was constructed from lightly frogged red bricks and roughly hewn Kentish ragstone blocks and ran on an east-west alignment. In Trench 1 it had a length of 4.90m, in Trench 6 a length of 1.80m and a height of 0.48m. The wall was cut directly into sand [7] in Trench 6, and into subsoil [2] in Trench 1. The presence of a surviving post-medieval wall along the southern perimeter of the site would suggest that this area was not subjected to level of terracing and landscaping observed across the remainder of the site.

- The earliest phase of archaeological activity evidenced during the evaluation occurred in the late post-medieval period as demonstrated by the wall running through Trenches 1 and 6. It is probable that this is the same as a wall depicted on the 1896 Ordnance Survey map (Figure 4). The map shows a dividing wall running on an ENE-WSW alignment with the formal parkland to the south and greenhouses to the north. It is possible that the wall was in existence by the time of the 1869 Ordnance Survey map but the area of the wall is shrouded by trees. The presence of the wall foundation along the southern perimeter of the site suggests that this area lies outside the most significant areas of modern terracing discussed below.

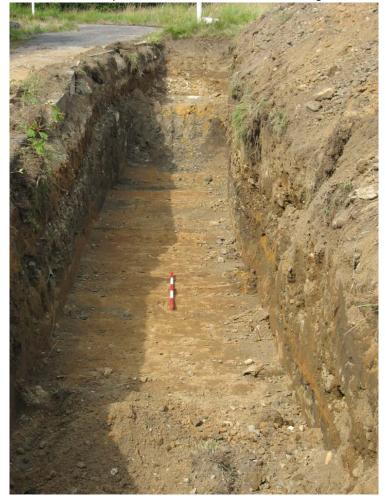
Plate 2: Depth of Truncation, Trench 5 Looking W

7.5.1 The site showed evidence of severe truncation through terracing into the natural deposits across the whole area during the construction of the education centre in the 1980s. A considerable amount of the material removed at this stage was redeposited across the site forming made ground and levelling layers [8] associated with this phase of the sites' development.

- 8.3 The site had undergone significant horizontal truncation through terracing in the 1980s. With the exception of the southern perimeter, It appears that the site was reduced to below the level of the uppermost natural stratum across its entire area and then built up with redeposited material where needed. This process has effectively removed any archaeological features or deposits that may have previously been present. The palaeoloarchaeological investigation revealed that no river gravels were present in the designated area of investigation and no redeposited artefacts were recorded in the colluvial deposits.
