**STAUNTON COUNTRY PARK,
MIDDLE PARK WAY, HAVANT,
HAMPSHIRE**

**ARCHAEOLOGICAL WATCHING
BRIEF REPORT**

PCA REPORT NO: 11088

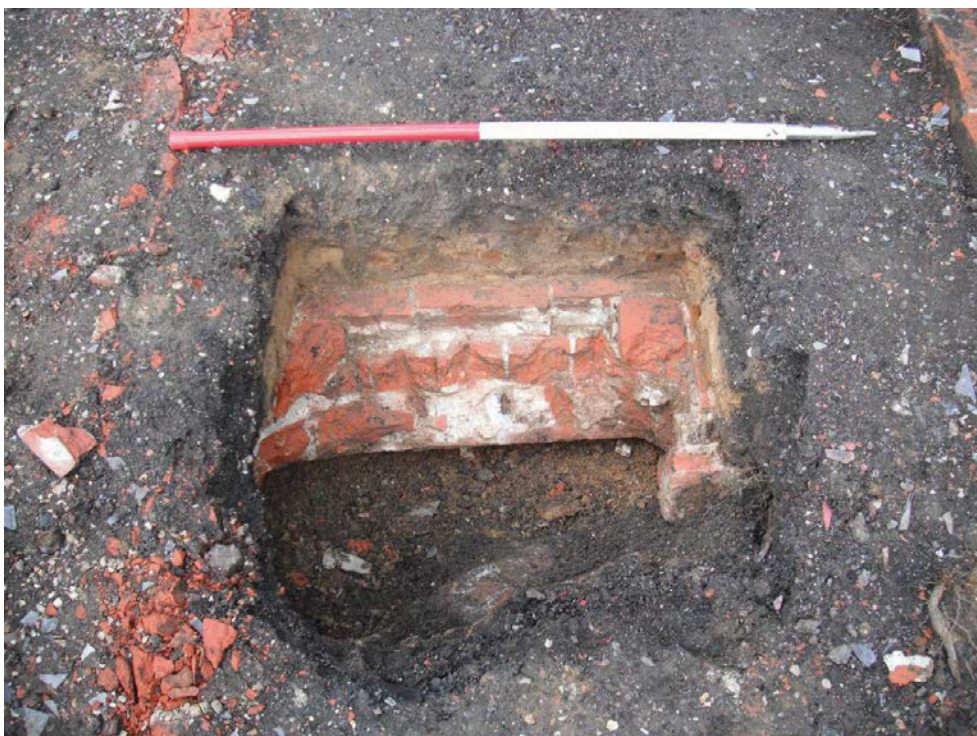
Plate 1: Vaulted Conduit in Foundation Pit 3

- 7.3.2 Where observable in the limited extent of the foundation pits, the wall footings comprised courses of brickwork laid in two rows, e.g. [602] in FP 6, and in one example, [404] in FP 4, on edge. The vaulted conduit recorded in FP 3 [303] (Figure 4, Plate 1) and in FP 9 [901] appeared to have been partially demolished and did not survive to its full height.

- 7.4.1 Two bricks were recovered from the watching brief as samples of brick from the vaulted conduit [303] exposed in FP 3. The bricks are un-frogged examples, typical of the 19th-century structural remains observed on the site. No other significant finds were observed or recovered from the watching brief.

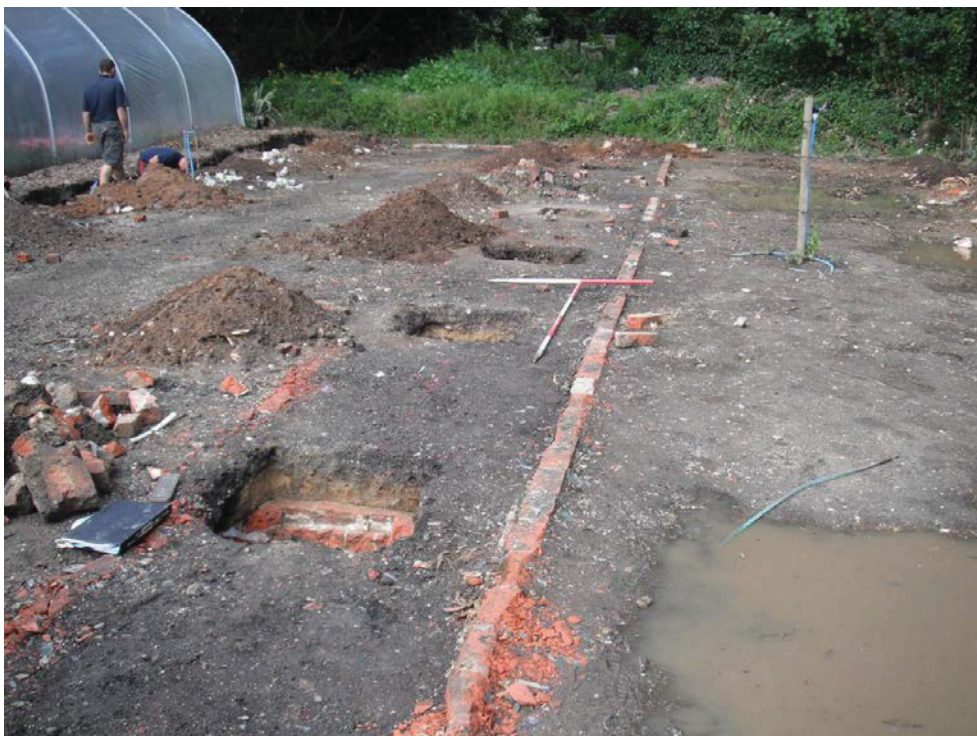
Plate 2: View North across the site

- 7.1.1 This section provides a summary of the results of the watching brief and is based on the site archive. A list of context descriptions is provided in Appendix 1.
- 7.1.2 At the commencement of the watching brief the site had been cleared to ground level, which comprised garden soil (Figure 4, Plate 2). The rectangular outline of the demolished 1960's Hartley Houses Nos. 1 & 2 was visible at ground level and was represented by parallel rows of brickwork footings.
