AN ARCHAEOLOGICAL WATCHING BRIEF ON THE WEST HANDYSIDE CANOPY AREA, KING'S CROSS CENTRAL, LONDON BOROUGH OF CAMDEN

SITE CODE: KXI07

# PCA REPORT NO. R11095

An Archaeological Watching Brief on the West Handyside Canopy Area, King's Cross Central, London Borough of Camden

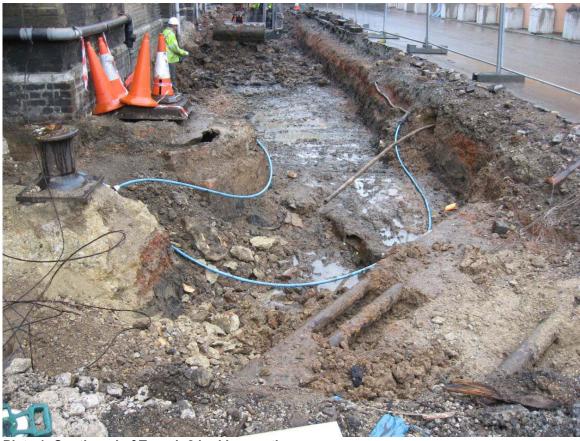
Plate 1: South end of Trench 2 looking north

- 6.2.1.4 A bobbin shaped metal protrusion with a diameter of 0.31m was observed in the southern end of Trench 2, to the immediate west of the railway line (Plate 1). It was interpreted as a capstan that was used to shunt wagons along "Railway Line 16". The trench was not excavated to a sufficient depth to determine whether a below ground hydraulic mechanism was associated with the device. It therefore remains uncertain

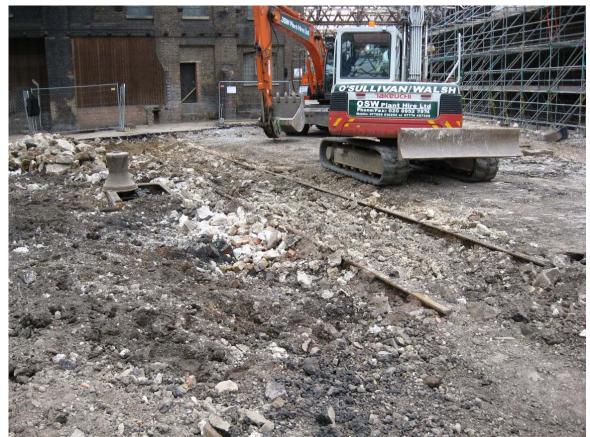
Plate 2: West Handyside Watching Brief Area looking south

- 6.3.1.1 A hydraulic capstan, [3315], was found to the immediate east of Railway Line [3314] just below the modern ground surface. It was 1.64m in length and 1.02m in width and was found close to the top of the archaeological sequence. It consisted of a sunken, hollow, metal box, located just below ground level, which presumably once housed the hydraulic mechanism that powered the device. An upstanding, revolving capstan head was also found. The hydraulic mechanism had been removed from the sunken box and a deposit of concrete had been poured into it after it fell out of use. Power, which took the form of high pressure water, was probably supplied by one of the two hydraulic pipes that were seen protruding from the western outer face of the metal box; the other pipe presumably ferried waste water away. The capstan head, a bobbin shaped protrusion, formed the southeast corner of the structure. This was the main above-ground component of the device, which was capable of rotating. Chains anchored to this revolving mechanism were presumably used to shunt wagons along Railway Line [3314].

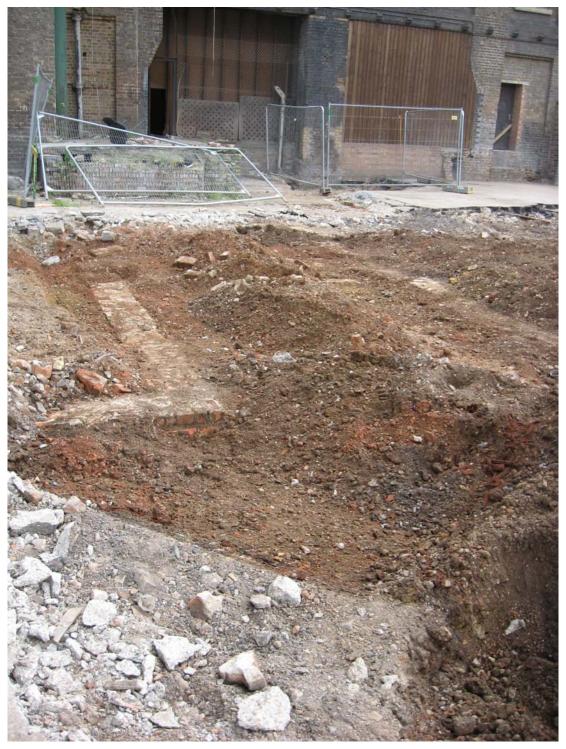
Plate 3: Remains of platforms in the West Handyside Watching Brief Area, looking south

- 6.2.2.3 The western platform was probably constructed in order to load or unload the wagons that utilised railway line [3314], whilst the eastern platform may have handled goods that were brought in or despatched on an adjacent track. Although no archaeological evidence of a neighbouring line was found to the east of [3314] during the watching brief, the former existence of such a feature can be inferred from a series of historic maps dating from 1852 onwards (Figures 3 to 5). The most detailed and non-schematic of these is the Humber Plan of 1866 (Figure 5), which suggests that a second line, running parallel with [3314], entered the Midland Goods Shed at this time; earlier but relatively crude sources, including Captain Gatton's Sketch Plan of 1852 (Figure 3) and the Stanford Map of 1862 (Figure 4), tentatively suggest that this track may have been in existence from 1852 onwards.
