**AN ARCHAEOLOGICAL
EVALUATION AND
GEOTECHNICAL WATCHING
BRIEF - A11 FIVEWAYS TO
THETFORD IMPROVEMENT**

Site Code: ELV078

National Grid Reference: TL 727741 – TL 850818

**Written and Researched by Alexander Pullen
Pre-Construct Archaeology Ltd, September 2011**

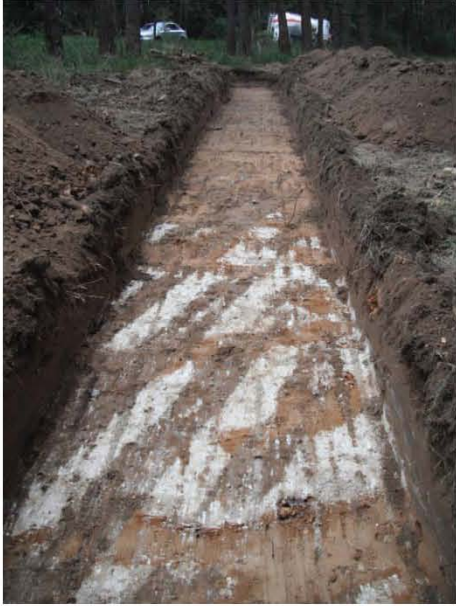
Trench 1 with modern plough scars.

- 4.4 Significant disturbance to subsurface deposits was encountered in Trench 12, where mechanical grubbing out of tree stumps prior to replanting was observed. Evidence of deep modern ploughing ('subsoiling') was observed in Trenches 1-4 and in 10 and 11 (an area formerly supporting an irrigated conifer plantation). A lot of root activity (including old tree stumps) was present in trenches 8 and 9.

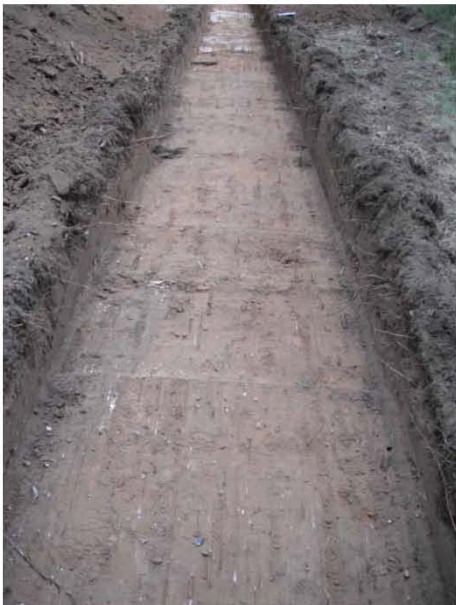
Trench 2.

- 4.1 No archaeological finds or features were present in any of the 15 geotechnical pits monitored by PCA.
- 4.2 No archaeological features were present in any of the thirteen evaluation trenches. A single piece of early Romano-British pottery of 1st or 2nd century date was present in the subsoil [5] at Trench 2. Two flint artefacts (both scrapers) were recovered from the plough soil [30] at Trench 11. These are not diagnostic pieces but probably date from the Neolithic (Bishop, B. pers. com).

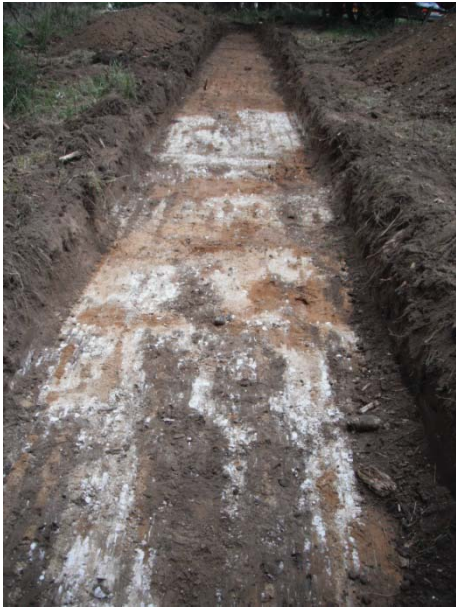
Trench 3 – rooting in foreground.

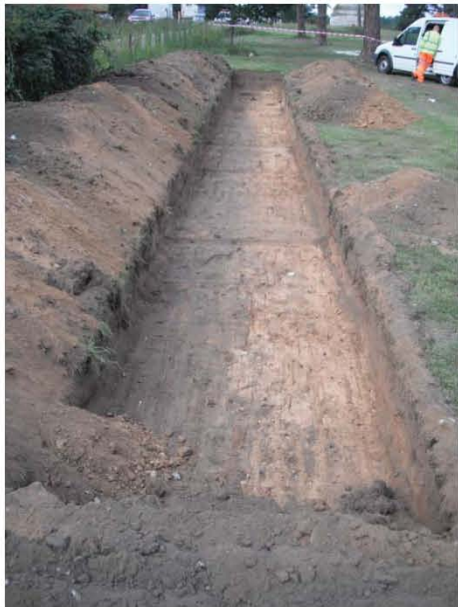
- 4.5 Trench 5 contained a modern linear feature (containing wire, bottle glass, crisp packets etc) running parallel with the A11. This was probably a ditch to prevent unwanted access to the grass area around the war memorial.

Trench 5 showing modern feature to left of trench.

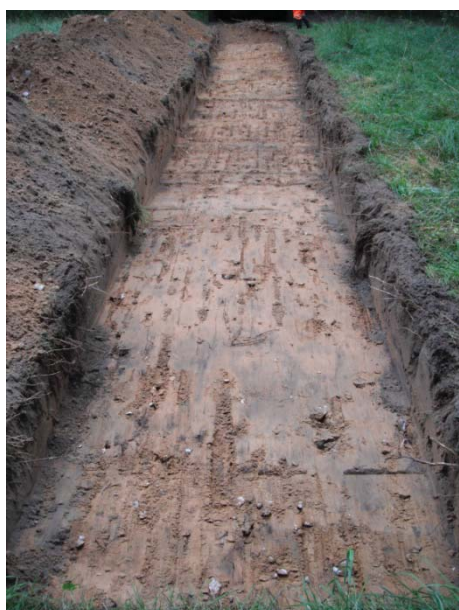
Trench 8

- 5.3 In Trench 12 disturbance due to forestry activity was severe. In all other trenches, the impact of forestry activity was limited to the occasional presence of modern plough marks (which did not extend significantly below the level of the base of the subsoil) and occasional locally severe tree rooting (e.g. Trenches 8 and 9).

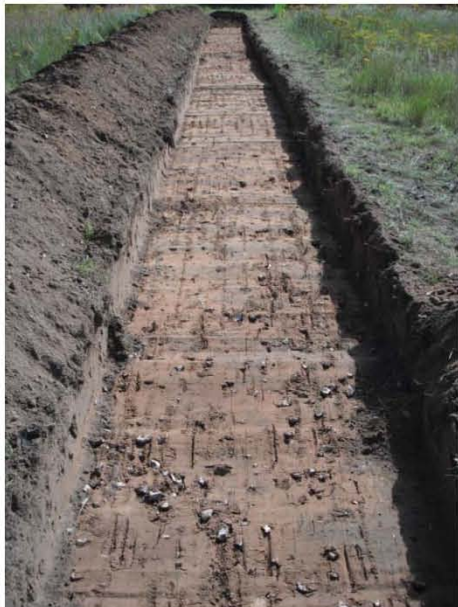
Trench 11.

- 5.2 The presence of two probable Neolithic flint artefacts from the plough soil in trench 11 [30] clearly indicates some level of prehistoric activity at or near this location. Earlier evaluations of the study corridor demonstrate a significant potential for archaeological remains dating to the Neolithic period to be present elsewhere along the route both in the form of stray artefacts and sub-surface remains (see Highways Agency 2008).
