**ARCHAEOLOGICAL INVESTIGATIONS AT
THE LIGHTFOOT CENTRE, WHARRIER STREET,
WALKER, NEWCASTLE-UPON-TYNE,
TYNE AND WEAR**

ASSESSMENT REPORT

DECEMBER 2011

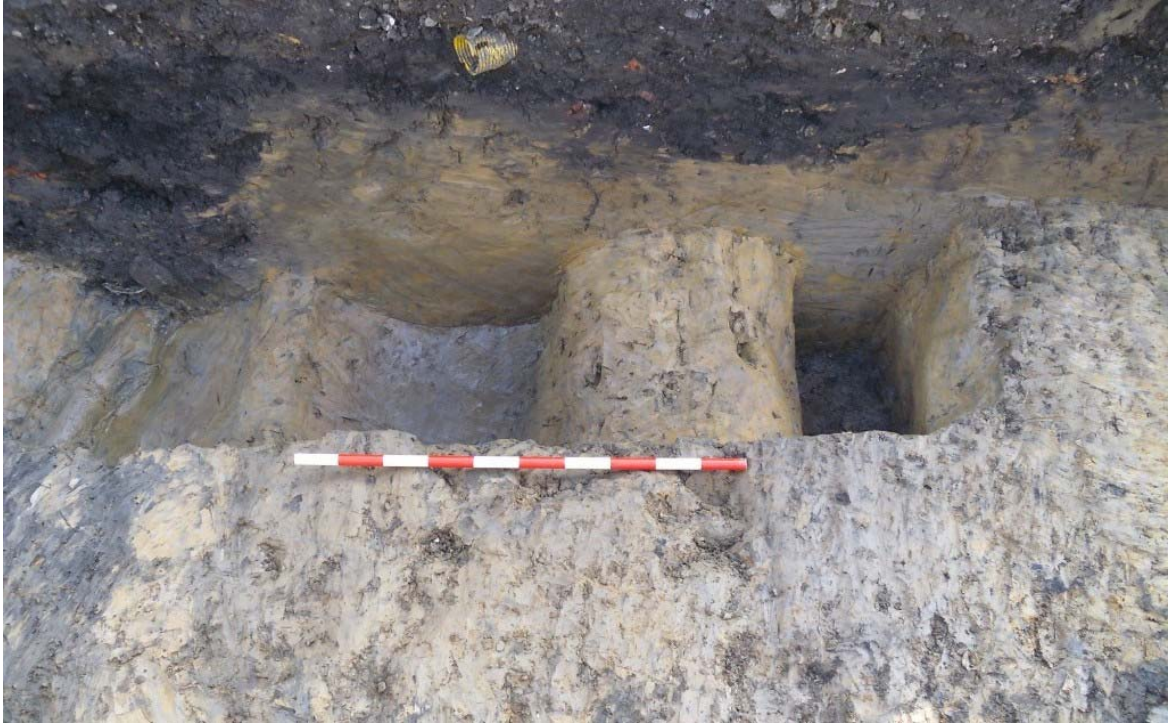
Plate 1. Trench 2, Phase 2b ditches [209] and [212], looking south (*1m scale*)

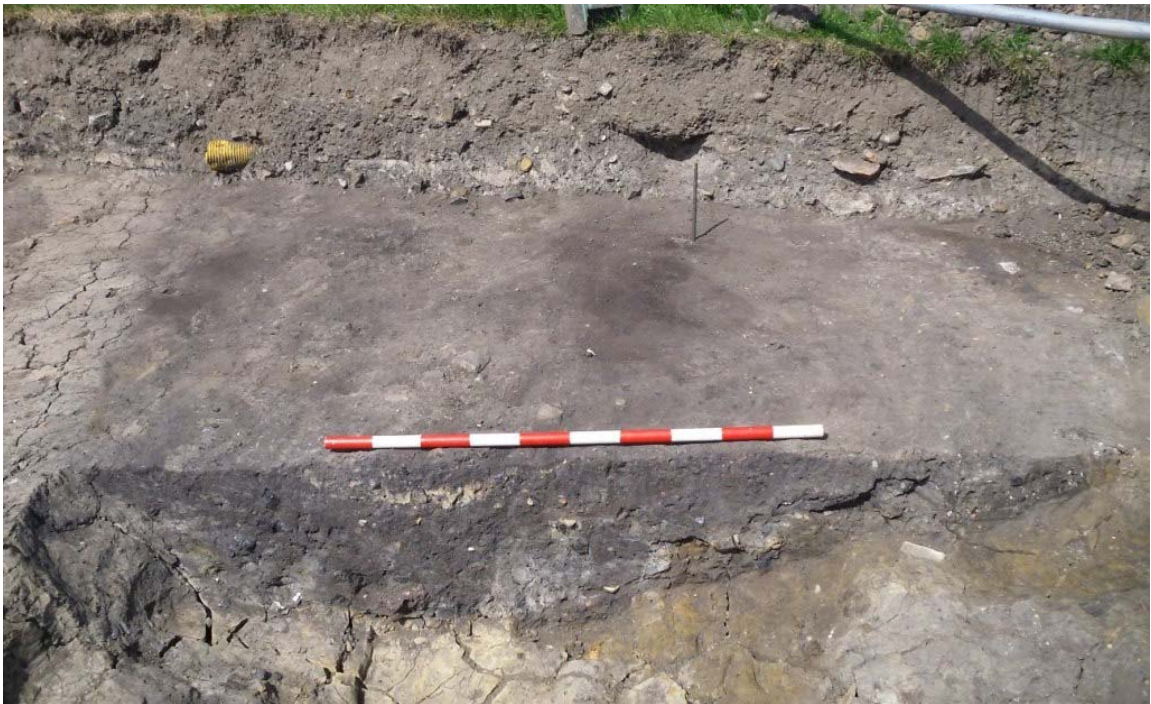
Plate 2. Area B, Phase 3 waggonway ditch [2013], looking north-west (*1m scale*)

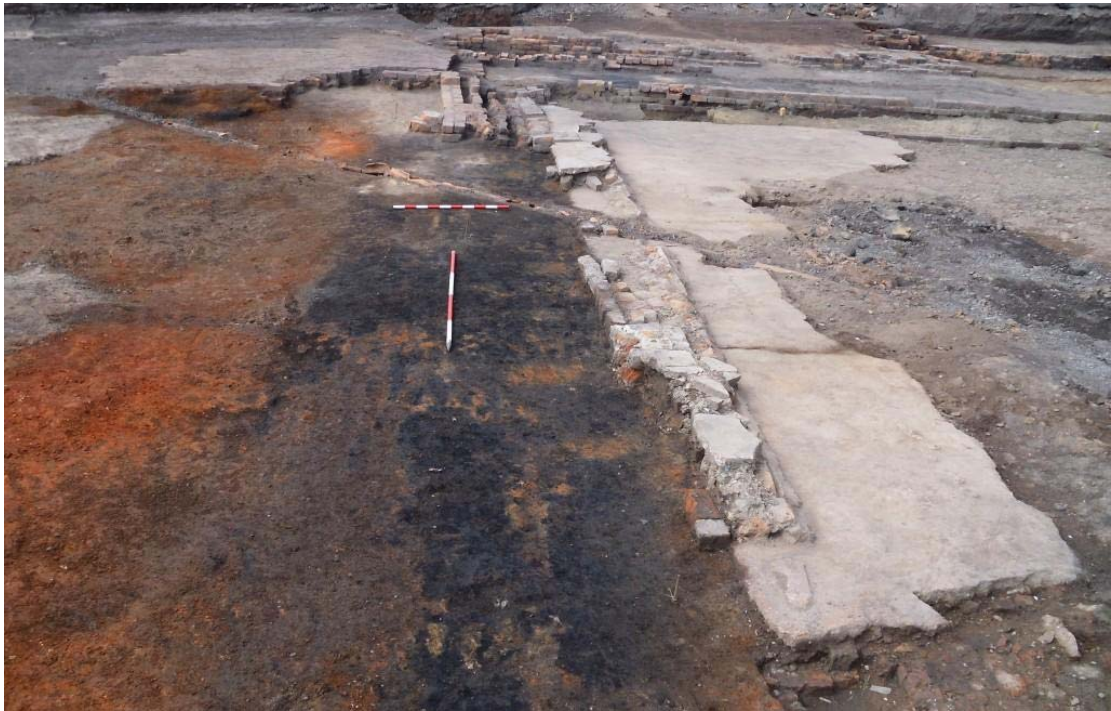
Plate 3. Area A, Phase 4a deposit [1068] (centre), Phase 4d structures (right) (2m and 1m scales)

5.4.1.3 Along much of its northern extent, extensive clayey ash deposit [1056] was directly overlain by a distinctive layer, [1068], predominantly comprising compact black ash. This was exposed across a linear area measuring at least 12m west-east by up to c. 2.10m north-south and was recorded at a maximum height of 34.02m OD (Plate 3). This deposit was notable for the presence of a fairly regular, although patchy, network of light to mid reddish brown burnt clay throughout. On this basis this area has been interpreted as representing the location of a brick clamp pre-dating the St. Anthony's Brickworks building and potentially of early-mid 19th century date.

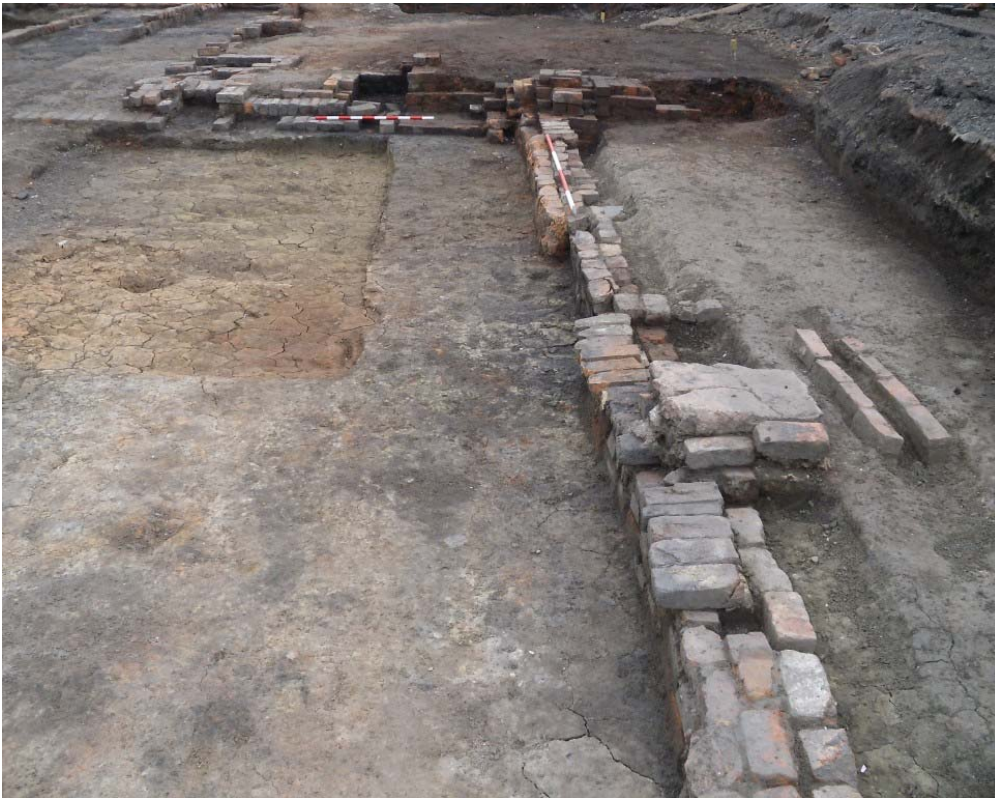
Plate 5. Area A, Phase 4 brickworks western external wall, [1001], looking south (*2m and 1m scales*)

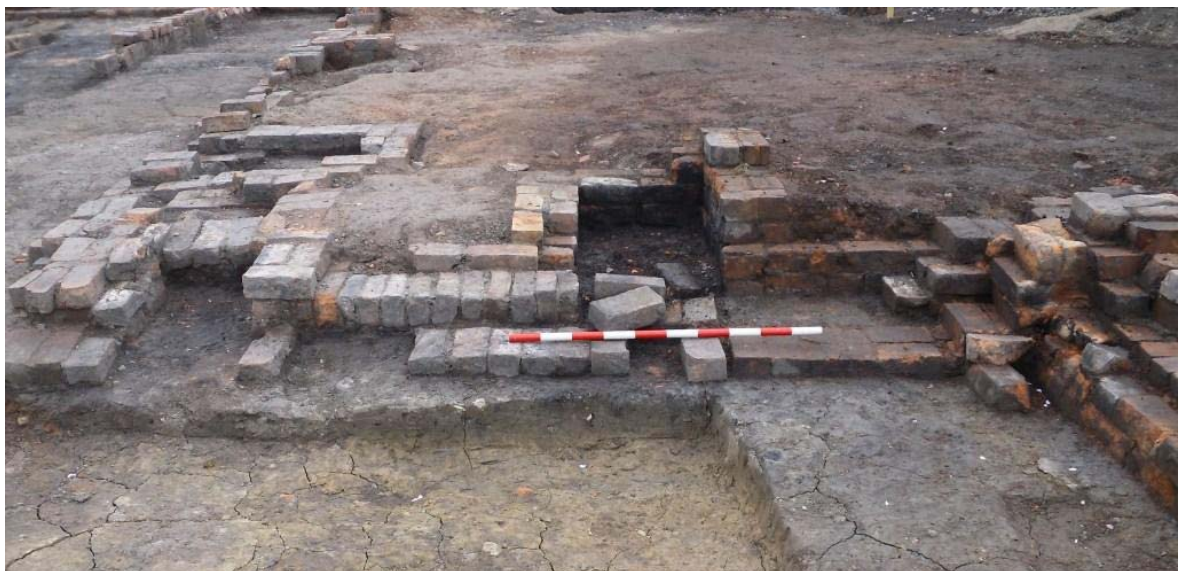
Plate 6. Area A, Phase 4b brickworks western external wall and associated structures, [1100], etc., looking south (*1m scale*)

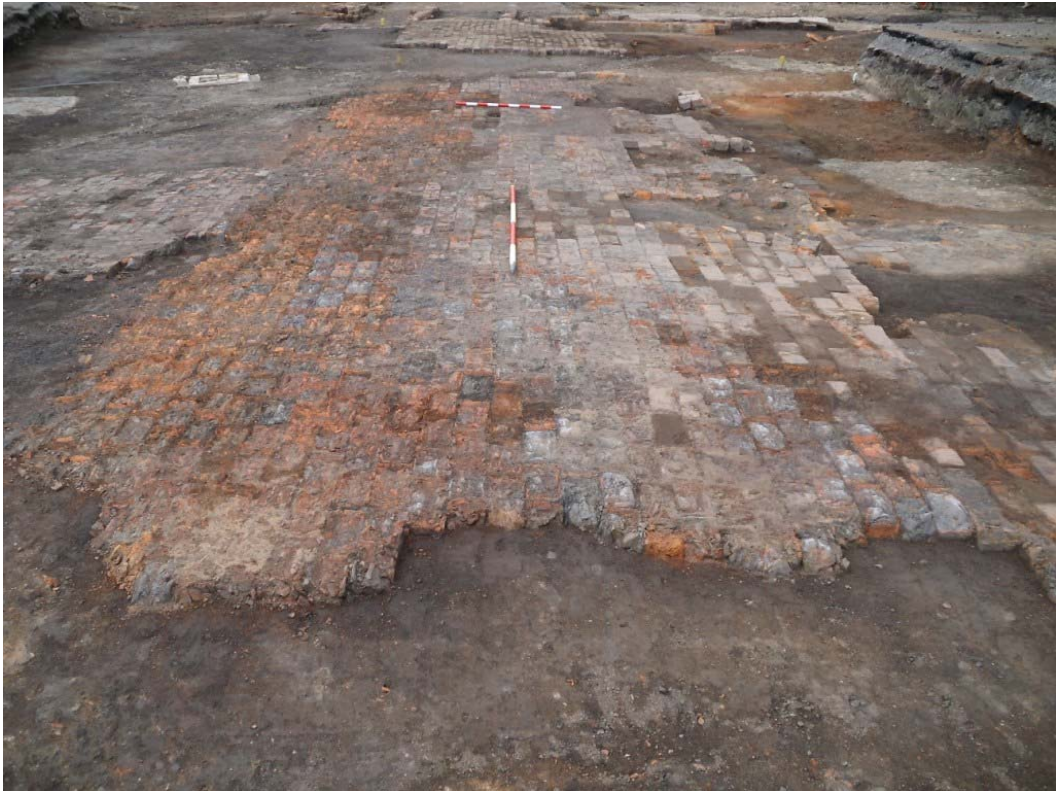
Plate 7. Area A, Phase 4b brick surface [1064] (southern part), looking north (2m and 1m scales)

- 5.4.2.24 The surface comprised bed laid bricks, with no bonding material, using predominantly pressed wire-cut common bricks (average size 230mm x 115mm x 75mm), broadly dateable to the late 19th century, with occasional firebricks. Across the southern area of the surface the bricks were highly degraded, probably through wear (Plate 7). The surface has been interpreted as the surviving remains of an external yard for the original brickworks and, to the south, an access road running roughly west-east and adjacent to the original brickworks, which would explain the higher degree of wear on the southern area of surface. The surface was probably retained for use when the brickworks was re-built, as discussed below.

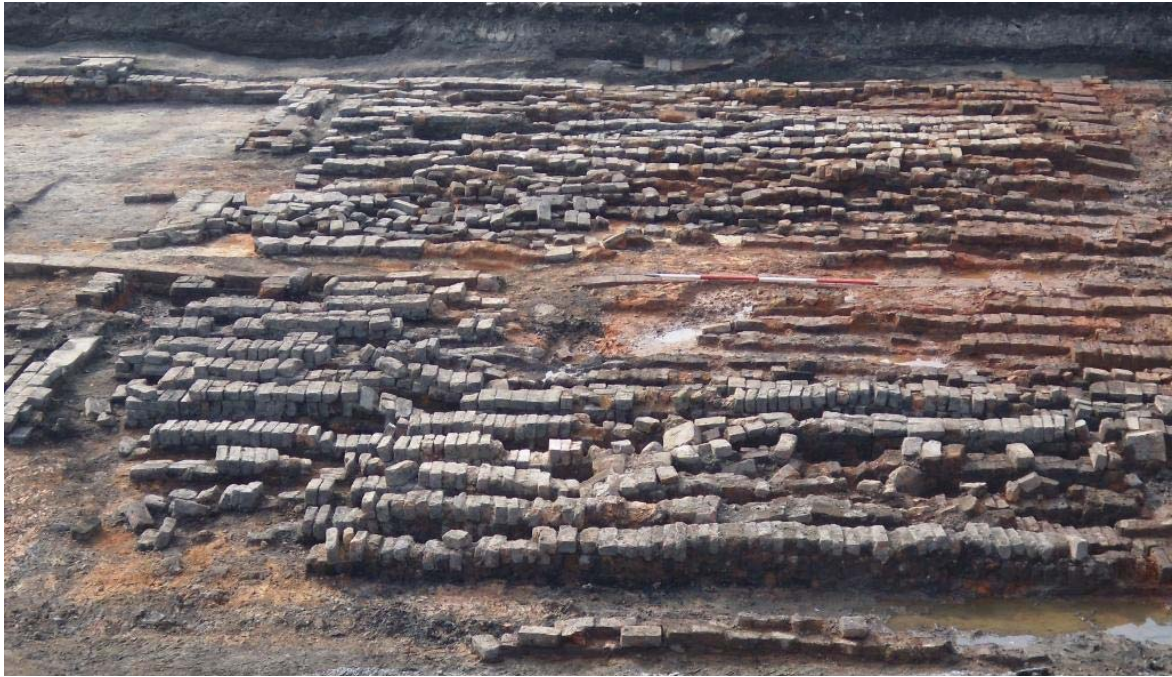
Plate 9. Area A, Phase 4b brickworks drying chamber, looking west (*2m scale*)

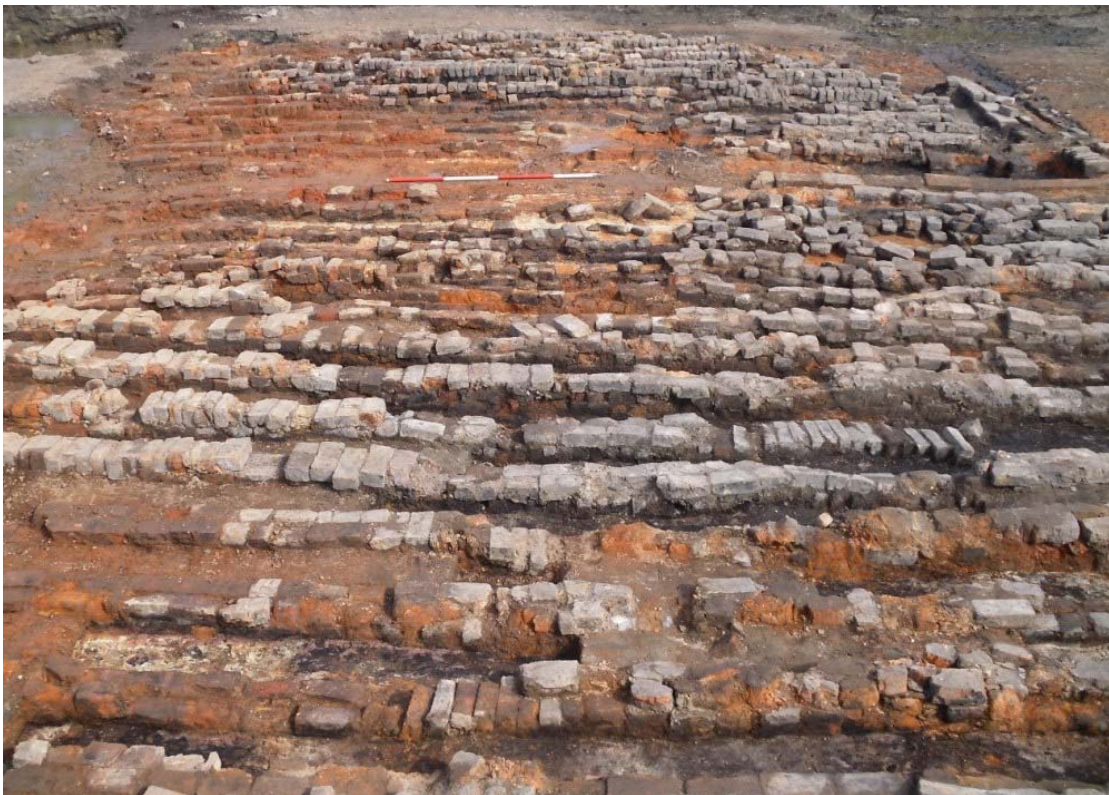
Plate 10. Area A, Phase 4b brickworks drying chamber, looking east (*2m scale*)

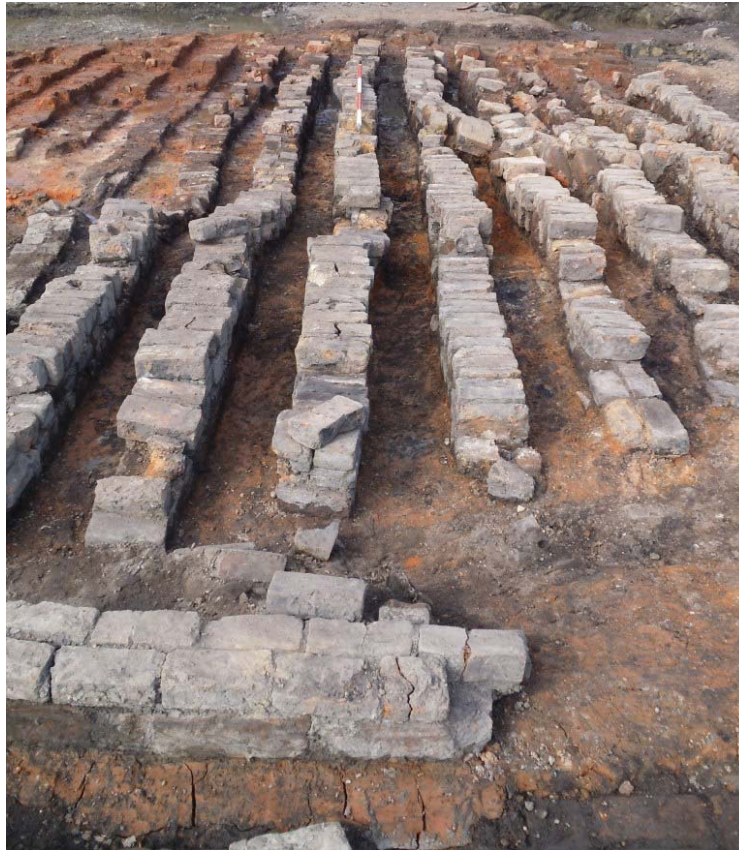
Plate 11. Area A, Phase 4b brickworks drying chamber, eastern part, looking north (2m scale)

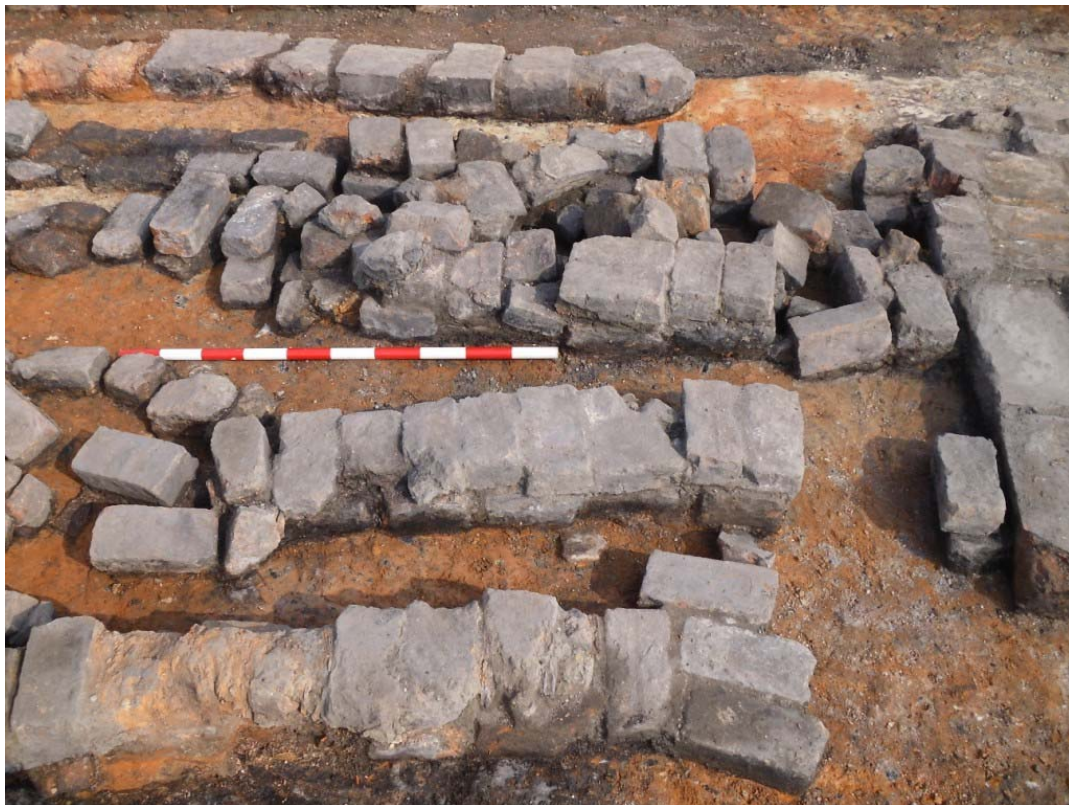
Plate 12. Area A, Phase 4b brickworks drying chamber, eastern part, looking north Area A, Phase 4b brickworks drying chamber, flue detail, looking east (1m scale)

5.4.2.20 Many of the bricks within the flue walls were in poor condition, some highly fragmented, this evidently the result of exposure to high temperatures. While this may in part have occurred *in situ*, the preferred interpretation is that over-fired waste bricks from the brickworks were used in the construction of the flue walls. The maximum surviving length for any flue wall was c. 8.95m (wall [1022]) and the walls were generally c. 0.24m wide. The maximum surviving height was c. 0.40m (wall [1013]), where five dry bonded courses, laid in irregular header and stretcher bonds, survived. The maximum height recorded on any of the drying chamber flue walls was 34.05m OD. In general, and apart from the lack of bonding material, the walls appeared to have been poorly constructed so that some parts had a slightly sinuous form, and there were also several collapsed or missing sections, most notable in the central part of the chamber. The northernmost portions of 15 of the flue walls, [1004]-[1008], [1010]-[1012], [1020], [1023], [1024], [1028]-[1030] and [1036], were notable for their more robust construction, in each case this being a rectangular structural element, c. 0.48m in length constructed using firebricks laid in stretcher bond, bonded with sandy mortar.

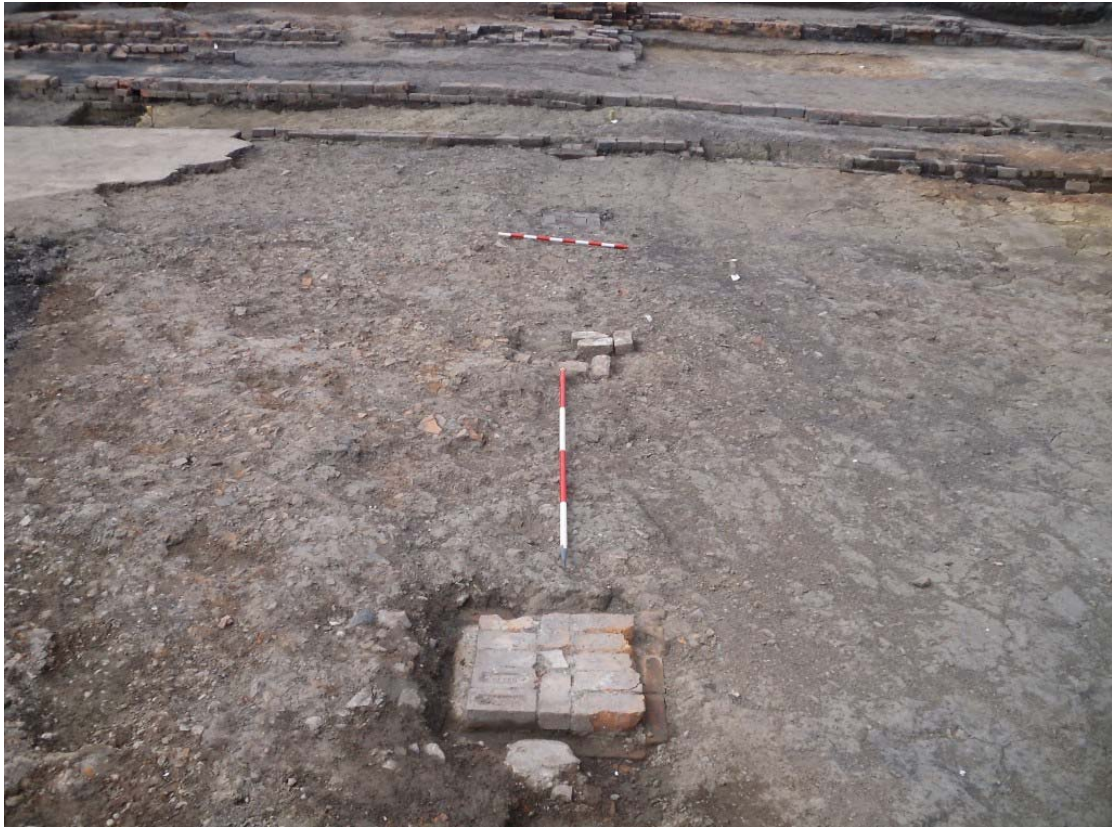
Plate 13. Area A, Phase 4d make-up deposit [1075] and piers [1080], etc., looking west (2m & 1m scales)

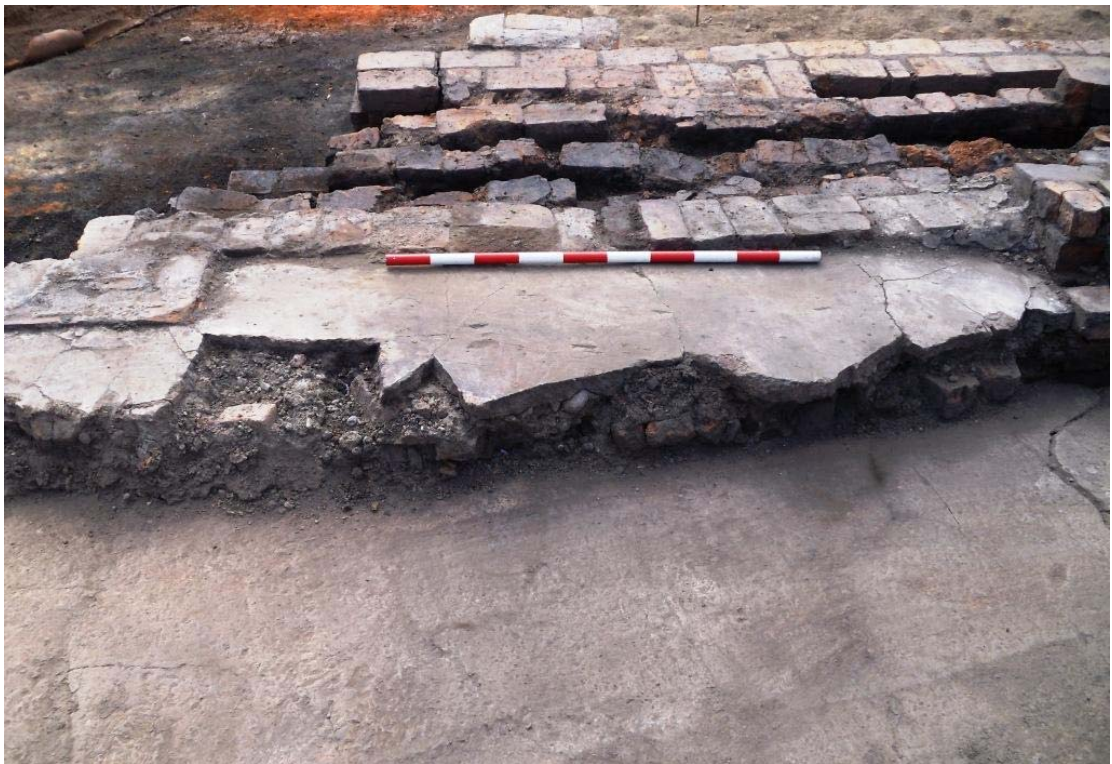
Plate 14. Area A, Phase 4d successive concrete surfaces [1071] and [1075], detail, looking south (1m scale)

- 5.4.4.7 To the east of the southernmost extent of wall [417] was an intermittent roughly west-east aligned wall, [1141], which survived in extremely fragmentary condition but was recorded for a total distance of 8.10m (Figure 7; Plate 14). It survived to a height of 0.20m, in two courses of pressed wire-cut common brick (average size 220mm x 120mm x 70mm). These were laid in header and stretcher bond in the westernmost and easternmost portions of the wall, respectively, so that it was effectively just a single-brick skin and thus certainly an internal subdivision. Two buttresses or piers, [1065] and [1074], were recorded in association with wall [1141]. The first, buttress [1065], lay to the west, abutting the north side of wall [1141] and measuring 0.52m west-east by 0.24m north-south. It was probably added to provide greater structural stability. At the eastern extent of the wall was the second, buttress [1074], measuring c. 0.50m square. This may represent the location of an aperture, probably a doorway, in the line of the wall. Both buttresses or piers were similarly constructed using common brick (average size 120mm x 120mm x 70mm).

- 5.4.4.11 Surviving parts of a later internal concrete surface, [1076], were recorded north of the west-east line of wall [1141], with a combined extent of c. 9.60m west-east by up to c. 0.60m north-south (Figure 7; Plate 14). Up to 60mm thick, this surface overlay a compact brick rubble make-up deposit, [1070]. Again, due to the poor level of survival, surface [1076] is difficult to interpret conclusively; it may have originally formed part of a more extensive surface, possibly a complete replacement of surface [1071] within this internal portion of the building, or it may have been a more limited structure lying internal to the west-east sub-division, and possibly associated with the aforementioned structure [1072].
