AN ARCHAEOLOGICAL WATCHING BRIEF ON
THE SLAGGYFORD TO TIPALT OHL REFURBISHMENT,
NEAR EALS BRIDGE, KNARSDALE,
NORTHUMBERLAND

An Archaeological Watching Brief on the Slaggyford to Tipalt OHL Refurbishment, near Eals Bridge, Knarsdale, Northumberland

Central National Grid Reference: NY 6827 5525

Site Code: SLA 10

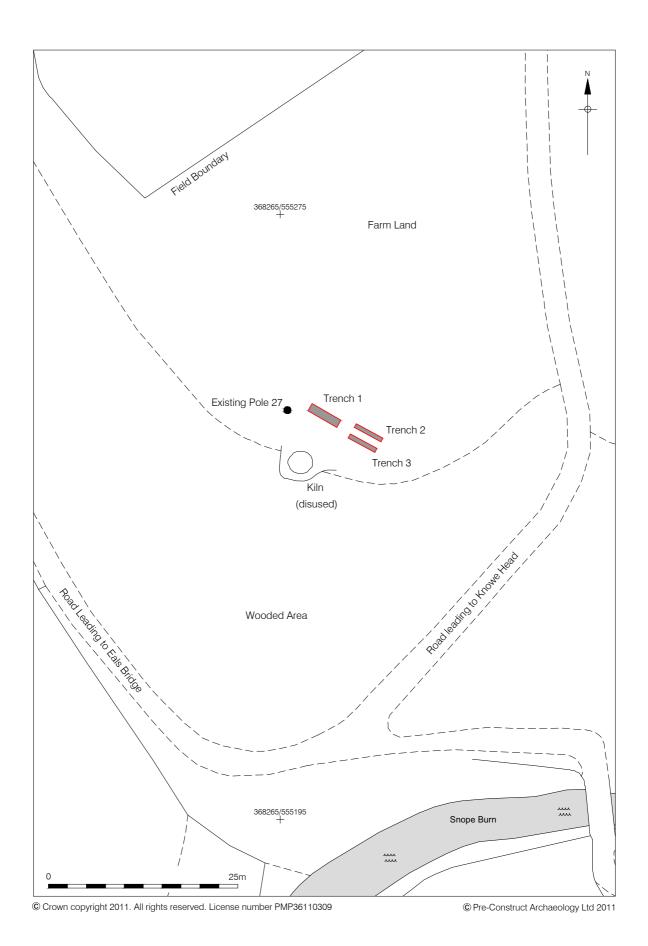
Figure 2 Trench Location 1:500 at A4

- 2.2.4 The replacement pole for Pole 27 could not be sited at its intended location due to the presence of the lime kiln. It was, therefore, sited c. 2.50m south-east of the original pole in an area of land that had recently been fenced off to enclose a recently created pond, surrounded by pasture. The foundation pit for the new pole was therefore situated within this pasture, east of the new fence. Two foundation pits for supporting stays were sited to the south-east, one either side of the new fence.

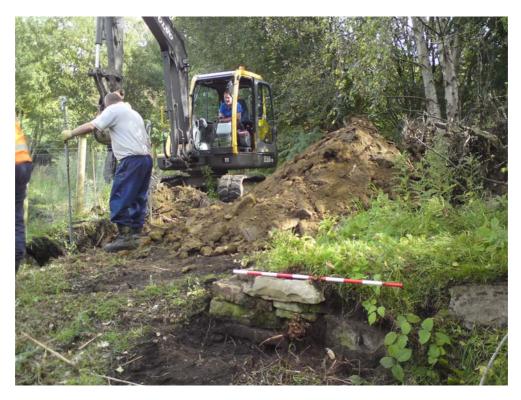
Figure 3. Excavation of Trench 3, lime kiln in foreground, looking south-east (scale 1m)

- 4.1.3 Groundworks were undertaken by personnel from NEDL. Undergrowth was cleared from the area of the lime kiln by hand to establish the limits of the structural remains (Figure 3). It became apparent that the replacement pole for Pole 27 could not be sited at its intended location due to the presence of the lime kiln. It was therefore sited c. 2.50m south-east of the original pole in an area of land that had recently been fenced off to enclose a recently created pond, surrounded by pasture. The foundation pit (Trench 1) for the new pole was situated within this pasture, east of the new fence, as was the first of two foundation pits (Trench 2) for supporting stays, while the second stay foundation pit (Trench 3) was located west of the new fence (Figure 2).

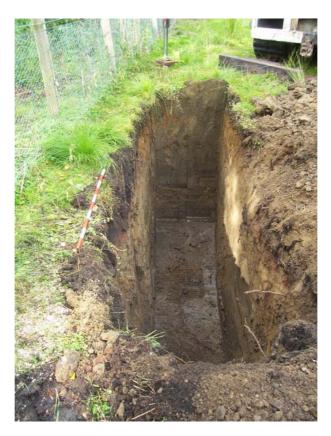
Figure 4. Trench 1, looking north-west (scale 1m)

- 5.1.1 Naturally deposited material was observed in Trench 1, from a depth of the *c.* 0.50m below ground level to the base of the trench, to the base of the excavation at a depth of *c.* 2.35m. Due to the depth of the trench, it was not possible to examine the lowermost deposits in detail, although as recorded remotely, these deposits, [04], seen from a depth of *c.* 1.70m below ground level, comprised bands of firm, mid orange brown and mid blue grey sandy clay with frequent flecks and patches of manganese.

- 5.2.1 The uppermost glaciofluvial deposit in Trench 1 was overlain by a layer, [02], of very mixed composition, comprising patches of pinkish brown silty clay, which appears burnt in places, and orange brown sandy clay. This deposit, up to c. 0.30m thick, contained moderate inclusions of small, medium and large rounded to sub-angular stones, occasional charcoal flecks and fragments, and small fragments of clinker. This deposited extended across the trench and was encountered from a depth of 0.28m below ground level. It is interpreted as representing material dumped in this area during recent landscaping associated with the construction of the pond and erection of the new fenceline. The burnt material within this dumped deposit is likely to represent waste material originating from the lime kiln situated close by.

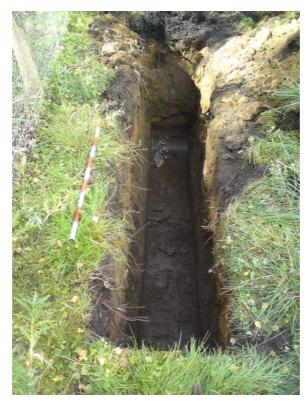
Figure 5. Trench 2, looking north-west (scale 1m)

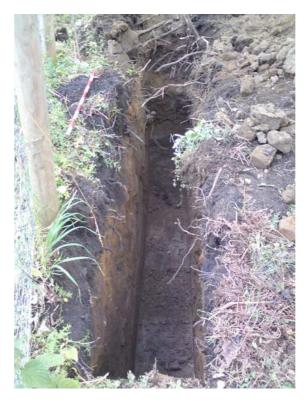
Figure 6. Trench 3, looking south-east (scale 1m)

- 4.1.4 The foundation pit for the replacement for Pole 27 and the two stay foundation pits were mechanically excavated under archaeological supervision. A tracked five and half tonne excavator was used, utilising a toothless bucket (Figure 3). Trench 1, to accommodate a double pole for the OHL, measured 4.40m NW-SE x 1.10m wide x 2.35m deep (Figure 4). Trench 2, located to the south-east, to accommodate the first stay for the pole, measured 4.0m NW-SE x 0.55m wide x 1.45m deep (Figure 5). Trench 3, located to the south-west of Trench 2 and for the second stay, measured 4.0m NW-SE x 0.60m wide x 1.65m deep (Figure 6).
