PEARTREE STREET, LONDON BOROUGH OF ISLINGTON EC1

AN ARCHAEOLOGICAL EVALUATION

PCA REPORT NO: 11105

An Archaeological Evaluation on Land at Peartree Street, London EC1, London Borough of Islington

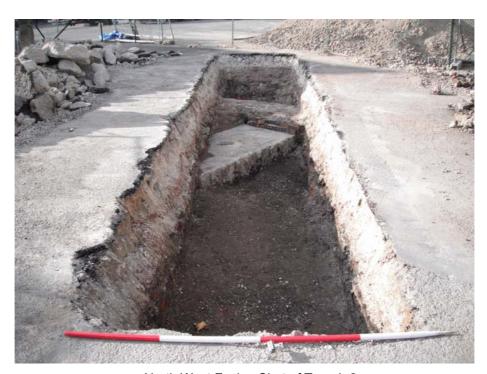
- 8.2.1 Trench 2 revealed two made ground deposits relating to the disuse of the 19th Century Chartered Gas Works. Cut through this was a north-south wall, which was in turn sealed by an east-west concrete foundation. All of the above structural contexts related to 20th century buildings that post-date the Chartered Gas Works. All walls and deposits within the trench were sealed by a modern bedding layer and tarmac for the present day car park.
- 8.2.2 The walls in Trench 2 all dated to the late 19th to early 20th century and appear to be the north to south orientated building shown on the 1913 OS map (Fig. 8) that superseded the Chartered Gas Works, with an internal east-west concrete foundation.
- 8.2.3 Trench 2 was positioned within a Gasometer (Fig. 4), although no evidence for this structure was located.

North West Facing Shot of Trench 2

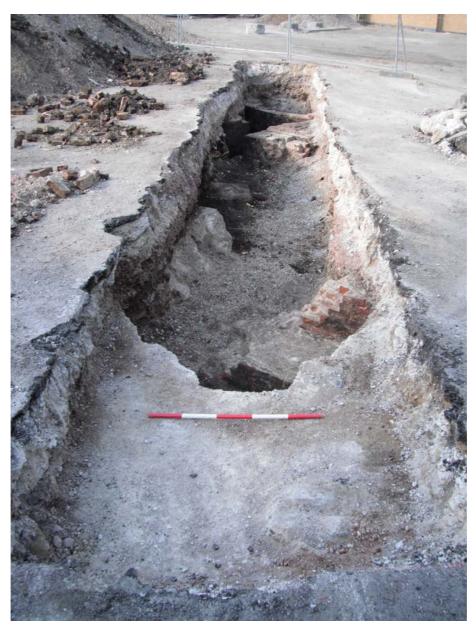
8.3.1 The earliest features encountered in Trench 3 were parallel walls in the corners of Gas Works structure with associated iron pipe, remnants of a brick arch, concrete base, and also truncated east-west running walls in the southern part of Trench 3. These structures all appear to be related to the Retort House building of the Chartered Gas Works (Fig 4). , All exposed features and structures had been sealed by a rubble and clinker backfill/demolition deposit, which was in turn truncated and sealed by a modern drain cut and the present day tarmac car park.

North West Facing Shot of Trench 3
