**HAROLD WOOD HOSPITAL,
ROMFORD, RM3 0BH: PHASE 2B**

**AN ARCHAEOLOGICAL
EVALUATION AND WATCHING
BRIEF**

PCA REPORT NO: 11161

SITE CODE: GUB12

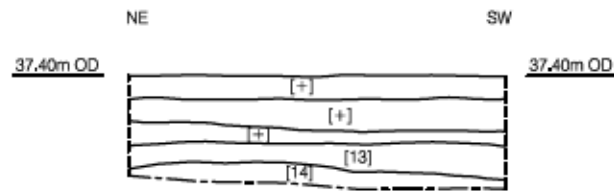
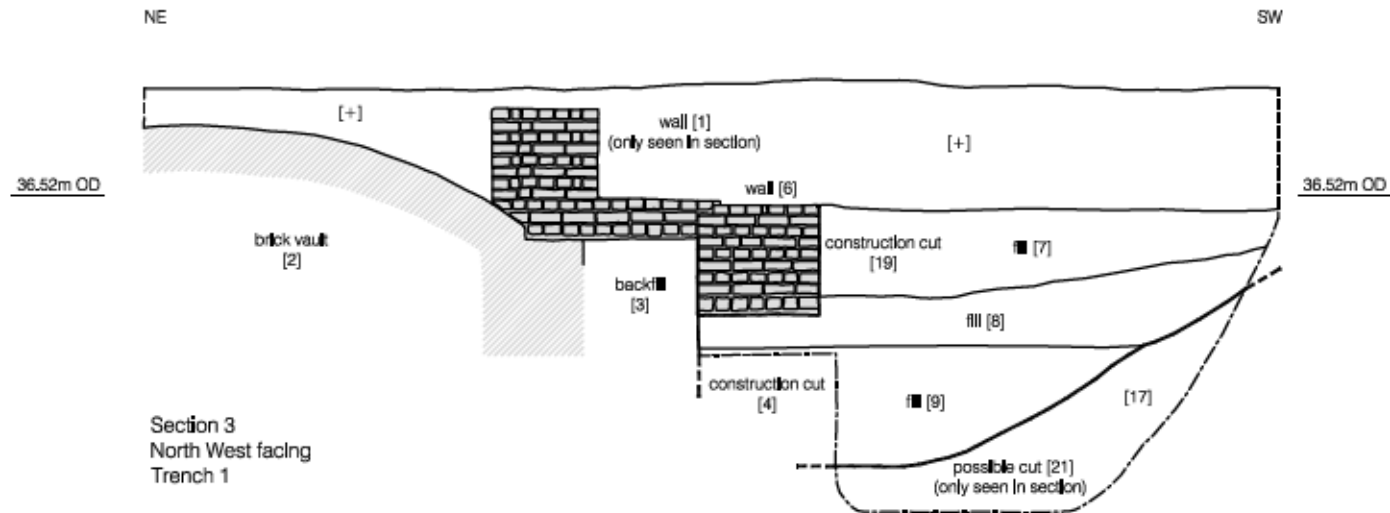
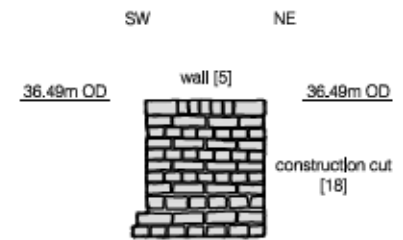
Figure 4
Trench 1 Sections
1:50 at A4

Section 1
North West facing
Trench 1

Section 3
North West facing
Trench 1

Section 4
South East facing
Trench 1

- 7.1.1 Natural clay [14] was observed at the base of the western end of the trench between 36.71m AOD and 36.83m AOD. This was overlain by a layer of mixed light yellowish brown and light brownish yellow brick earth [13] which showed signs of root disturbance and lay at a height of 36.93m AOD and 36.97m AOD. It was between 0.20m and 0.30m thick.

- 7.1.2 Natural clay [17] was observed in the eastern end of the trench at between 36.57m AOD to the west and 35.60m AOD to the east. This reflects truncation by a cut feature [21] whose precise form and function remain unclear. It contained three fills: two clay backfilled deposits [7] and [8], as well as a fill arising from the presence of water [9]. Fill [7] is dated by ceramic finds to the period c. 1660-1700 and included sherds of Combed Slipware and possibly Metropolitan Slipware, whilst fill [8] was dated to the late 16th and 17th centuries, comprising mostly transitional Redwares with one sherd of post-1580 Redware.

- 7.1.3 The exact character of feature [21] remains unclear due to the limited extent exposed within a small machine-dug sondage. It was 1.20m deep and was traced for a distance of 2.90m east-west. Whether this was a pond or a moat suspected to have existed in this area remains uncertain. No trace of this feature was observed in either Trenches 2 or 3 to the north, where its size, extent in plan and depth would have rendered it visible and relatively unaffected by modern truncation. It can be seen from the map regression in Figure 7, where the trenches and pertinent features have been overlaid to the 1st Edition OS Map from 1868, that features suggested from that map do not survive in the ground.

- 7.1.4 This feature was partially truncated by two walls [5] and [6], built probably in rapid succession, although the exact sequence is unclear. Both use almost identical unfrosted re-used red bricks and mortar. These walls are here dated to the 19th century but their function also remains unknown. Wall [6] was aligned northwest-southeast, whilst [5] was aligned on a more north-northwesterly axis. It is thought that they represent revetting along a reduced line of the moat/pond from a period pre-dating the construction of The Grange in 1884.

- 7.1.5 To the east of these walls lay a brick arch [2], springing to the east from a vertical wall, which lay within a very clearly visible construction trench [4]. This structure extended beyond the immediate confines of the trench to the north, south and east and was not exposed in its entirety in either plan or elevation. The top of the arch was exposed at a height of 36.98m AOD (just 90mm below ground level in this area.), whilst its western external wall (from which the vault sprang) lay at a height of 36.26m AOD

- 7.1.6 A brick construction [1] was observed only in the southern section of Trench 1, but was observed to be later in date than both the vaulted structure [2] and possible garden wall [5] onto both of which it was built. In particular it was observed that the lowest brick courses superimposed onto [2] had been cut to fit the curvature of the vault, and that the mortar employed within [1] was indurated and very coarse, gritty and sandy in composition, strongly suggesting a somewhat later date (and actually very similar to that used in the construction

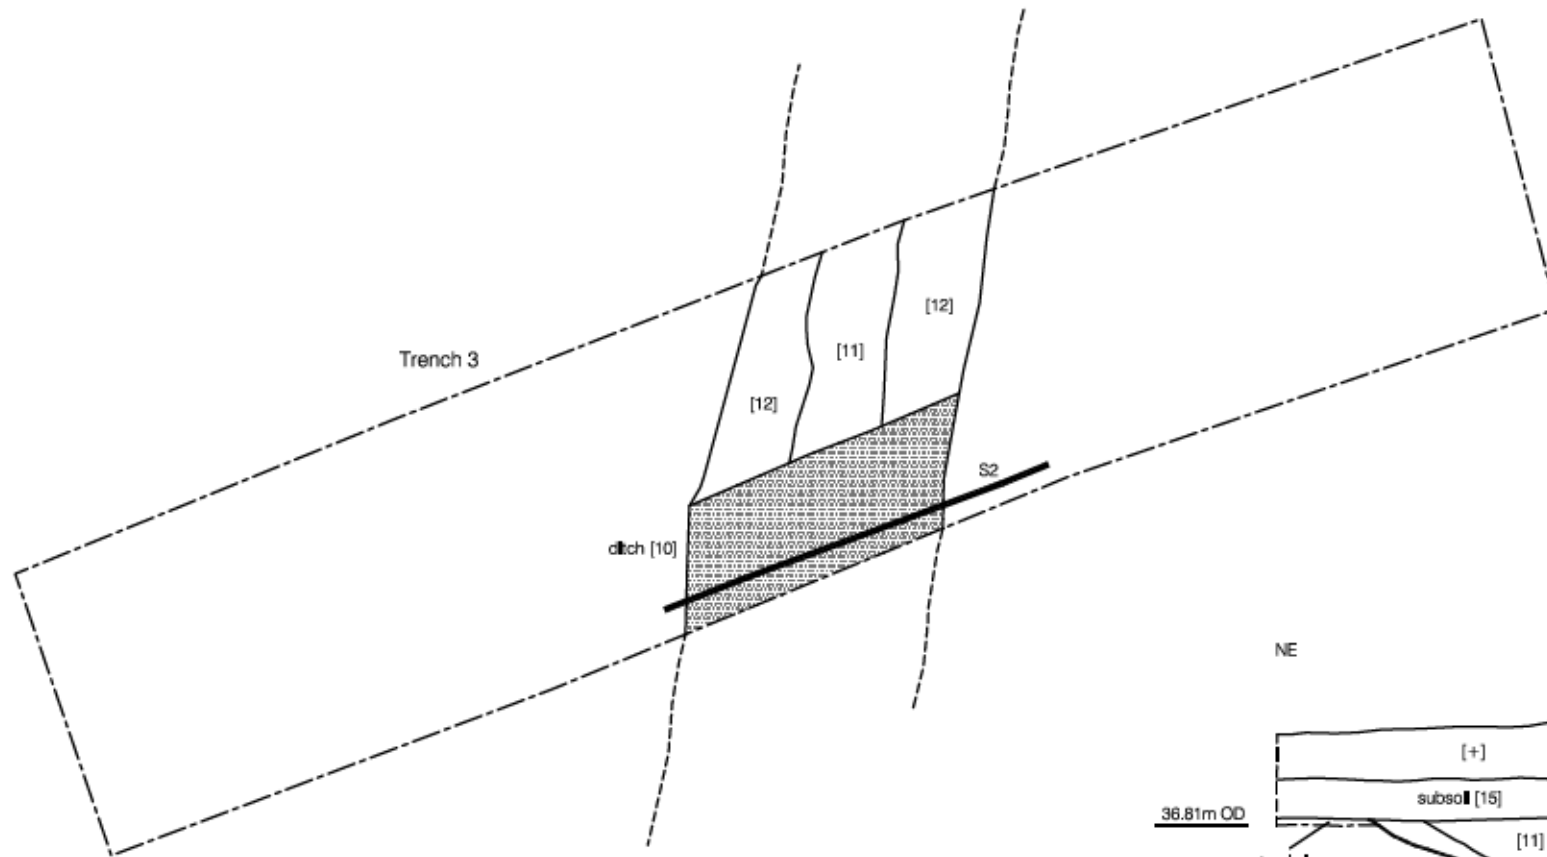
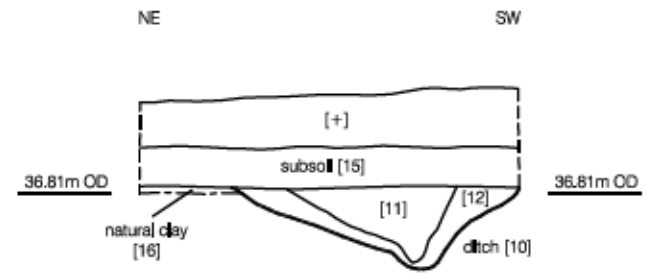
Figure 5
Trench 3 Plan & Section
1:50 at A4

Section 2
North West facing
Trench 3

excavated slot

- 7.3.1 The only archaeological feature within Trench 3 was an apparently linear feature [10] aligned approximately northeast to southwest. It was cut into natural clay [16] whose surface lay at a height of between 36.85m and 36.90m AOD.

- 7.3.2 Feature [10] when first machined appeared to be very ill-defined and unpromising, but with longer exposure appeared to develop progressive linearity. Upon excavation it proved to be 0.55m deep and contained two fills, a more visible light greenish bluish grey secondary fill [11], which was up to 0.50m thick. This lay above an earlier fill [12] bearing a much closer resemblance to the surrounding natural clay and therefore possibly another secondary fill arising from the slumping of the feature's sides. Both fills produced finds of prehistoric pottery, consistent with Late Bronze Age plainwares c.1100-800BC (pers comm. Matt Brudenell), whilst [11] also produced a 'squat' flake in good sharp condition, most likely of later prehistoric date, c. late second / first millennium BC (pers comm. Barry Bishop).

- 7.3.3 Given its linear nature and its apparent absence from Trench 1, where it might have been expected to continue, this might represent a relatively discrete feature. No further accompanying archaeological features were discovered within this trench.

- 7.3.4 Feature 10 was sealed by clay subsoil [15] which lay at a height of 37.11m AOD, and was 0.25m thick. This in turn was sealed by modern made ground, which was approximately 0.40m thick.

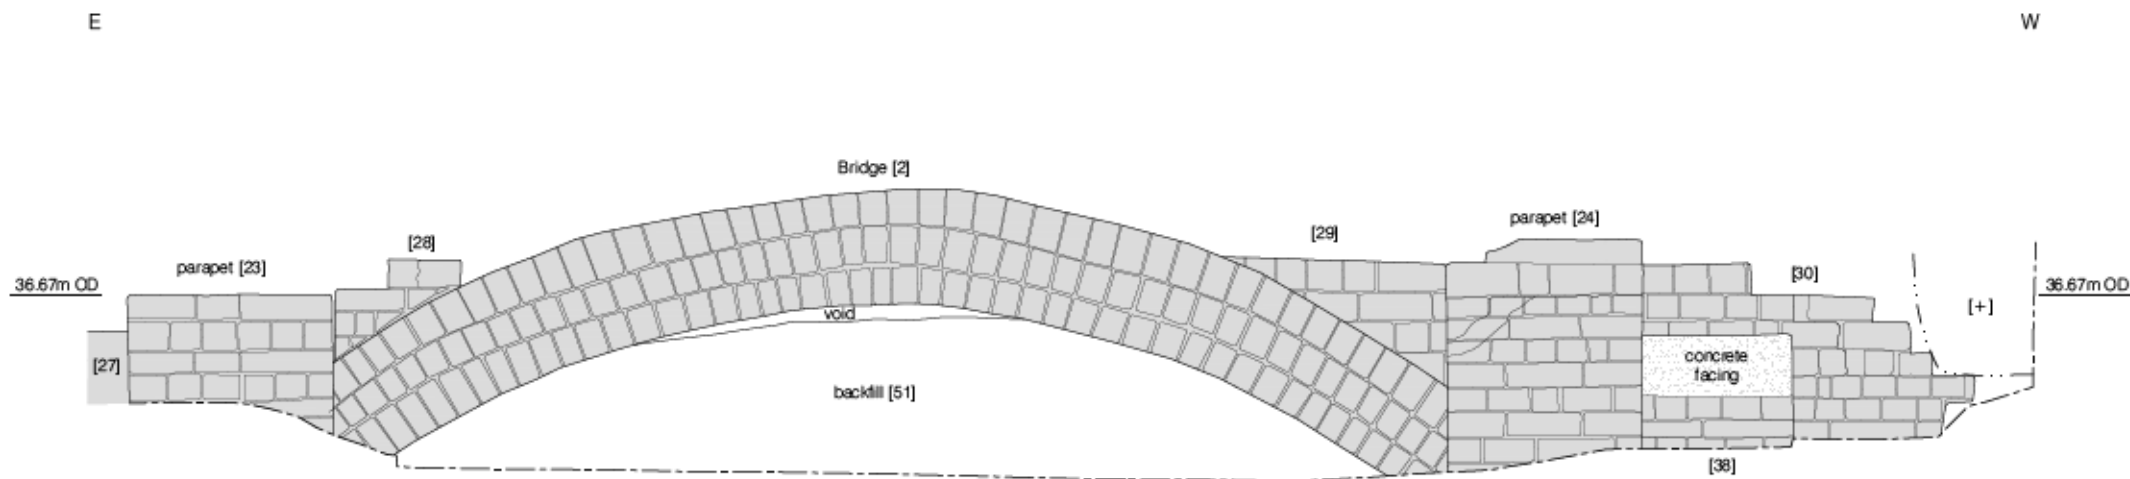
Figure 9
 Section 6
 1:25 at A4

Elevation of Bridge [2]
 North facing
 Watching Brief extension at Western end of Trench 1

- 36.29m AOD, the full depth of which was not ascertained. To the west, the construction cut [4] was recorded in the evaluation, while to the east cut [50] was filled by compact mortar and crushed brick. The arch [2] springing from these walls consisted of three courses of unfrosted red brick. The top of this arch was recorded at 36.99m AOD. This has been interpreted as the abutments and arched span of an east to west aligned bridge over the moat/pond recorded in Trench 1 (context [21]; probably related to, and possibly dating from, the construction of the Grange.

- 7.5.9 Waterlain deposits [51 and 52] were identified beneath the span and to each side. Fill [51] consisted of very dark brown grey sandy clay silt immediately beneath, and filling, the arch [2]. Beneath this fill [52] was a light grey brown silt clay with darker grey silt clay mottling towards the base within which roundwood fragments were observed. The full depth of this deposit was not reached, but has been interpreted as moat/pond fill. The eastern edge of the moat/pond was not observed, but natural glacial clay was observed to the east of construction cut [50].
