**An Archaeological Evaluation at York Engineers' Triangle,
York Railway Station, Cinder Lane, off Leeman Road, York**

Site Code: YET 11

**© Pre-Construct Archaeology Limited
February 2012**

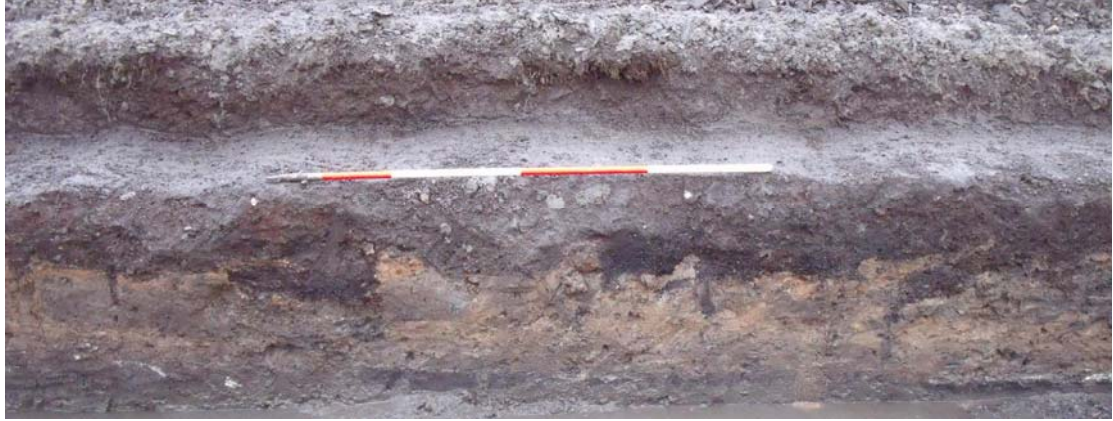
Figure 8 Trench 1, representative part of southwest facing section, towards northwest end of trench (*scale 2m*)

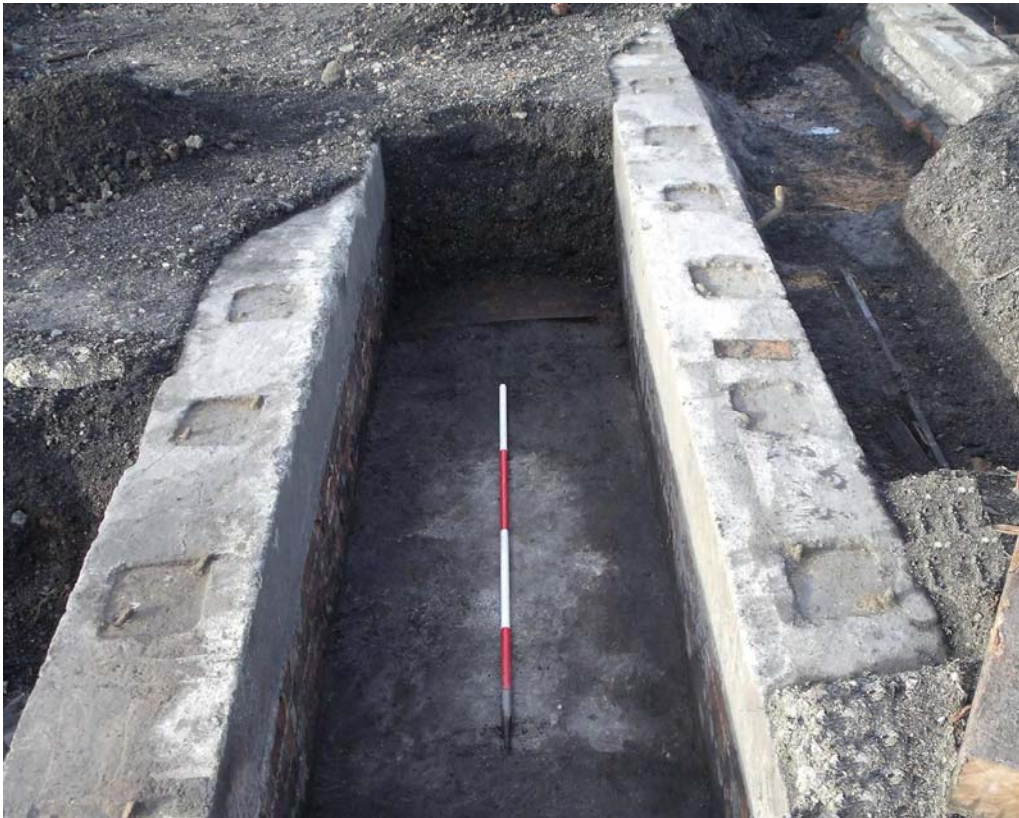
Figure 9 Trench 2, Inspection Pit 1, looking west (*scale 2m*)

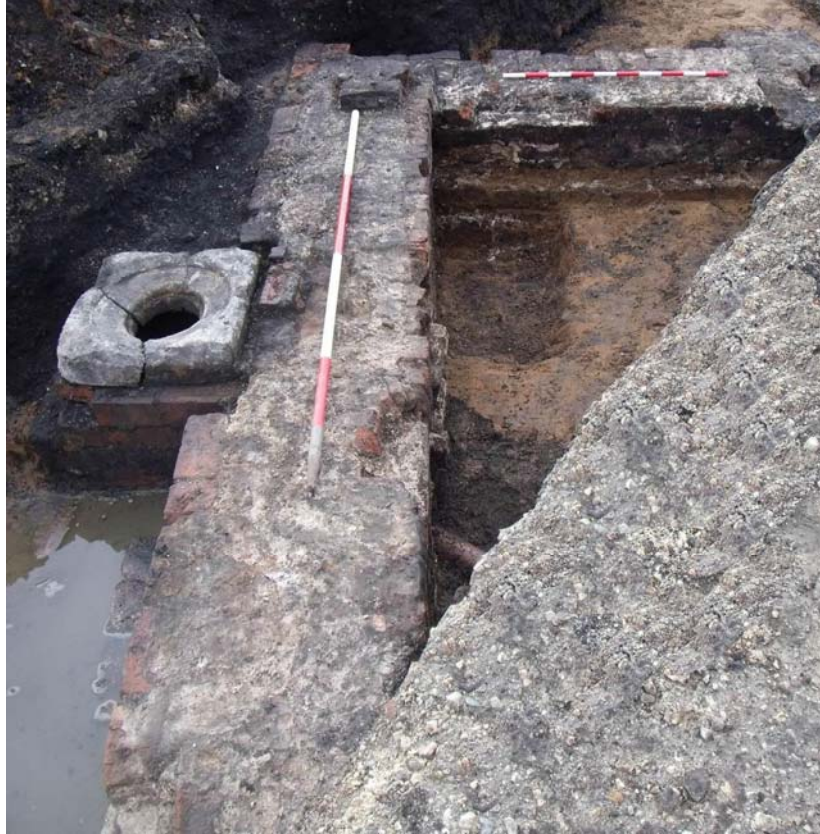
Figure 10 Trench 2, southwest corner of 1841 Engine Shed, looking west (*scales 2m & 1m*)

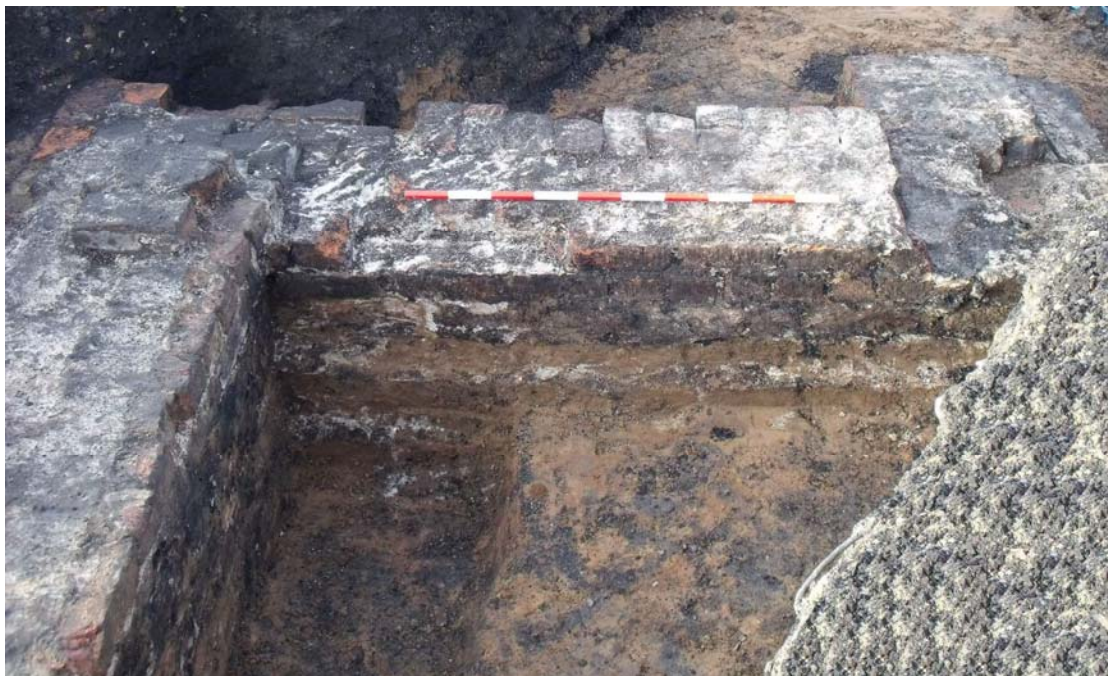
Figure 11 Trench 2, 1841 Engine Shed, wall [297] detail, looking west (*scale 1m*)

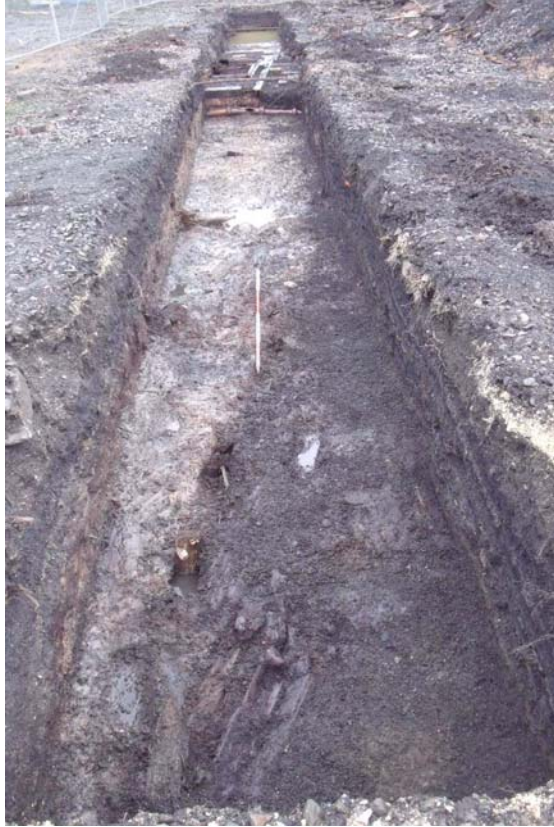
Figure 12 Trench 3, view along the trench, looking SSW (*scale 2m*)

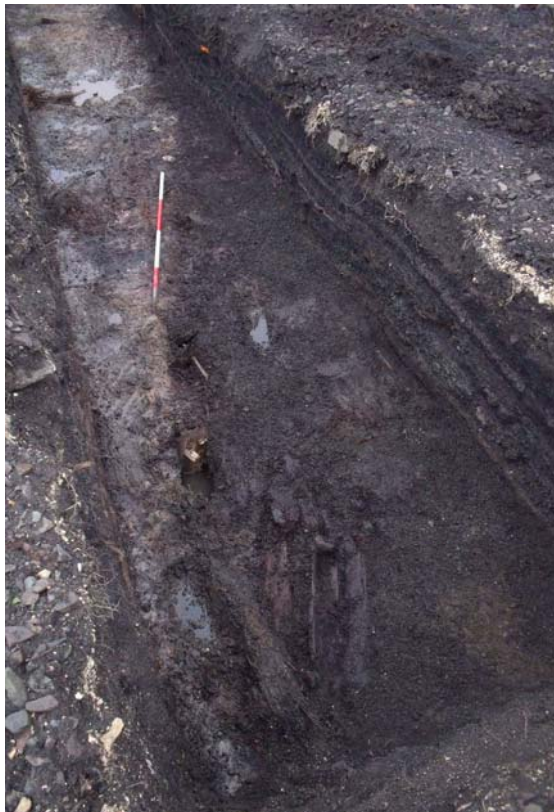
Figure 13 Trench 3, revetting in feature [411], looking southwest (*scale 2m*)

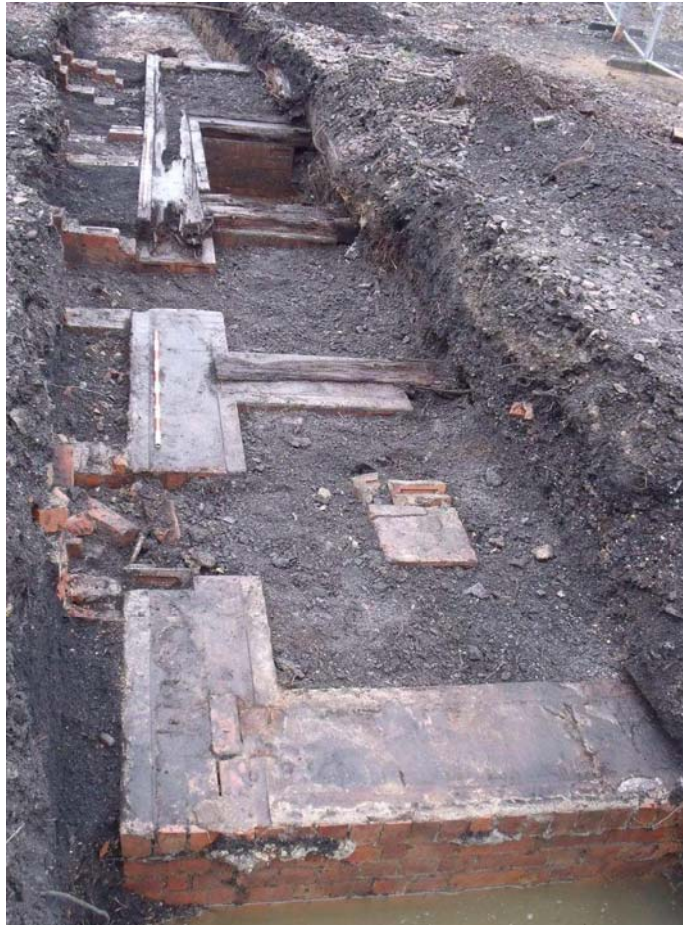
Figure 14 Trench 3, Structure [400], looking NNE (*scale 1m*)

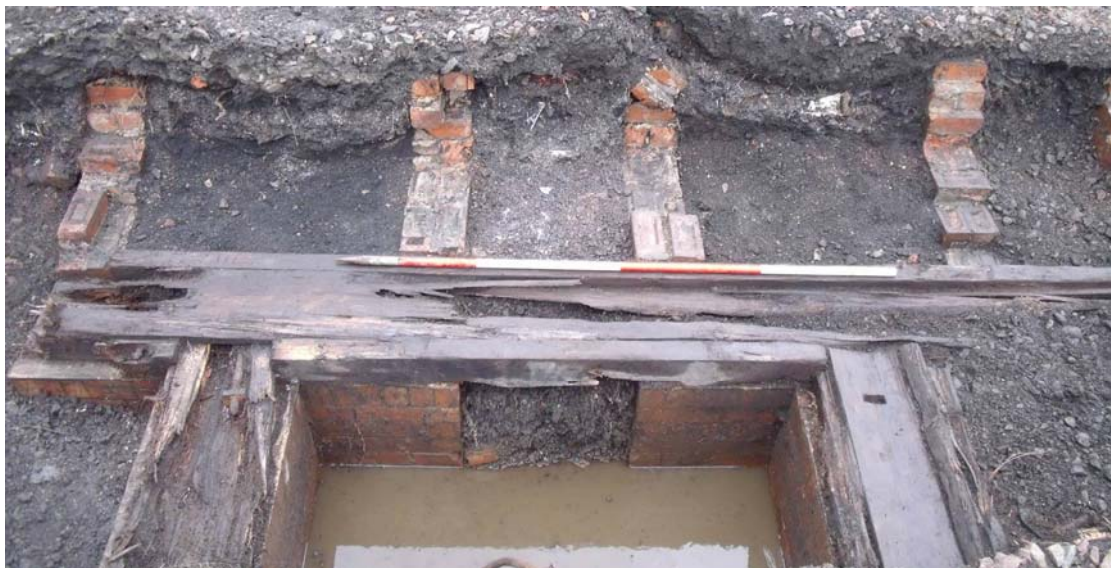
Figure 15 Trench 3, Structure [400], timber [371] detail, looking north-west (*scale 2m*)

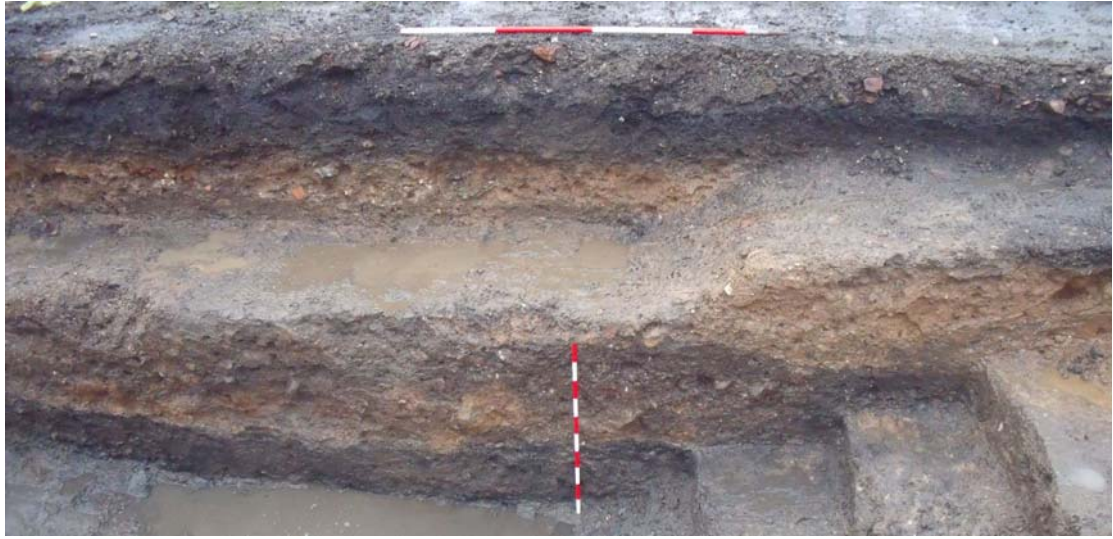
Figure 16 Trench 5, southeast facing section, northeast end of Slot 1 (*scales 2m & 1m*)

5.4.7 The sequence of deposits recorded in Slot 1 at the north-eastern end of Trench 5 overlying the putative alluvial gravel had a maximum combined thickness of 1.10m and was recorded at a highest level of 11.97m OD. The mixed artefactual assemblages recovered from these deposits suggest that material had been dumped in this area during the post-medieval period, possibly deposited as ground consolidation or levelling material. The condition of the Roman material was notable; large and unabraded fragments of pottery were recovered along with large fragments of building material, some of which had mortar still attached, suggesting that significant Roman deposits had been disturbed somewhere in the near vicinity during the post-medieval period and dumped in this area.

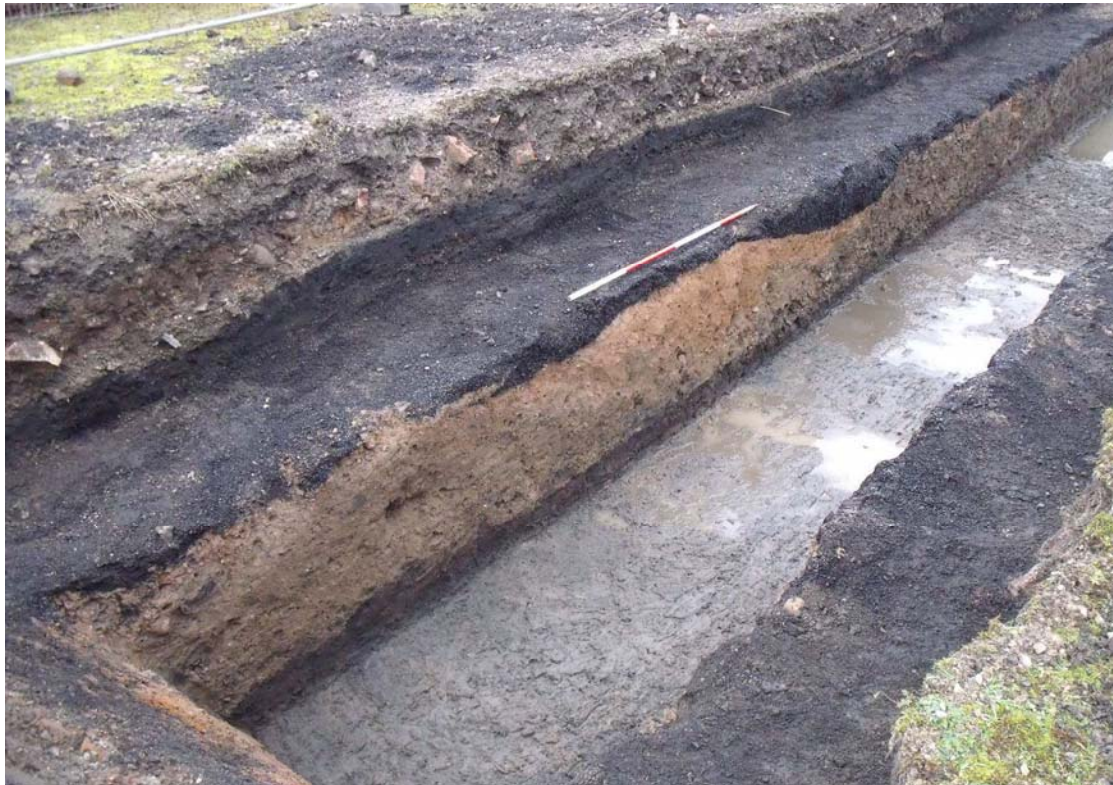
Figure 17 Trench 5, south-east facing section, southwest end of Slot 2, (*scale 2m*)

5.4.8 The series of deposits overlying deposit [157] within Slot 2 was of notably different composition to the series of deposits overlying layer [129] in Slot 1. At the very north-eastern end of Slot 2, layer [157] was overlain by a deposit of loose sand, [158], with frequent fragments of mortar and building material. This was up to 0.38m thick and was overlain by another dump of building rubble, [156], comprising sand and degraded building material. A large sandstone block, [159], was situated a short distance to the south-west of these deposits, overlying deposit [157]. This was a rectangular block (340mm x 240mm x 320mm) with four circular holes, one of which contained a wooden peg, 40mm in diameter and 50mm deep in a square arrangement towards the centre of the block; it was probably a sleeper block derived as demolition material from a nearby structure within the 19th-century railway landscape.

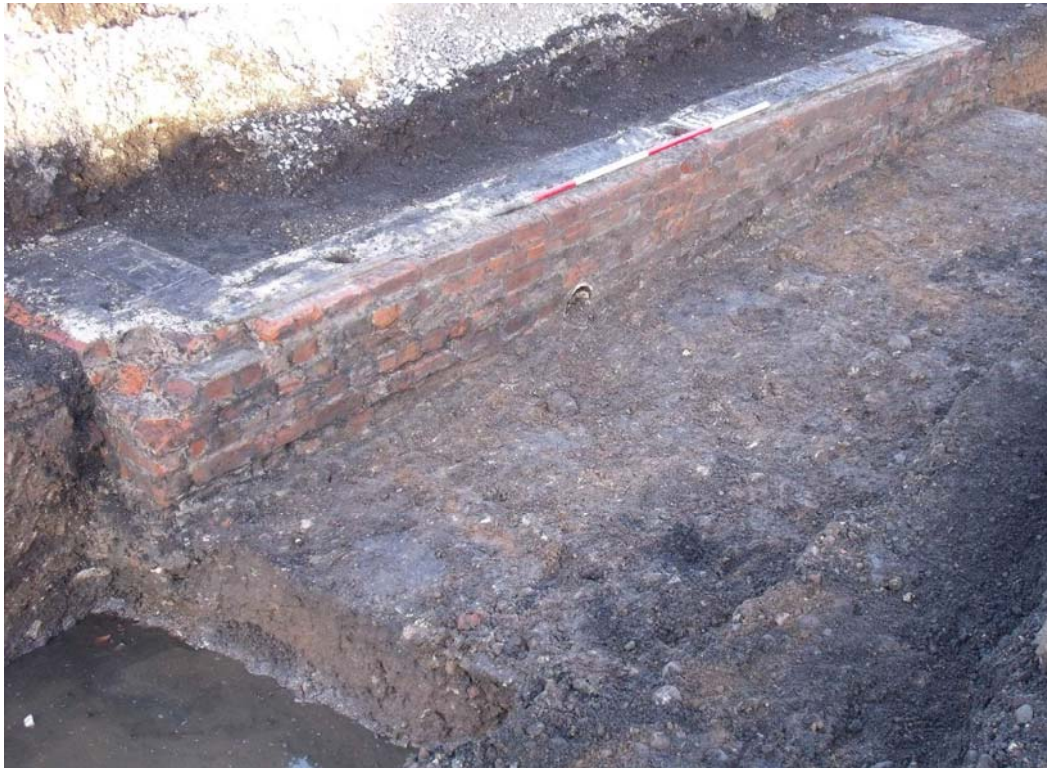
Figure 18 Trench 6, Structure [350], looking northeast (*scale 2m*)

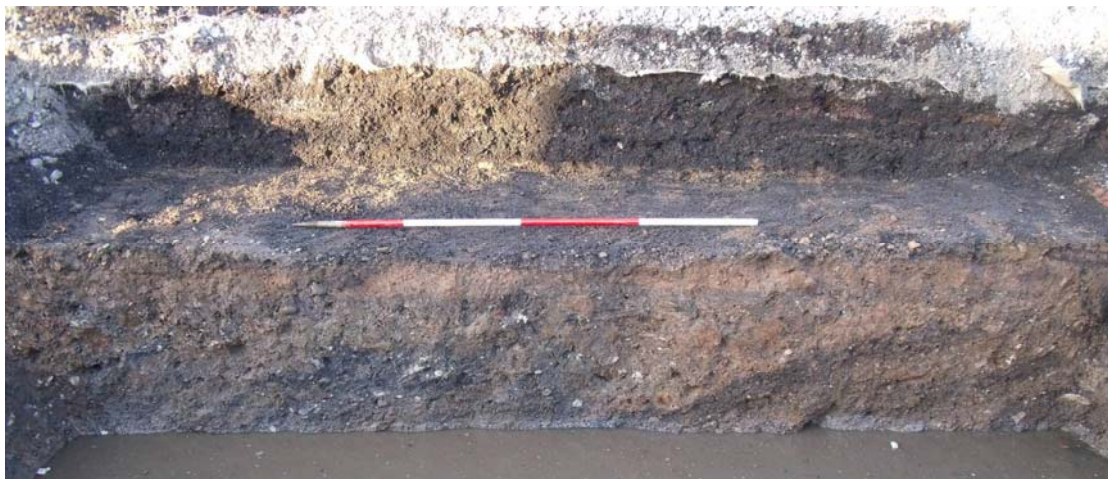
Figure 19 Trench 6, representative part of SSE facing section, towards west end of trench (*scale 2m*)

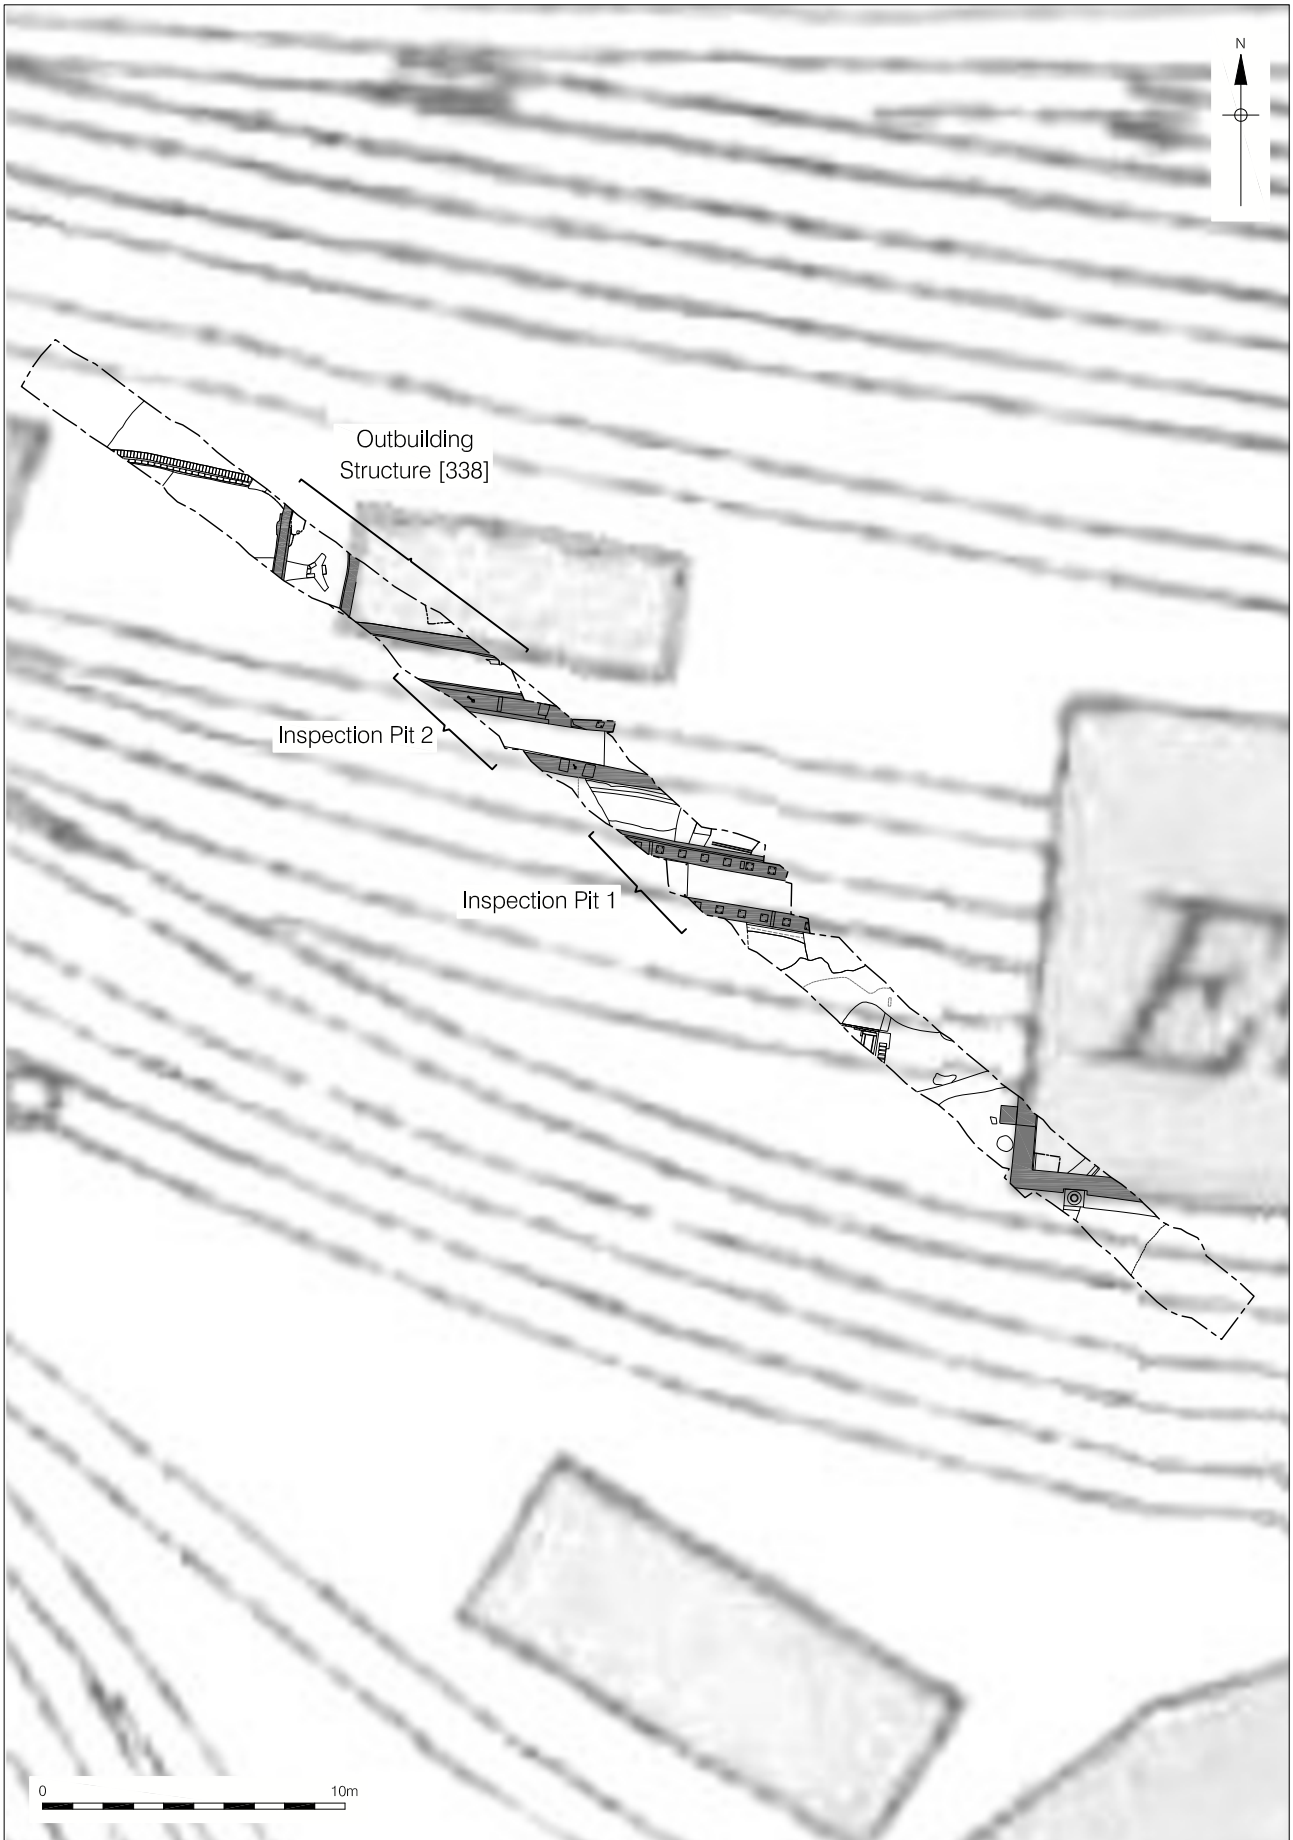
Figure 20
Plan of Trench 2 overlain on 1892 Ordnance Survey map
1:250 at A4

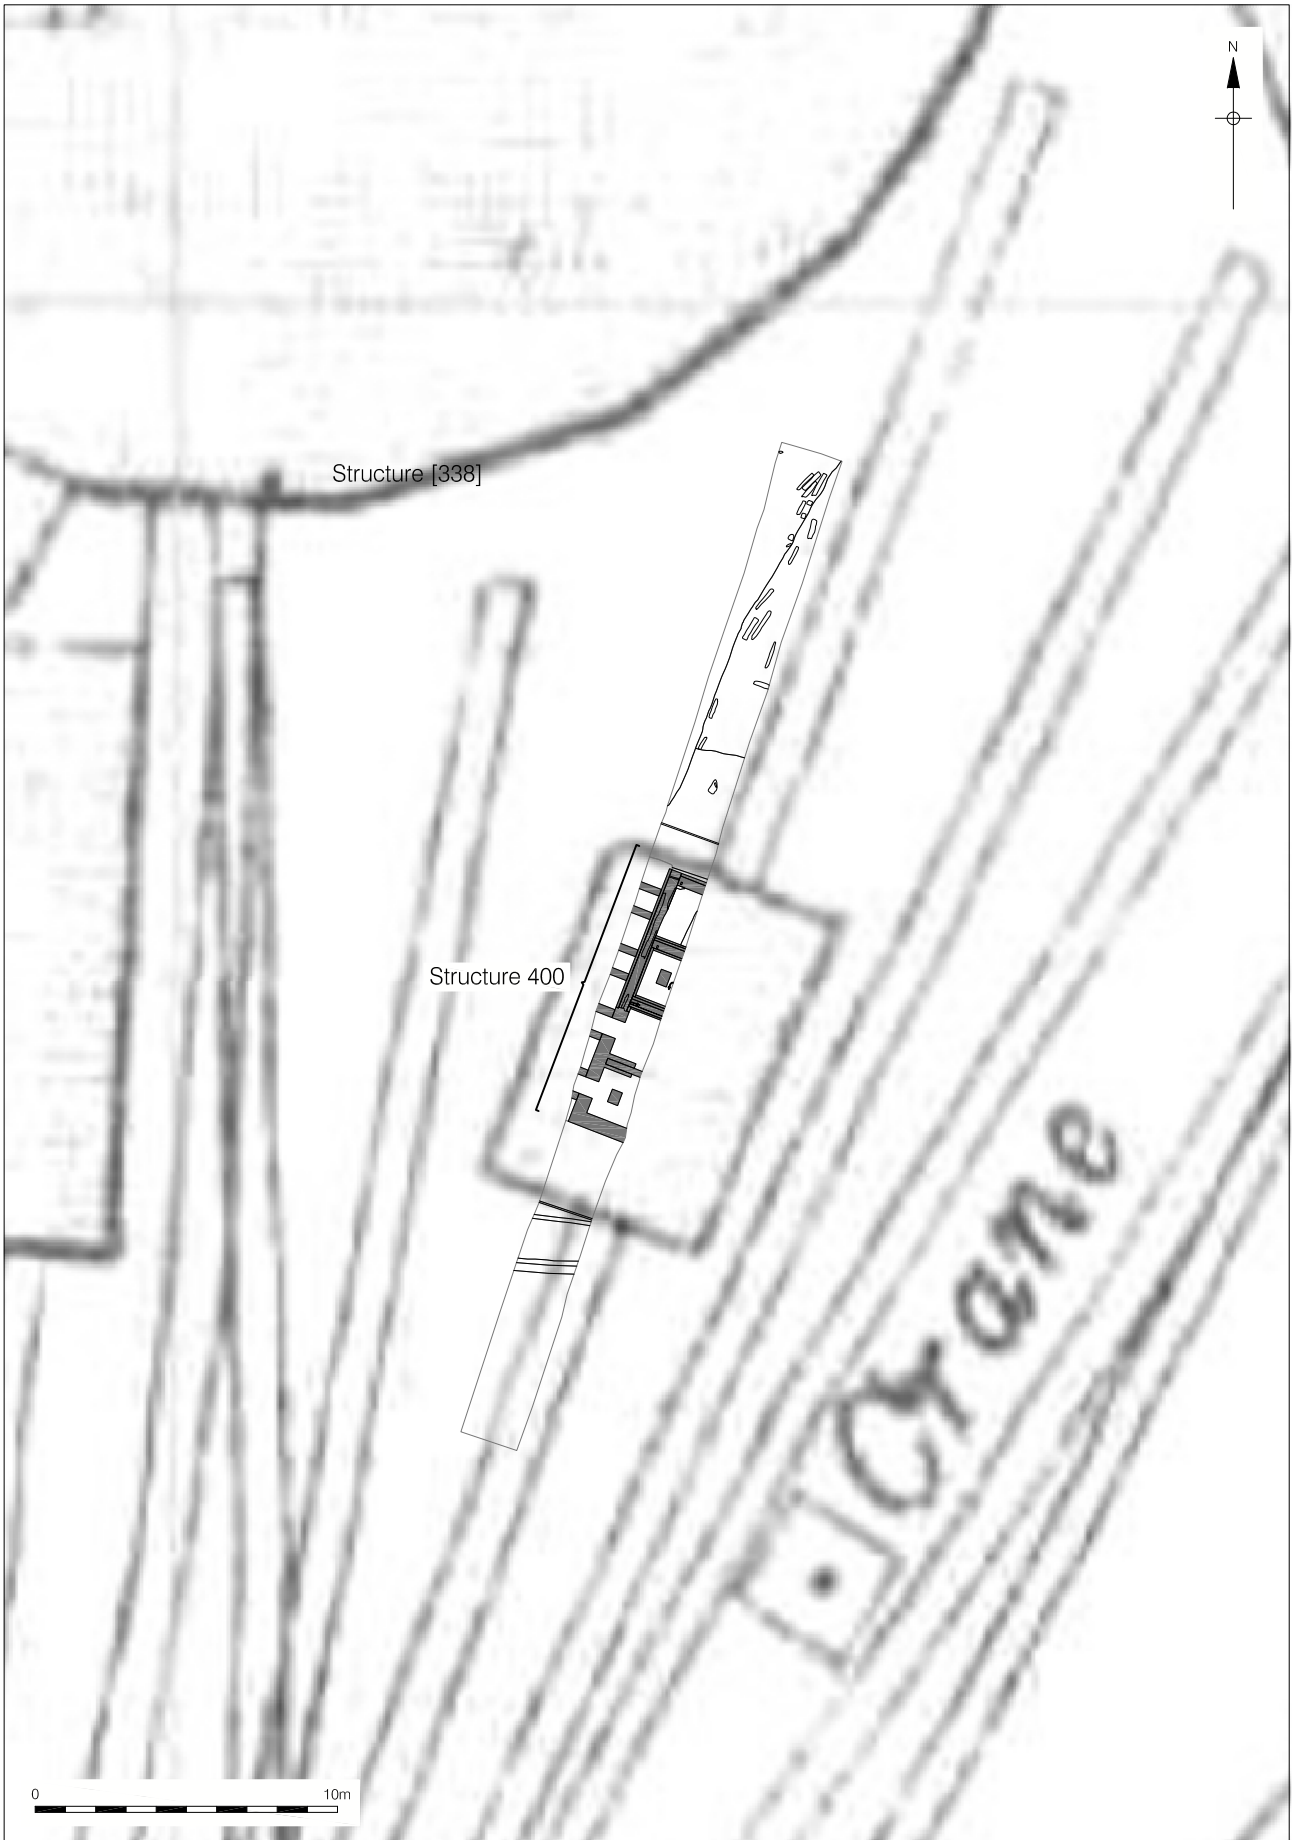
Figure 21
Plan of Trench 3 overlain on 1909 Ordnance Survey map
1:250 at A4
