**BRAMSHILL LAKE  
UPGRADE TO DAM AND SLUICE  
THE POLICE STAFF TRAINING  
COLLEGE, BRAMSHILL  
HAMPSHIRE  
RG27 0JH**

**ARCHAEOLOGICAL  
WATCHING BRIEF REPORT**

**REPORT NO: R11175**

**MARCH 2012**

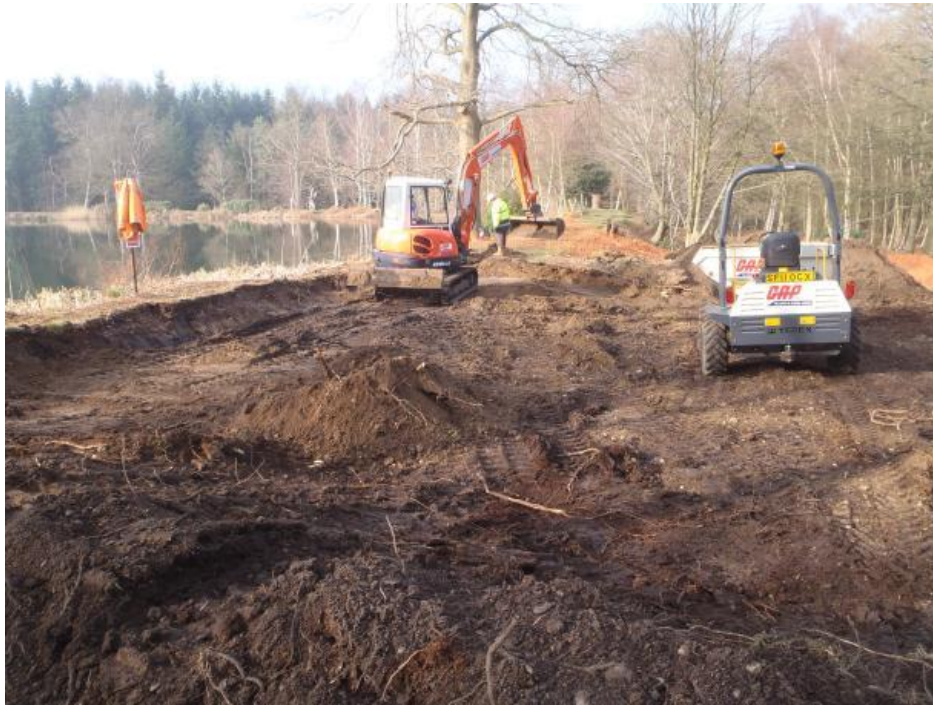
7.1.1 The groundworks for the auxiliary spillway (**Figure 2**) consisted of the topsoil stripping of an area c.20m by 10m by 0.30m deep on the north-eastern crest of the lake embankment (**Plate 1**). A c.20m long by 0.40m wide by 0.40m deep north to south orientated slot was excavated along the western side of the strip for the construction of a reinforced concrete beam (**Plates 2 and 3**).

**Plate 1: View looking north during excavation of auxiliary spillway**

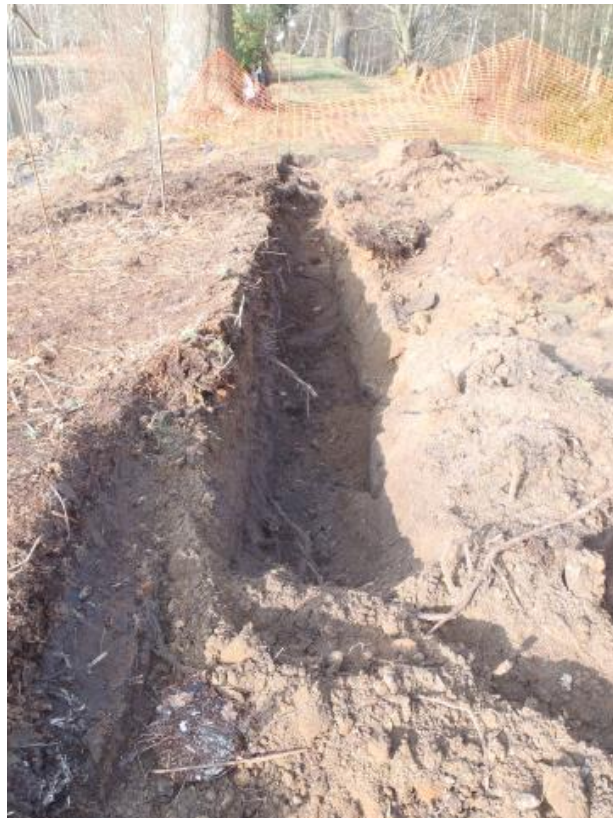
**Plate 2: View looking north of slot for concrete beam**

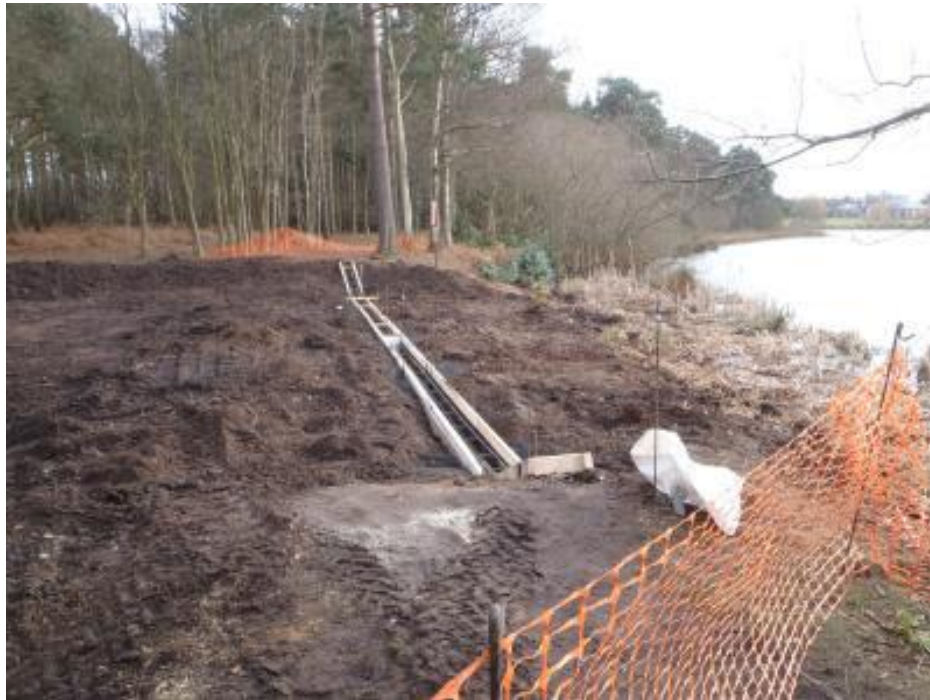
**Plate 3: View looking south of completed slot for concrete beam**

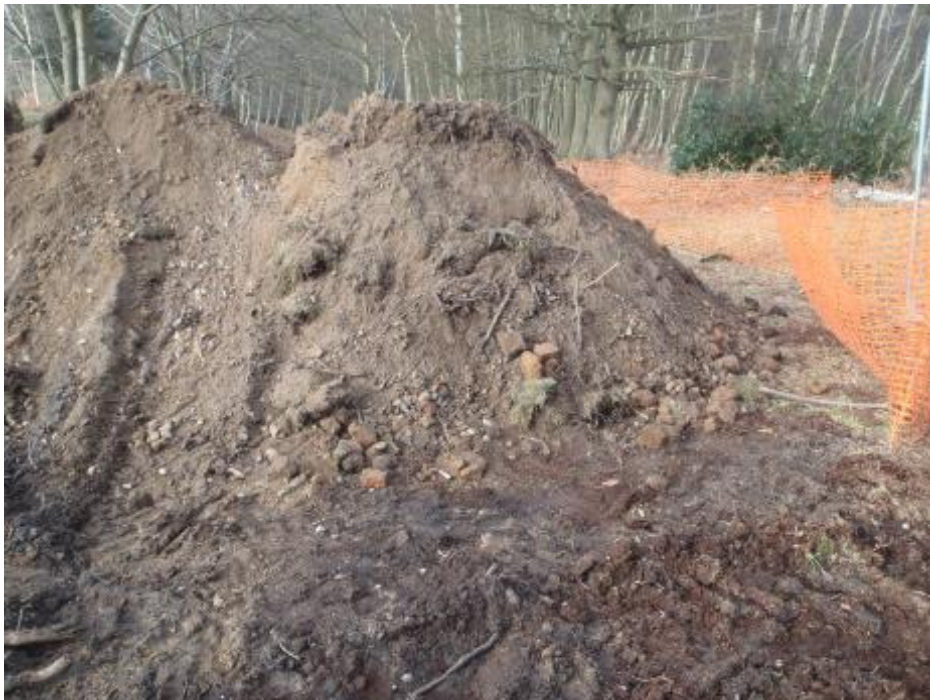
7.1.2 No archaeological features or deposits were revealed during the machine excavated strip and the material excavated consisted of topsoil overlying redeposited grey silty sand, which had most probably been originally excavated out of the lake and used to form the encircling embankment. Within the embankment material were moderately occurring fragments of red brick and tile of post-medieval date (**Plate 4**).

8.1.1 No finds of any archaeological significance were identified during the course of the watching brief. However, occasional complete unfroged red brick and moderately occurring fragments of unfroged red brick and red tile were observed in the embankment fill of the auxiliary spillway area. In the main spillway area a band of complete and fragmentary unfroged red brick and tile was observed in section and most probably acted as a basal and stabilizing layer for the lake embankment. The complete red brick measured 250mm x 110mm by 50 to 60mm.

**Plate 4: Excavated material from auxiliary spillway containing brick and tile rubble**

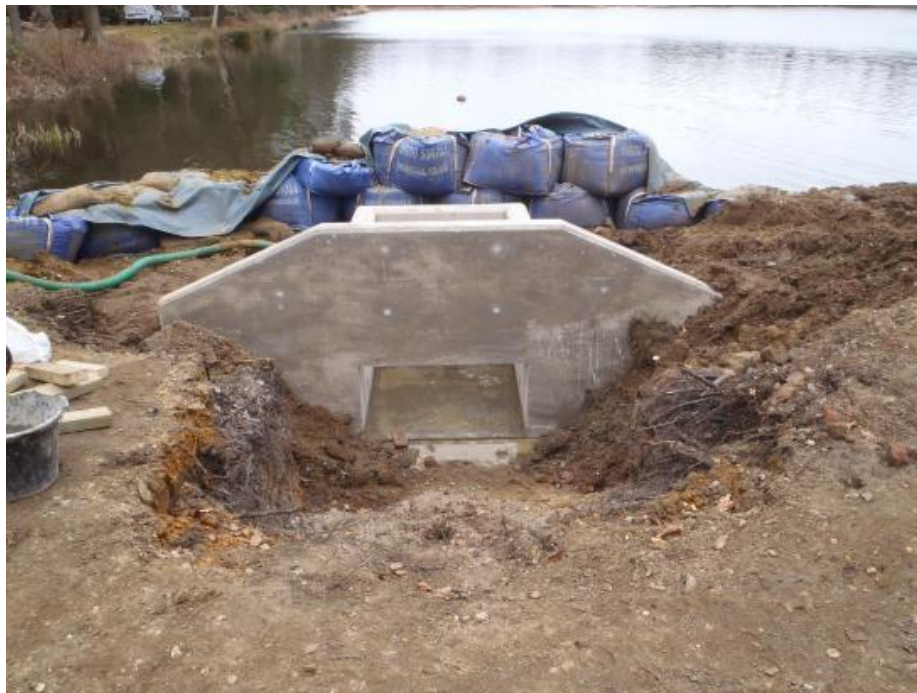
7.2.1 The groundworks for the main spillway (**Figure 2**) consisted of the machine excavation of an area c.20m long by 2.3m wide by up to 2.60m deep on the south-western corner of the lake embankment. The area was excavated from the edge of the lake, where a temporary cofferdam was constructed (**Plate 5**), and extended west across the line of the rear access road (**Plate 6**) and terminated further to the west of the road (**Plates 7 and 8**).

**Plate 5: View looking east of cofferdam and newly constructed culvert head.**

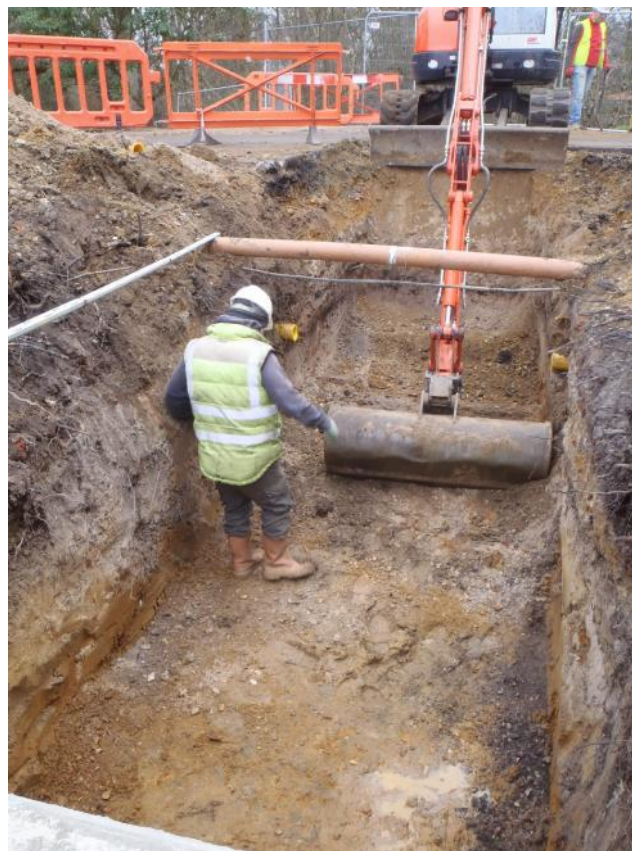
**Plate 6: View looking east of main spillway area on eastern side of rear access road**

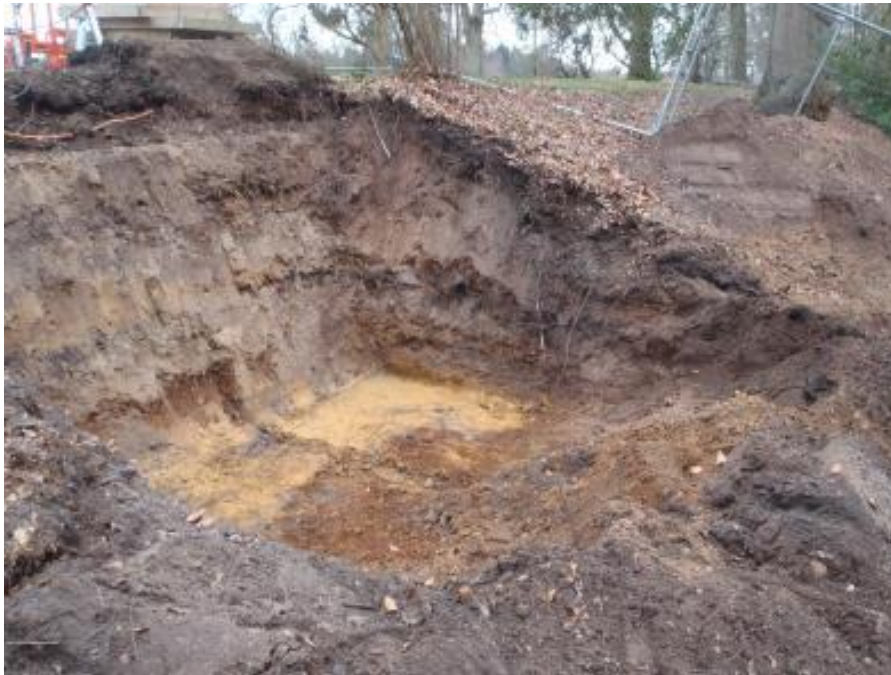
**Plate 7: View looking south of main spillway area to west of rear access road**

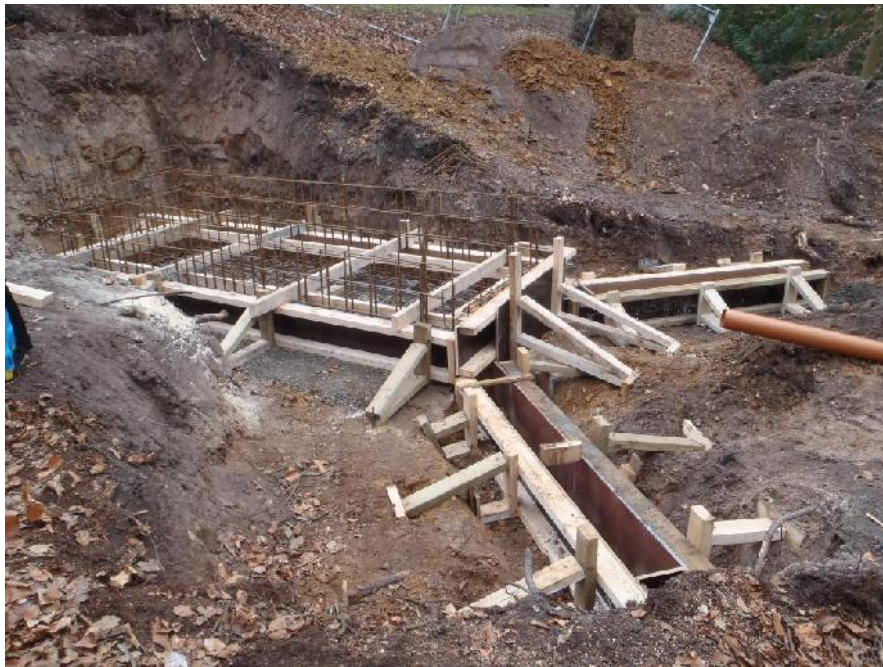
**Plate 8: View looking south of main spillway area to west of rear access road showing culvert under construction.**

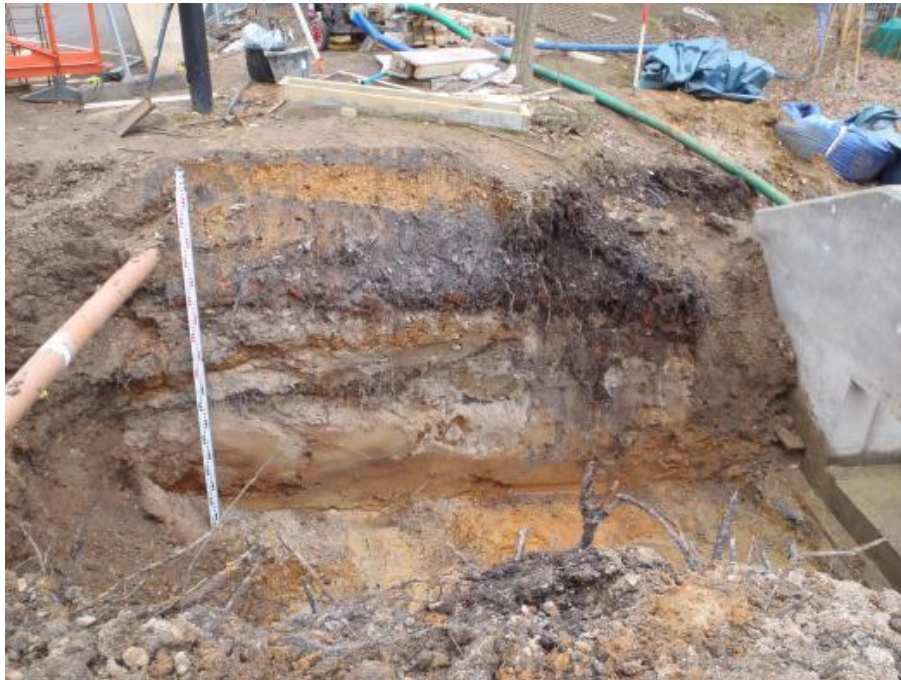
7.2.2 The excavation revealed the make-up of the encircling lake embankment (**Plate 9**), which consisted of up to 0.90m of topsoil and mixed redeposited sand, which overlay a 0.15m band of red brick and tile rubble, which had most probably been put in place to add a stable base and stability to the embankment. The brick and tile capped up to 0.70m of grey redeposited sand and gravel, which overlay a very thin buried topsoil with heavy rooting action. The buried topsoil overlay natural deposits of orange coloured sand with occasional gravel. This further overlay a yellow silty clay sand natural at the base of the excavated slot.

7.2.3 The brick and tile rubble was only evident on the eastern side of the road. On the western side of the road the excavated material contained no inclusions.

- 9.1.3 However, within the area of the main spillway area it was possible to discern the make-up of the encircling lake embankment. This comprised of topsoil and redeposited sand over a band of red brick and tile rubble, which had been used to add stability to the embankment. The brick band overlay a further deposit of redeposited sand and gravel, which overlay the natural deposits of orange to yellow coloured sand. It is likely that the embankment was formed out of the material excavated from the lake at the time of its construction.

**Plate 9: View looking north of main spillway area on eastern side of rear access road showing section through lake embankment**
