**An Archaeological Watching Brief at 32 Lincoln's Inn Fields, City of Westminster WC2A 3PH**

**Site Code: LIN11**

**Written and Researched by Peter Boyer and Douglas Killock**

**Pre-Construct Archaeology Limited, January 2013**

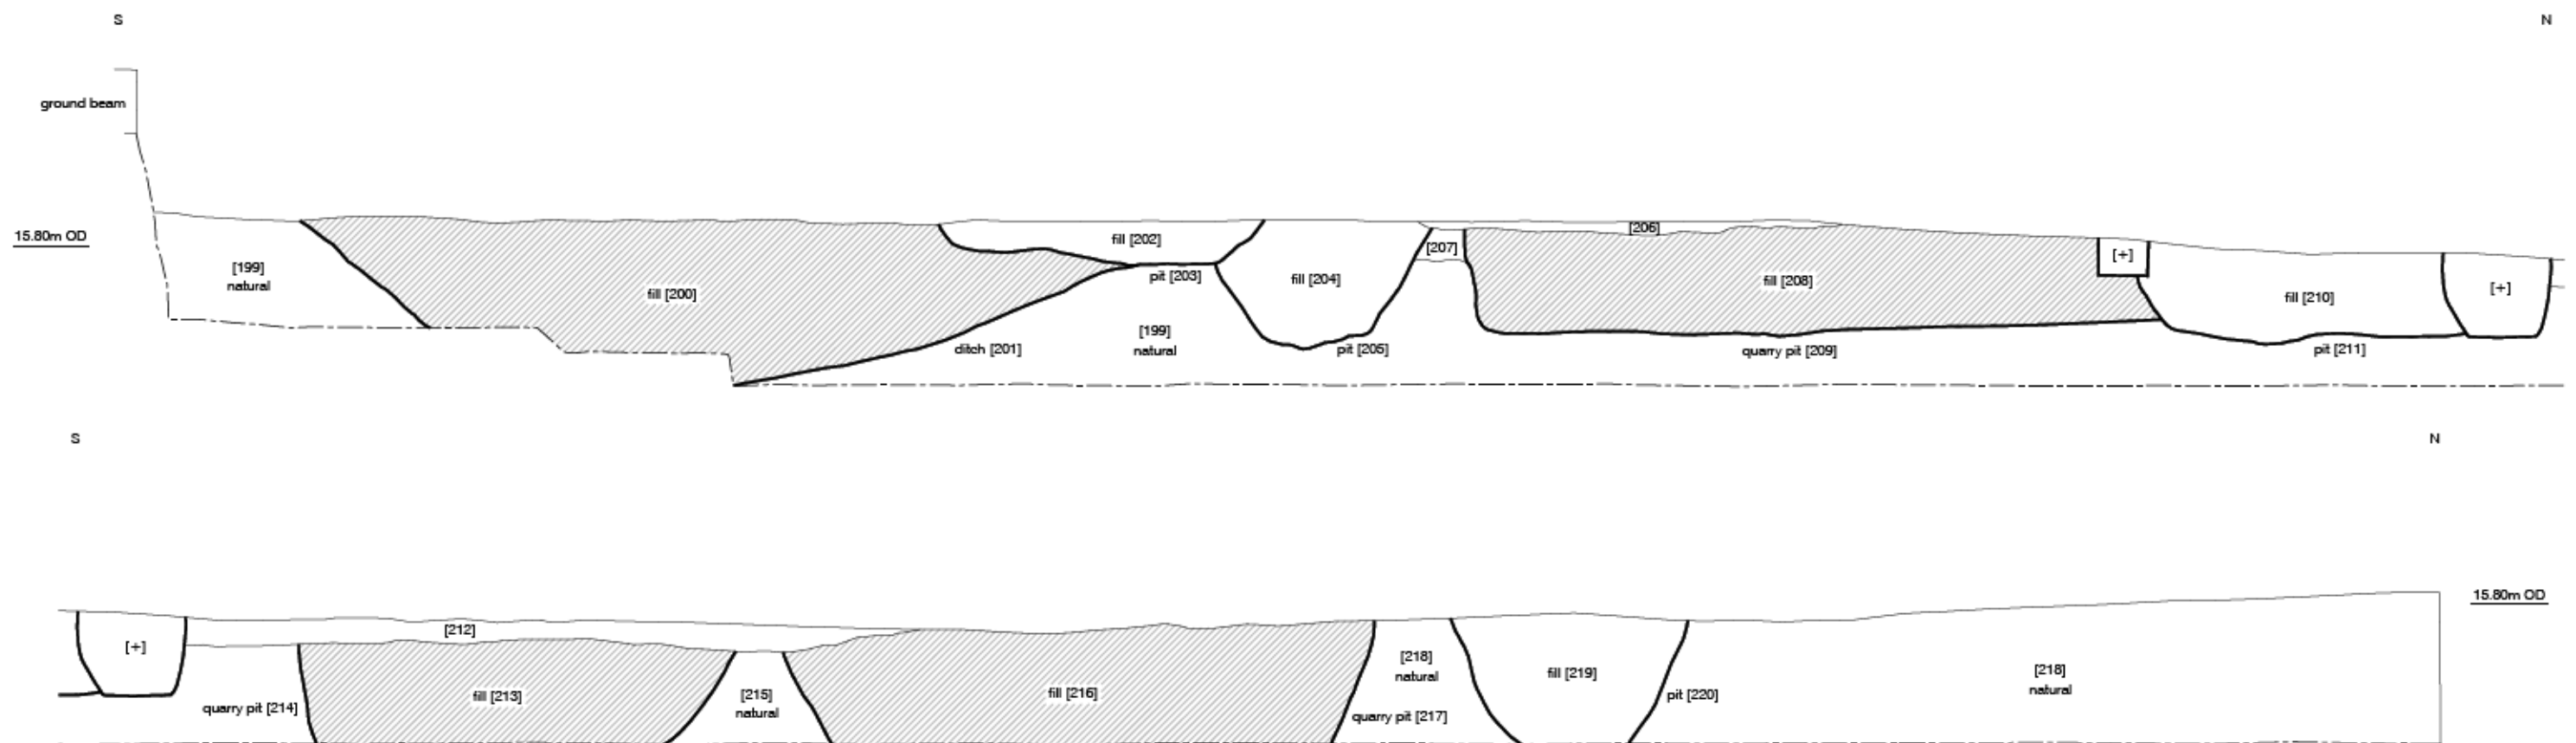
Figure 7  
Sections through Phase 2 features  
Section 40, Pavilion; Sections 34,37,38 & 39, Room B40  
1:40 at A3

Section 40  
East facing  
Pavilion

Phase 2, 15th-16th Century Features

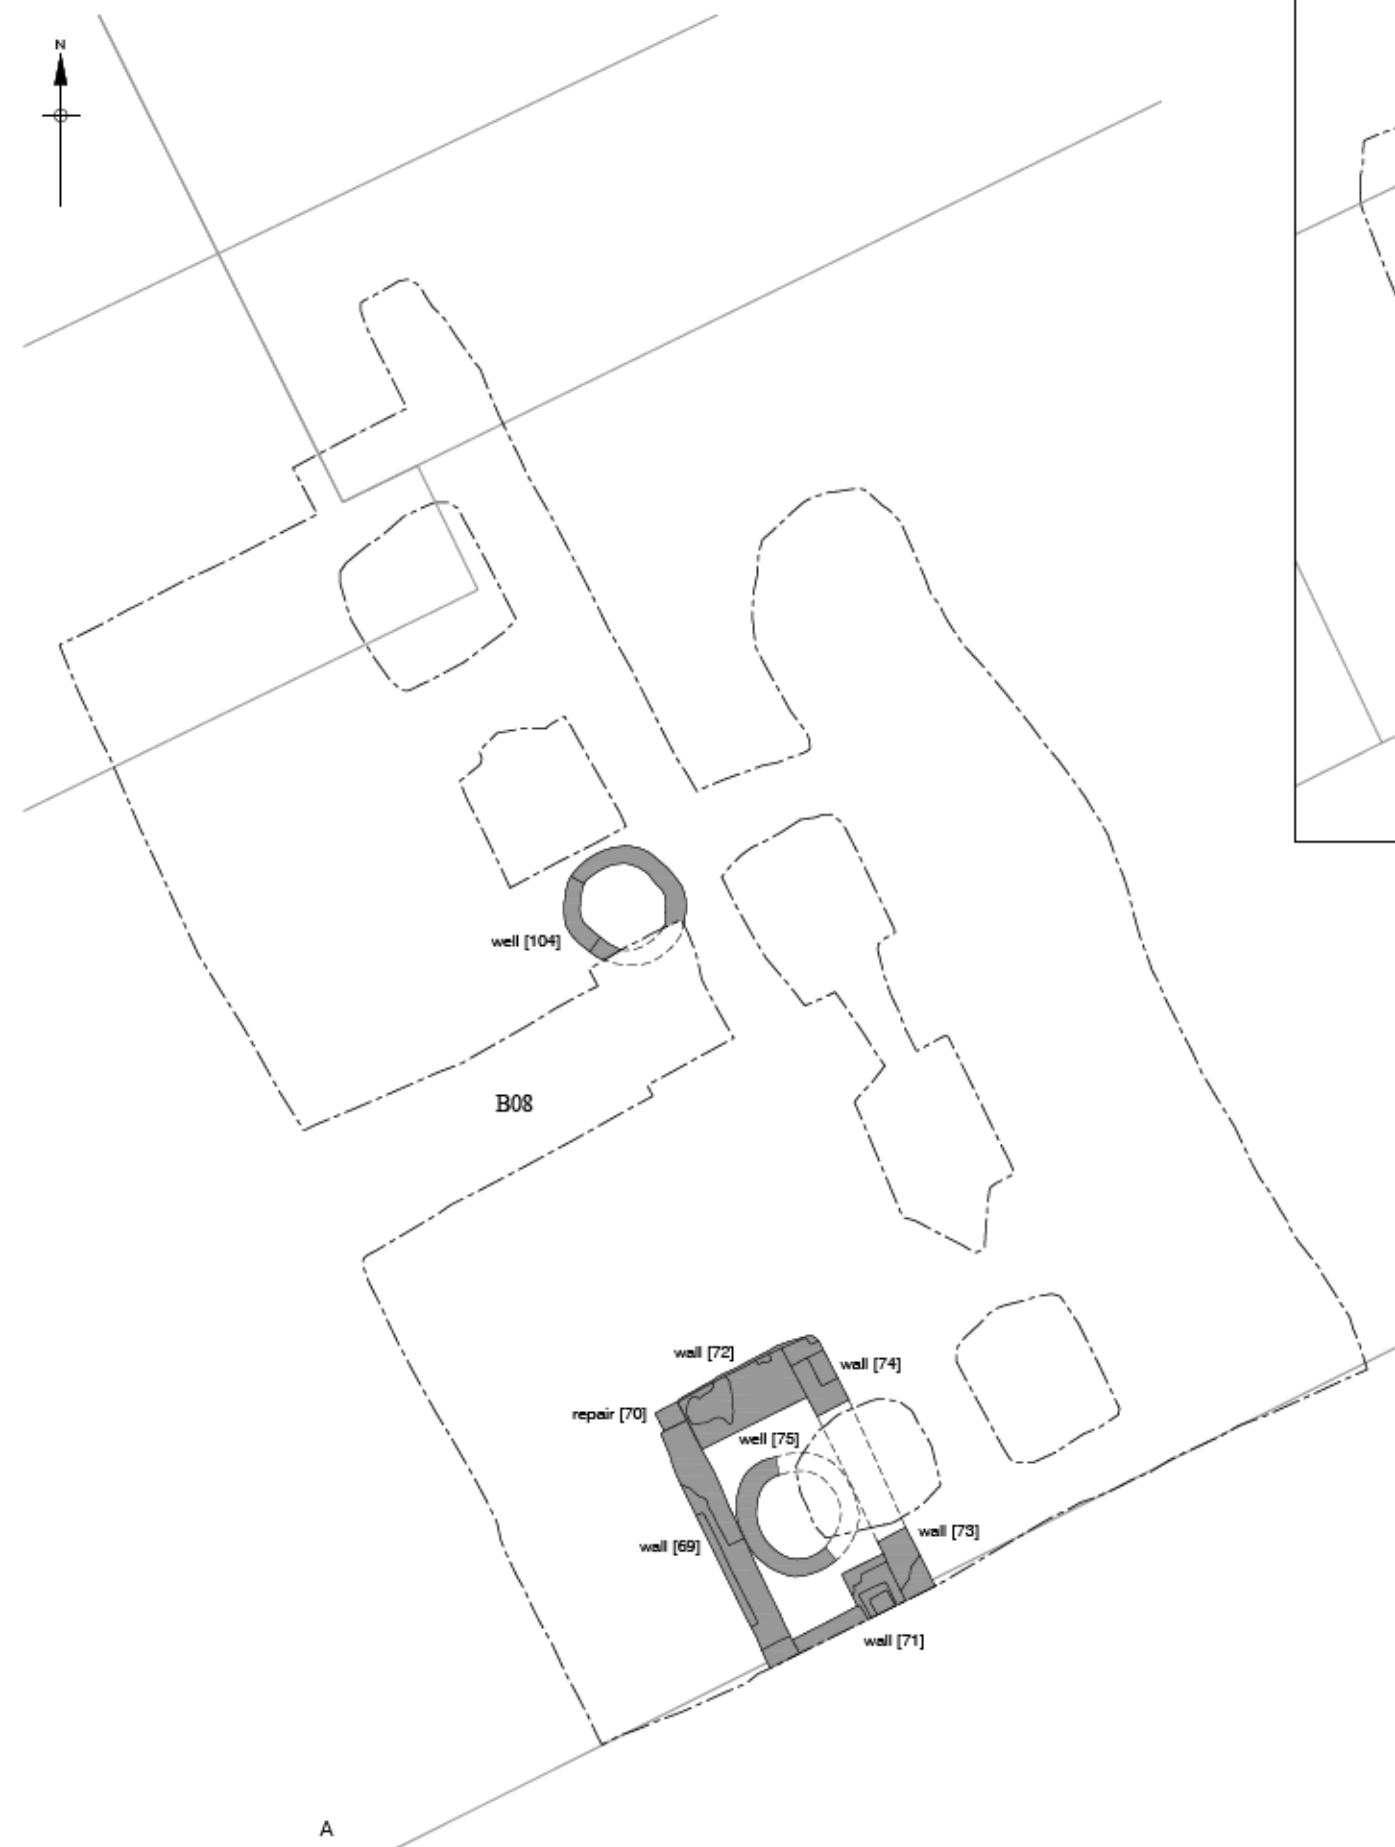
Figure 10  
Phase 4, 18th Century  
1:100 at A3

Phase 4 features in relation to properties fronting Lincoln's Inn Fields, Serle Street, Portugal Street and open courtyard behind (map detail from Horwood, 1792-99; property boundaries from Ordnance Survey, 1874)

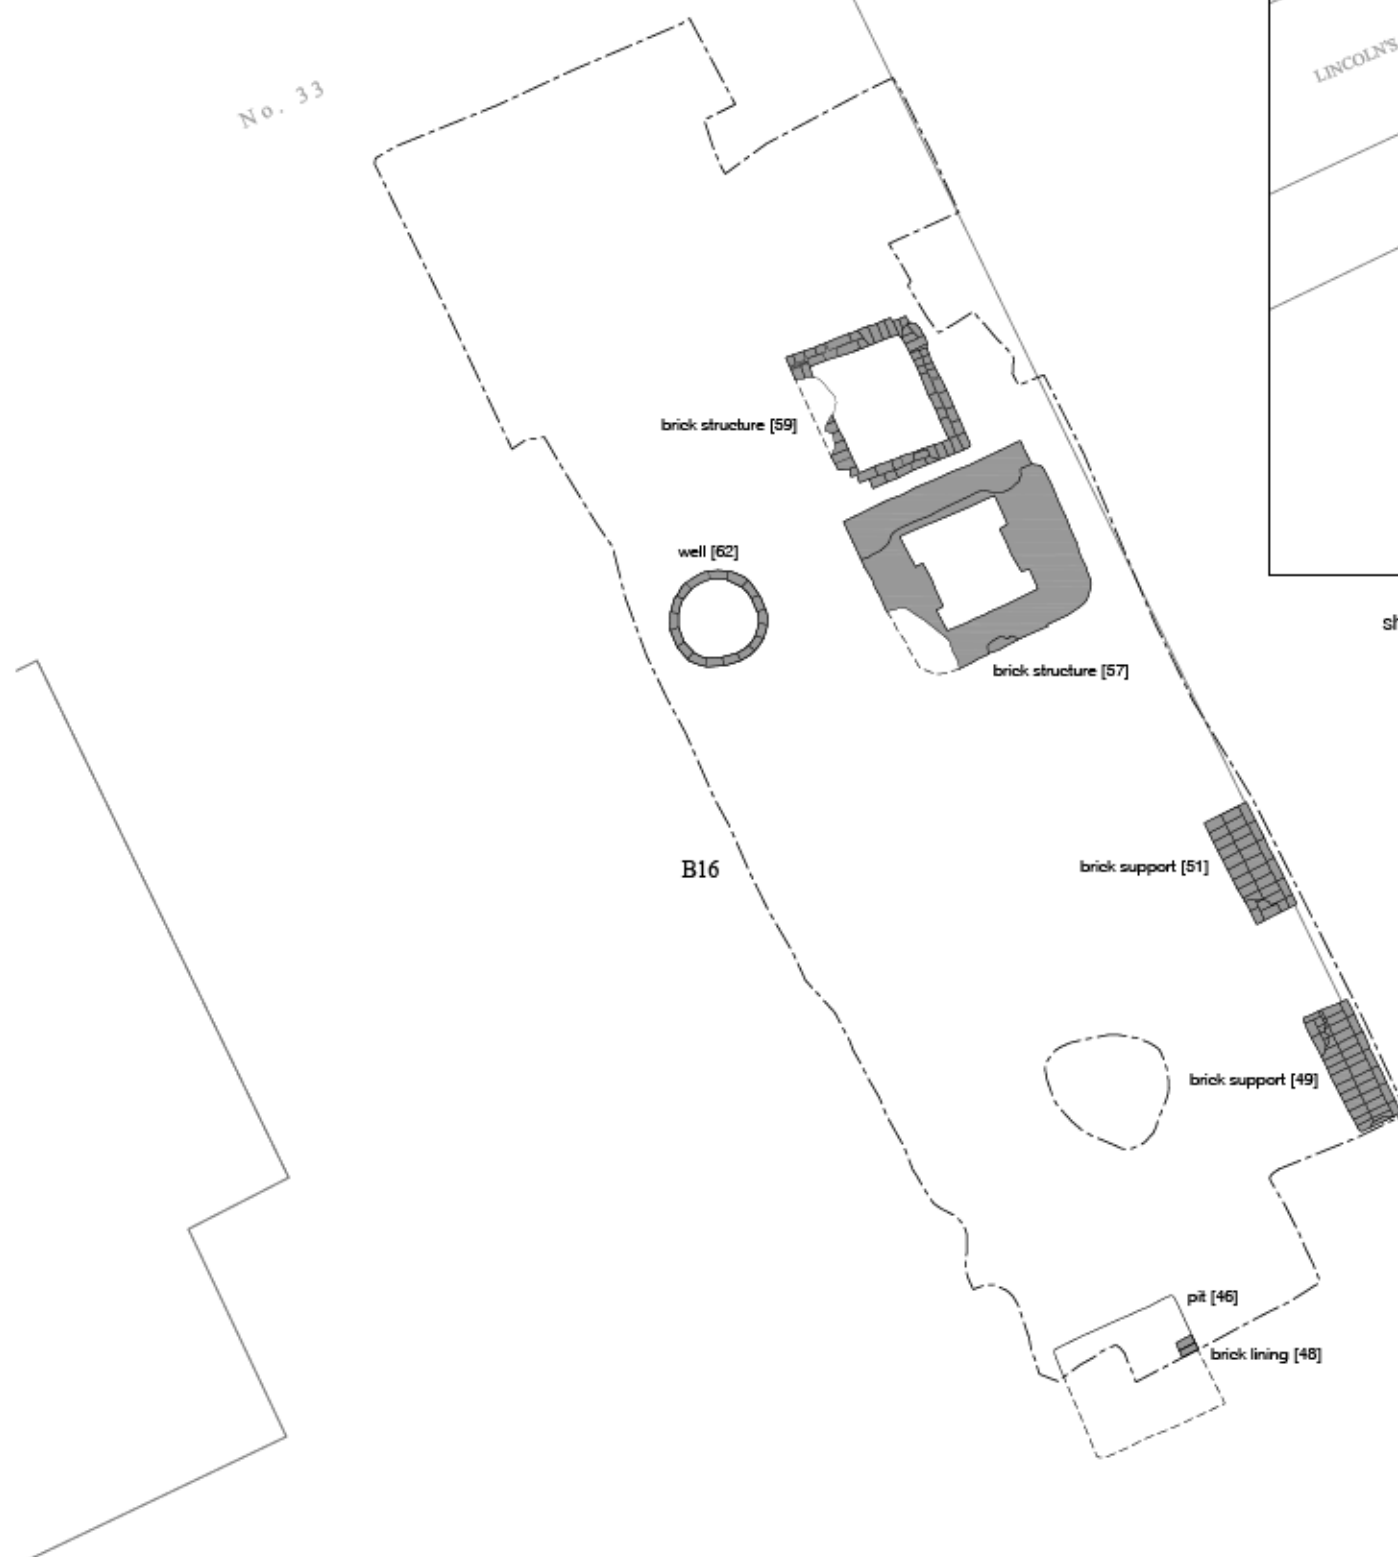
Figure 11  
Phase 5, 19th Century  
1:100 at A3

Phase 5 features in relation to No. 33 Lincoln's Inn Fields  
shading indicates pre-1824 structures within the property boundary  
(map detail from Ordnance Survey, 1874)

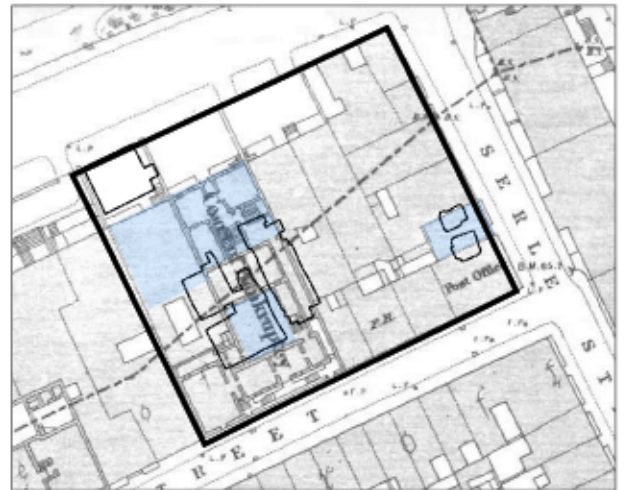
First Edition Ordnance Survey, 1867-74  
Property boundaries relating to Phase 4 & 5 masonry structures highlighted in blue

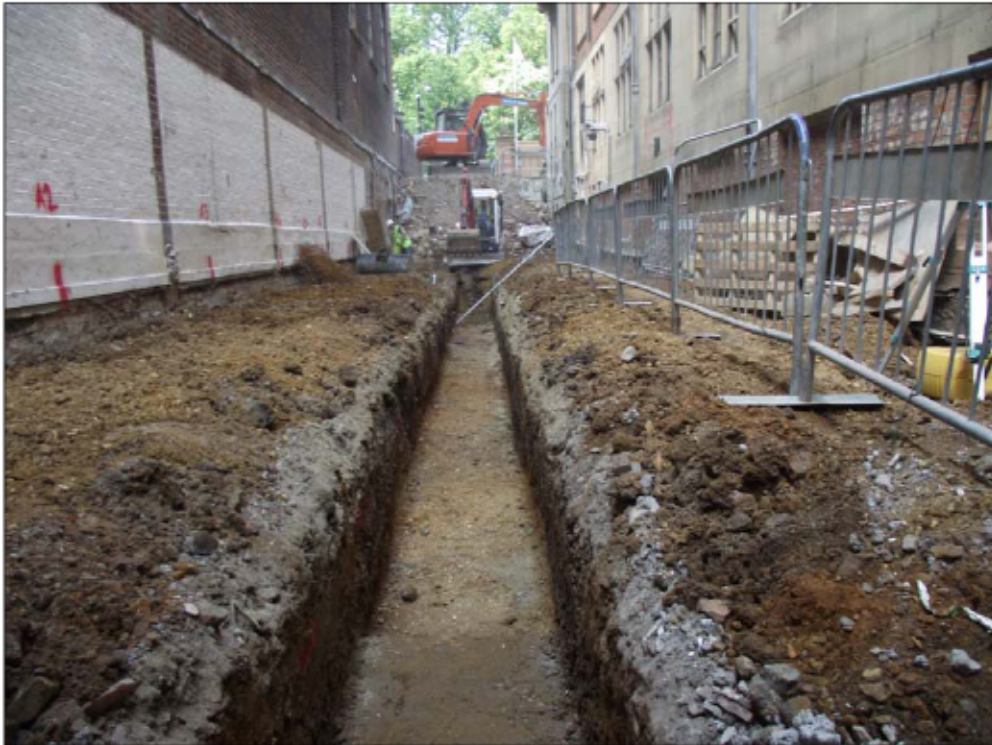
PLATE 1: Main foundation trench under excavation in the Pavilion area

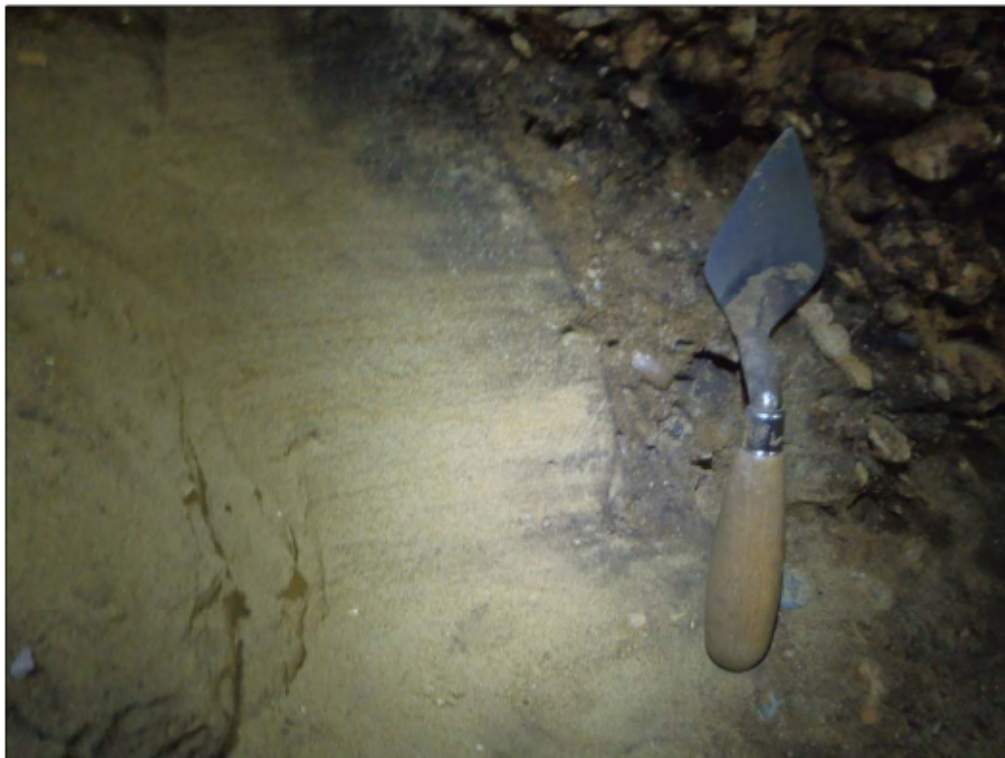
PLATE 2: Sand Dune Layers [99] In Room B08, Looking East

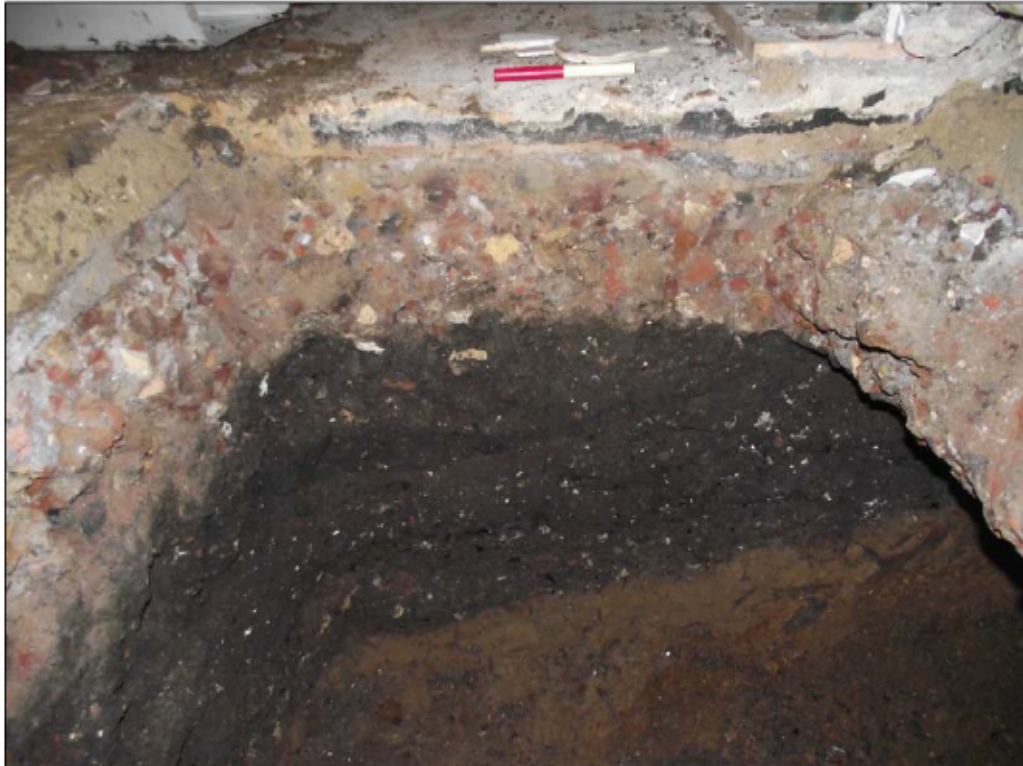
PLATE 3: Pit [171] as seen in Underpin 2, looking south-west (scale 0.2m)

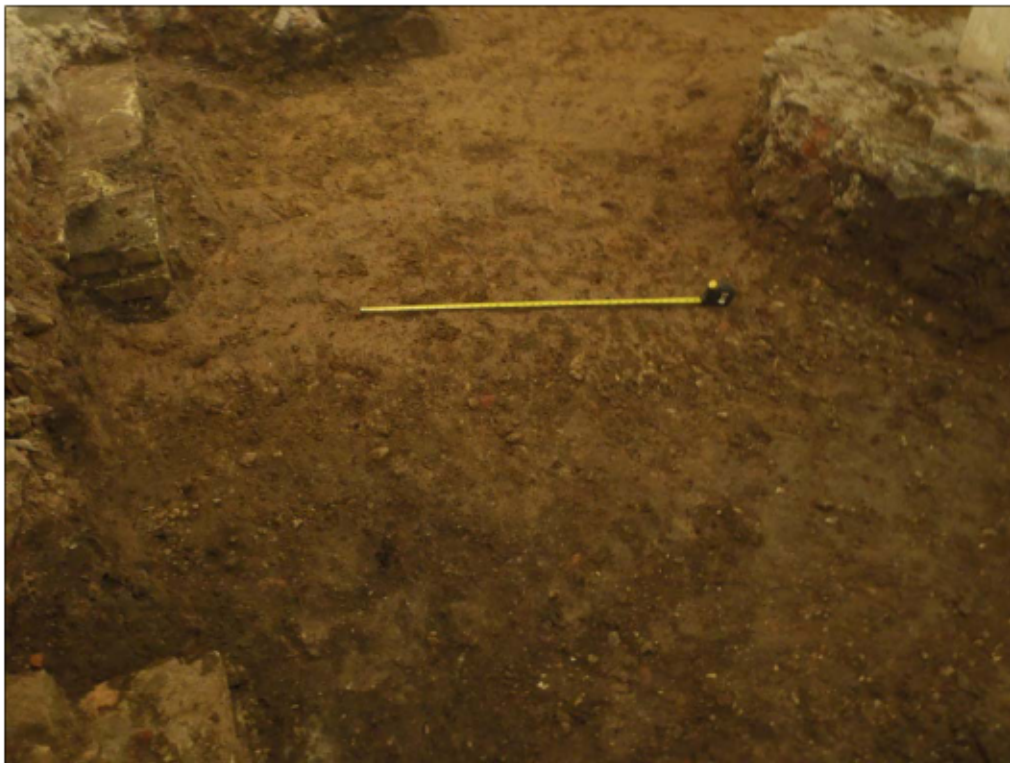
PLATE 4: Pit [37] cutting Layer [39] Room B16, looking SSW (scale 1m)

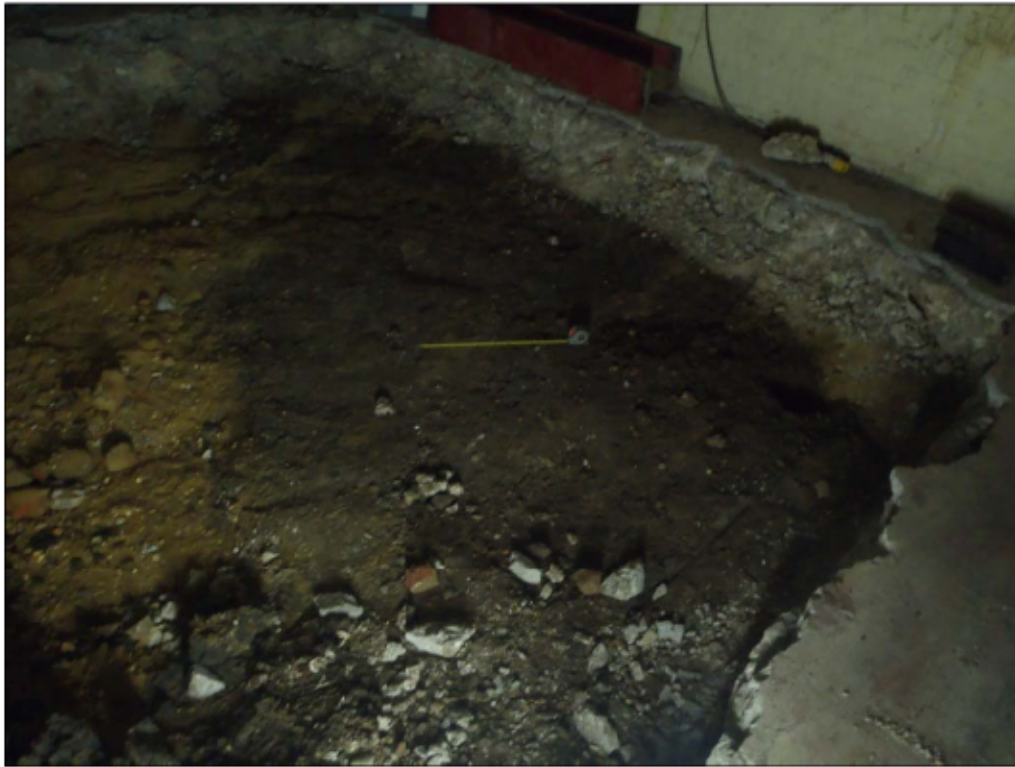
PLATE 5: Ditch [131] Room B28, looking south-east (scale 1m)

- 8.3.14 Two further features apparently belonging to this phase were recorded towards the eastern edge of the site. An east-west aligned ditch [131] extended across Room B28 (Figure 8; Plate 5), continuing beyond the eastern edge of the building but appearing to terminate at the western edge of the room, it was certainly not visible in Rooms B41 and B27 to the west. The ditch was up to 2.24m wide and extended below the level of ground reduction. In common with the large pit it was backfilled with loose material [130] containing a great deal of discarded rubbish such as animal bone, pottery and building materials, the latter artefactual types again dating to the early post-medieval period. The ditch was on a very similar alignment to ditch [107] to the west and although when recorded only extended as far as the western edge of Room B28, may originally have extended further west and also drained into the large pit.

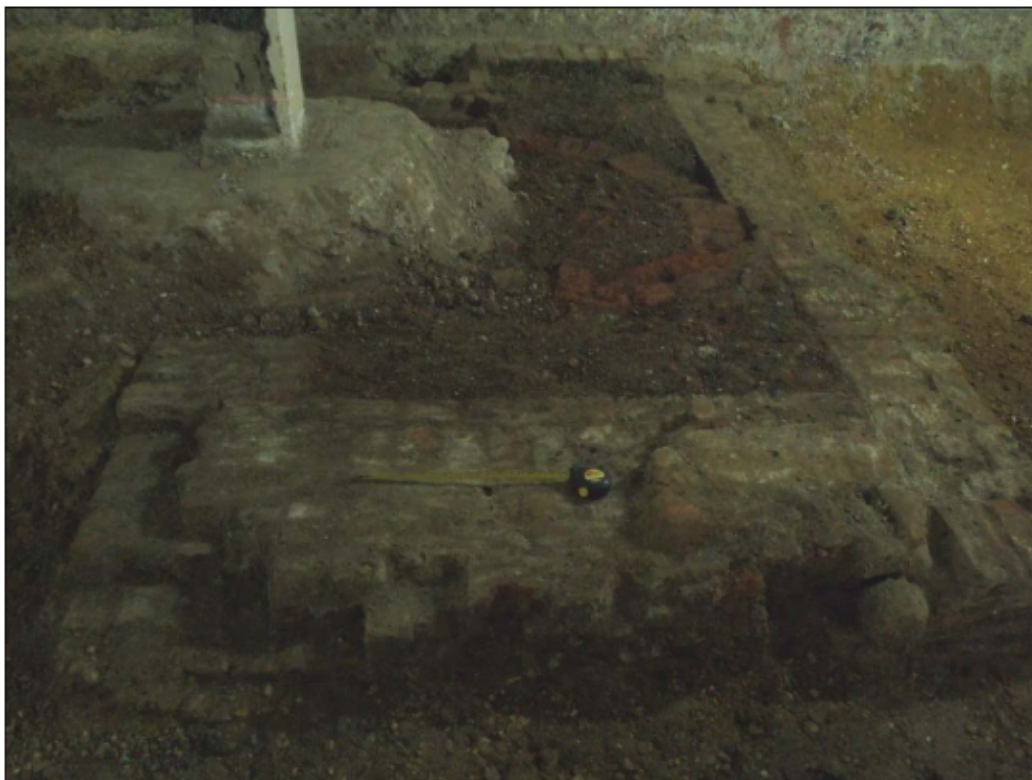
PLATE 6: Brick Structure [69] and Well [75] Room B08, looking south-east (scale 0.5m)

- 8.4.3 The rectangular structure was aligned parallel with the current building with its southern wall almost flush with that of Room B08, though it was clearly much earlier. At the time they were constructed the 'well' and the rectangular structure would have lain in an external yard area (see Section 9 below for further detail), the 'well' possibly providing the water for the property in which it was located, though it may have been soakaway. It is unclear what function the rectangular structure served, but was certainly associated with the 'well'. It may have been the foundation of a structure that enclosed the well or it may have been constructed to support the slightly flimsy brick lining of the 'well'.

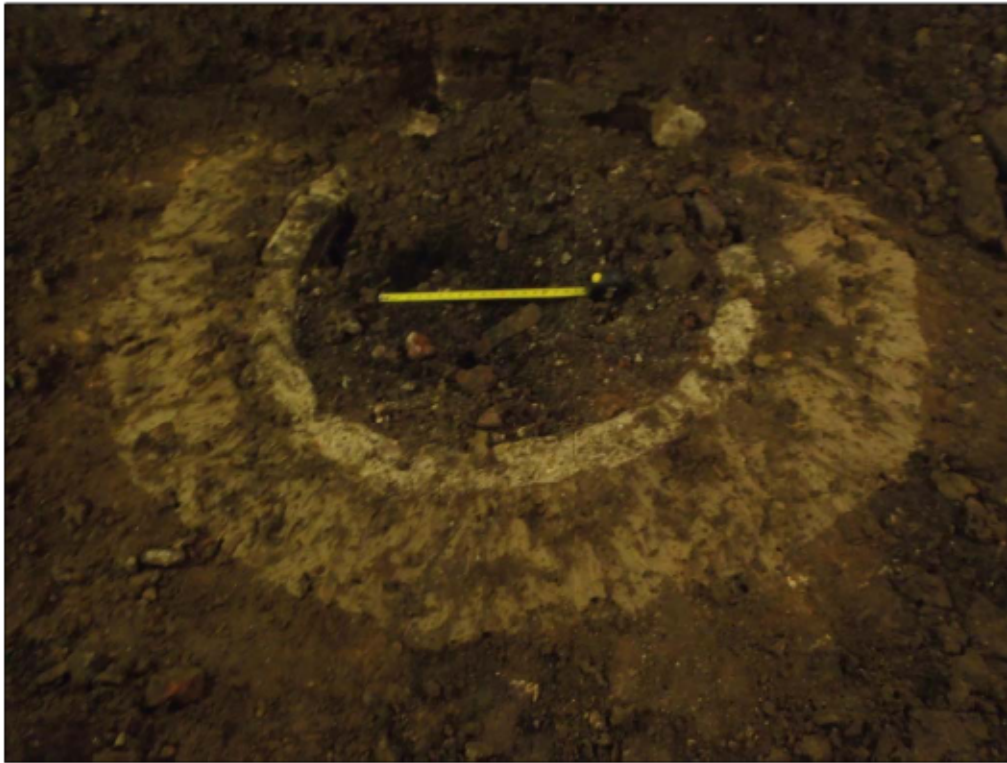
PLATE 7: Well [62] Room B16, looking south-west (scale 0.5m)

was a thick layer of very stiff, light brown clay [61]. The well structure had been backfilled with a loose, very dark grey sandy silt [63], which included brick broadly dated 1750-1900.

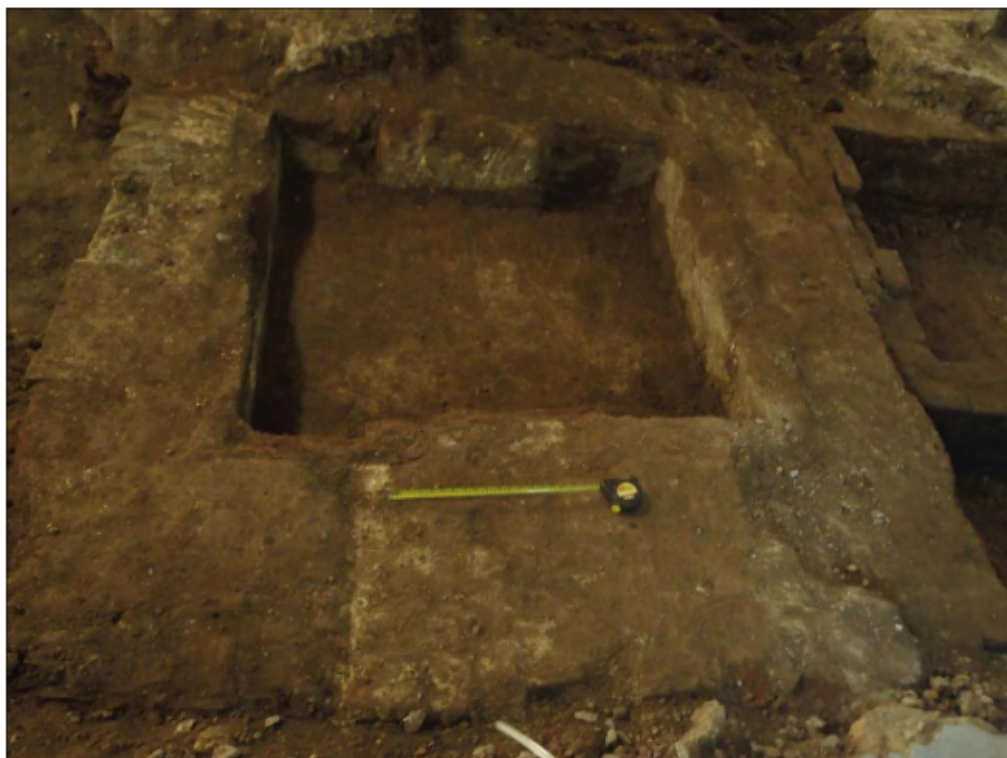
PLATE 8: Brick Structure [57] Room B16, looking south-west (scale 0.5m)

- 8.5.2 To the east of the well was a rectangular structure [57] (Plate 8), which externally measured 2.69m by 2.41m. It comprised walls up to 0.85m thick, constructed from red frogged bricks, very similar to those in well structure [62], variably bonded as headers and stretchers with a hard, light grey lime mortar. The surviving structure stood up to 0.34m high and was set on a concrete base. The central parts of the east and west walls had been thickened internally such that the plan of the internal area was a broad 'H-shape'. The feature was backfilled with a loose, light to mid greyish brown sandy silt [56] that included pottery dated 1805 – 1900. The function of the structure was unclear but appears to have been located internally within a predecessor of the current building. Immediately to the north was another rectangular structure [59] (Plate 9), comprising walls up to 0.25m wide, constructed from red unfrogged bricks, which appeared to have been re-used from an earlier structure, mostly bonded in alternating courses of headers and stretchers with a soft, light yellowish brown lime mortar. The structure measured 1.97m by 1.79m and stood up to 0.41m high. It had no apparent base and was backfilled with a lightly indurated, dark brownish grey clayey silt [58], finds from which suggested a deposition date of 1830 to 1850. Again the function of the structure was unclear but would have lain within a predecessor to the current building.

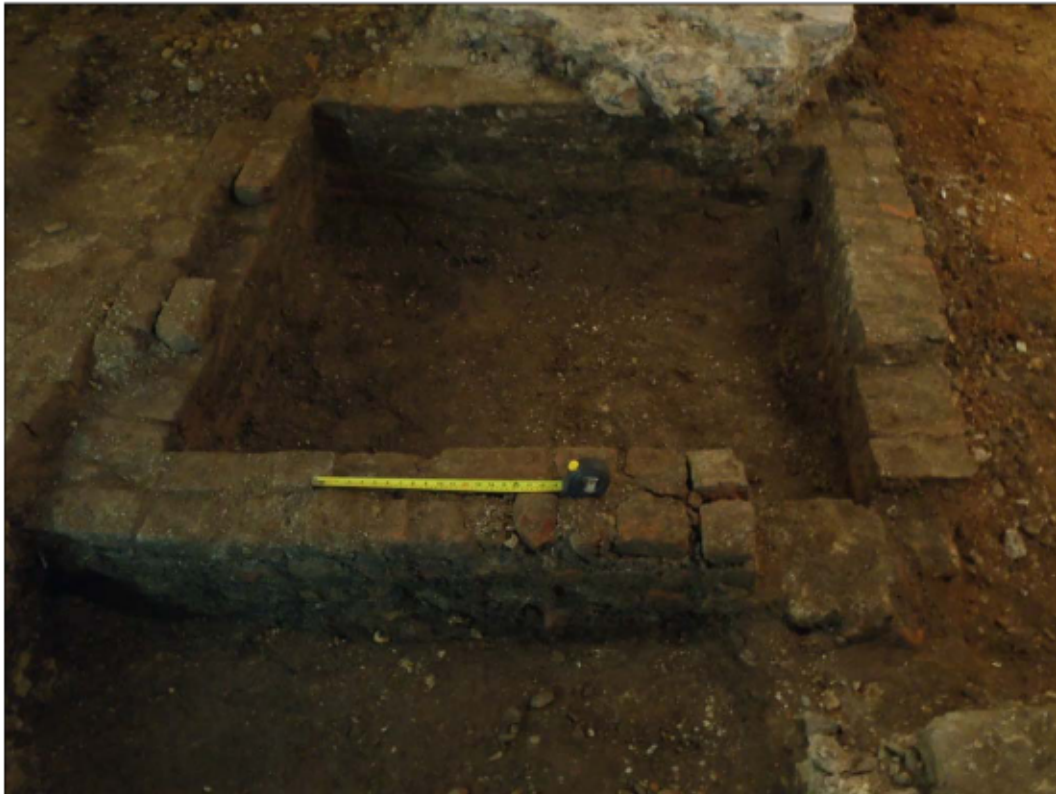
PLATE 9: Brick Structure [59] Room B16, looking south-west (scale 0.5m)

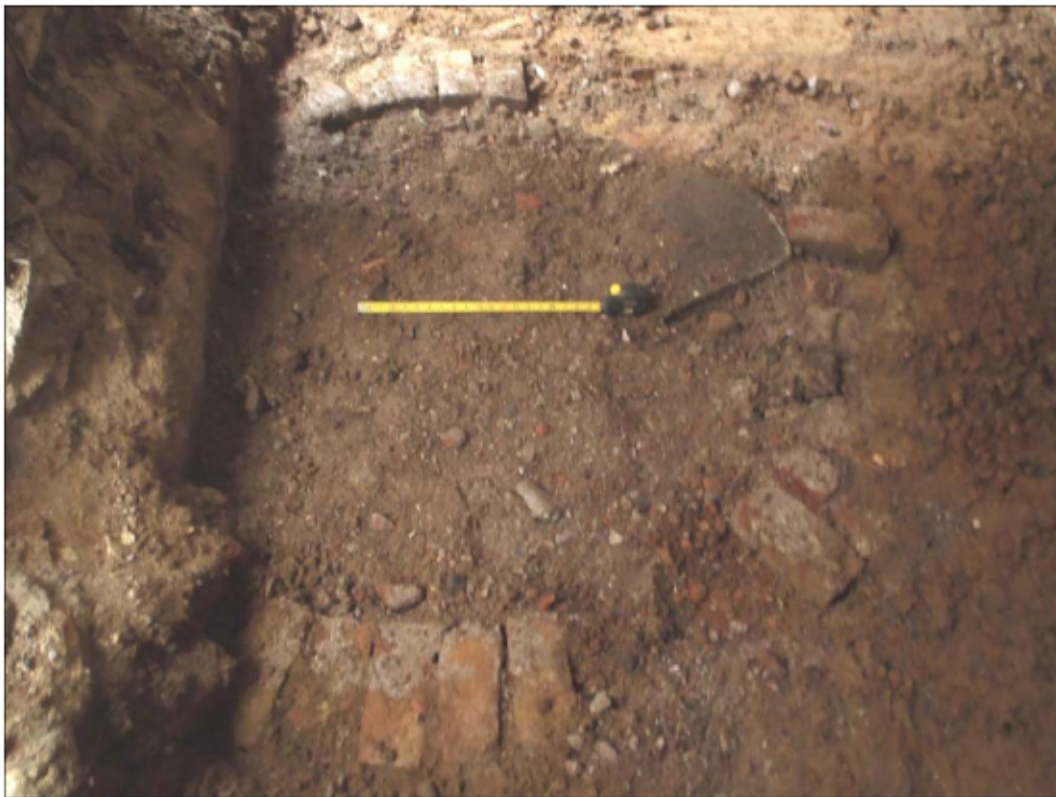
PLATE 10: Soakaway [307] Room B40, looking south-west (scale 0.5m)
