**PEARTREE STREET,  
LONDON BOROUGH OF ISLINGTON  
EC1**

**AN ARCHAEOLOGICAL WATCHING  
BRIEF**

**PCA REPORT NO: 11176**

**SITE CODE: PEA11**

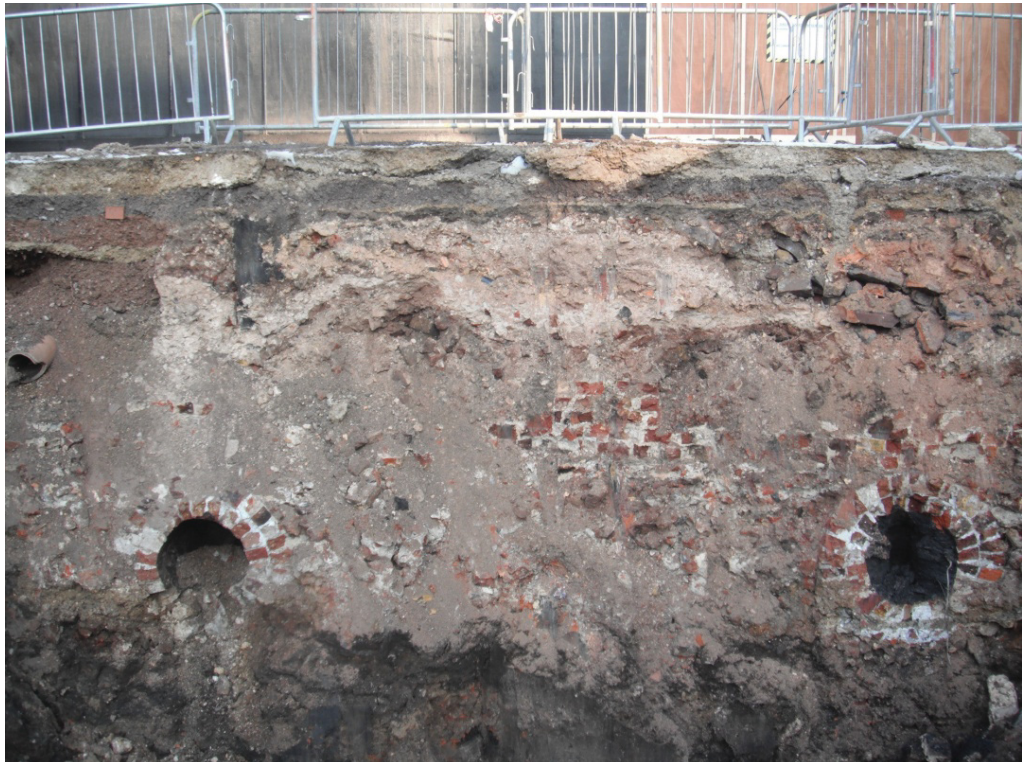
- 7.1.15 **Central Retort Base and Flues:** During the removal of the western wall of the Retort House a brick base [37] and two integral under floor flues , [24] & [25], were observed in section (see Plate 1 below). These were highly truncated by a large modern brick drainage tank. The brick base measured over 11.5m north south and was approximately 1m thick. It may have once spanned the majority of the south eastern quarter of the Retort House. The underlying flues were both 0.9m in diameter, with an internal diameter of 0.45m. These probably carried either fresh air to, or hot exhaust gases from, the furnace to the chimney.

Plate 1; Flues [24] & [25] below Retort Base [37], looking west

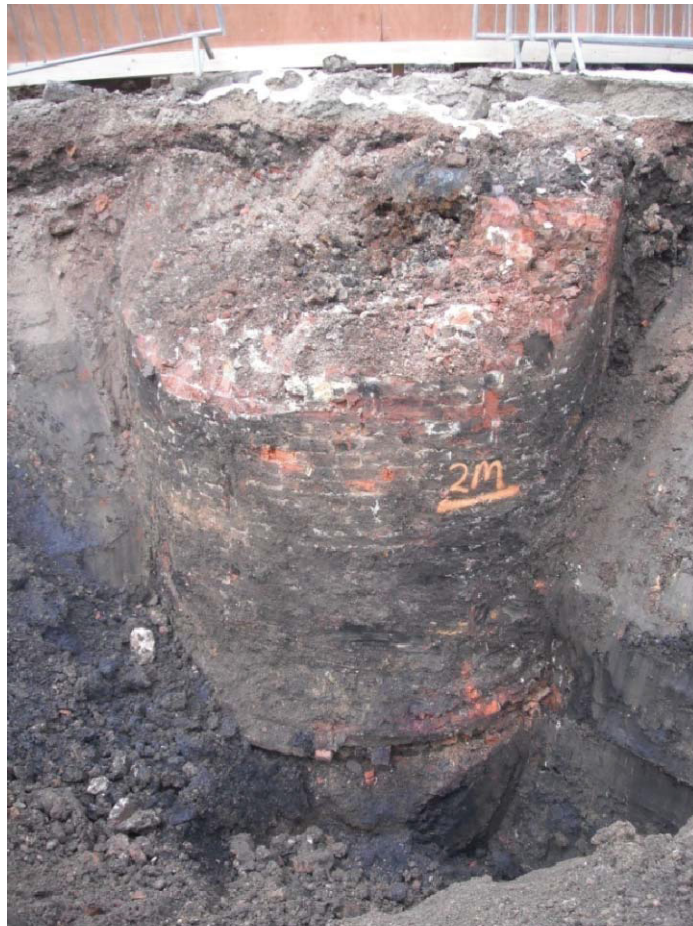
- 7.1.18 **The western well** (see Plate 2 below) was constructed from red brick 3032 and measured 2.7m in diameter. The well head was surmounted by a large cast iron pipe which returned towards the north immediately below the modern slab level. The well appeared to be approximately 3.5m deep, as a slightly stepped out footing was observed at the base.

Plate 2; Western Gasometer Well [22] looking west
