## **HISTORIC BUILDING RECORDING**

**At Cranes Foundry  
Nacton Road  
Ipswich  
Suffolk**

**March 2012**

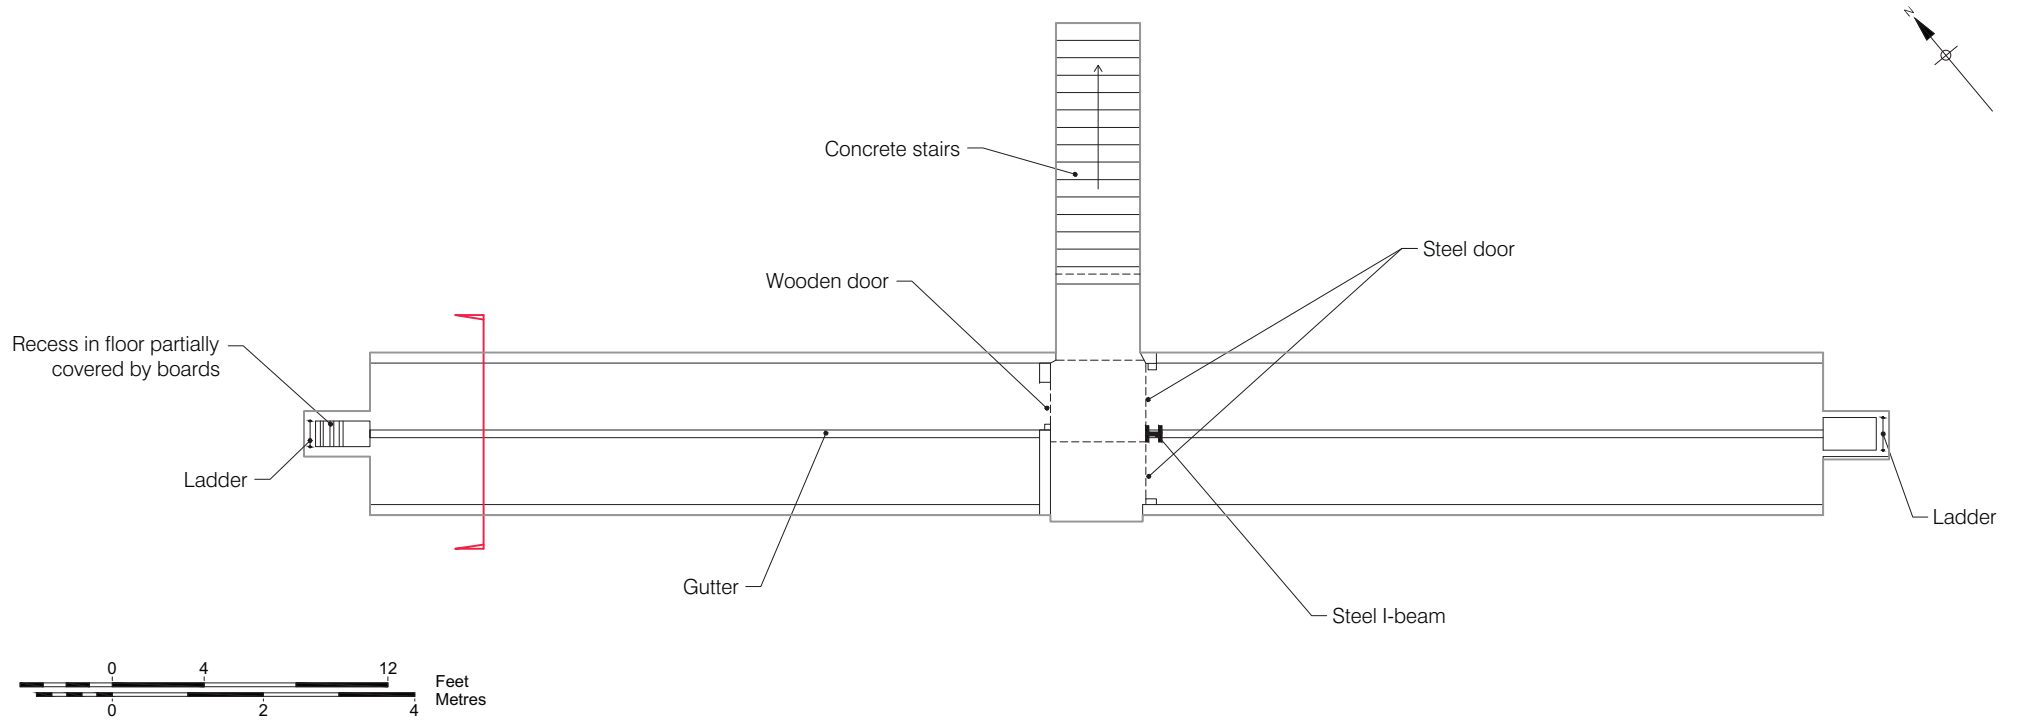
Figure 3  
Plan and Section of Air Raid Shelter 1, Building 27  
Plan 1:100, Section 1:50 at A4

South North

- 4.3.2 Site plans were provided by the Client and these formed the basis of the drawn survey reproduced in this report (**Figures 2 and 4**). The exception to this was the production of on-site measured drawings of a double chamber air raid shelter found beneath the south end of the main building block. This plan and cross section were then drawn in AutoCAD and are included in this report (**Figure 3**).

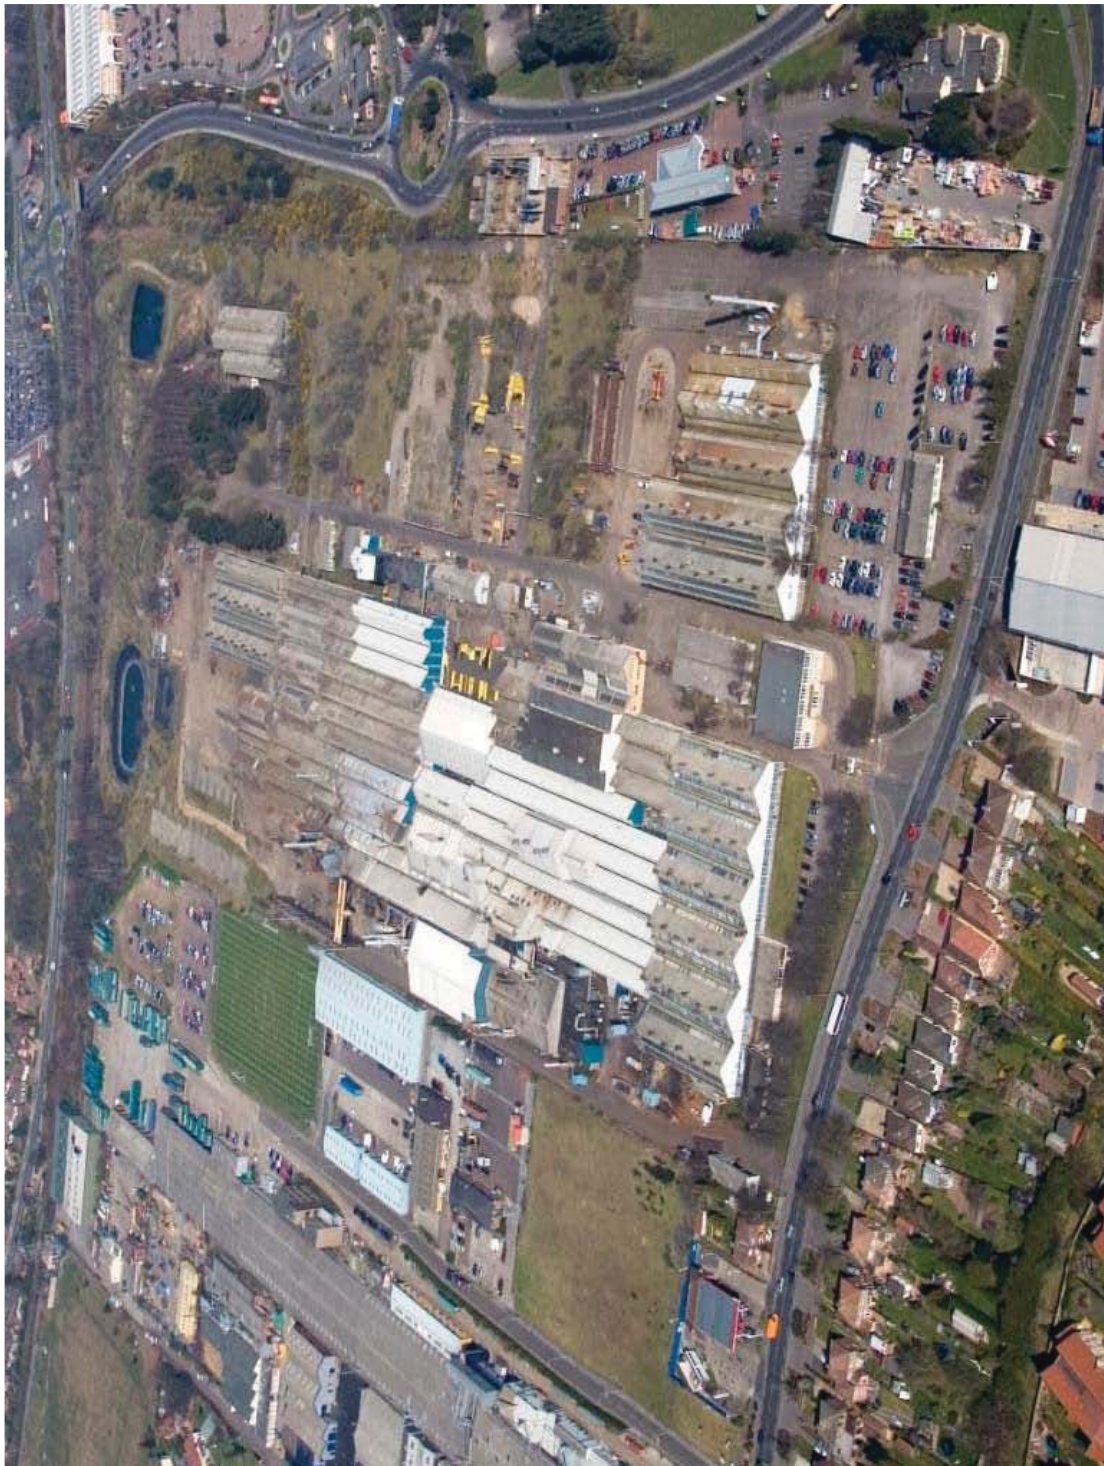
**Plate 1.** Aerial view of the Crane's Foundry site looking north, c.2005 when still in operation.

- 6.3.1 Building 2 was found at the southern end of the site at the entrance to the site from Nacton Road (**Figure 2; Plate 1**). This small, rectangular single storey brick structure had a flat roof and was located between the inward and outward traffic lanes. It was designed to be used by security guards to monitor and control access (**Plates 11 and 12**). The south elevation was dominated by a wide timber framed window that continued onto the east and west elevations. In both of these side windows were sliding glass panes to allow for communication with vehicle drivers or pedestrians. The building was shown on an aerial photograph from 1985, although it had been standing for a number of years by this date.

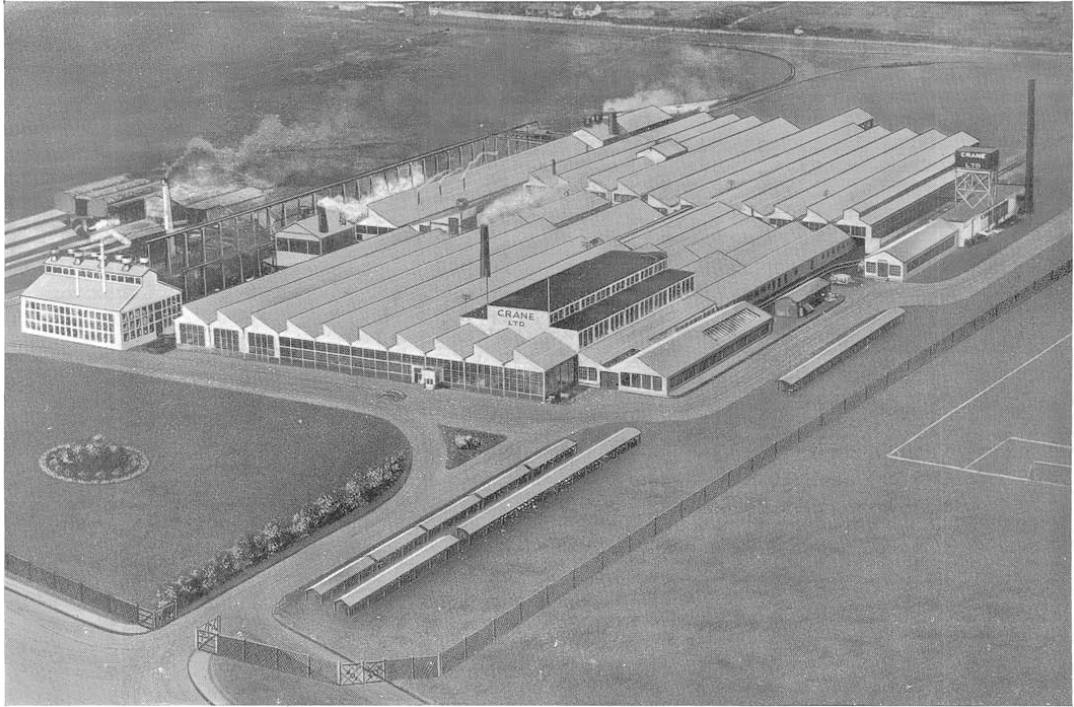
**Plate 3.** Aerial view of Crane's site, published in *'Foundry Trade Journal'* February 1938, looking north. Since the previous image was produced, the factory has been extended north and two new buildings erected along its east side.

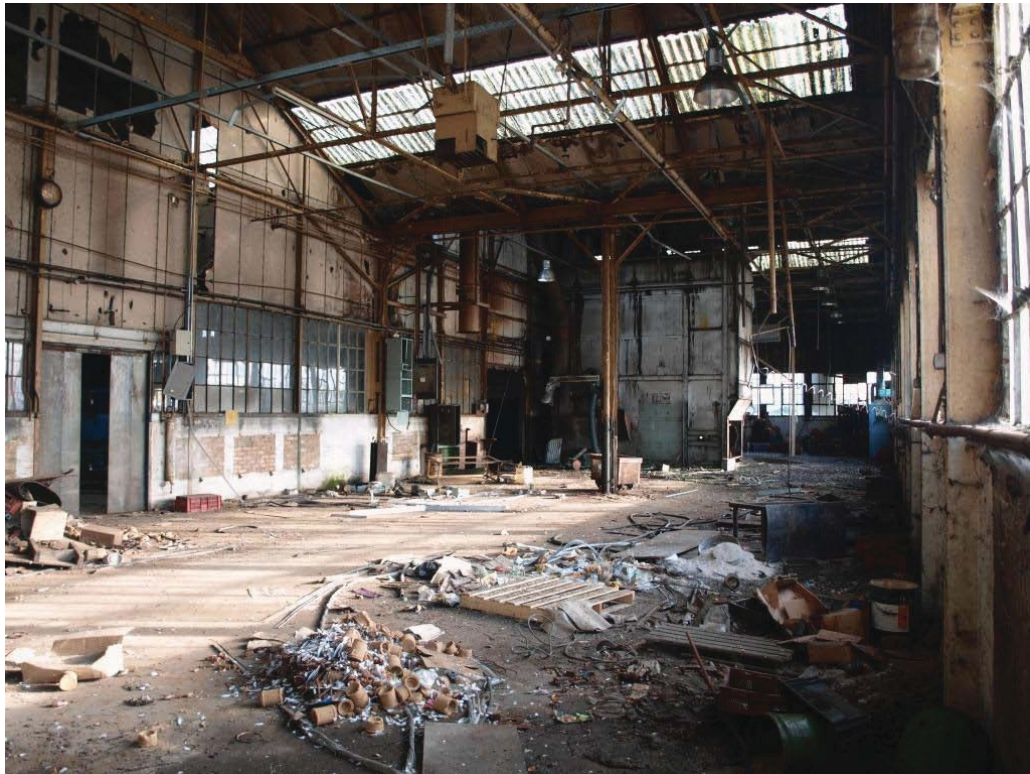
**Plate 21.** Southeast corner of Old Bronze Foundry (5) with oil fired oven.

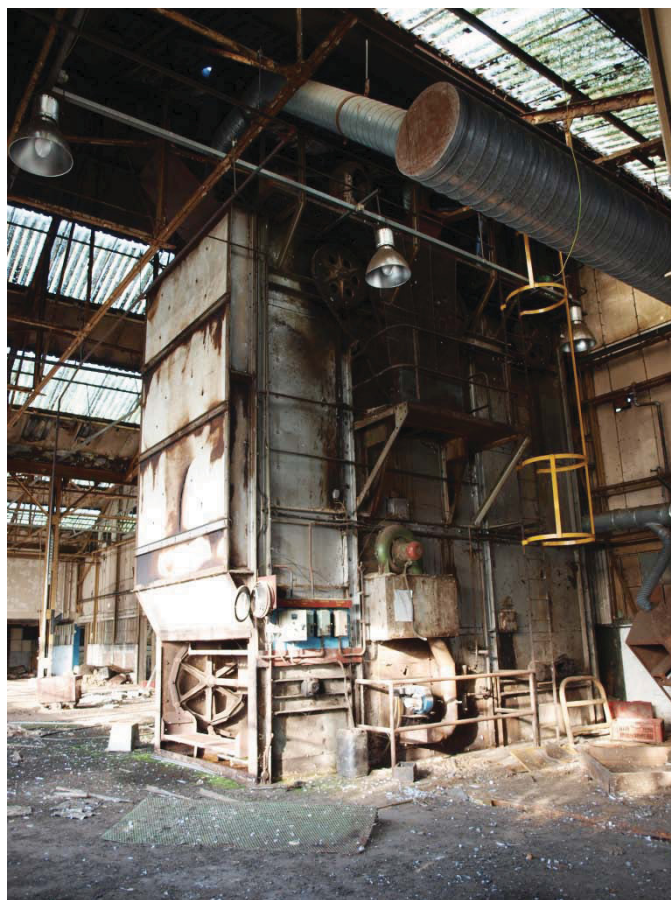
**Plate 22.** Oil fired oven in large space at south end of eastern half of Old Bronze Foundry (5).

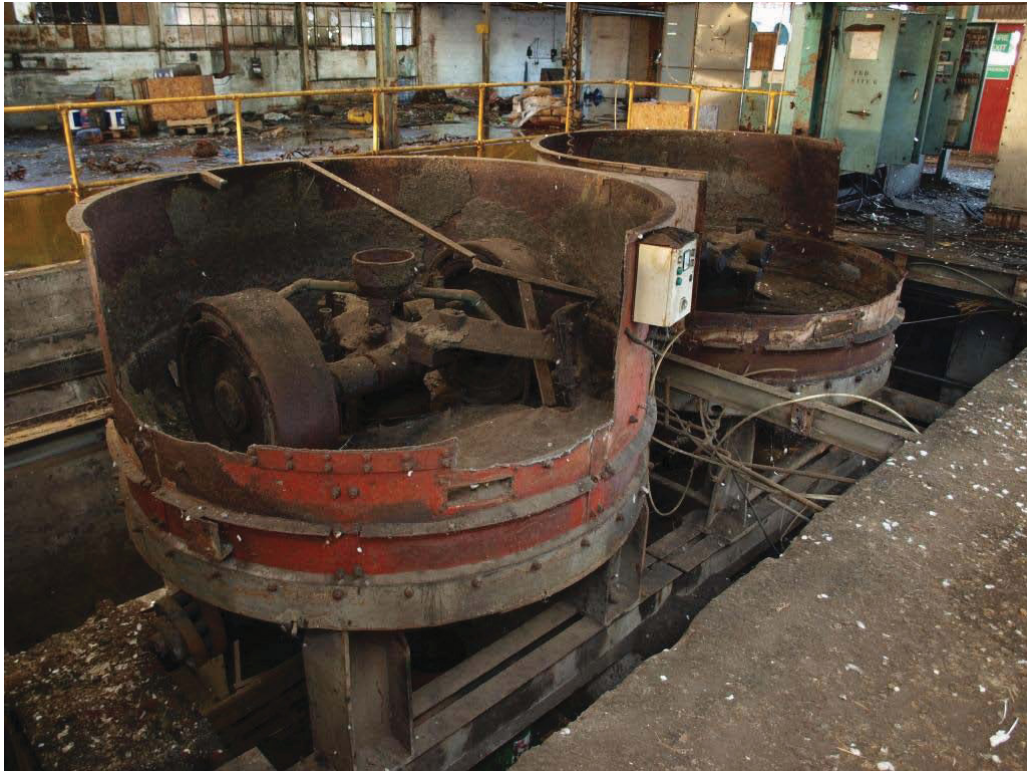
**Plate 25.** Detail view sand treatment machinery found at the north end of the eastern half of the Old Bronze Foundry (5).

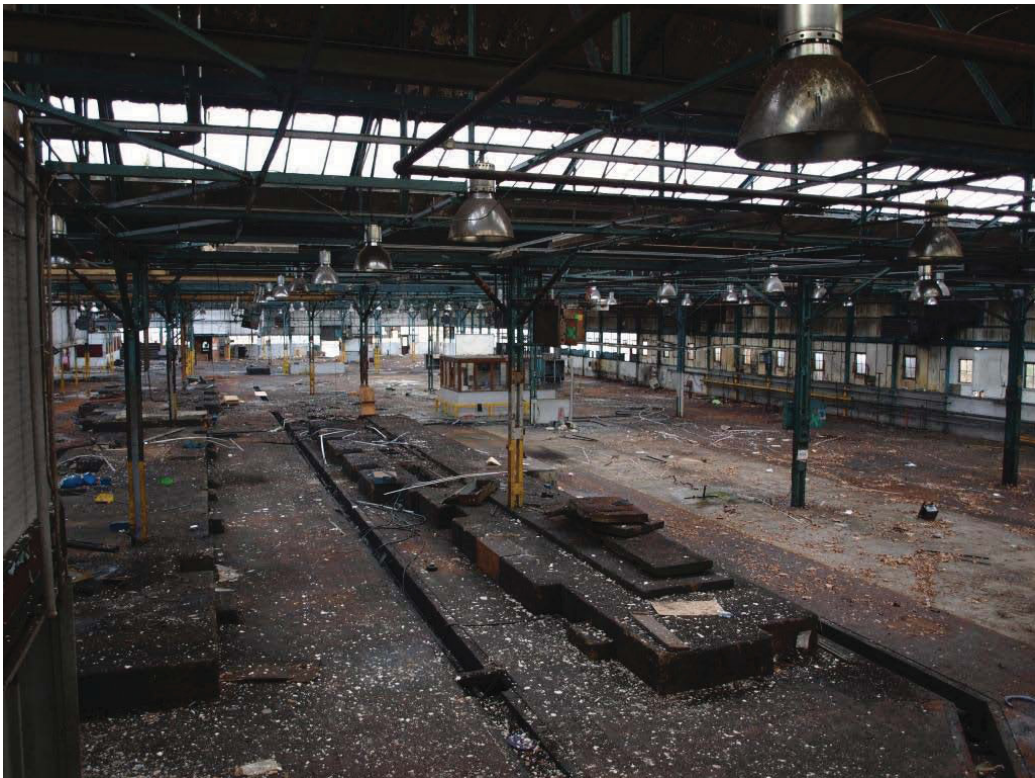
**Plate 36.** View of raised machine bases in the Union Machine and Assembly Building (7).

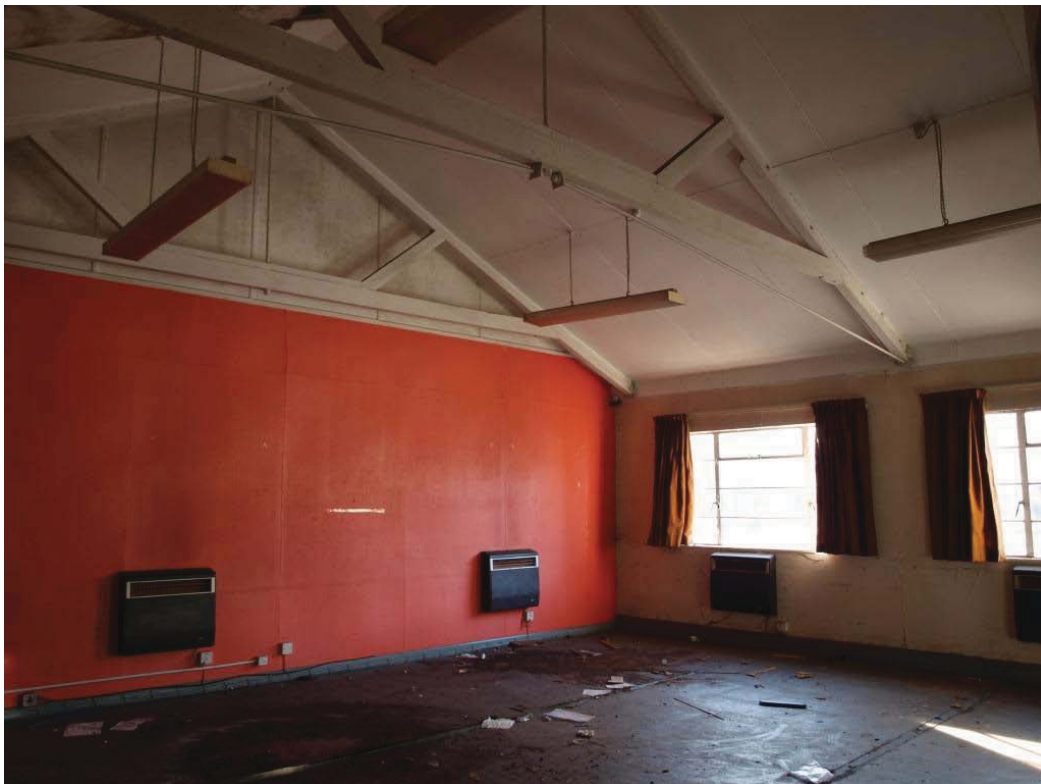
**Plate 40.** Large interior space at the east end of the Works Pavilion, showing the timber roof truss construction with metal tie rods for additional strength.

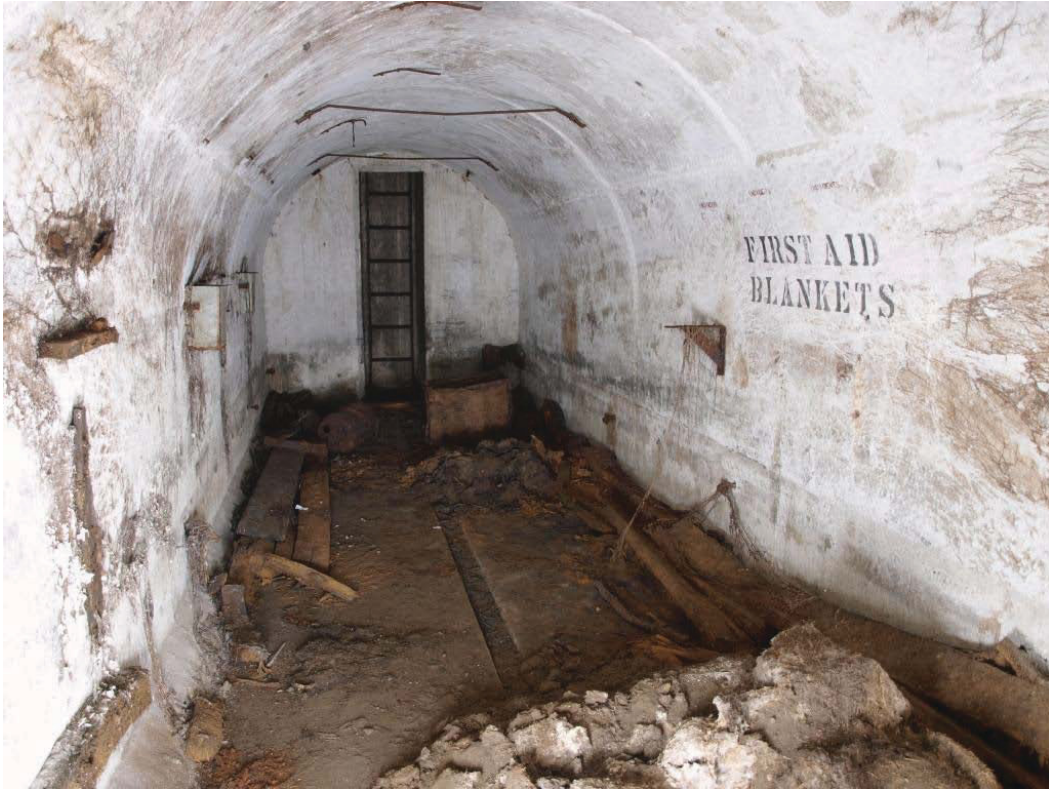
**Plate 55.** Interior of Air Raid Shelter 2, looking north, showing remains of original timber benches and signage.

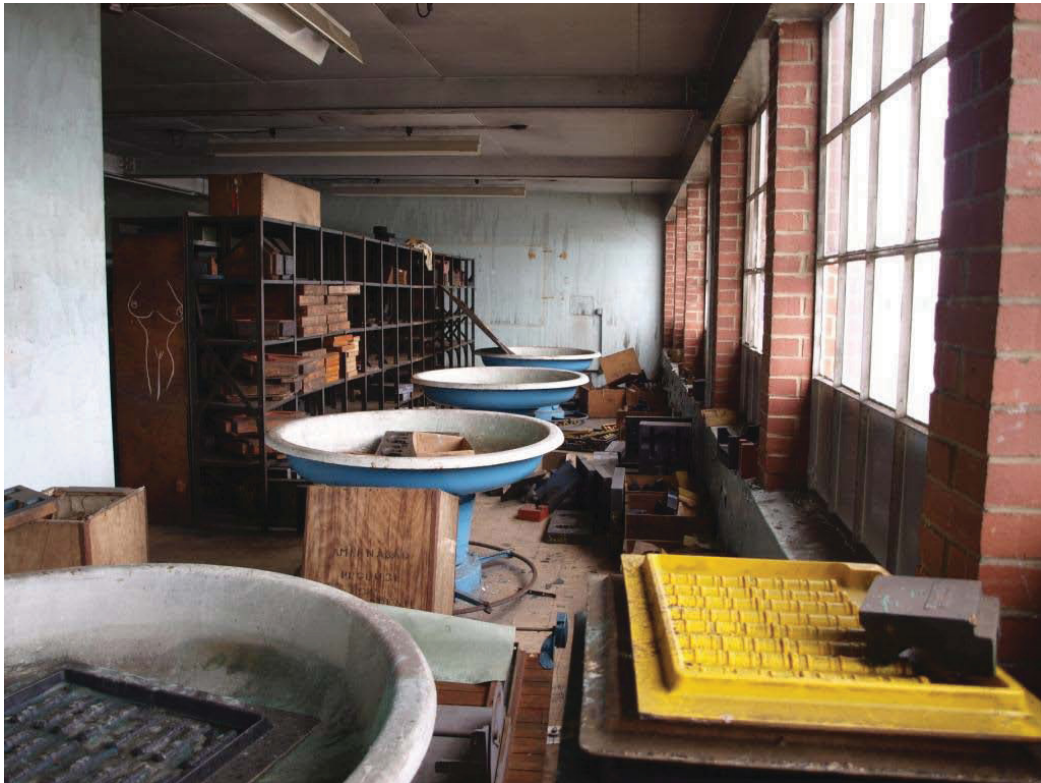
**Plate 79.** Mezzanine at the north end of the first floor of Building 29. Formerly a changing room with large communal sinks, the room had latterly been used for storage.
