**WIDBURY HILL FARM BARNs,
WIDBURY HILL, WARE,
HERTFORDSHIRE**

**ARCHAEOLOGICAL
EVALUATION VIA 'STRIP, MAP
AND RECORD' AND
ARCHAEOLOGICAL
MONITORING AND RECORDING**

Archaeological Evaluation Via 'Strip, Map, and Record' and Archaeological Monitoring and Recording at Widbury Hill Farm Barns, Widbury Hill, Ware, Hertfordshire

Report Number: R11198b

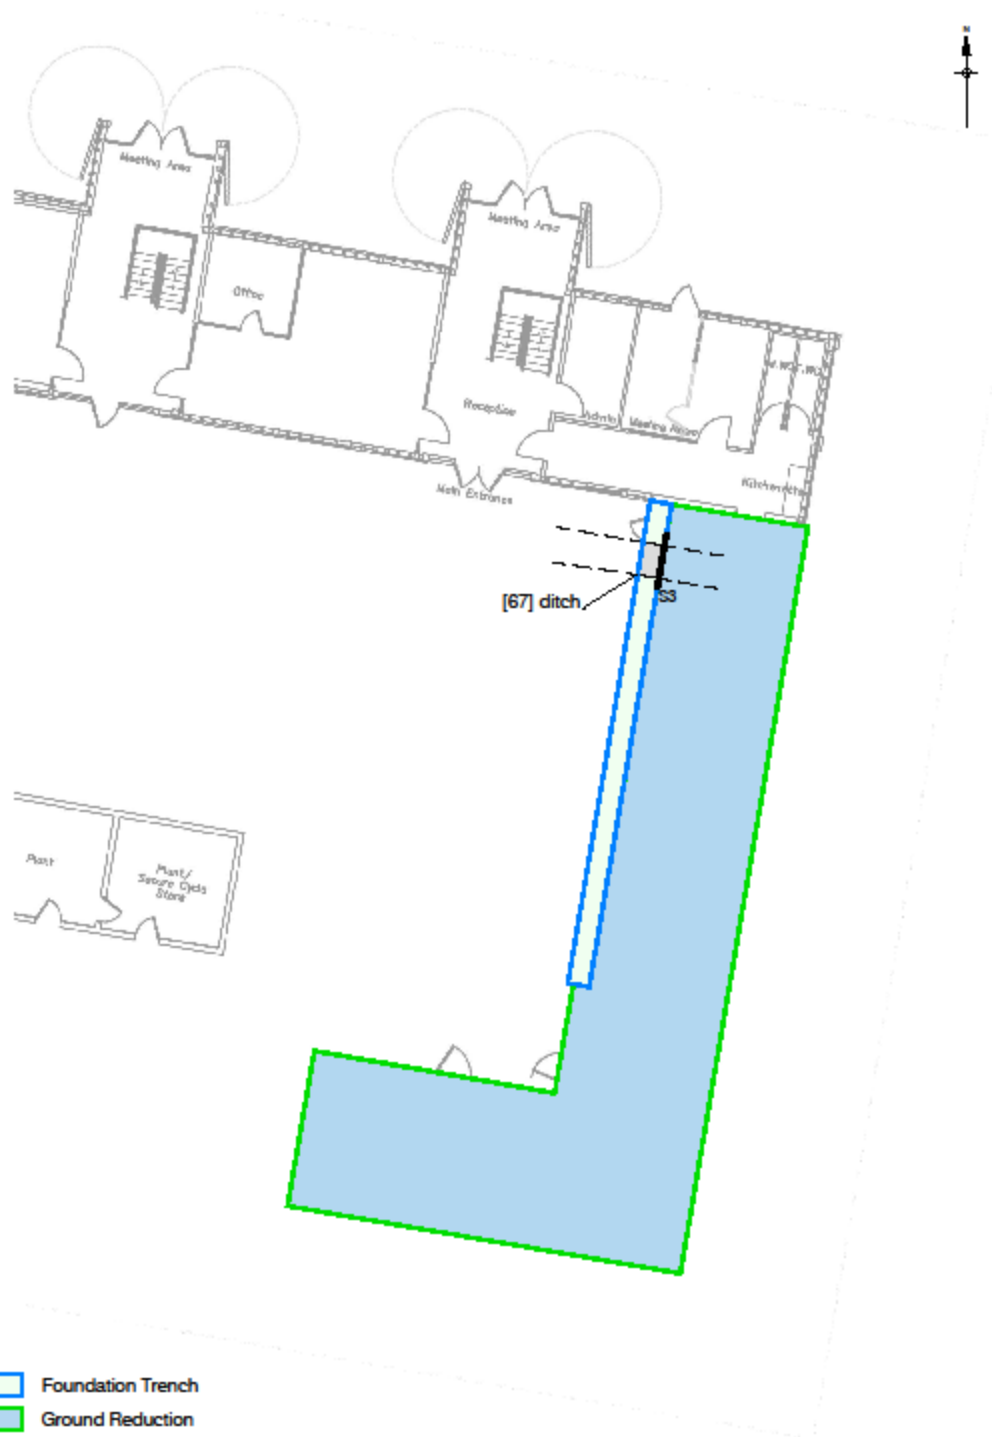
Figure 9
The Piggery (Building 2), Plan and Area Monitored
1:200 at A4

- 2.20 It was originally intended that the only work requiring archaeological monitoring within the piggery was the ground reduction following removal of the concrete floor, and the cutting of internal service trenches. However, it became clear during the breaking out of the floor that the external walls facing into the courtyard area were without foundation. It was therefore necessary to remove these walls and excavate a 1m deep foundation trench for new walls along their footprint, which was archaeologically monitored (Fig. 9).

- 2.21 Following the breaking out of the concrete floor, ground reduction within the piggery was archaeologically monitored between the 12th and 14th May. Excavation of the north-south foundation trench was monitored on the 20th June 2012. The formation level within the piggery was only 300mm below the base of the concrete floor and consequently ground reduction did not fully penetrate recent deposits (Plate 12). However the excavation of the foundation trench (Plate 13) revealed the complete stratigraphic sequence.

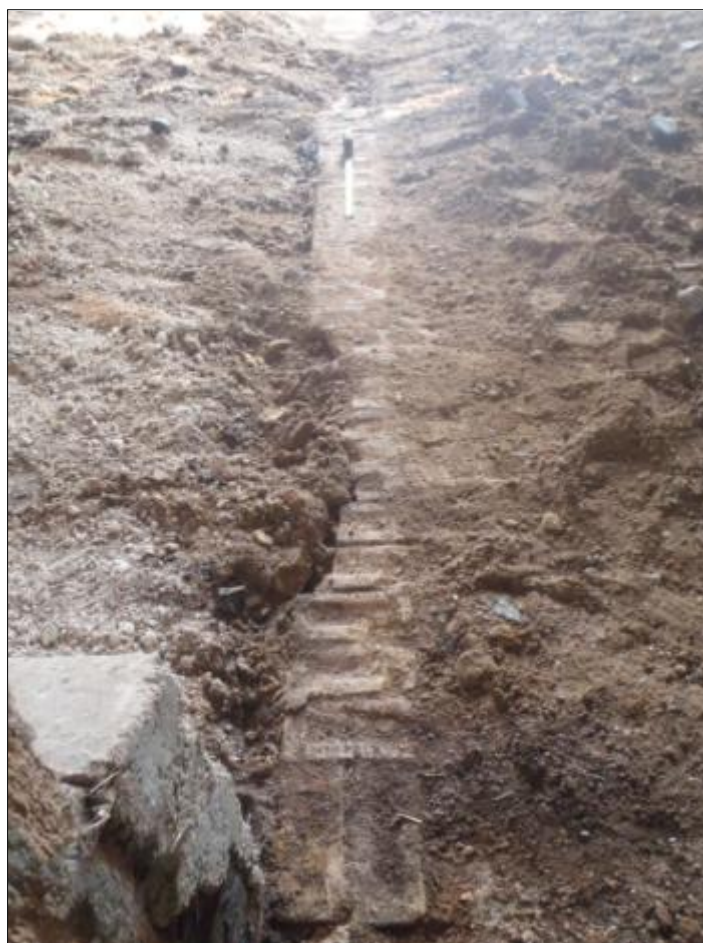
Plate 5: Internal partition wall [12], looking south

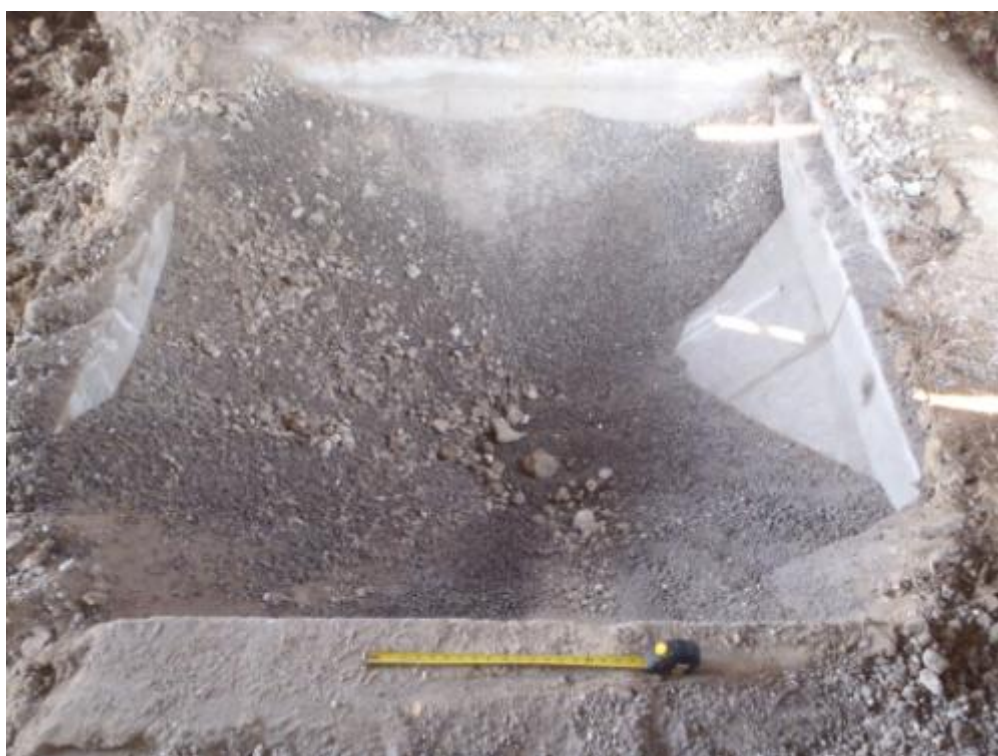
- 2.11 Removal of loose surface deposits in the central midstrey revealed a large concrete hopper [24] (Fig. 4; Plate 6), located within the northern end of an extensive modern cut [22] that extended the full width of the midstrey to the southern edge of the barn and was up to 1.9m deep. It had been backfilled with variable waste materials [21] including abundant CBM fragments along with wood, plastics and baler twine. The function of the hopper and the large pit were unclear but were possibly associated with the storage of animal feed. A date of 1965 scratched into concrete forming a rough repair to the barn southern wall maybe an indication of the date of excavation of the large pit and instillation of the concrete hopper.

Plate 6: Concrete hopper [24] *in situ*, looking west

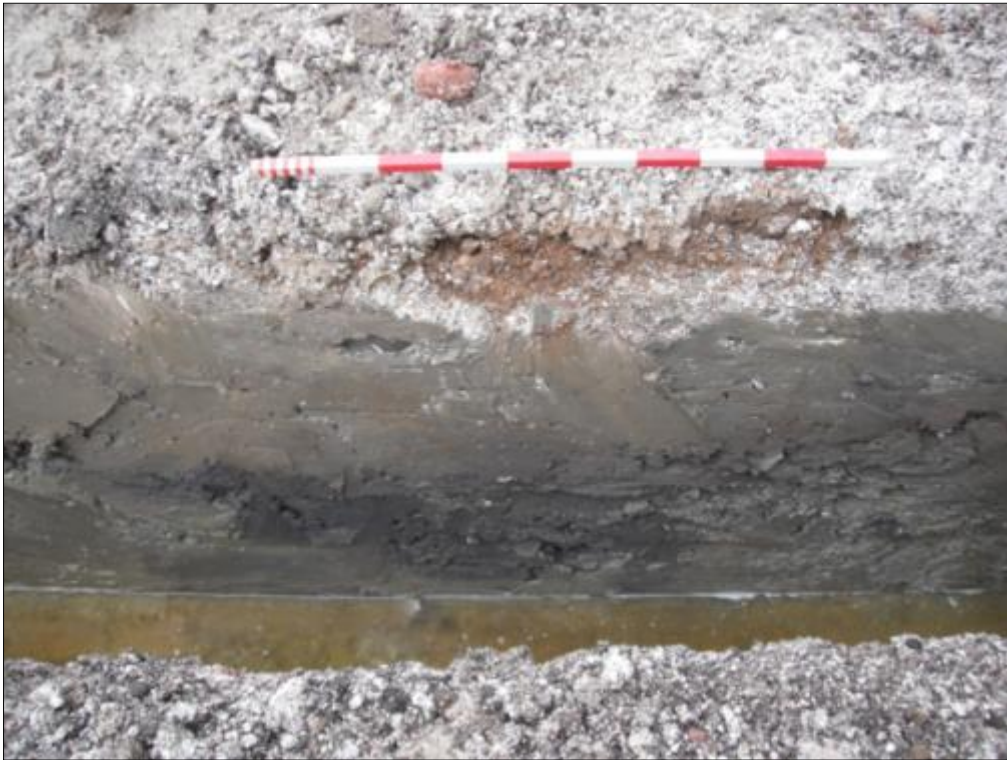
- 2.14 A ditch [6] was observed in two sections of the foundation trenches running parallel to the main barn. The feature was approximately 2m wide and 0.8m deep, and truncated the natural clay [3] (Figs. 6 & 7; Plate 8). The lower fill of the ditch [5] was a dark grey organic silt with occasional wood fragments. This was overlain by stiff clay [4] which appeared to represent deliberate capping or infilling of the feature. The ditch was probably associated with the main barn building, though its fills contained no dating evidence.

Plate 8: Ditch [6], looking west

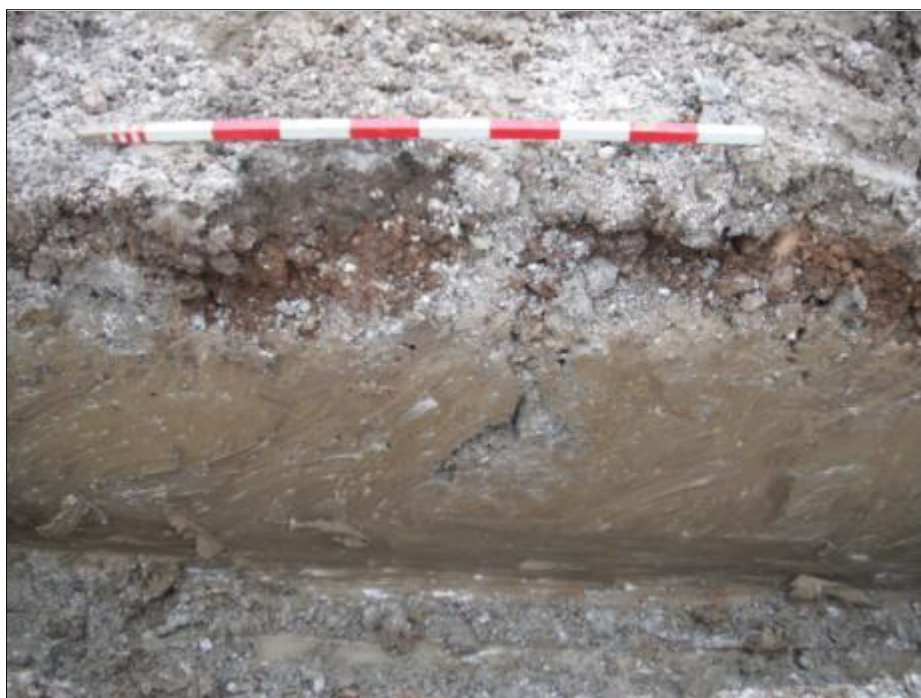
- 2.15 Overlying the infilled ditch was a 0.20m thick layer of chalk and flint rubble [2] with occasional post-medieval CBM inclusions, which elsewhere directly overlay the natural clay (Plate 9). The chalk rubble was in turn overlain by orange-gravel make up for the concrete yard surface [1].

Plate 9: Layers [1] and [2] overlying natural clay [3], new building foundation, looking east

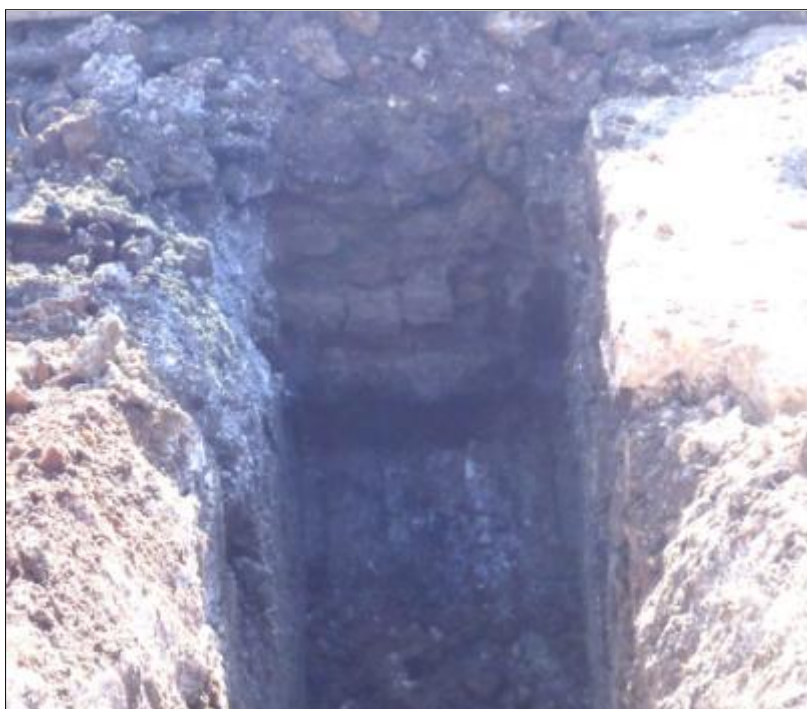
Plate 11: Wall footing [58] in courtyard building south foundation trench, looking east

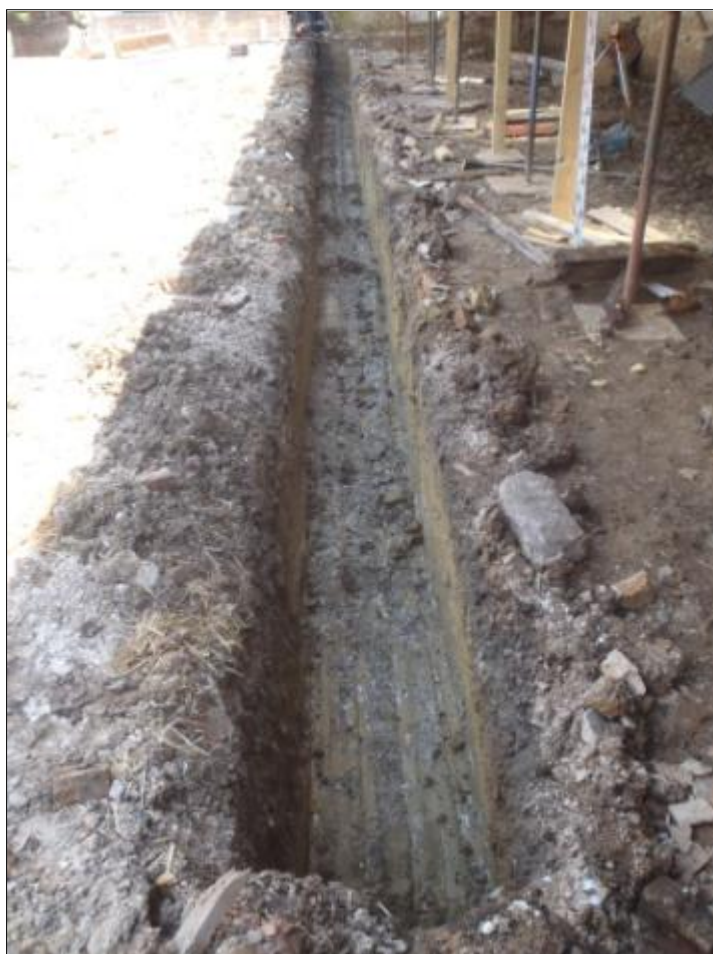
Plate 13: Piggery foundation trench, looking north

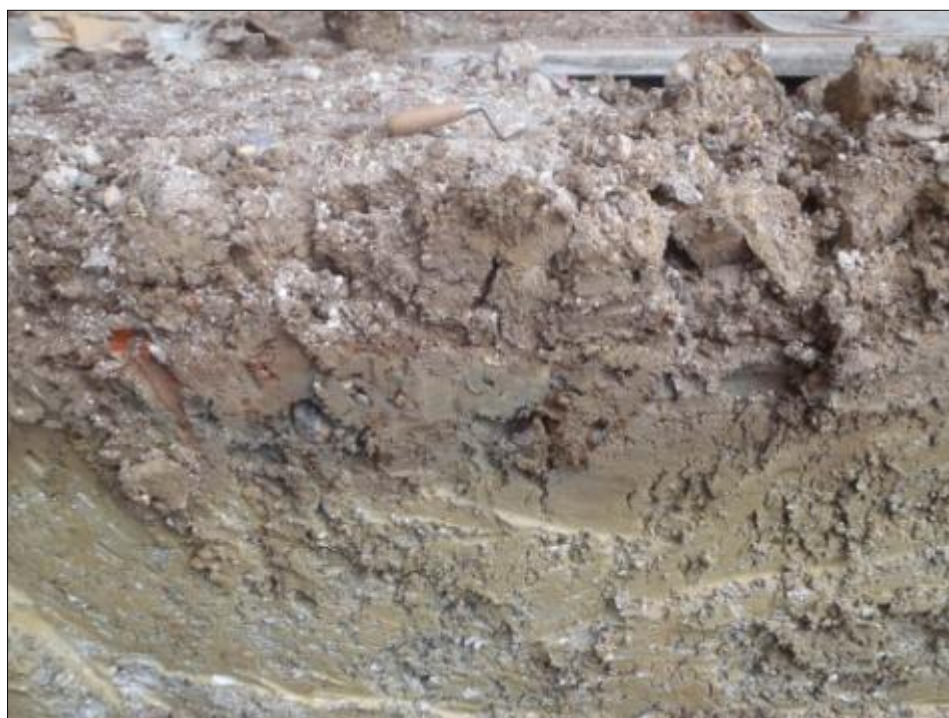
was 1.14m wide and 0.31m deep and appeared to be the eastern continuation of drainage ditch [6] recorded in the foundation trench for the new extension to the west, though it was narrower and shallower in the piggery excavation, reflecting its downwards slope from east to west. It was backfilled with a single deposit of mid brownish grey clayey silt [66] and overlain by a variable deposit of mixed silty clay [56] incorporating some redeposited natural clay but also more recent materials such as CBM and bean cane fragments. Overlying this made ground was a layer of crushed and compacted chalk [55], up to 0.25m thick, which covered an area 1.55m wide along the western side of the north-south range of the piggery and along the northern side of the east-west range. Finally, the entire internal area of the piggery was capped with a 0.15m thick layer of modern concrete and bedding [54].

Plate 14: Ditch [67], looking east
