**EAST WING
SOMERSET HOUSE
STRAND
CITY OF WESTMINSTER**

**ASSESSMENT OF AN
ARCHAEOLOGICAL
EXCAVATION & WATCHING
BRIEF**

An Assessment of an Archaeological Excavation and Watching Brief at the East Wing, Somerset House, Strand, City of Westminster, London, WC2R 1LA

Site Code: EAF 10

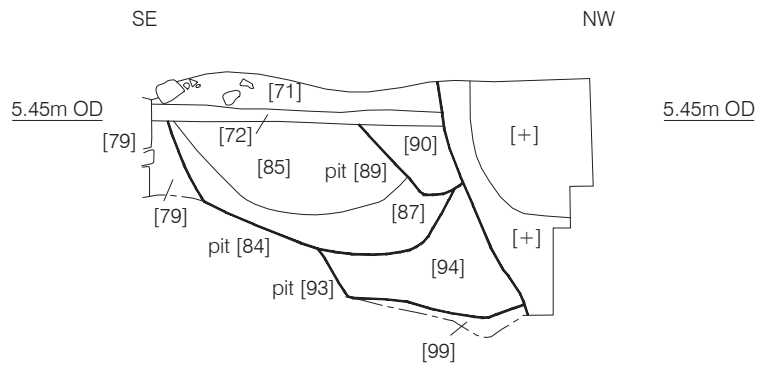
Figure 5
 Section 8
 1:25 at A4

Section 8
 Room 45
 Northeast Facing

7.2.3 Cutting through the levelling sequence described above was a single Saxon pit, [93] (Figs. 3 & 5). Only the southern portion of this pit was observed; with recorded dimensions of 2.22m east-west by 0.60m north-south and c. 0.60m deep. The pit

- 7.3.1 Sealing the Saxon pit and stakehole group in Room B45 was a levelling layer, [79] (Fig. 5). This levelling layer was only observed in the northern half of Room B45, the recorded area of which measured 3.05m east-west by 1.20m north-south. Consisting of a brownish grey silty clay the deposit was located at c. 5.38m OD and was 0.15m thick. This levelling deposit contained a pottery assemblage which dated to 1080-1350. This assemblage included London-type ware, the former white-slipped and green-glazed (LOND) and the latter with North-French style decoration (LOND NFR) (Appendix 2). Much like the earlier Saxon deposits of the previous phase this deposit contained a varied range of re-deposited Roman tile (Appendix 6). This included sandy, Reigate and Calcareous Roman tile which dates to the early and late Roman period. Also recovered however, were a number of fragments of glazed medieval tile which provides a more pertinent date of 1240-1600. This therefore provides a *terminus post quem* of 1240 for the deposition of this layer.

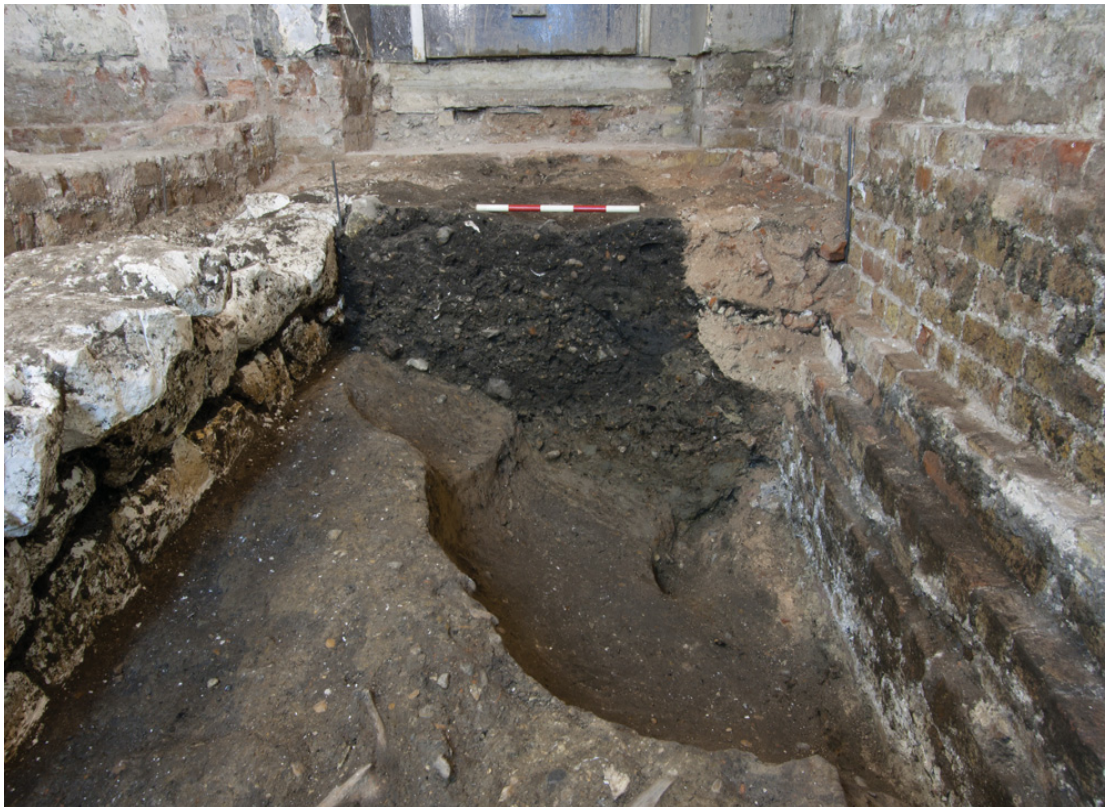
Plate 1: Saxon and medieval pits [93], [84] and [89] and Section 8 in Room B45, facing southwest

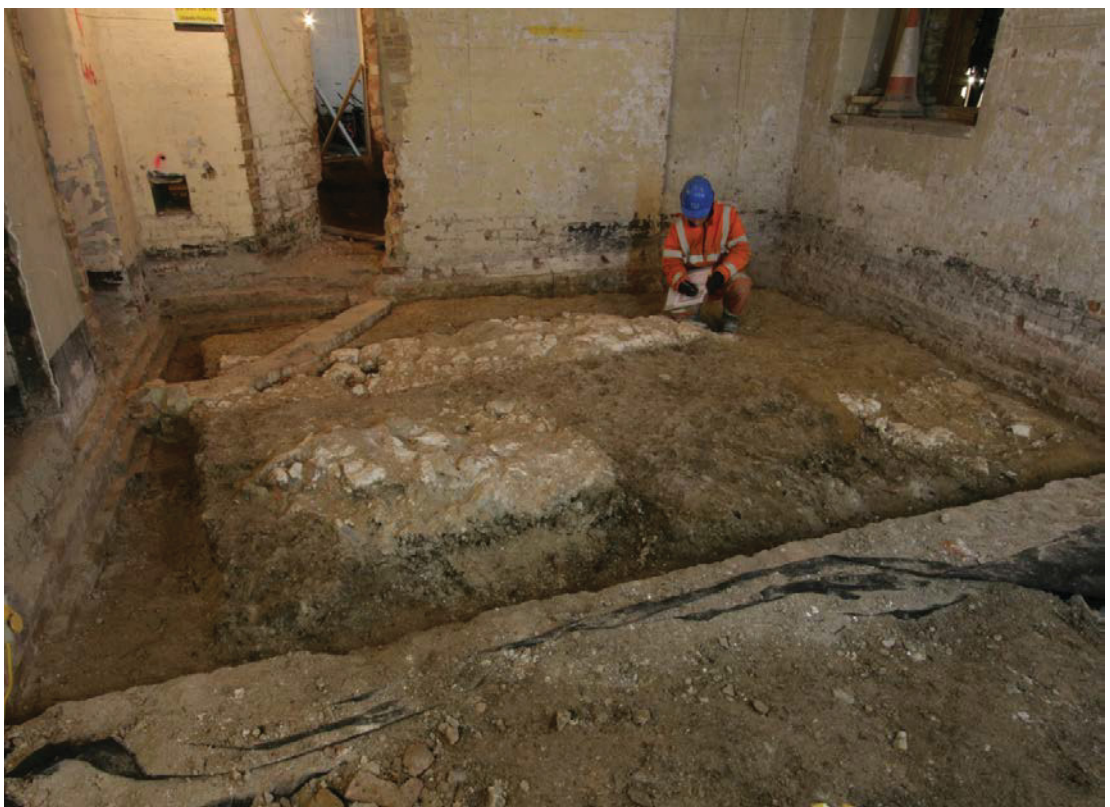
Plate 2: Chalk foundations [73], [74] and [75] in Room B52, facing north

7.4.7 Cutting into levelling deposits [78], [77] and [80] in Room B52 were three apparent chalk foundations, [73], [74] and [75]/[76]. The most substantial of these, [75]/[76], was located in the northern part of the room on a northeast-southwest alignment. This foundation was composed of roughly hewn chalk blocks set within a brown gravelly mortar potentially identified as Type 4 mortar with dates to the late medieval/early

- 7.4.8 Located to the south of the above chalk foundation were two more chalk foundations, [73] and [74]. These two foundations consisted of almost identical roughly hewn chalk blocks bonded by a similar brown gravelly mortar (Appendix 6). Foundation [73] was located on the western side of the room and measured c. 1.10m northwest-southeast by 1.30m northeast-southwest. It appeared that this foundation was aligned northwest-southeast but the small surviving area makes this difficult to determine. The northern end of this feature would therefore then have had a butt-end and the southern end which was truncated would have continued in that direction. Again this chalk foundation was located at c. 5.90m OD and as it was unexcavated its depth remained unrecorded. Chalk foundation [74] was located in the eastern side of the room on the same northeast-southwest alignment as foundation [75]/[76]. This ran for a length of c. 1.40m terminating at its western end and apparently continuing beyond the excavation limit at its eastern end. Recorded at 5.78m OD this foundation had a similar width to the others at c. 1m and again as it remained unexcavated its depth was unknown.

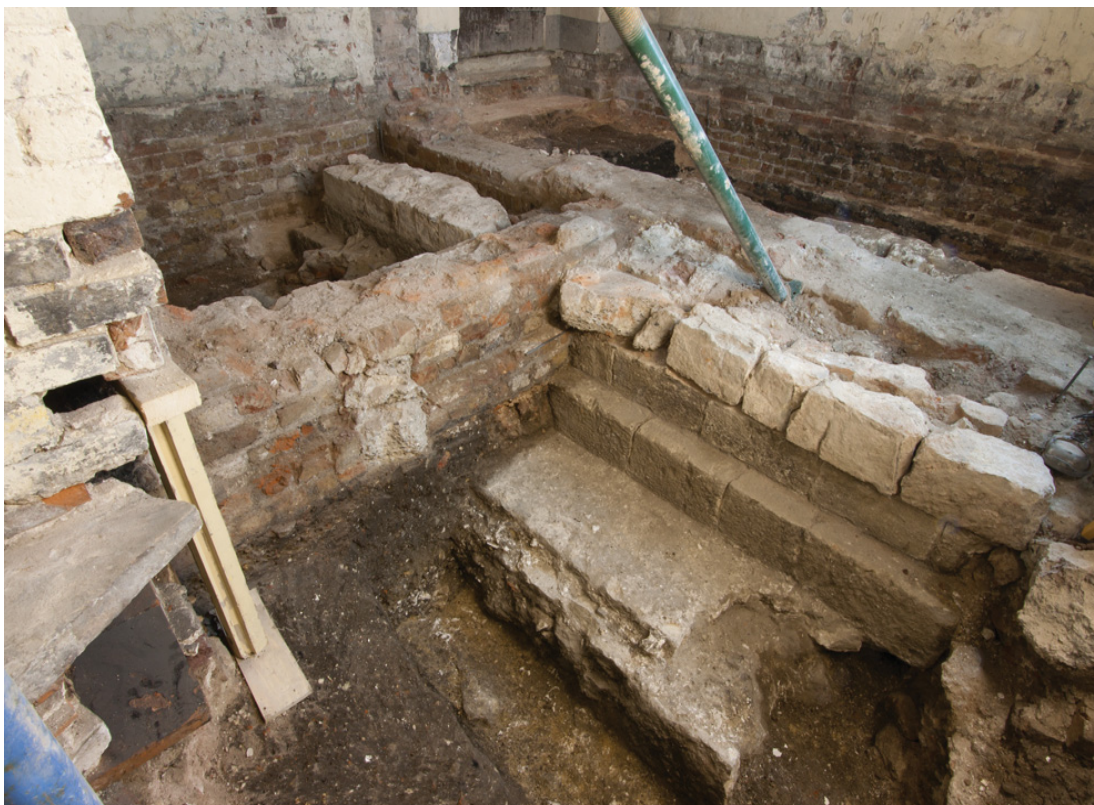
Plate 3: Tudor masonry wall [69] in Room B45, facing west

- 7.5.9 Recorded in the southern part of Room B45 was a substantial masonry wall, [69] (Fig. 8 Section 7). This masonry wall was partially installed upon the southern side of large chalk foundation [70] from the previous phase, effectively re-using this older foundation. Running throughout Room B45 for c. 4m the masonry part of the wall had a width of c. 2.50m. This masonry foundation of this wall was composed of Kentish ragstone and Hassock stone which sat upon a wider plinth, [98], on the southern side. The stonework of the southern face which sat upon the plinth consisted of well made fresh Kentish ragstone, mouldings and ashlar examples forming a neat external face. The highest part of the surviving wall was c. 5.76m OD with the plinth, [98], being located at c. 5.15m OD, below which was the rubble foundation. The overall recorded height of the wall was 0.70m but continued below the excavation limit. This substantial wall relates directly to the Tudor Somerset House and may even represent the southern outer wall of the Lower Court.

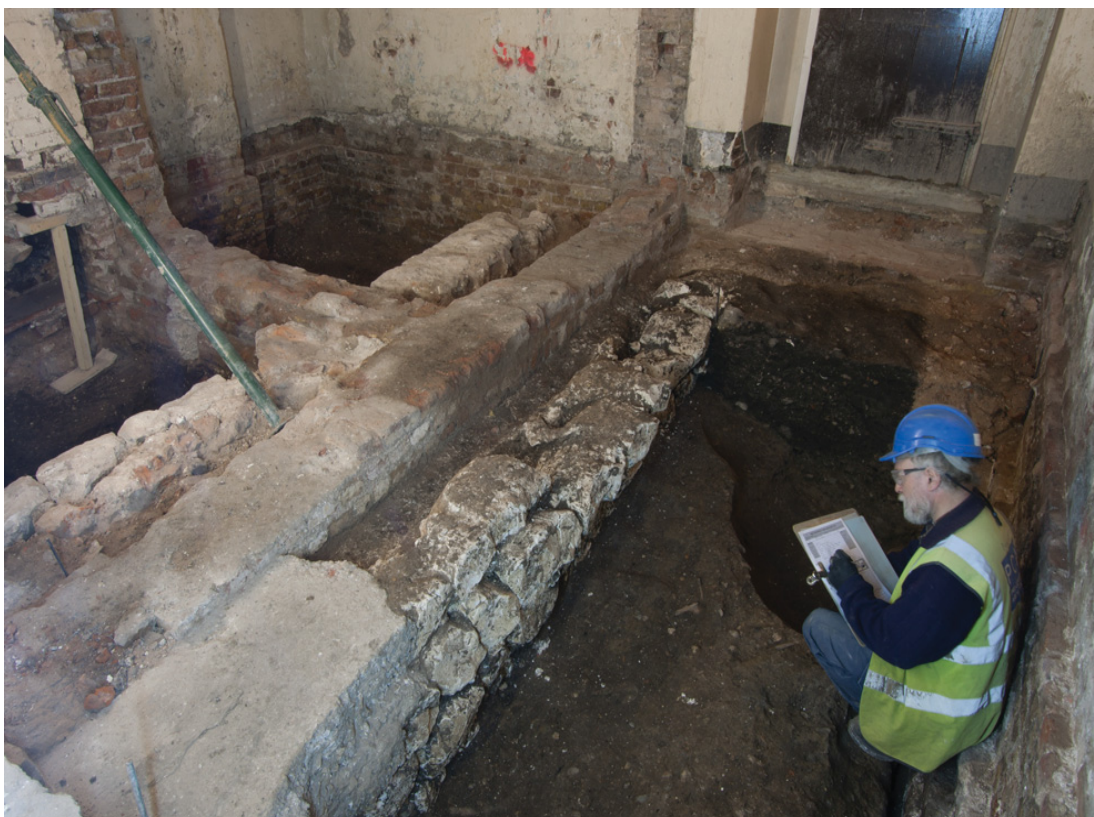
Plate 4: Chalk wall foundation [70] in Room B45, facing south

- 7.4.4 Cutting through levelling deposit [71] in the centre of Room B45 was an extensive chalk foundation, [70]. This chalk foundation consisted of moderate to large sized roughly hewn chalk blocks bonded with a soft brown gravelly mortar, tentatively identified as Type 4 mortar which dates to the late medieval/early post-medieval period (Appendix 6). The chalk foundation was aligned westsouthwest-eastnortheast, running for 3.30m through the room. The width of the chalk foundation was obscured by a later Tudor masonry addition to the southern side of the wall, [69], but was at least 1.30m wide. Located at c. 5.76m OD the wall was at least 0.70m deep but continued deeper below the excavation limit. The northern face of the chalk

foundation saw chalk blocks which were somewhat more neatly squared off and finished although it is unlikely that this was an exposed face which would have been above ground. The continuation of this chalk wall foundation was recorded as [191] in Lightwell 1 directly to the east (see above).

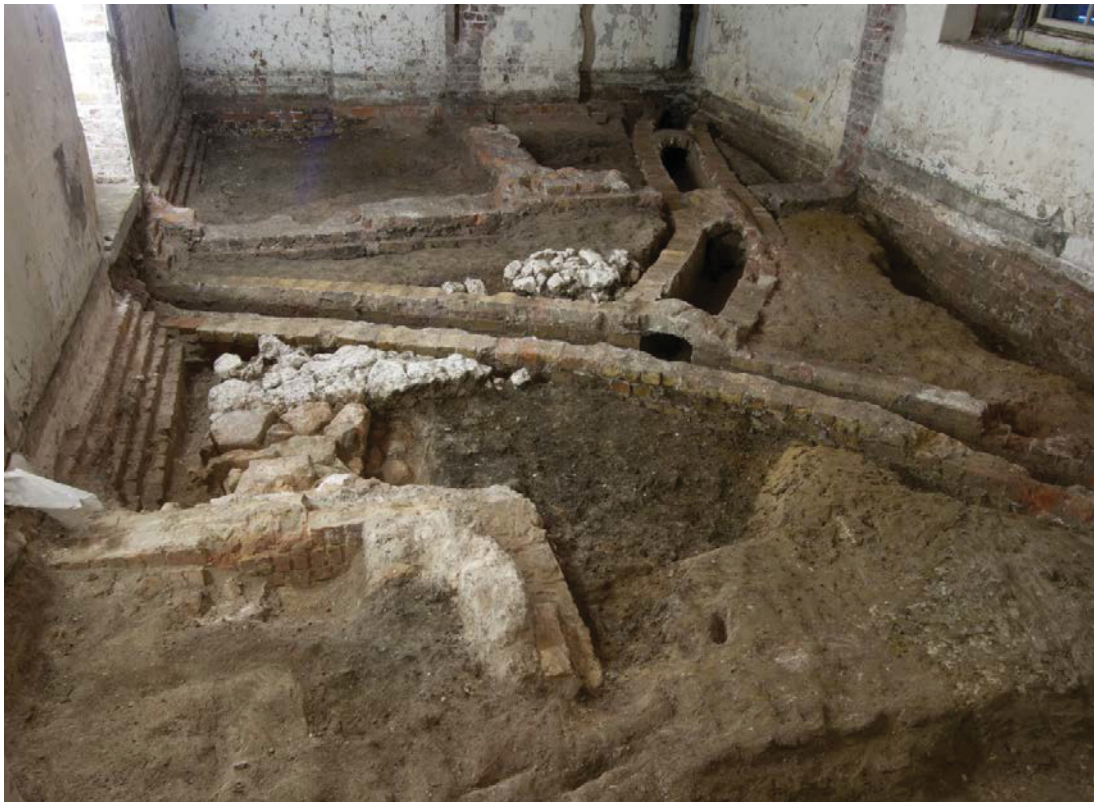
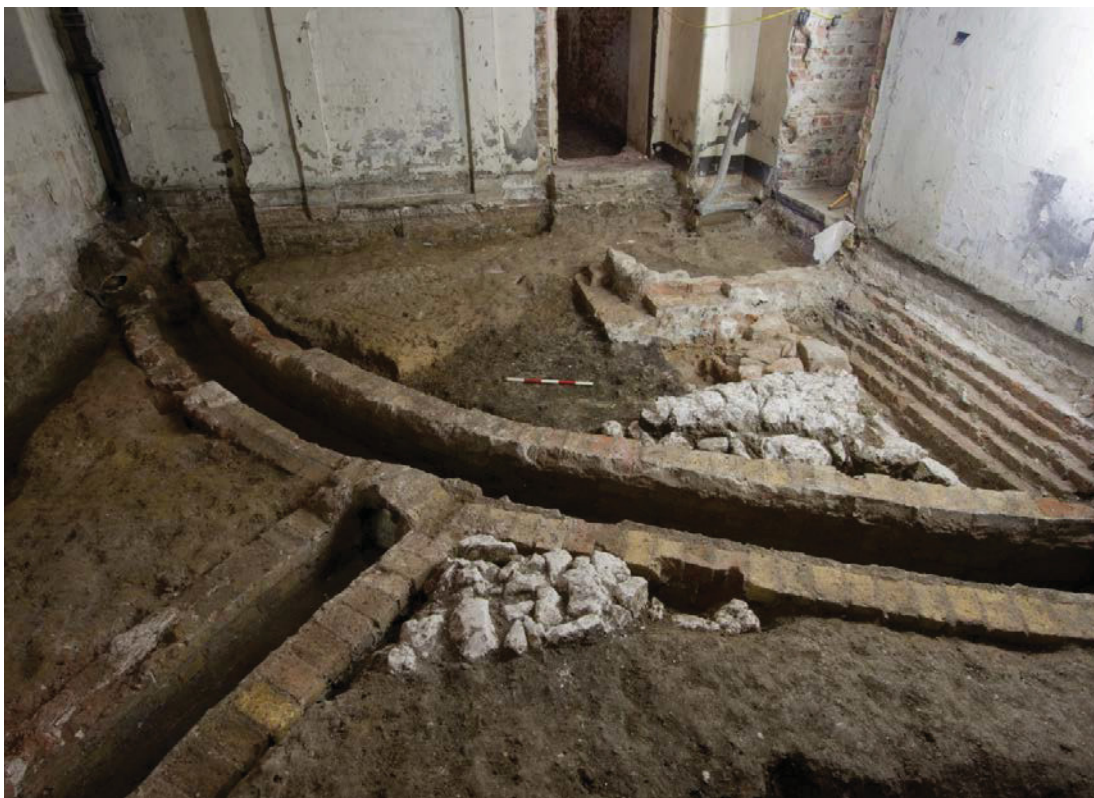
Plate 5: Chalk foundation [124]/[127] and masonry foundation [125] truncated by late 18th-century brick drainage culvert [124] in Room B47, facing southeast

Plate 6: Chalk foundation [124]/[127] and masonry foundation [125] truncated by late 18th-century brick drainage culvert [124] in Room B47, facing northwest

7.4.5 Cutting levelling layers and medieval pit [141] in Room B47 were two wall foundations, [125] and [124]/[127]. Wall foundation [124]/[127] was composed of roughly hewn chalk blocks running on an almost northeast-southwest alignment for c. 2.50m. This chalk foundation had a width of c. 1.40m and was located at c. 5.78m OD. The foundation was truncated at both its eastern and western ends and would most likely have continued east originally. No continuation of the chalk foundation was recorded further west past the later truncation however which suggests that the foundation ended in the approximate location it was truncated. The full depth of the chalk foundation was not recorded but it was at least 0.35m deep.

7.4.6 Abutting the northern side of chalk foundation [124]/[127] was a second wall foundation, [125]. This second foundation had a different composition; it consisted of roughly hewn blocks of Reigate and Hassock stone which had no bonding material or mortar (Appendix 6). This masonry foundation appeared to run on northwest-southeast alignment, perpendicular to chalk foundation [124]/[127]. However, the masonry foundation was heavily truncated on the northern, eastern and southern sides and therefore the true dimensions of this masonry did not survive. The western face however represented its true edge. The recorded length of the foundation was c. 0.84m but would have originally continued both north and south. The surviving width was c. 0.90m but again would originally have been wider, extending east. This masonry foundation was recorded at the same level as the chalk foundation, c. 5.78m OD, and its full depth was not recorded. Both these chalk and masonry foundations within Room B47 most likely represent a structure which was demolished prior to the construction of the Duke of Somerset's Tudor palace, but their alignment might suggest that they were part of the original build of the palace.

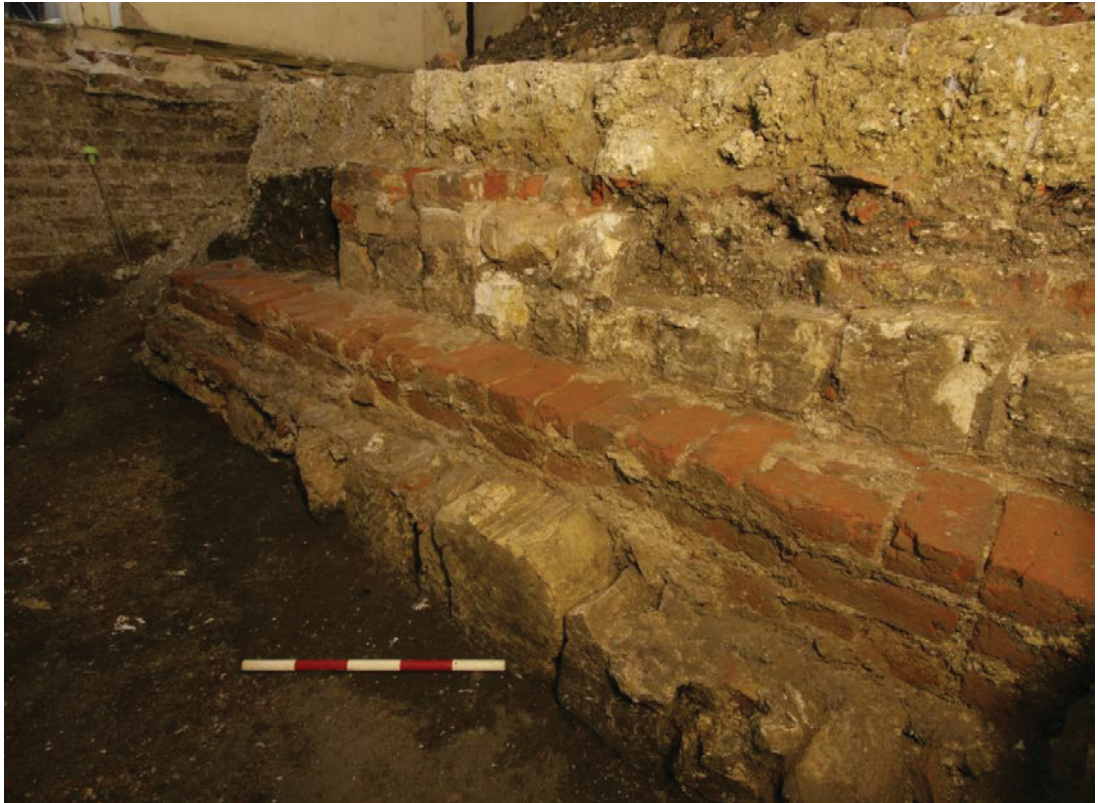
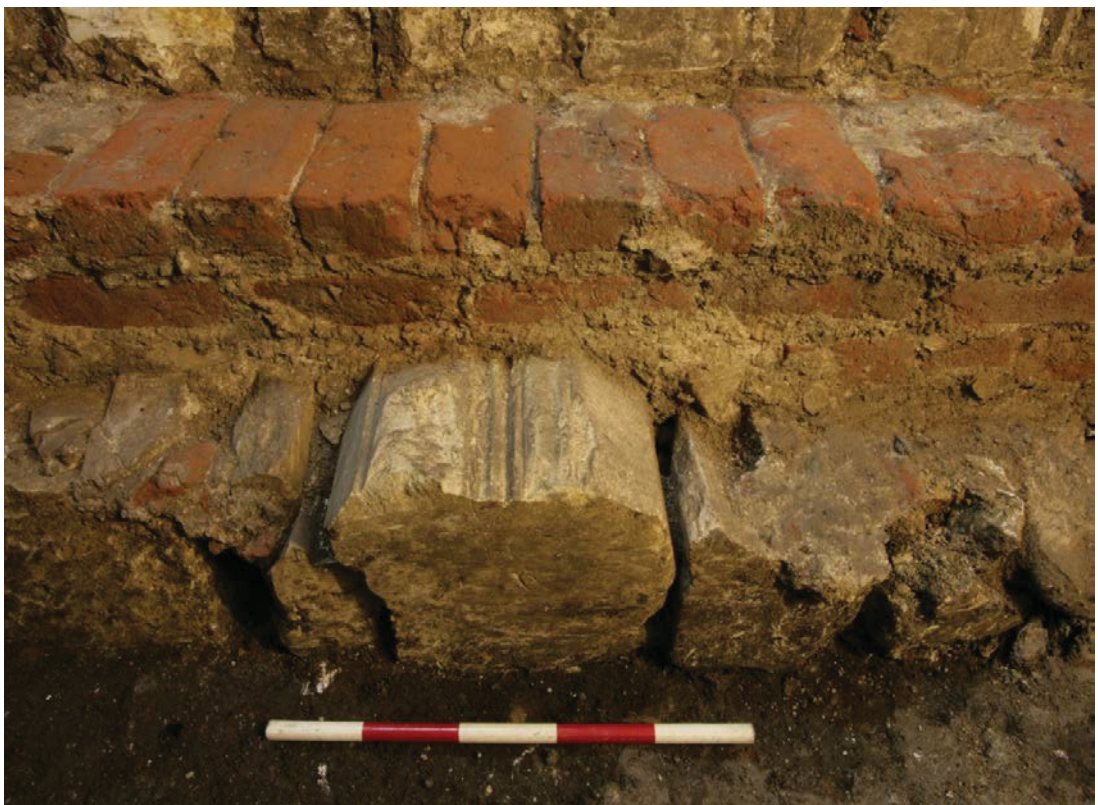
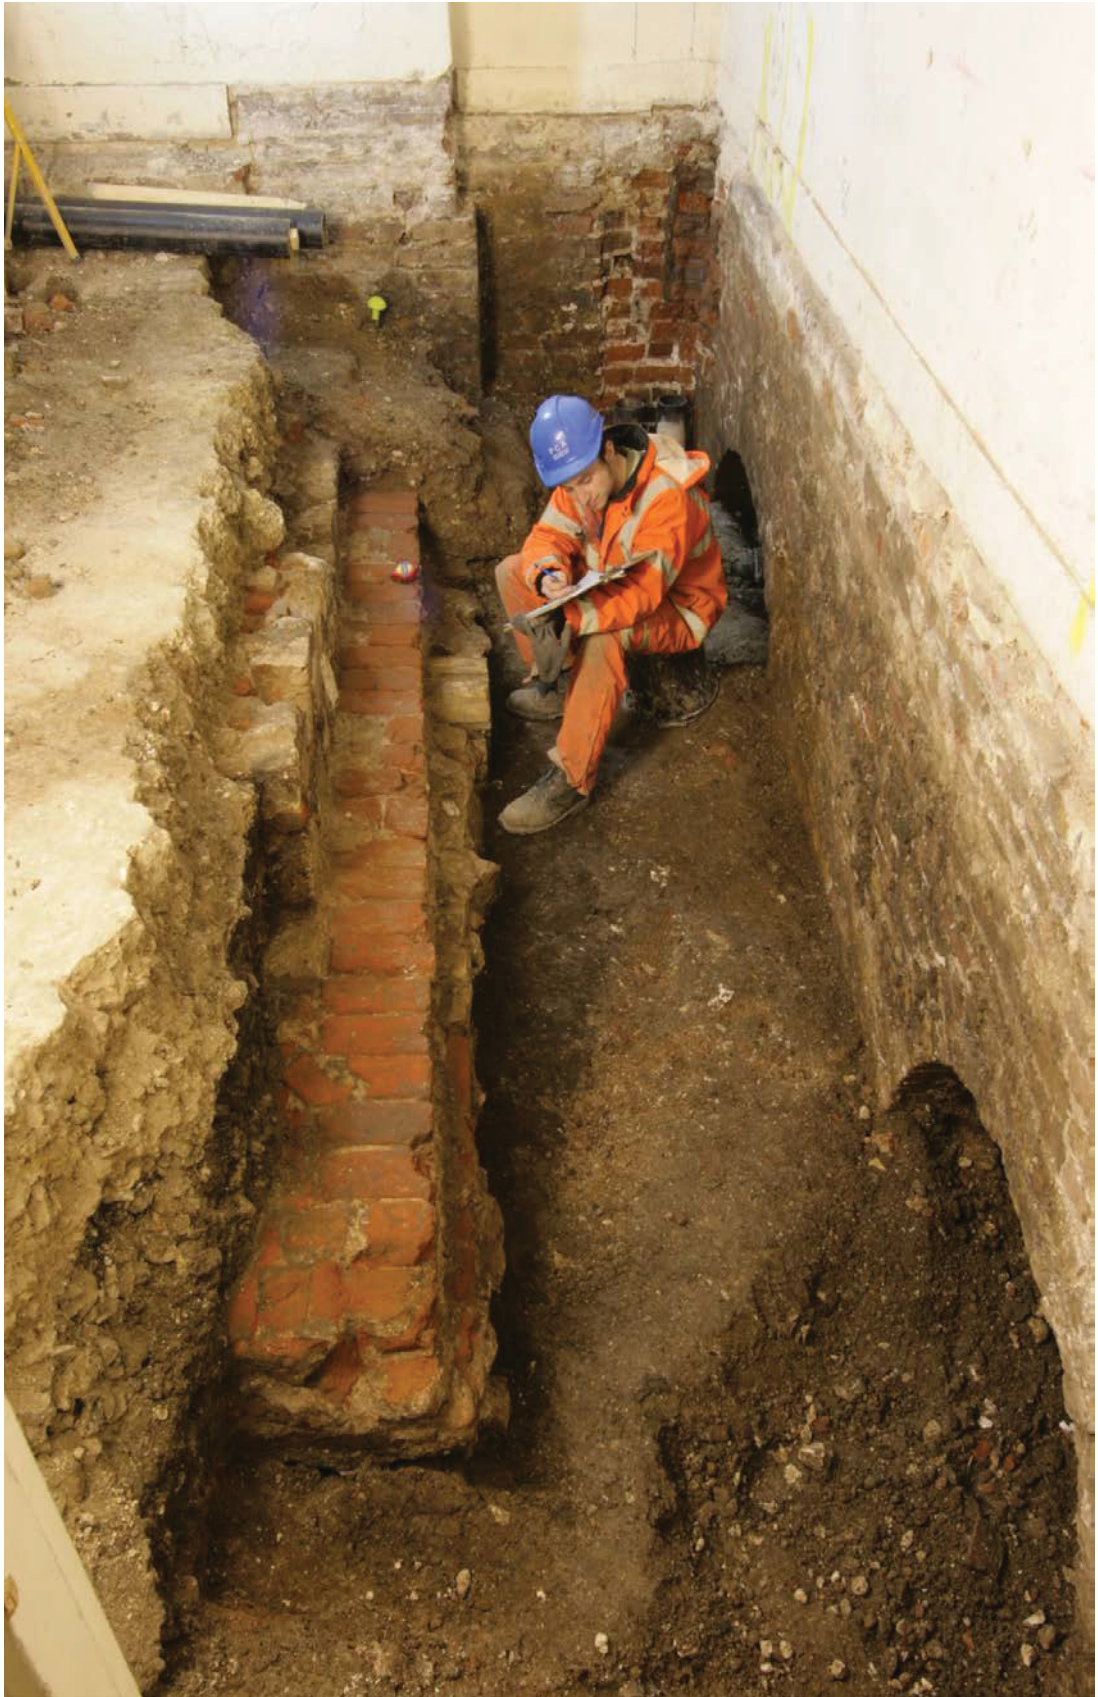
Plate 7: Brick and masonry wall [171], [172] on masonry rubble foundation [173] in Room B60, facing south

Plate 8: Detail of masonry rubble foundation [173] in Room B60, facing southwest

Plate 9: Brick and masonry wall [171], [172] in Room B60, facing northwest

7.6.1 Cutting the levelling deposit in Room B60 was brick and masonry wall [171], [172], and [173] (Figs. 7 & 8). Aligned northwest-southeast the wall ran through the eastern section of Room B60. Running for c. 4.60m in length the wall had a recorded width of 0.60m but continued west beyond the limit of the excavation. The recorded eastern elevation of the wall represented the eastern face of the wall. A masonry rubble foundation was laid into a trench upon which was built the brickwork of the wall. This rubble foundation, [173], was located at 4.24m OD and was c. 0.30m deep. The masonry rubble within this foundation largely consisted of reused Tudor style bay window masonry of mould and guttering in Caen stone and bath-stone. One particular

masonry piece, WSN 8, was a complex high moulding window jamb which had a mason's mark on it (Appendix 6). Mortared onto the top of the masonry foundation was between two and three courses of red Tudor 3033 fabric bricks, [172]. These bricks were located at 4.38m OD and the brickwork itself was c. 0.28m high. Sat upon the Tudor red bricks was a regular course of masonry and chalk blocks, [171]. This masonry course was located at c. 4.80m OD and consisted again of reused mouldings and ashlar blocks of predominantly Caen stone. This again included bay window masonry pieces such as an ornate curved mould Caen stone with diagonal tool marks, WSN 20 (Appendix 6). This brick and masonry wall represents an external garden wall directly south of the Tudor Somerset House as illustrated on various cartographic sources (Fig. 9). The re-use of classic Tudor style masonry within the rubble foundation may suggest a slightly later date for this phase of garden wall, possibly be associated with rebuilding and alterations in the 17th century.

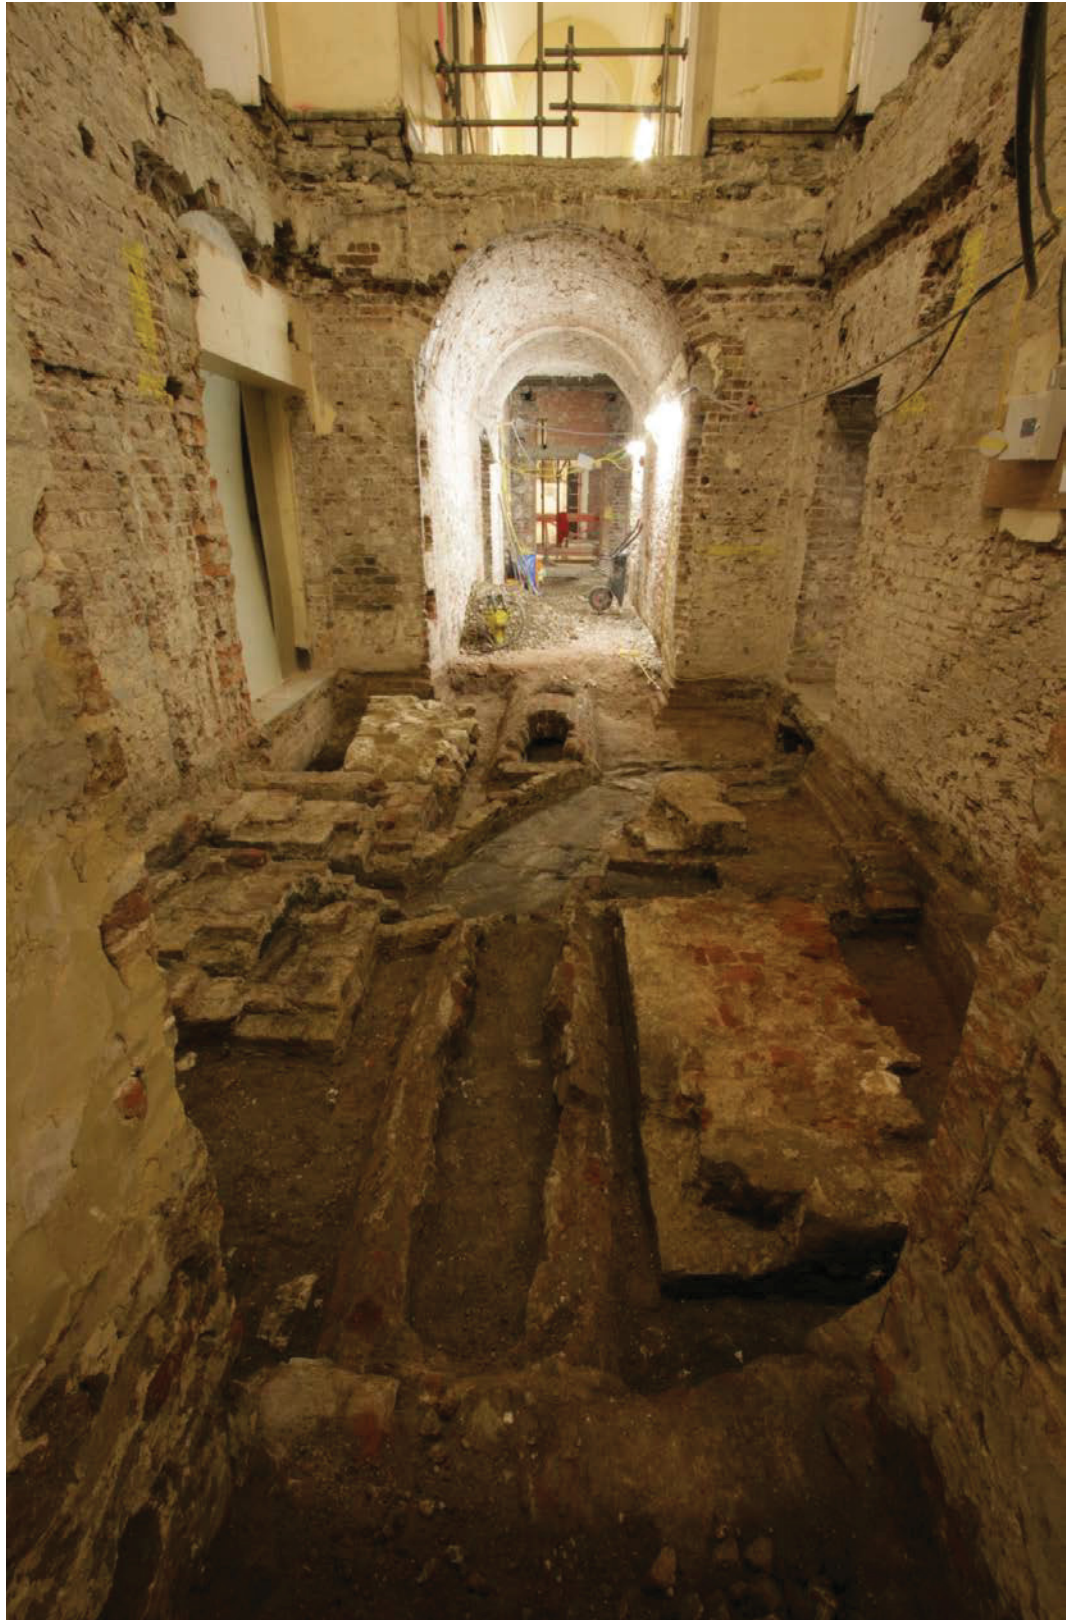
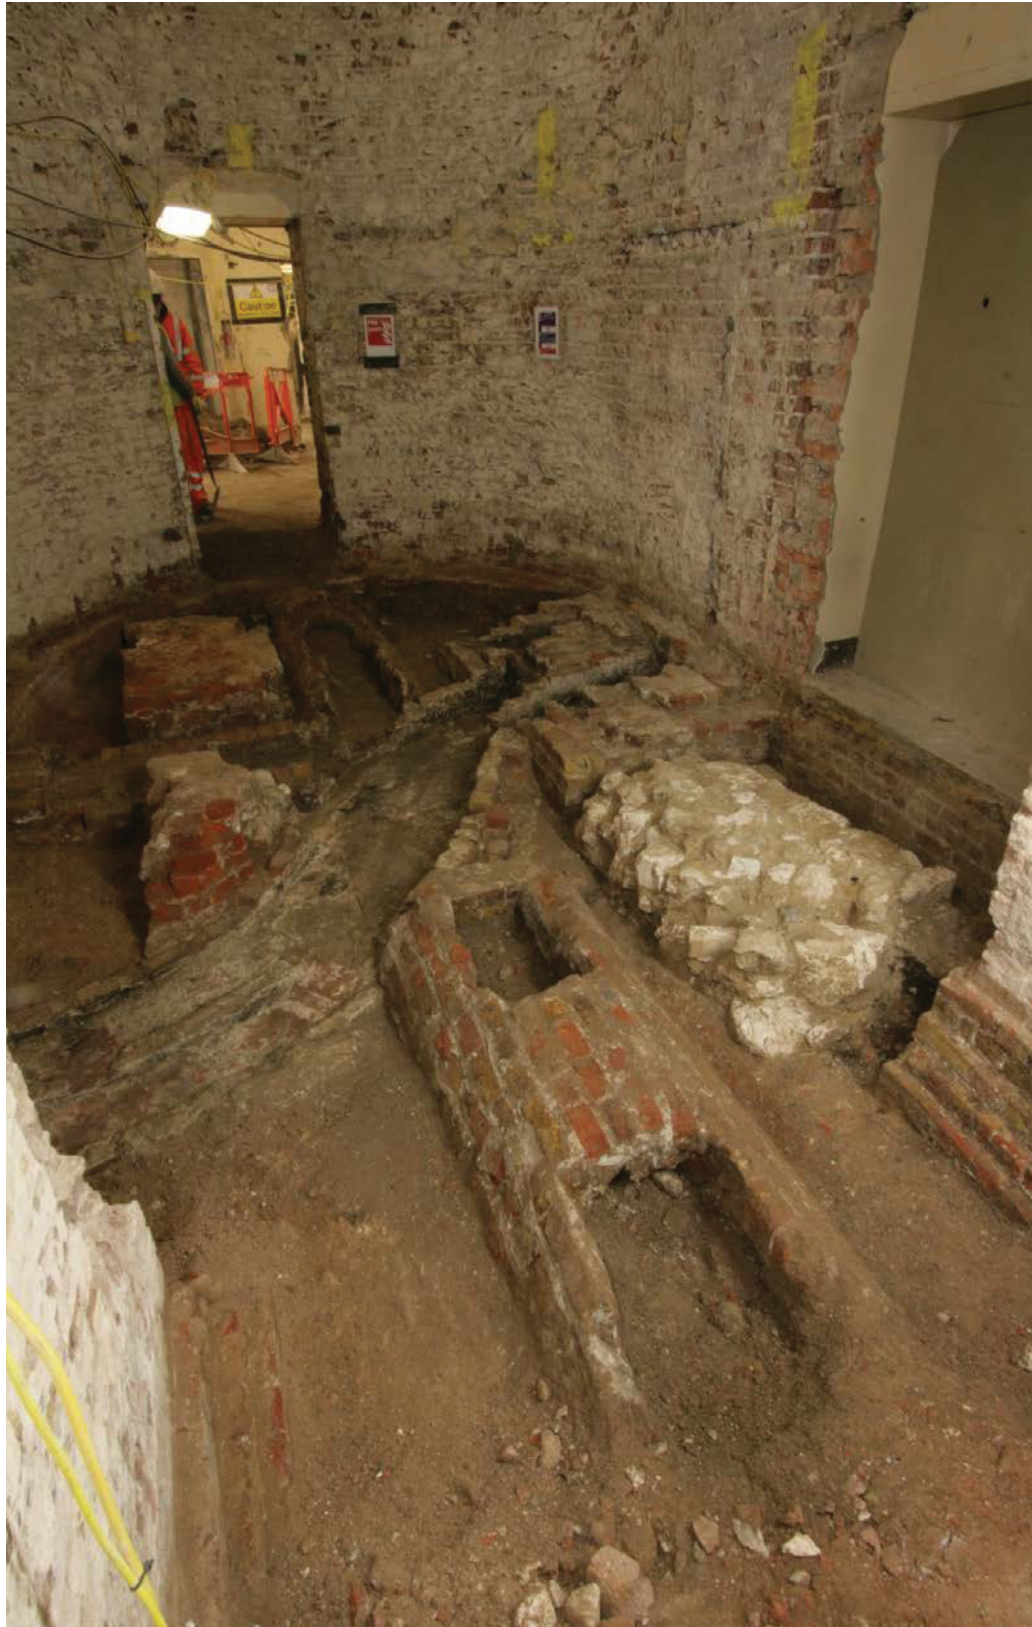
Plate 10: Multi-period activity in Lightwell 1; chalk foundation [191], Tudor brick walls [192] and [193], late 18th-century brick drainage culverts [189] and [190] and 19th-century brick flue structure [198], facing northwest

Plate 11: Multi-period activity in Lightwell 1; chalk foundation [191], Tudor brick walls [192] and [193], late 18th-century brick drainage culverts [189] and [190] and 19th-century brick flue structure [198], facing south

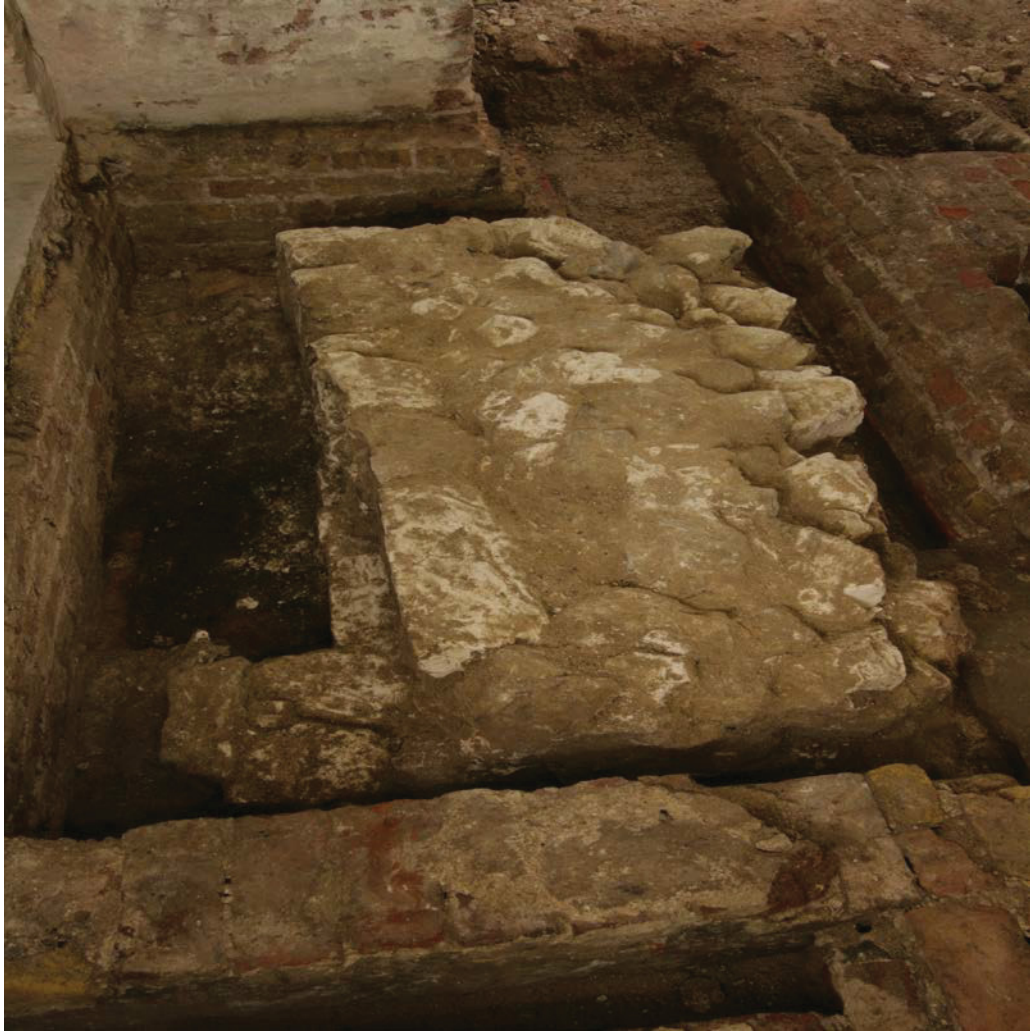
Plate 12: Chalk foundation [191] in Lightwell 1, facing northwest

- 7.4.3 Recorded cutting levelling layers [196] and [191] in Lightwell 1 was a chalk wall foundation [191]. This wall foundation consisted predominantly of roughly hewn chalk and some ragstone blocks. It was aligned northnortheast-southsoutheast, running for c. 1.70m before returning c. 0.40m to the west on a westsouthwest alignment. The western and northern faces of the foundation were observed; whereas all the rest represented disturbed faces, being truncated by later activity. This original western face saw the chalk and ragstone squared off more neatly than the rest of the foundation. Therefore the full original width of this foundation was not recorded. The foundation, located at a highest level of c. 5.87m OD, had a recorded depth of 0.40m but continued below this level. The mortar which bonded the chalk and ragstone in this foundation, a soft brown gravel mortar with numerous flint, chalk and ragstone inclusions (potentially identified as Type 4) suggests a late medieval or early post-medieval date (Appendix 6). However, mortar types can be problematic when used to date structures and cannot be taken as absolute or definitive. The western continuation of this foundation, [70], was recorded in Room B45 directly west of Lightwell 1 (see below).

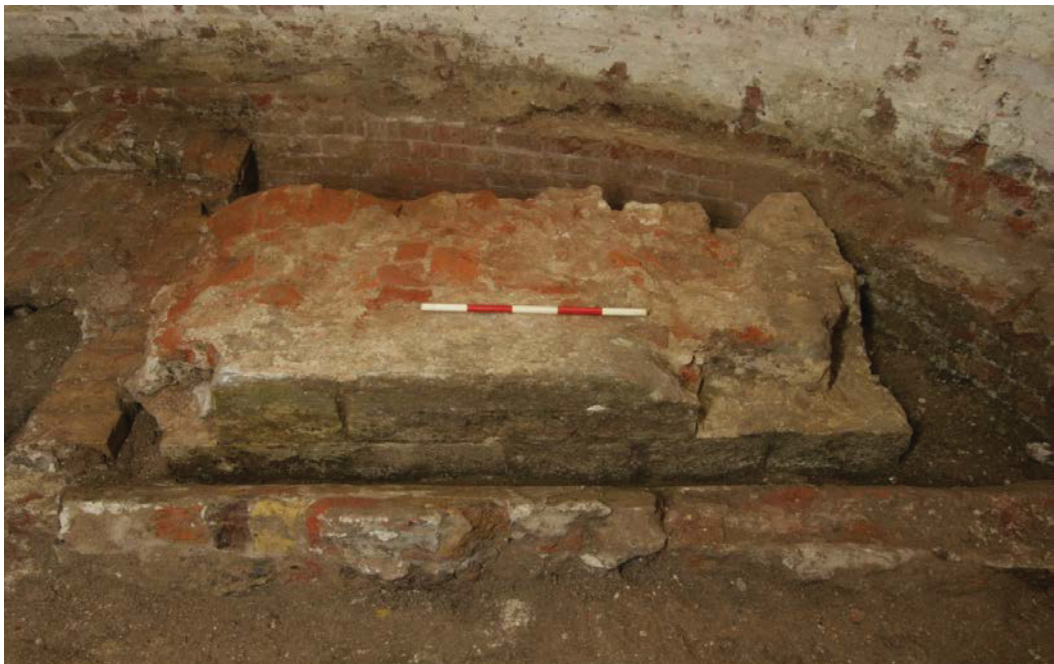
Plate 13: Tudor brick wall [192] with masonry facing in Lightwell 1, facing northeast

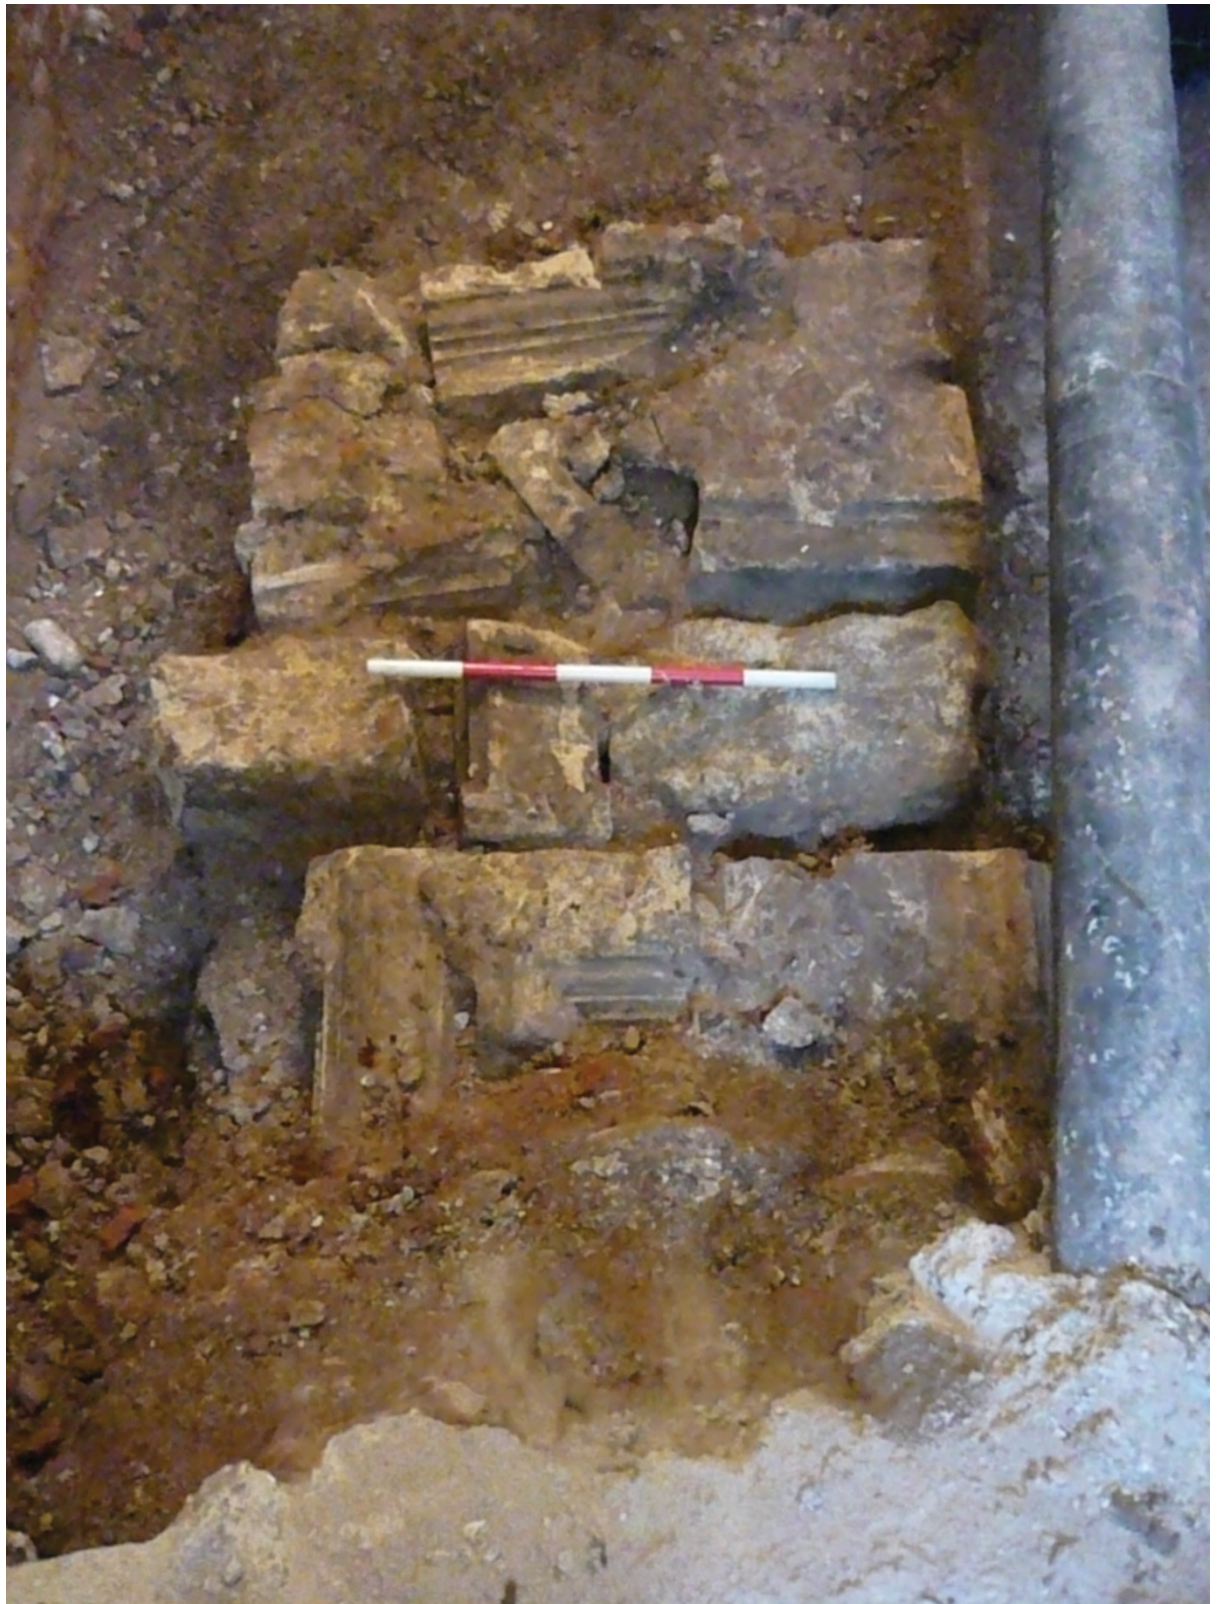
Plate 14: Masonry wall foundation [26] in L1/L2, facing northeast

- 7.6.2 Recorded in the base of Room L1/L2 was a masonry wall foundation [26] upon which sat brick wall [25]. Aligned northeast-southwest through the centre of the room the badly truncated remnants of the wall ran for c. 1.72m and were c. 1m wide. These were not true dimensions however and only represent those surviving and recorded. Masonry rubble foundation [26] was located at 4.34m OD and consisted predominantly of reused mouldings and ashlar blocks of Kentish ragstone, Reigate stone, Corsham stone, Magnesium limestone or Beer stone, Barnack stone and Caen stone. Other stone in this group included an unidentified stone of note with similarities to Dundry stone, Wheatley stone or more likely a French Tertiary or Jurassic limestone. Much like the masonry foundation [173] in Room B60 a large amount of this reused Caen stone represented Tudor style bay window fragments. This included numerous tramline mullions, cornices and window sill fragments. Directly on top of this rubble foundation was a brick wall [25]. Located at c. 4.66m OD and had a surviving height of 0.34m. This brick wall was composed of red Tudor 3033 fabric bricks. The mortar which bonded these bricks was identified as a hard grey-cream mortar, Type 1, which suggests a late 18th-century date (Appendix 6). This seems unlikely however as this brick wall clearly predates the current Somerset House which was built c. 1775. The identification and use of mortar as a dating guide can be problematic however. The presence of re-used Tudor masonry in the foundation suggests a somewhat later date for this wall and may represent rebuilding and alterations which occurred during the 17th century. The wall most likely however represents an external garden wall south of the Tudor Somerset House as illustrated on numerous cartographic sources.
