**THE MARSHALLING YARD, G-GATE
OLYMPIA, HAMMERSMITH ROAD, W14
8UX**

**AN ARCHAEOLOGICAL EVALUATION
SUMMARY REPORT**

SITE CODE: GO112

PCA REPORT NO: R11286

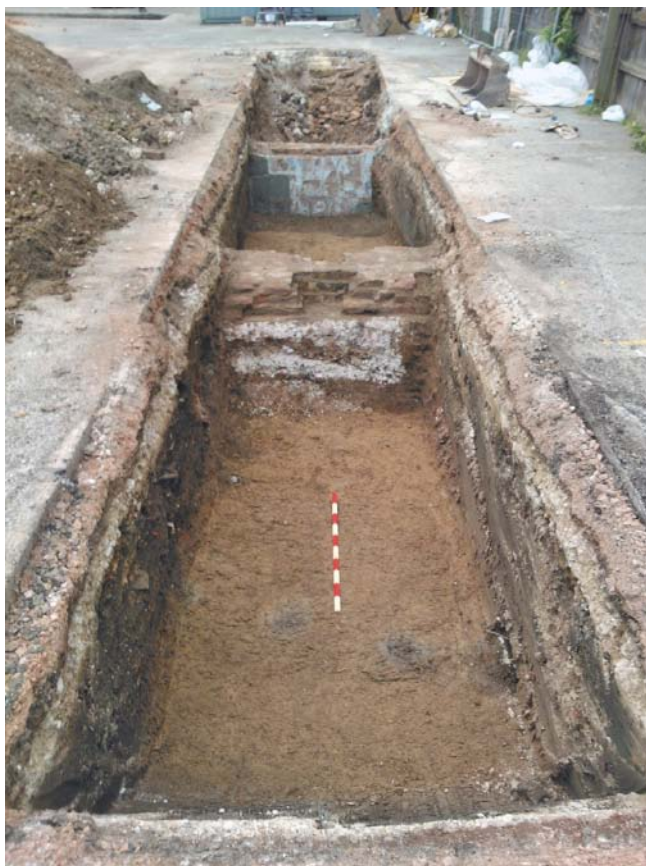
Plate 1; Trench 1, facing south.

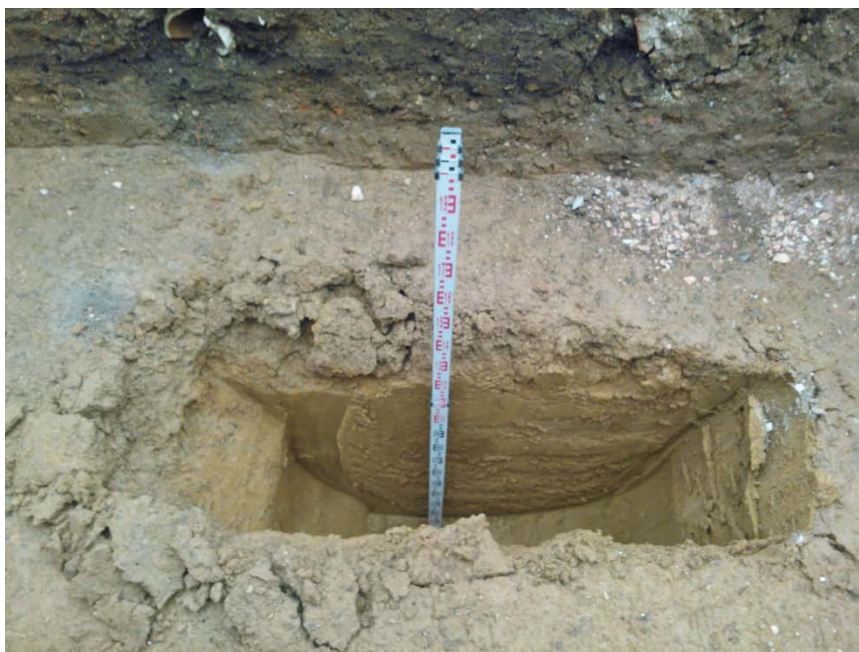
- 2.1.1 The earliest deposit observed comprised of a firm mid yellowish brown silty clay (or natural brickearth) [7]. It was observed at the base of the machined sondage (Plate 2) at the northern end of the trench at 3.68m OD.

Plate 2; Sondage within Trench 1, looking east

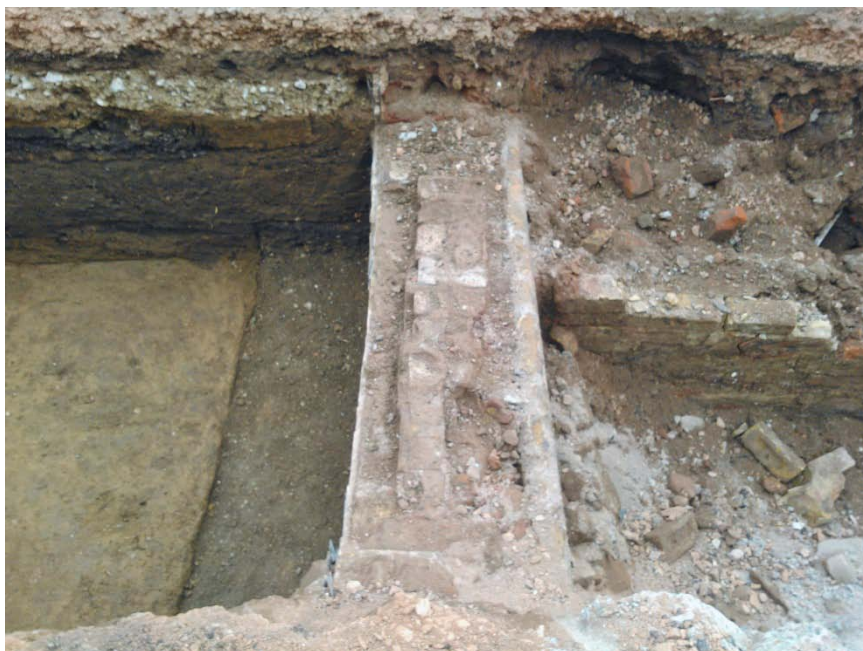
- 2.1.5 Two walls were observed truncating these earlier layers, the northern most of which likely pertains to the early 20th century development that appears on OS Maps in 1921. The southern wall formed the northerly extent of a substantial basement within which lay demolition rubble (Plate 3). This building likely represents the remains of the public house which appeared on site from the mid 19th century.

Plate 3; Northern basement wall of 19th century pub, looking east.

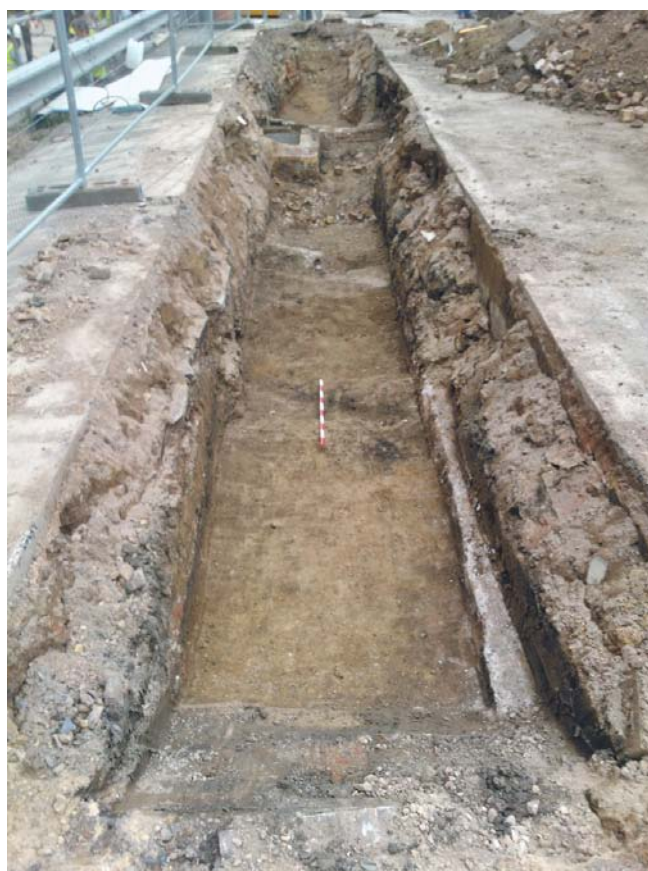
Plate 4; Trench 2 looking south.

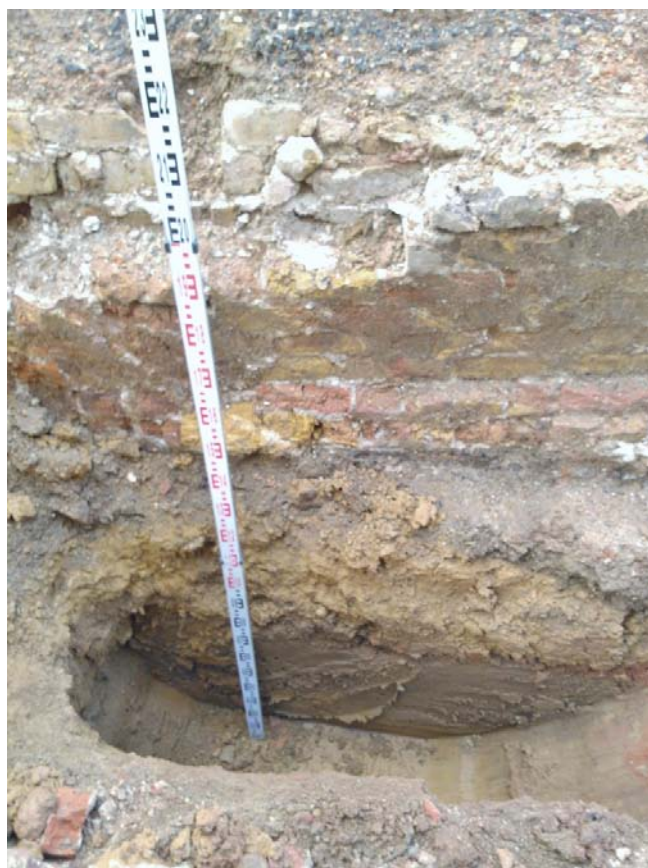
- 2.2.1 Natural brickearth [22] was observed in a machine excavated sondage at the southern end of Trench 2 (Plate 5) at 4.30m OD.
- 2.2.2 Overlying was a 0.55m thick layer of redeposited clayey brickearth [21] at 4.85m OD, which could possibly be the same as layer [6] encountered in Trench 1. A fragment of burnt flint, CBM and clay tobacco pipe stem were recovered from this context.

- 2.2.5 Observed in the western section, adjacent to the late 18th-19th century wall, was a more substantial wall foundation [15] comprised of frogged yellow stock brick bonded with cement mortar (can be seen in Plate 5). It measured 3.40m in length by 0.30m in width into the LOE. It is likely this represents the eastern edge of the 19th century bank shown on historic maps.

Plate 5; Sondage in south of Trench 2

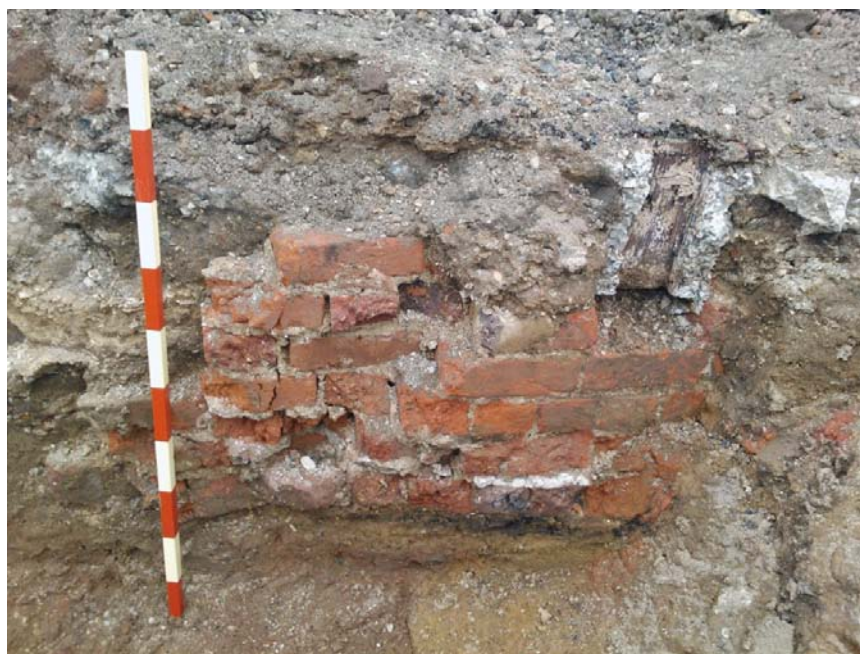
- 2.2.3 Sealing this was a layer of reworked brickearth resembling context [5] in Trench 1. It was 0.40m thick and was observed at 5.25m OD.
- 2.2.4 Truncating this layer was the construction cut [16] for a late 18th – early 19th century wall foundation [1]. It extended for 1.40m in a NW-SE direction and beyond the LOE of the trench. Its primary fill [19] comprised of a dump of broken peg tile and mid yellowish brown sandy silt [19] and was recorded at 4.89m OD. The foundation itself [1] was constructed from unfrogged orange/red fabric brick bonded with a friable mid yellowish brown lime mortar in English style (Plate 6). It appeared to be one course thick and as such possibly represents a property boundary. Some evidence for later repointing was observed towards the base. It was observed, primarily in section, at 6.09m OD.

Plate 6; Late 18th – early 19th century wall as seen in west facing section.

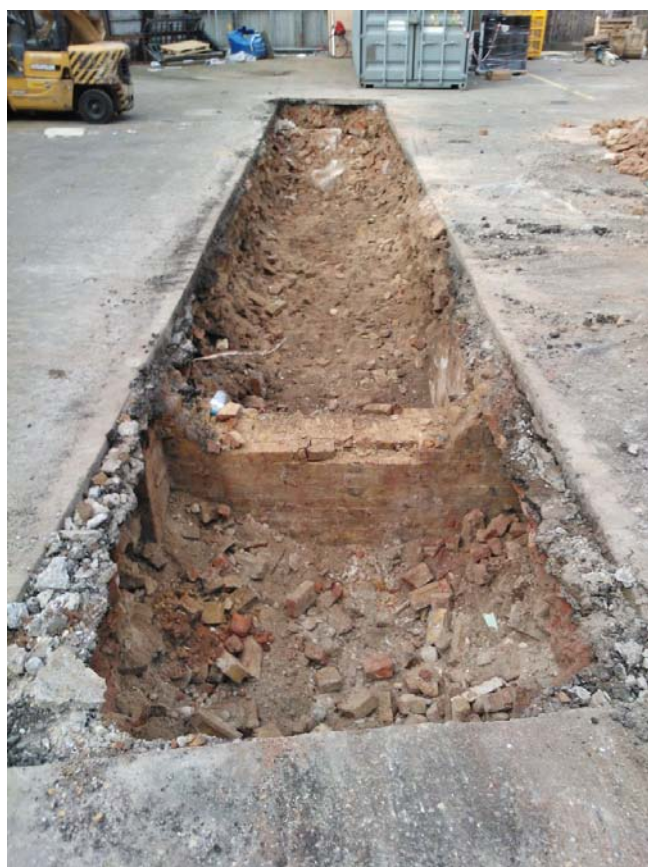
2.3.1 As suggested from the historic OS maps contained in the desktop assessment, Trench 3 lay within the footprint of the 19th century pub and bank buildings and as such a high degree of truncation was encountered.

Plate 7; Trench 3 looking west.

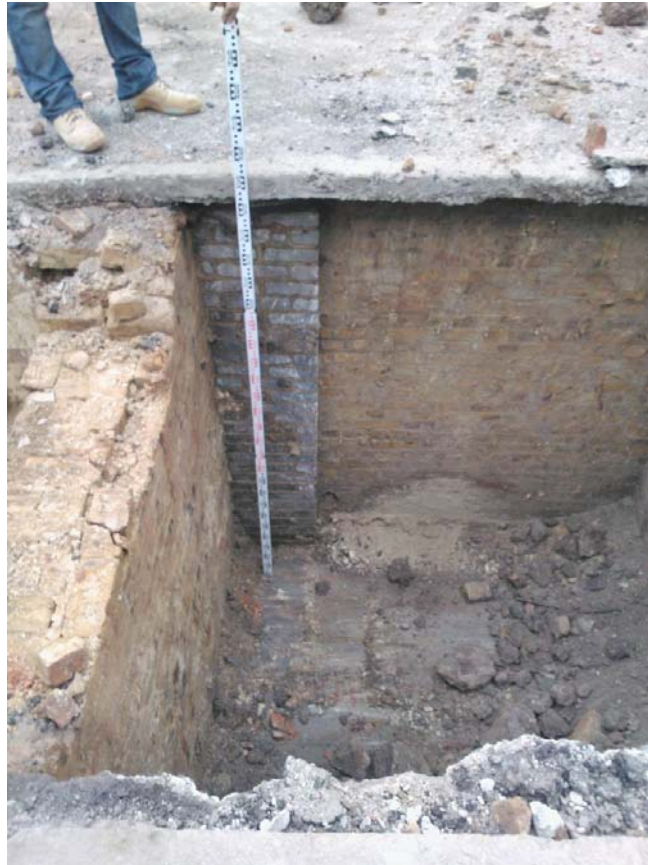
2.3.2 No natural brickearth was observed in the trench. Instead the basements of the aforementioned 19th century structures extended to 2.55m below current ground level, whereupon a slab of unknown thickness was encountered. The slab was recorded at a height of 3.60m OD, and was not broken out. A 0.50m thick wall [18] was observed running north-south towards the eastern end of the trench (Plate 8), which likely represents the internal dividing wall between the bank and the pub. It was constructed from frogged, yellow stock brick and bonded with cement mortar. The western side (within the pub cellar) was rendered with plaster. This was overlaid by a 2.35m layer of demolition rubble [17].

Plate 8; Sondage at east end of Trench 3 revealing basement slab.
