**UNIVERSITY OF READING**  
**BRIDGES HALL**  
**WHITEKNIGHTS ROAD**  
**EARLEY READING**  
**BERKSHIRE**

**ARCHAEOLOGICAL**  
**EVALUATION REPORT**

**SITE CODE: BHR12**  
**REPORT NO: R11299**

**SEPTEMBER 2012**

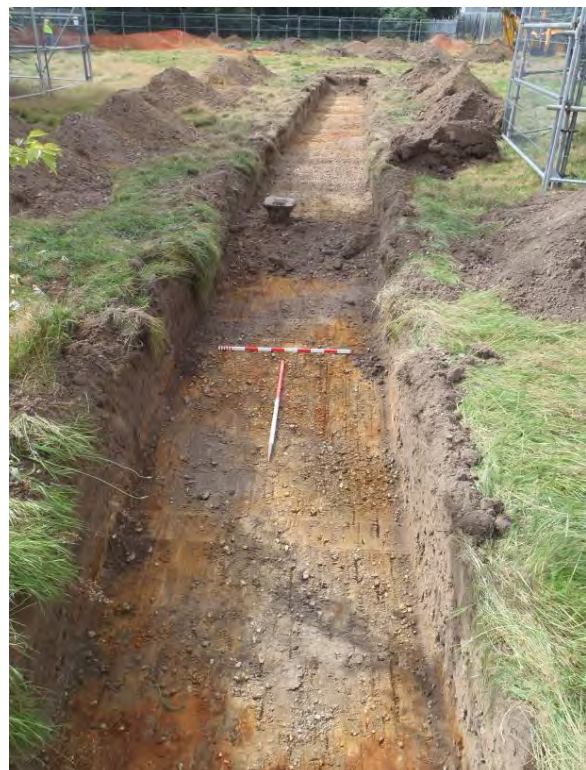
**Plate 3: Trench 1: view looking south**

5.5.1 Modern services and features were identified within Trenches 1, 3, 4, 5, 6, 7, 9, and 11. The modern services revealed comprised of plastic ducting containing fibre optic cables, ceramic pipes either for water or electric cables and a former water monitoring well within Trench 1 (**Plate 3**).

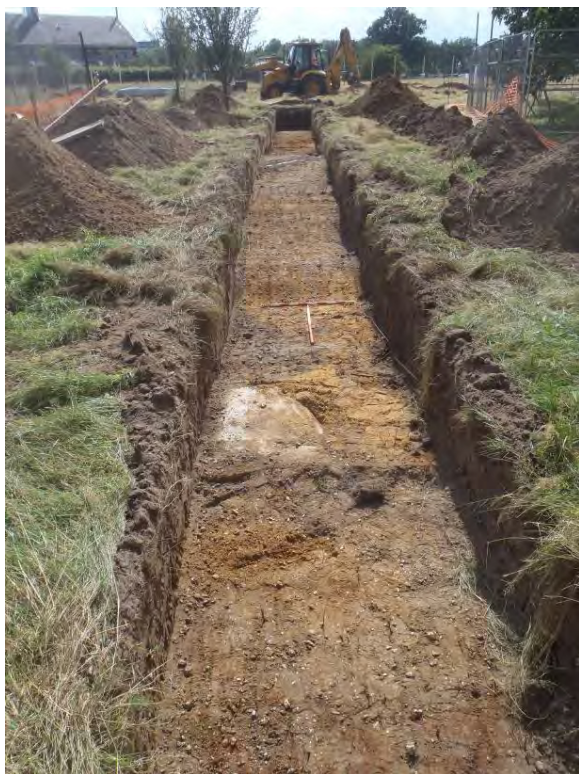
**Plate 4: Trench 3 – view looking south west**

5.5.2 At the north-west end of Trench 3 a square piece of concrete was revealed (**Plate 4**) that is likely to be part of a crane base that was used at the time of the construction of Bridges Hall in the 1960s.

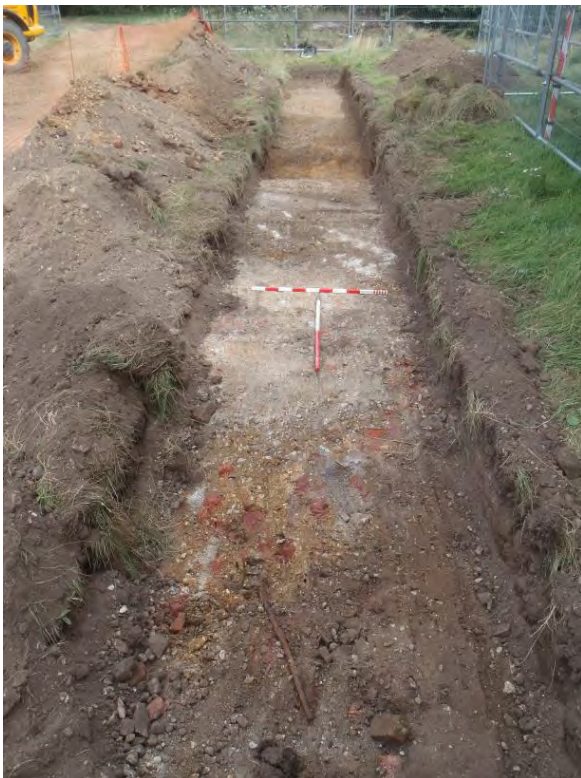
**Plate 8: Trench 9 – view looking north east**

5.5.3 Within Trench 9 a substantial amount of building rubble was revealed from the construction of Bridges Hall (**Plate 8**) that was shown to contain fragments of asbestos resulting in the curtailment of the excavation of this trench.

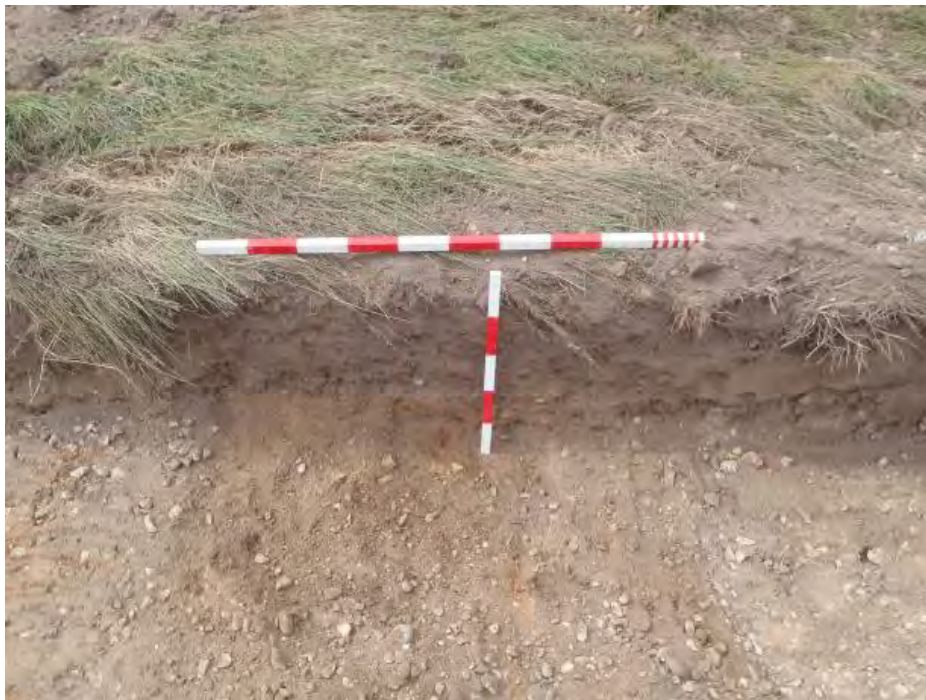
**Plate 16: Trench 4 – view looking south west of representative section**

5.2.1 The general soil profile revealed across the site showed a natural geology of a moderate to firmly compacted reddish – brown sand and gravel. This was overlain by a subsoil of up to 0.25m in depth comprised of a moderate to firmly compacted mid- grey brown sandy silt with occasional small to large pebbles. The subsoil was overlain by a topsoil and turfline up to 0.25m deep and comprised of a moderately compacted mid grey brown sandy silty loam (**Plates 16 and 17**).

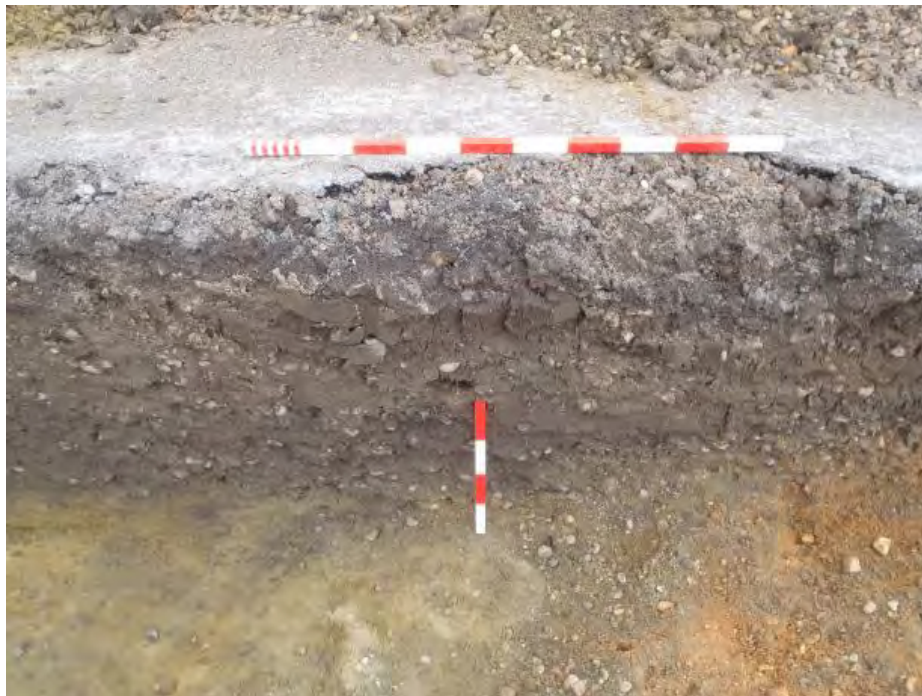
**Plate 18: Trench 13 – view looking east of representative section**

5.2.2 The only exception to the general soil profile was in Trench 13, which was located within a former tennis court. The soil profile within Trench 13 comprised of a natural mid-grey sand (**1305**) overlain by the natural sand and gravel (**1304**), which underlay up to 0.40m of made ground comprised of a dark brown grey silty sand (**1303**), which acted as a base for a

0.10m thick layer of sand and gravel hardcore (**1302**) on which had been lain the 0.10m thick asphalt surface (**1301**) of the tennis court (**Plate 18**).

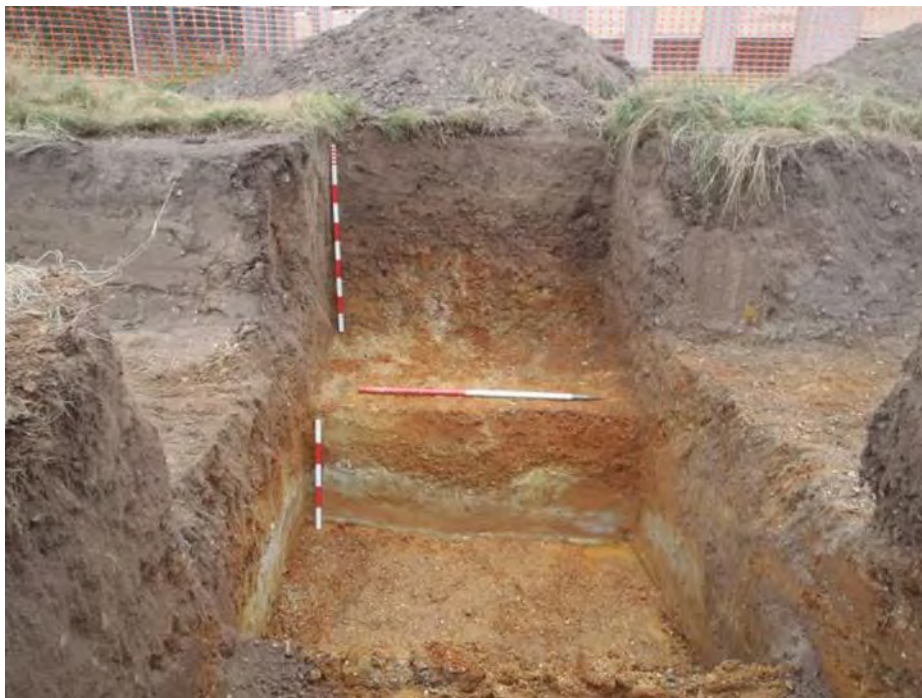
**Plate 19: Trench 3: view looking north west of section in lift pit – Block D**

5.3.1 A 4.75m by 1.80m by 1.80m deep test pit was excavated in the proposed location of a lift pit within Trench 3. The excavated depth of 1.80m represented the maximum depth of impact of the proposed lift pit.

5.3.2 The section revealed within the lift pit (**Plate 19** and **Section 1**) was excavated to the top of a firmly compacted mid reddish brown sand and gravel (**305**) at a height of 64.28m aOD. This was overlain by an up to 0.32m thick layer of a moderately compacted light blue grey to mid reddish brown mottled sand natural (**304**). Overlying layer **304** was up to 1.05m of a firmly compacted mid reddish brown sand and gravel (**303**) that along with the subsoil (**302**) and topsoil (**301**) was observed in all of the excavated trenches.

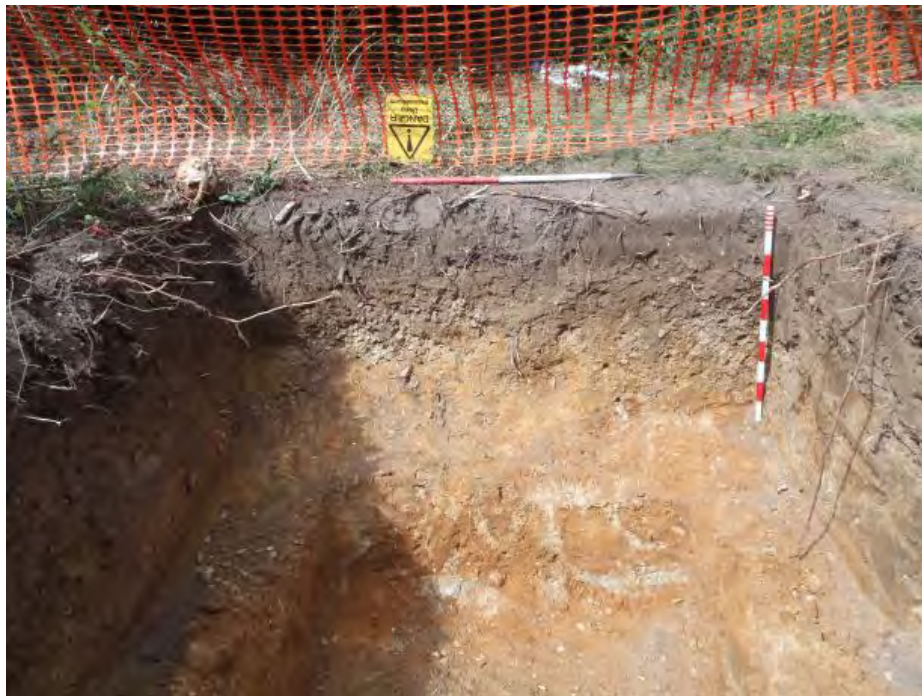
**Plate 20: Trench 16 – view looking north west of section in lift pit – Block A**

5.4.1 Excavation to depth of 1.70m (63.98m aOD) was undertaken within Trench 16 and represented the maximum depth of impact of a proposed lift pit measuring 3.0m by 2.6m in size.

5.4.2 The excavated section (**Plate 20** and **Section 2**) revealed up to 1m of firmly compacted reddish – brown sand and gravel natural (**1603**) although the deposit appeared to show some signs of disturbance and being well sorted (QUEST *pers. comm.*). The sand and gravel was overlain by up to 0.35m of mid-brown sandy silt subsoil (**1602**), which underlay the 0.35m deep topsoil (**1601**) that had been disturbed by tree and shrub roots.
