**POETS' CORNER YARD,  
WESTMINSTER ABBEY**

**AN ARCHAEOLOGICAL  
EVALUATION**

**PCA REPORT NO: R11323**

**NOVEMBER 2012**

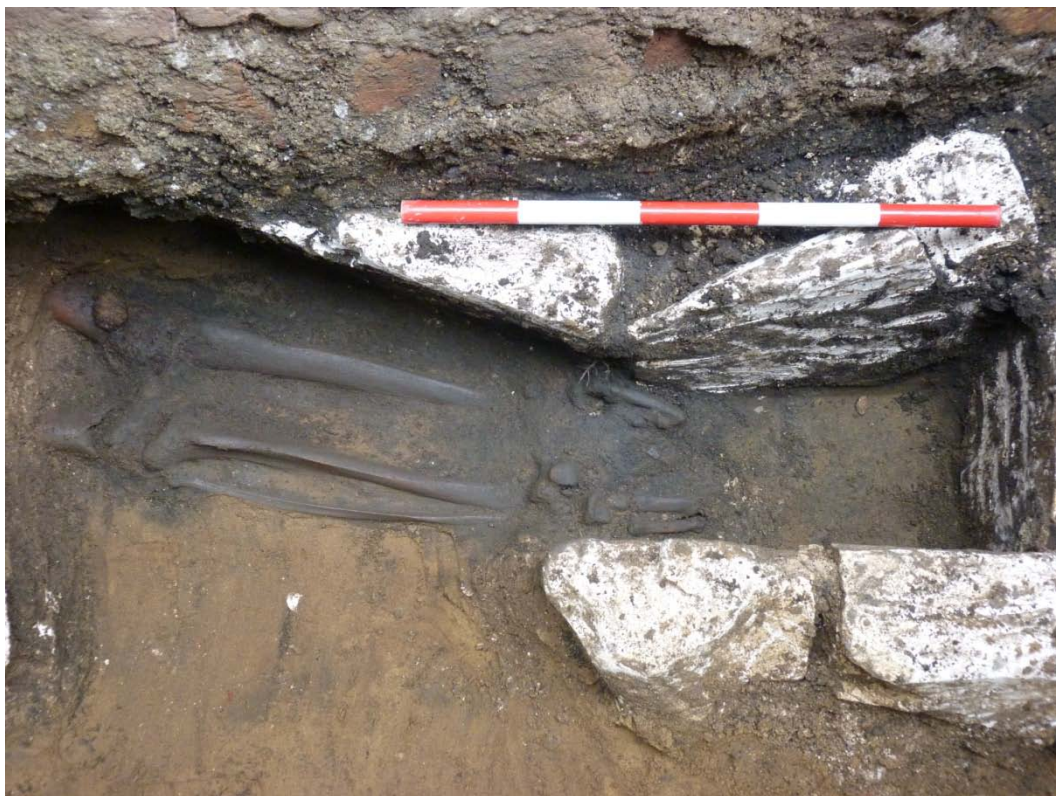
*Plate 1: Cist Tomb [62] with Skeleton [64], View to North*

below). Filling the grave cut was a deposit of loosely compacted light brown mottled sandy silt and lime mortar, [56], with occasional chalk flecks and burnt clay inclusions as well as very occasional sub-angular pebbles.

4.3.2 Sealing the chalk blocks of the cist tomb, and extending across the entire trench, was a circa 0.29m thick layer of cemetery soil comprising very dark brown, organic sandy silt [55], first observed at 4.35m OD. In addition to a relatively high quantity of Roman ceramic building material and opus signinum (AD 50-250) excavation of the layer also yielded a few sherds of pottery dated to the 11th to early-mid 12th century as well as a high amount of disarticulated human bone.

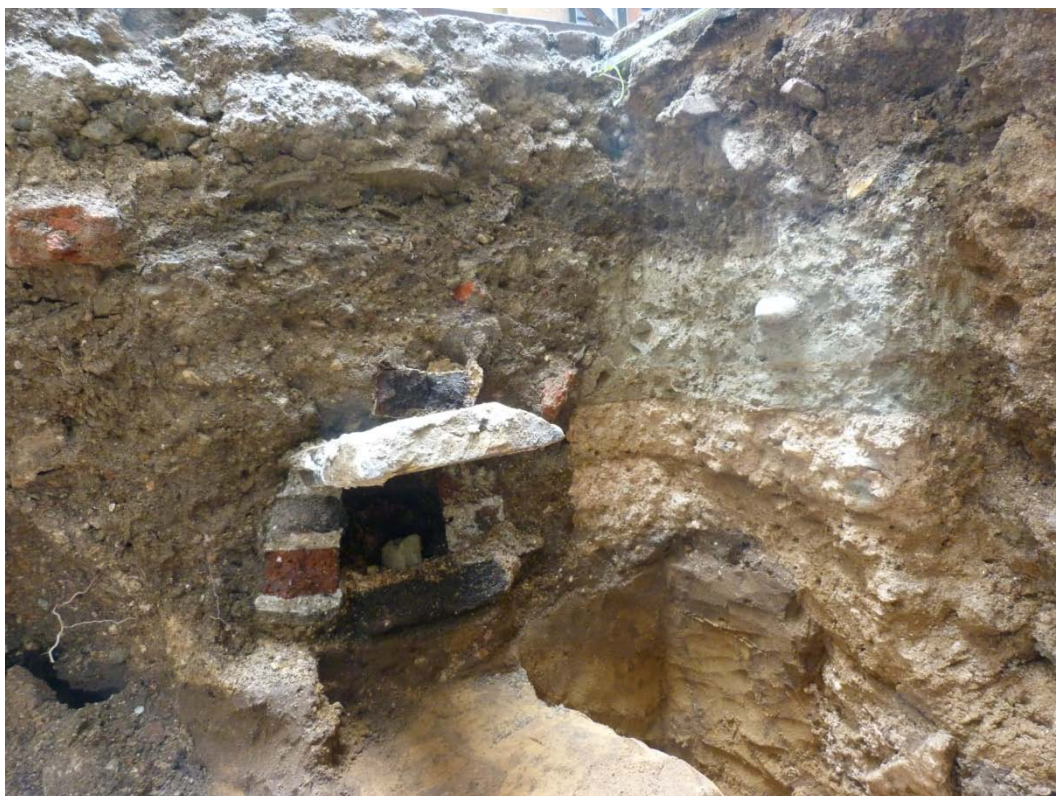
*Plate 2: Brick Drain [10] in Trench 1, View to Northeast*

- 4.7.2 The drain itself [10] had been constructed with pinkish purple fabric bricks laid in two parallel stretcher bonded lines two courses high and spaced 0.15m apart. Both the base and cap comprised broken York stone slabs measuring on average 320mm x 230mm x 50mm while the bricks used measured 220mm x 100mm x 65mm and were set in a moderately soft light grey sandy lime mortar. The drain had been truncated to the south and to the north the drain extended beyond the limits of the trench; as exposed it measured 0.48m north-south by 0.40m east-west by 0.28m high. On the top of the stone cap the highest point was at 4.44m OD. The bricks date between the 18th century and the early- to mid-19th century. Filling the construction cut for the drain was a relatively compact deposit of greyish brown clayey silt [9] with occasional ceramic building material flecks and small angular Reigate stone chips. Pottery and glass recovered during the excavation of the fill dated the feature to the 19th century.

- 4.7.3 Filling the interior of the drain was a deposit of very loose dark greyish brown silty sand, [12]. Excavation of this deposit yielded no datable material.

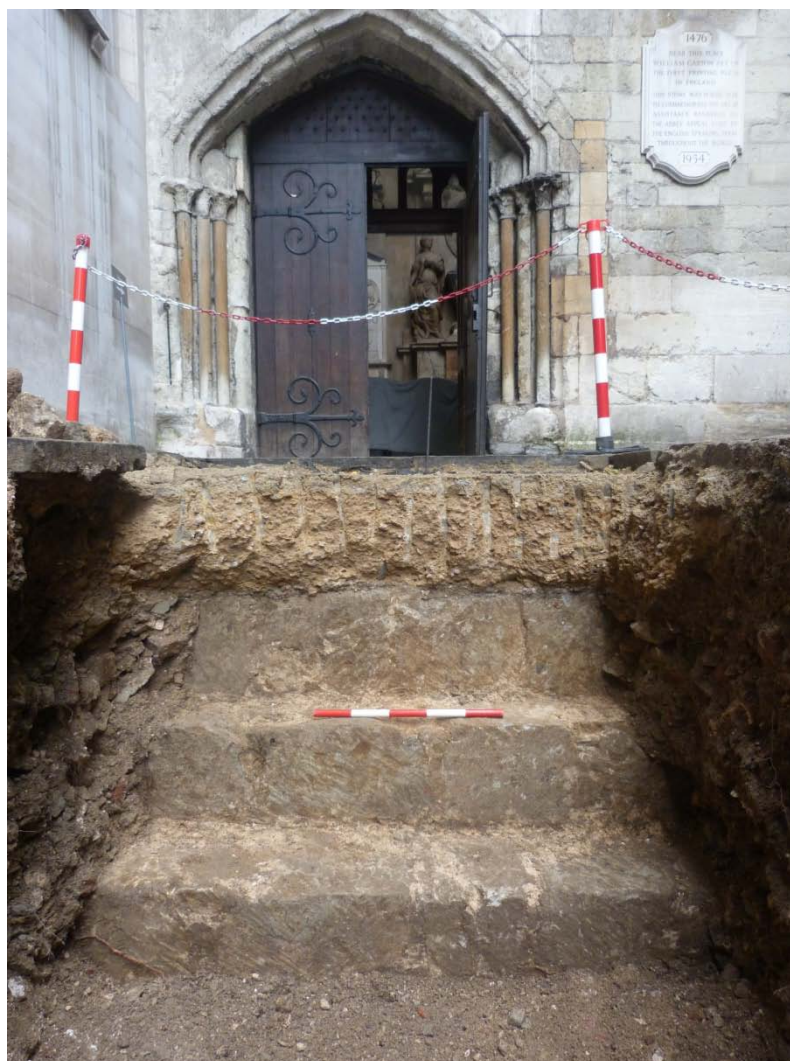
Plate 3: Stepped Footing [8] for South Transept, View to West

- 1.3 The footing for the south transept was recorded in Trench 1 and was seen to consist of a stepped retaining wall of Reigate stone blocks. This was consistent with the footing for the north transept as seen during an excavation in the north green in 2009. The 'basin' formed by this Reigate stone wall had been filled with lime concrete in order to form a solid raft to support the church and buttresses.
