**THE BLUE LION, 2  
HORNINGSEA ROAD, FEN  
DITTON, CB5 8SZ**

**ARCHAEOLOGICAL TRIAL  
TRENCH EVALUATION**

**ARCHAEOLOGICAL EVALUATION AT THE BLUE LION, 2  
HORNINGSEA ROAD, FEN DITTON, CAMBRIDGESHIRE**

**Site Code: CHFD12**

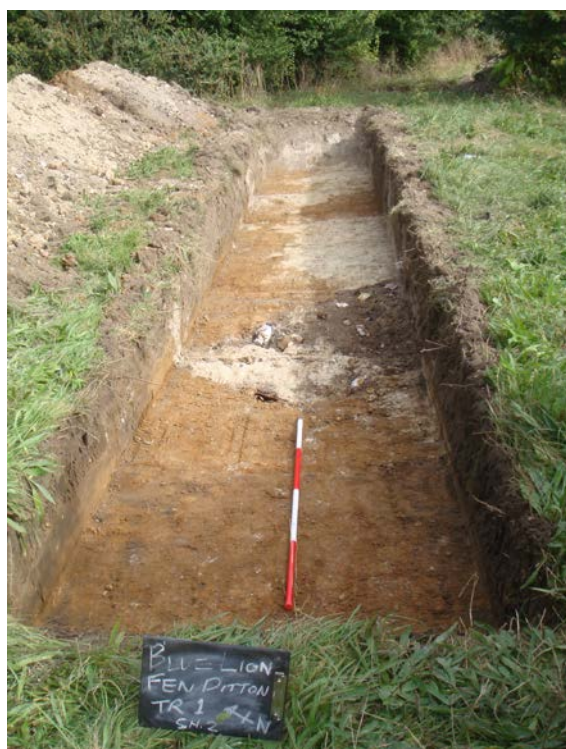
- 3.8 Cutting into the garden/cultivation soil (20) in Trench 1 was a rubbish pit or backfilled test pit [17], which contained modern rubbish including Coca Cola cans. Despite the deep overburden, which would have afforded some protection to any underlying archaeology, no earlier archaeological features were present in this area.

PLATE1: Trench 1, view north-east towards modern Pit [17]

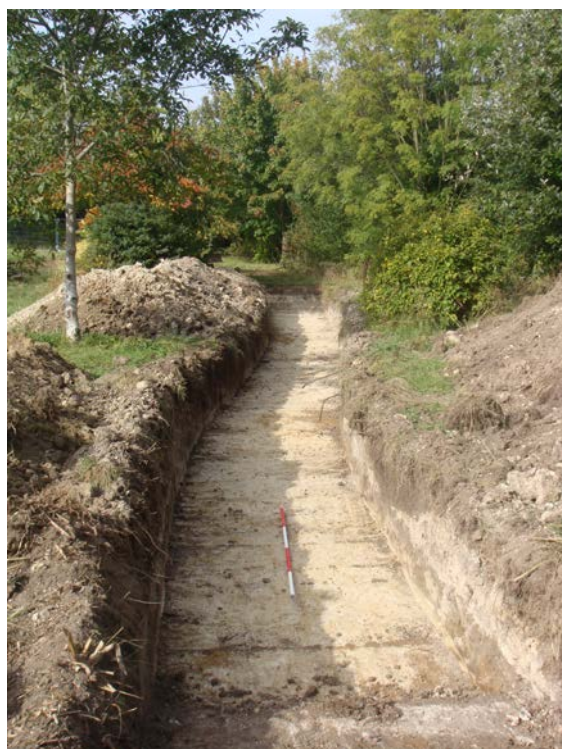
PLATE 2: Trench 2, view north-west

directly overlay the subsoil in Trench 1, whilst the features in Trench 5 were sealed by a made ground rubble layer [33], 0.40-0.60m deep. The deposits overlying the subsoil were particularly deep towards the north-east end of Trench 1 and north-west end of Trench 2, where 0.30m of made ground (8), comprising mixed redeposited natural chalk and brick/ concrete rubble, underlay the topsoil. This deposit appeared to relate to the breaking-up of an earlier car park or area of hard-standing.

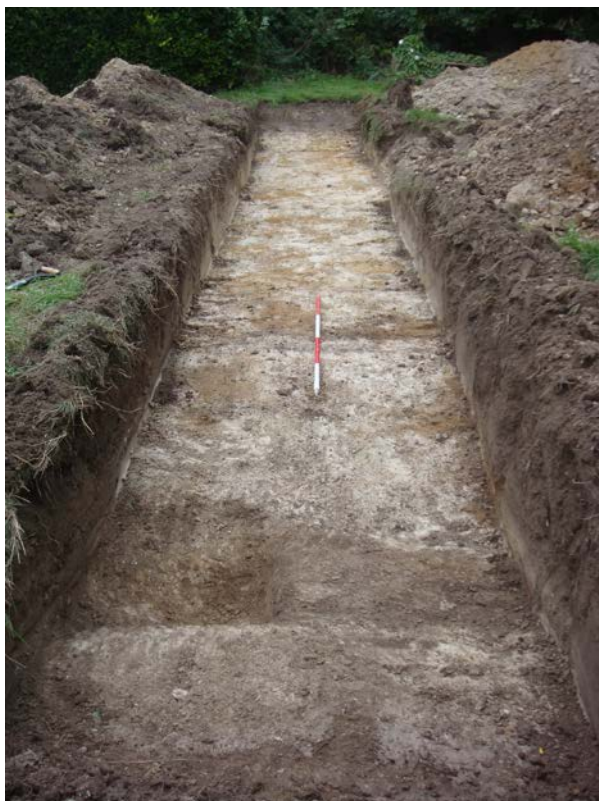
- 3.5 A narrow, shallow, irregular gully [22] was cut through the subsoil at the west end of Trench 3. Its fill (23) contained degraded brick fragments and two pieces of glazed post-medieval pottery and may have been either a drainage ditch or, given its irregular base, part of a tree hollow. Trench 5, located in the narrow space between the standing pub buildings and the western site boundary, contained two small shallow pits, [13] and [15], and a ditch, [11], all of which had similar dark brown-grey silty clay fills devoid of finds. Ditch [11] was cut through the subsoil but elsewhere in the trench this deposit had been completely removed so that the two pits could only be seen cutting the natural geology. The composition of these features' fills, and the stratigraphic position of [11], might suggest a similar date to post-medieval ditch [22] in Trench 3.

PLATE 3: Trench 3, view south-east with post-medieval ditch [22] in foreground

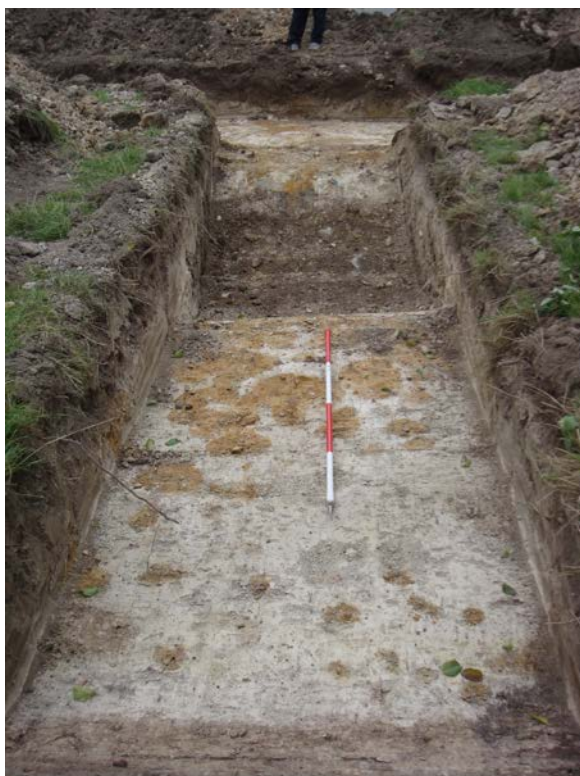
- 3.3 Probably the earliest feature recorded cutting through the subsoil, though the exact level from which it was cut had been masked by extensive recent disturbance, was a large (3.10m wide), linear feature [21] crossing Trench 4 on a north-west to south-east alignment, the positioning and course of which matched a projected line of the Fleam Dyke. Due to the large size of the feature, its considerable depth (cut c. 1.8m into the natural chalk), very steep sides, and the nature of its fills (see below), it was excavated by machine under close archaeological supervision. This ditch had been deliberately backfilled with deep deposits of building rubble, including brick, concrete, gravel and at least eight concrete kerb stones from the breaking-up of a road or car-park, (25) and (26), followed by capping layers of compacted redeposited natural chalk, (27) and (28), apparently dumped in a single event. It seems likely that the ditch of the Fleam Dyke did originally run through the site but was deliberately scoured-out and backfilled with hardcore during the construction of the pub in the 1950s/60s or during

subsequent landscaping of the car park and garden area, in order to stabilise an area of soft ground.

PLATE 4: Trench 4, view north-east towards ditch [21], mid-excavation

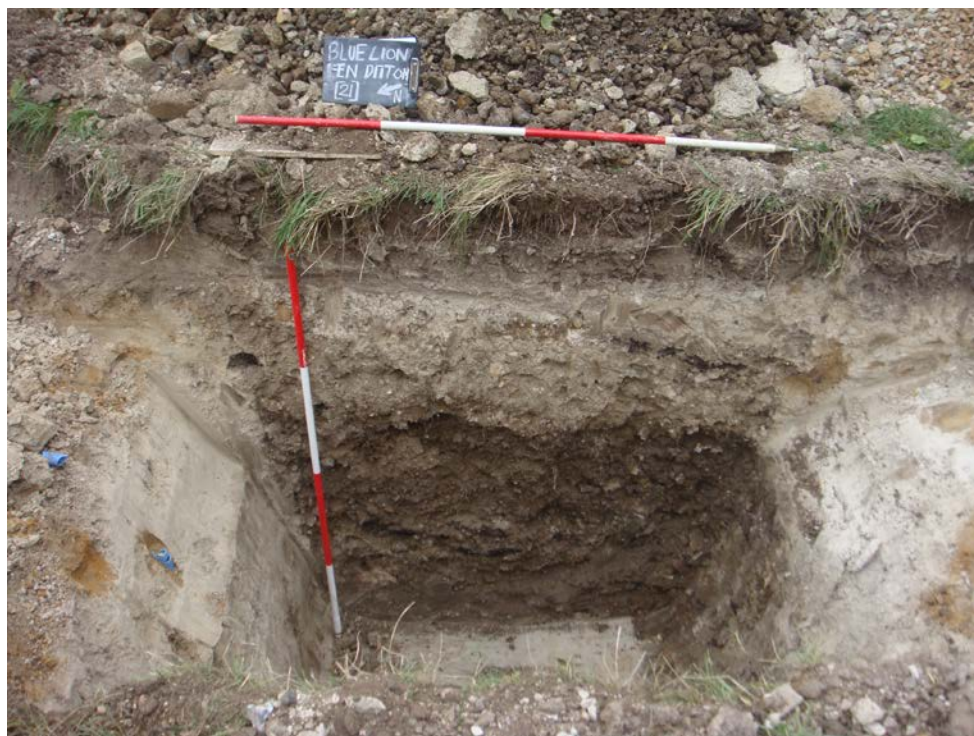
- 3.4 Although the unsafe depth of the ditch ruled out manual excavation of its lower fills, the mechanical excavator was able to remove the fill in gradual spits under supervision and there was no sign of any earlier deposits (relating to the original ditch lining or silting) surviving in this location. Deposit (28), which infilled the top of the ditch on its southern side, had an unusual profile and was initially thought to be the remains of a bank. However, it contained lenses of asphalt and was therefore shown to be another modern capping deposit, its unusual profile probably relating to being pushed in this direction by machine when the ditch was being filled-in. It is unclear whether the ditch continued further north-west across the site as Trench 5, which was also positioned to attempt to pick up the line of the Dyke, had to be shifted southwards from its proposed position to avoid a live service.

- 3.7 The sequence of overlying deposits above the infilled ditch in Trench 4 included several chalk levelling layers; (32) and (29), suggesting that the ground in this area remained prone to slumping even after the ditch was filled in. In Trench 6 the subsoil was overlain by 0.70m of made ground and rubble levelling deposits (35) and (34).

PLATE 5: Trench 4, ditch [21], north-west-facing section (2m scale)

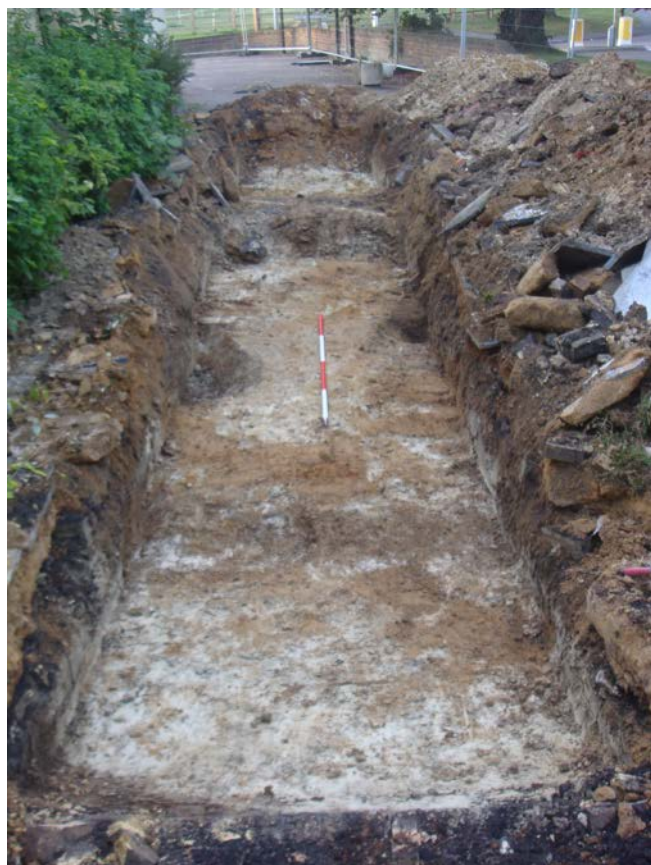
- 4.1 Areas in the south and west of the site appear to have been heavily-disturbed during the construction of the public house and car parking areas. Two shallow pits and a ditch were present below modern made ground in Trench 5, to the west of the pub building, none of which contained any finds.

PLATE 6: Trench 5, view south showing (from front to rear) undated ditch [11], pit [13] and pit [15]

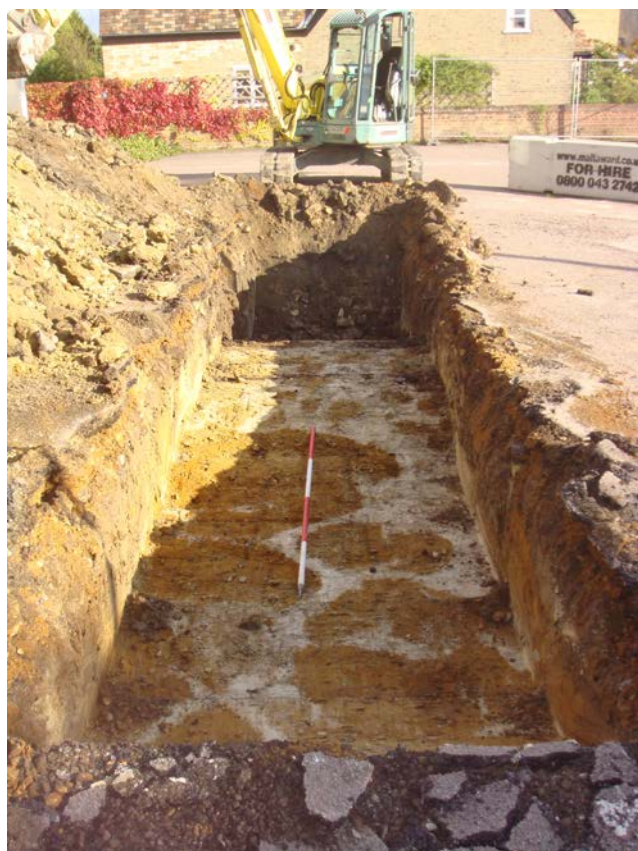
- 3.9 The stratigraphic sequence In Trenches 1, 2, 3 and 4 was completed by a thin layer of modern topsoil (7). The subsurface deposits in Trenches 5 and 6 had been heavily-disturbed during the construction of the pub and car park and were largely of recent date, though the stratigraphic sequence in Trench 5 was completed by a surface layer of paving slabs.

PLATE 7: Trench 6, view south-east towards collapsed modern brick soakaway/ drain
